Inspection Photos
Location Name: Silverback 36-A PAD
Location ID: 443555

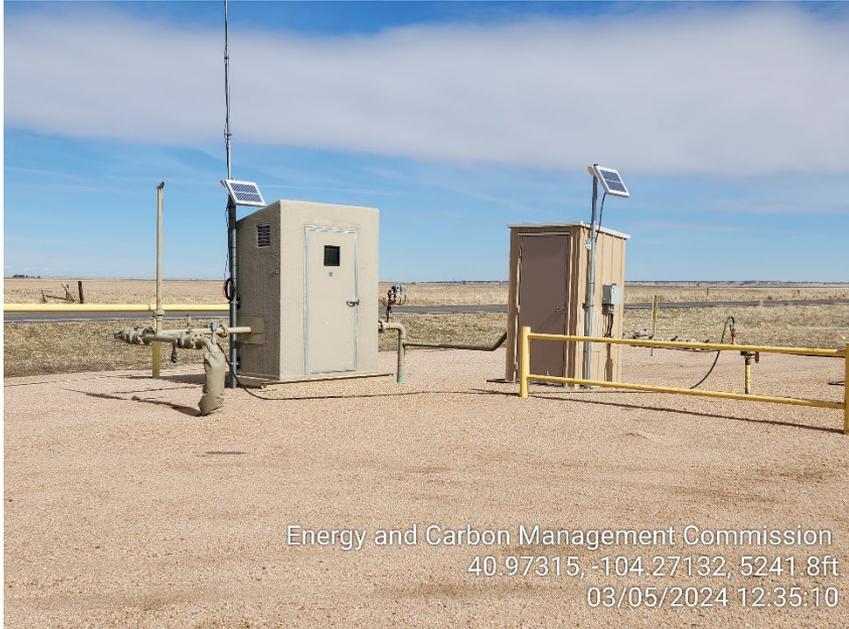
Photo 1 – Gas Meter House

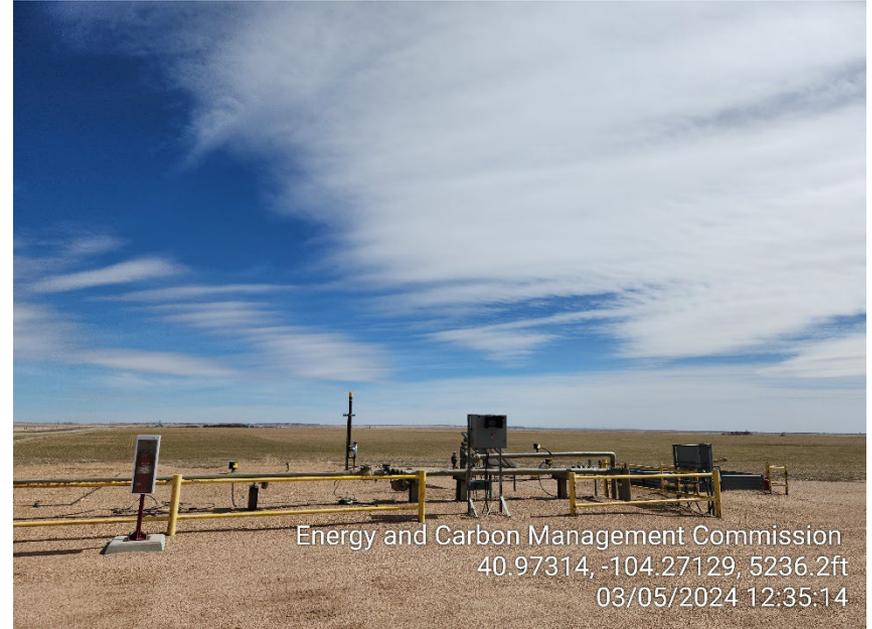
Photo 2 – Equipment

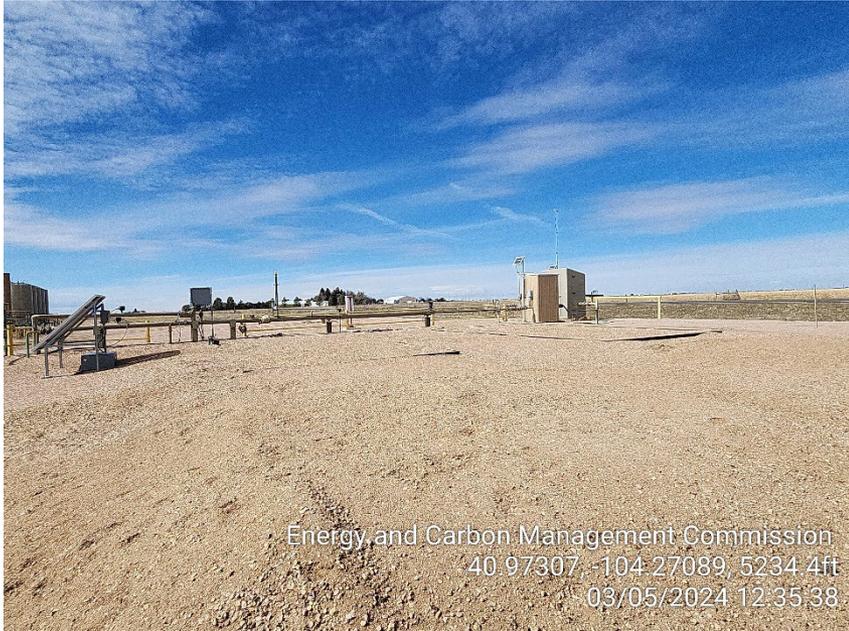
Photo 3 – Day Tanks removed from Location

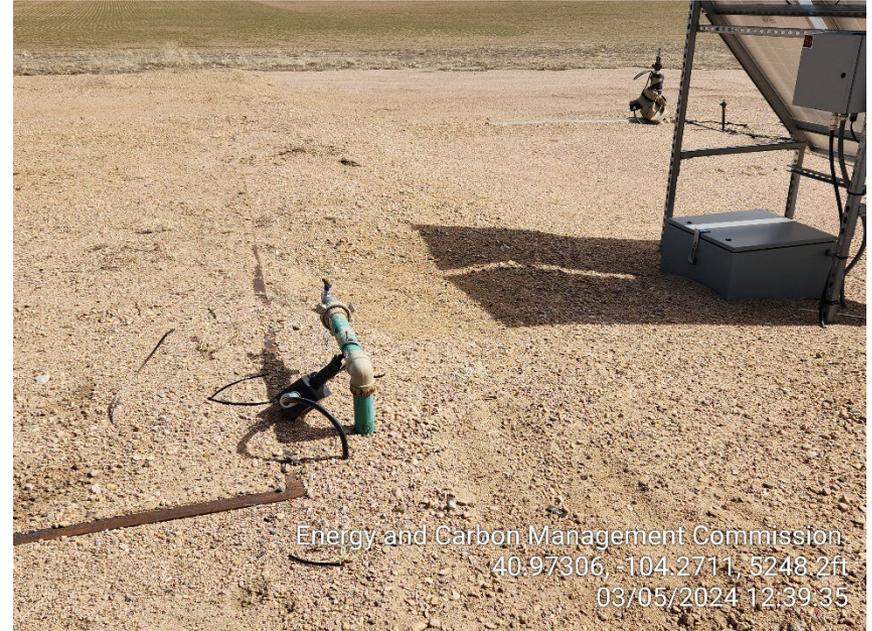
Photo 4 – Unmarked Riser

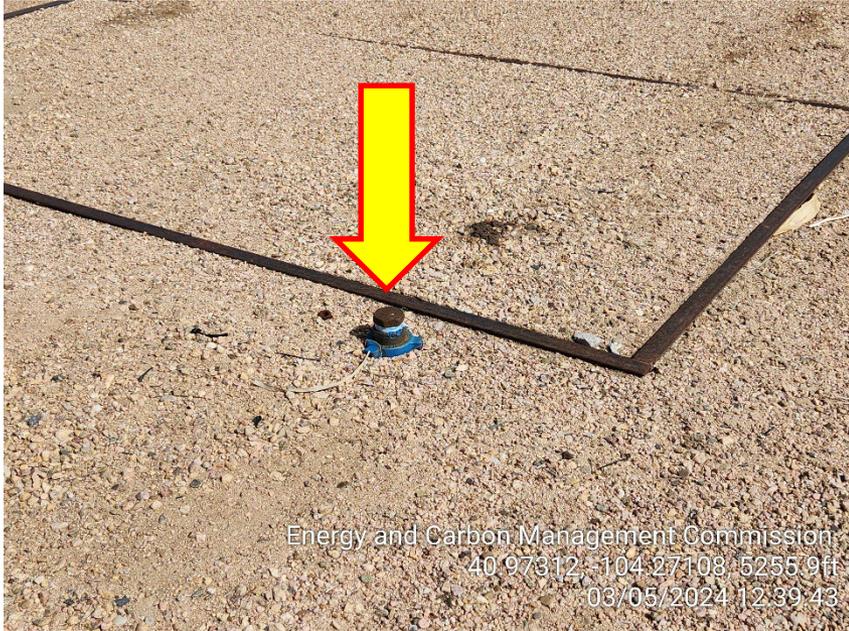
Photo 5 – Unmarked Riser

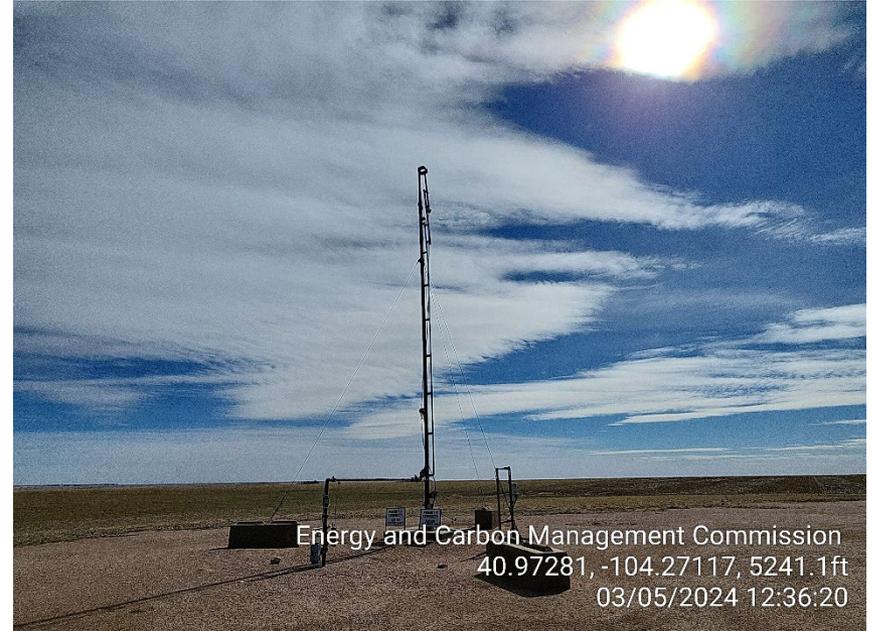
Photo 6 – Flare

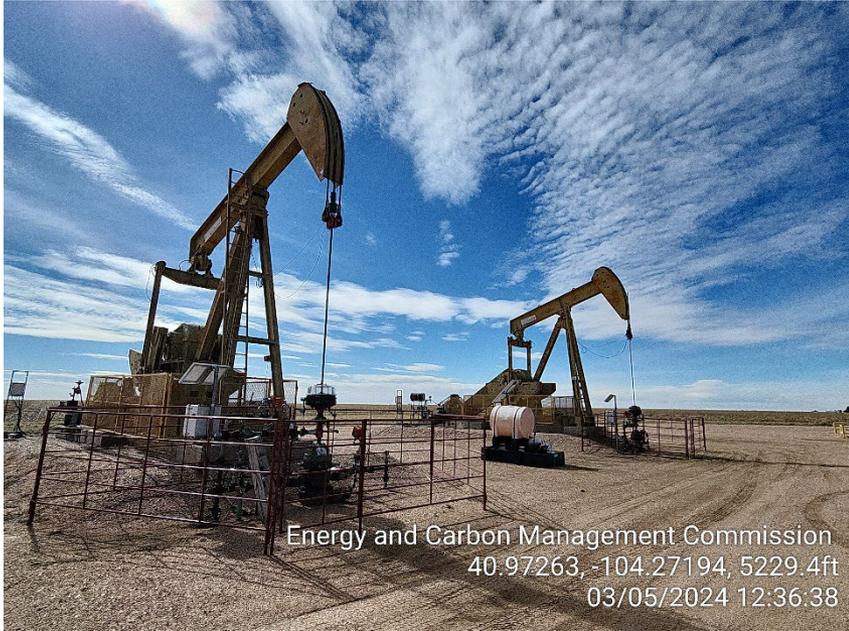
Photo 7 – Pumping Unit

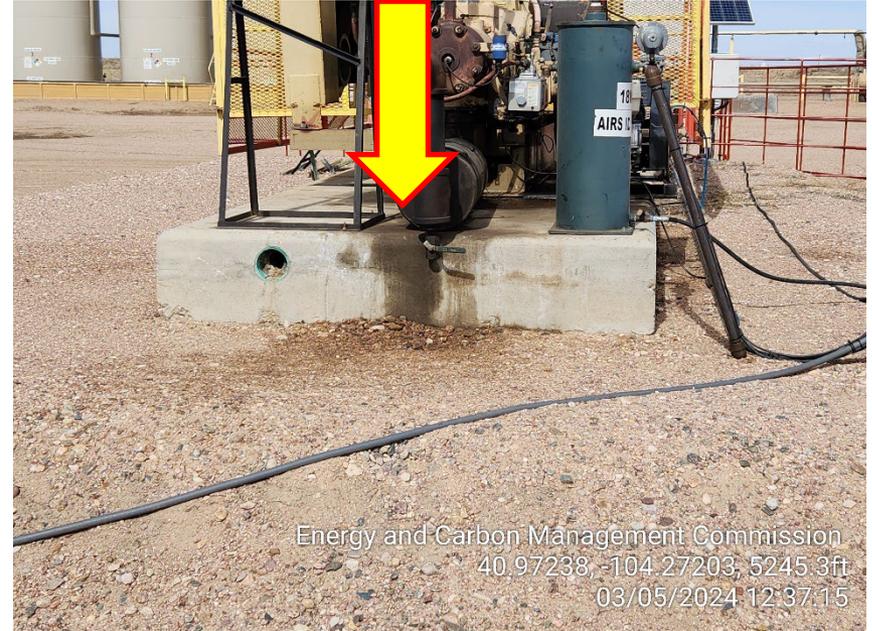
Photo 8 – Stained Soil at Gas Engine

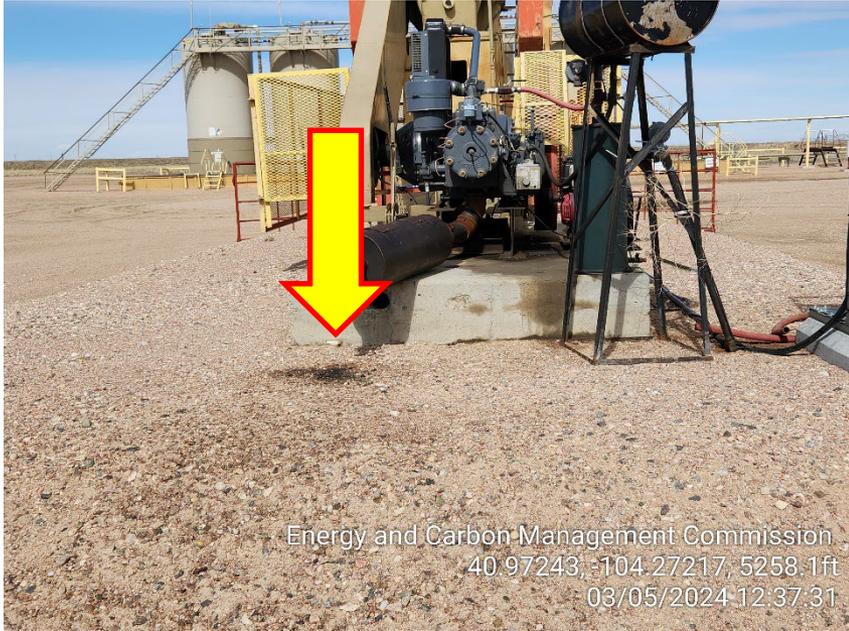
Photo 9 – Stained Soil at Gas Engine

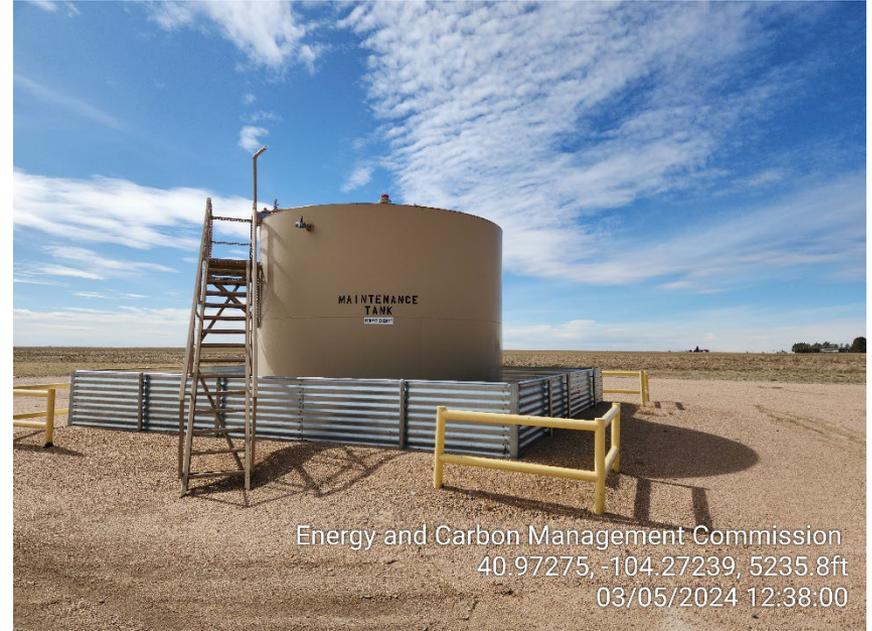
Photo 10 – Maintenance Tank

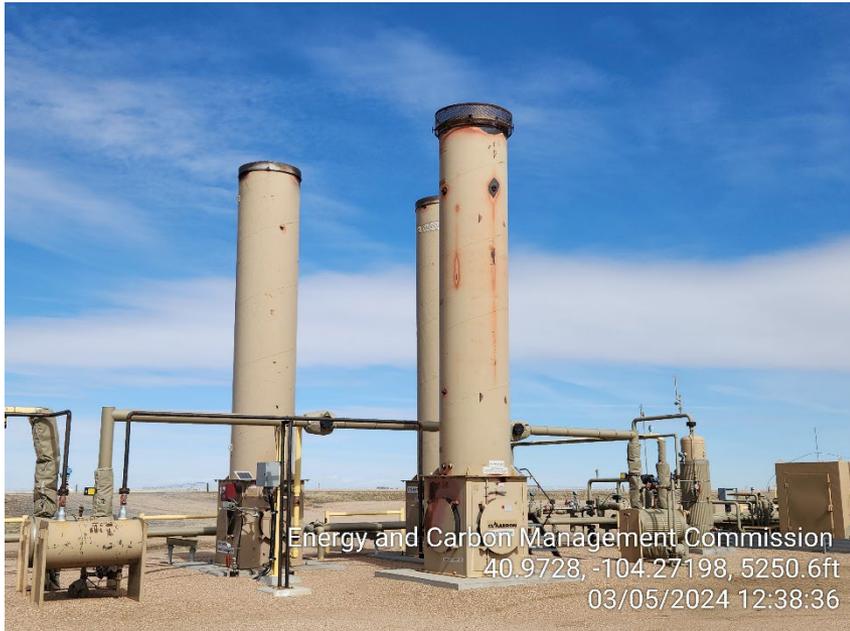
Photo 13 – ECDs

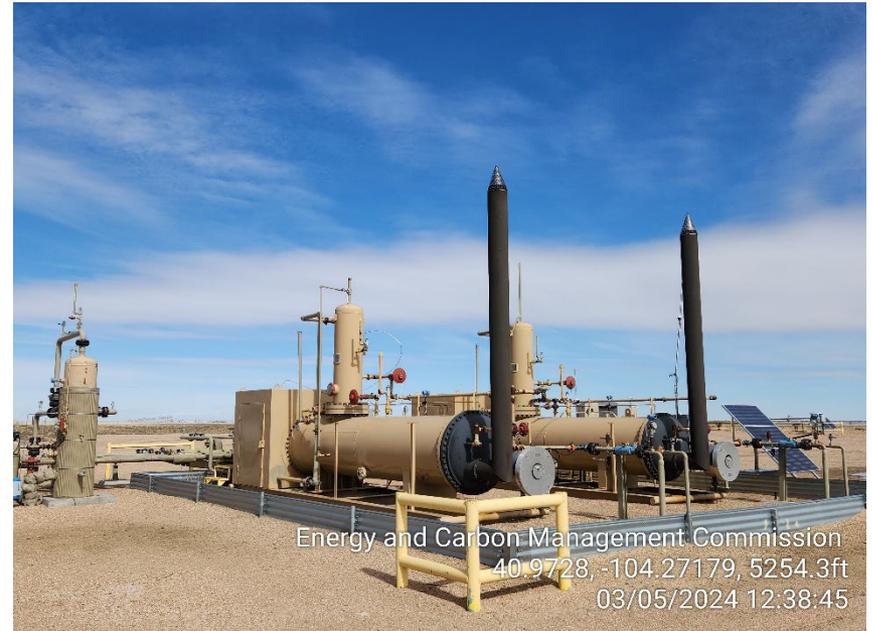
Photo 14 – Separators
