# Interim Reclamation and Stormwater Inspection

Operator: NOBLE ENERGY INC - 100322

Location ID: 327777

Location Name: Bernhardt State PC N 36-17

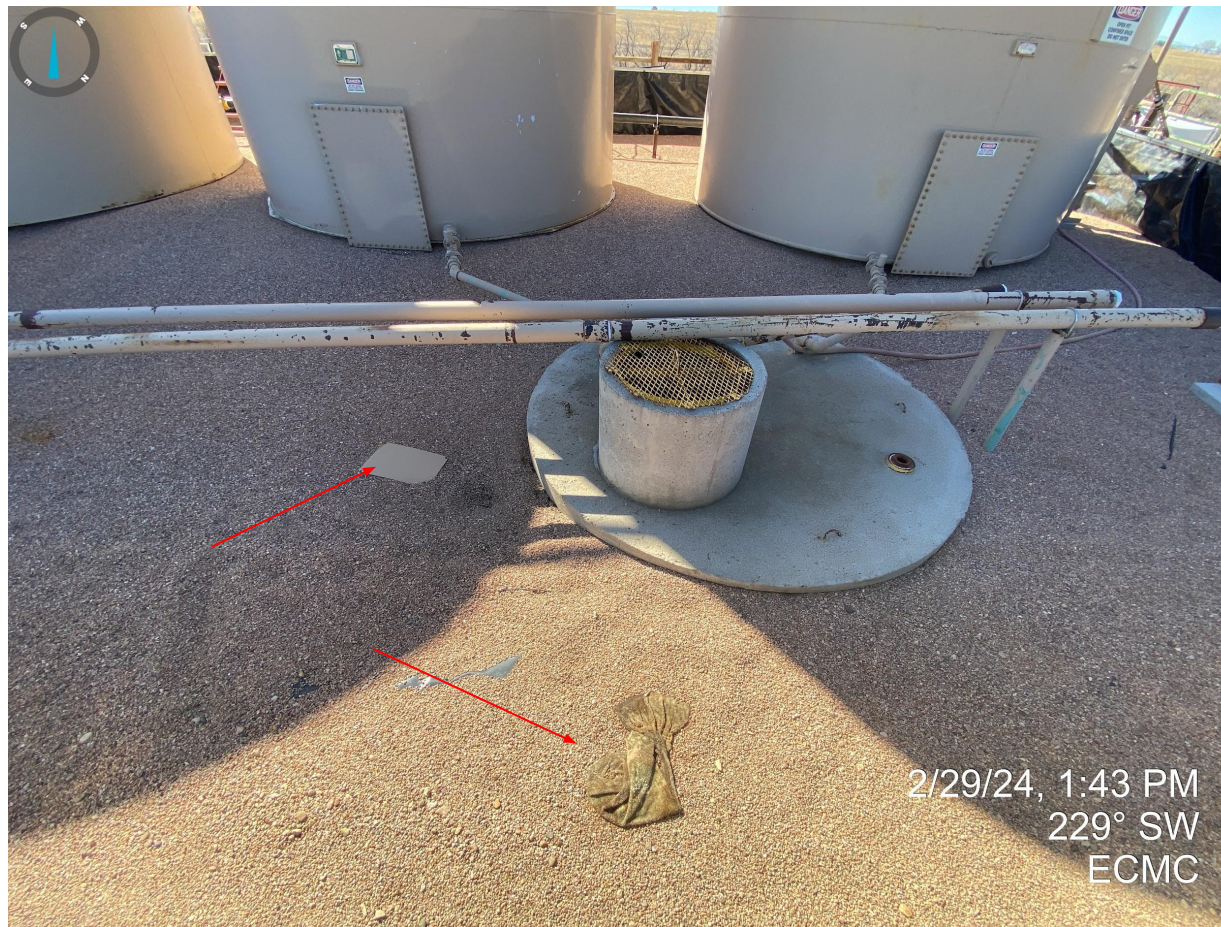
**Photo 1.** Debris within tank battery secondary containment.

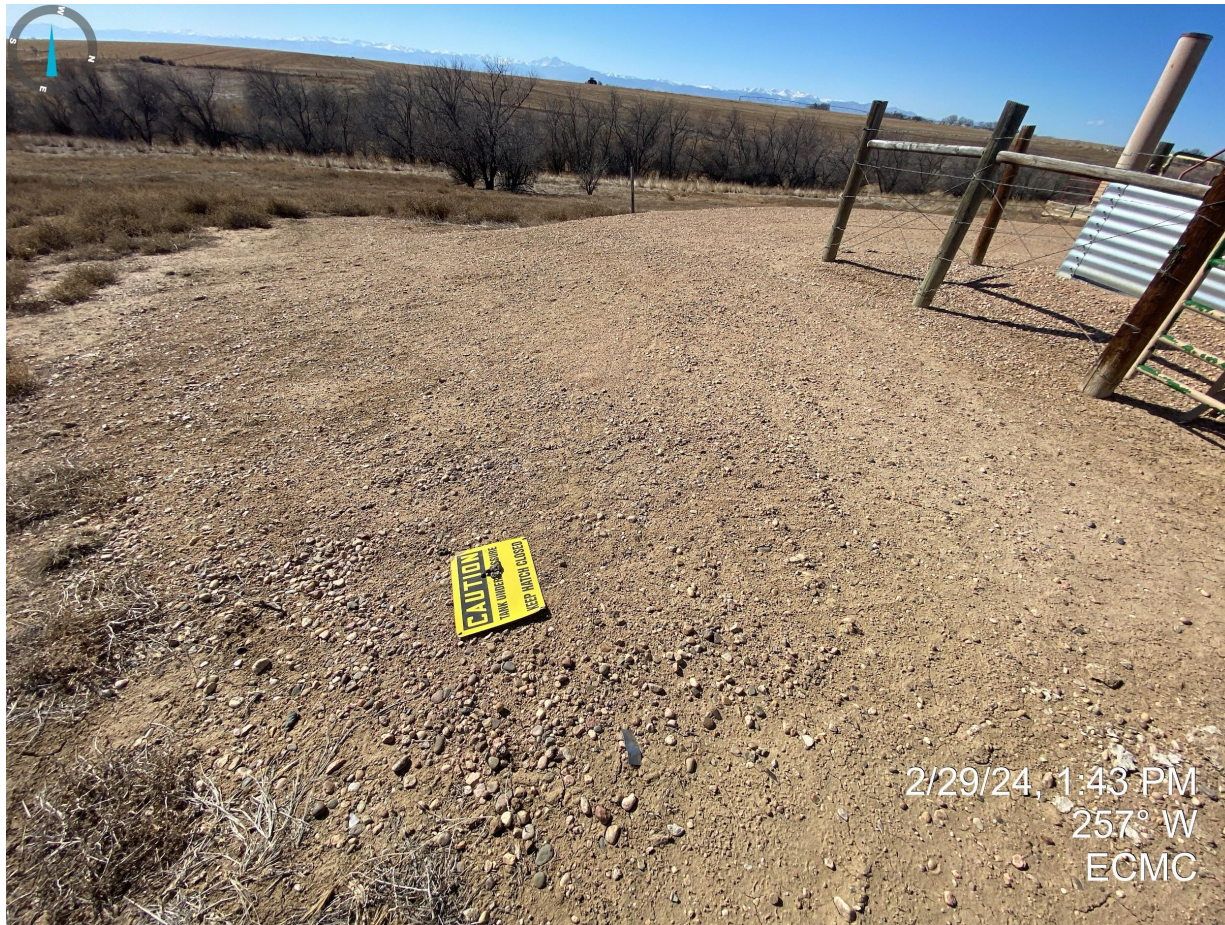
**Photo 2.** Debris observed outside and south of tank battery. Remove or repair/reinstall sign.

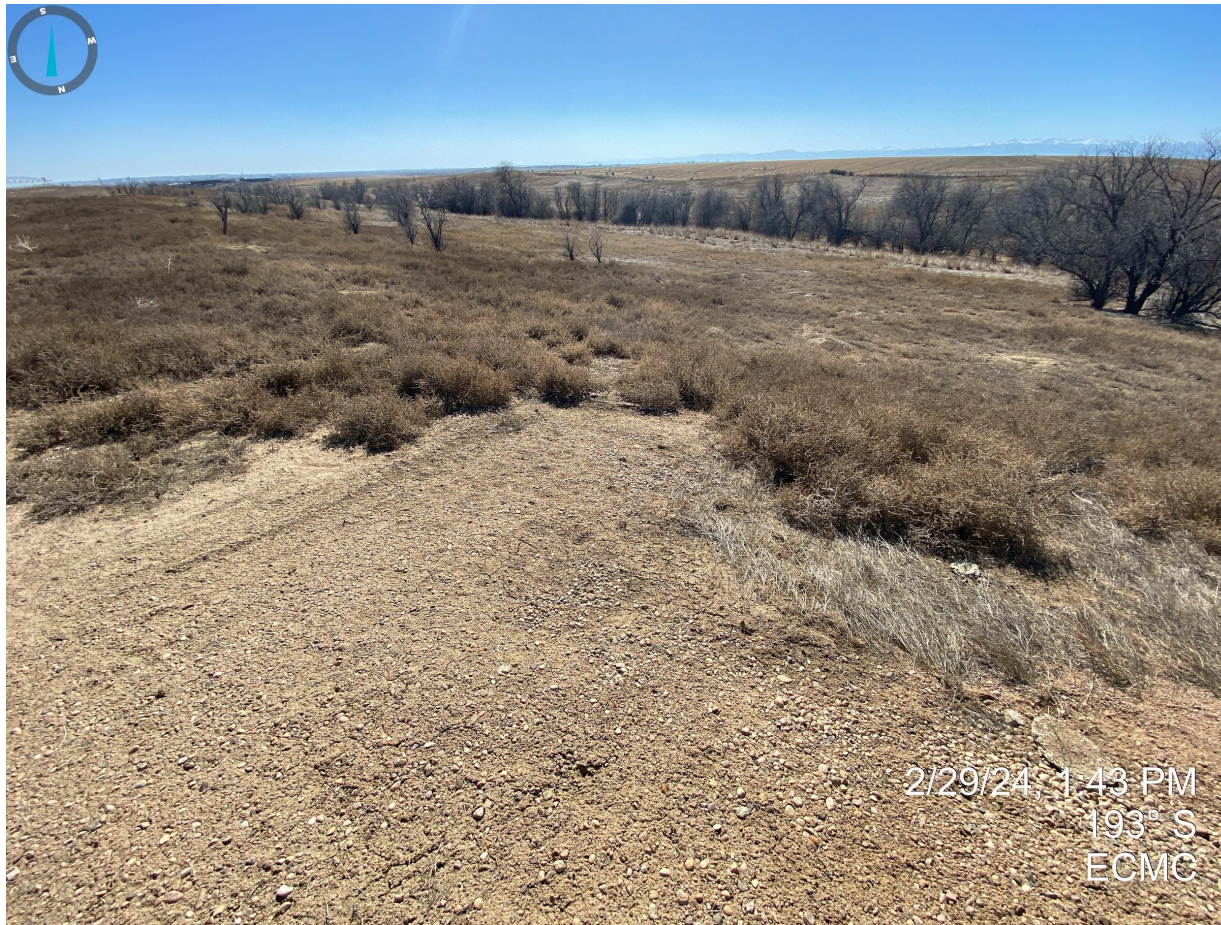
**Photo 3.** Southwest corner of location. Erosion degradation appears to have been repaired previously; no apparent stormwater control measures/BMPs observed to manage stormwater runoff. Bare soils require additional reclamation activities to stabilize the soils.

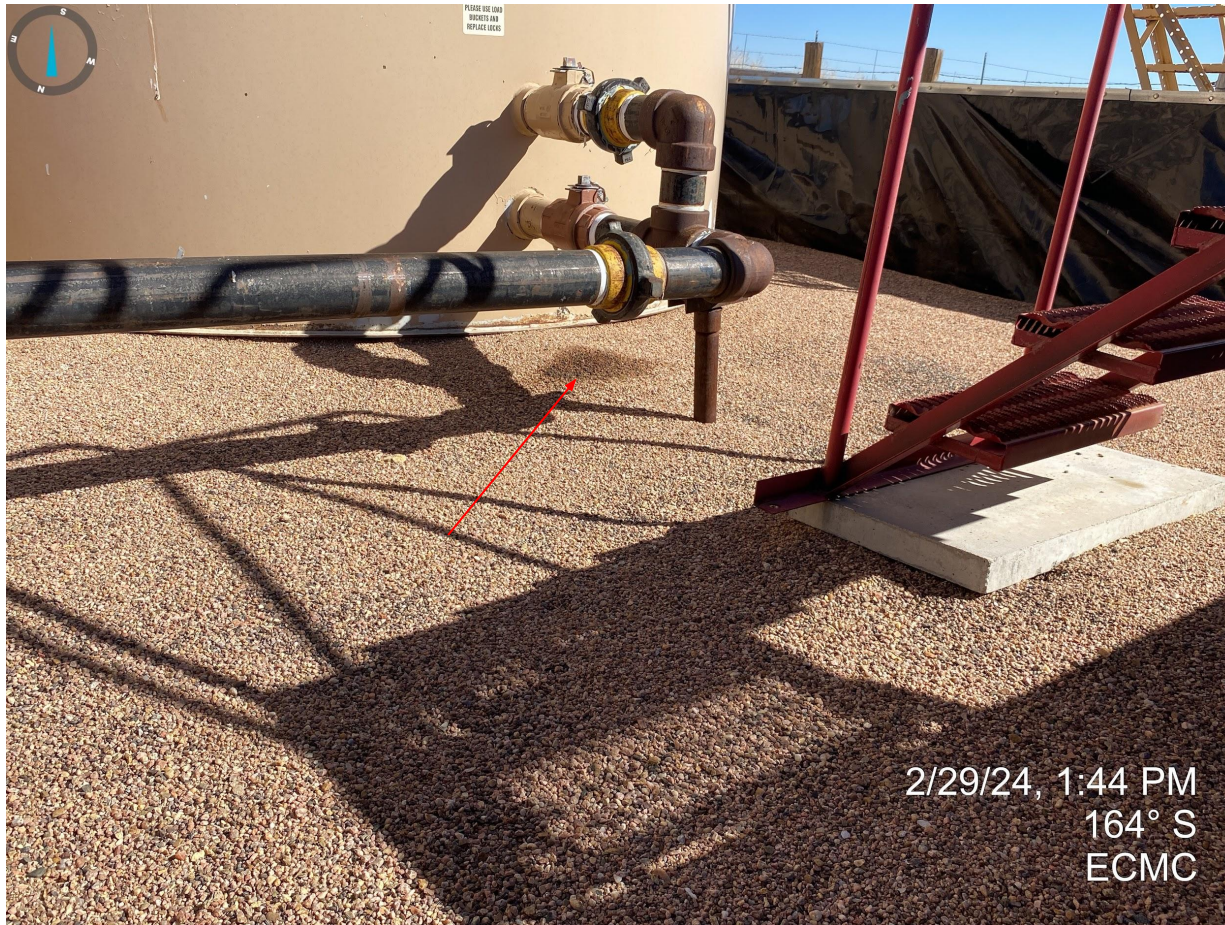
**Photo 4.** Stained soil observed at southern vertical steel tank.

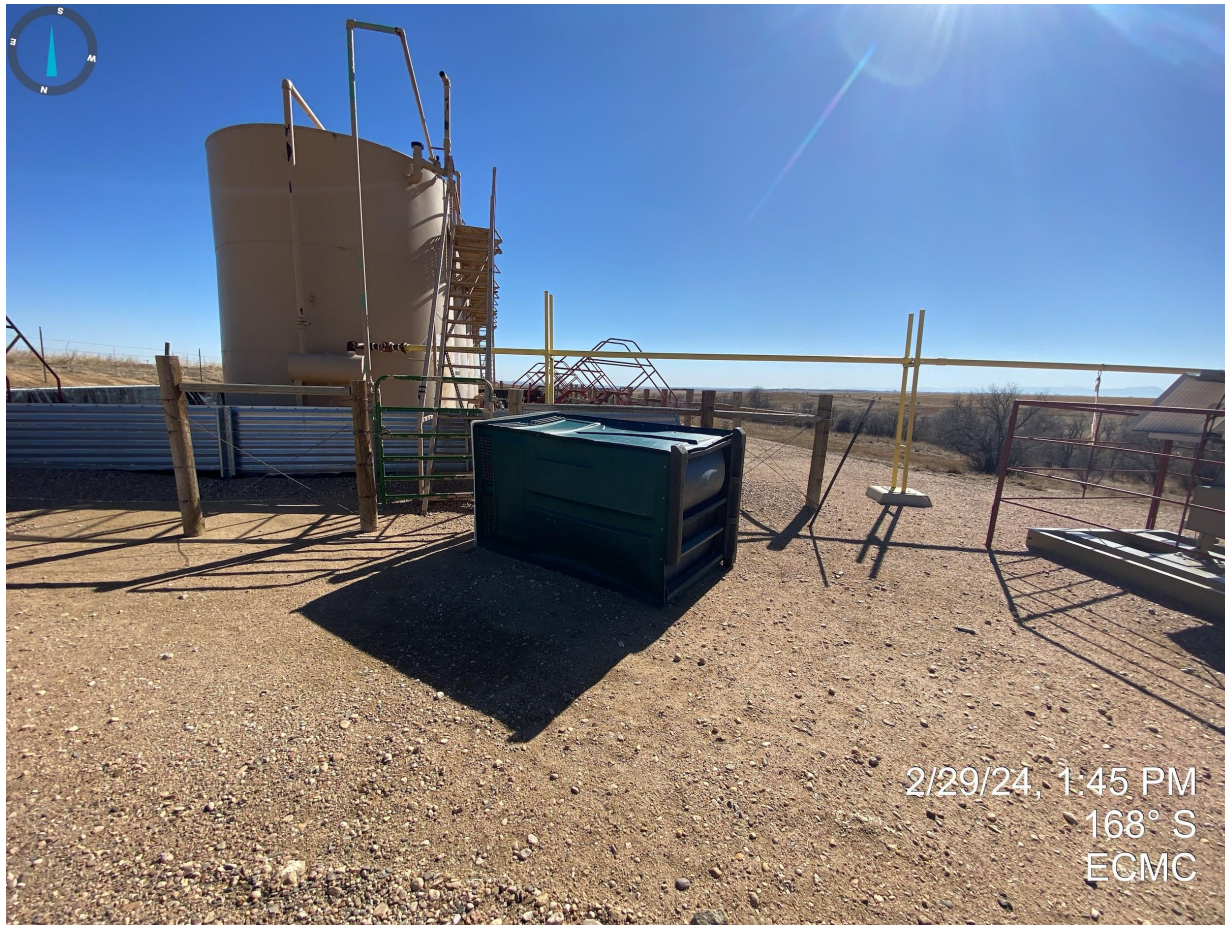
**Photo 5.** Porta john not properly anchored.

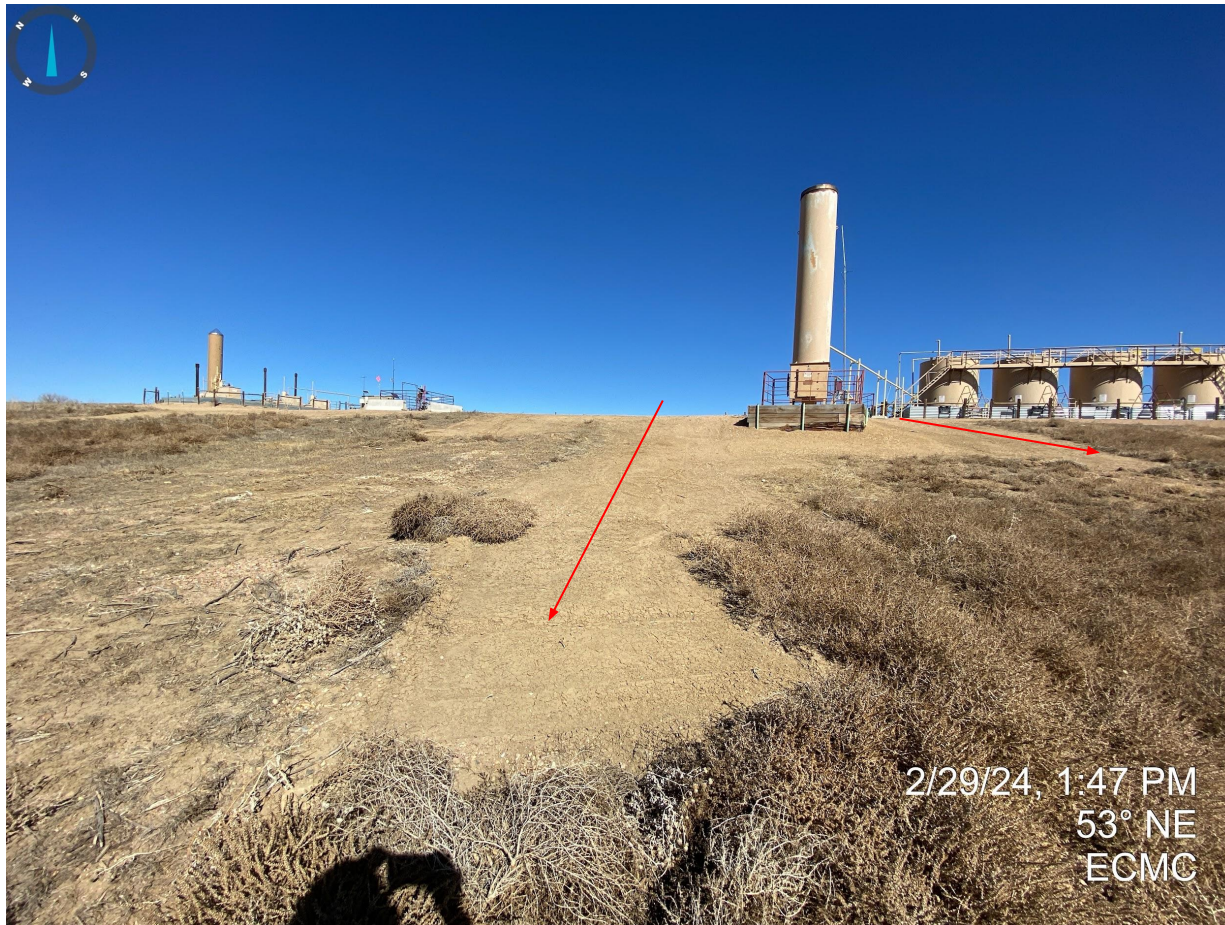
**Photo 6.** Western portion of location. Erosion degradation appears to have been repaired previously; no apparent stormwater control measures/BMPs observed to manage stormwater runoff. Bare soils require additional reclamation activities to stabilize the soils.

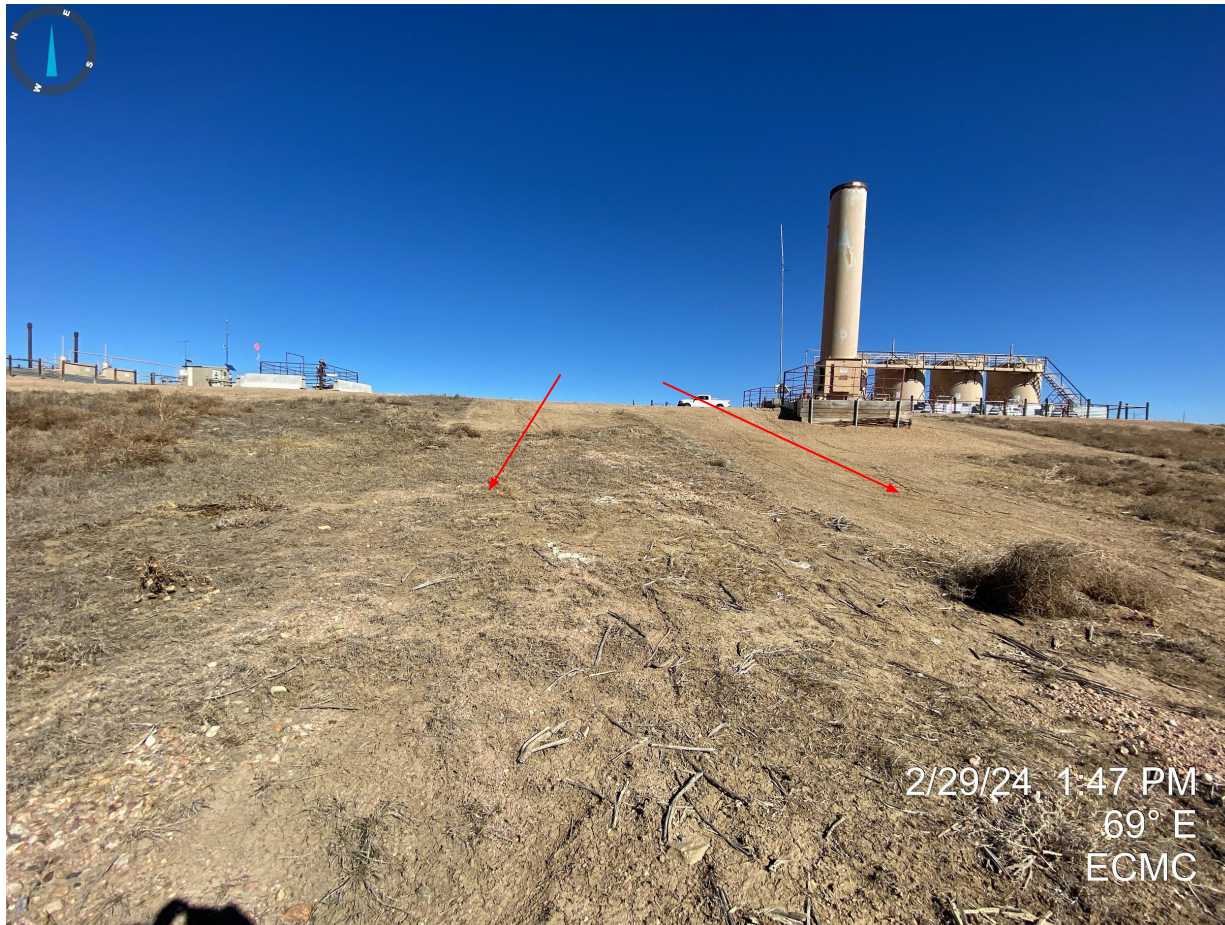
**Photo 7.** Western portion of location. Erosion degradation appears to have been repaired previously; no apparent stormwater control measures/BMPs observed to manage stormwater runoff. Bare soils require additional reclamation activities to stabilize the soils.

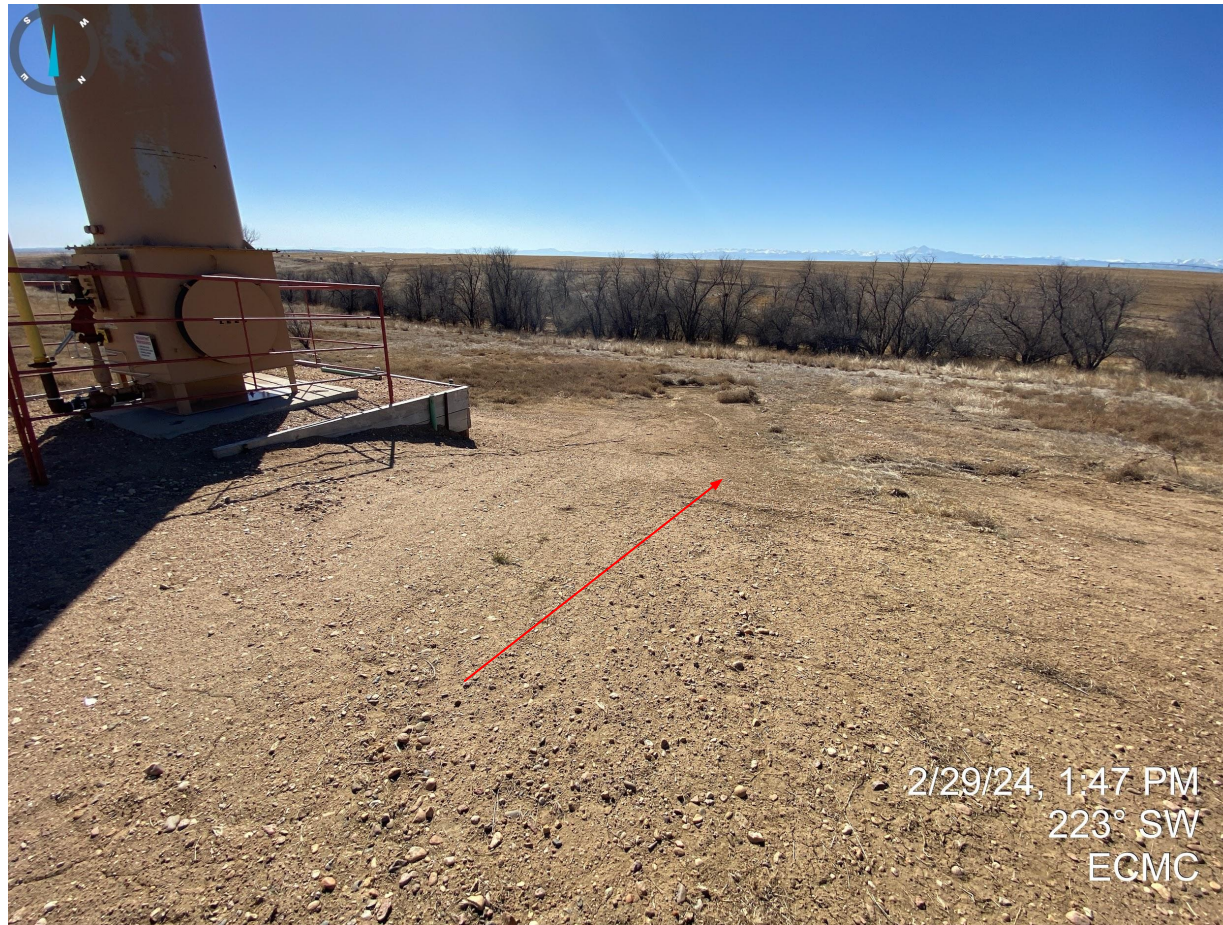
**Photo 8.** Western portion of location. Erosion degradation appears to have been repaired previously; no apparent stormwater control measures/BMPs observed to manage stormwater runoff. Bare soils require additional reclamation activities to stabilize the soils.

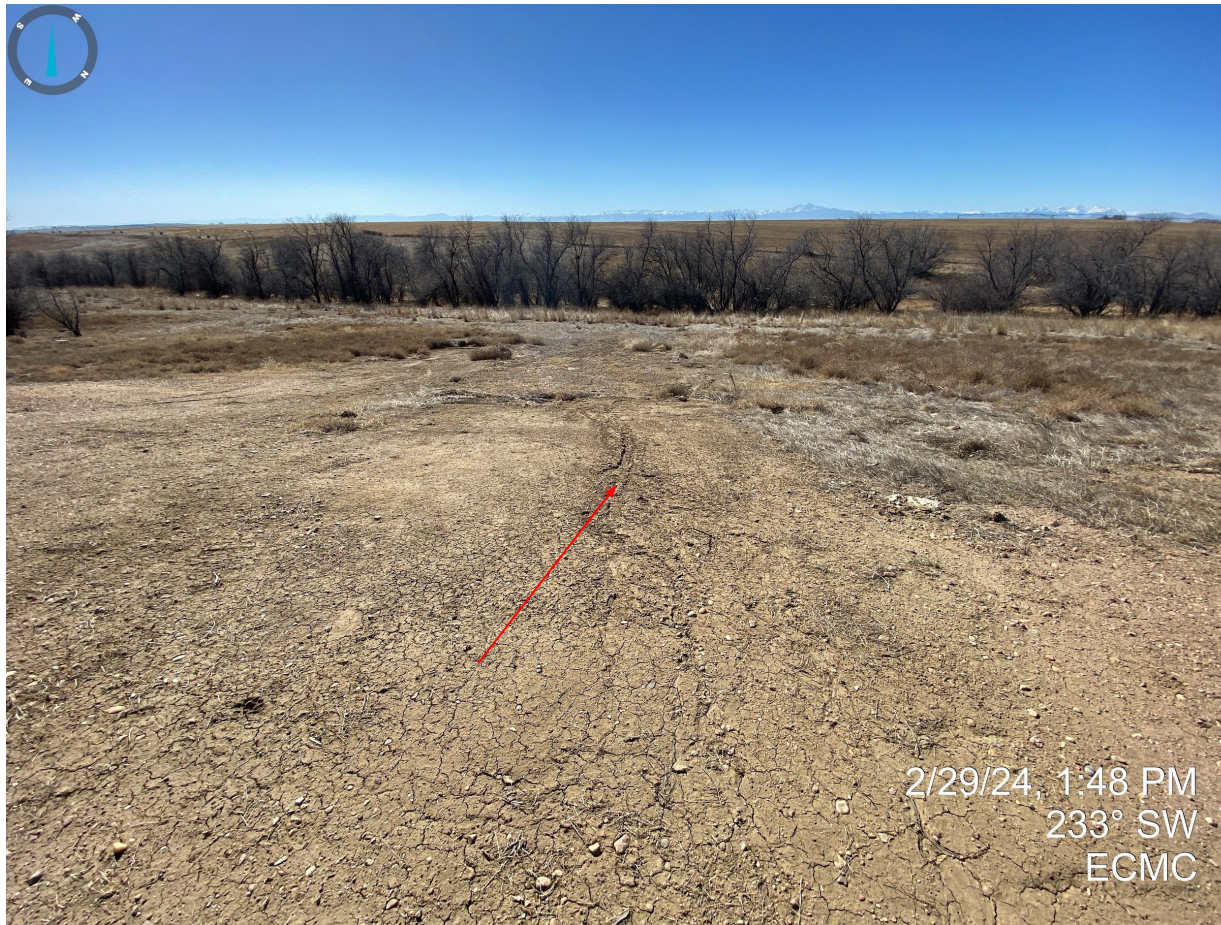
**Photo 9.** Western portion of location. Erosion degradation appears to have been repaired previously; no apparent stormwater control measures/BMPs observed to manage stormwater runoff. Bare soils require additional reclamation activities to stabilize the soils.
