**KT Resources LLC
Ant Hill Unit 21-22
Location ID: 398705**

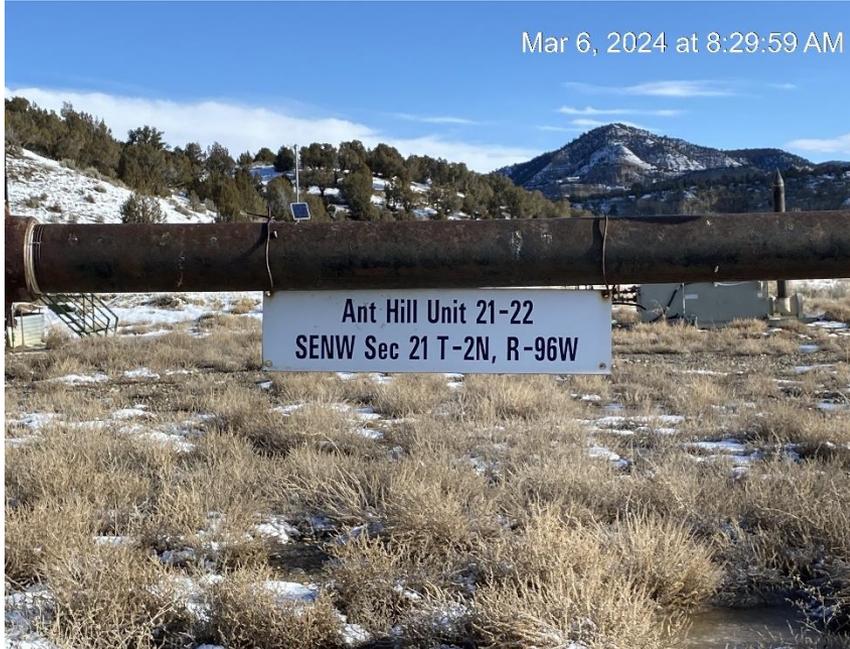
As signs are replaced additional information is required

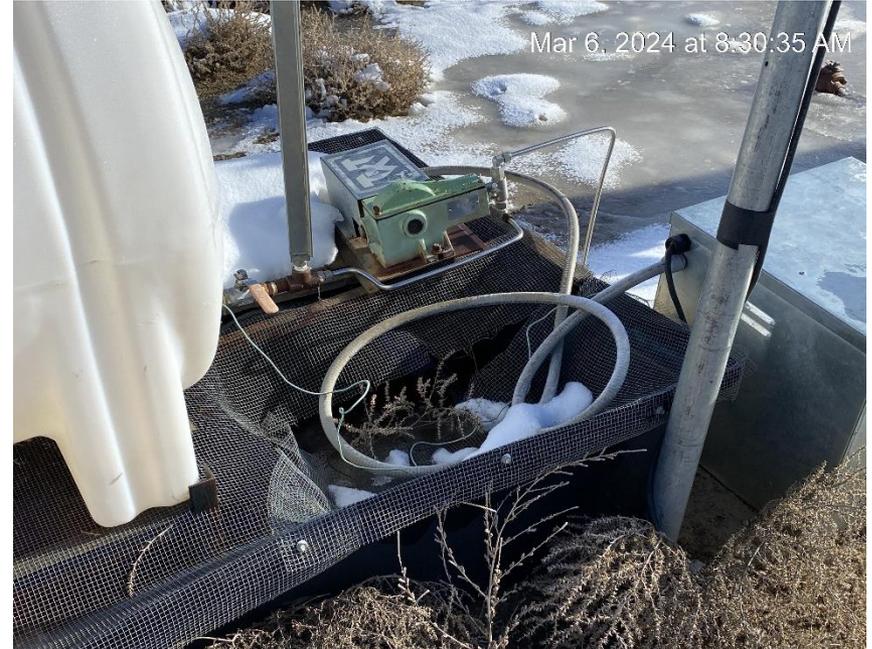
Inadequate wildlife protection

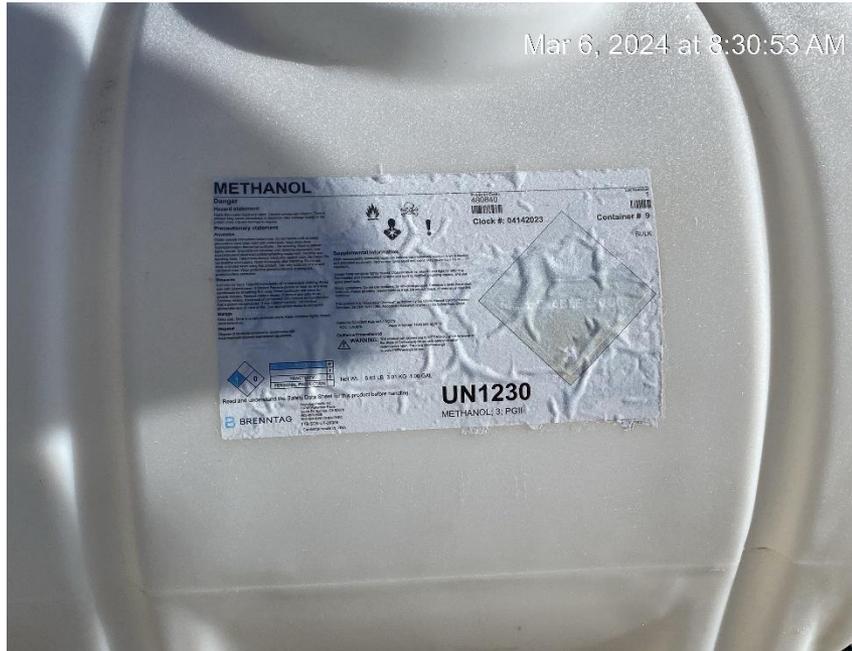
Replace illegible or damaged labels as required

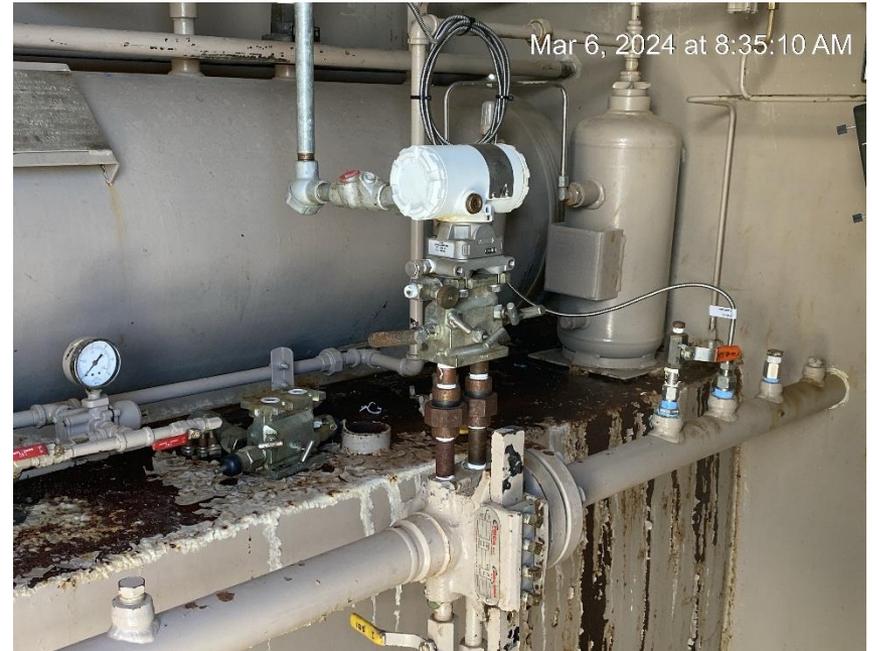
No visible display of gas meter calibration

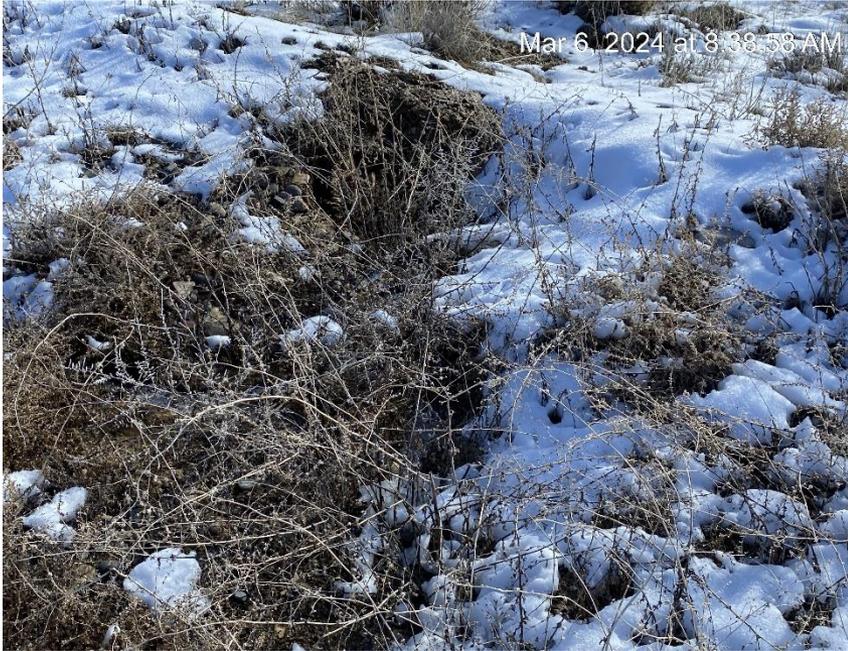
Erosion and sediment migration

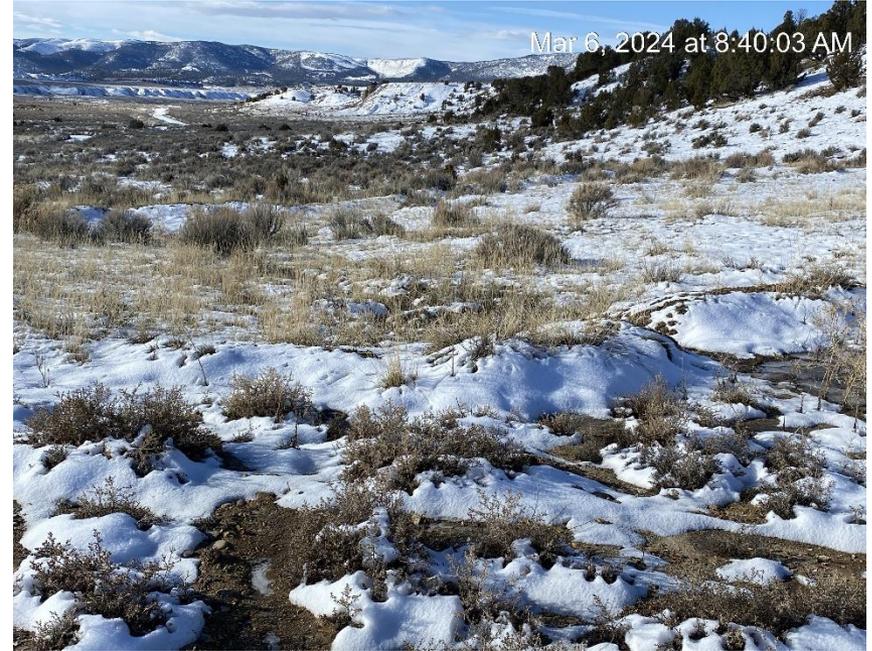
Erosion and sediment migration
