**KT Resources LLC  
Ant Hill Unit Wyatt 36-13  
Location ID: 316347**

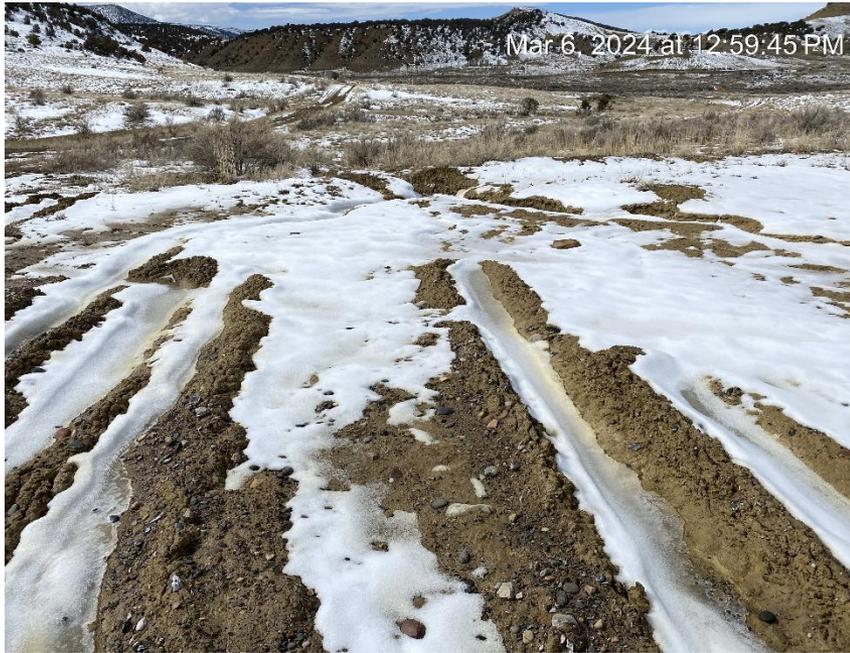
**Erosion and sediment migration**

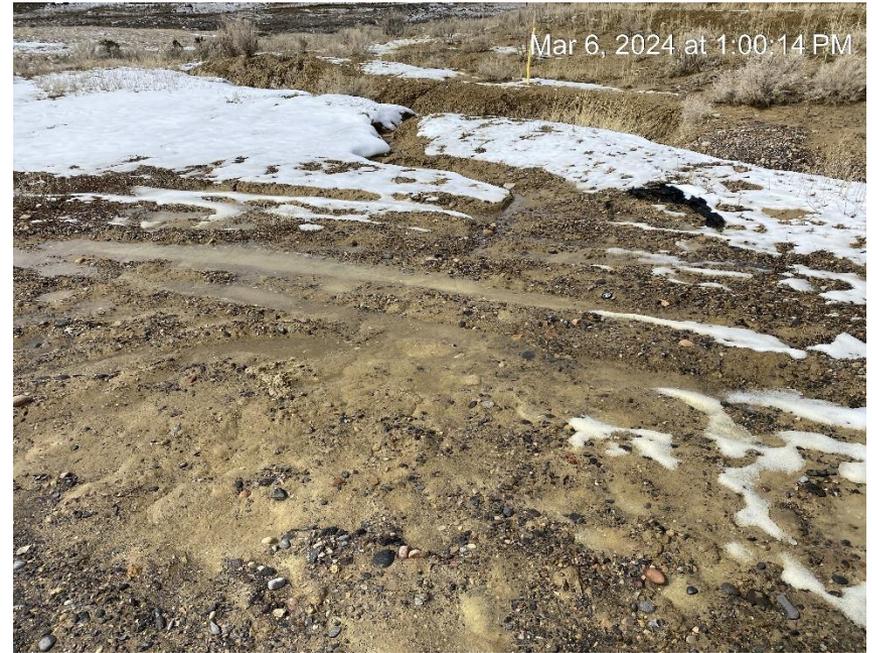
**Erosion and sediment migration**

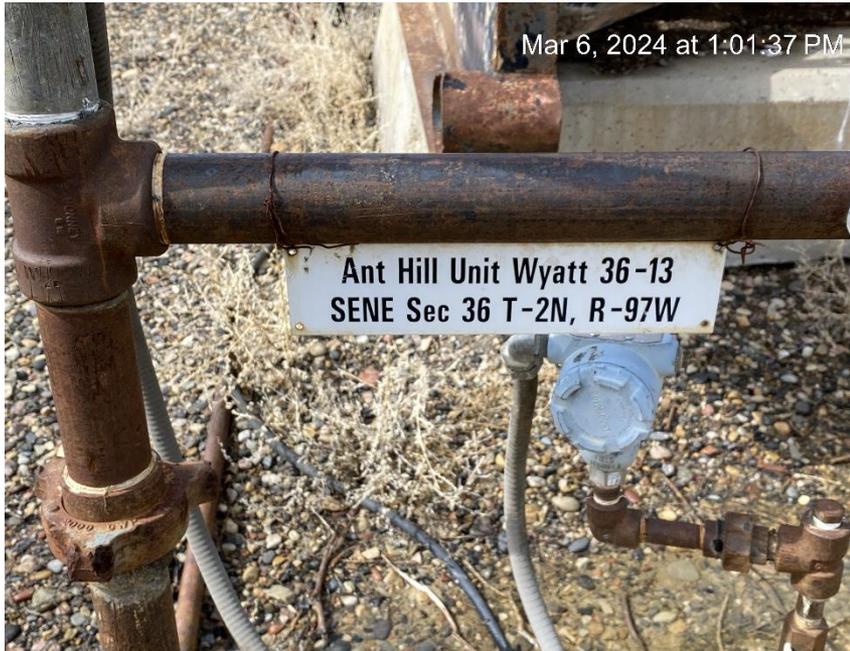
As signs are replaced additional information is required

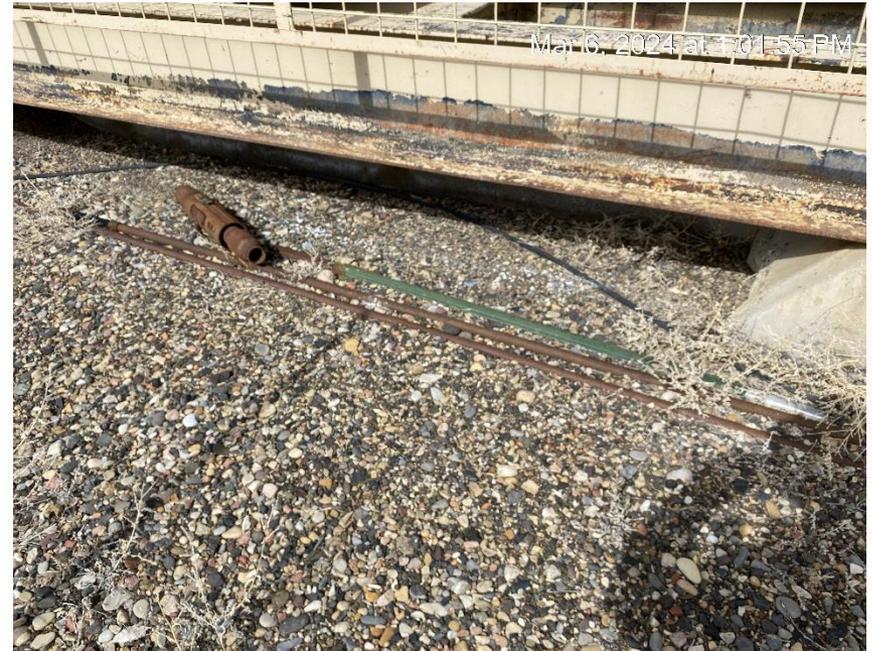
Debris

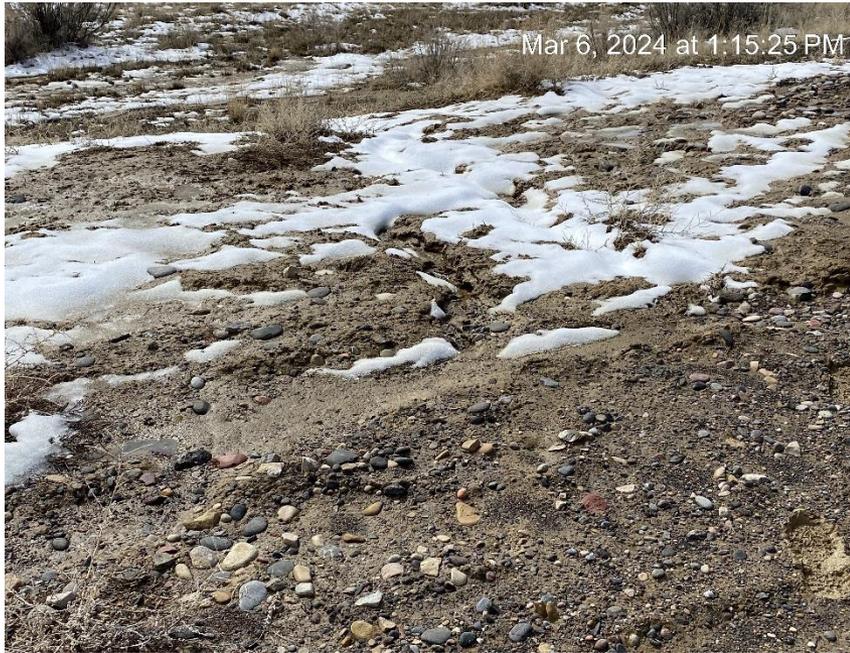
**Erosion and sediment migration**

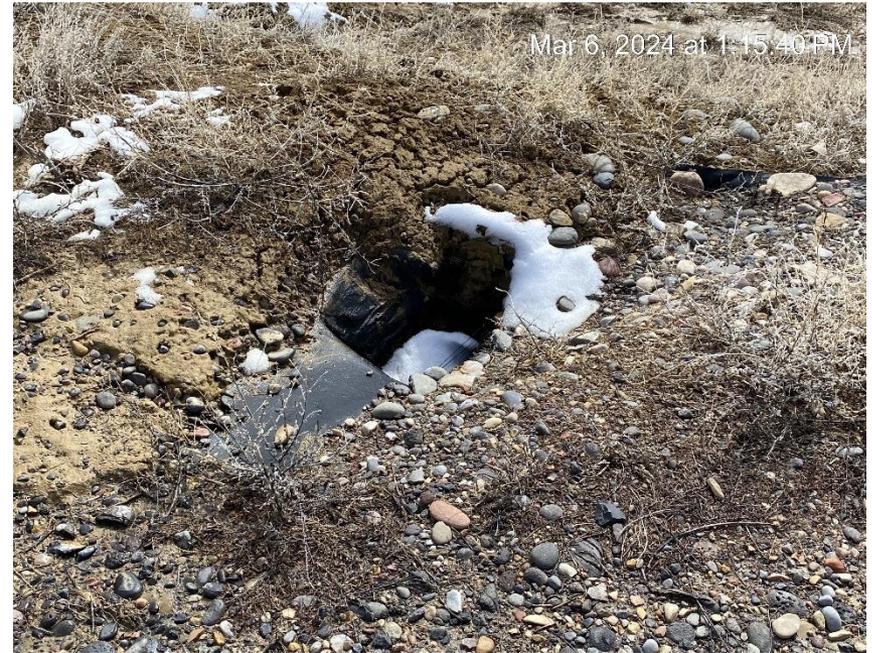
**Erosion and sediment migration**

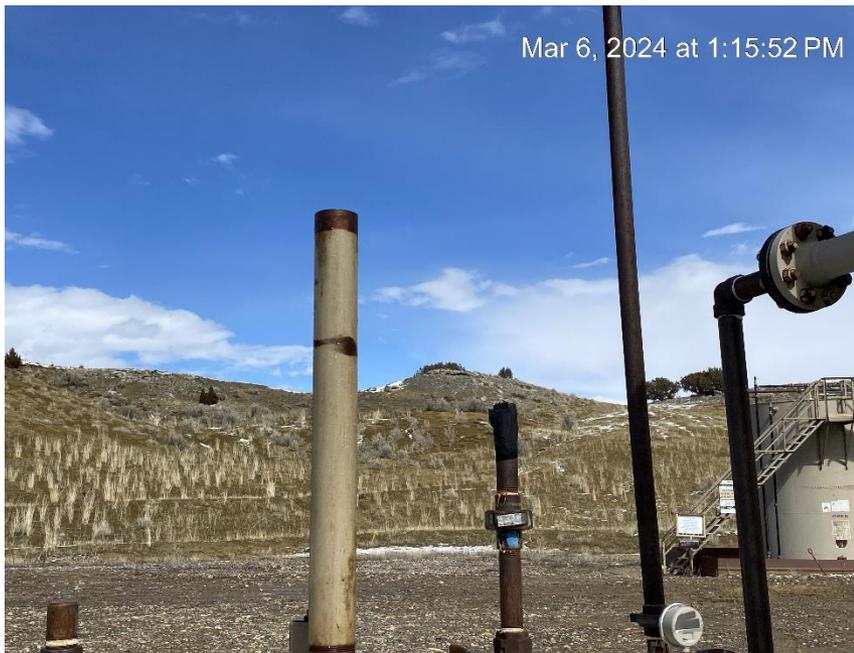
Relief rain protection missing

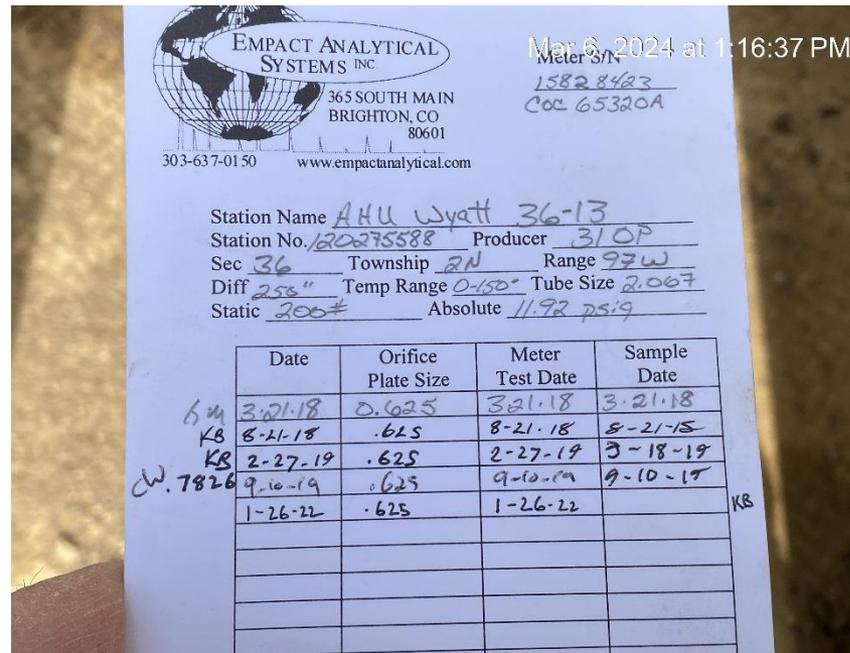
Calibration overdue

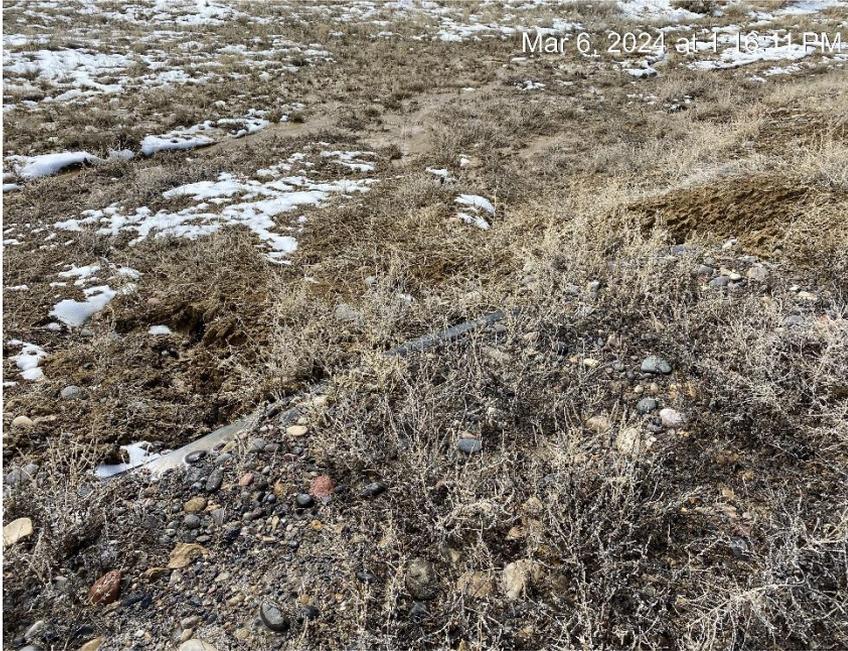
**Erosion and sediment migration**

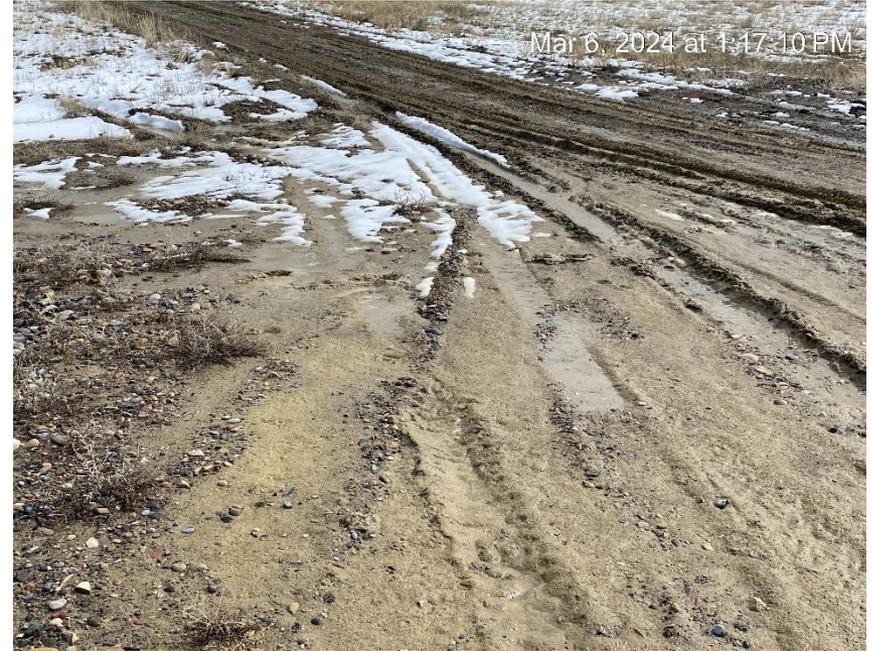
**Sediment migration**

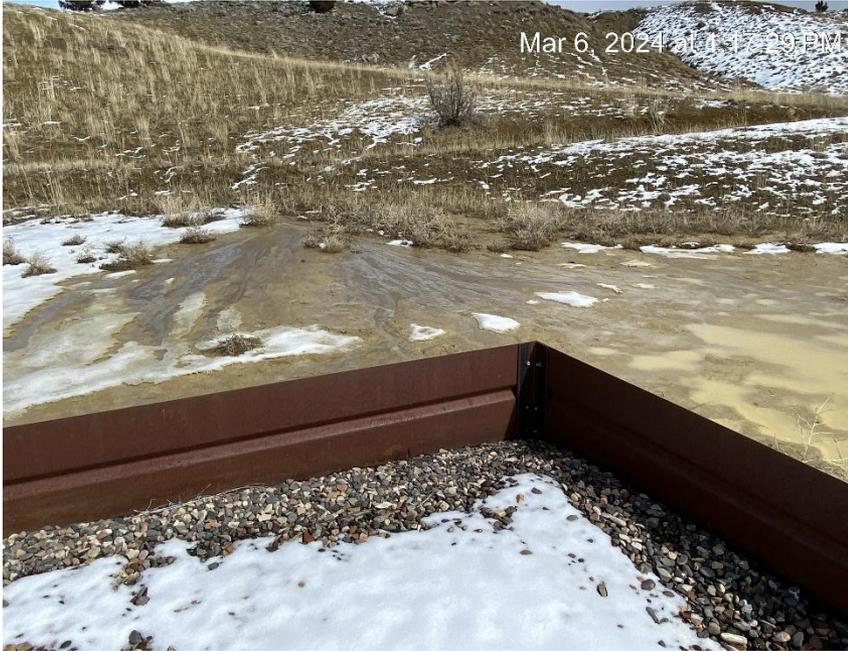
**Sediment migration**

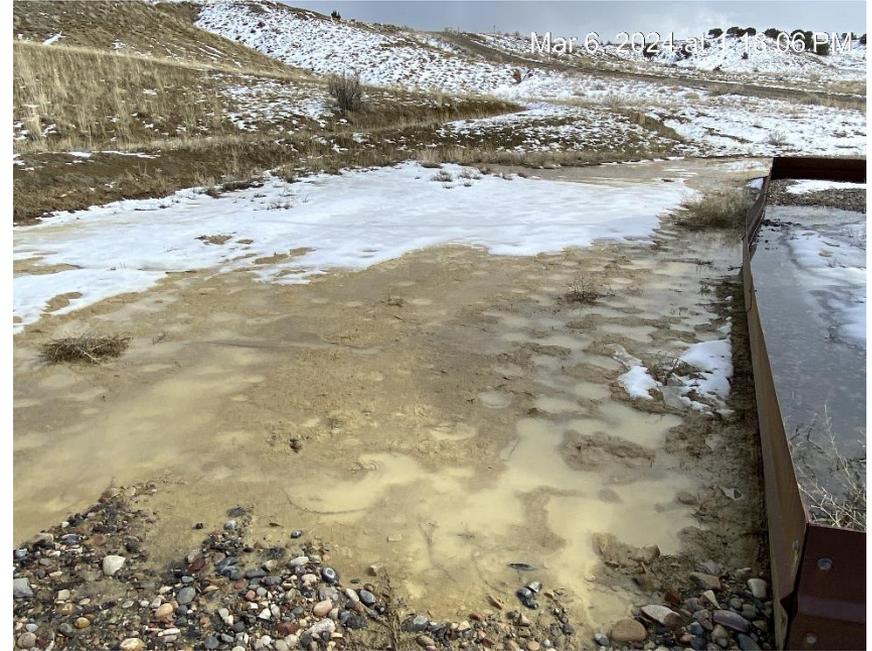
**Sediment migration**
