# Inspection Photos

**Operator:** TEP ROCKY MOUNTAIN LLC #96850

**Location ID:** 311663

**Inspection Doc:** 696205661

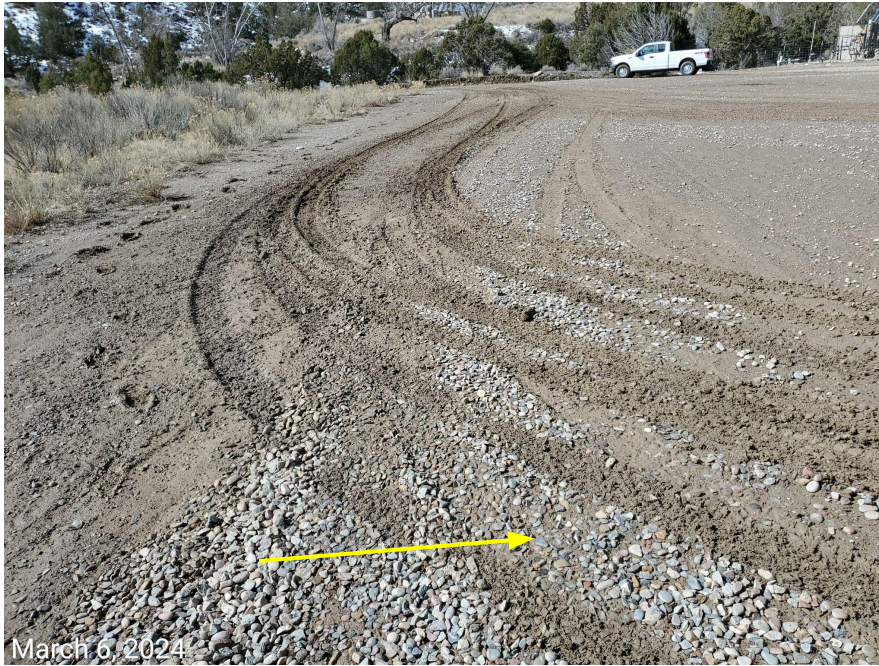
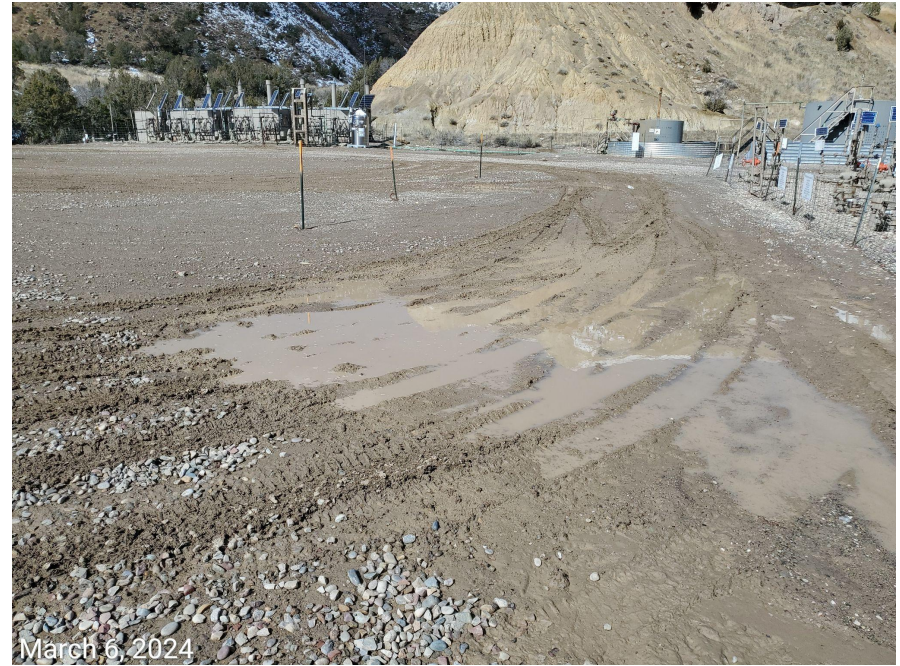
**Photo 1:** Photos taken from the working pad surface of the Location. Photos examples showing work to stabilize the working pad surface, as well as to minimize tracking and sediment transport is insufficient. Operator appears to have only placed gravel material over select portions of the Location. BMP alone is inadequate as tracking issues and degradation issues are recurring; sediment has already filled in large areas of the pad that had been graveled.

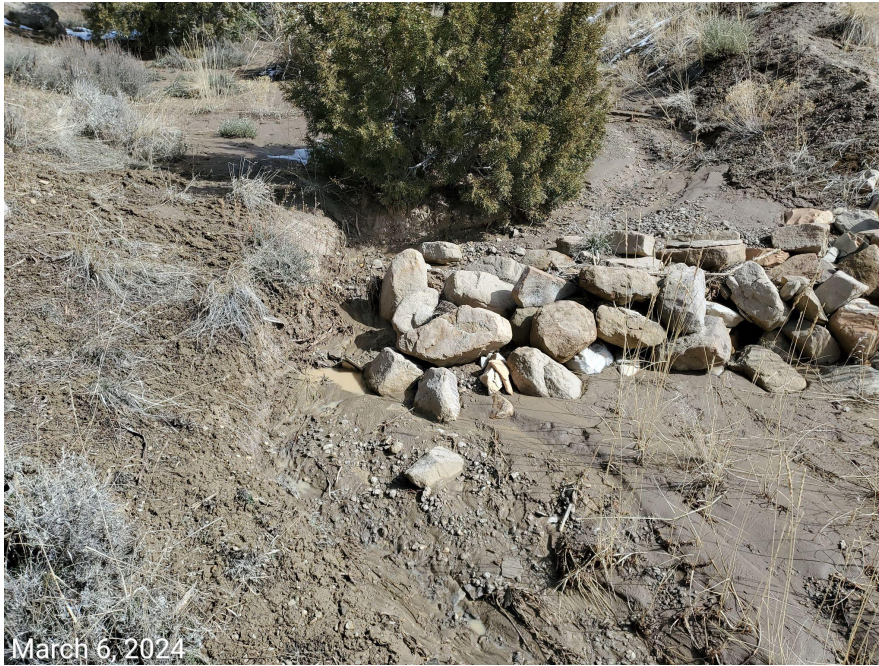
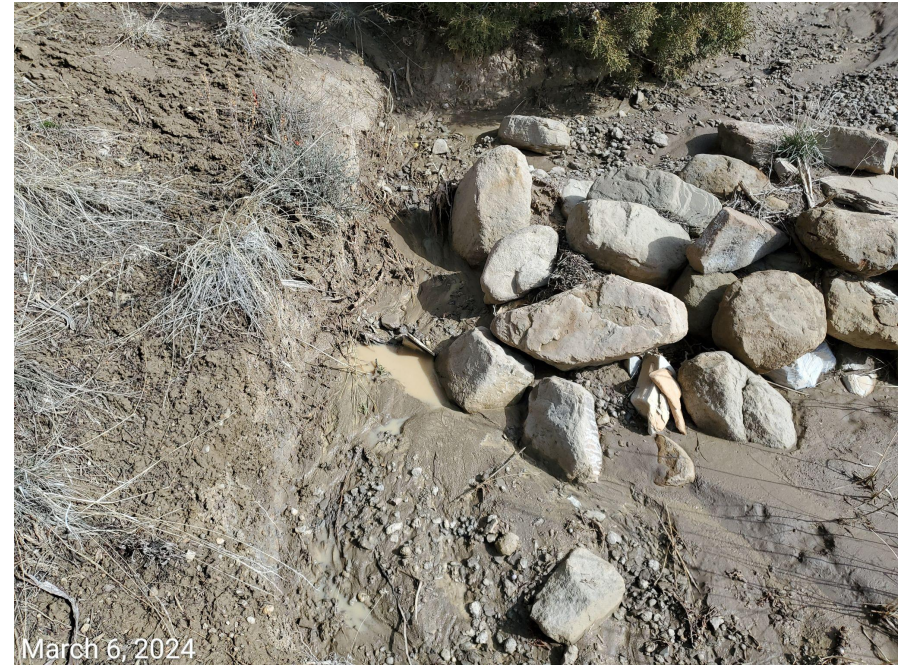
**Photo 2:** Photos taken from the ditch along the north end of the Location. Photo shows stormwater and erosion control BMPs remain missing or insufficient.

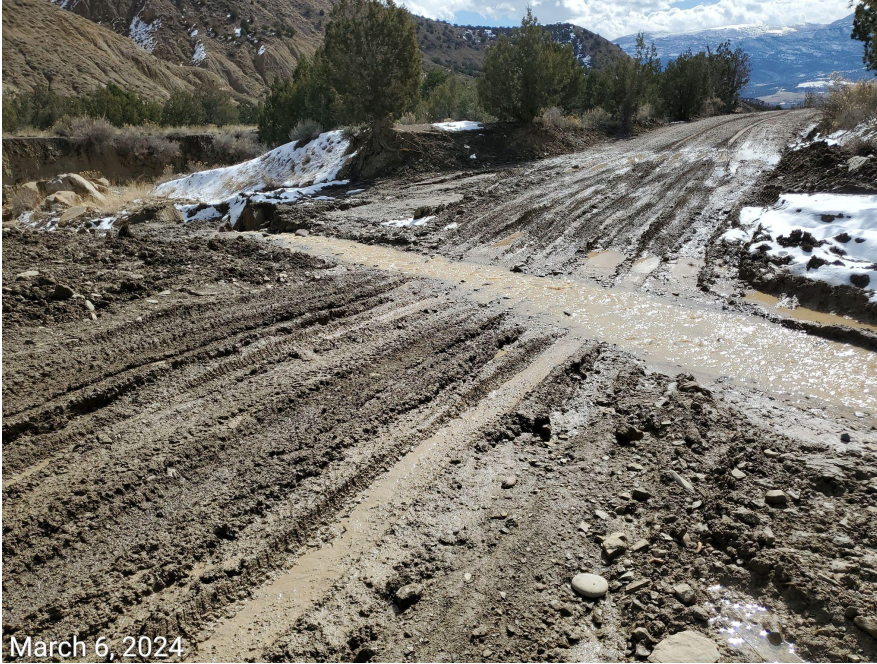
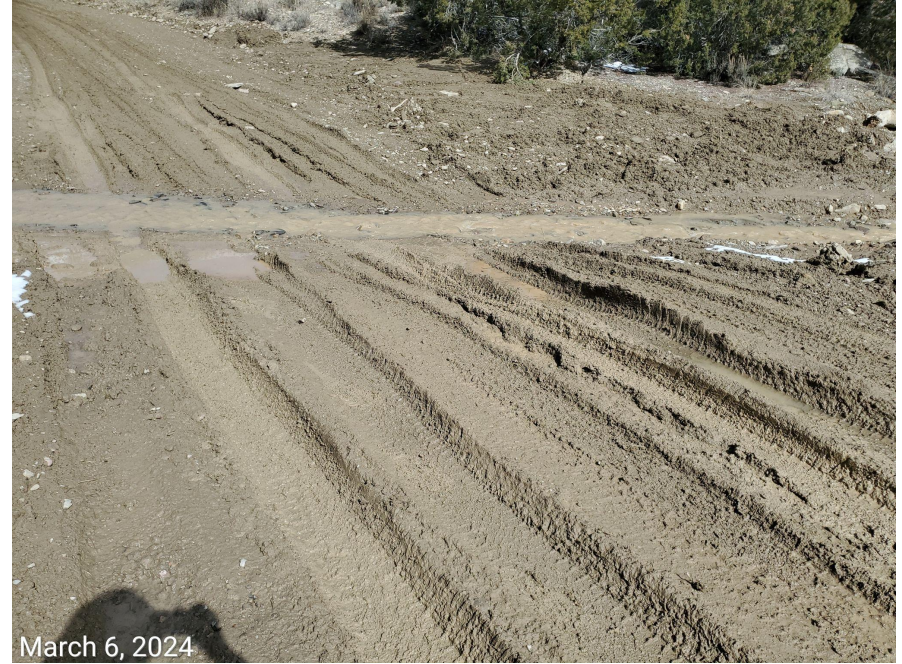
**Photo 3:** Photos 3-4 taken from the access road south of the Location. Photos examples showing that the road has not been constructed with a properly engineered stream crossing; vehicle tracking and degradation apparent at the crossing, impacting a riverine system and Waters of the State. Stream is a direct tributary to the Colorado river.

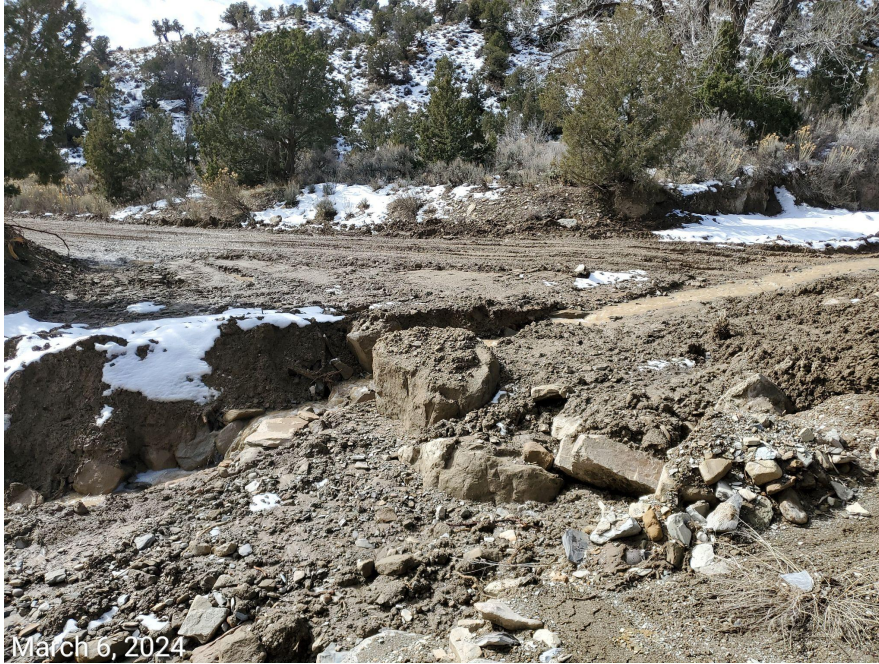
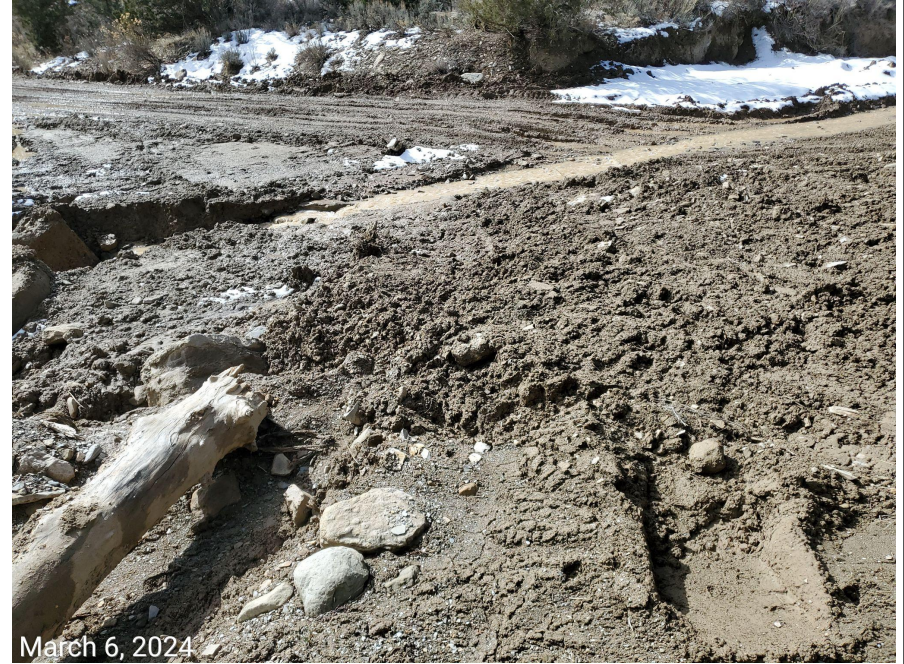
**Photo 4:** See comments under photo 3.
