# Inspection Photos

**Operator:** TEP ROCKY MOUNTAIN LLC #96850

**Location ID:** 322438

**Inspection Doc:** 696205669

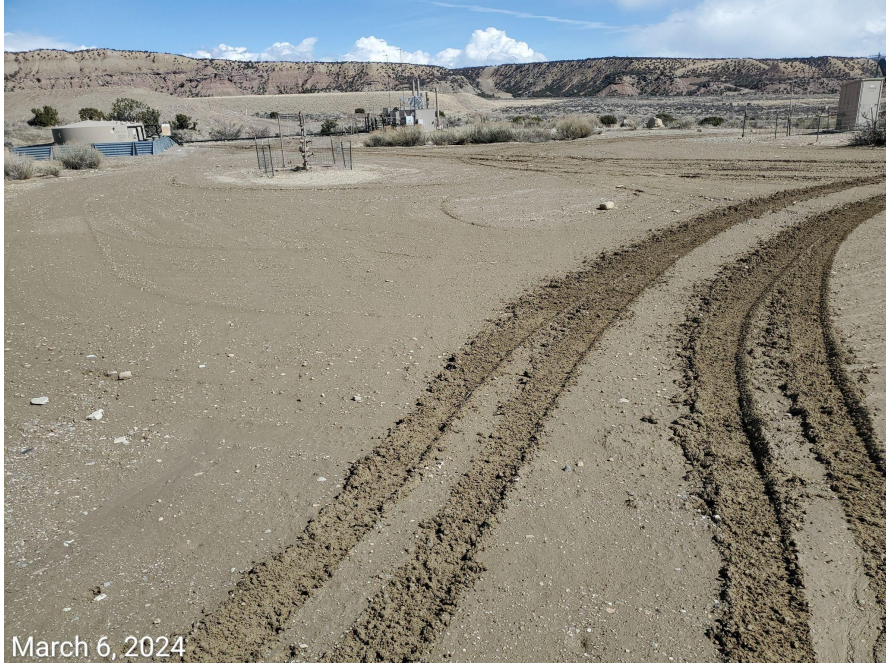
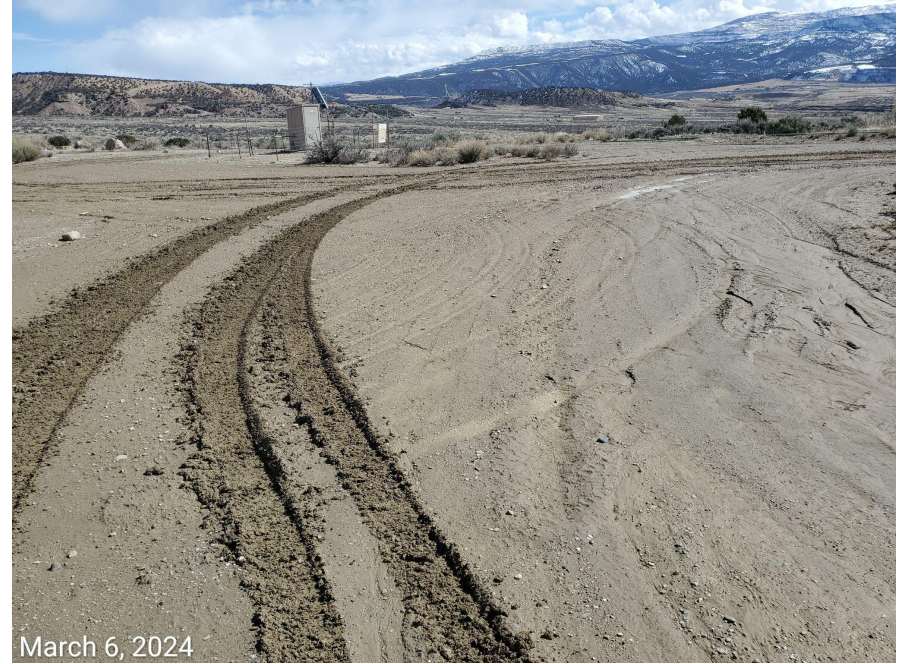
**Photo 1:** Photos taken from the west end of the Location. Photos provide an overview of the Location from east to southeast. Photos examples showing Stormwater and erosion control BMPs remain missing or insufficient; working pad surface lacks stabilization; tracking and erosion degradation observed.

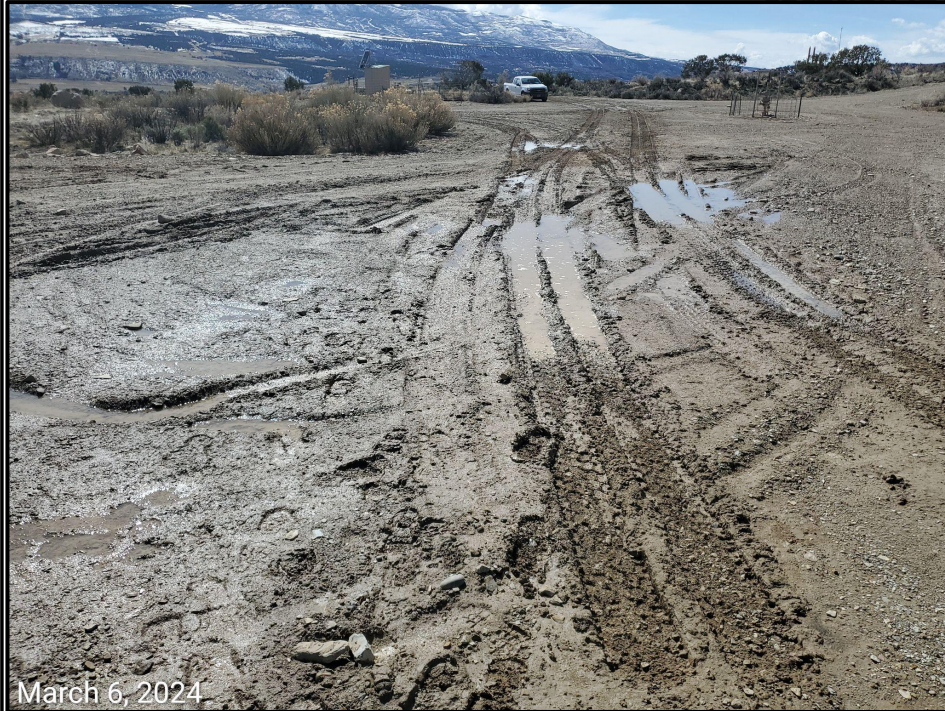
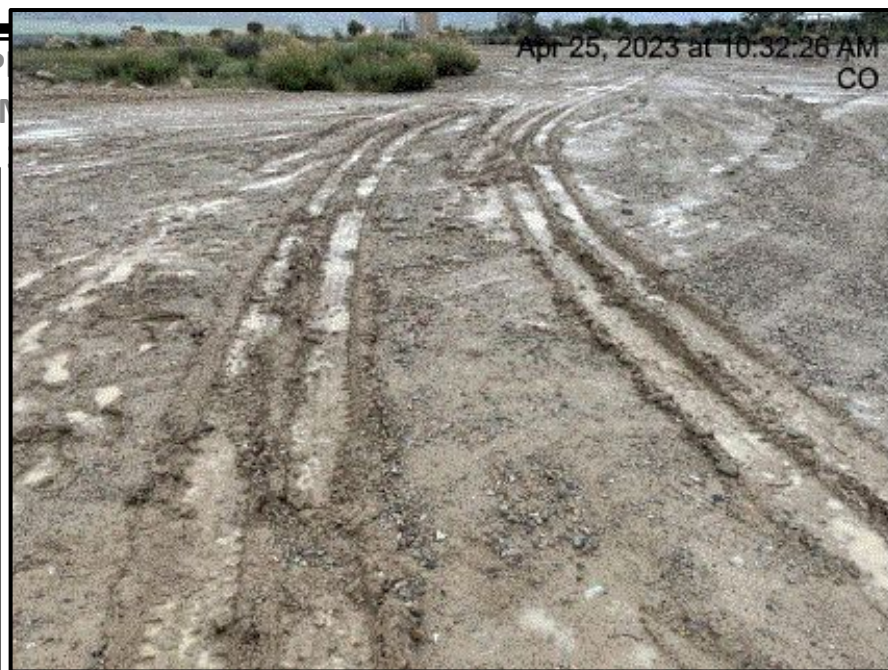
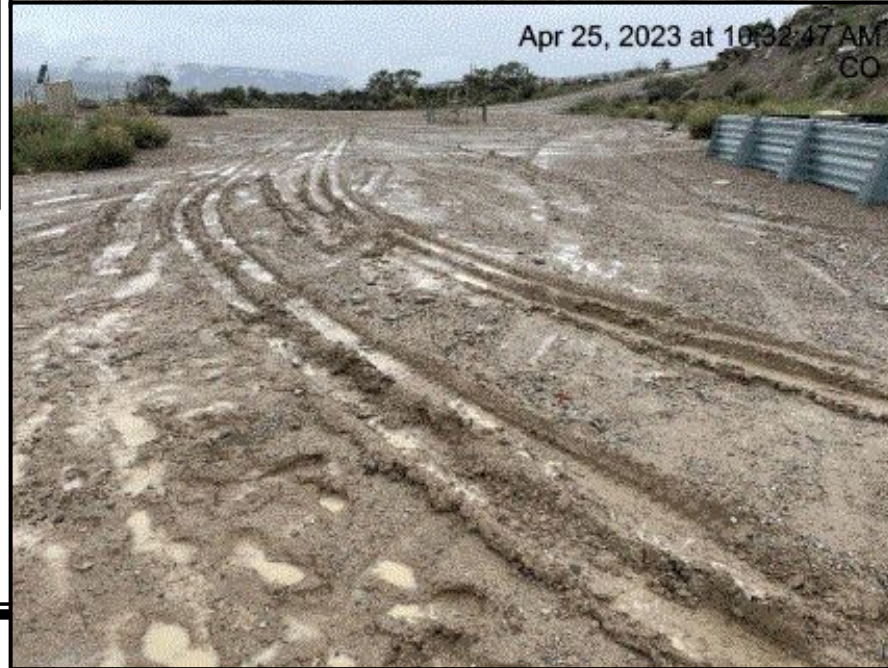
**Photo 2:** Photos right from the 4/25/2023 inspection #708900354, and show erosion degradation and tracking at the working pad surface. Photo left taken 3/6/2024 taken from the same area as photos right, and show BMPs to stabilize the working pad surface had not been installed or maintained; degradation and tracking has persisted.

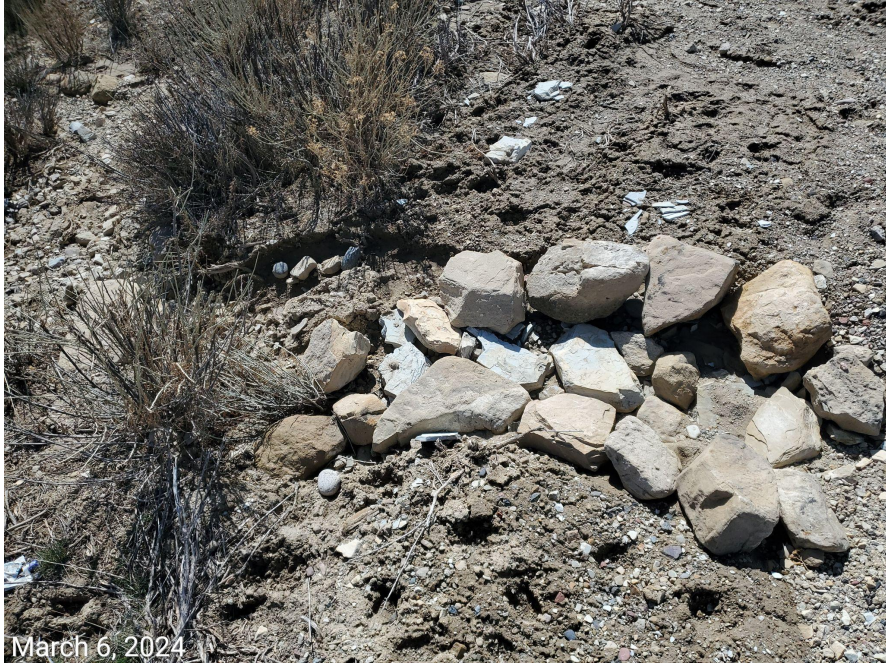
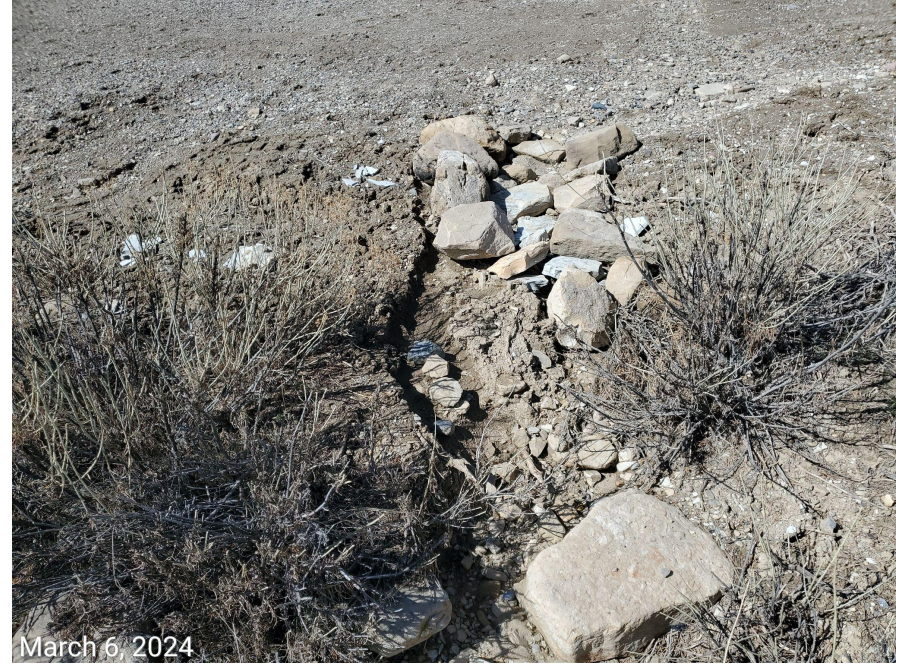
**Photo 3:** Photo taken from the edge of the working pad surface on the south end of the Location. Photos show operator has implemented rip-rap material within areas where stormwater runoff is resulting in erosion degradation; outlet has not been installed per good engineering practices or maintained in proper functioning condition; erosion degradation has persisted in these areas.
