Interim Reclamation and Stormwater Inspection

Operator: BONANZA CREEK ENERGY OPERATING
COMPANY LLC- 8960

Inspection Document #: 708200961

Location Name: Pronghorn 24-7 Booster

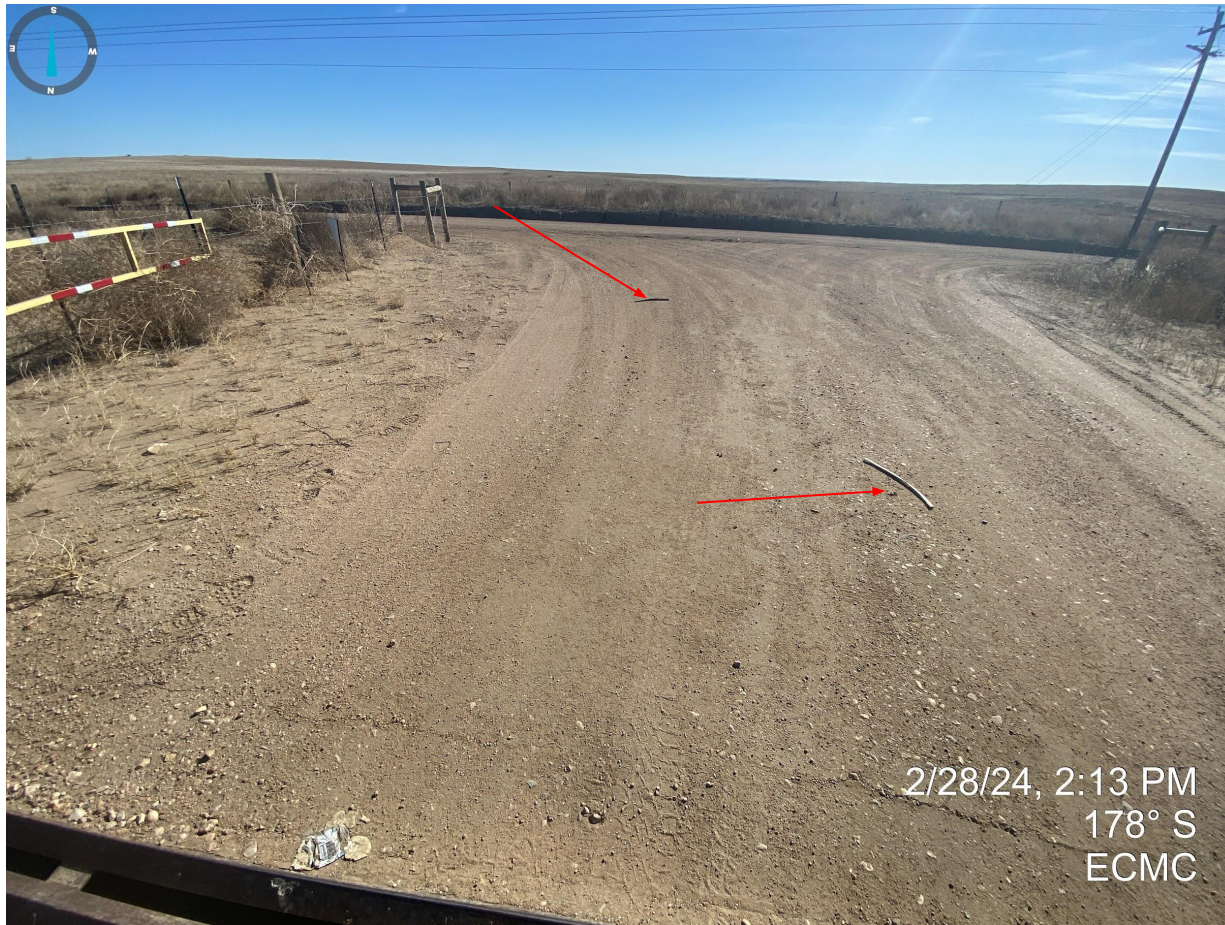
Photo 1. Trash/debris observed at entrance.

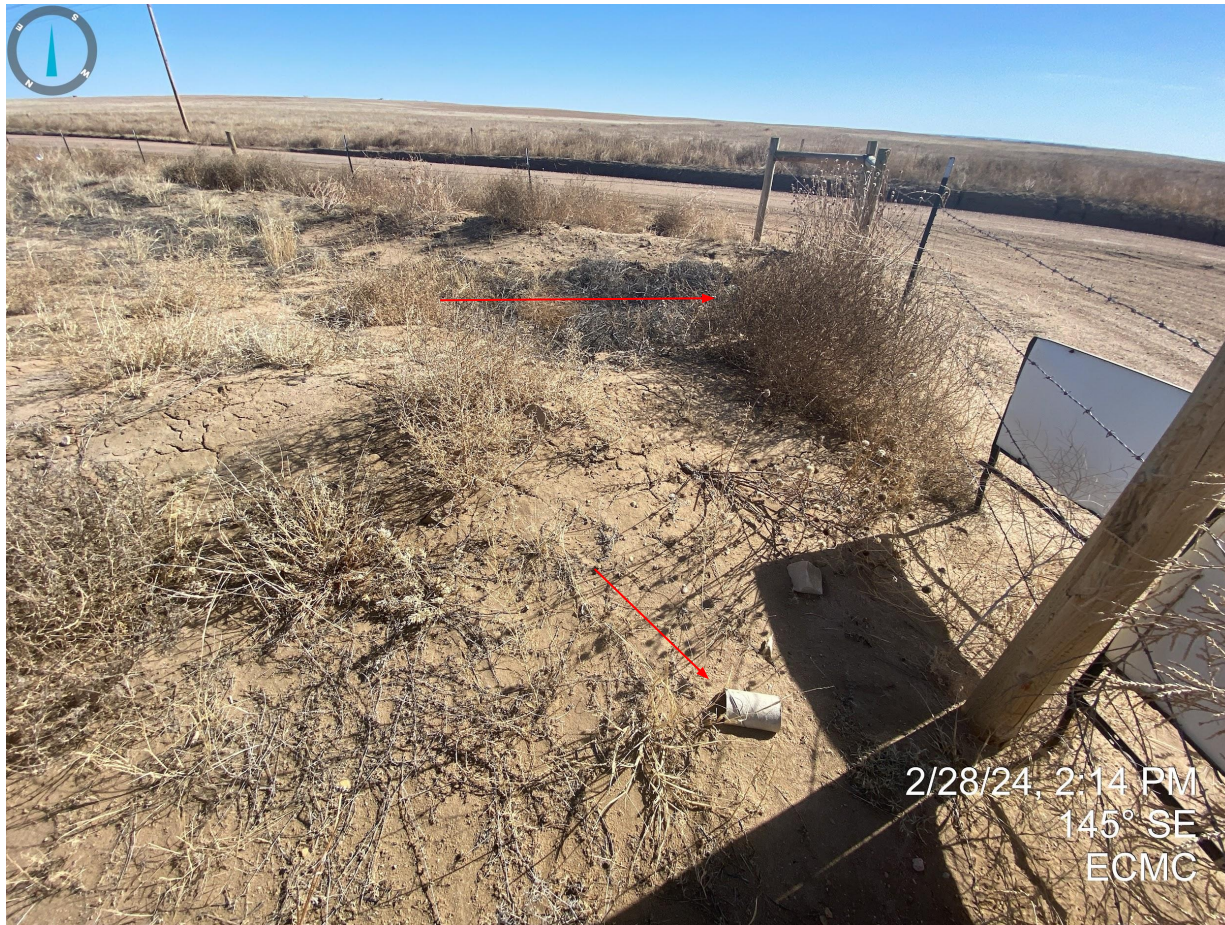
Photo 2. Trash and tumbleweed (undesirable vegetation) near entrance.

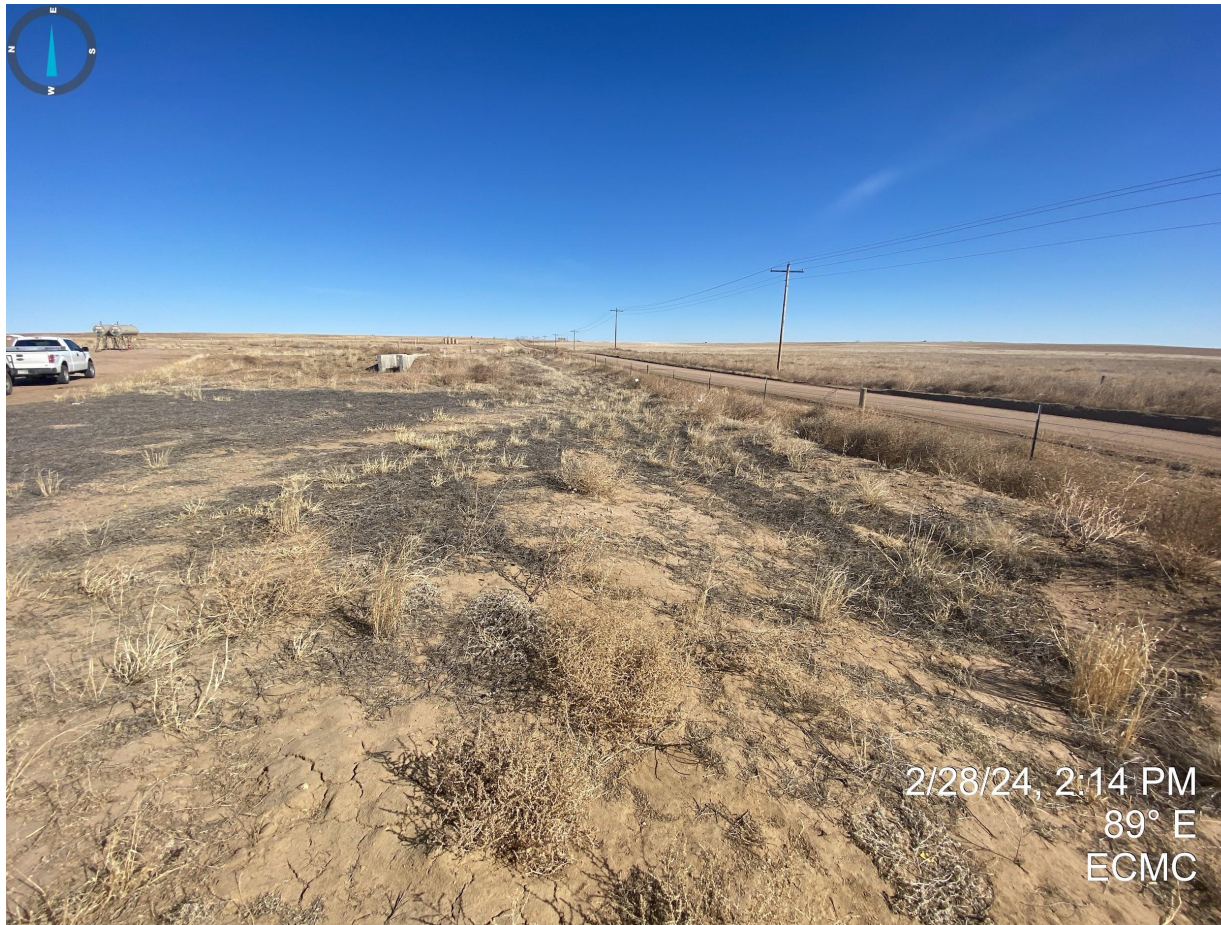
Photo 3. Taken near the entrance; interim areas are primarily exposed soils which are not properly stabilized with perennial vegetation.

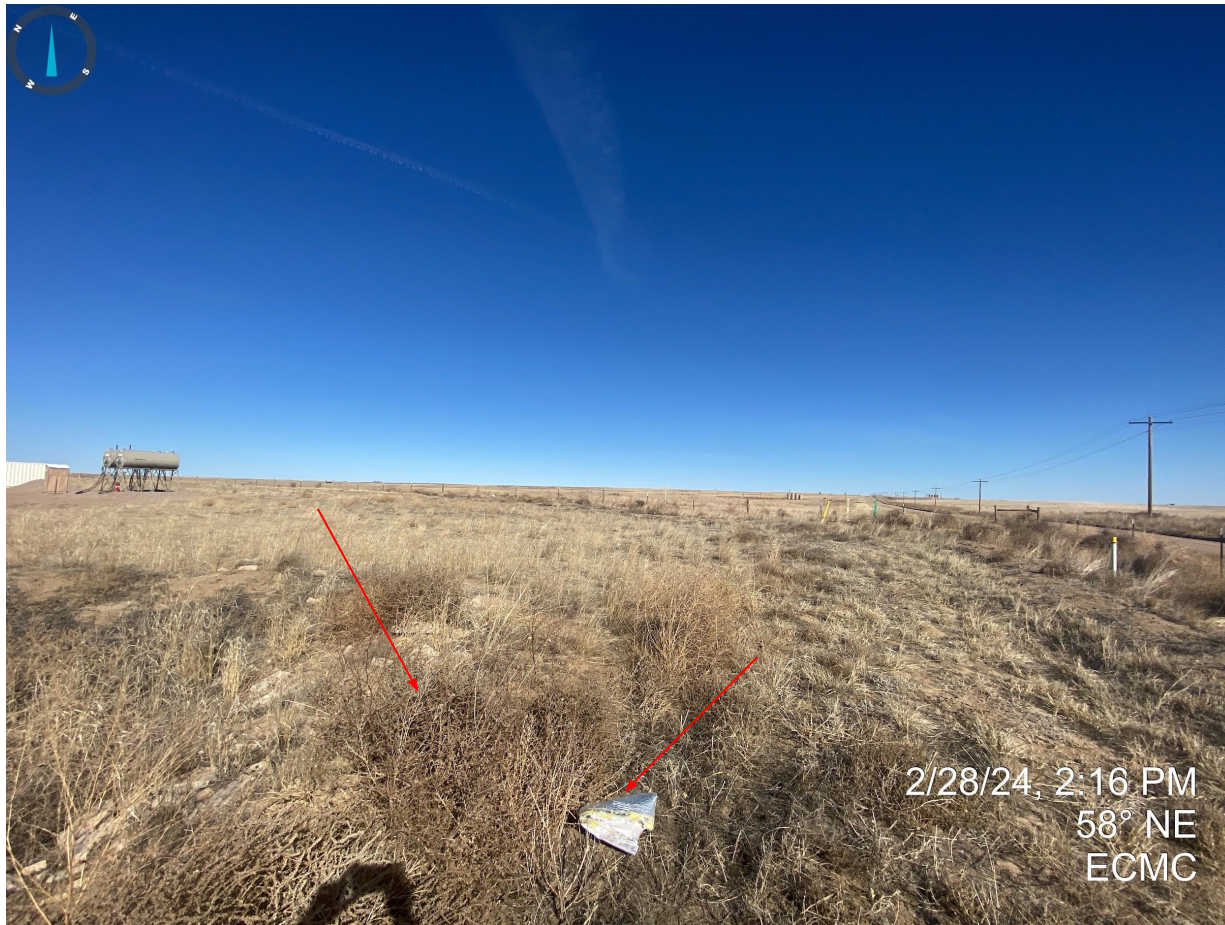
Photo 4. Taken near the southeast corner; trash and undesirable vegetation observed.

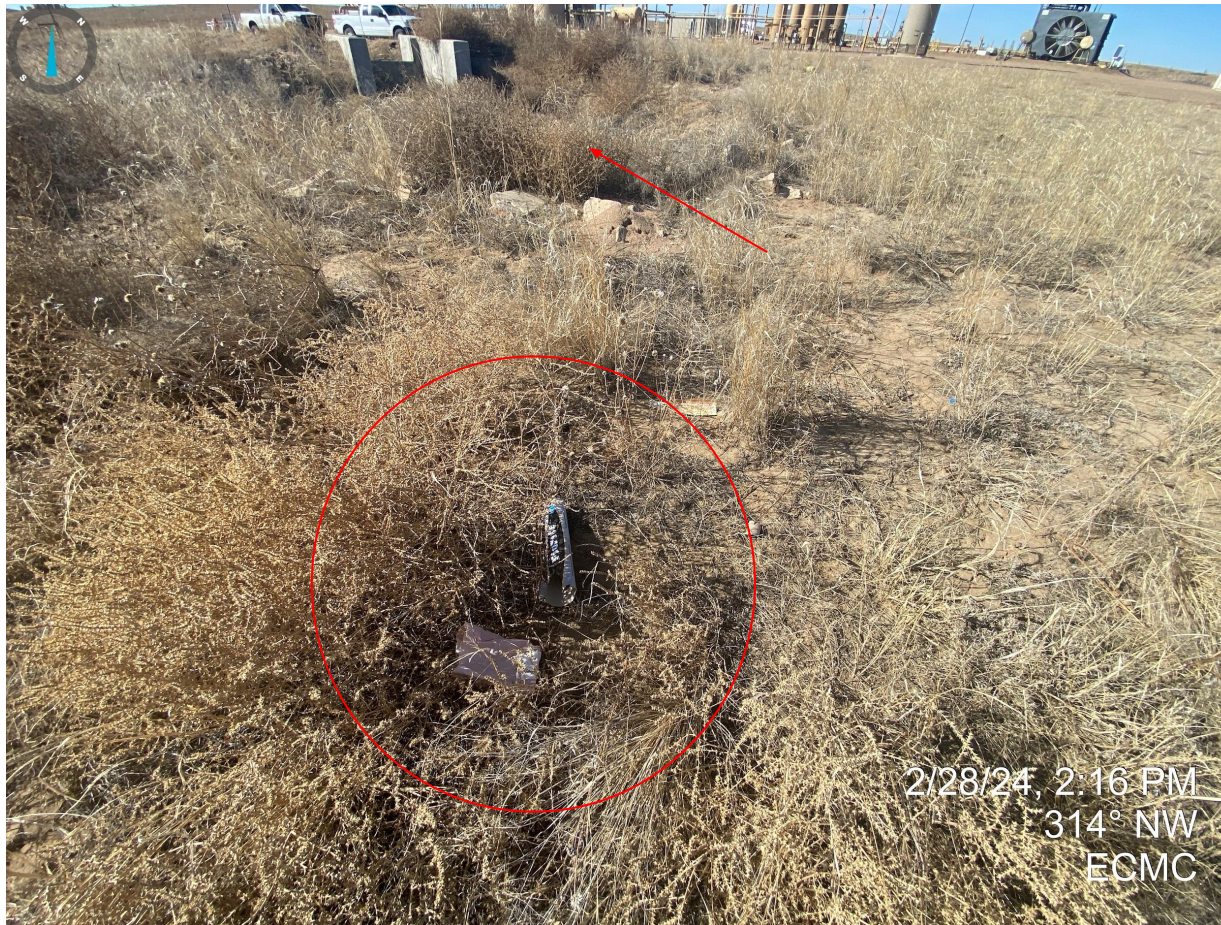
Photo 5. Taken near the southeast corner, by the sediment basin; trash and undesirable vegetation observed.

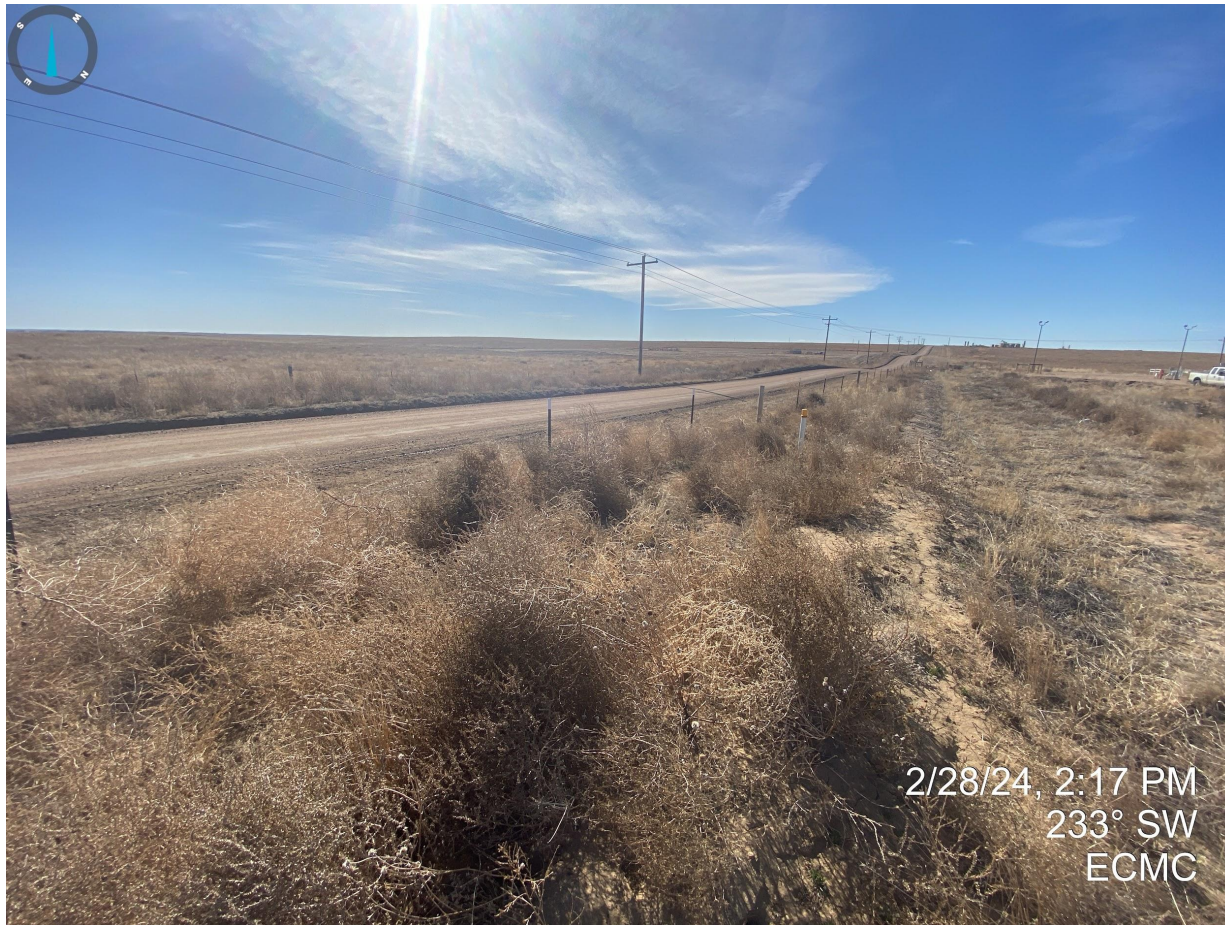
Photo 6. Tumbleweed accumulations observed on the southern fence line.

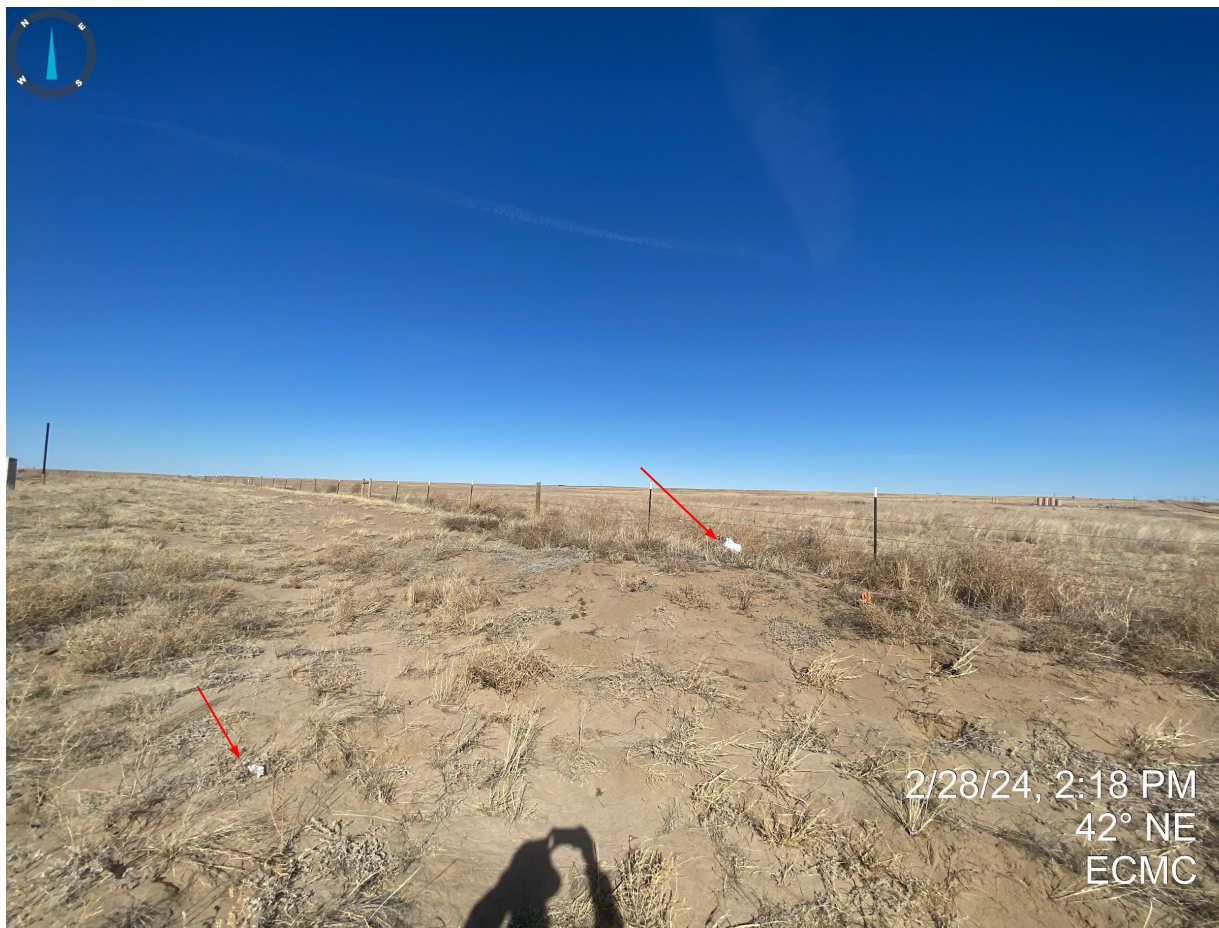
Photo 7. East side of location; interim areas are primarily exposed soils which are not properly stabilized with perennial vegetation. Trash indicated by red arrows.

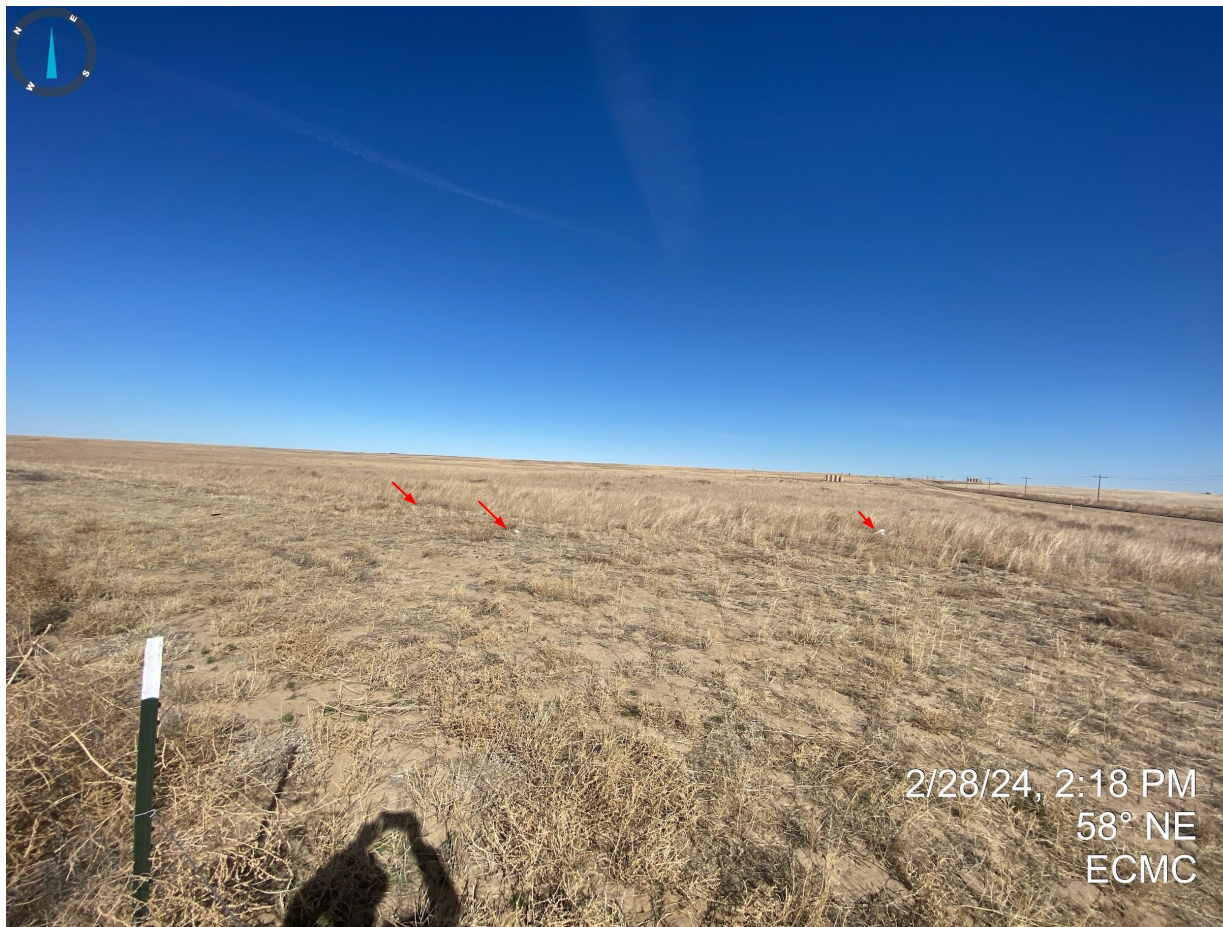
Photo 8. Eastside of location; trash observed off location into adjacent areas needs to be removed.

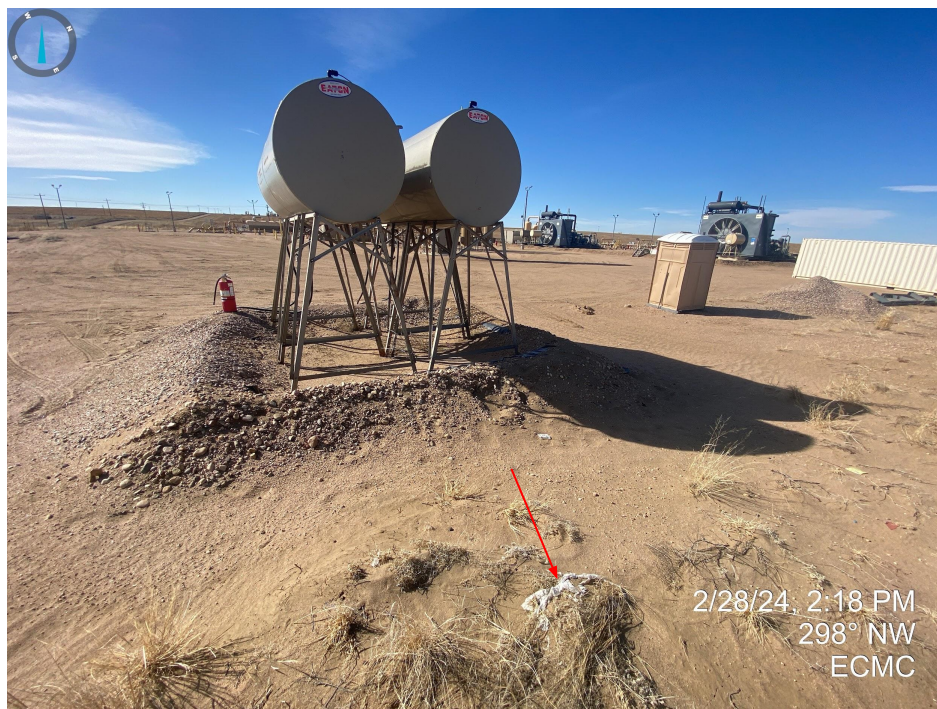
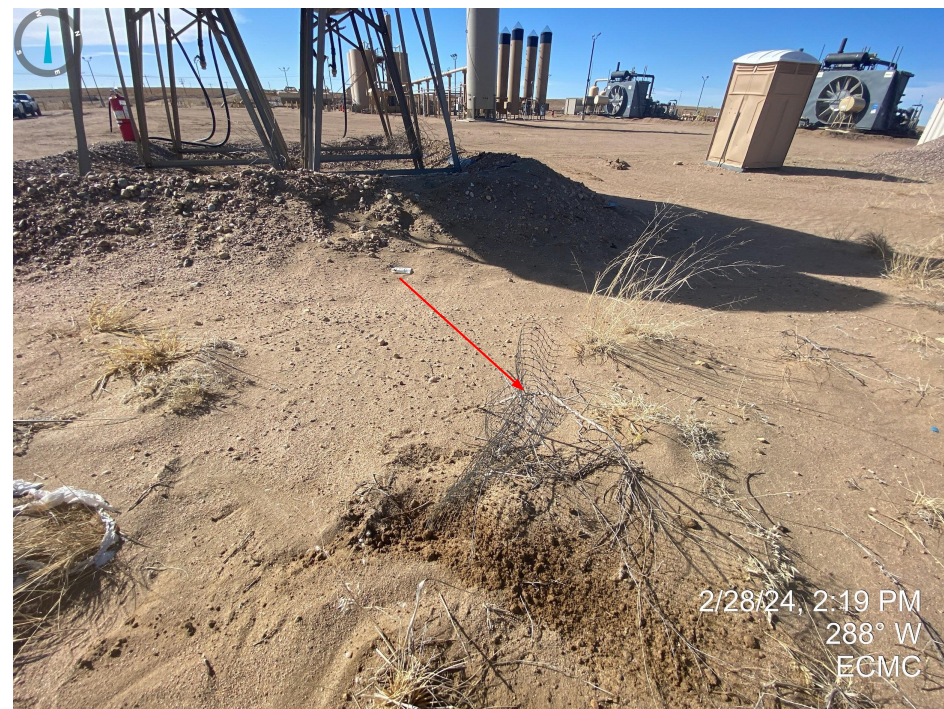
Photos 9 & 10. Unstabilized soils evidence by wind erosion and plastic netting (partially buried) and trash that requires removal.

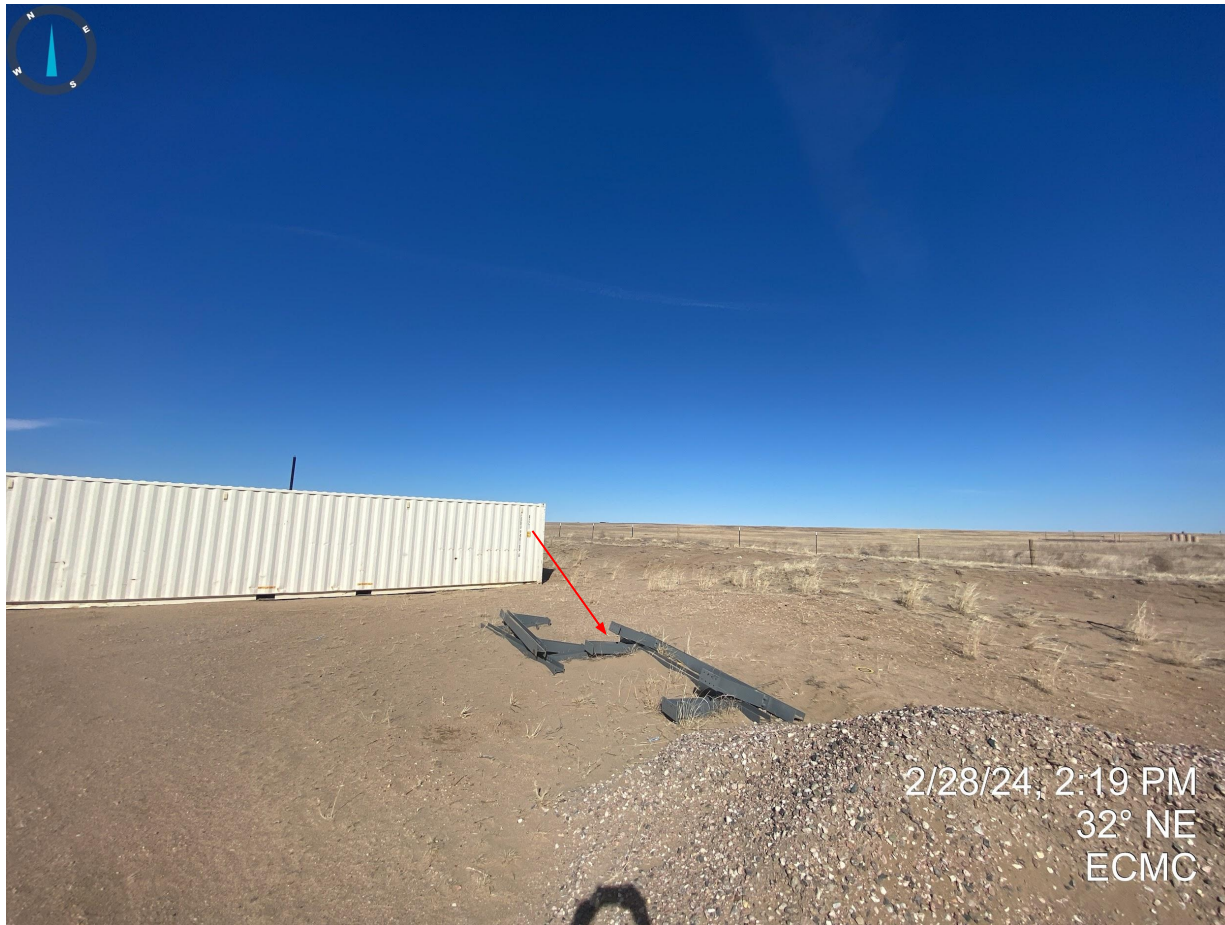
Photo 11. Unused equipment observed on the east side of location.

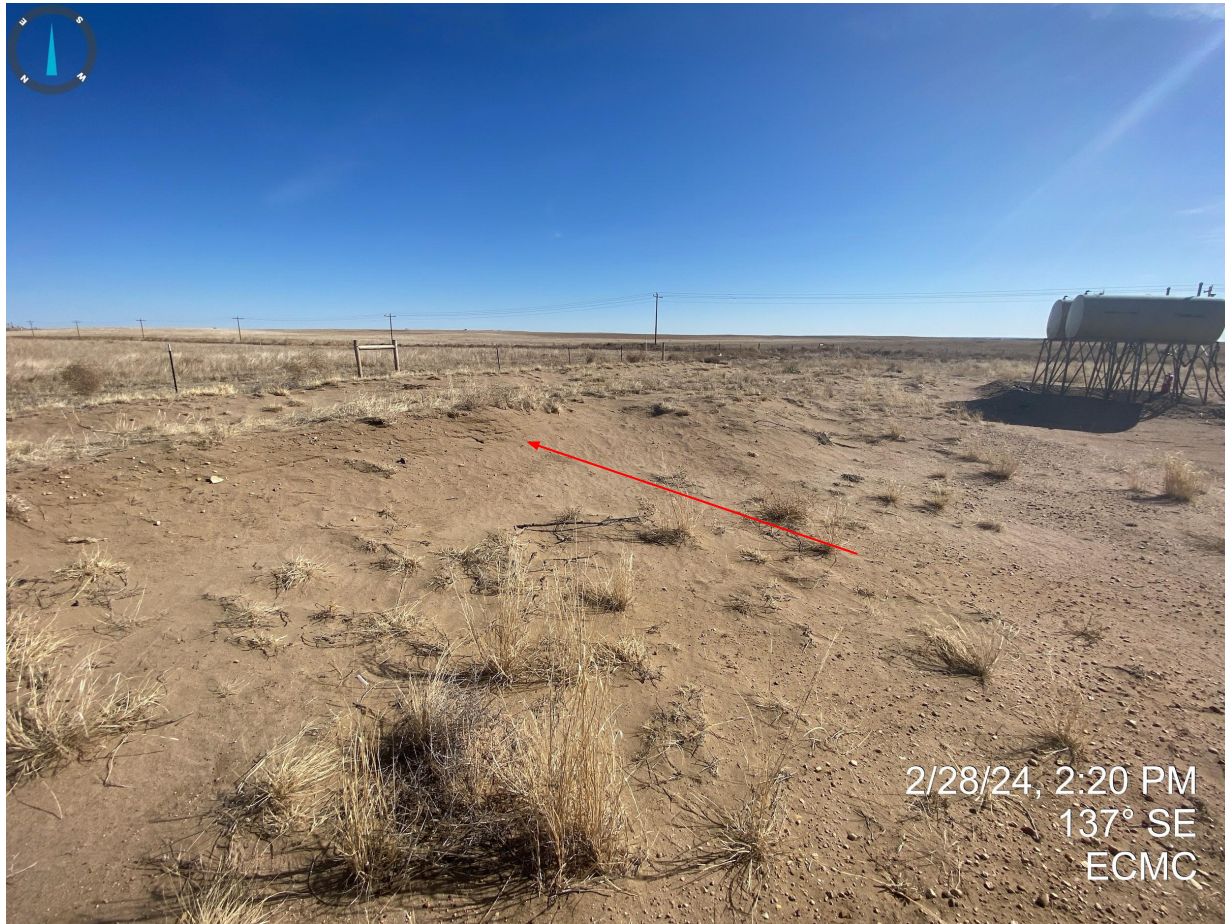
Photo 12. Evidence of wind erosion on unstabilized soils within the interim areas.

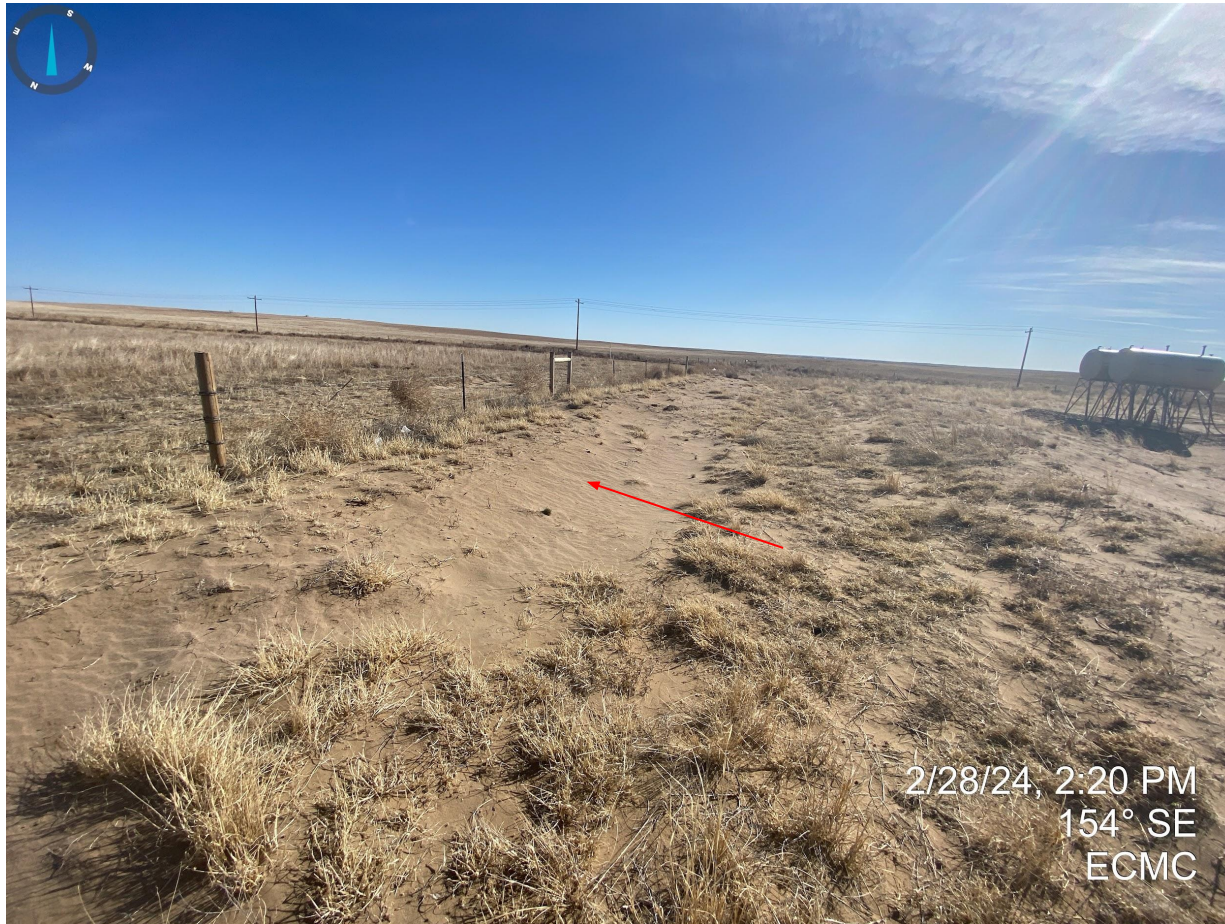
Photo 13. Continued from Photo 12.

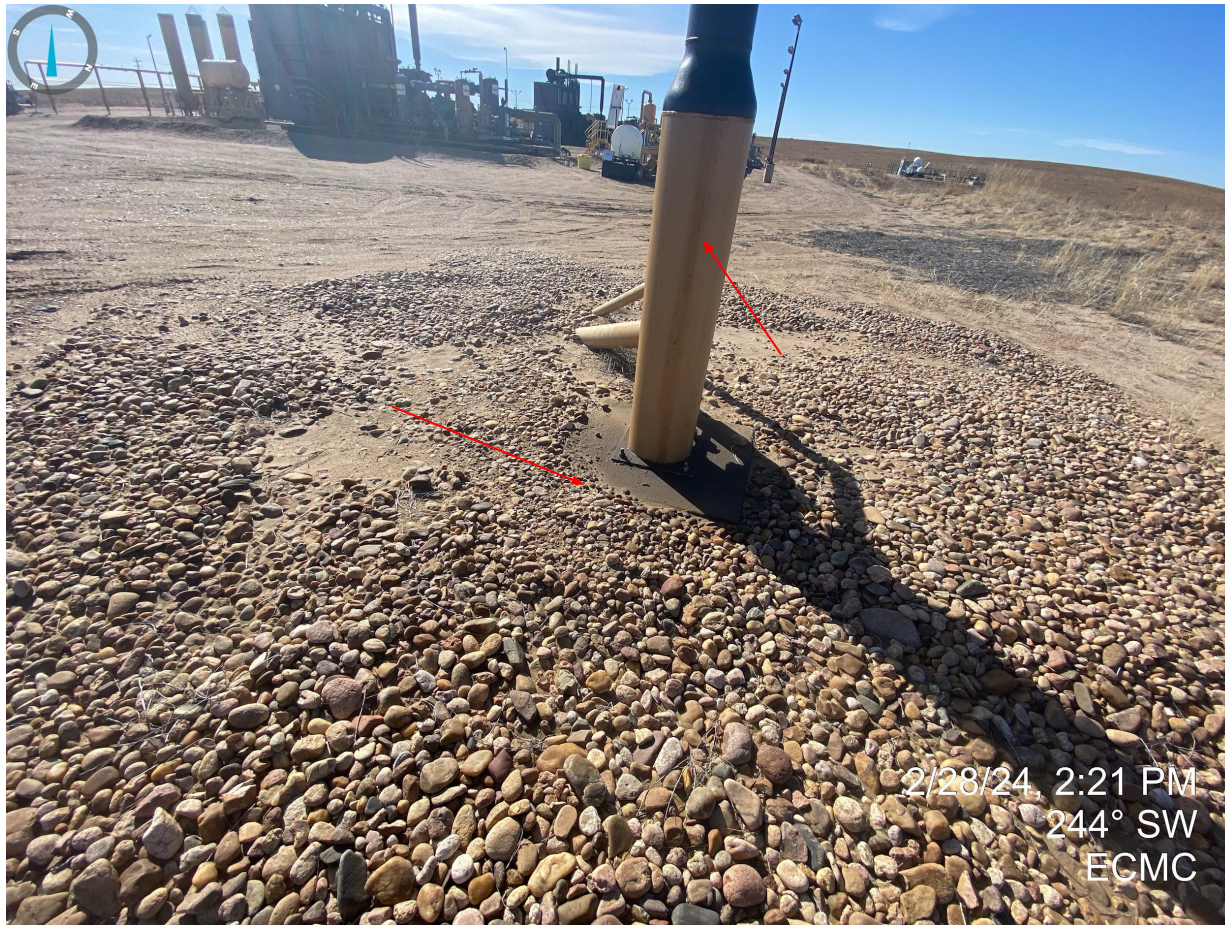
Photo 14. Stained soils and visible fluid on flare unit.

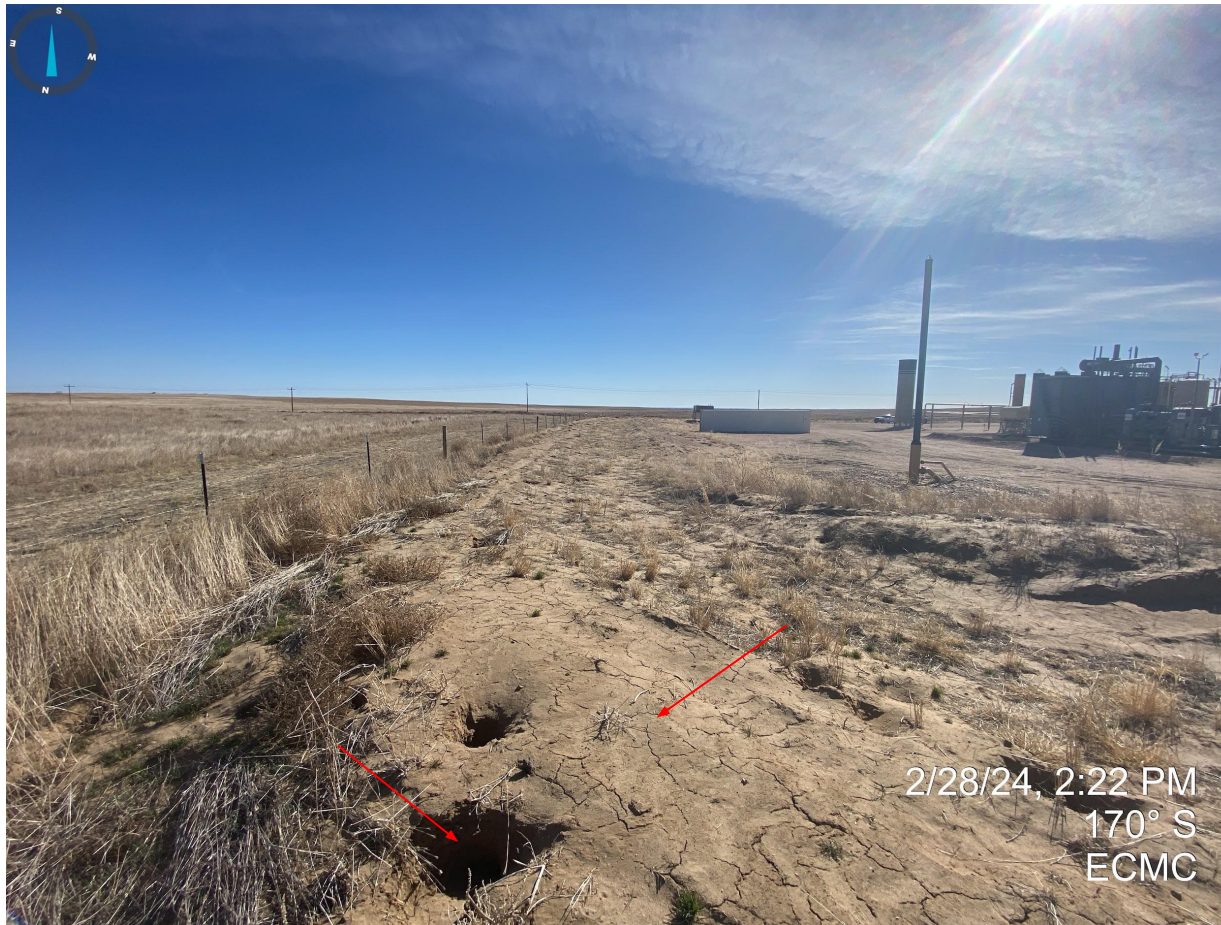
Photo 15. Northeast side of location; interim areas are primarily exposed soils which are not properly stabilized with perennial vegetation. Animal burrow/holes observed throughout the perimeter of the location.

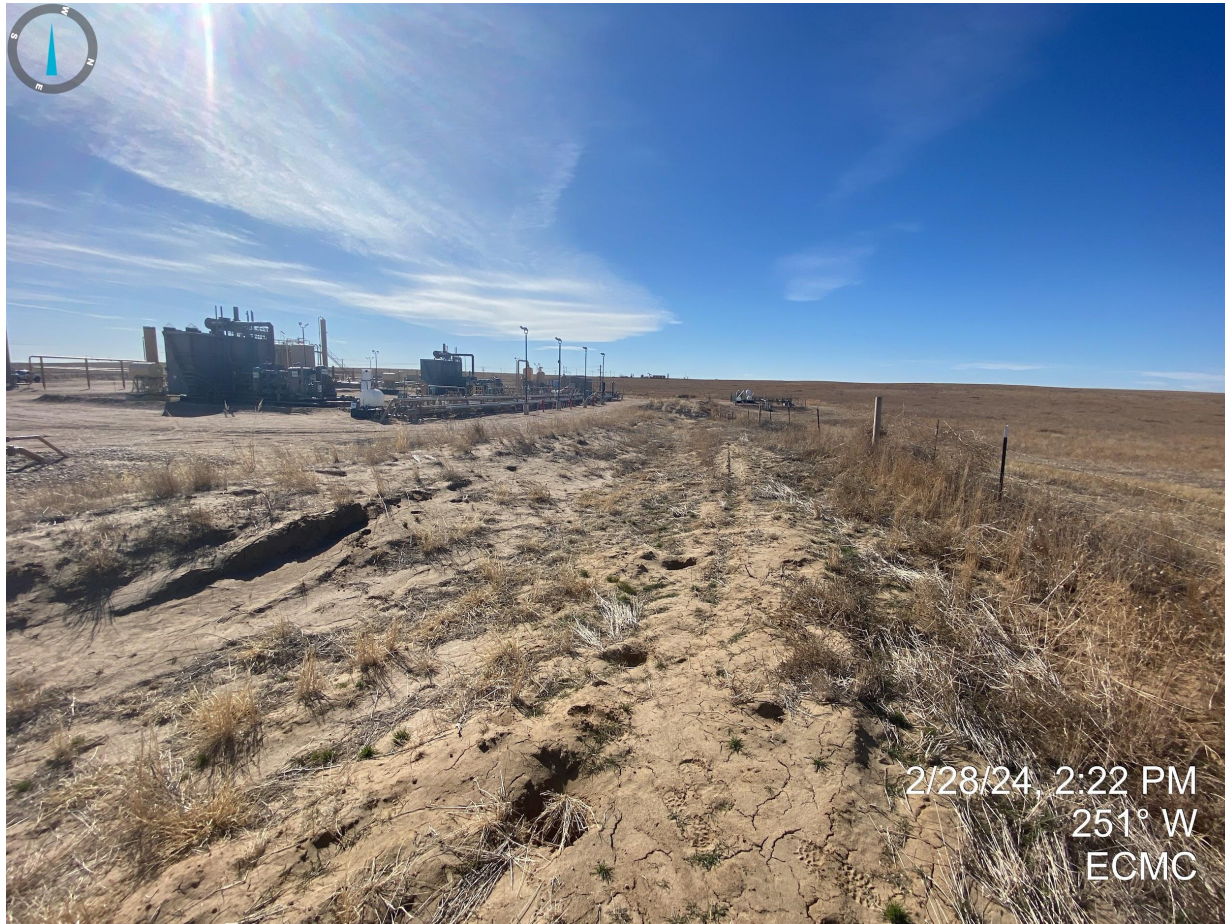
Photo 16. Continued from photo 15, facing west.

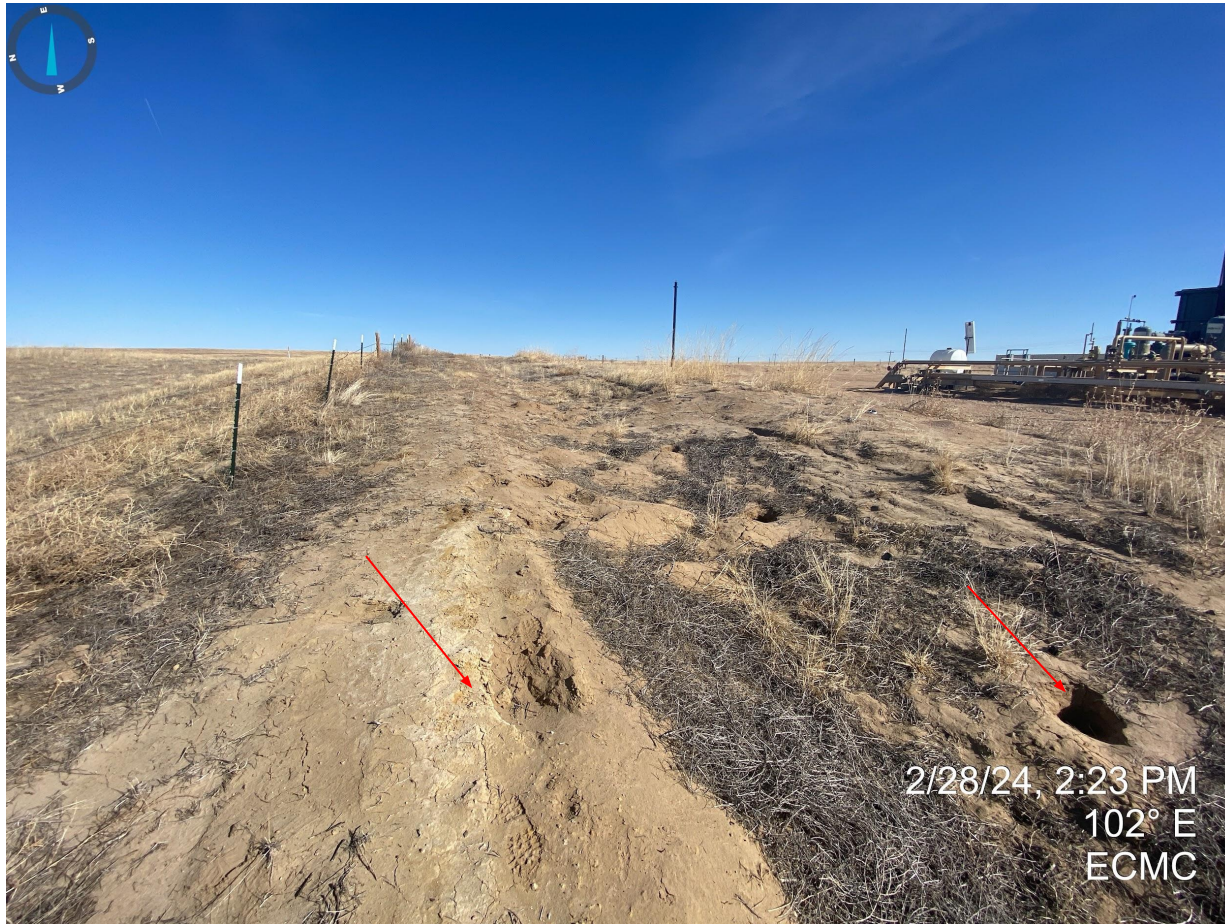
Photo 17. Northern portion of the location; interim areas are primarily exposed soils which are not properly stabilized with perennial vegetation. Animal burrow/holes observed throughout the perimeter of the location.

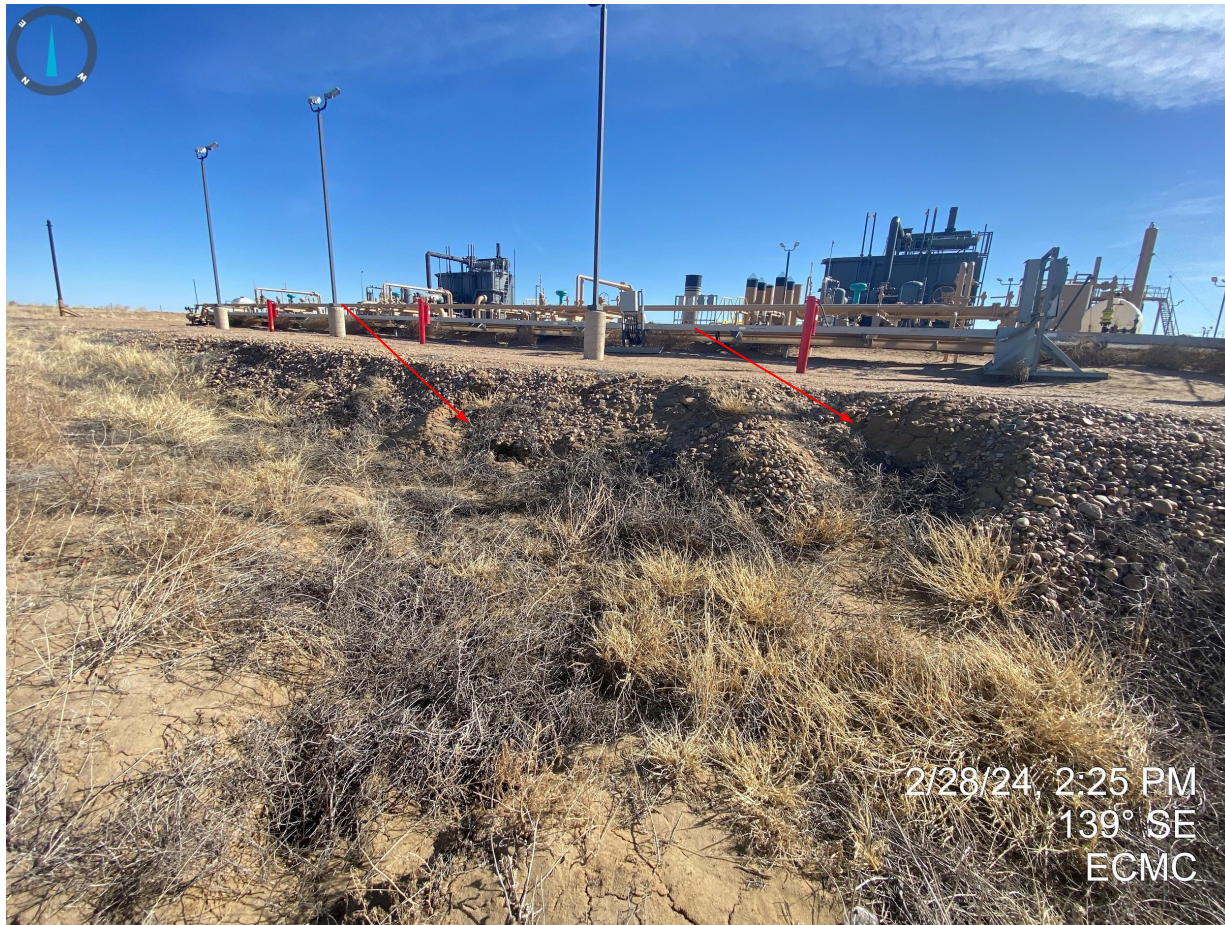
Photo 18. Erosion degradation occurring from unstabilized portions of the production areas; northside of location.

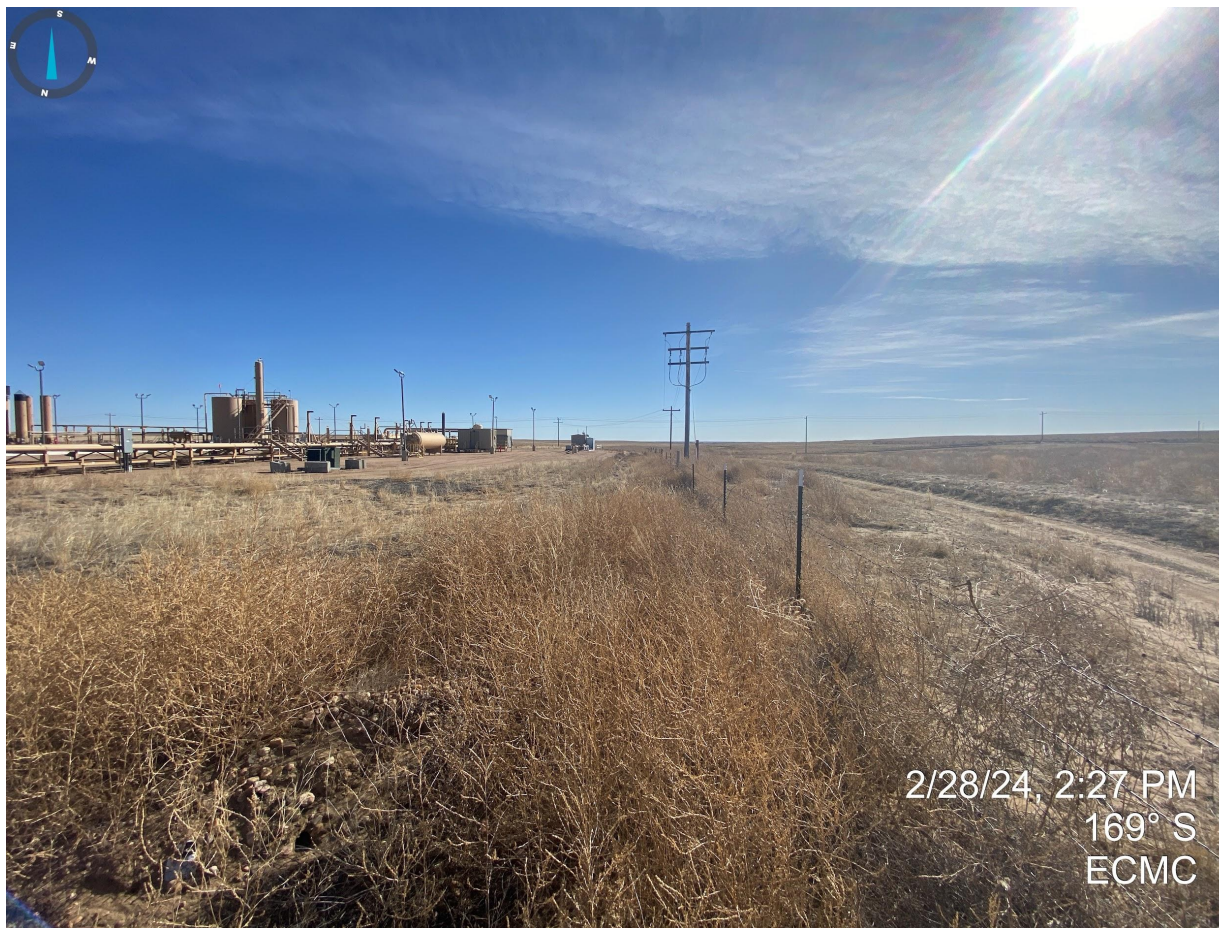
Photo 19. Northwest corner of the location; undesirable vegetation and tumbleweed accumulations observed.

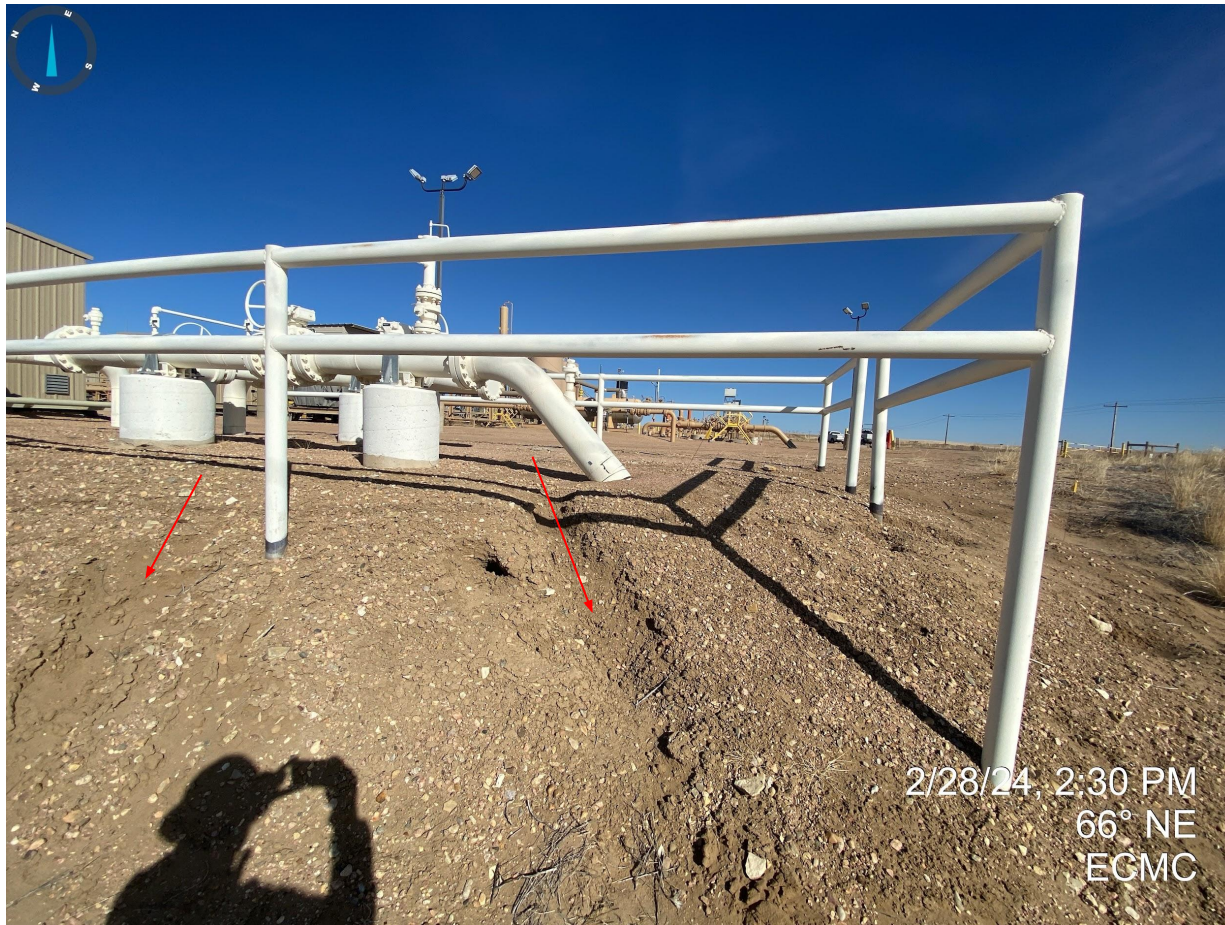
Photo 20. Erosion degradation occurring from unstabilized portions of the production areas; southwest corner of location.
