Interim Reclamation and Stormwater Inspection

Operator: BONANZA CREEK ENERGY OPERATING
COMPANY LLC- 8960

Inspection Document #: 708200961

Location Name: Pronghorn 24-7 Booster

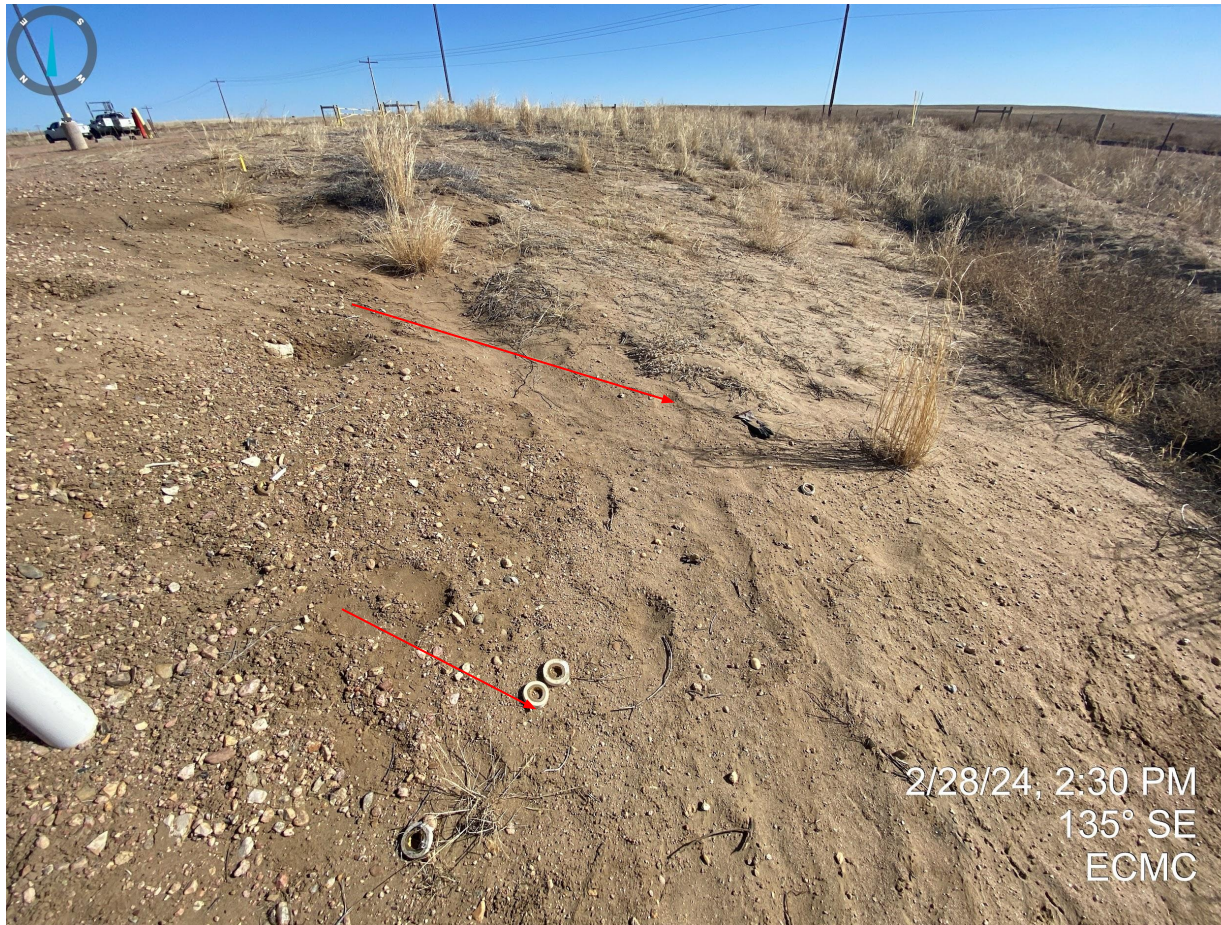
Photo 21. Trash/debris and unstabilized/exposed soils observed on the southwest corner of the location.

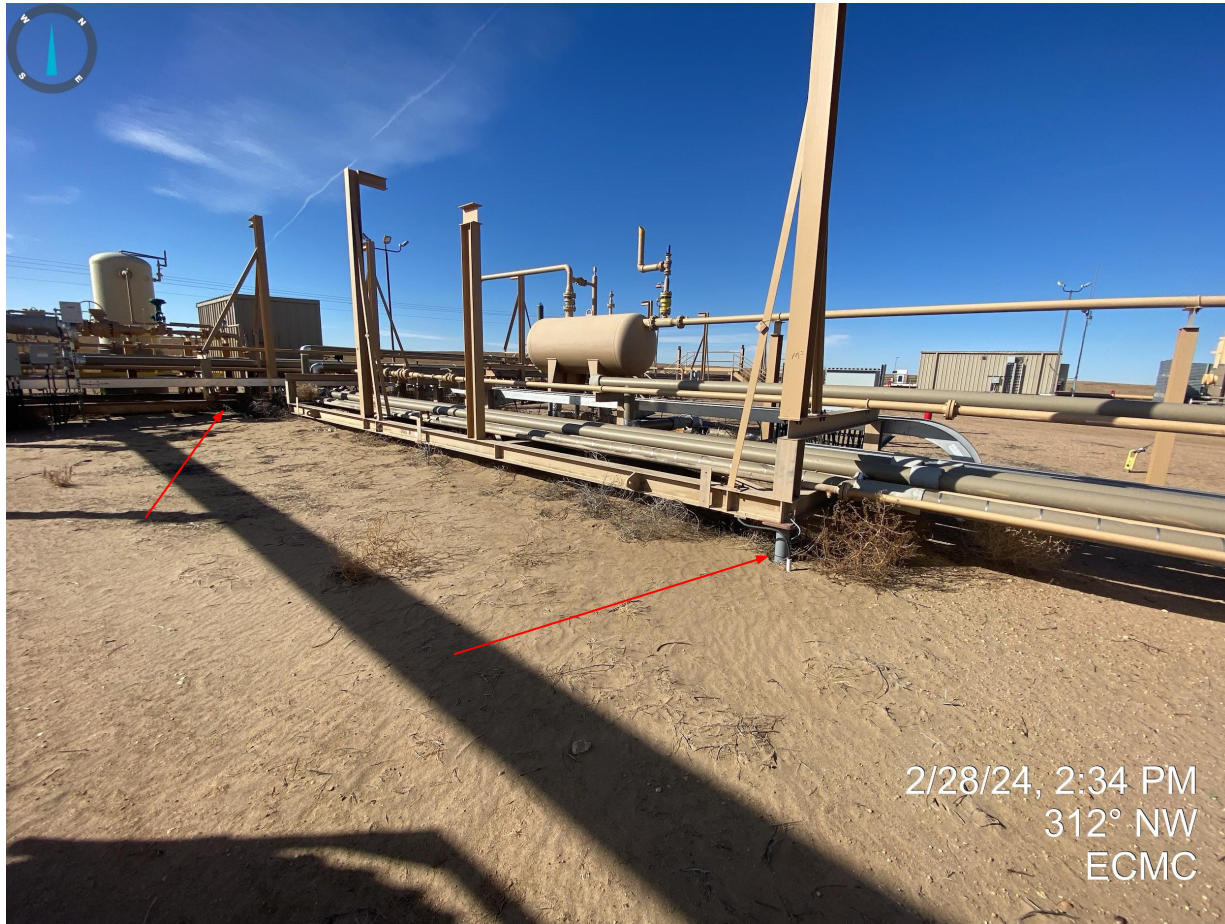
Photo 22. Tumbleweed accumulations within equipment.

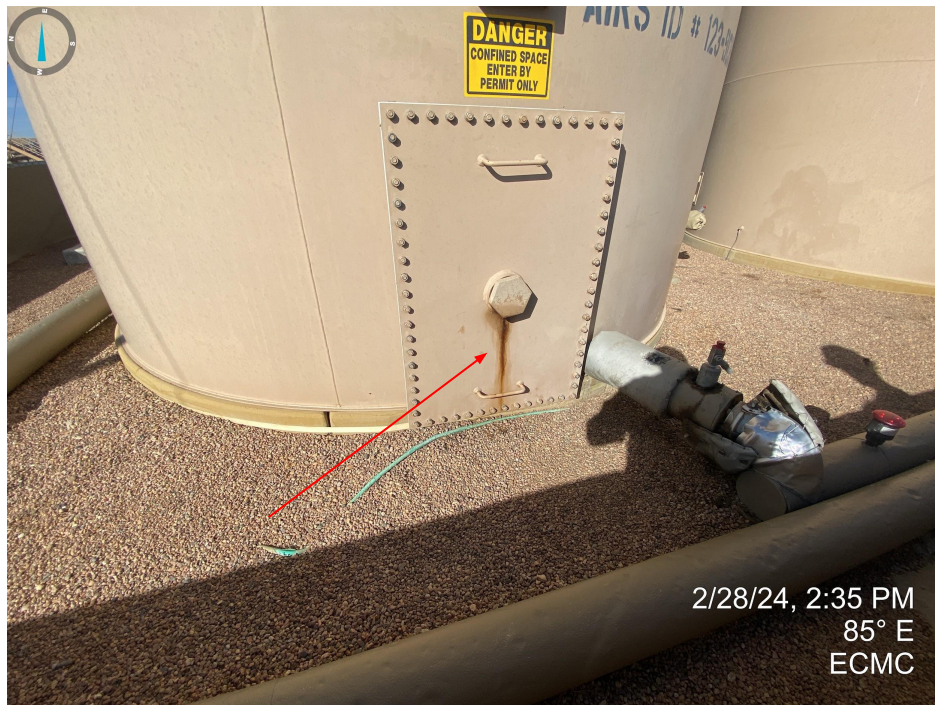
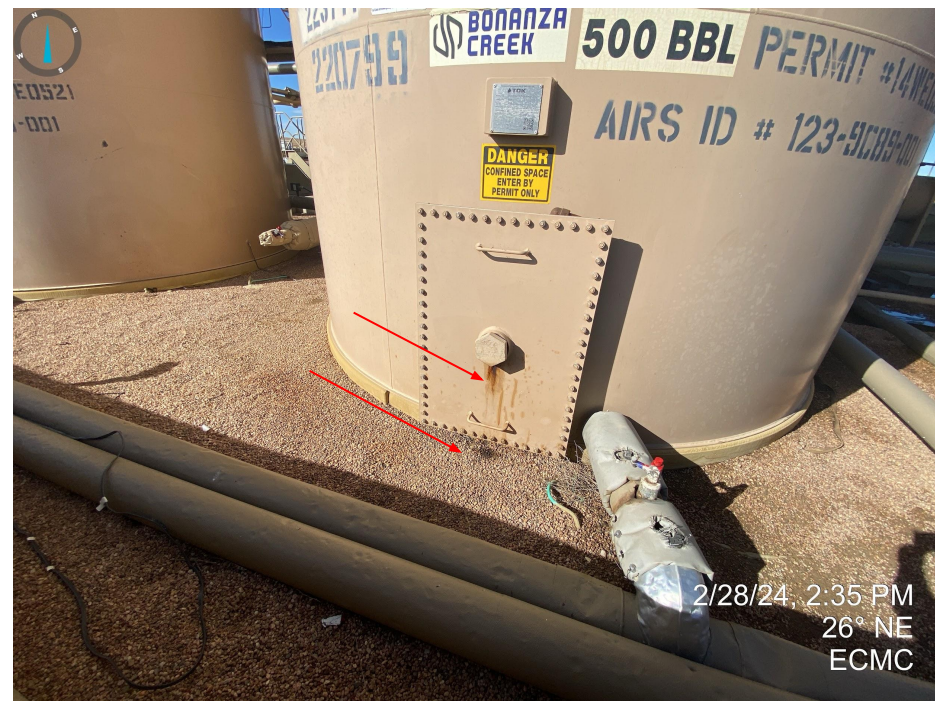
Photos 23 & 24. Stained soils and drips/drabs at tank battery bull plugs.

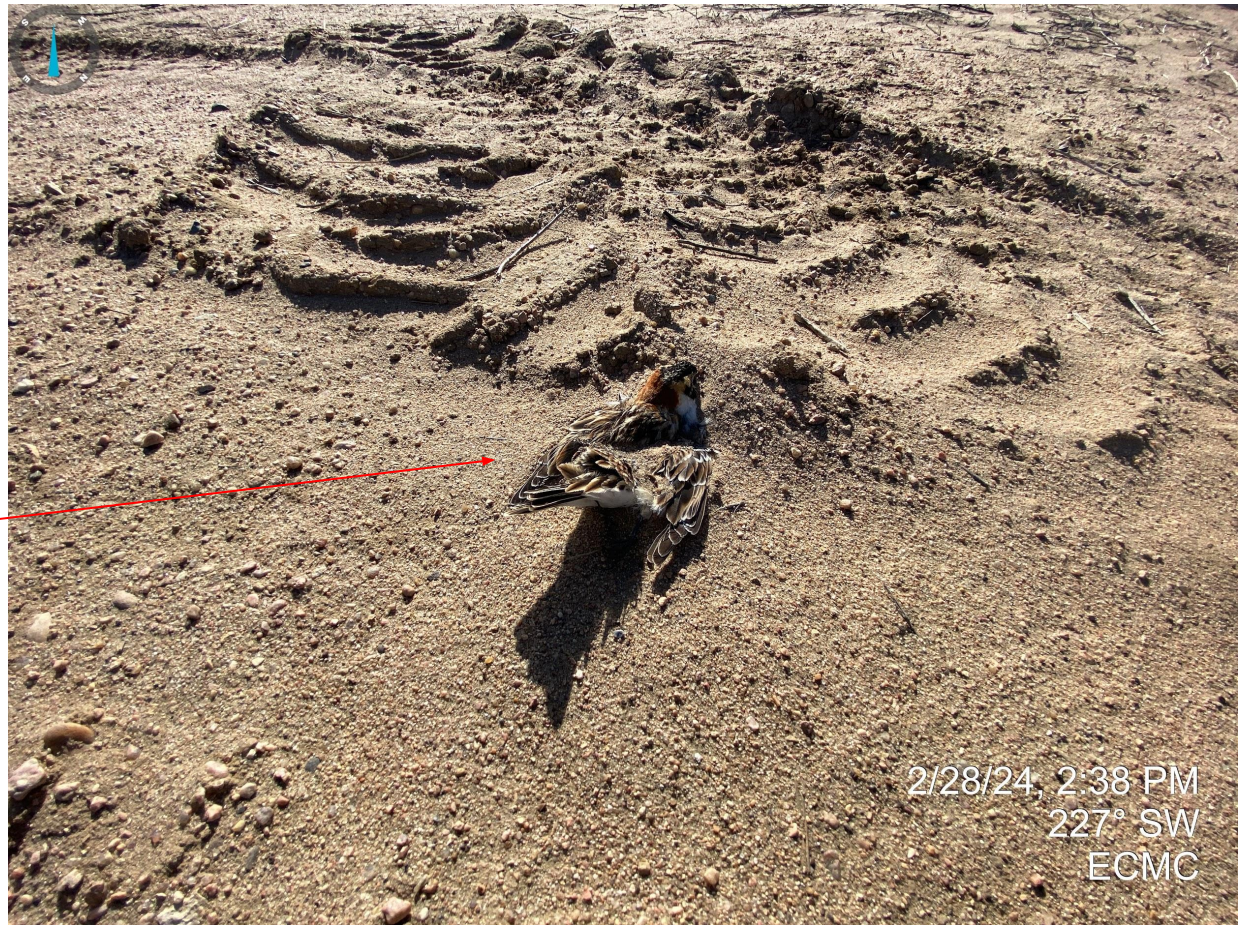
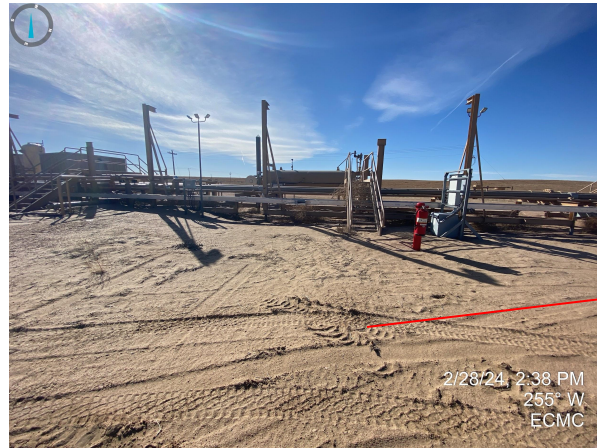
Photo 25. Wildlife mortality observed on location.

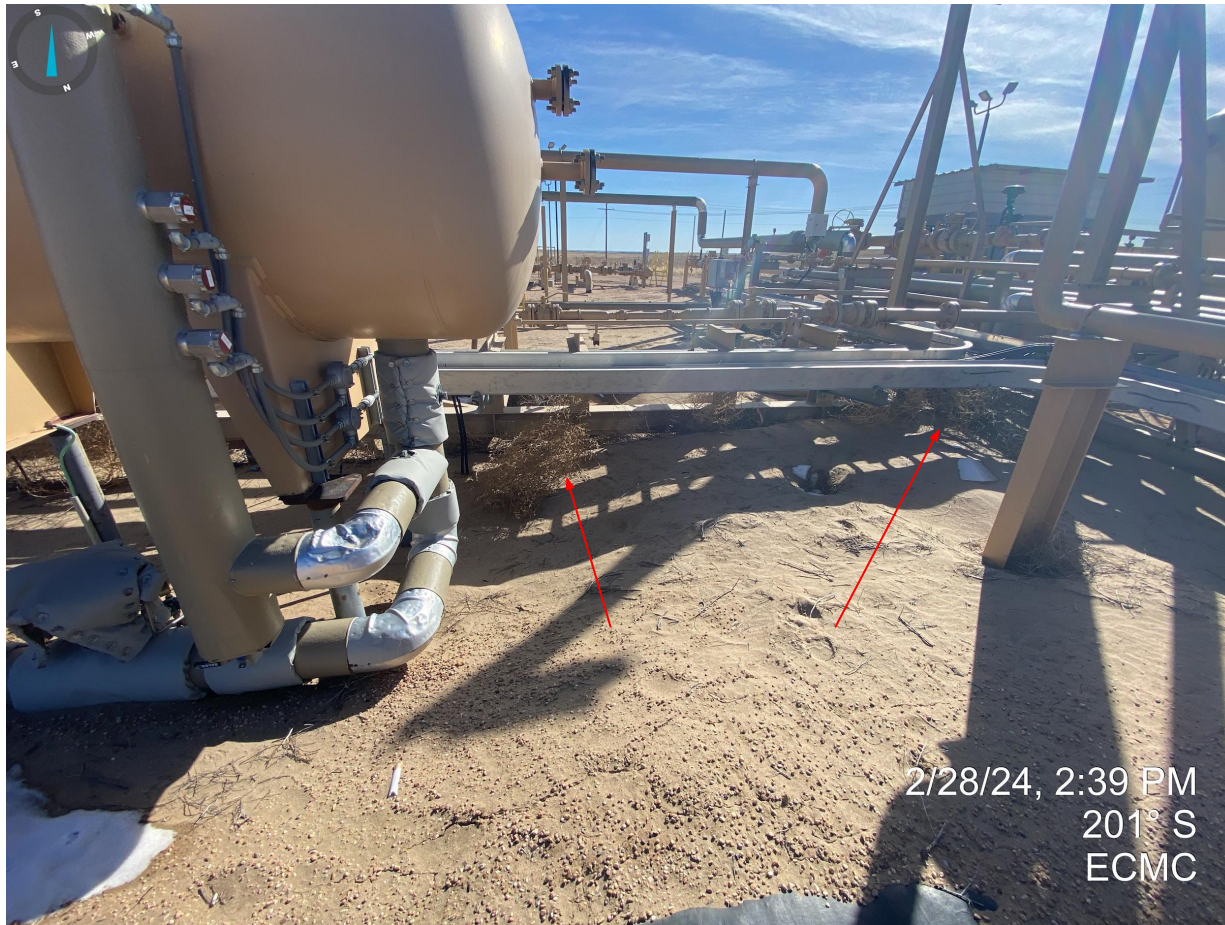
Photo 26. Tumbleweed accumulations within equipment.

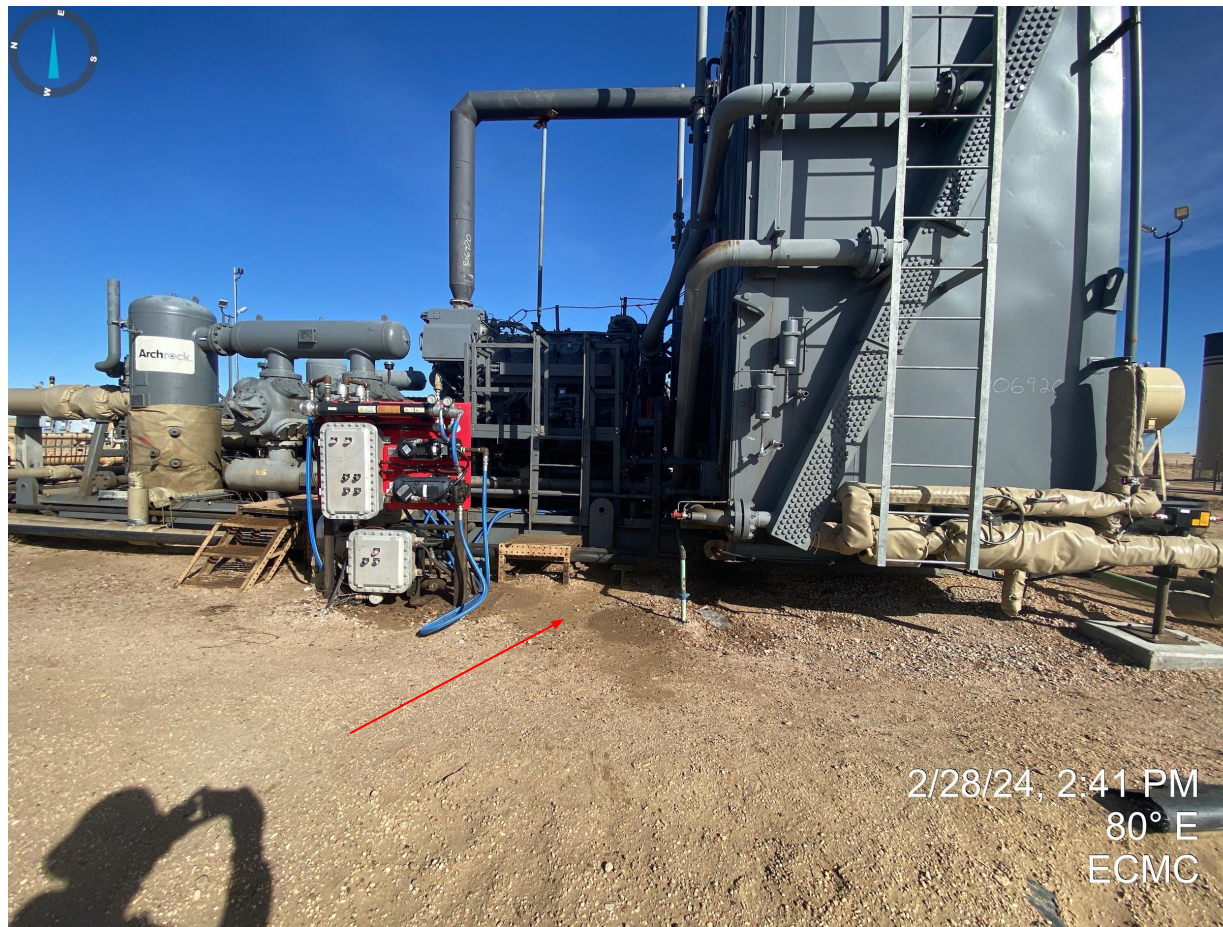
Photo 27. Stained soils observed at compressor.

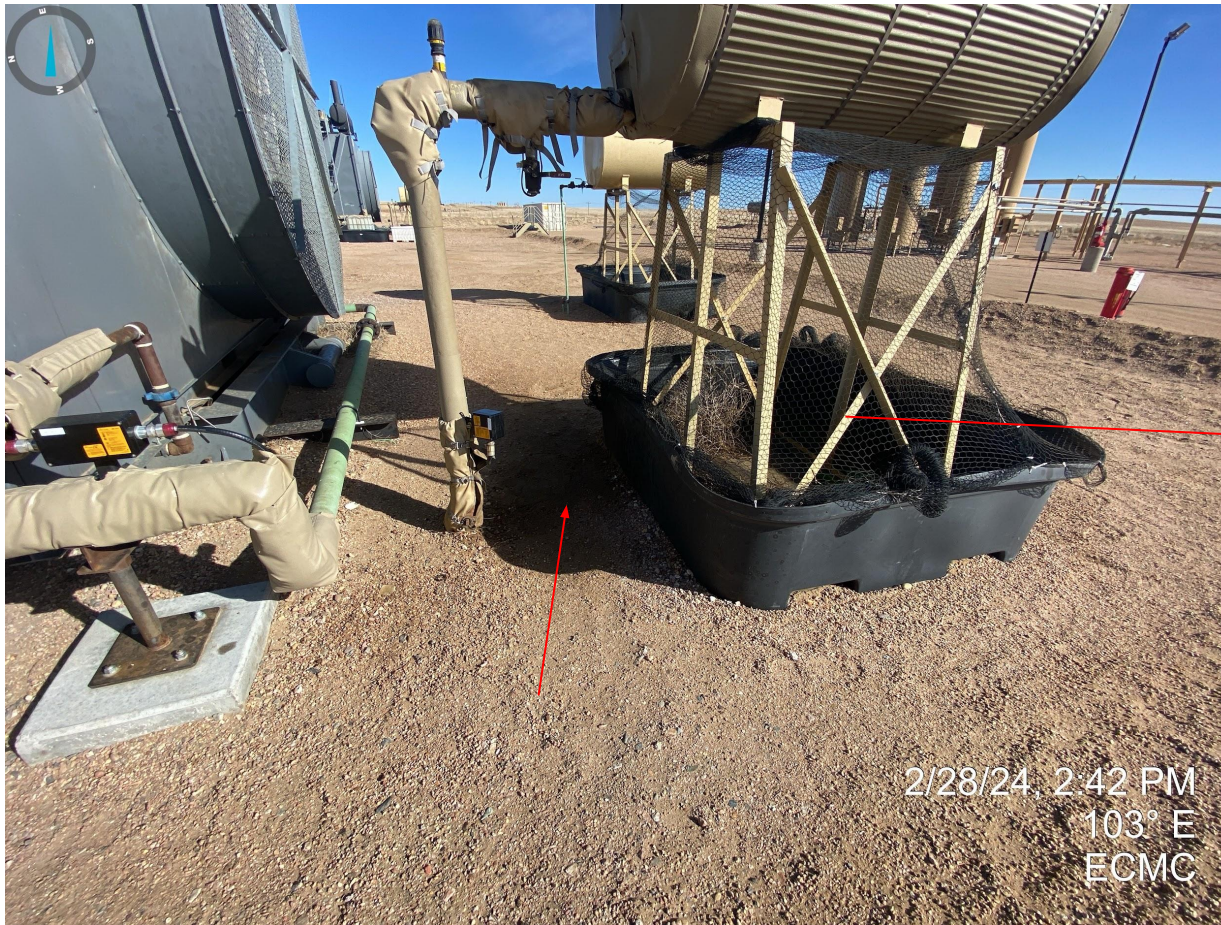
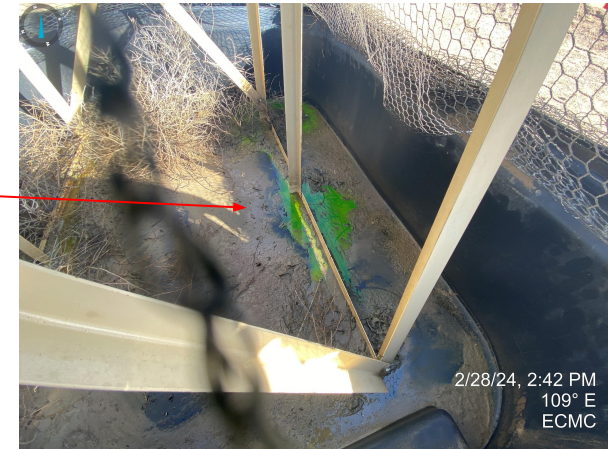
Photo 28. Stained soil and free fluid observed at compressor tank.

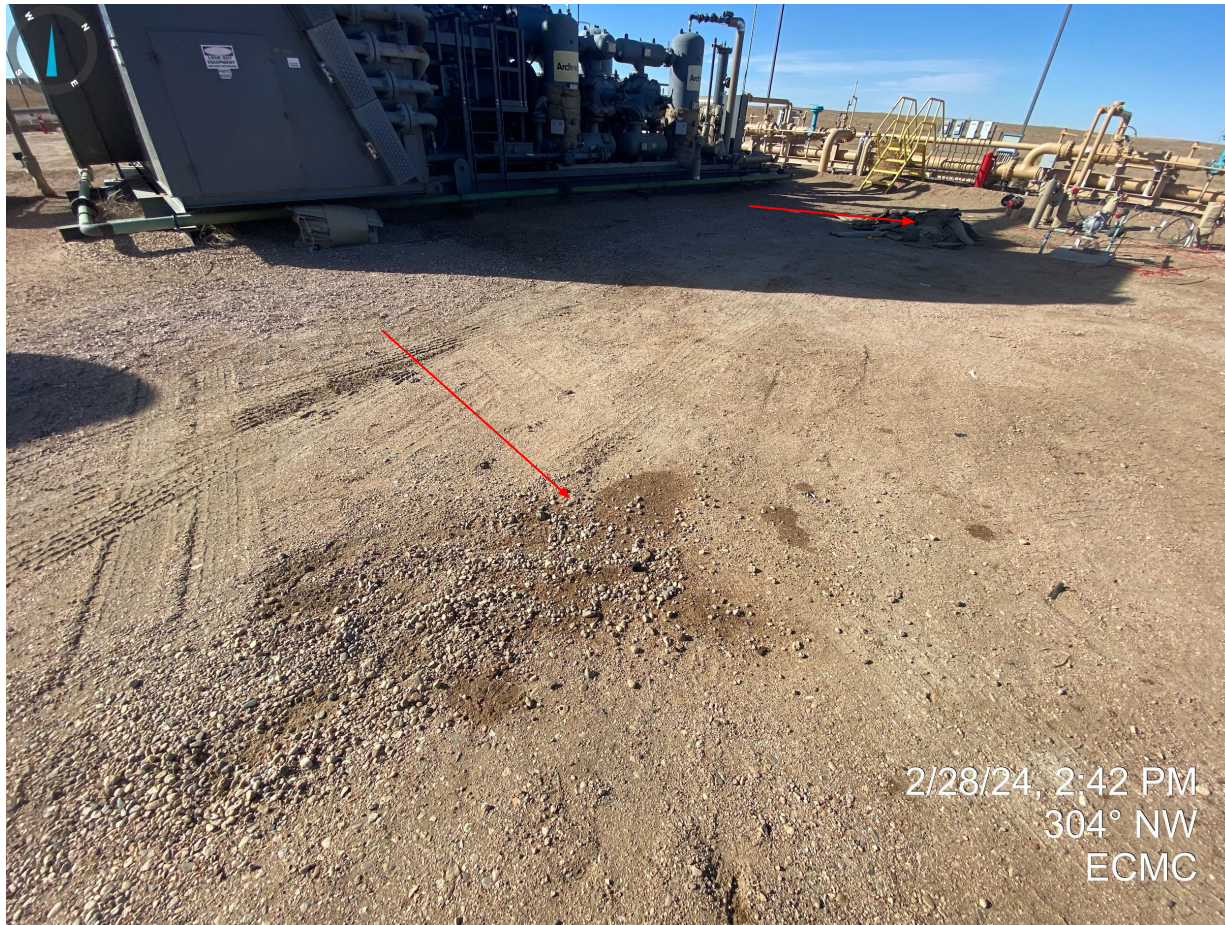
Photo 29. Stained soil and debris.

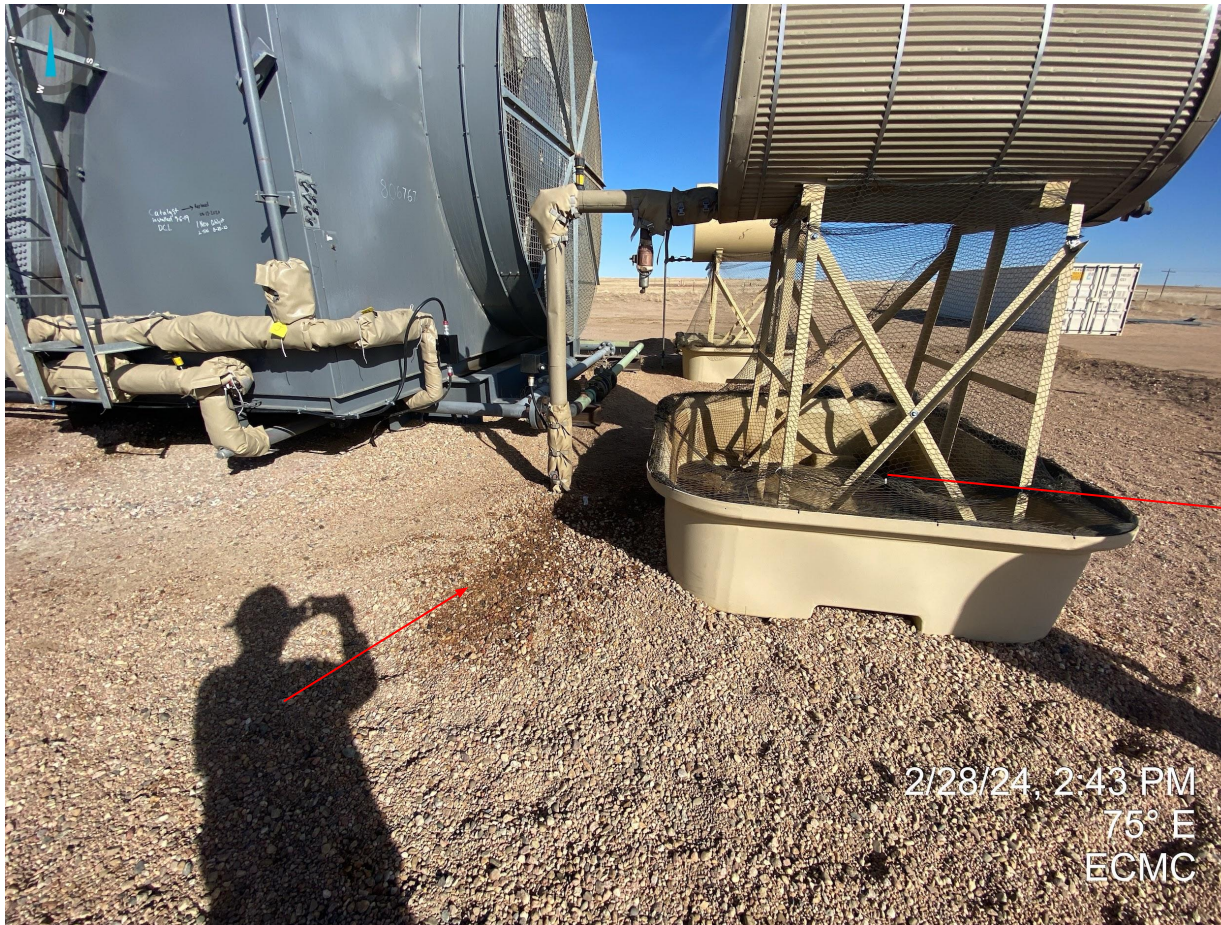
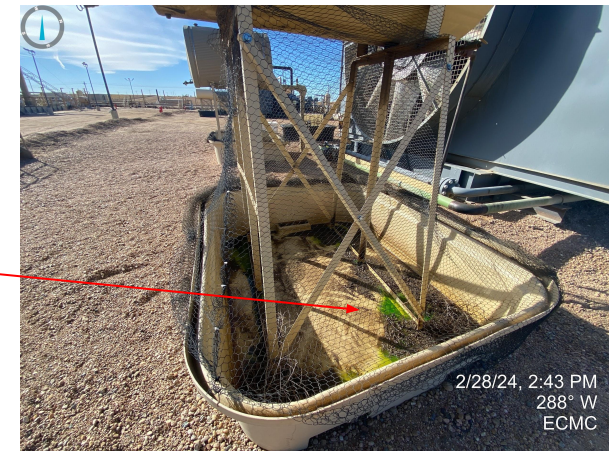
Photo 30. Stained soils and free fluids within secondary containment.

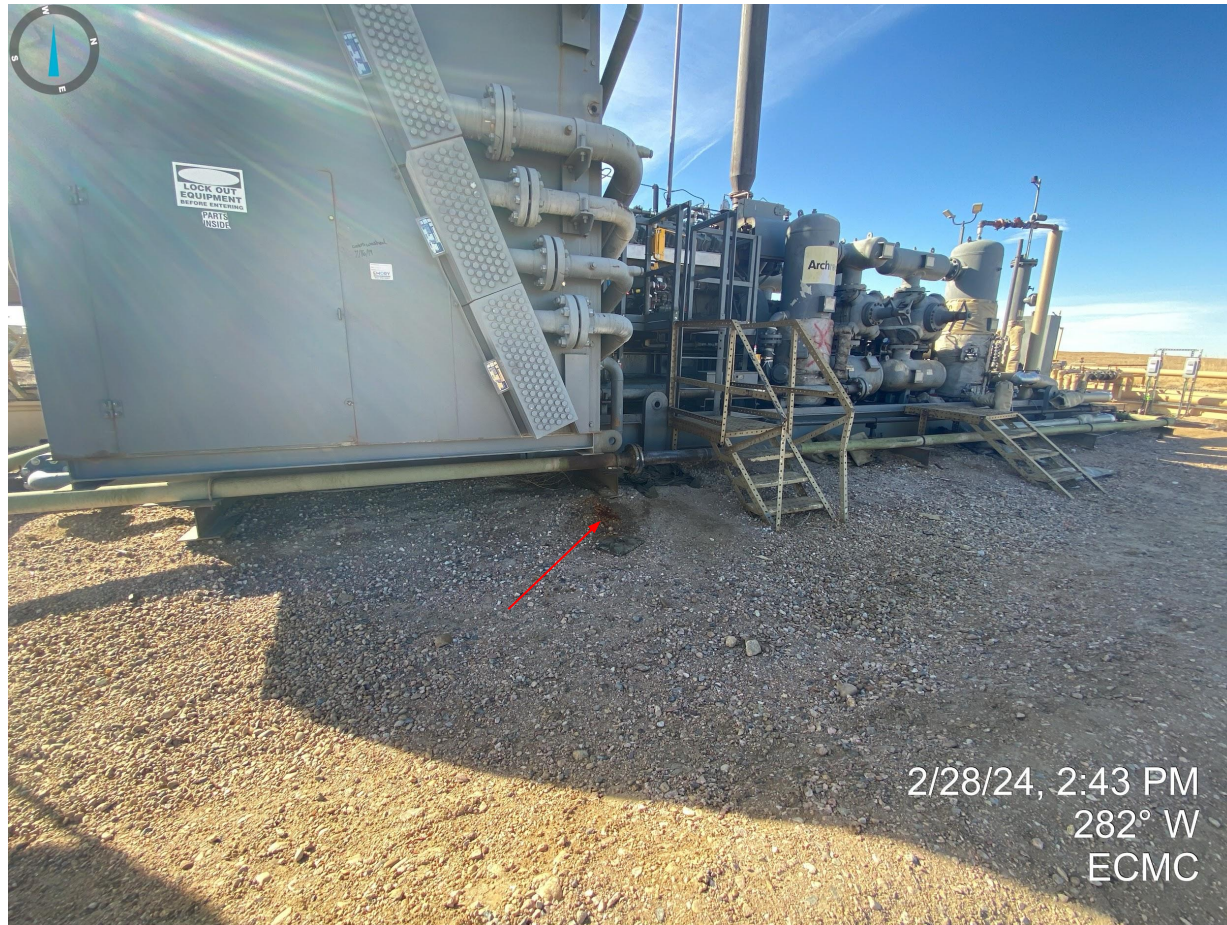
Photo 31. Stained soil at compressor.

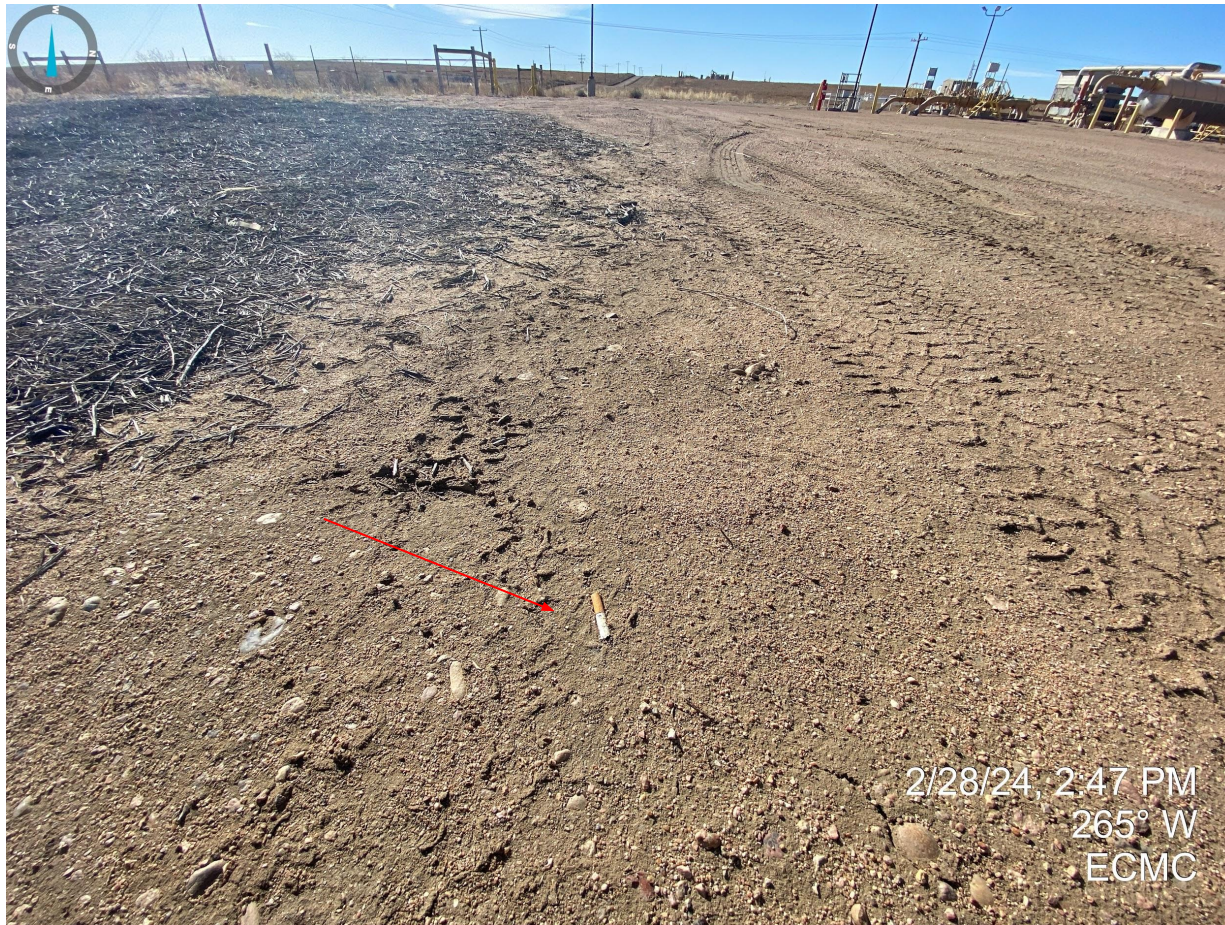
Photo 32. Cigarette butt observed on location.
