# Final Reclamation Inspection

Operator: Benson Montin and Greer Drilling Corporation - 7650

Location ID: 325330

Inspection Document #: 714000519

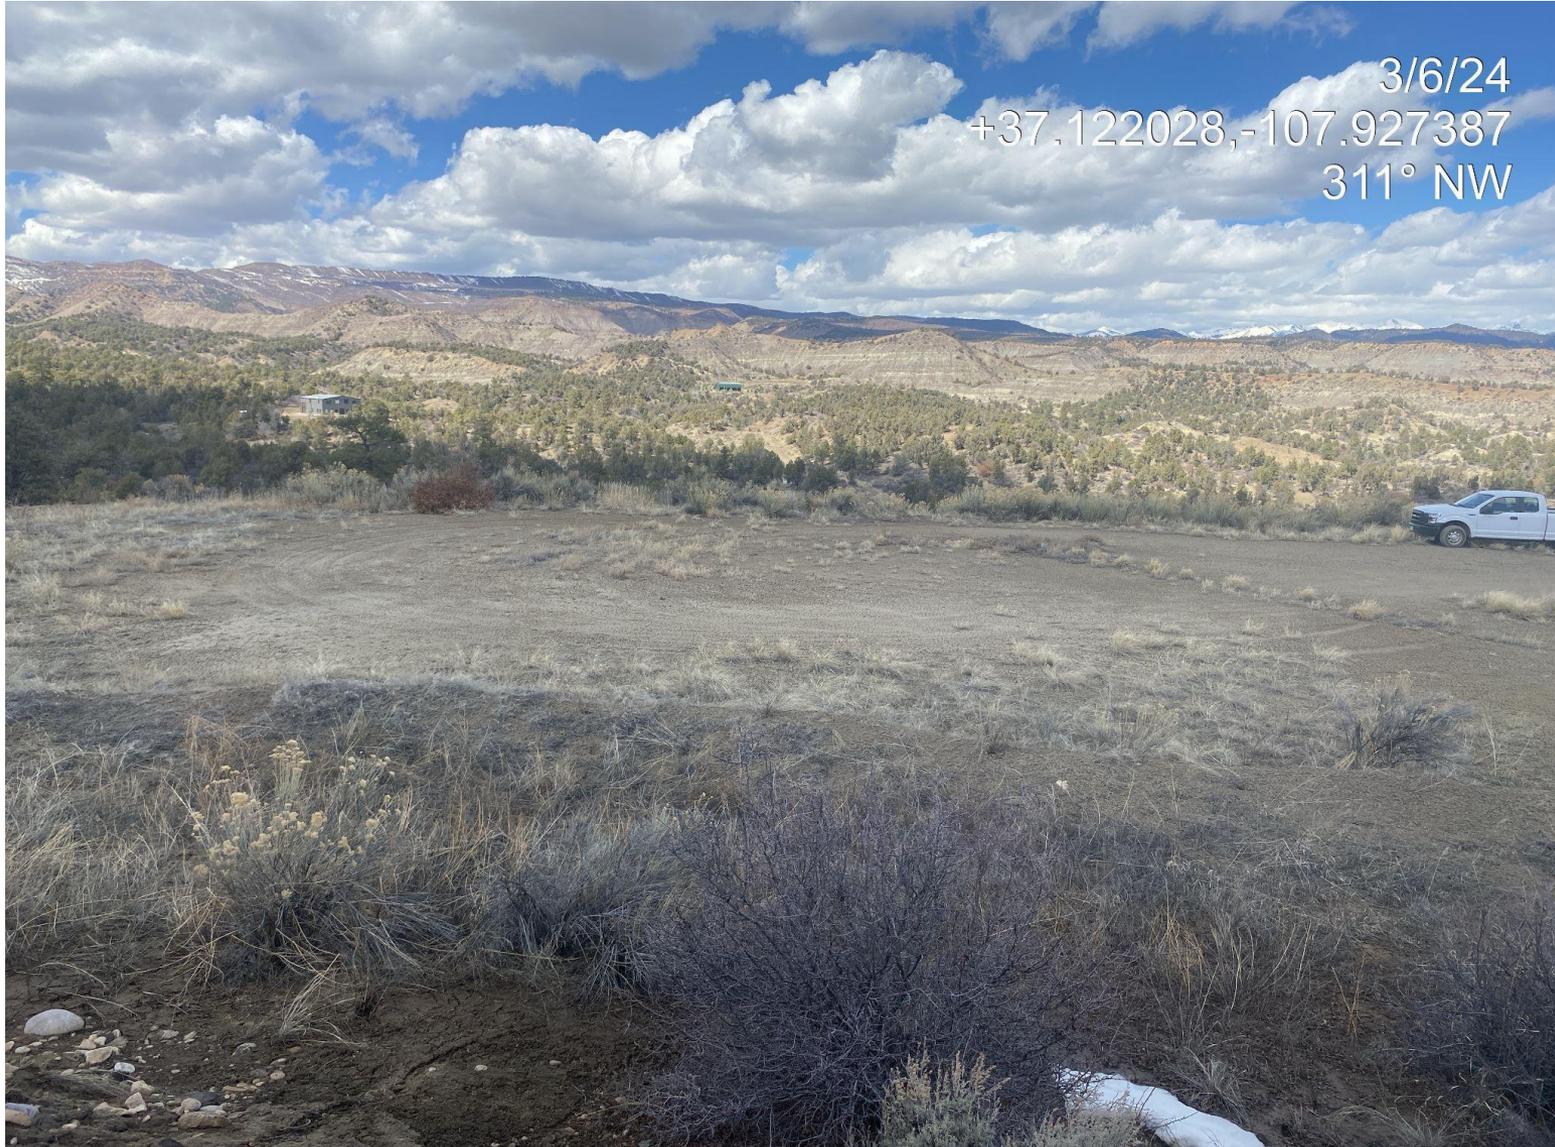
**Photo 1.** Overview of the project area taken from the southern edge facing northwest.

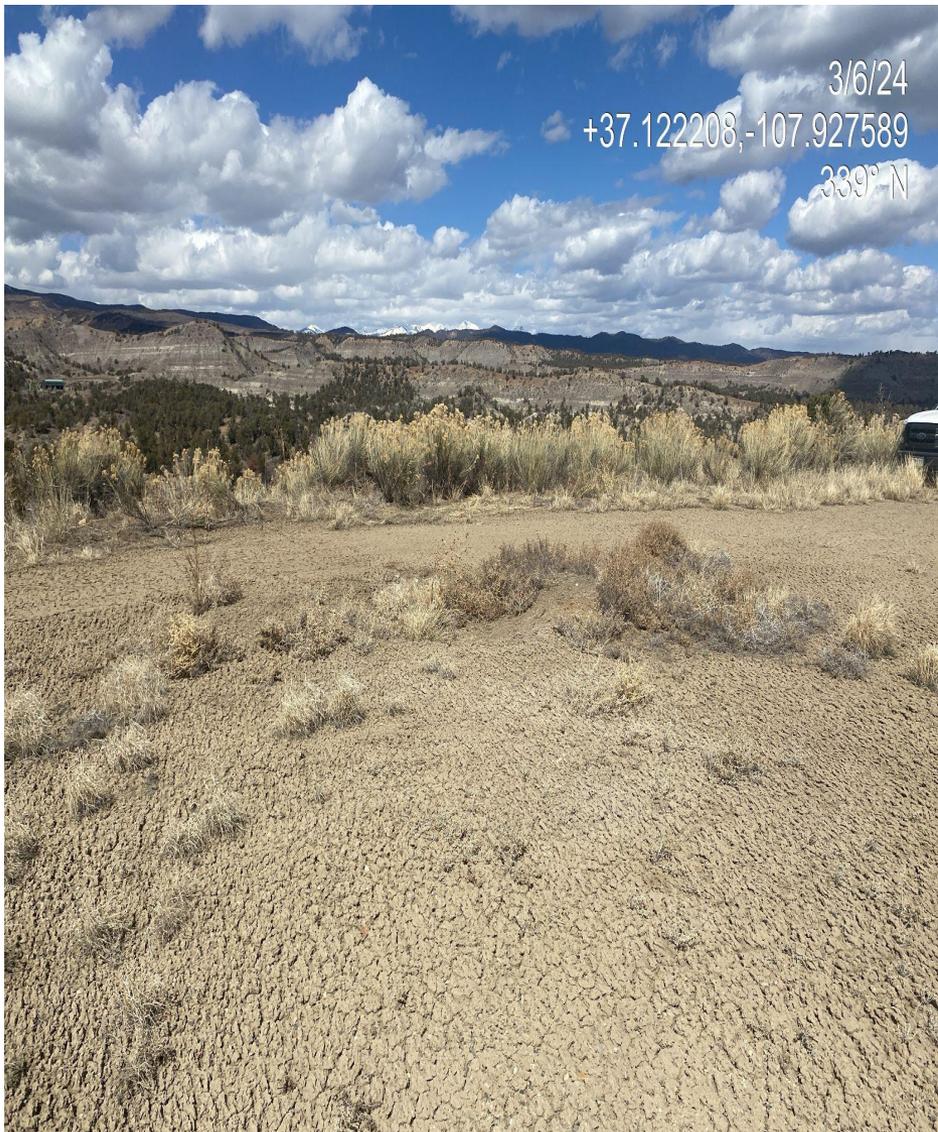
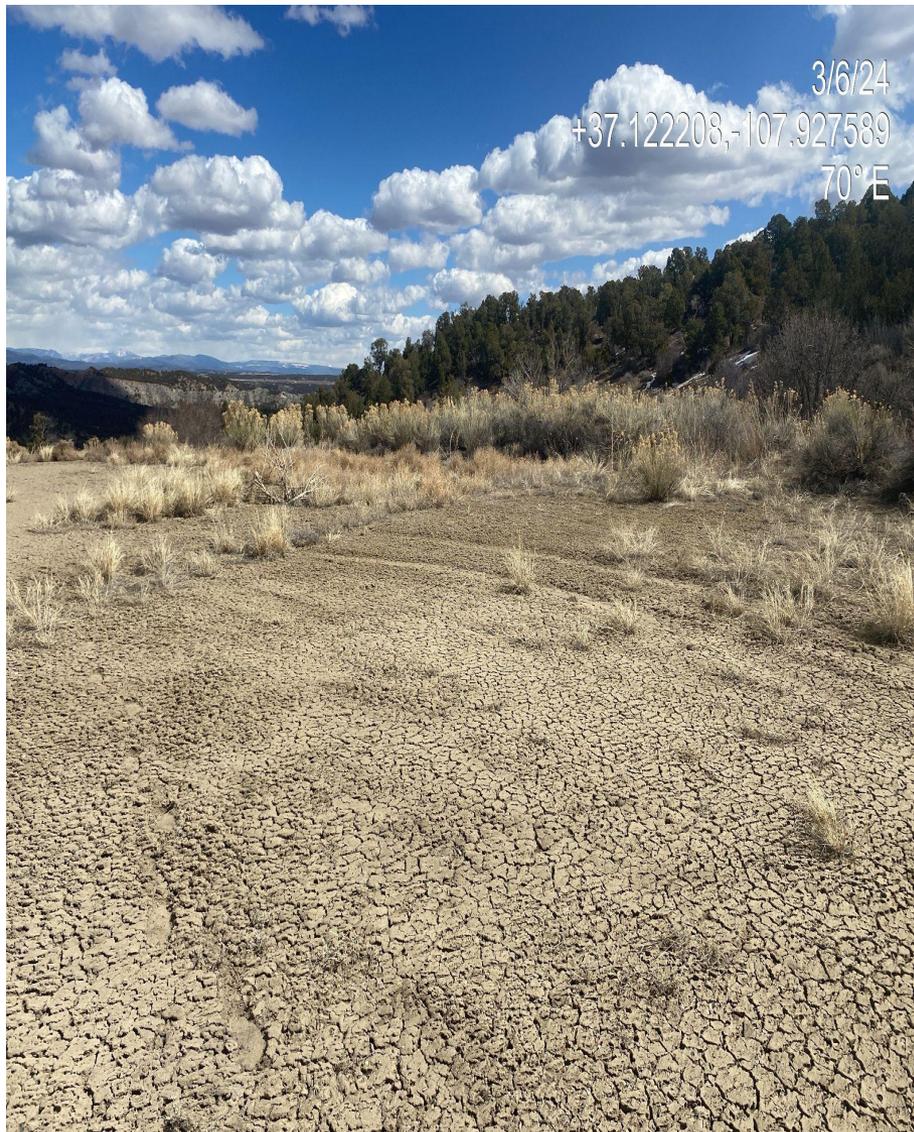
**Photo 2.** Cardinal photos taken from the center of the project area. Left photo facing north, right photo facing east.

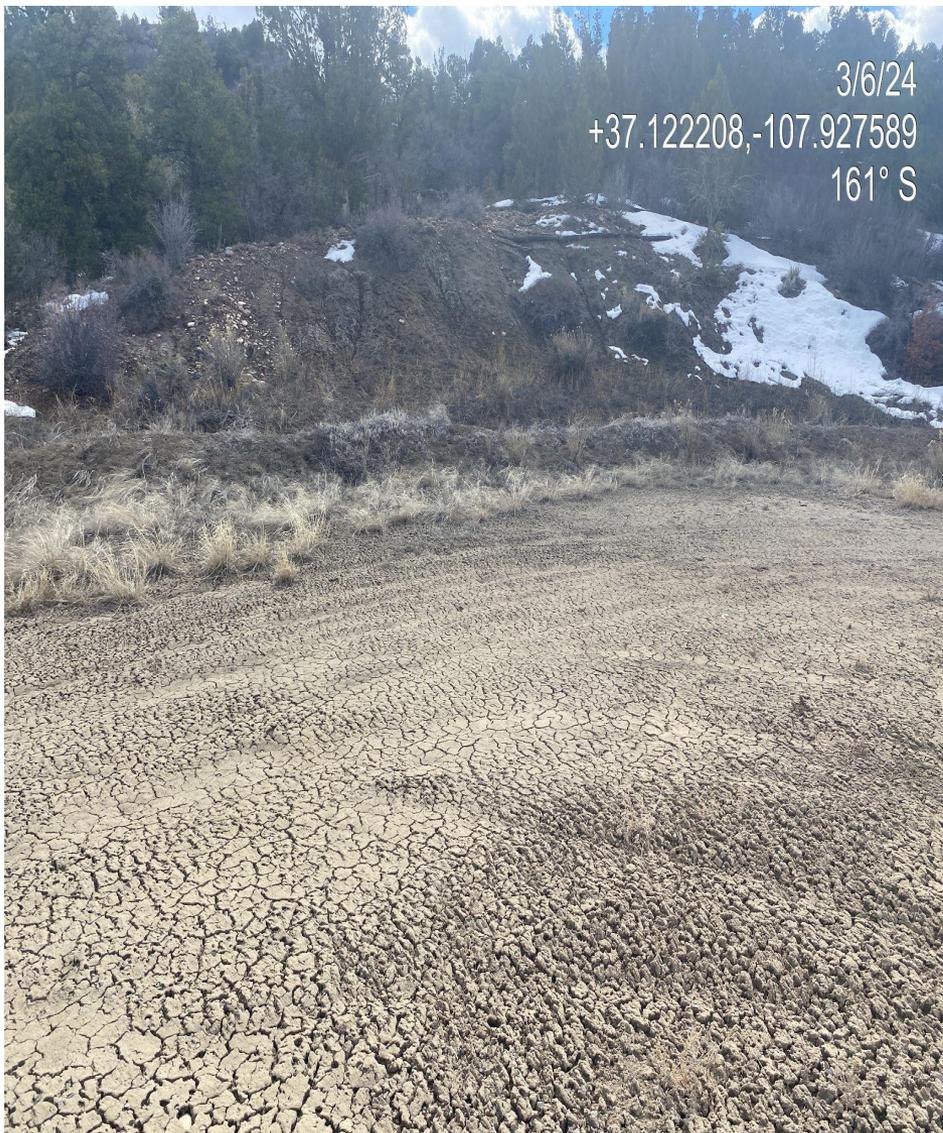
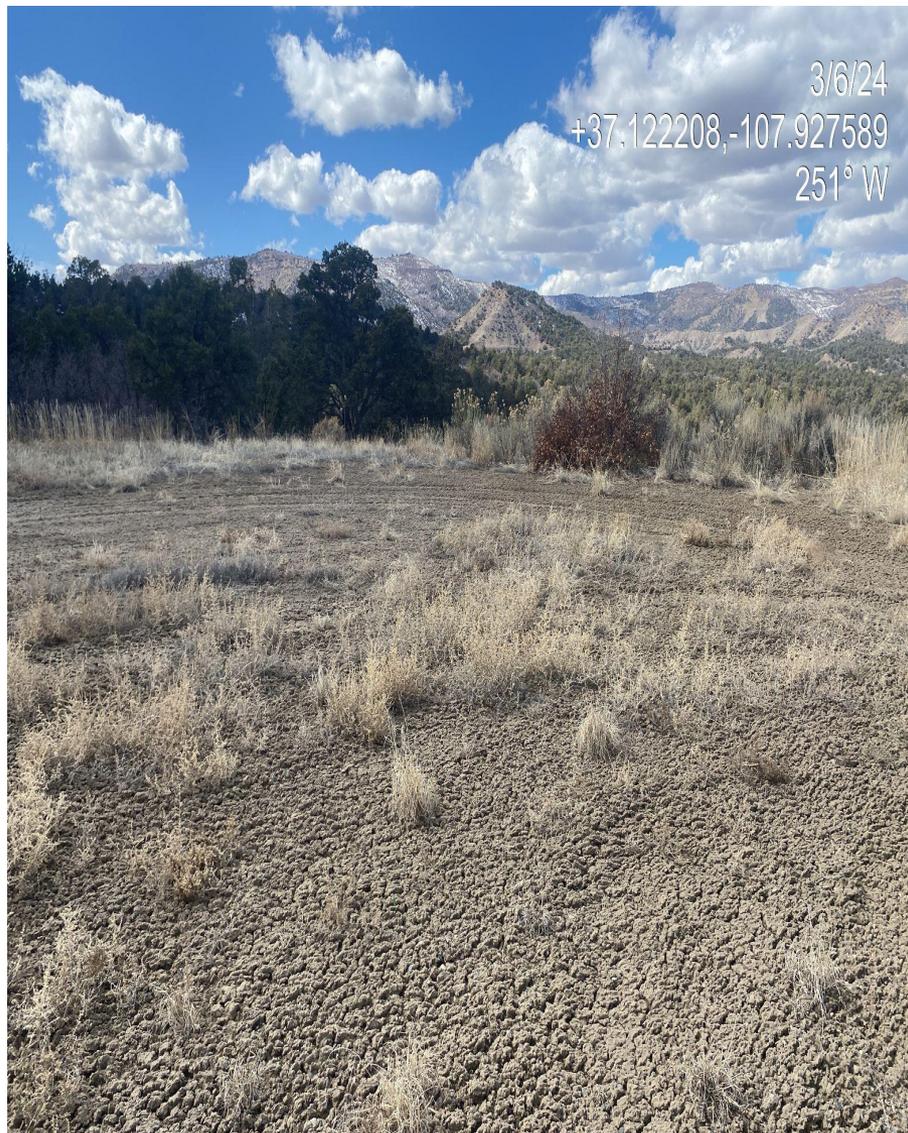
**Photo 3.** Cardinal photos taken from the center of the project area. Left photo facing south, right photo facing west. Note: Sparse vegetation at the well pad.

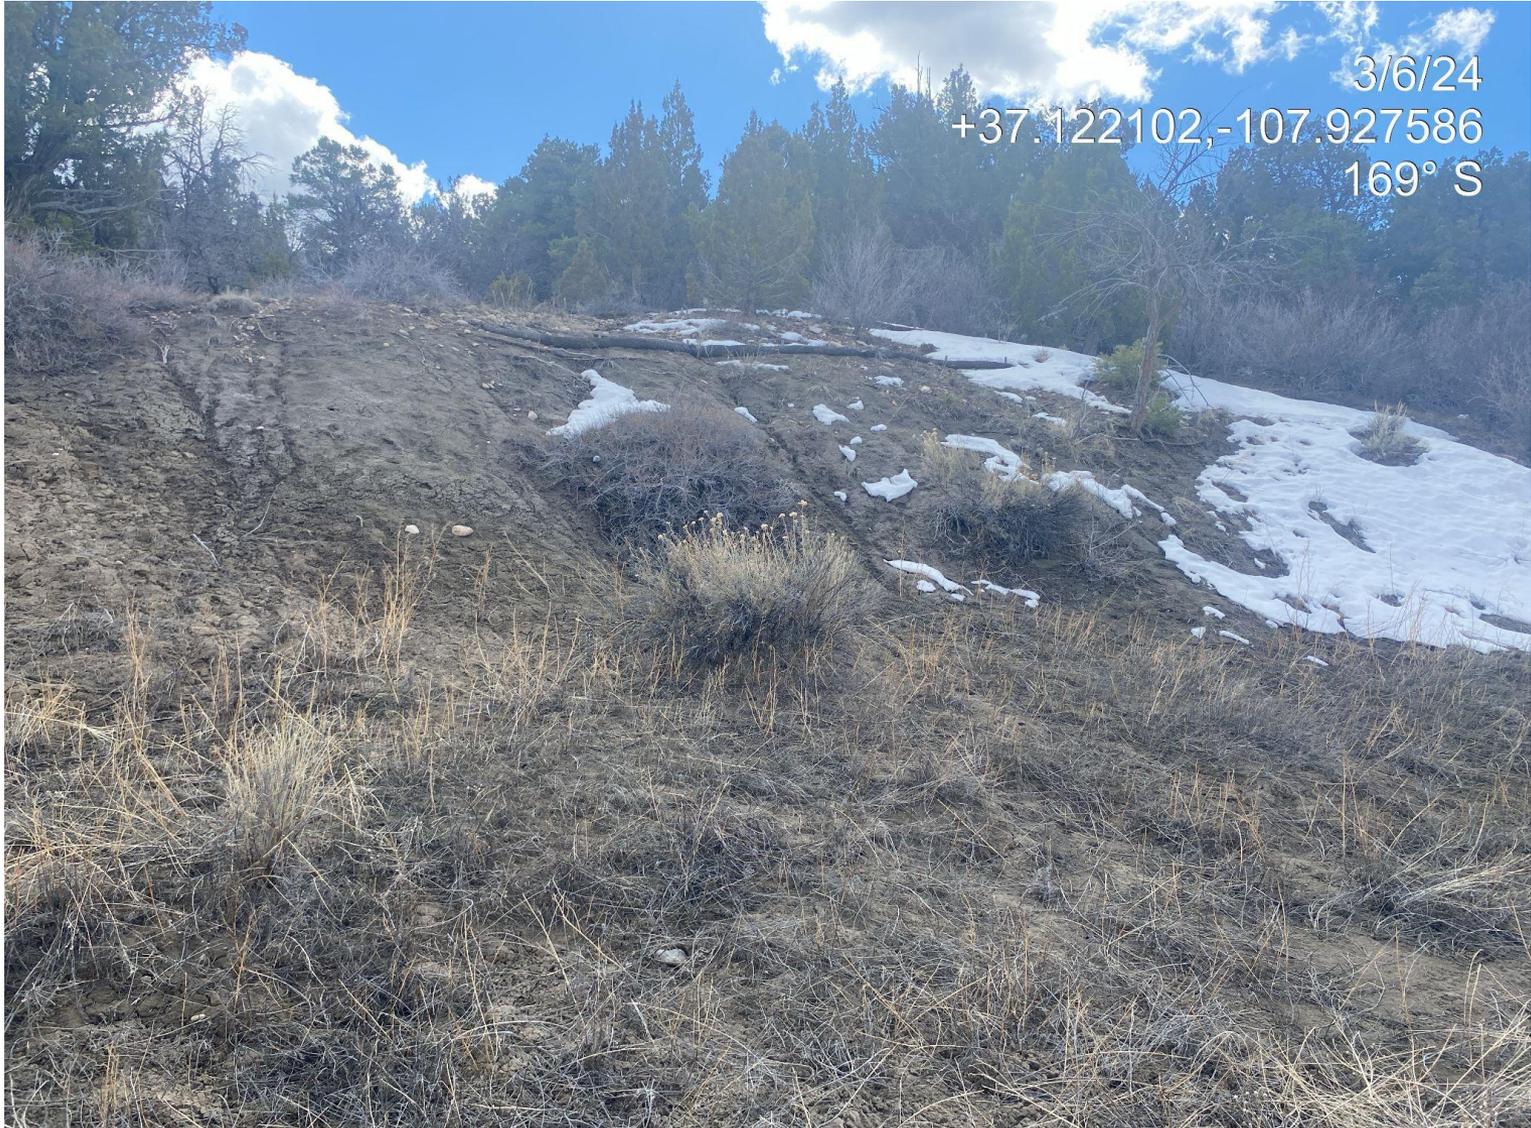
**Photo 4.** Rill erosion forming on the southern edge cut slope. Current stormwater BMPs are not functioning properly. Additional stabilization is needed in this area.

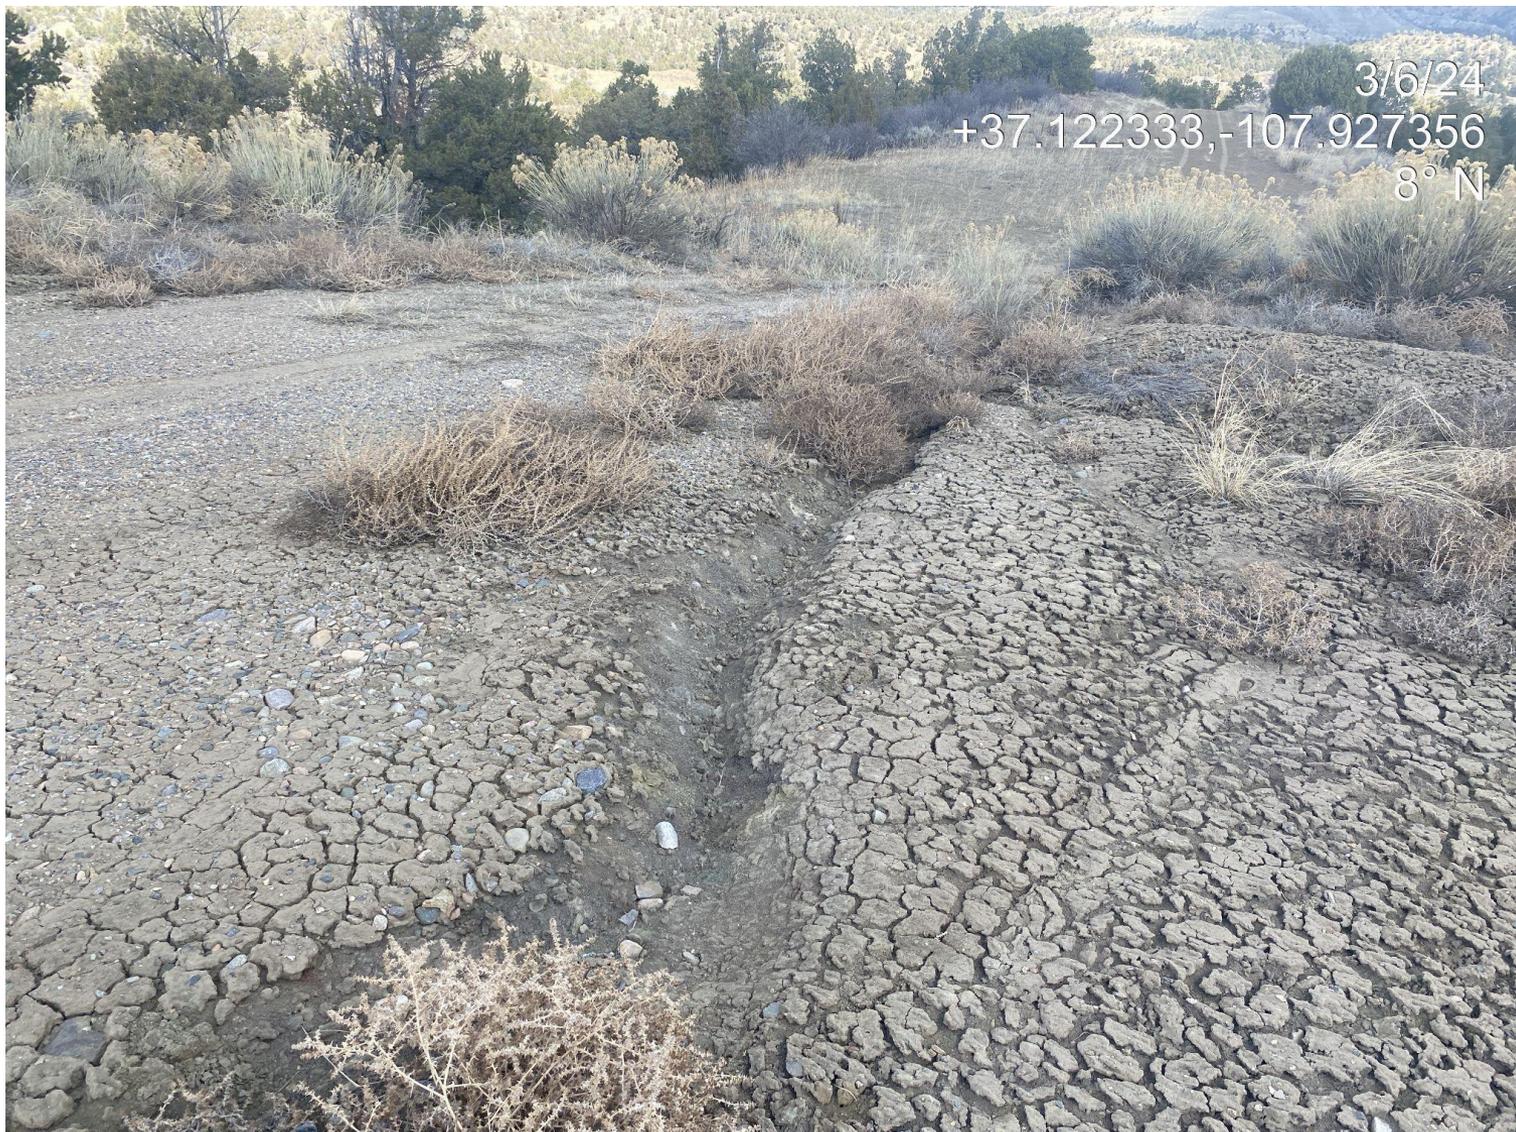
**Photo 5.** View of additional rill/gully erosion forming at the access point.

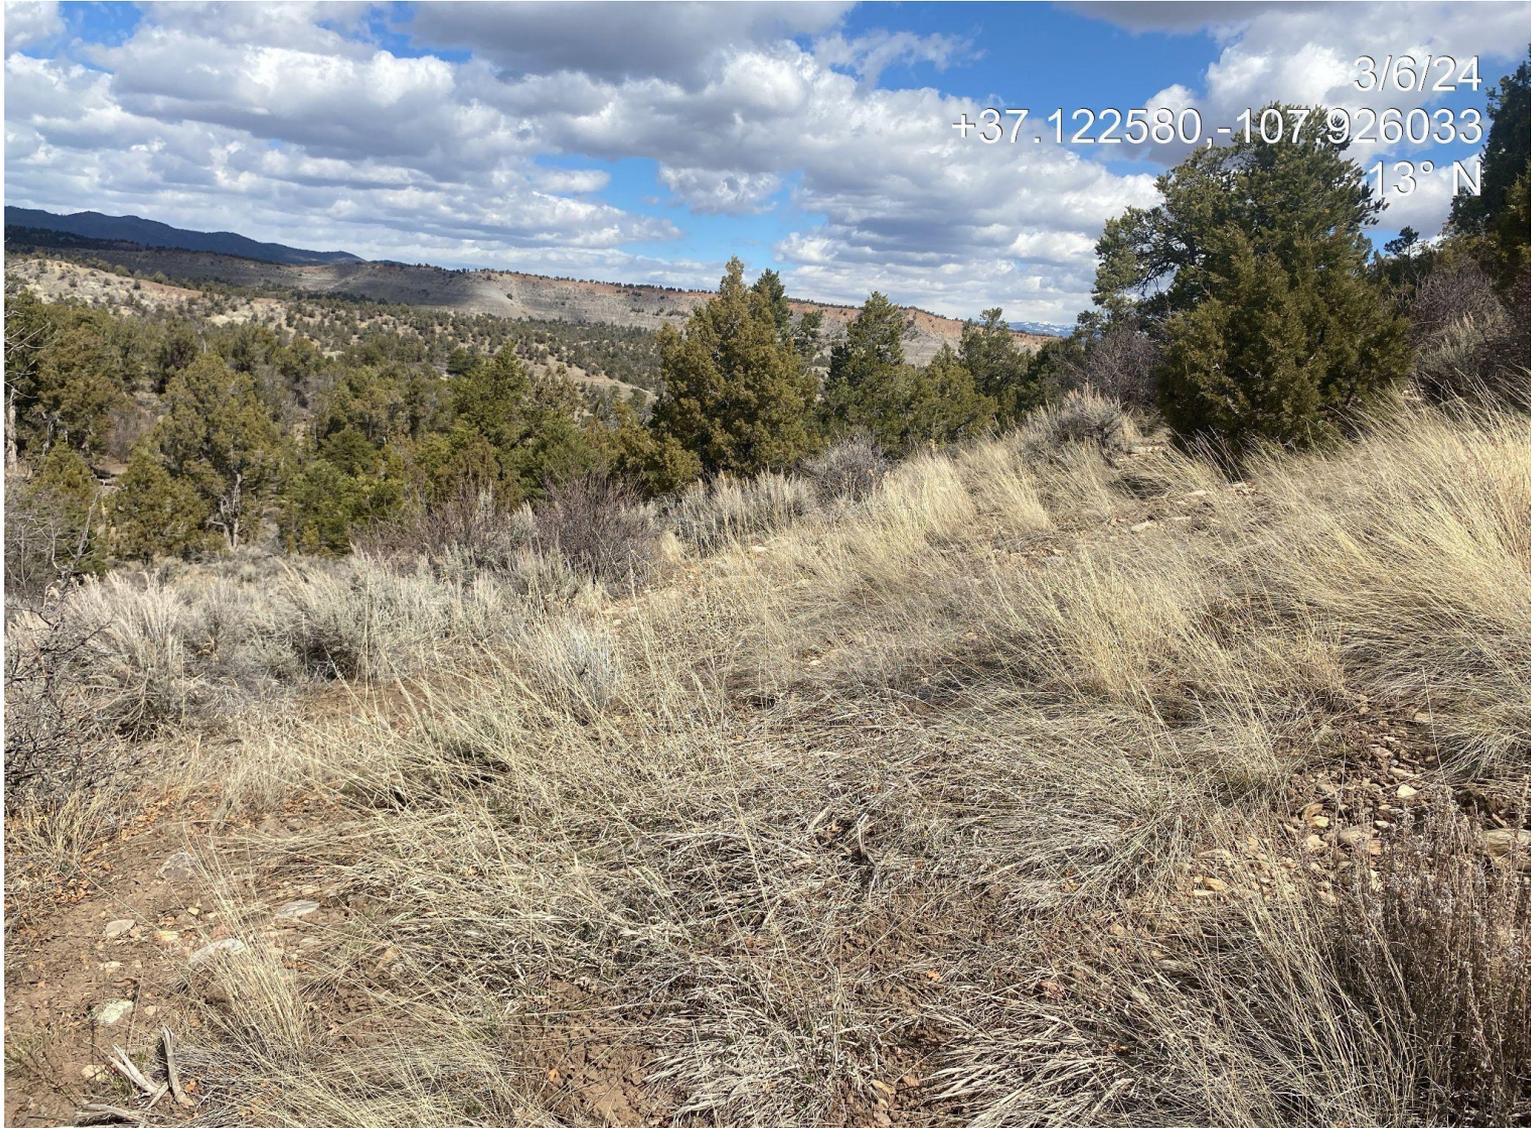
**Photo 6.** View of reference area comprised of smooth brome, rabbit brush, sagebrush and juniper.
