## Inspection Photos

Location Name: TEP ROCKY MOUNTAIN LLC SNYDER C Pad

Location ID: 336021

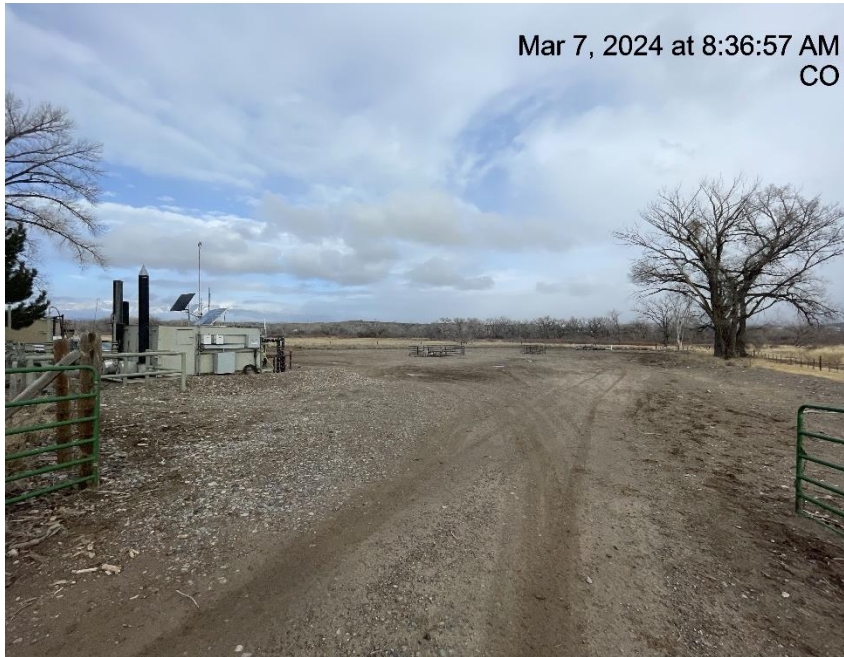
Photo # 8622 From entrance to location

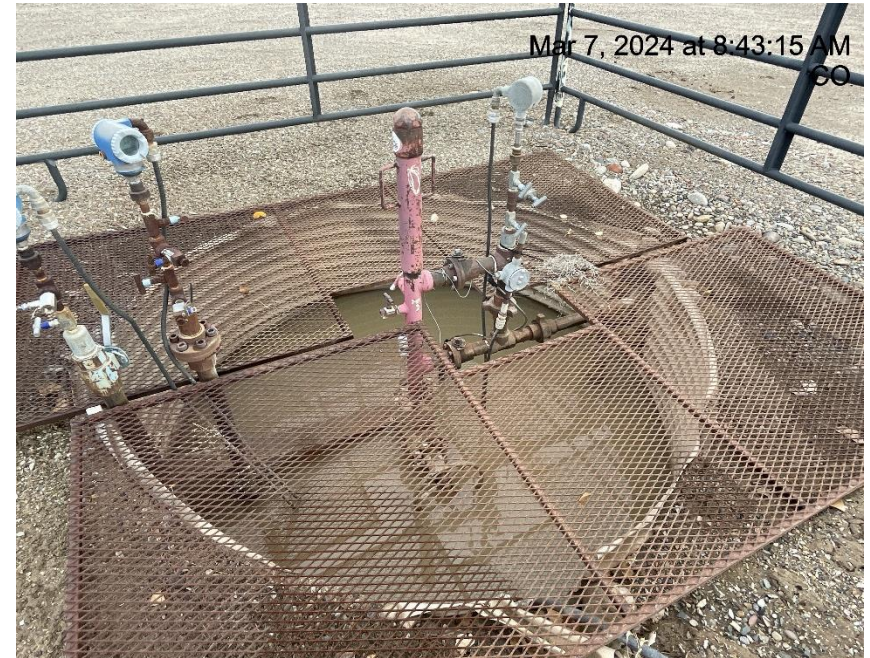
**Photo # 8629 Cellar lacks wildlife egress**

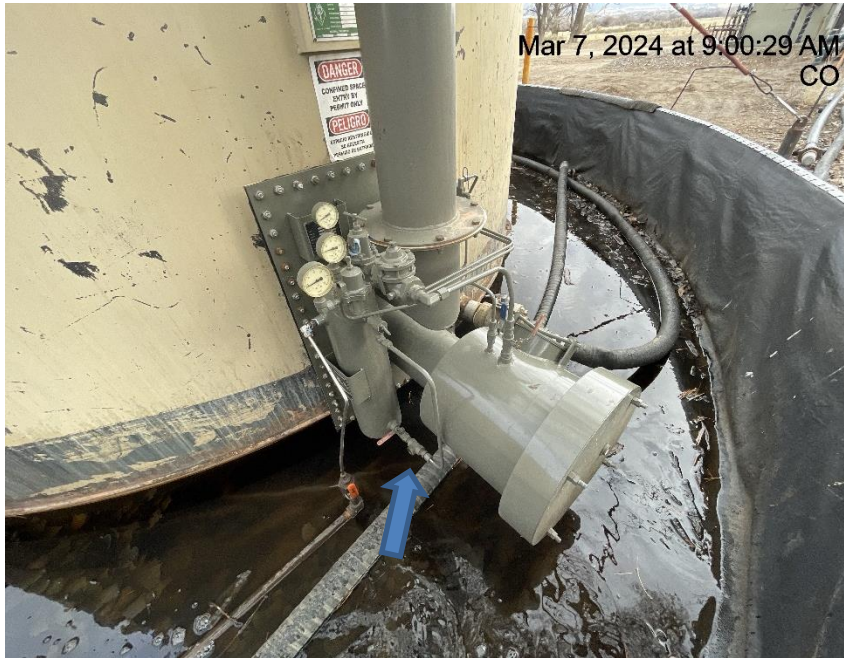
**Photo # 8630 PRV vent line terminates in an unsafe manner**

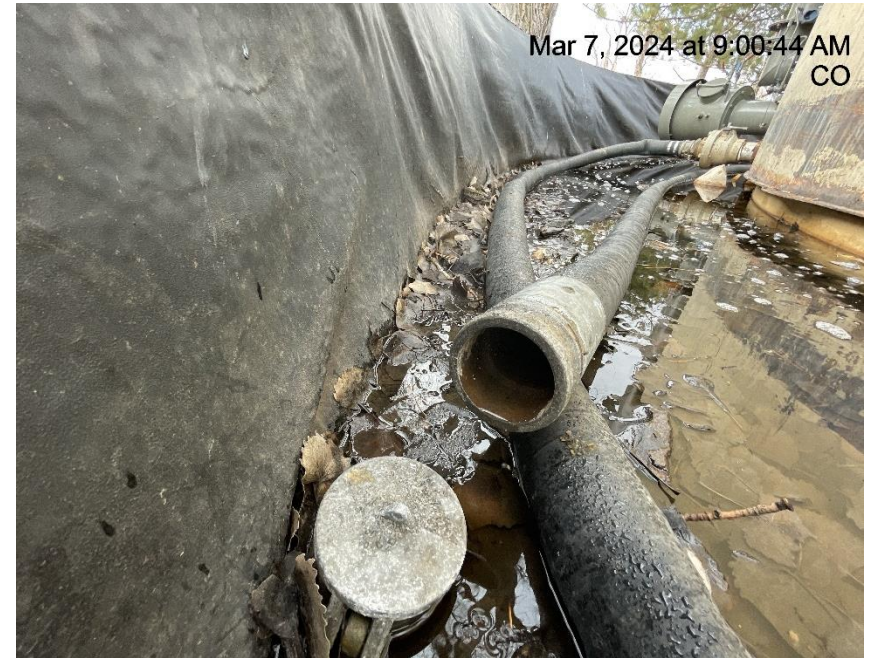
**Photo # 8631 Open ended load line**

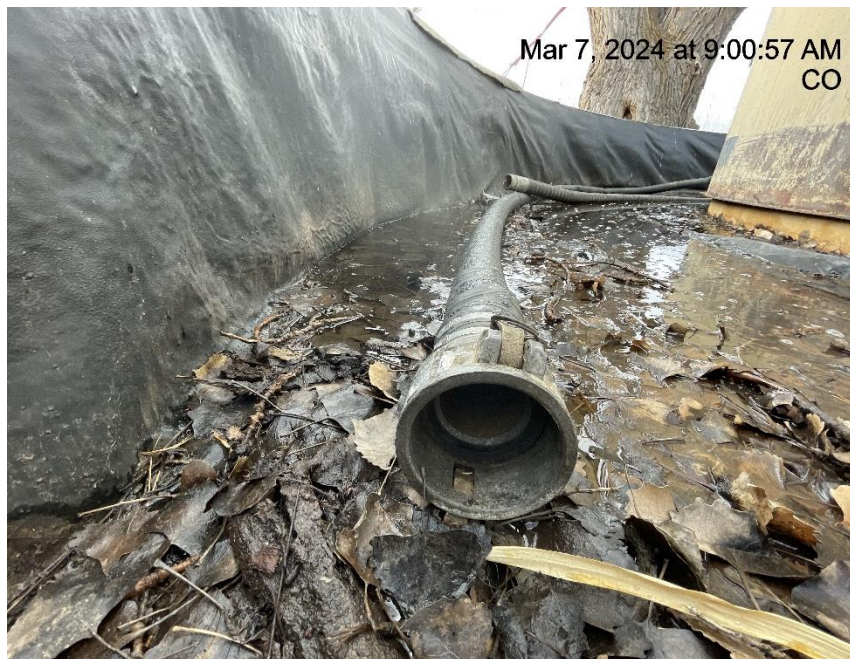
Photo # 8632 Open ended load line

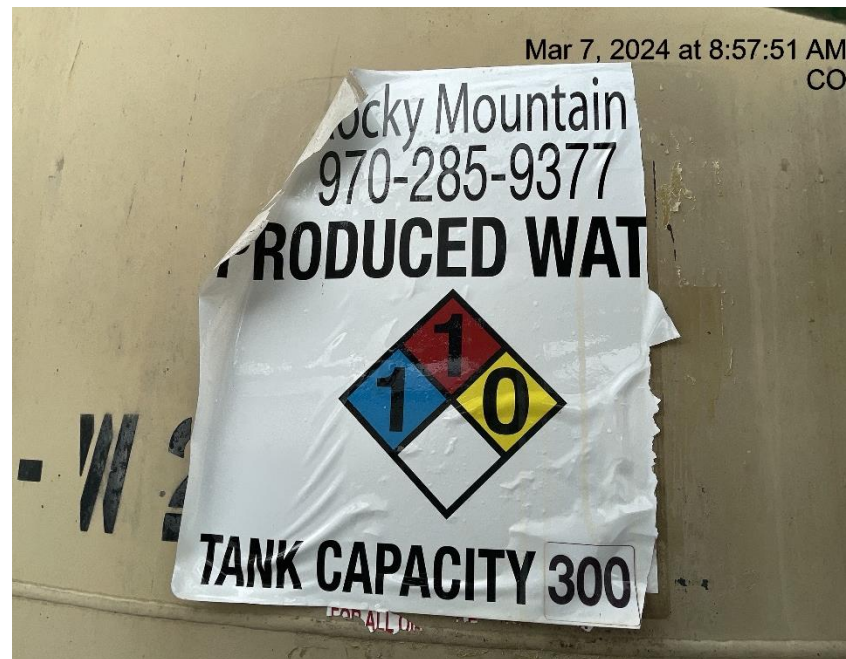
Photo # 8633 Tank label damaged & becoming illegible
