SITE-SPECIFIC QUALITY ASSURANCE & QUALITY CONTROL AUDIT

PERMIT CLOSURE REPORT – RANGELAND

Location Name: ECHEVERRIA-62N67W/2SENW

7 Mar 2024

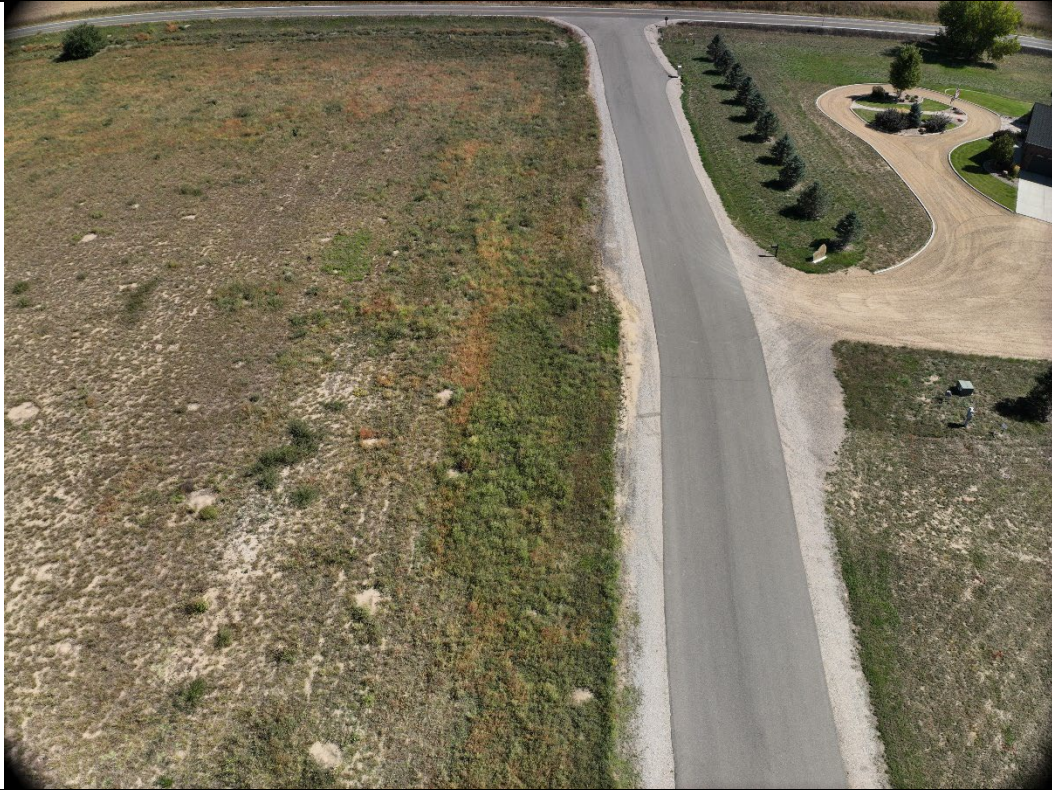
EAST – 40.168884 / -104.859445

In View – Well, Access Road, Flowline

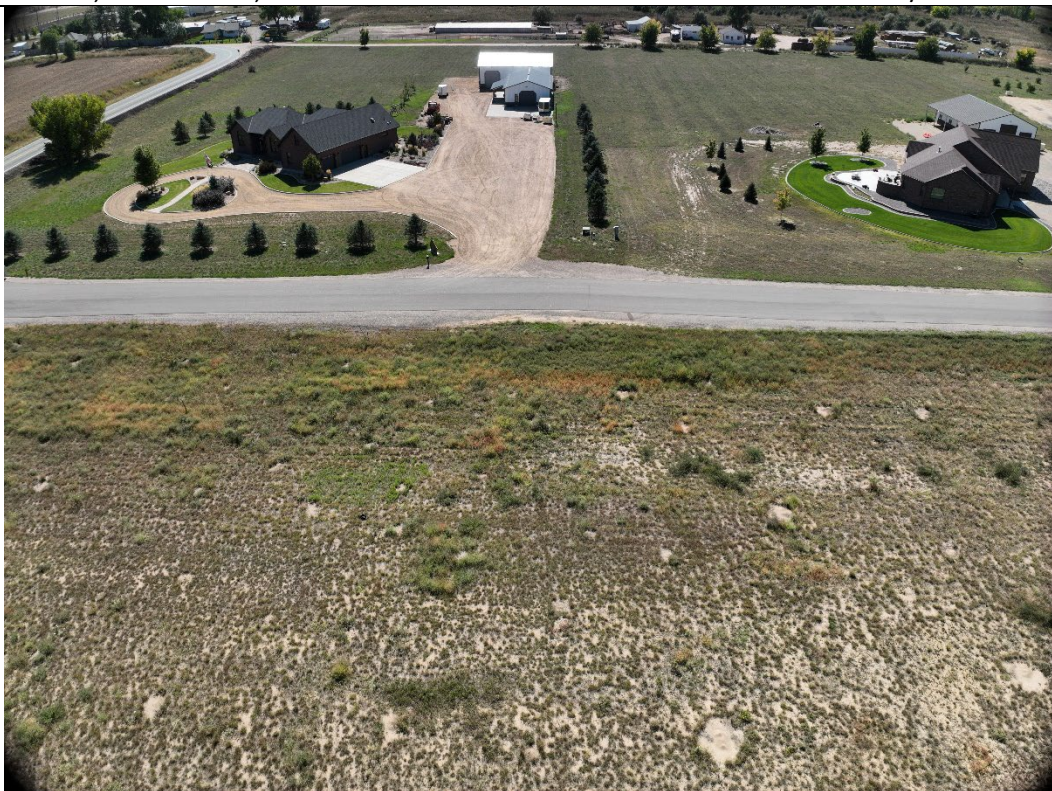
SOUTH – 40.169428 / -104.858925

In View – Well, Access Road, Flowline

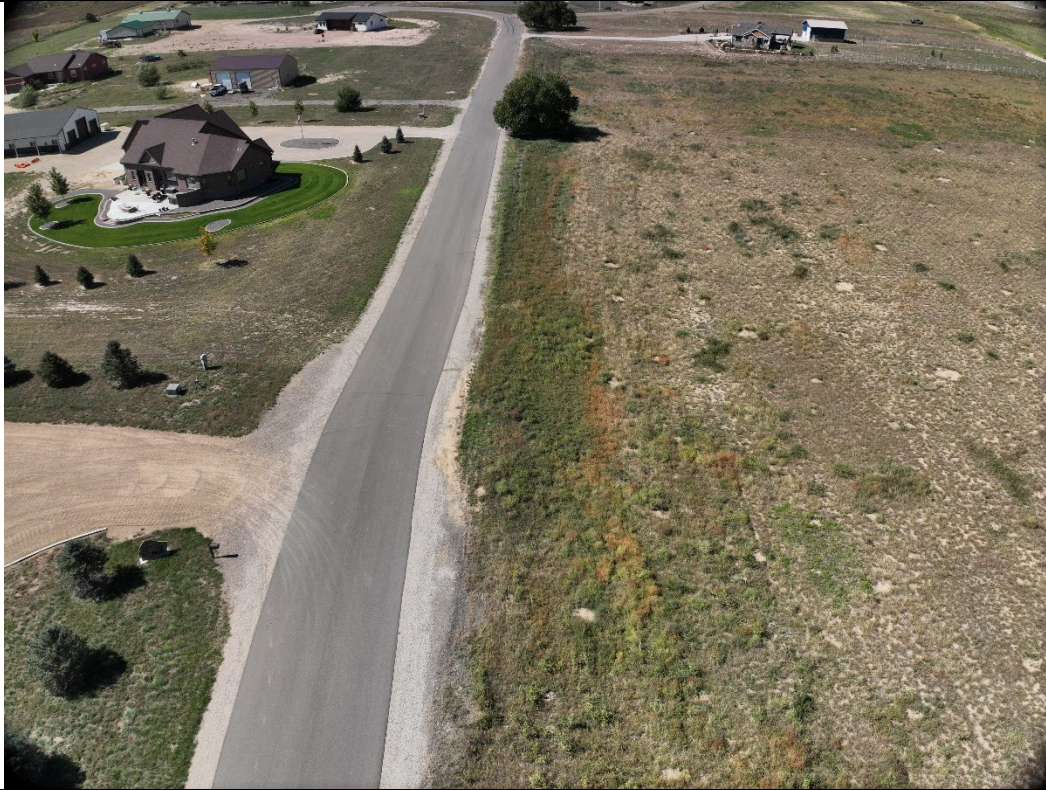
WEST – 40.168902 / -104.858386

In View – Well, Access Road, Flowline

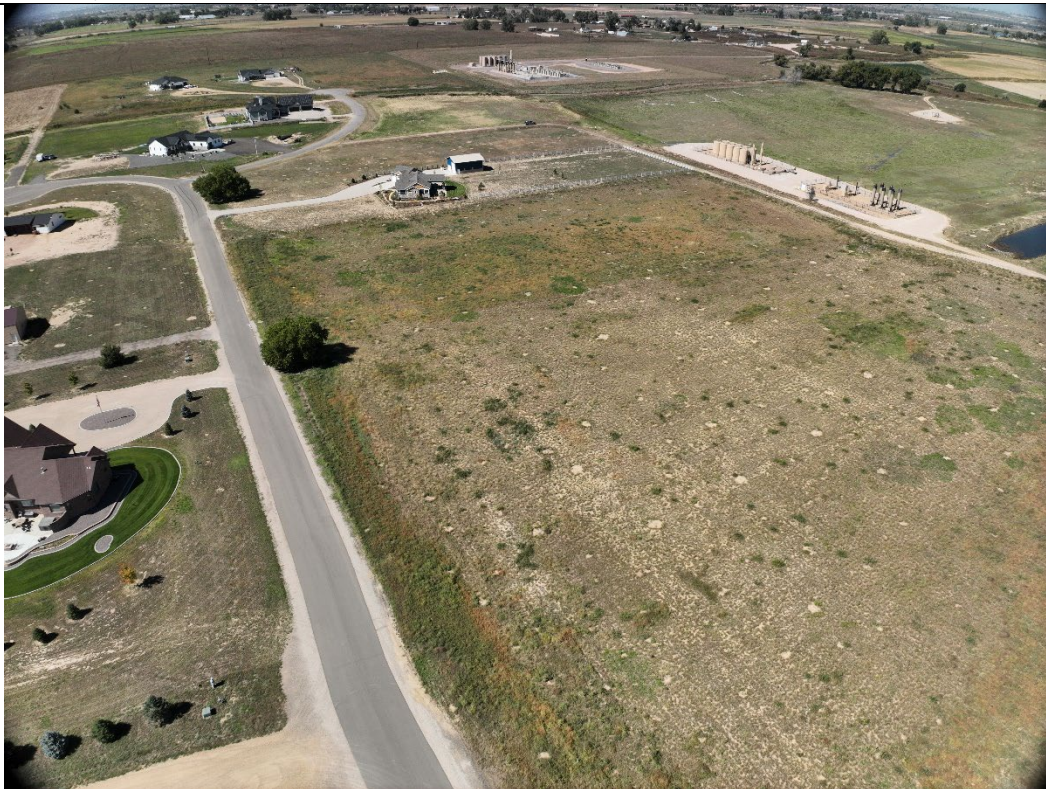
NORTHWEST – 40.168711 / -104.858215

In View – Well, Tank Battery, Access Road, Flowline

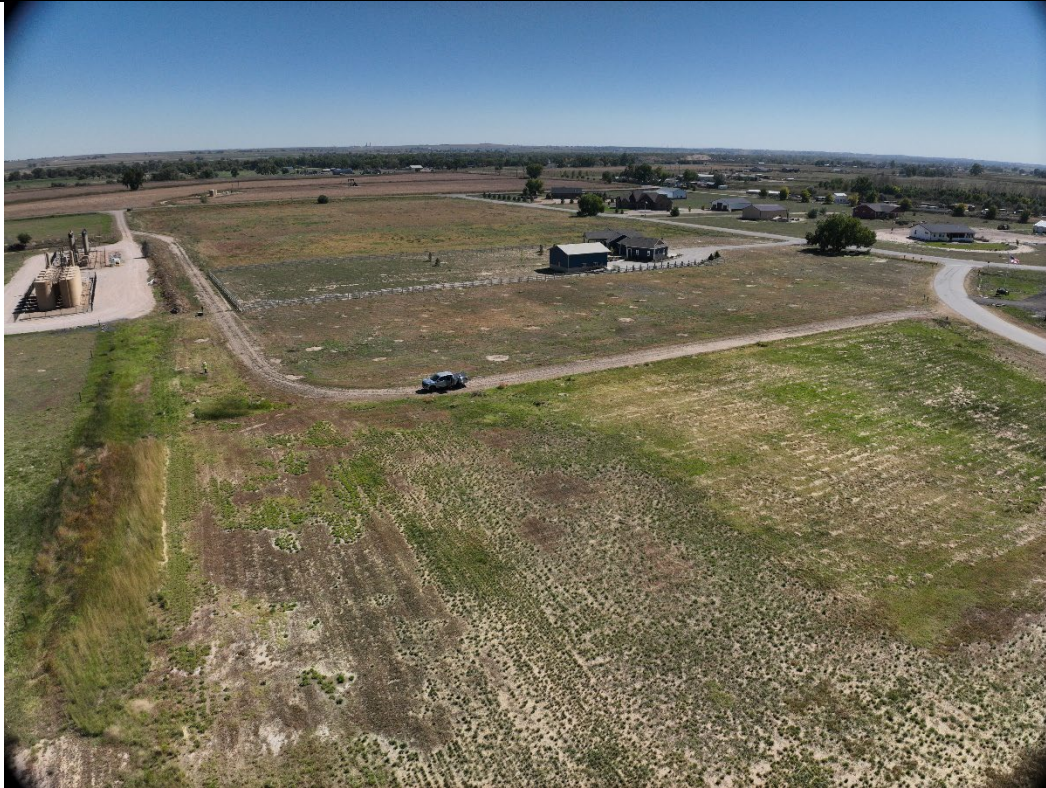
SOUTHEAST – 40.170786 / -104.863534

In View – Well, Tank Battery, Access Road, Flowline

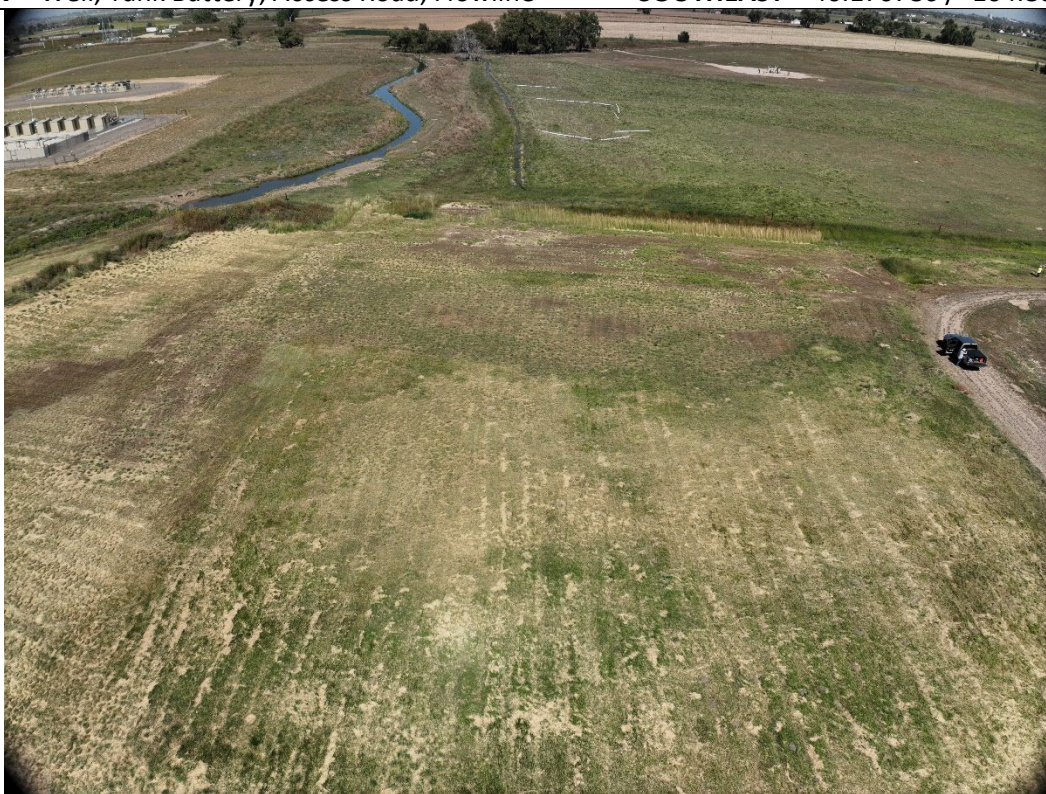
NORTH – 40.169911 / -104.863036

In View – Tank Battery, Flowline

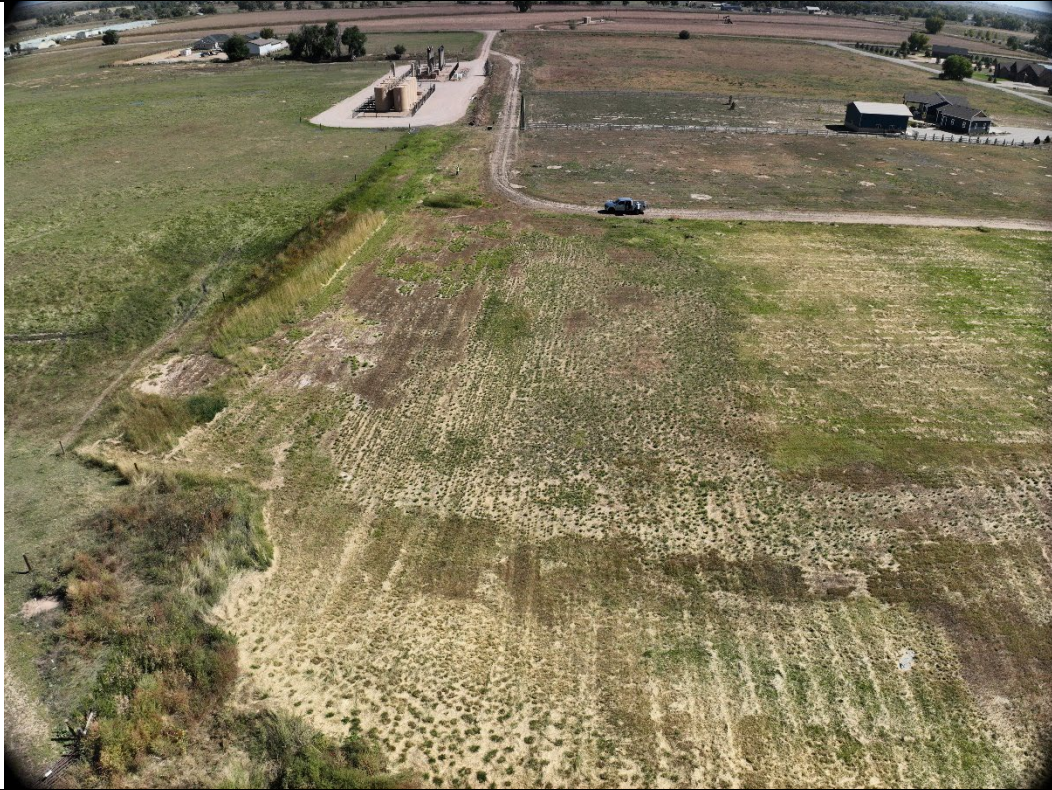
EAST – 40.170601 / -104.863776

In View – Tank Battery, Flowline

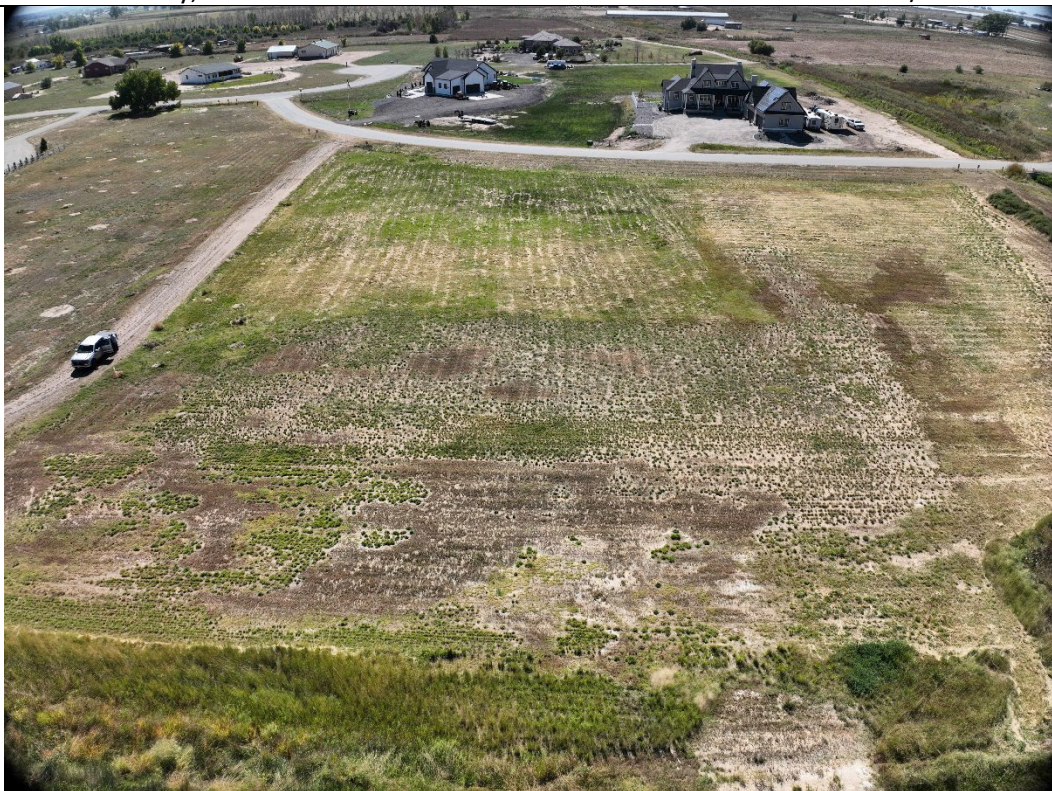
SOUTH – 40.171025 / -104.863020

In View – Tank Battery, Flowline

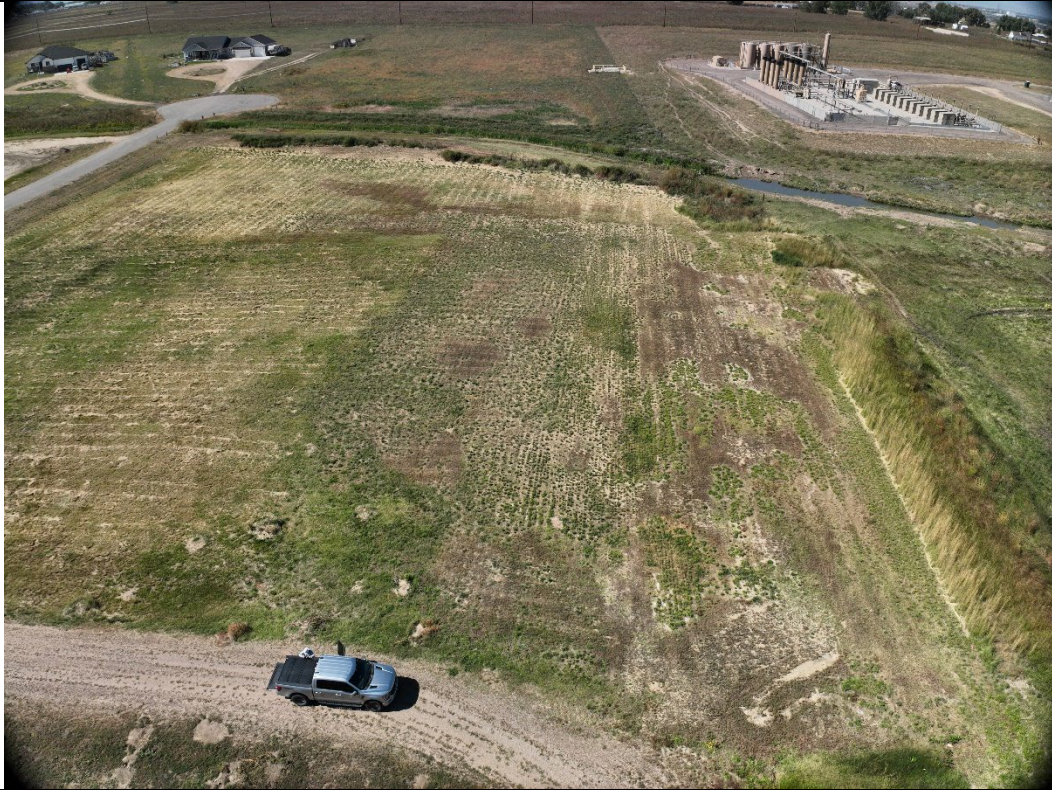
WEST – 40.170555 / -104.862272

In View – Tank Battery, Flowline

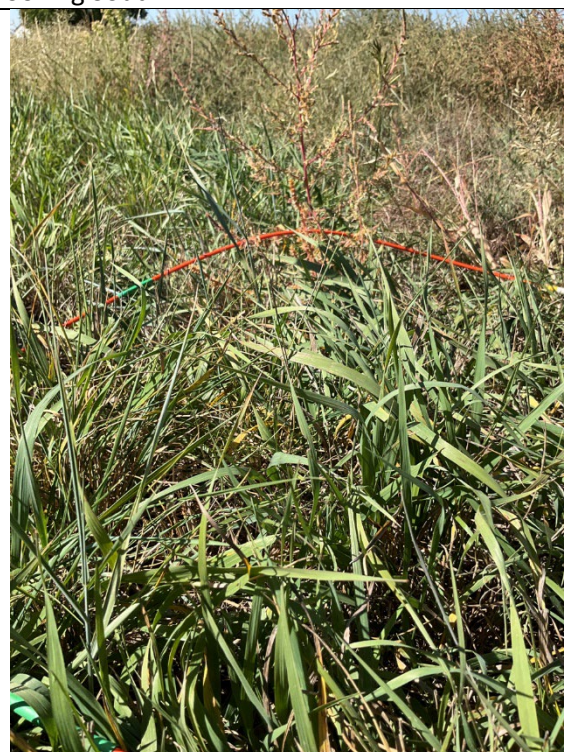
Western Wheatgrass – *Pascopyrum smithii* and
Kochia – *Kochia scoparia* – Common Weed
