Inspection Photos

Location Name: TEP ROCKY MOUNTAIN LLC GYPSUM RANCH B Pad

Location ID: 336037

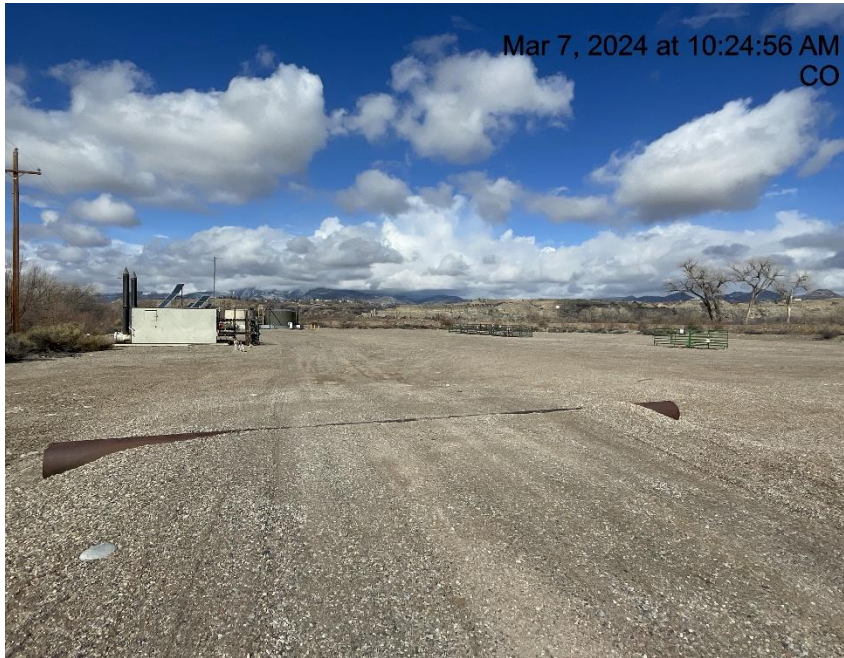
Photo # 9010 From entrance to location

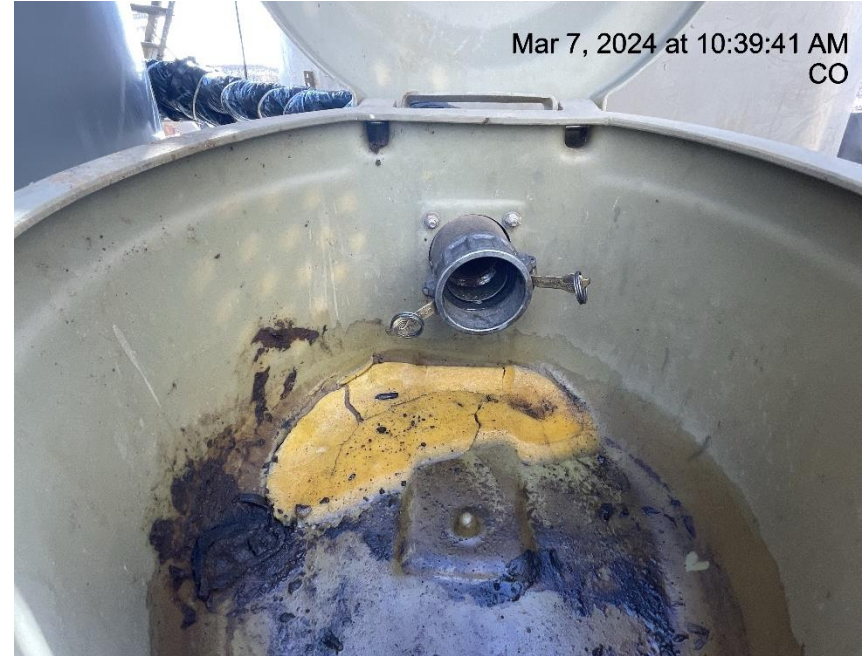
Photo # 9015 Open ended load line

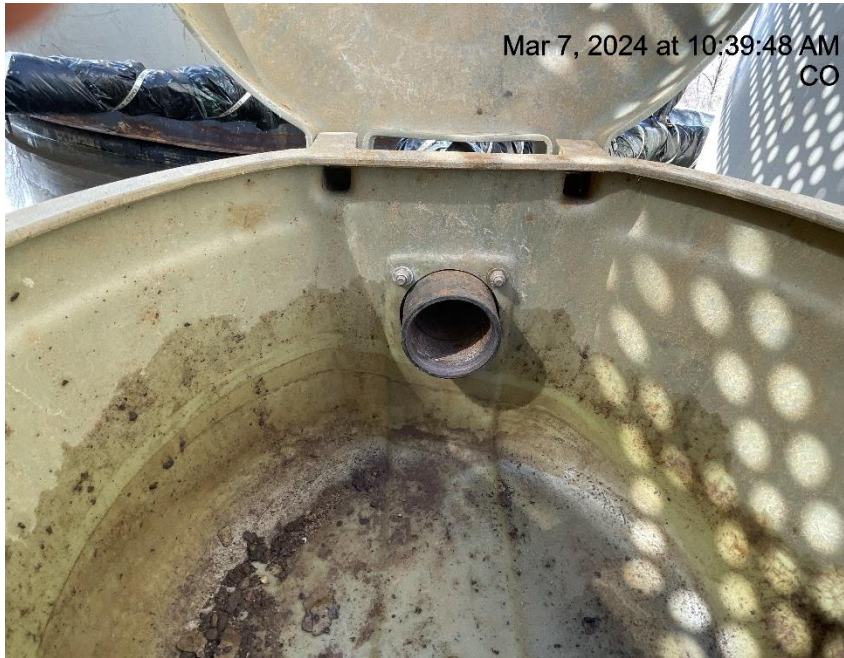
Photo # 9016 Open ended load line

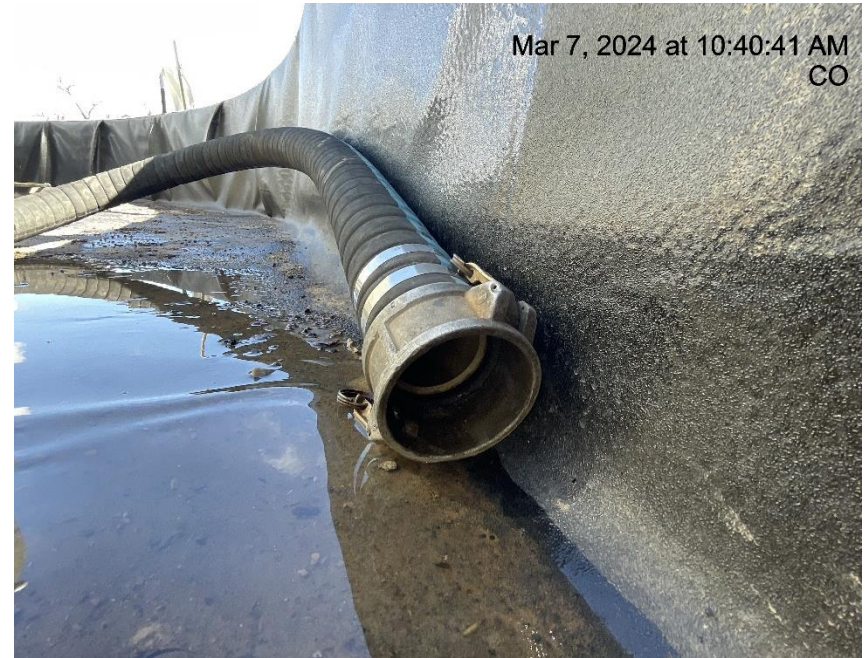
Photo # 9017 Open ended load line

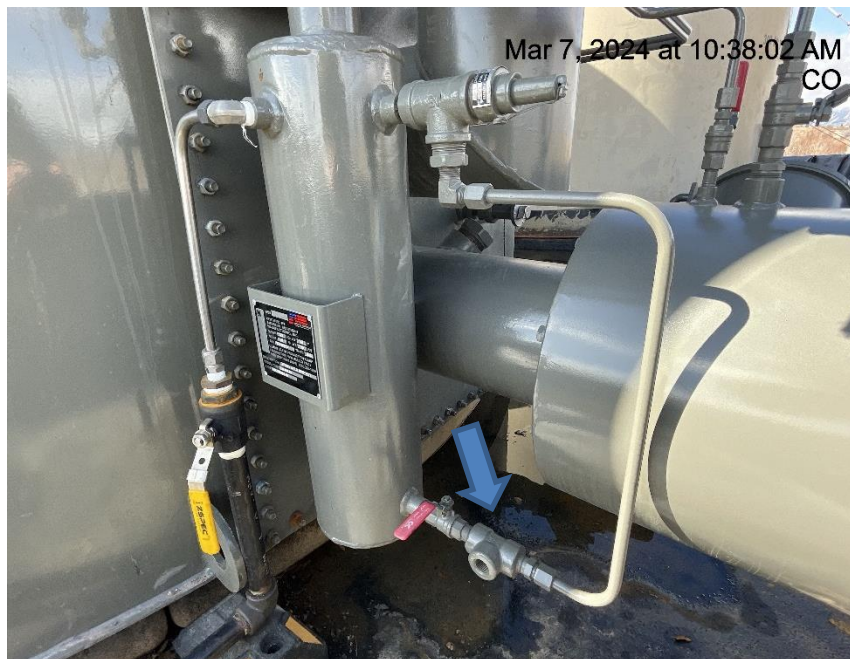
Photo # 9018 PRV vent line does not comply with CECMC pressure safety device rules & also terminates in an unsafe manner

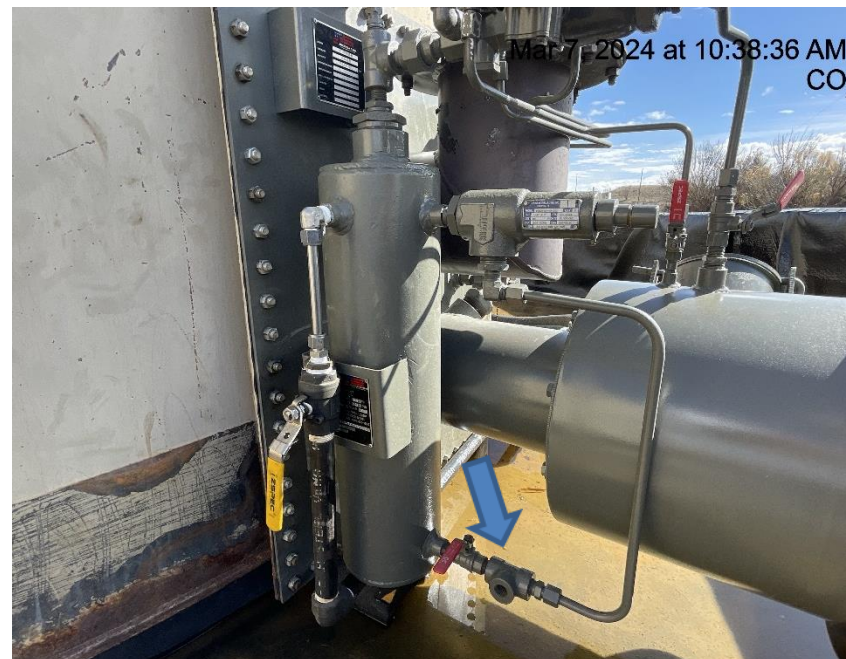
Photo # 9019 PRV vent line does not comply with CECMC pressure safety device rules & also terminates in an unsafe manner

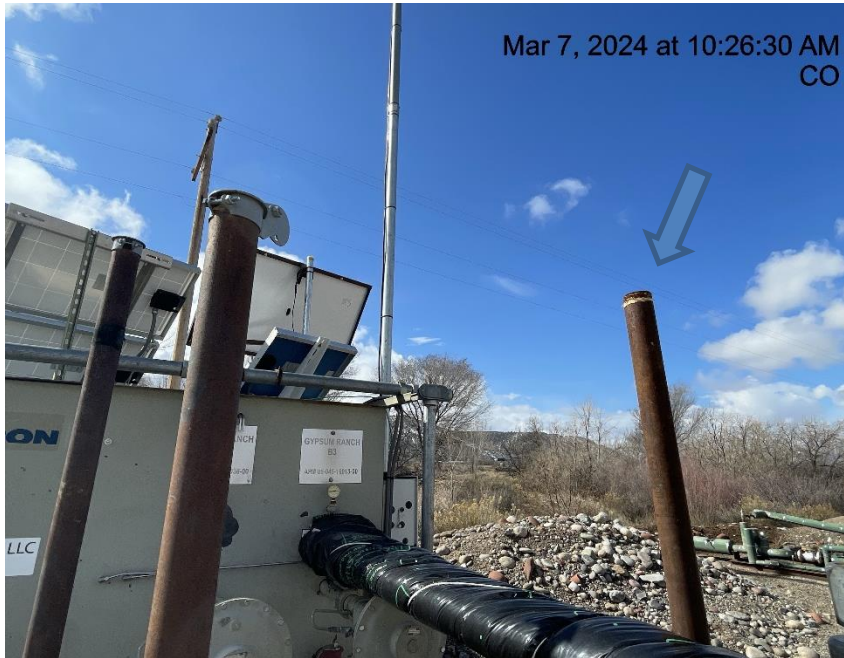
Photo # 9020 Open ended pipe/wildlife hazard

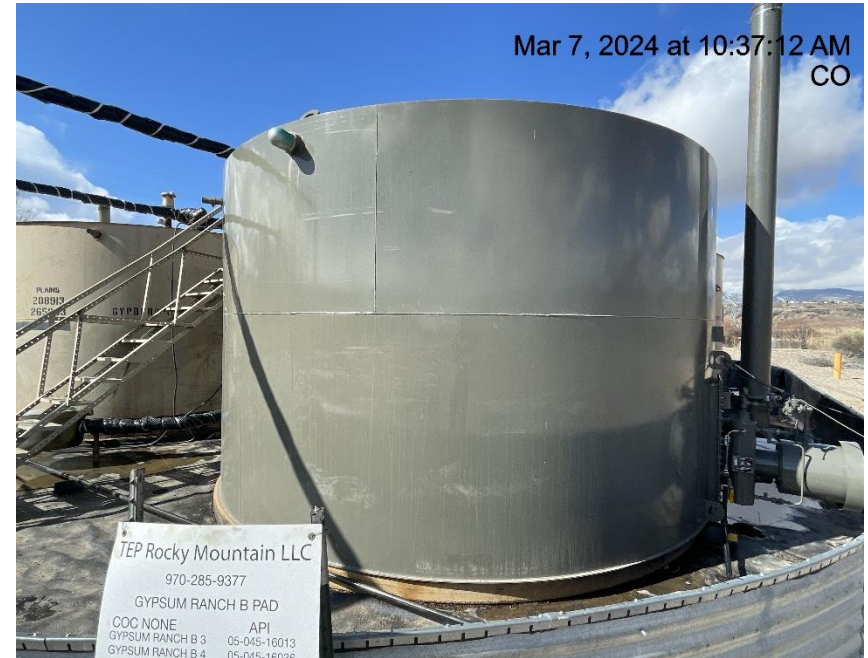
Photo # 9021 Tank lacks required labeling

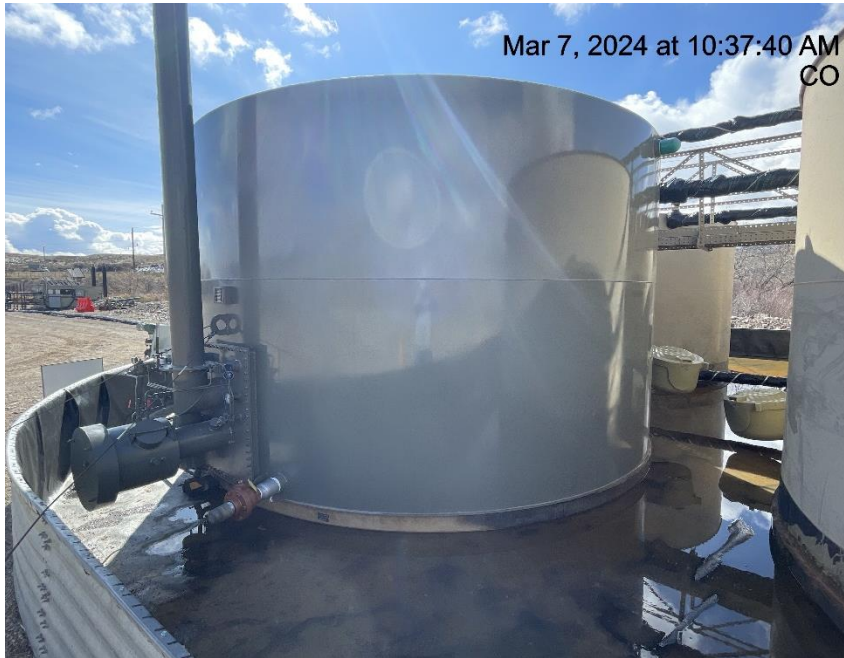
Photo # 9022 Tank lacks required labeling

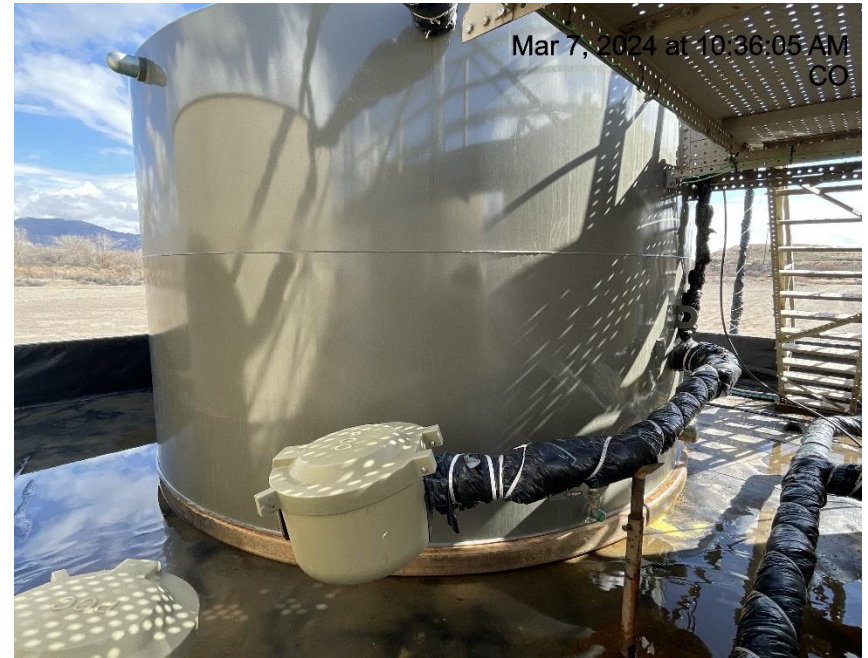
Photo # 9023 Tank lacks required labeling

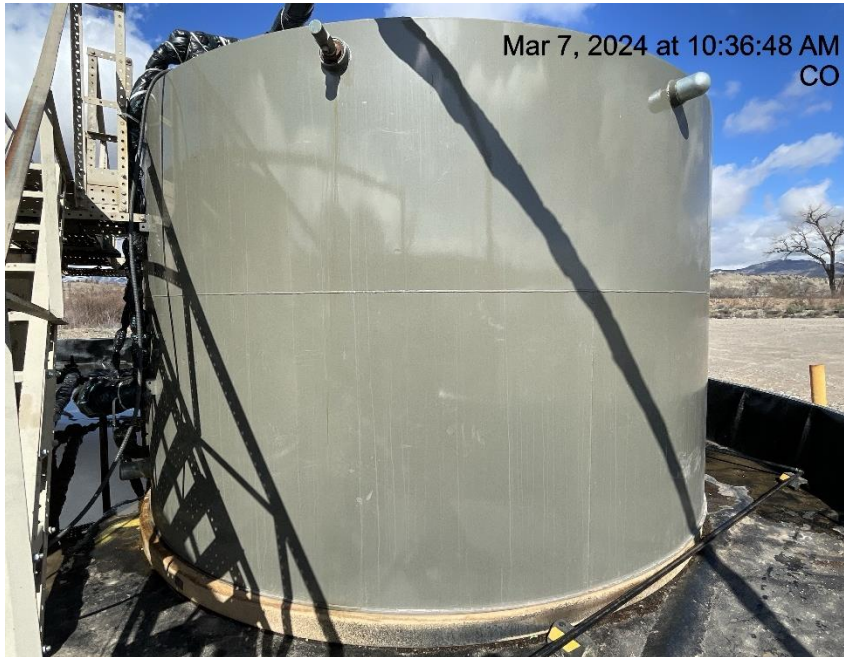
Photo # 9024 Tank lacks required labeling

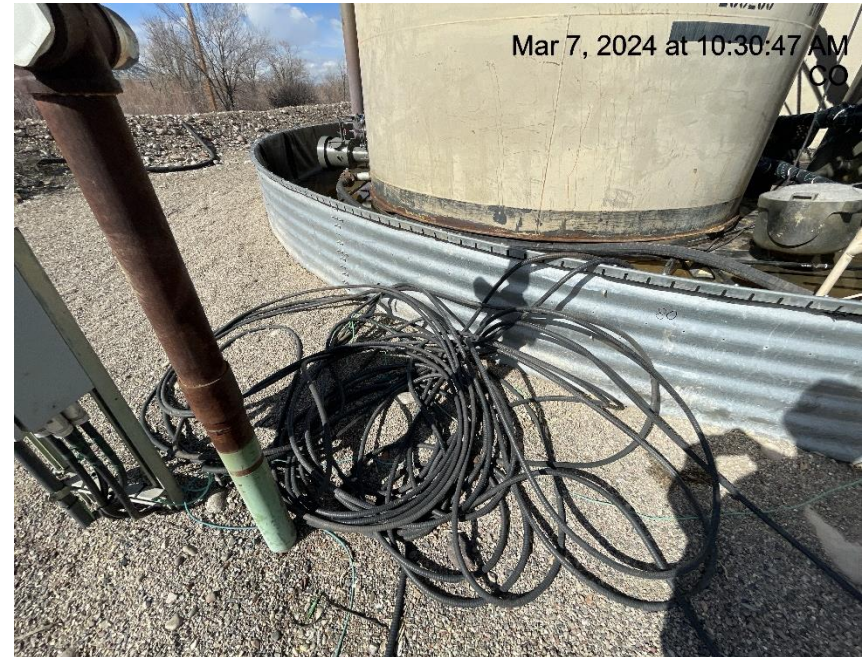
Photo # 9025 Debris

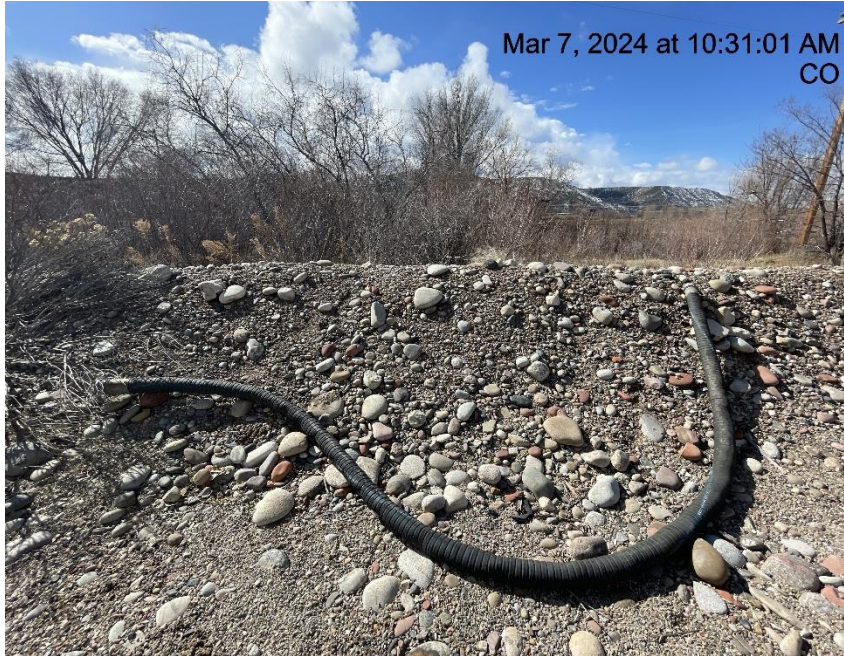
Photo # 9026 Debris

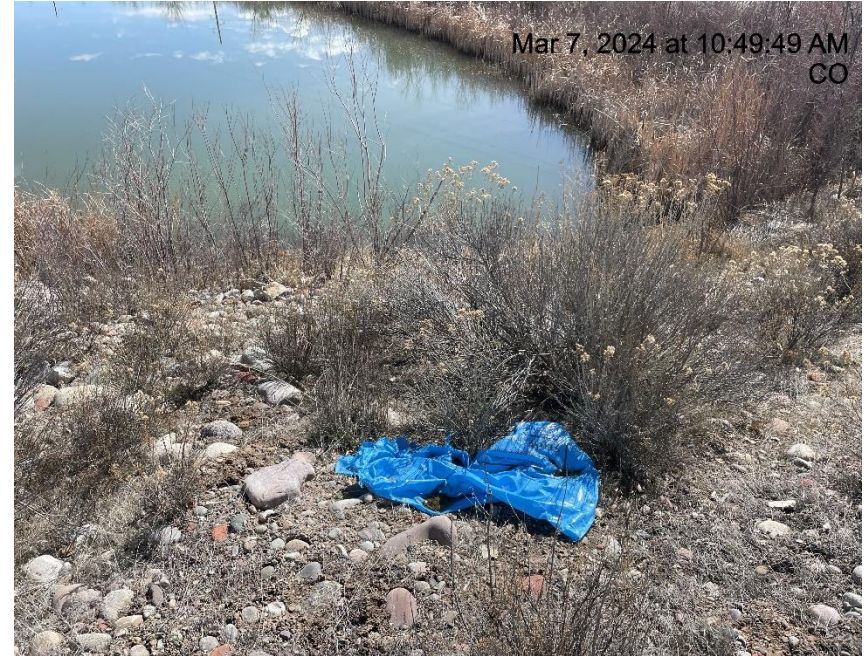
Photo # 9027 Debris
