# Interim Reclamation and Stormwater Inspection

Date: 03/11/2024

Operator: BONANZA CREEK ENERGY OPERATING  
COMPANY LLC - 8960

Location ID: 441915

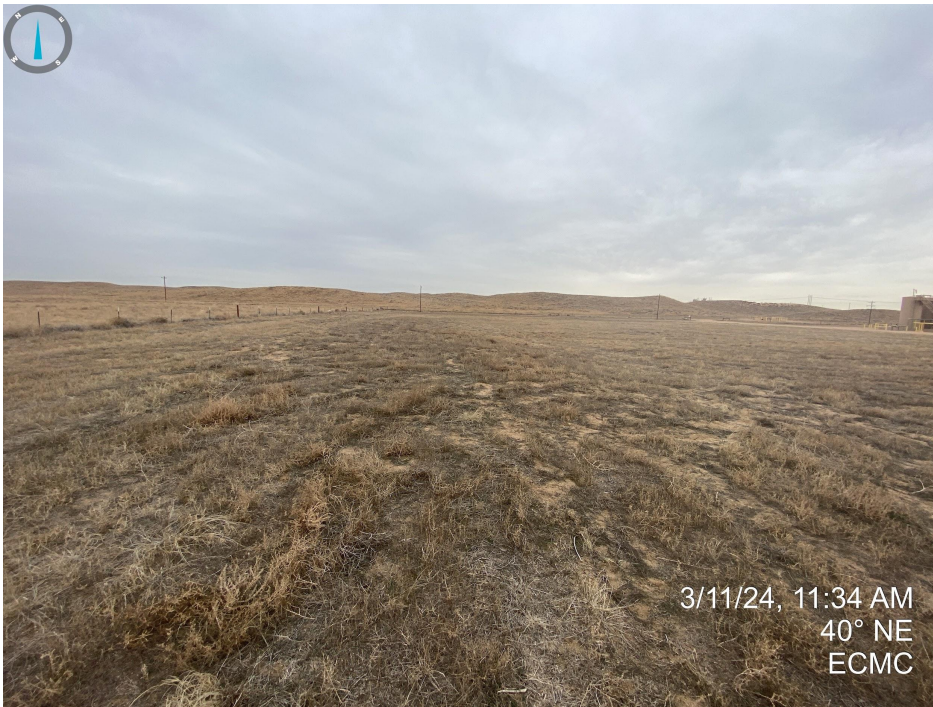
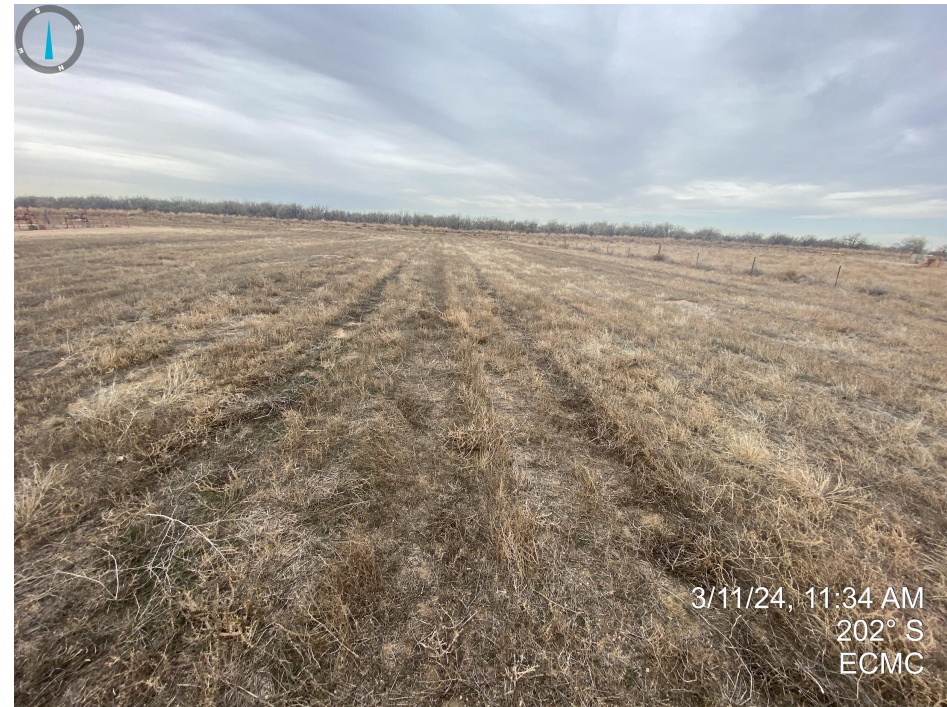
**Photos 1 & 2.** Western interim areas are not progressing towards Rule 1003 standards and regulations with evidence of undesirable vegetation (russian thistle and kochia) and areas of non-uniform vegetation cover resulting in exposed soils. Additional reclamation activities are required in order to comply with Rule 1003.

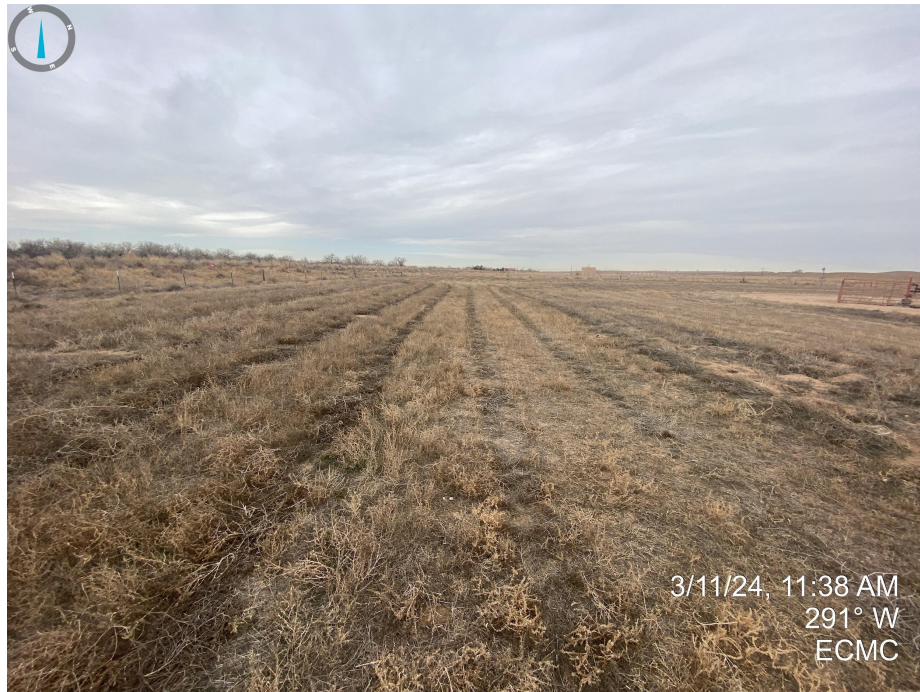
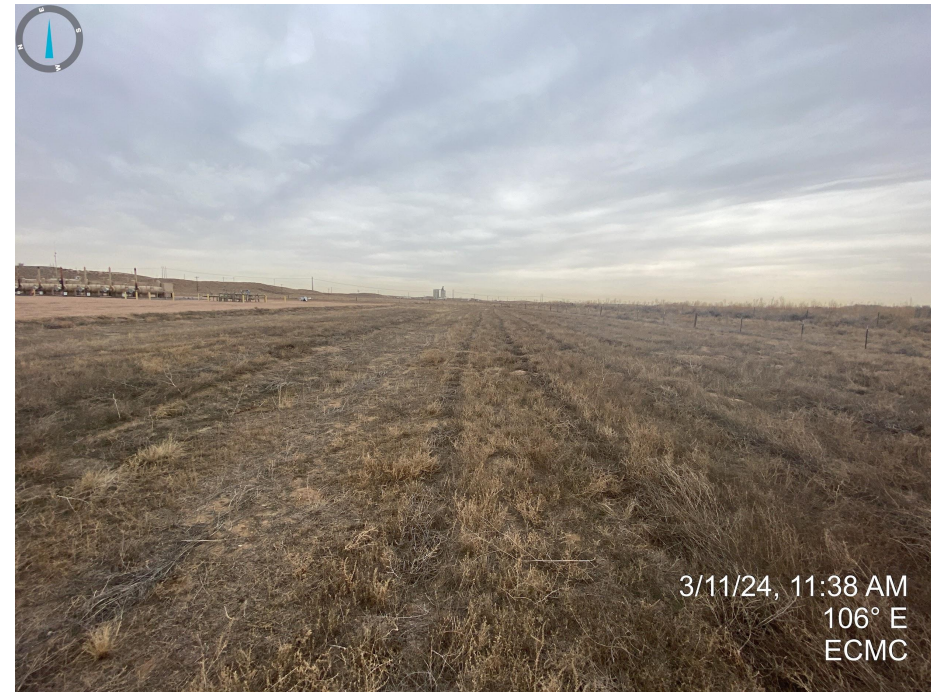
**Photos 3 & 4.** Southern interim areas; see comments in Photos 1 & 2.

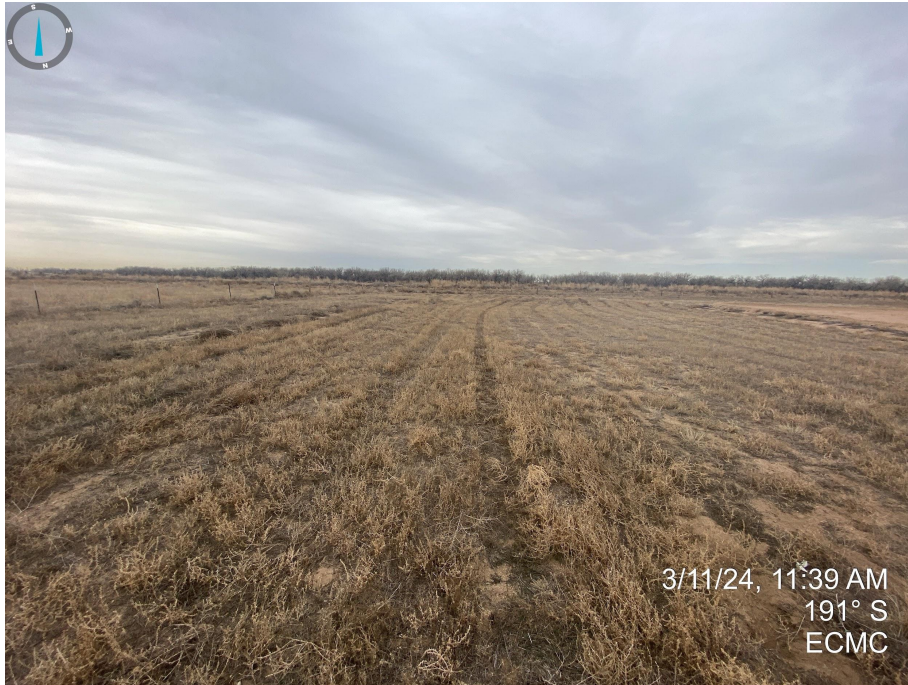
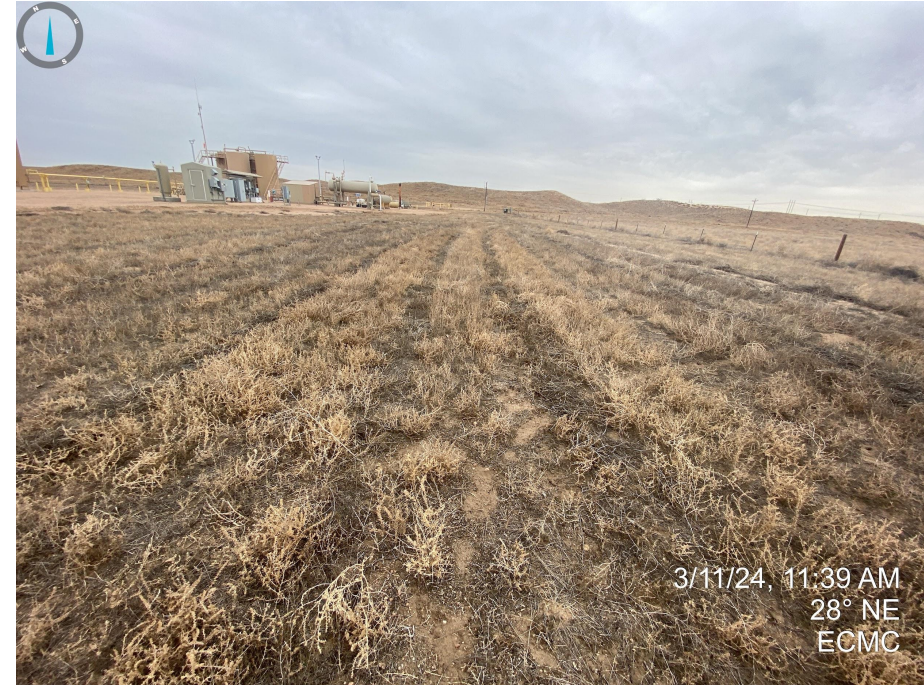
**Photos 5 & 6.** Eastern interim ares; see comments in Photos 1 & 2.

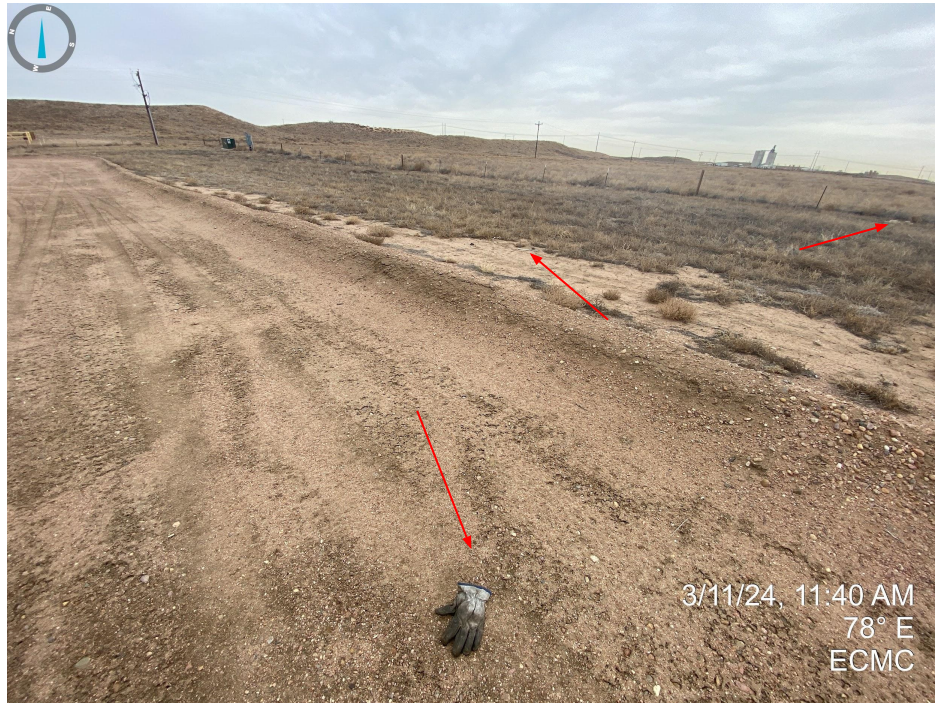
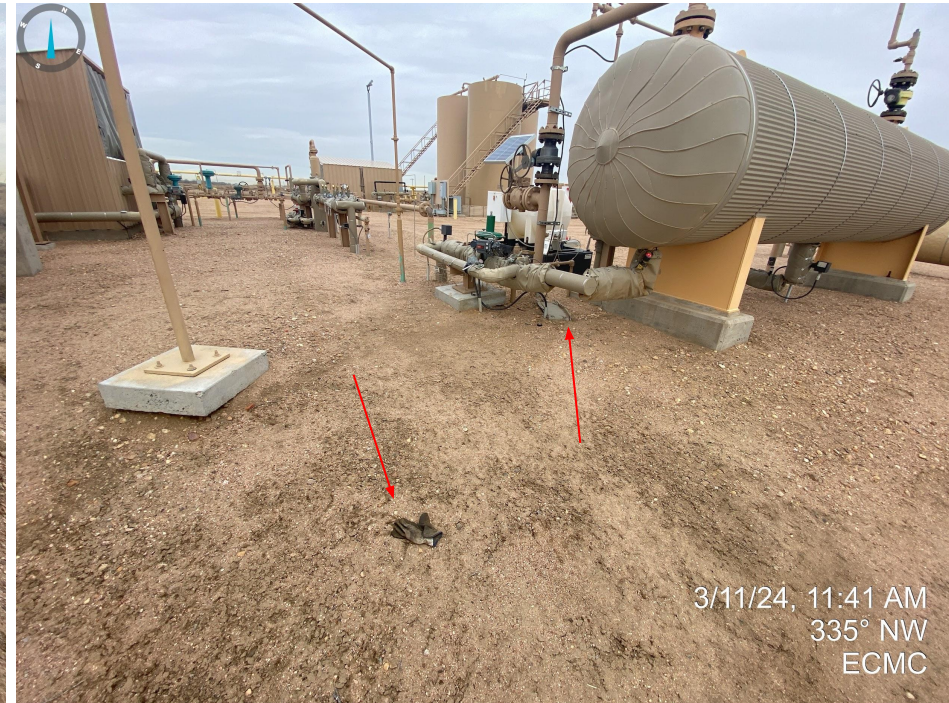
**Photos 7 & 8.** Debris observed on location. Operator shall self inspect the location and ensure all debris/trash has been removed.

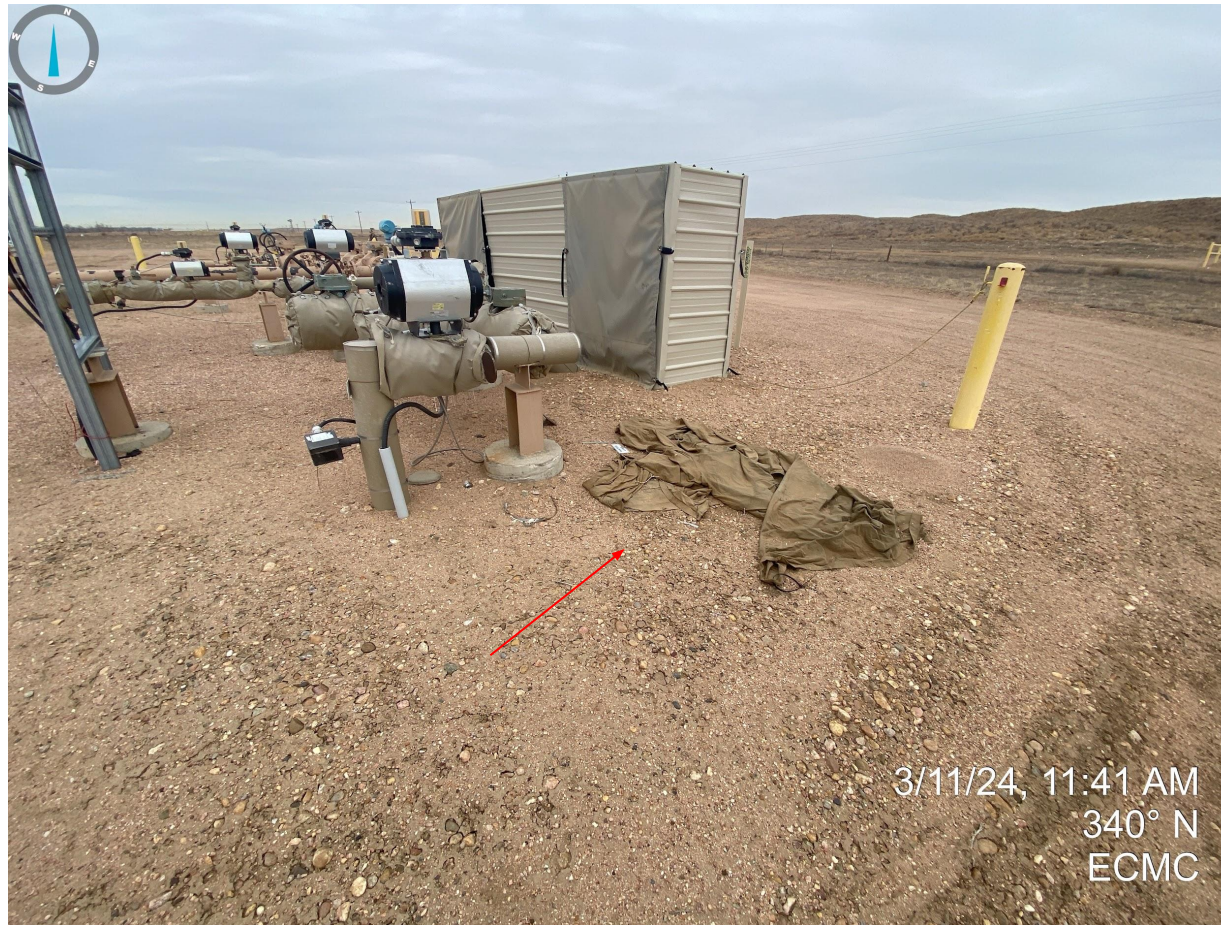
**Photo 9.** Debris on location. Operator shall self inspect the location and ensure all debris/trash has been removed.

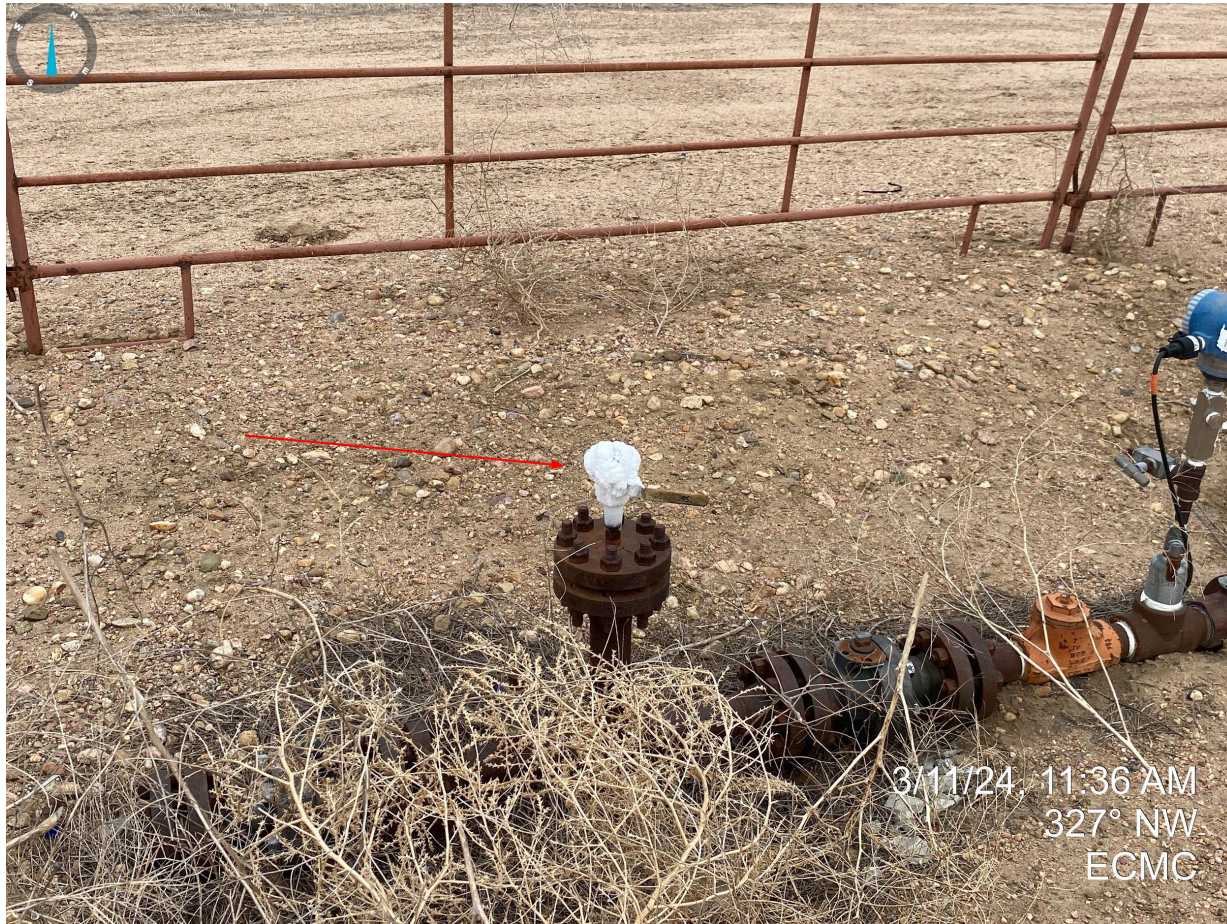
**Photo 10.** Audible leak and apparent frost accumulation on valve at Well API 123-41883.
