# Inspection Photos and Issue Report

**Operator:** ANSCHUTZ EXPLORATION CORP

**Location ID:** 484545

# Coyote Fed/0397-14, #484545

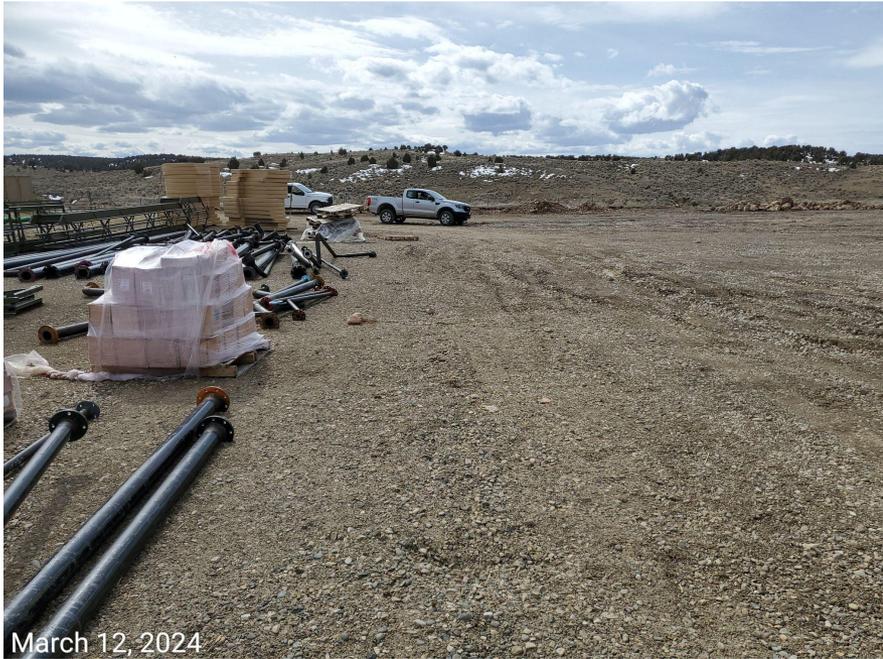
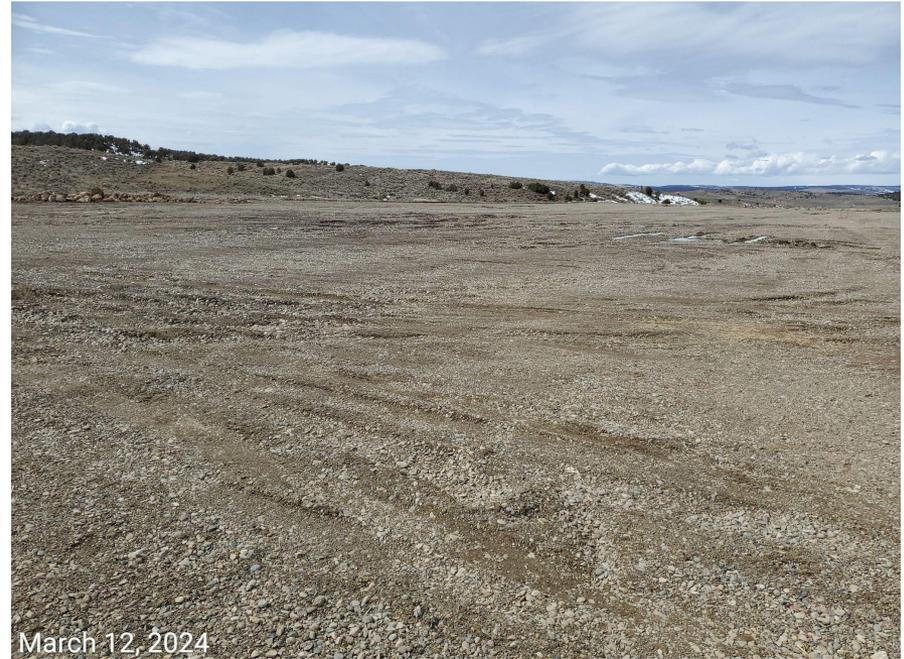
**Photo 1:** Photos 1-2 taken from the east end of the working pad surface. Photos provide an overview of the Location from south, southwest, northwest to north.

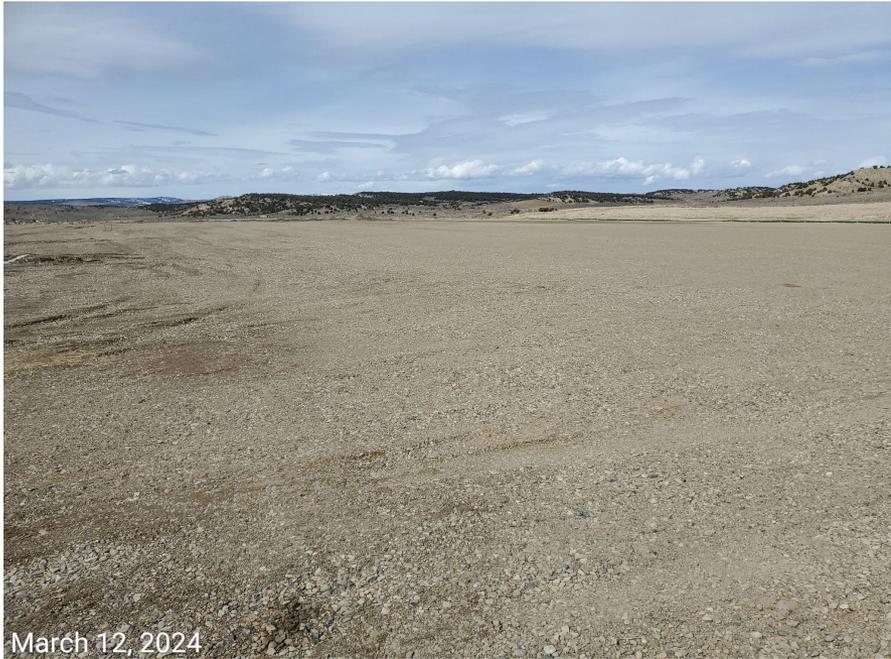
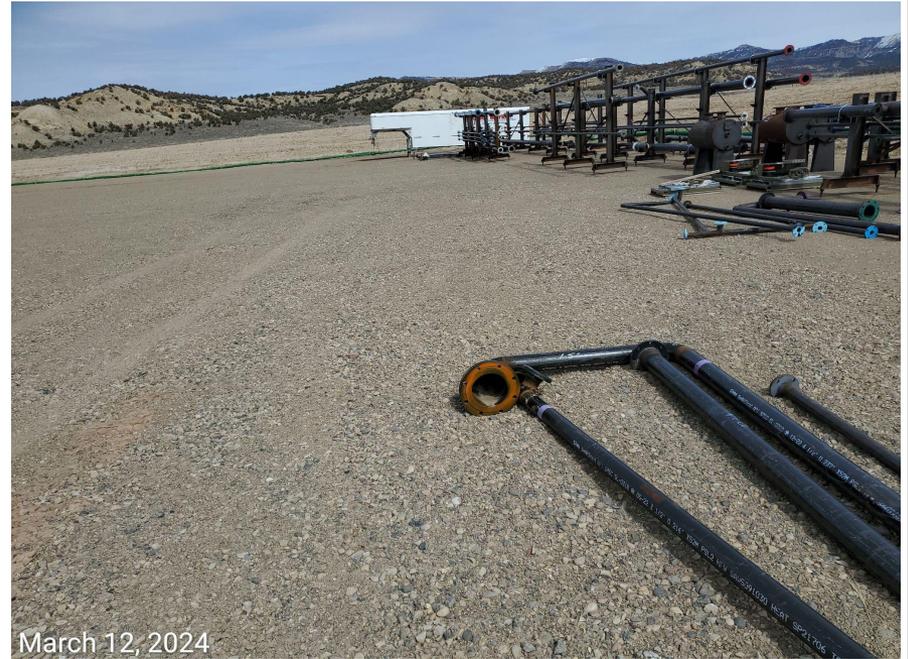
**Photo 2:** See comments under photo 1.

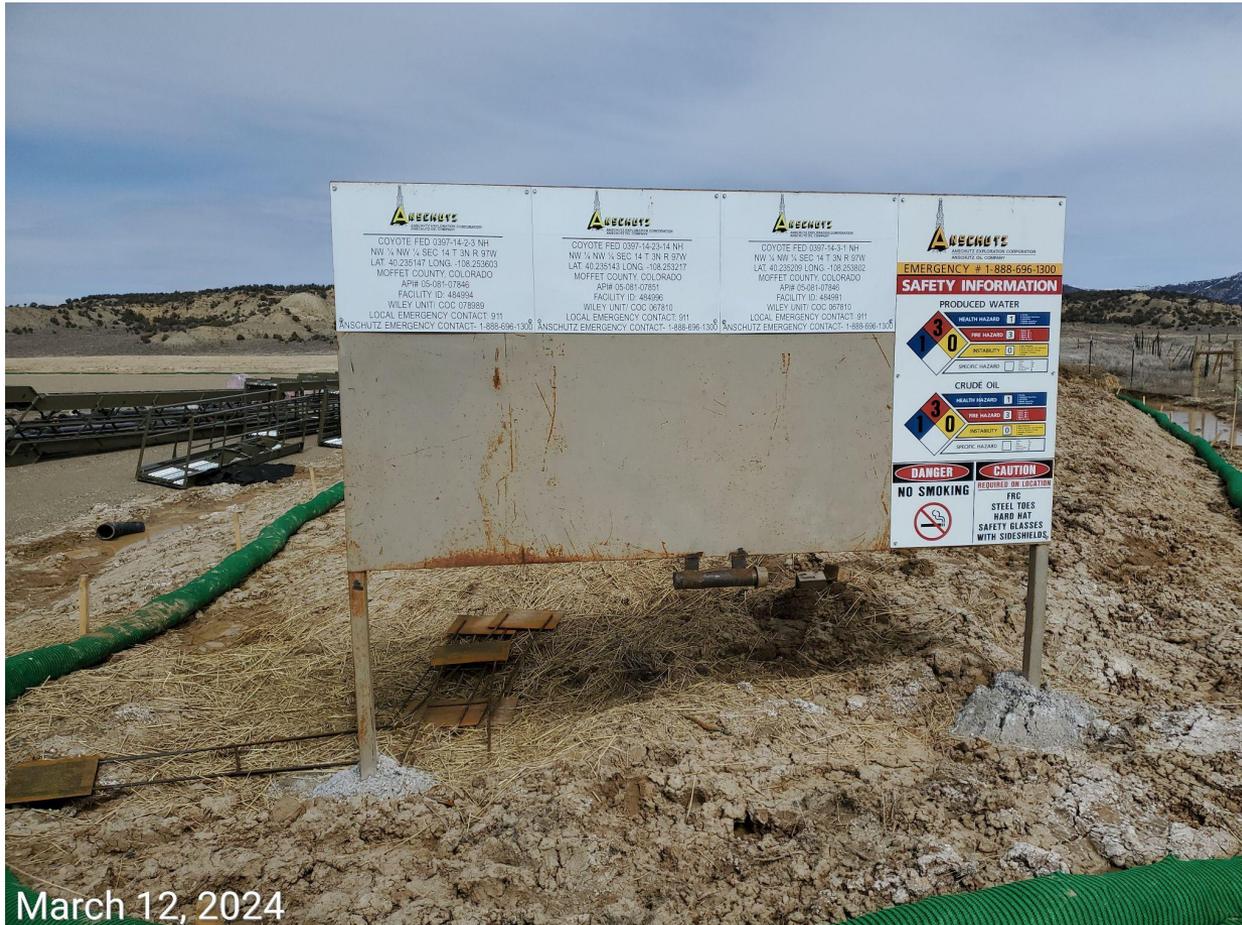
**Photo 3:** Photo taken from the Location entrance. Signage includes information regarding the permitted wells. Location name and Number not posted. Form 2A observed in tube at base of sign.

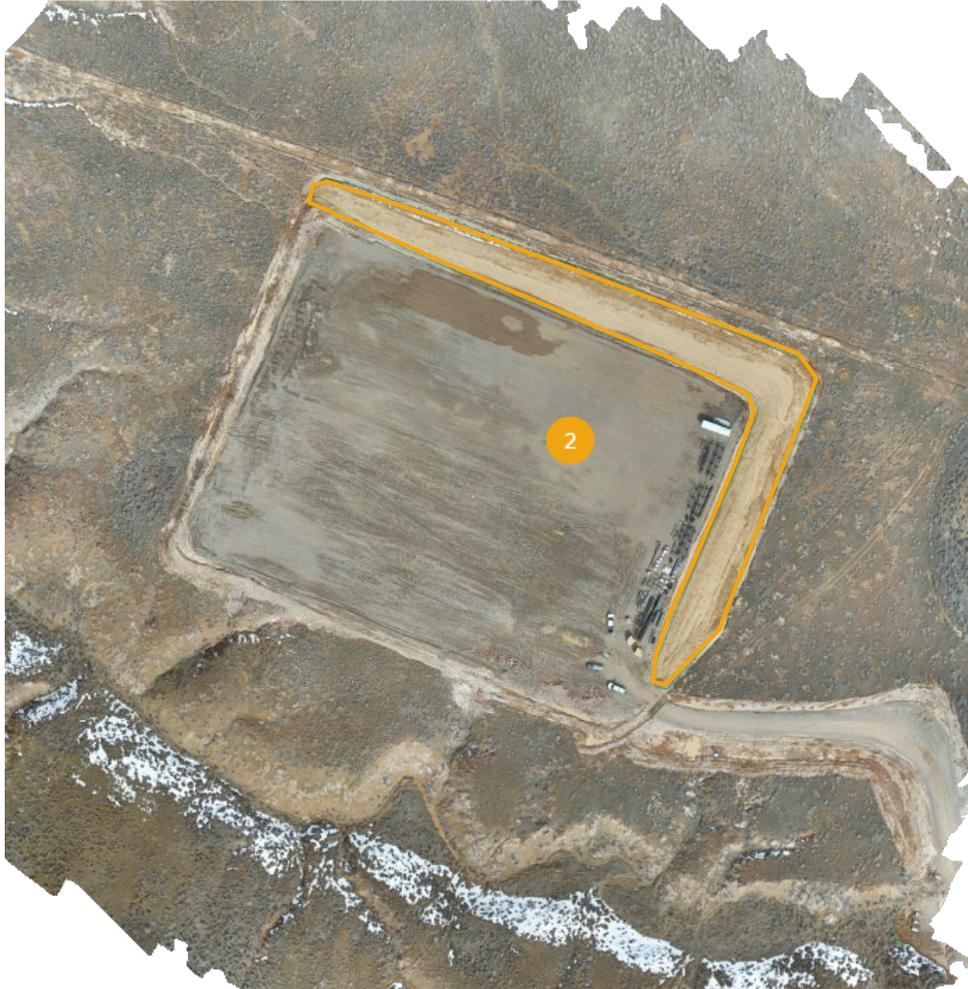
## 2 - Observation

Summary: Topsoil stockpile bare on the north and east ends of the Location. BMPs to protect the topsoil stockpile pursuant to 1002.b; to ensure topsoil stockpile remains properly segregated pursuant to Rule 1002.b; as well as to minimize erosion, degradation and sediment transport pursuant to Rule 1002.f are also missing or insufficient.

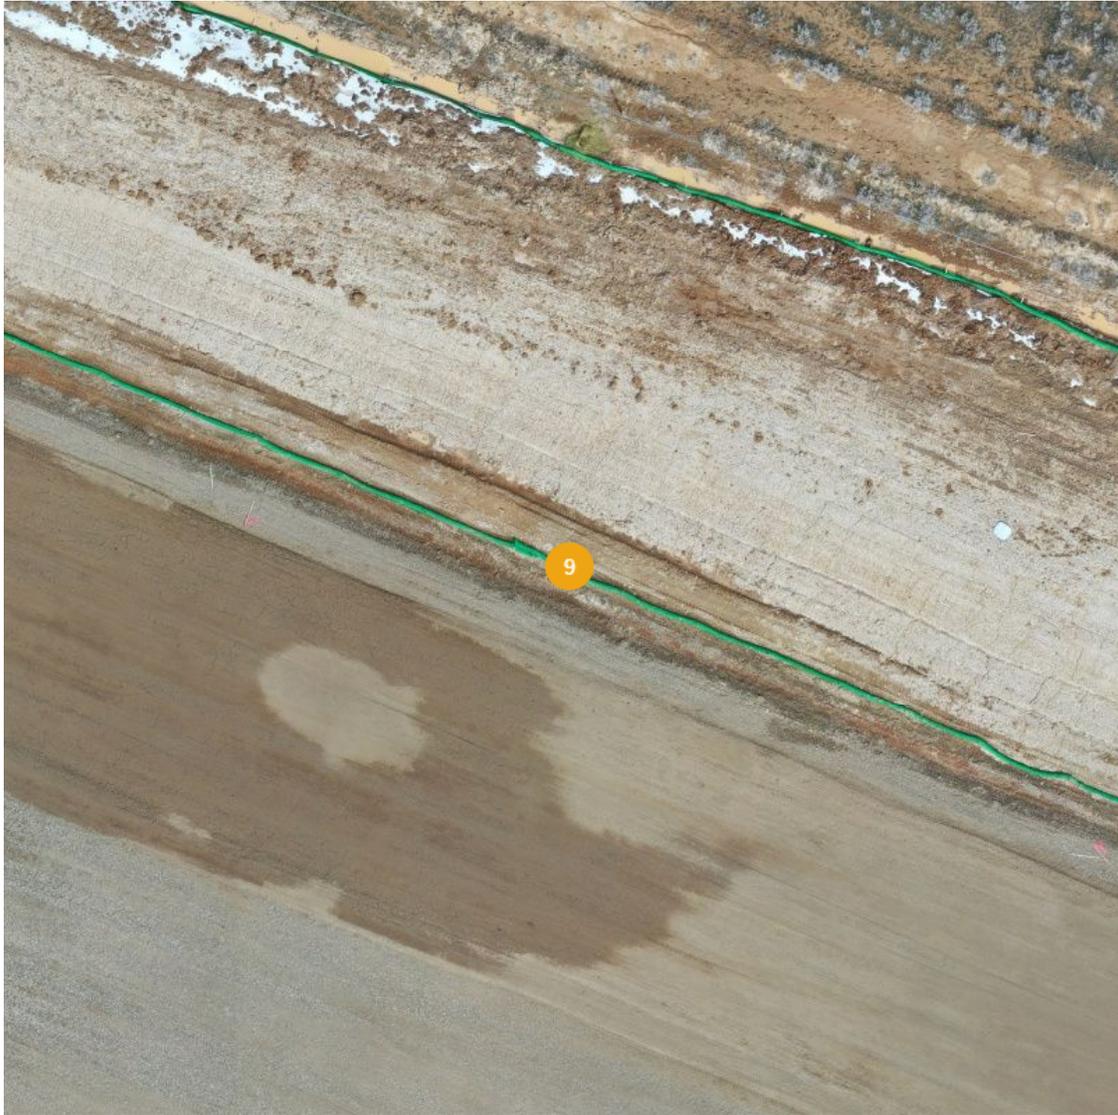
9 - Observation

Summary: Erosion log along perimeter of the topsoil stockpile has not been installed or maintained in proper functioning condition; BMP has not been placed along appropriate areas around the topsoil stockpile; BMP has not been properly staked per good engineering practice; BMP has not been trenched per good engineering practice.

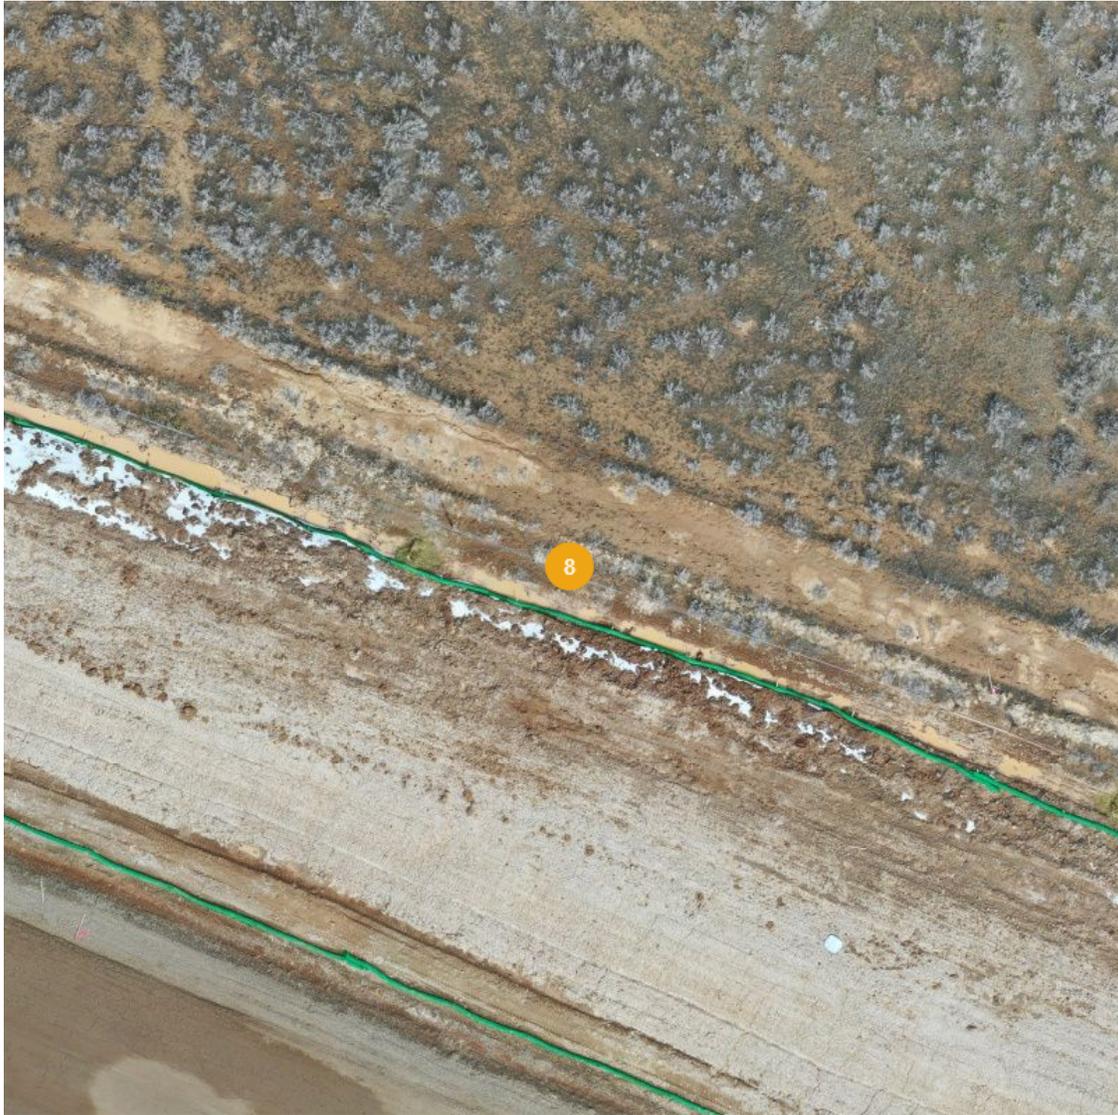
8 - Observation

Summary: Stormwater diversion ditch has not been constructed or maintained per good engineering practice; BMP has been constructed with vertical slopes. Slopes lack consolidation.

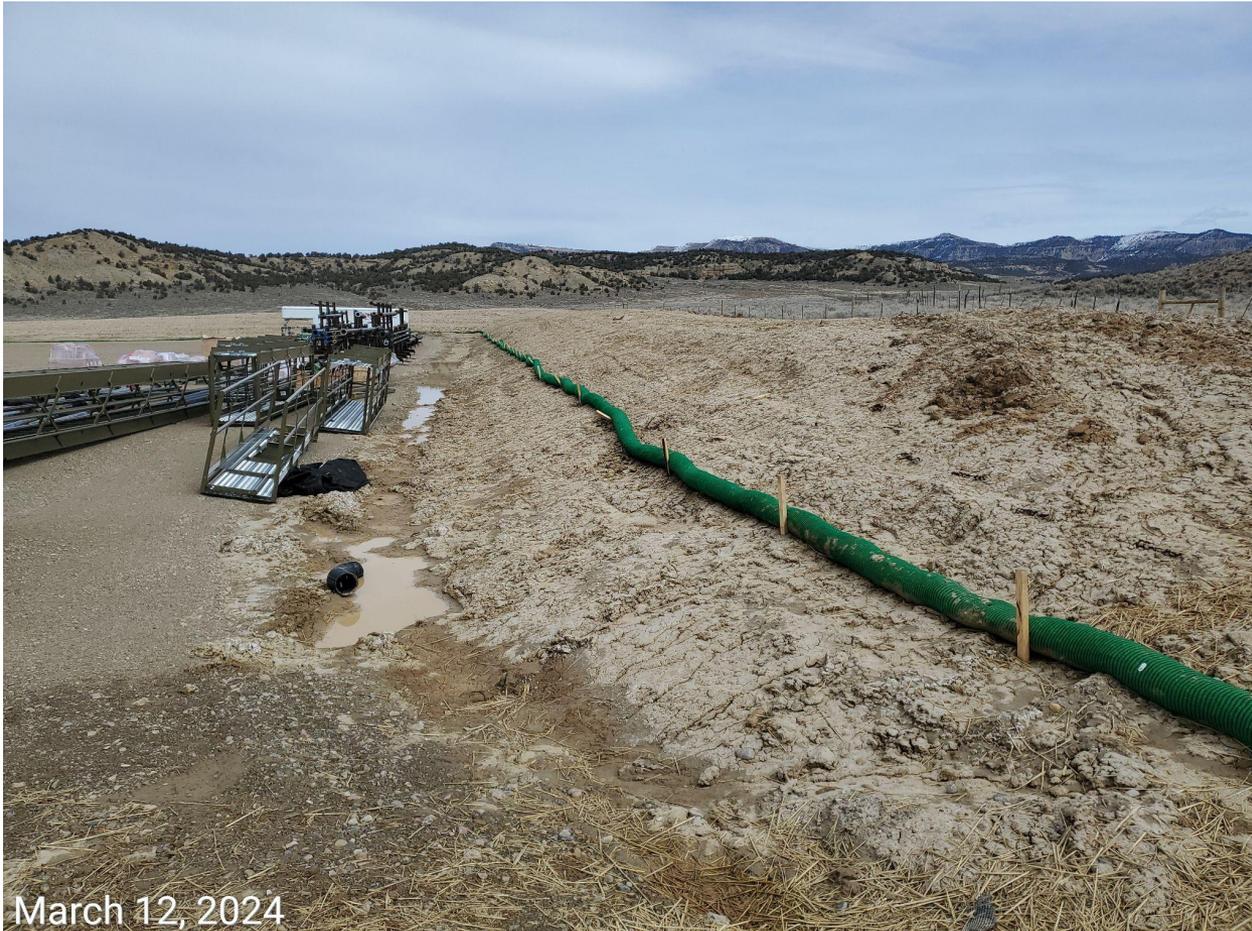
**Photo 4:** Photo taken from the east end of the Location, facing north. Photo example showing BMPs at the topsoil stockpile are inadequate; ditch has been constructed into the toe of the stockpile; erosion log has not been properly trenched/staked and has been placed halfway up the slope of the stockpile in places. Stockpile remains bare and at risk to wind/water erosion; erosion degradation observed.

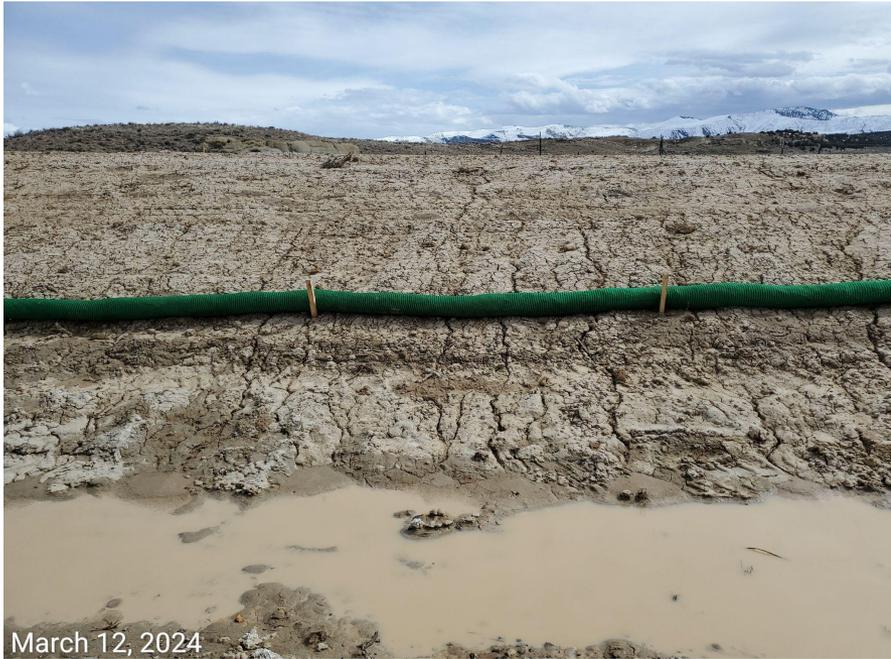
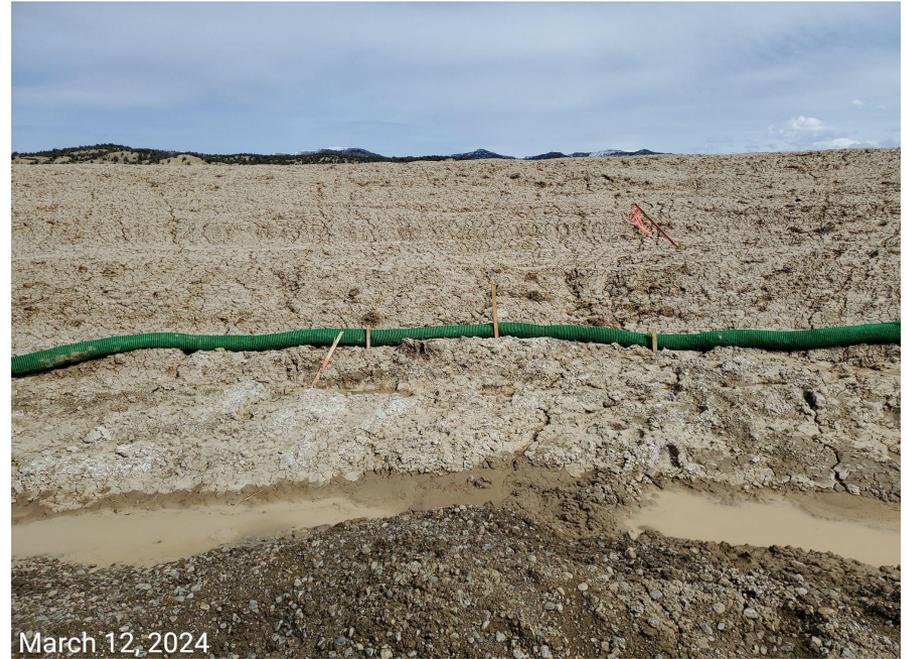
**Photo 5:** Photos show the topsoil stockpile on the east and north end of the Location. Photo example showing BMPs at the topsoil stockpile are inadequate; ditch has been constructed into the toe of the stockpile; erosion log has not been properly trenched/staked and has been placed halfway up the slope of the stockpile in places. Stockpile remains bare and at risk to wind/water erosion; erosion degradation observed. Protections at the topsoil stockpile remain missing or insufficient.

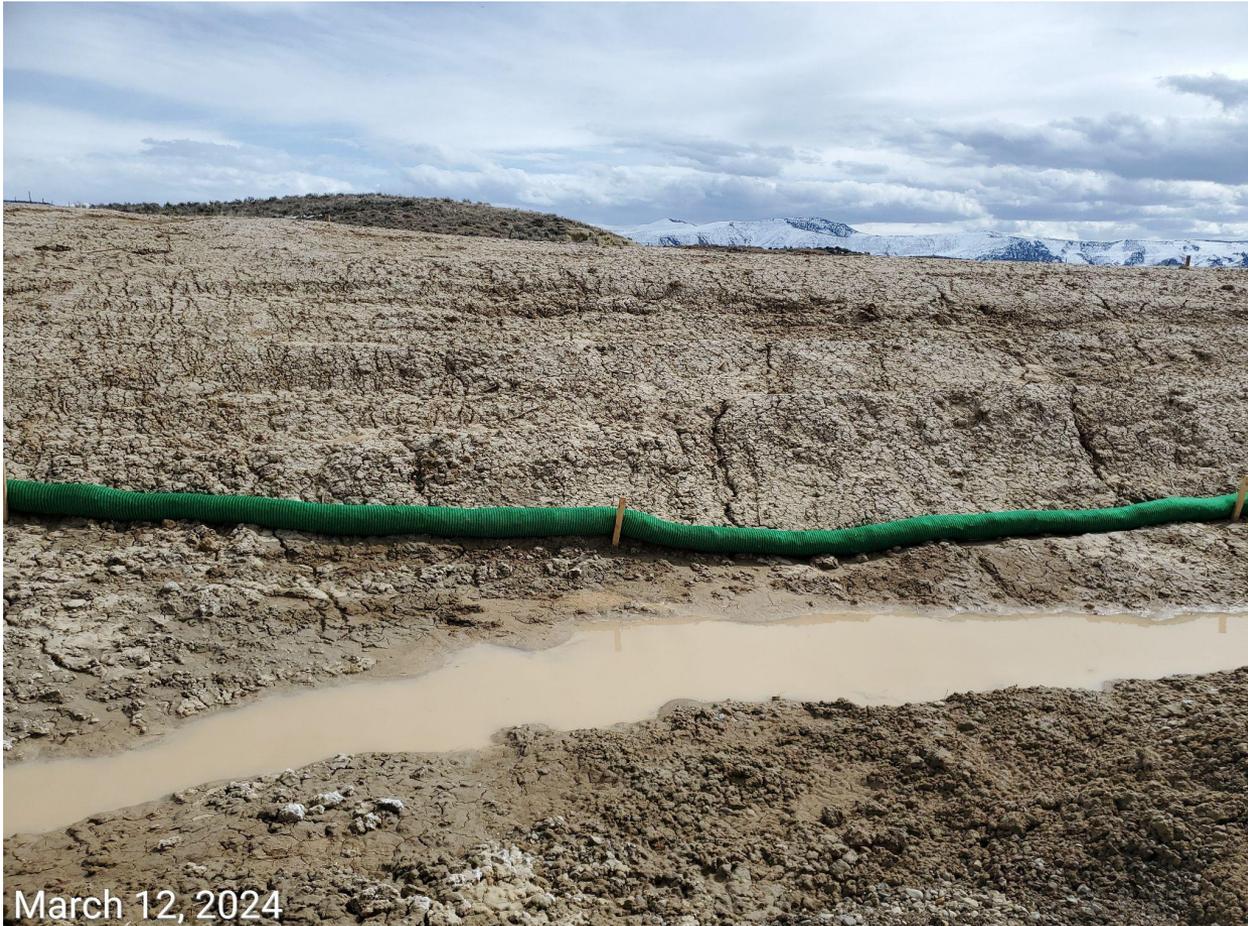
**Photo 6:** See comment under photo 5.

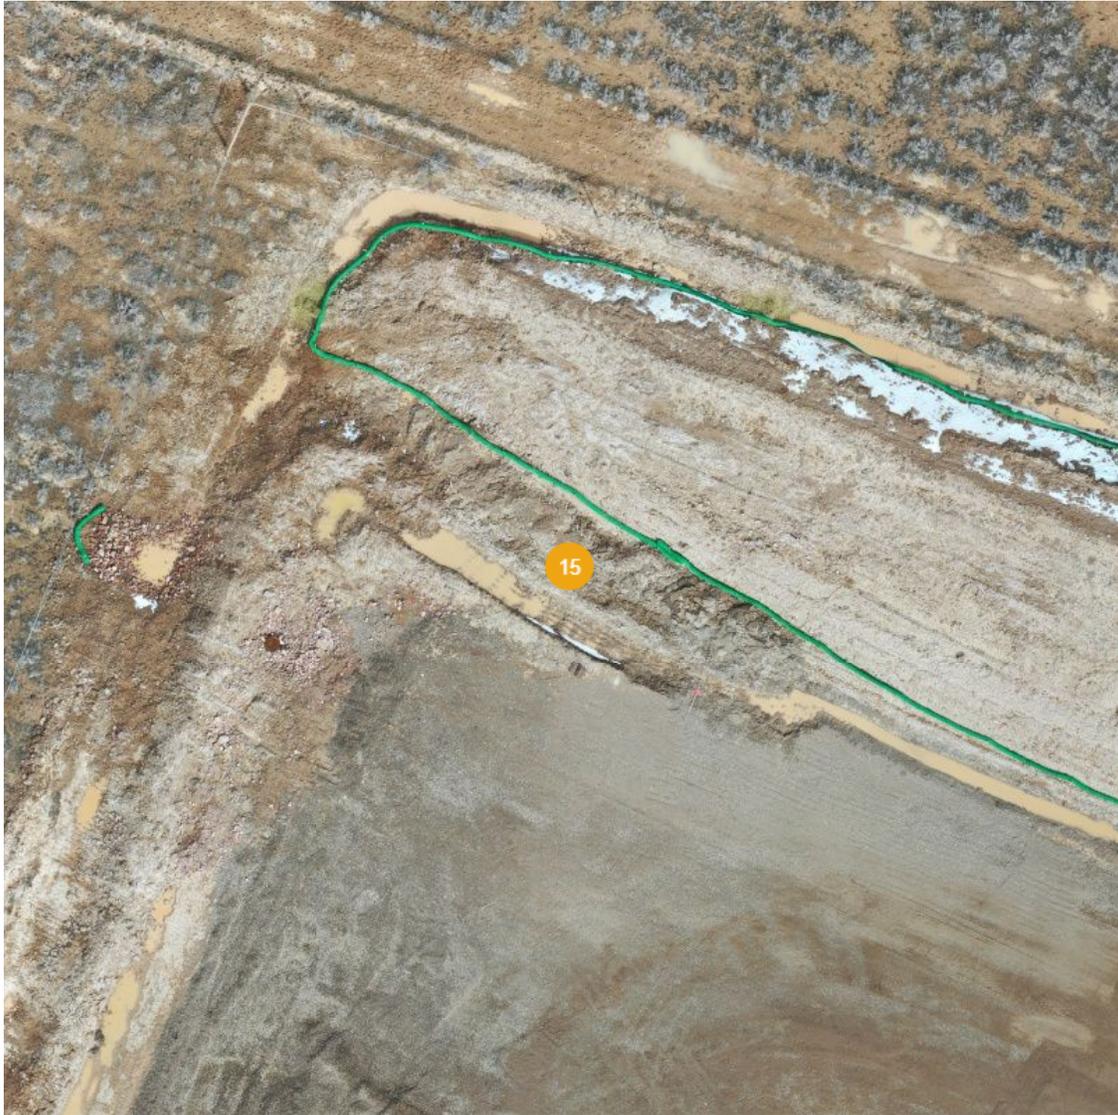
### 15 - Observation

**Summary:** Stormwater diversion ditch has not been maintained in proper functioning condition; sediment/material has been placed within the ditch. Ditch has been constructed into the toe of the topsoil stockpile

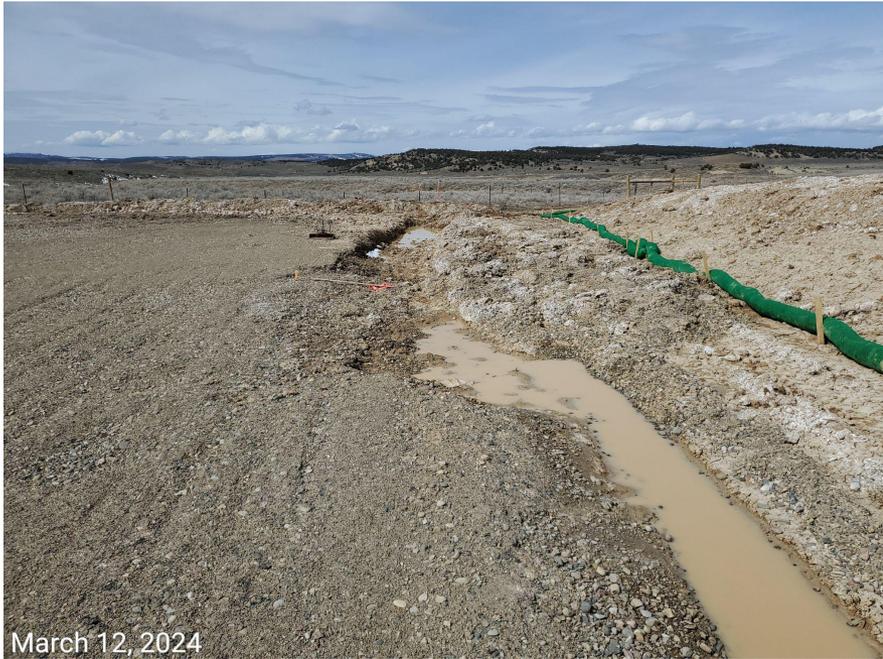
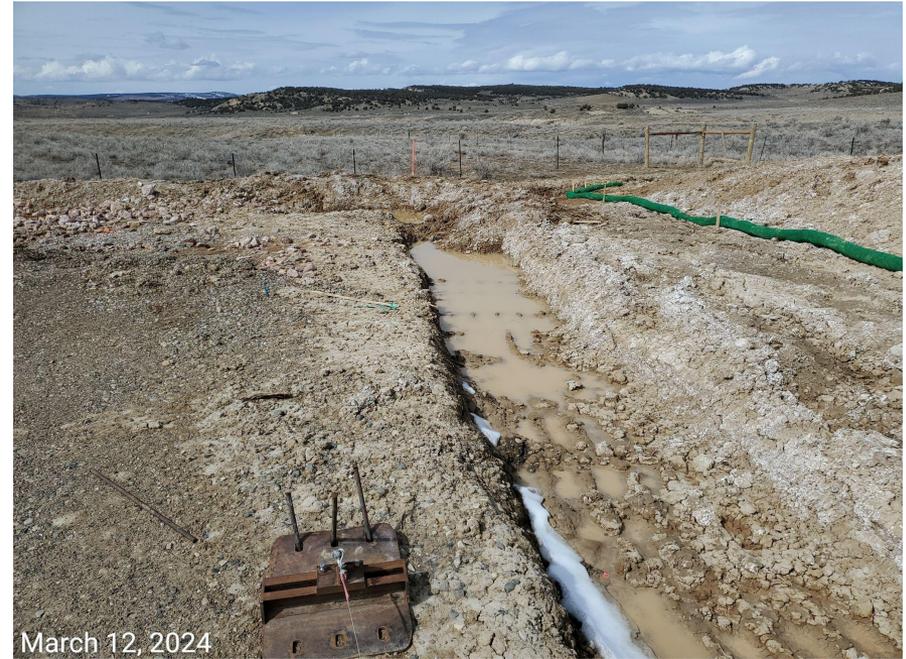
**Photo 7:** Photo taken from the northwest end of the Location. Photos examples showing the stormwater diversion ditch along the northern perimeter of the working pad surface has not been installed or maintained per good engineering practices. BMP has been constructed into the toe of the topsoil stockpile. Sediment has been pushed into the BMP.

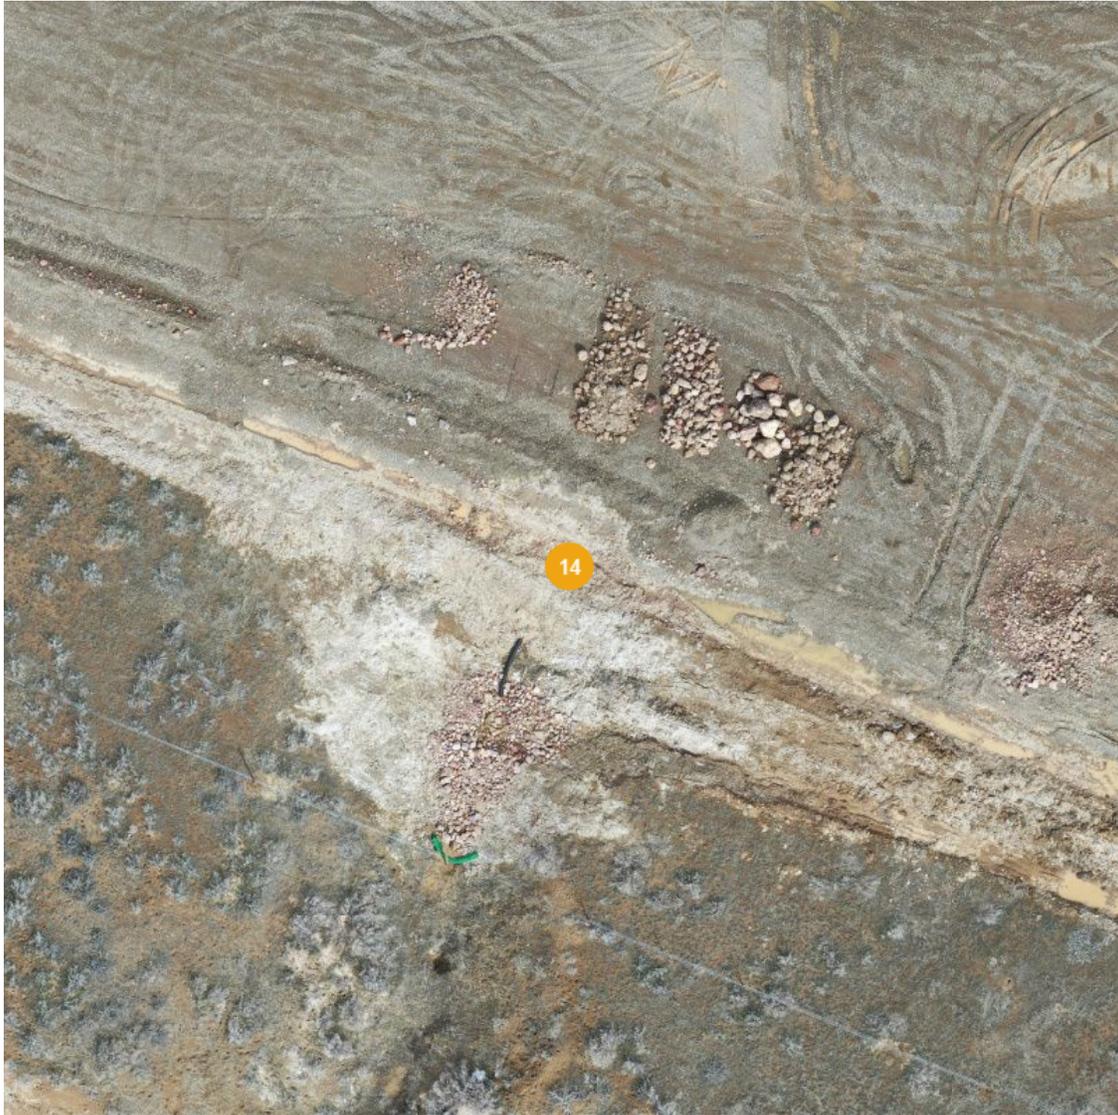
14 - Observation

Summary:	Sediment trap / Slope drain has not been constructed with a properly engineered basing and inlet.
Created:	Mar 13, 2024, 9:40am by Aaron Trujillo
Cost of Repair:	—
Lat/Long:	40.2345926, -108.2534581
Northing:	1340238.1 US ft
Easting:	2231385.9 US ft
Elevation:	5916.53 US ft
NAD83(2011) / Colorado North (ftUS) (US survey foot)

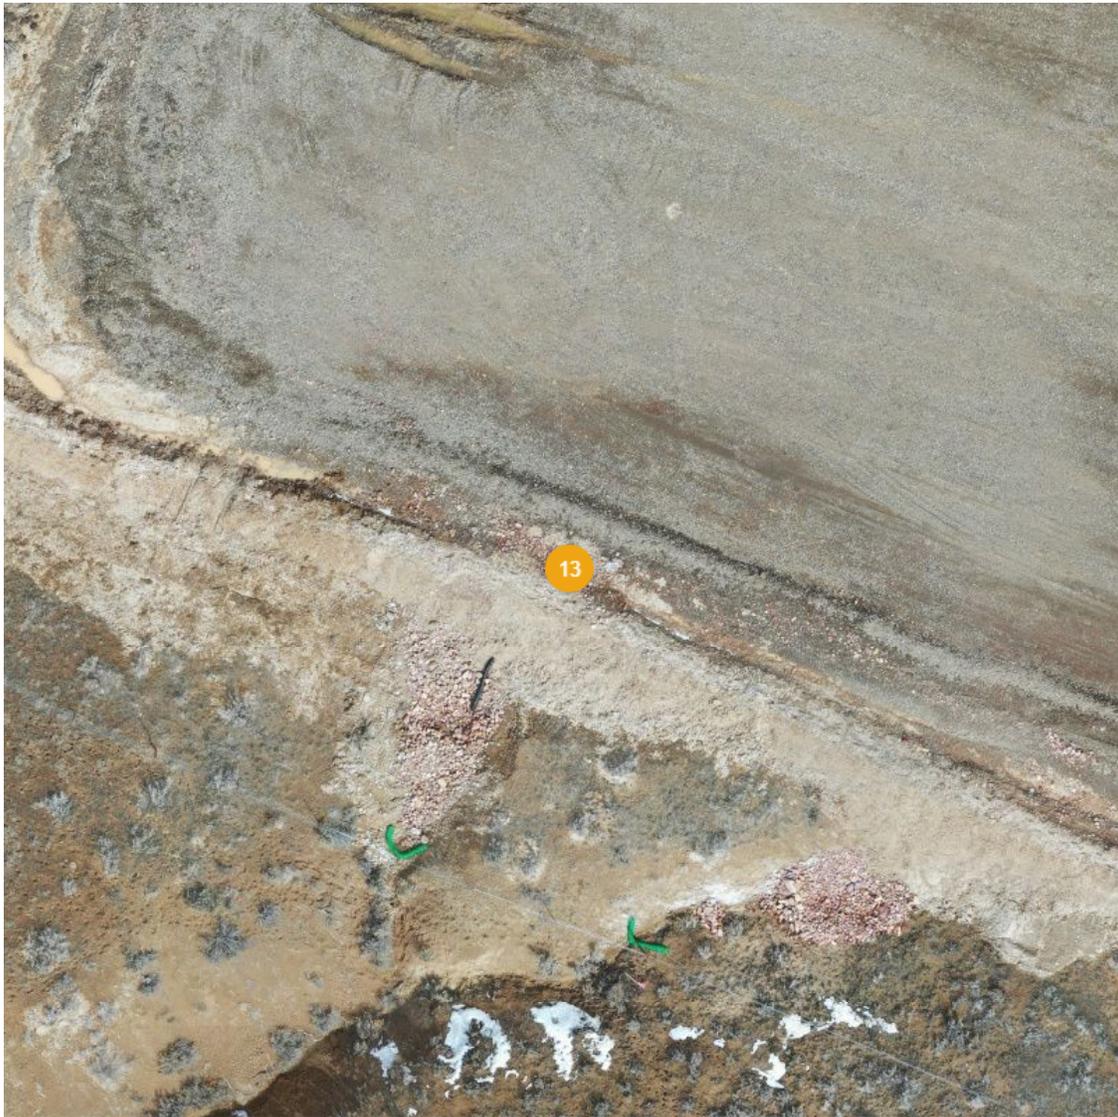
13 - Observation

Summary:	Sediment trap / Slope drain has not been constructed with a properly engineered basing and inlet.
Created:	Mar 13, 2024, 9:39am by Aaron Trujillo
Cost of Repair:	—
Lat/Long:	40.2348859, -108.2543592
Northing:	1340352.8 US ft
Easting:	2231137.8 US ft
Elevation:	5917.10 US ft
NAD83(2011) / Colorado North (ftUS) (US survey foot)

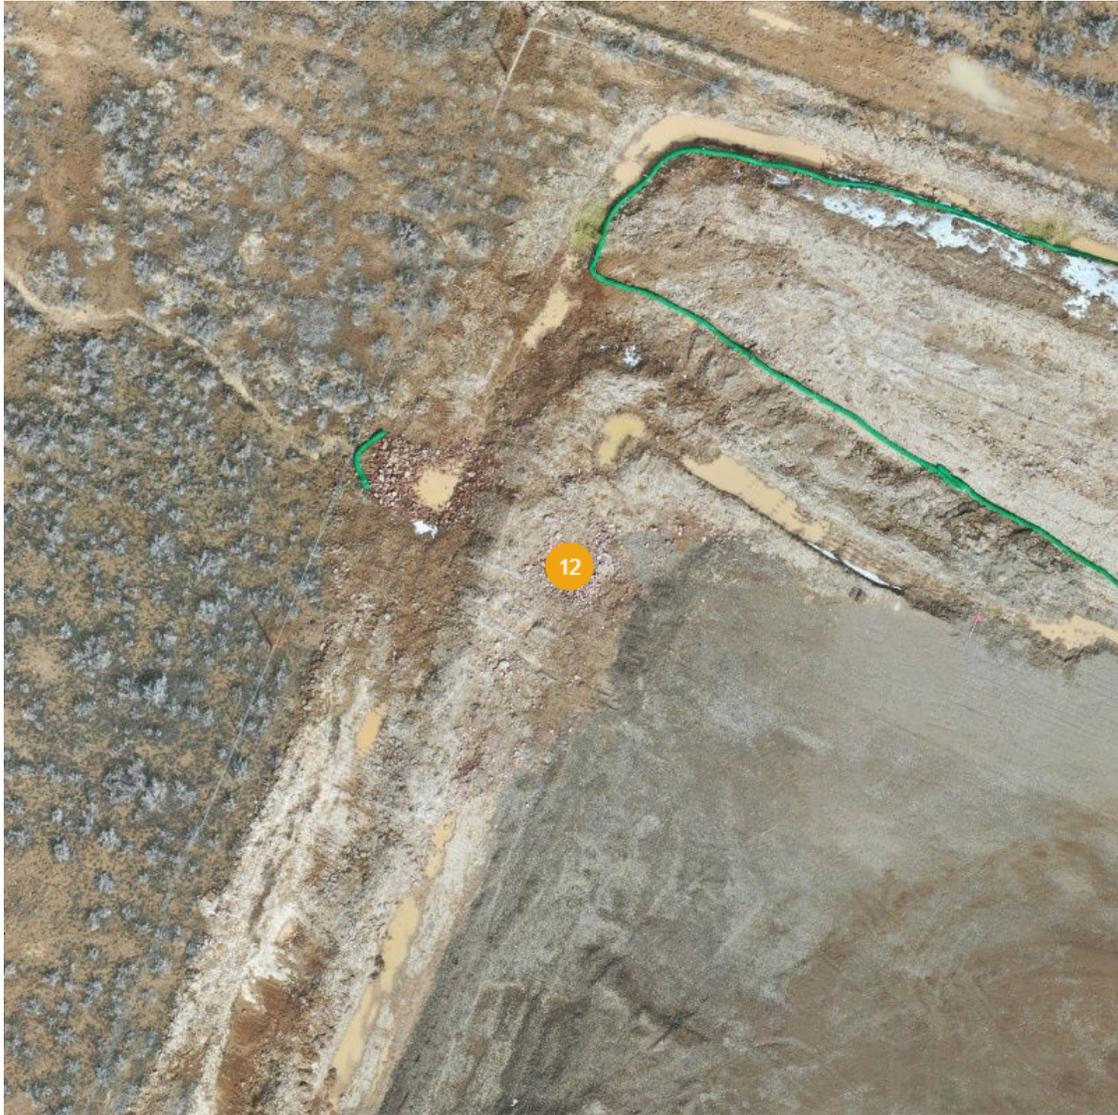
12 - Observation

Summary:	Sediment trap / Slope drain has not been constructed with a properly engineered basing and inlet.
Created:	Mar 13, 2024, 9:39am by Aaron Trujillo
Cost of Repair:	—
Lat/Long:	40.2359131, -108.2541443
Northing:	1340724.9 US ft
Easting:	2231209.3 US ft
Elevation:	5917.45 US ft

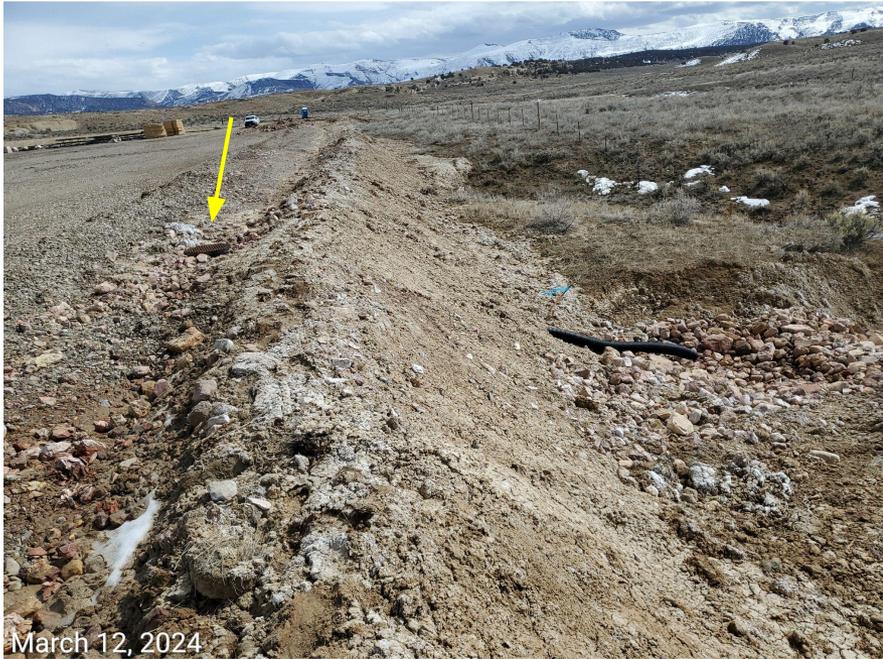
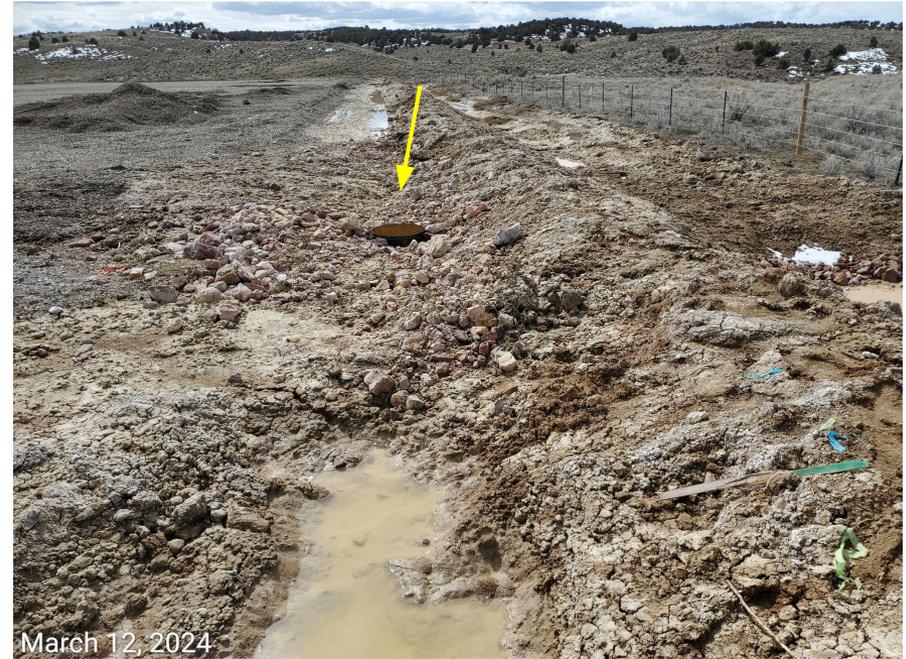
**Photo 8:** Photos examples showing the sediment traps and slope drains installed on the Location. BMPs have been implemented in conjunction with slope drains leading to rip-rap armored outlets. Outlets appear adequate however sediment traps and slope drains lack properly engineered basins, and inlet protections at the pipe connected to the slope drain.

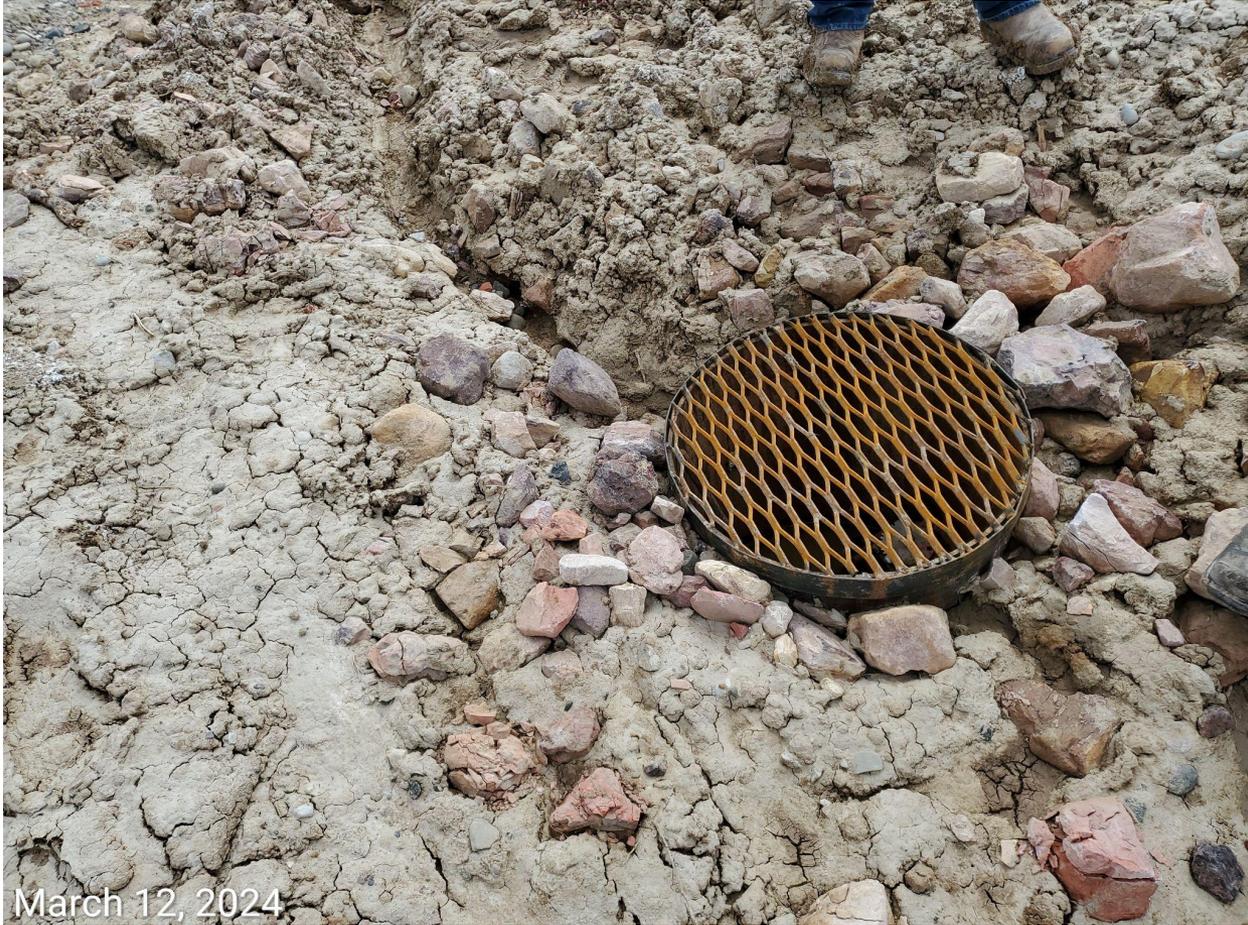
**Photo 9:** Continued from photo 8. Sediment traps and slope drains lack properly engineered basins, and inlet protections at the pipe connected to the slope drain.

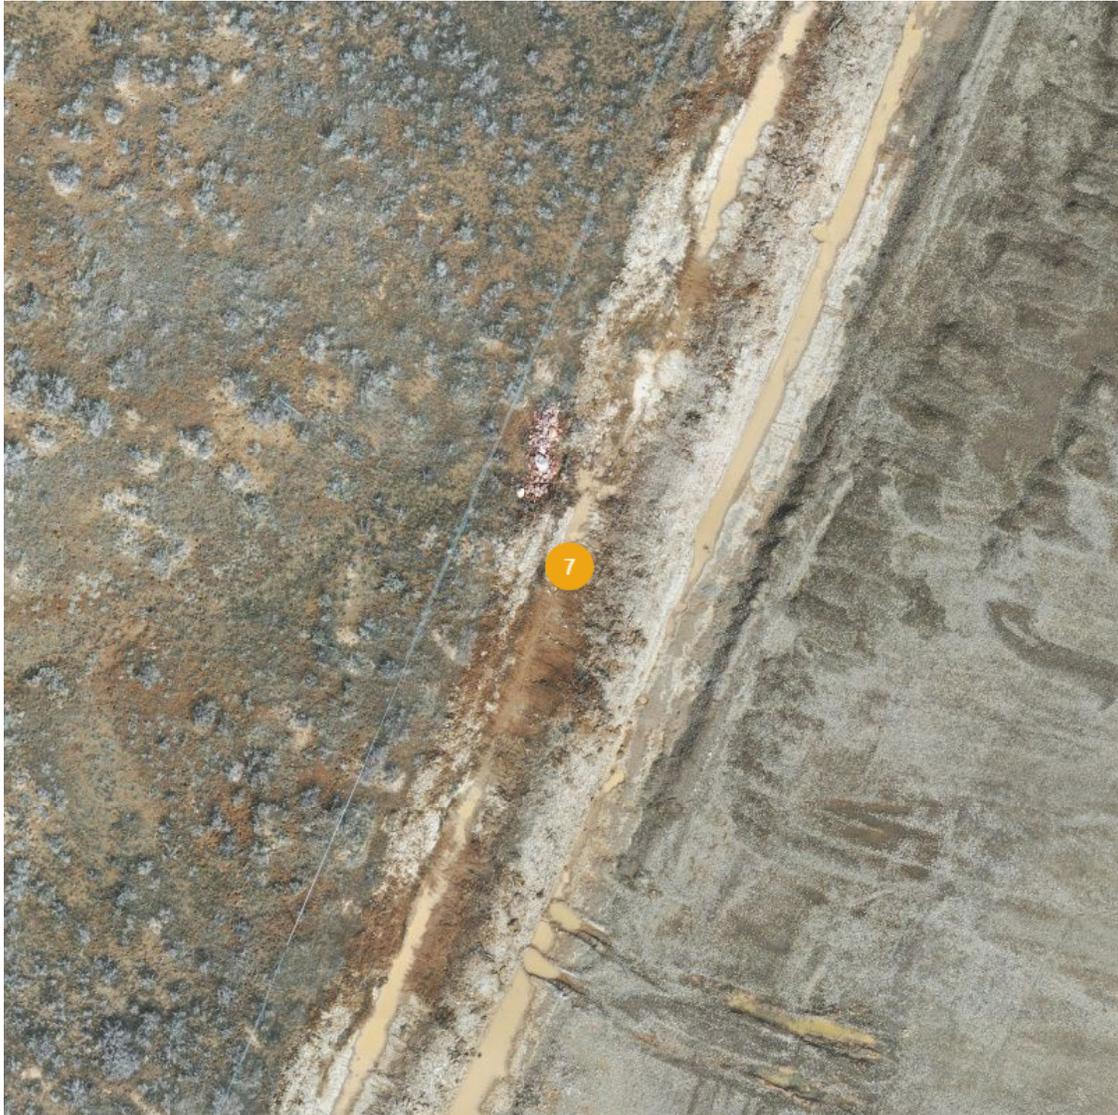
### 7 - Observation

Summary: Stormwater diversion ditch on the west end of the Location has not been installed or maintained per good engineering practice.

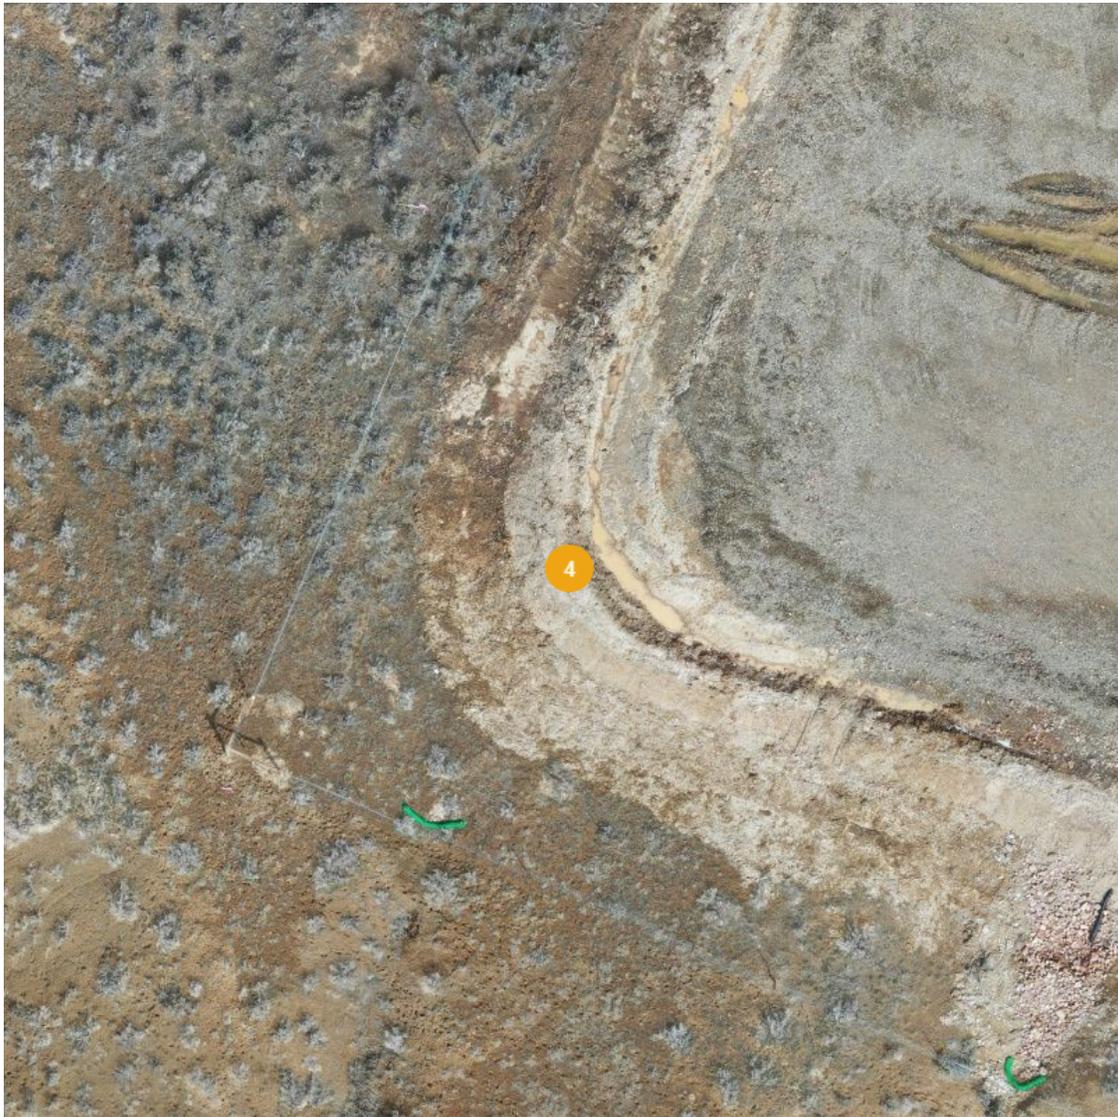
### 4 - Observation

Summary: Berm along the southern and wester perimeter of the working pad surface has not been installed per good engineering practice; BMP lacks proper consolidation.
