# Inspection Photos and Issue Report

**Operator:** ANSCHUTZ EXPLORATION CORP

**Location ID:** 484545

# Coyote Fed/0397-14, #484545

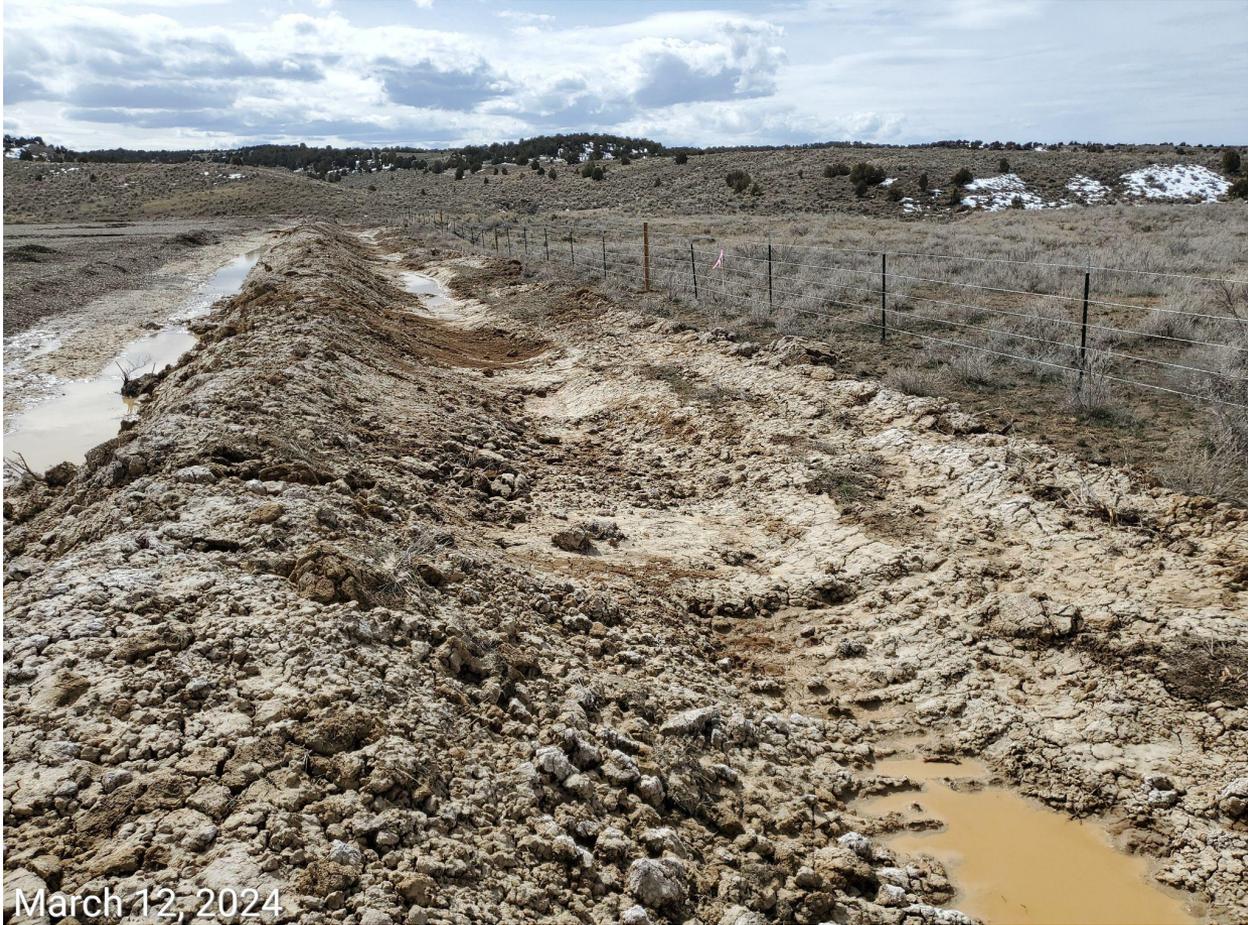
**Photo 10:** Photo taken from the west end of the Location, facing south. Ditch and berm have not been installed per good engineering practices. Perimeter controls to manage runoff in a manner that minimizes erosion, degradation and sediment transport remain inadequate.

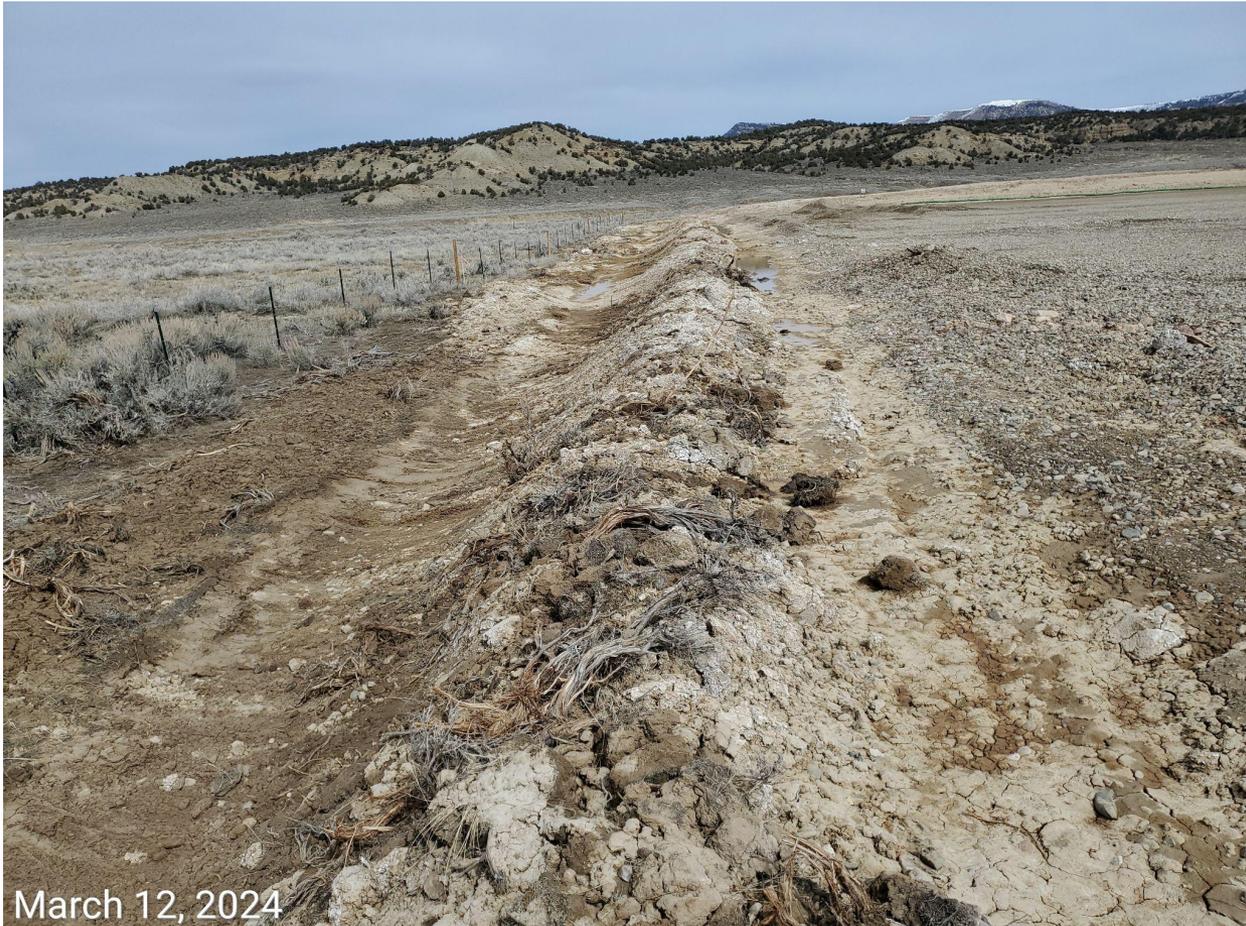
**Photo 11:** Photo taken from the southwest end of the Location, facing north. Ditch and berm have not been installed per good engineering practices. Perimeter controls to manage runoff in a manner that minimizes erosion, degradation and sediment transport remain inadequate.

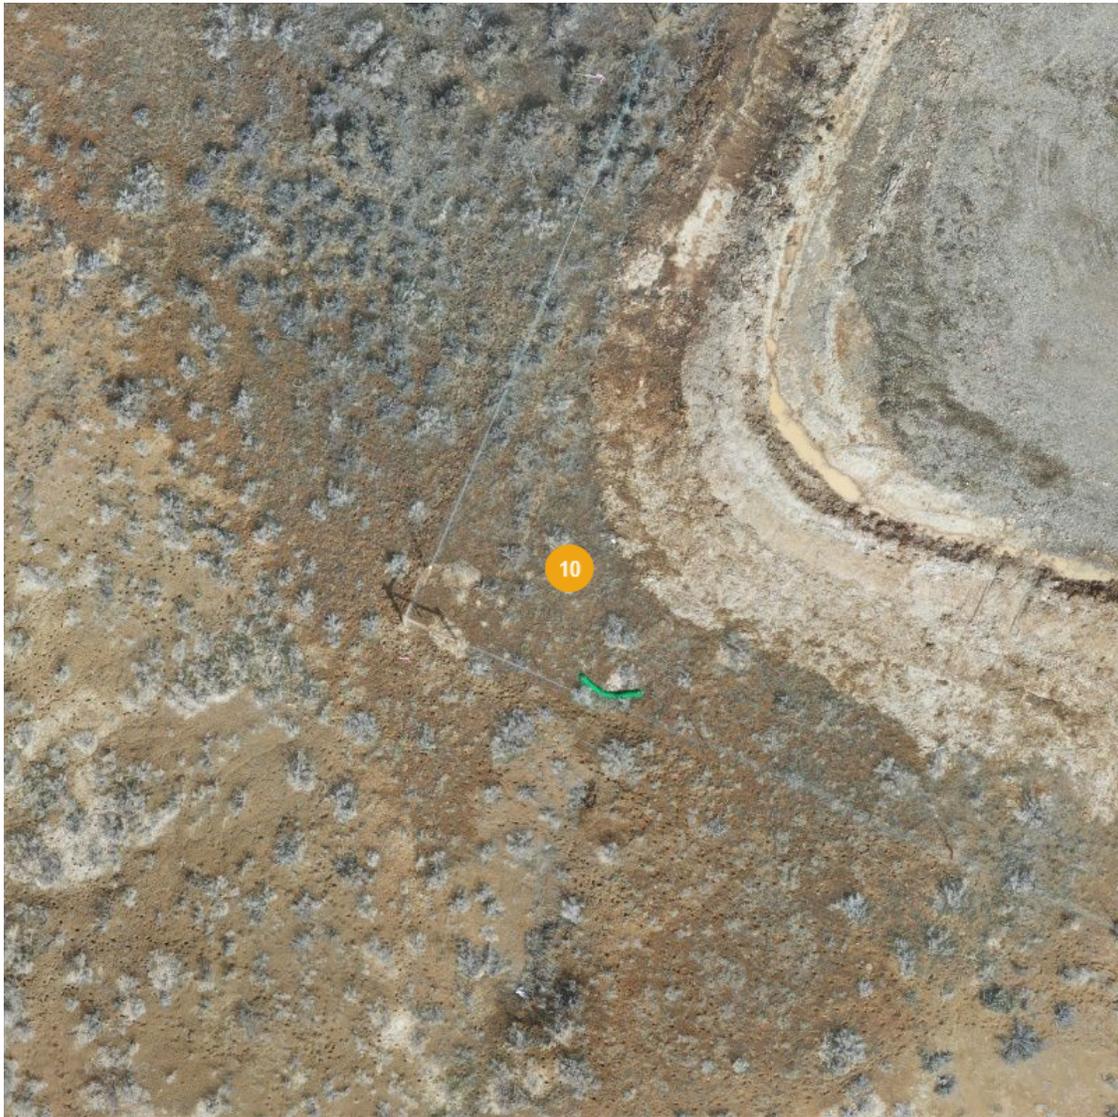
10 - Observation

Summary: Stormwater and erosion control measures along the perimeter of the disturbance remain missing or insufficient to manage runoff in a manner that minimizes erosion, degradation and sediment transport. Sediment transport/degradation from the slopes evident.

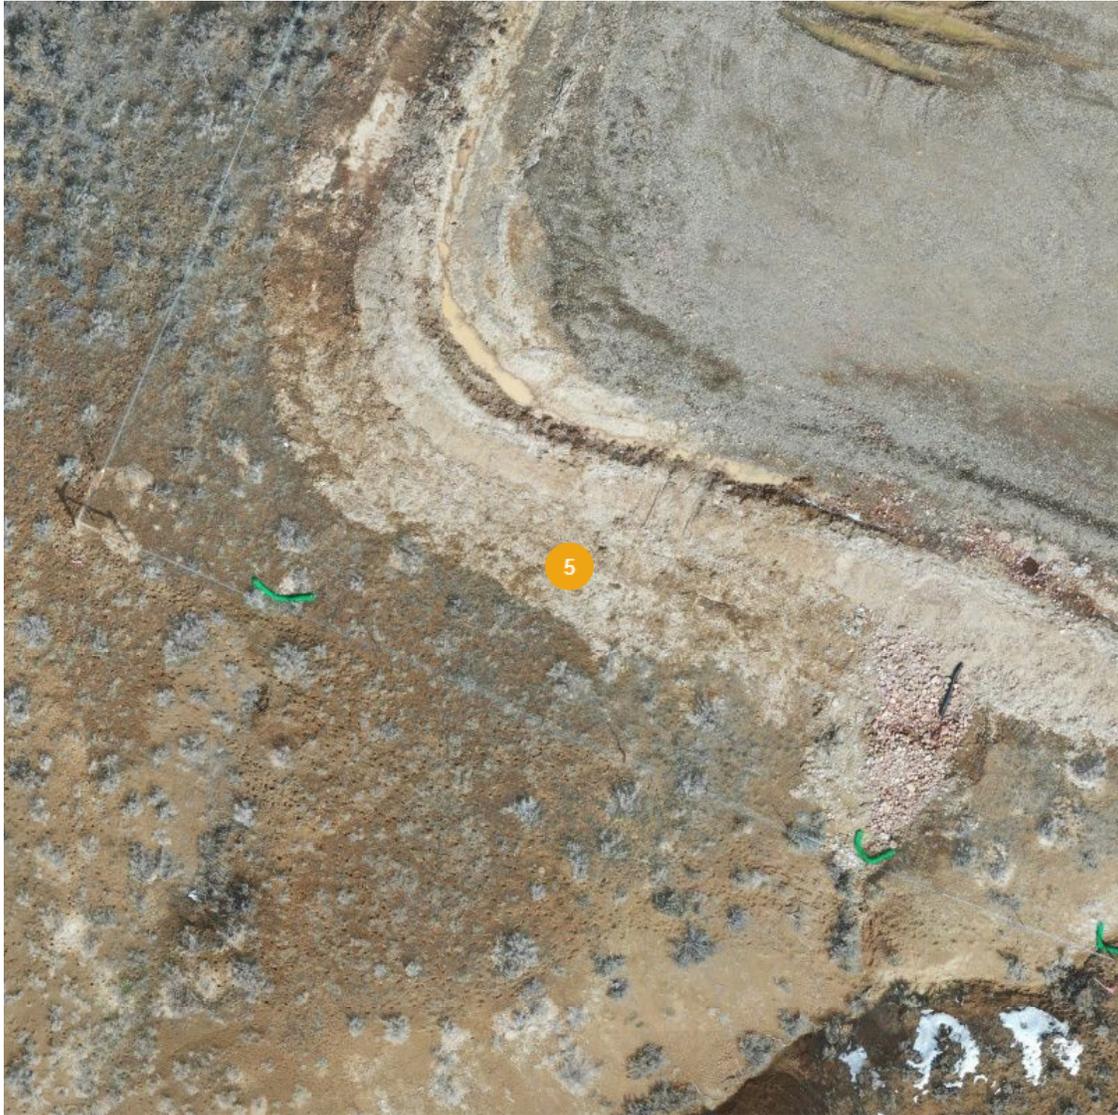
5 - Observation

Summary: Fill slopes lack stabilization; BMPs to minimize erosion and degradation missing or insufficient at slopes on Location.

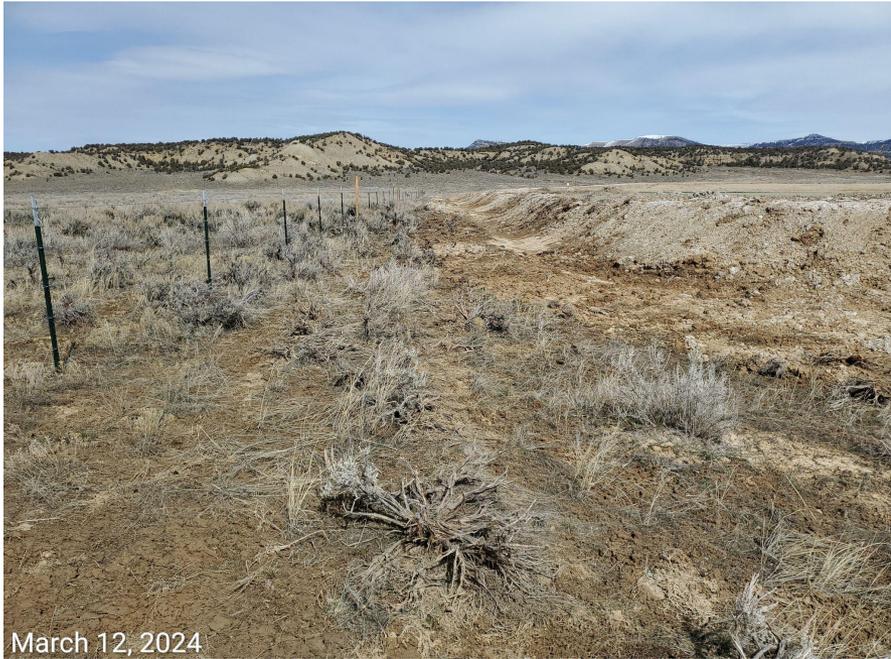
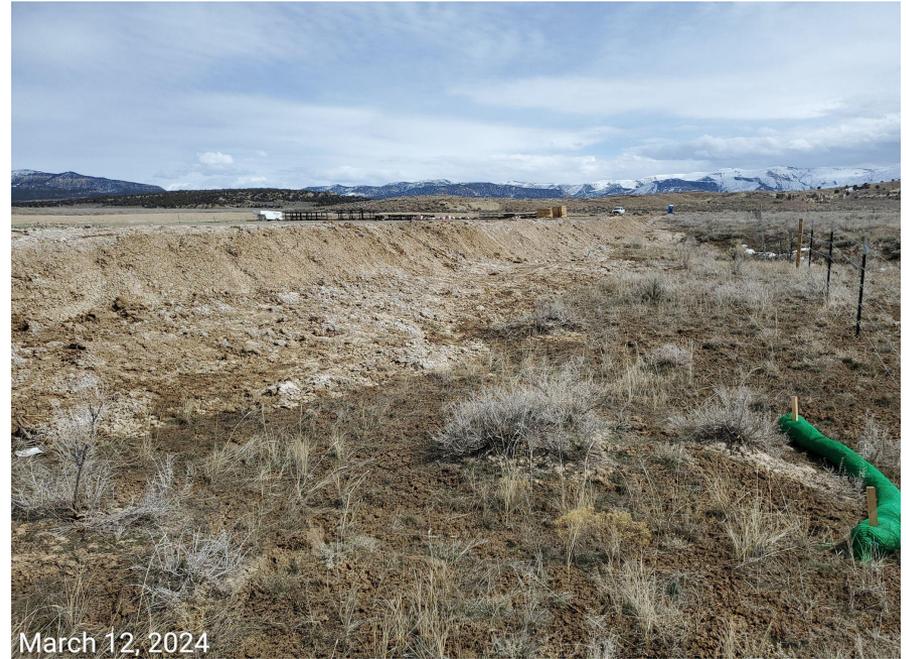
**Photo 12:** Photos taken from the southwest corner of the Location facing north and east. Photos examples showing slopes on the Location lack stabilization. Additionally, stormwater and erosion control measures along the perimeter to manage runoff in a manner that minimizes erosion, degradation and sediment transport remain missing or insufficient.

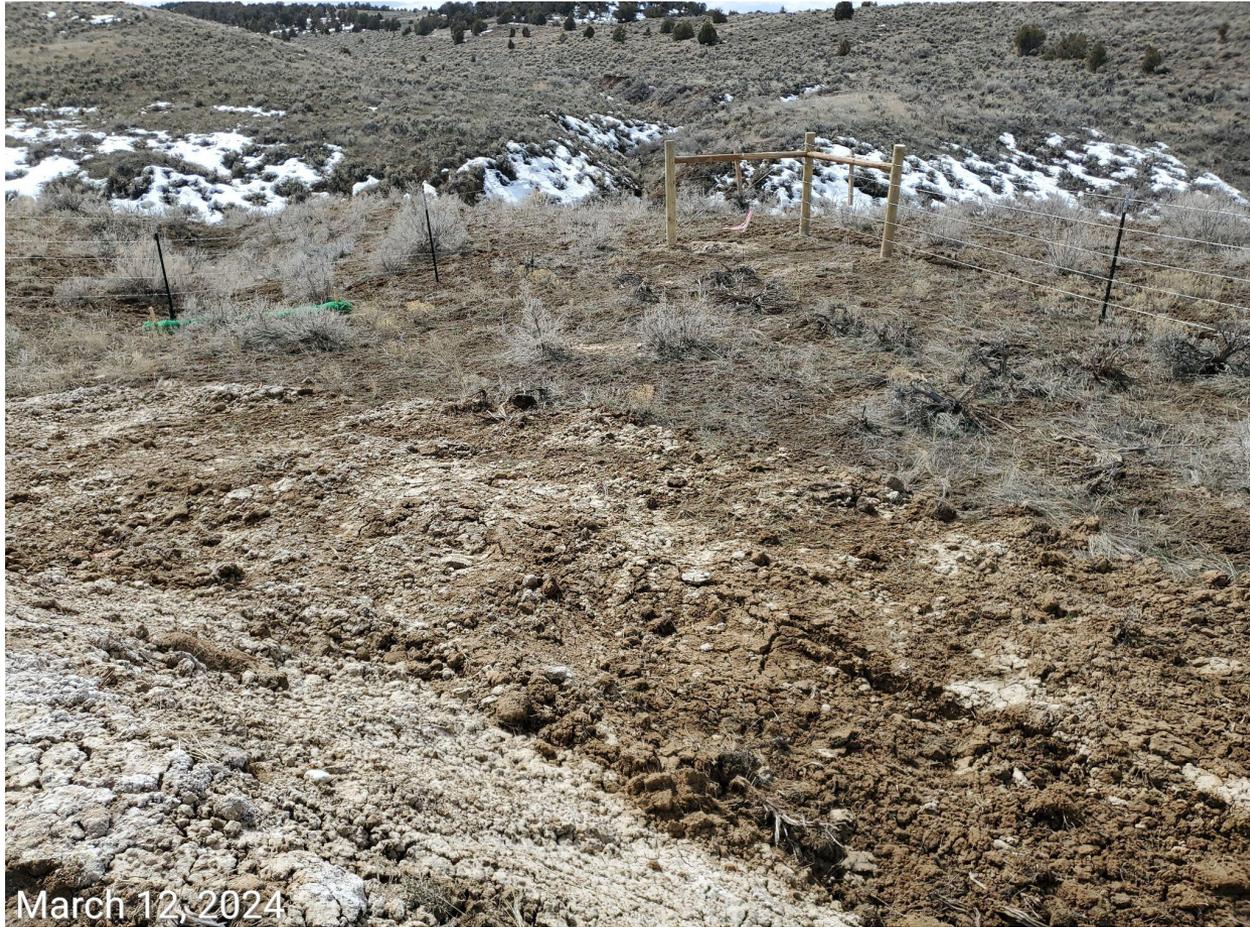
**Photo 13:** Photos taken from the southwest corner of the Location facing southwest. See comments under photo 12.

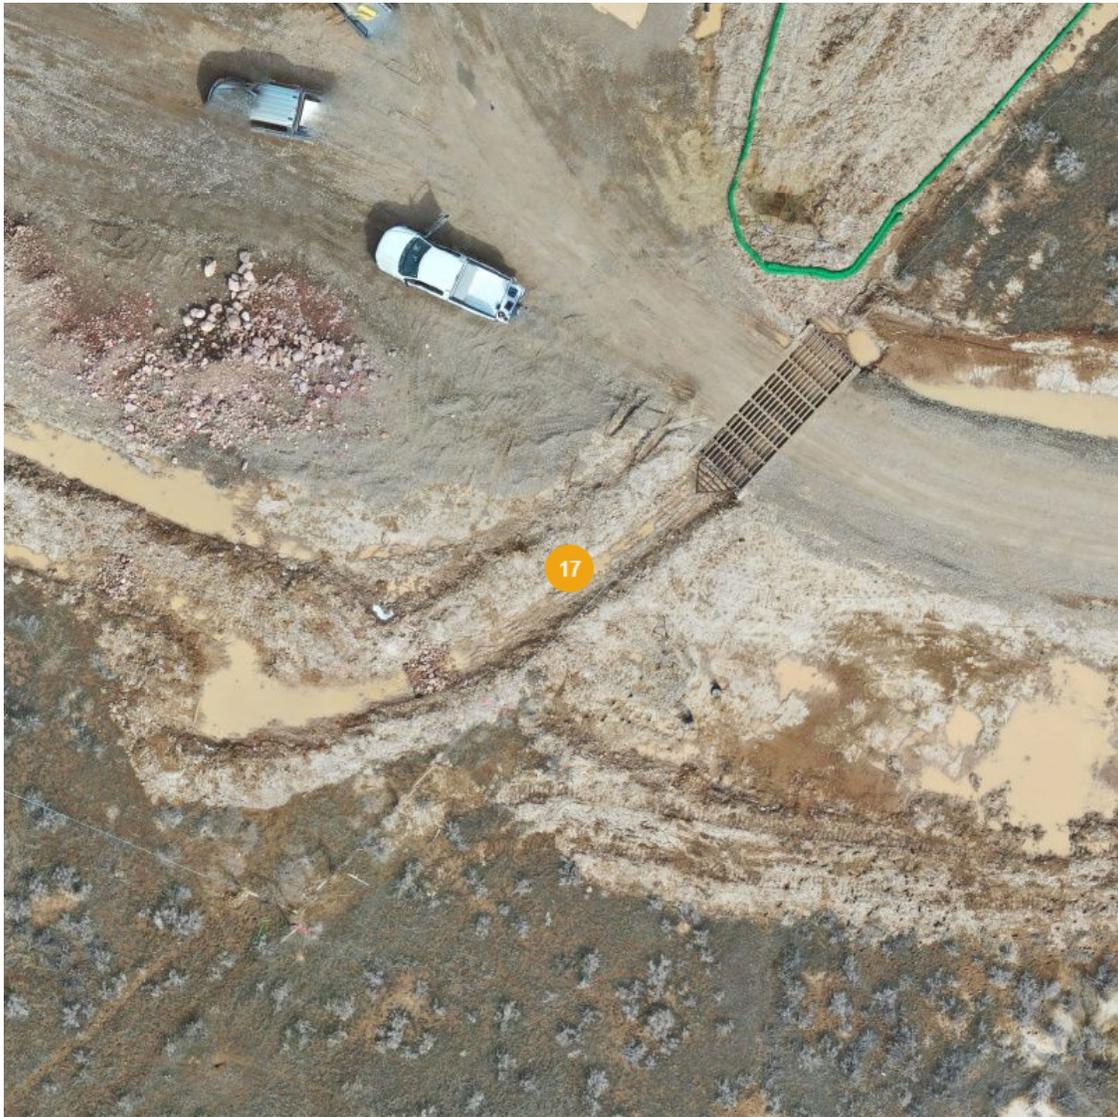
17 - Observation

Ditch and berm lack consolidation.

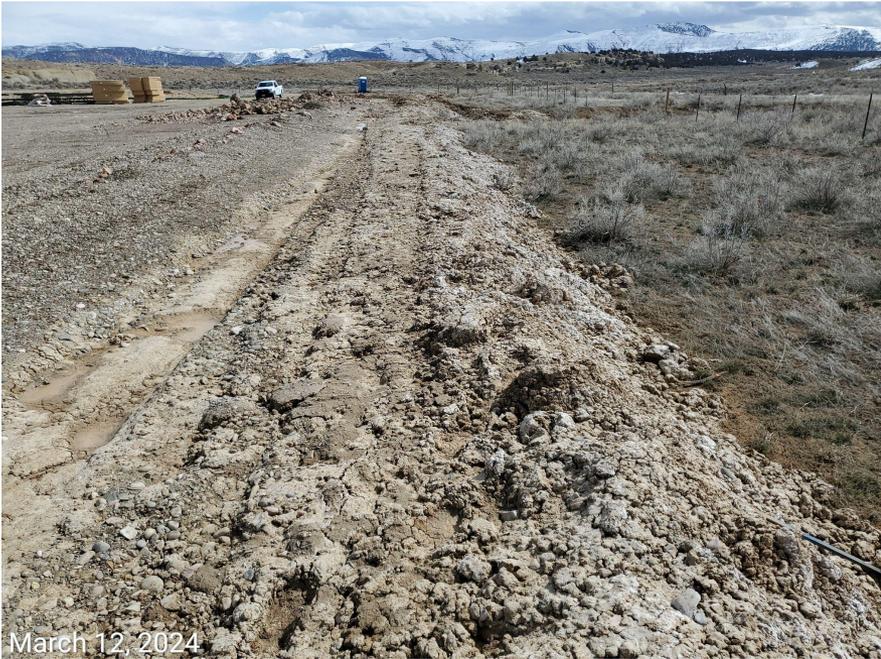
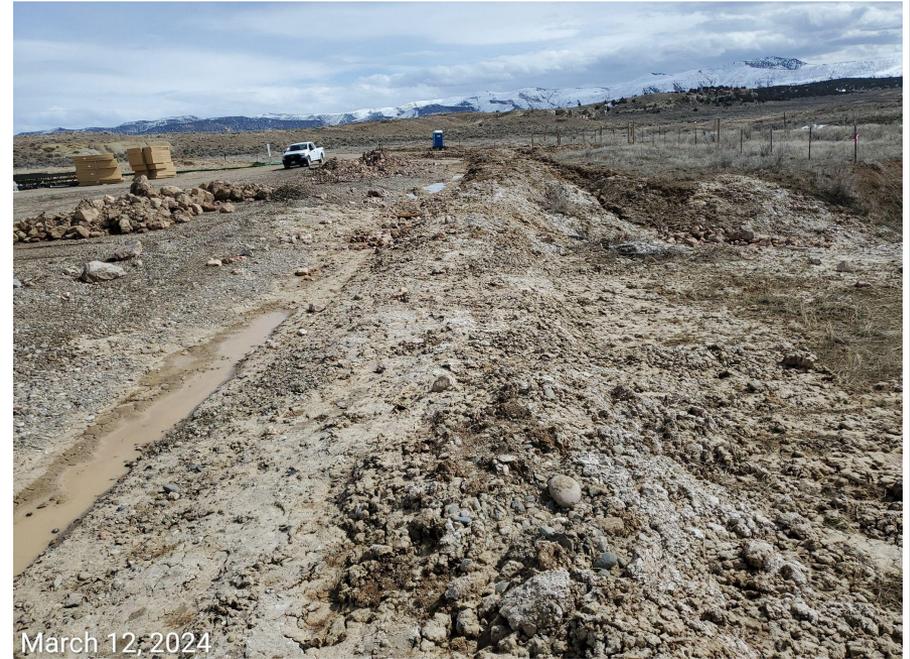
**Photo 14:** Photos taken from the southern end of the Location, facing east. Photos examples showing 1) slopes lack stabilization, 2) perimeter controls remains missing or insufficient to manage runoff in a manner that minimizes erosion, degradation and sediment transport remain missing or insufficient, and 3) the ditch/berm has not been installed per good engineering practices and lacks consolidation.

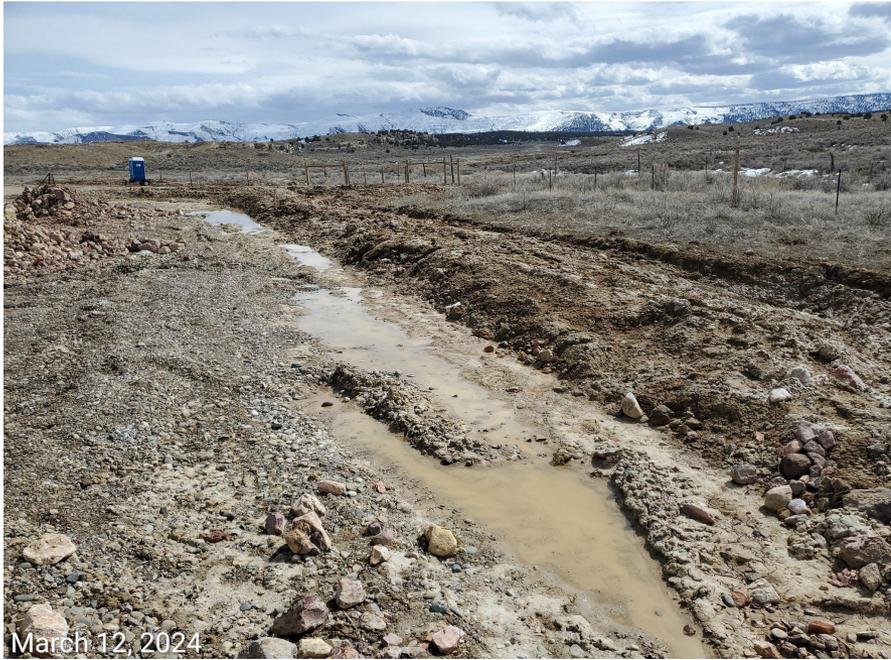
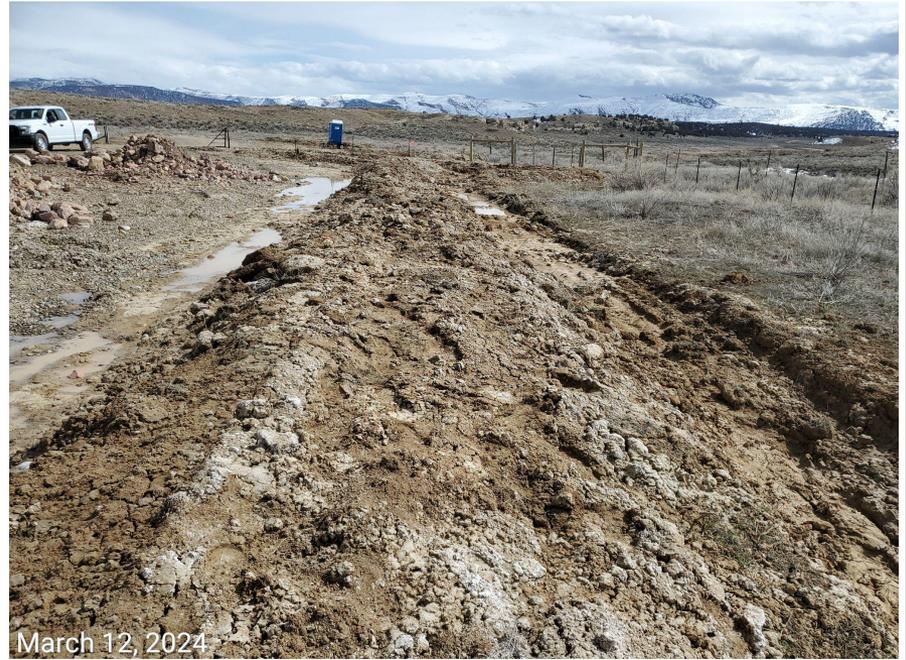
**Photo 15:** Photos taken from the southwest end of the working pad surface. Photos examples showing that the ditch/berm have not been installed per good engineering practices and lacks consolidation.

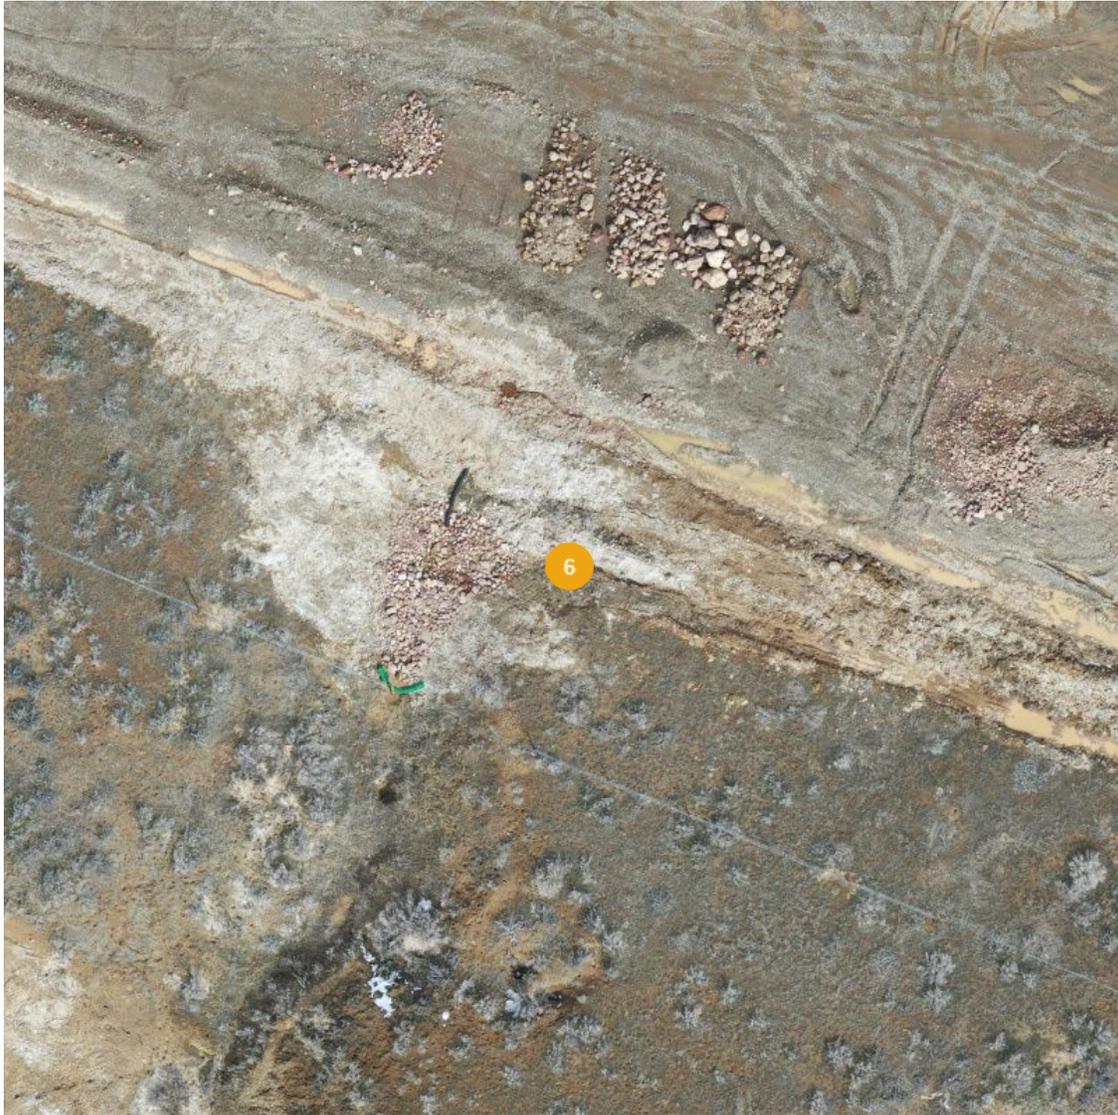
6 - Observation

Summary:	Outlet protections inadequate; erosion/degradation within the ditch observed.
Created:	Mar 13, 2024, 8:48am by Aaron Trujillo
Cost of Repair:	—
Lat/Long:	40.2345294, -108.2534319
Northing:	1340214.9 US ft
Easting:	2231392.5 US ft
Elevation:	5913.13 US ft

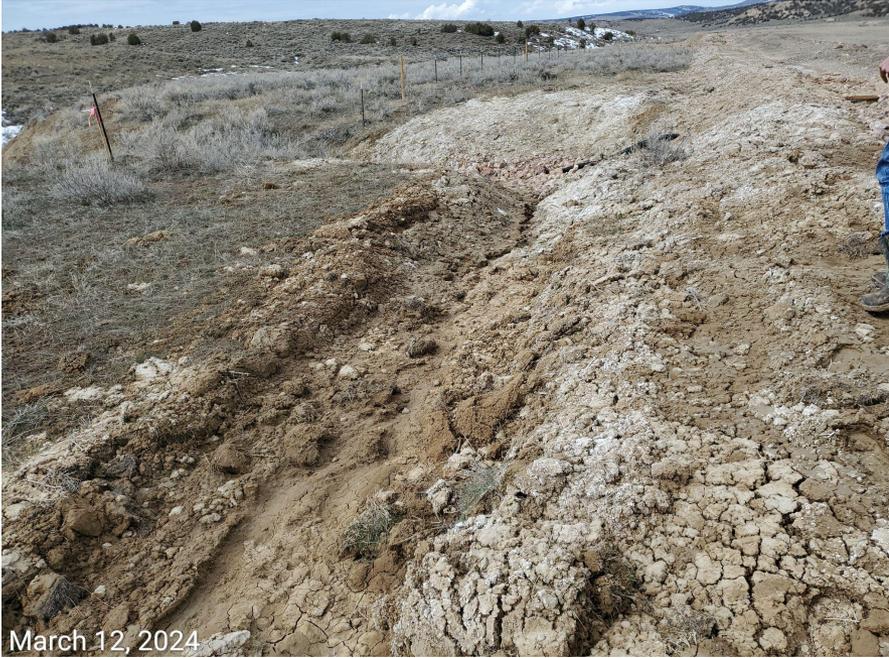
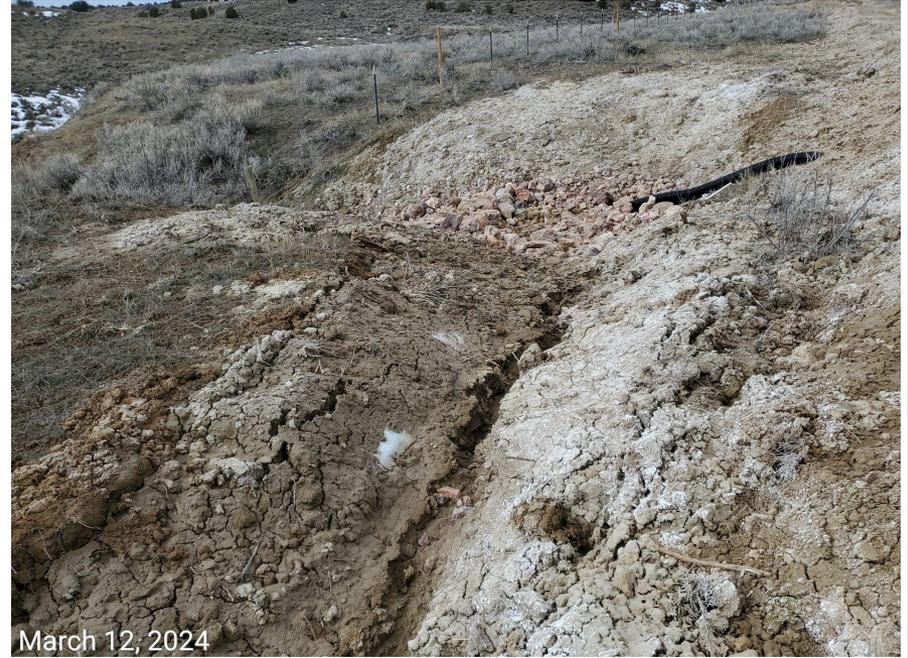
**Photo 16:** Photo taken from the ditch on the southeast end of the Location. Photo shows Outlet at the ditch leading off-site is inadequate, resulting in erosion degradation within the control.

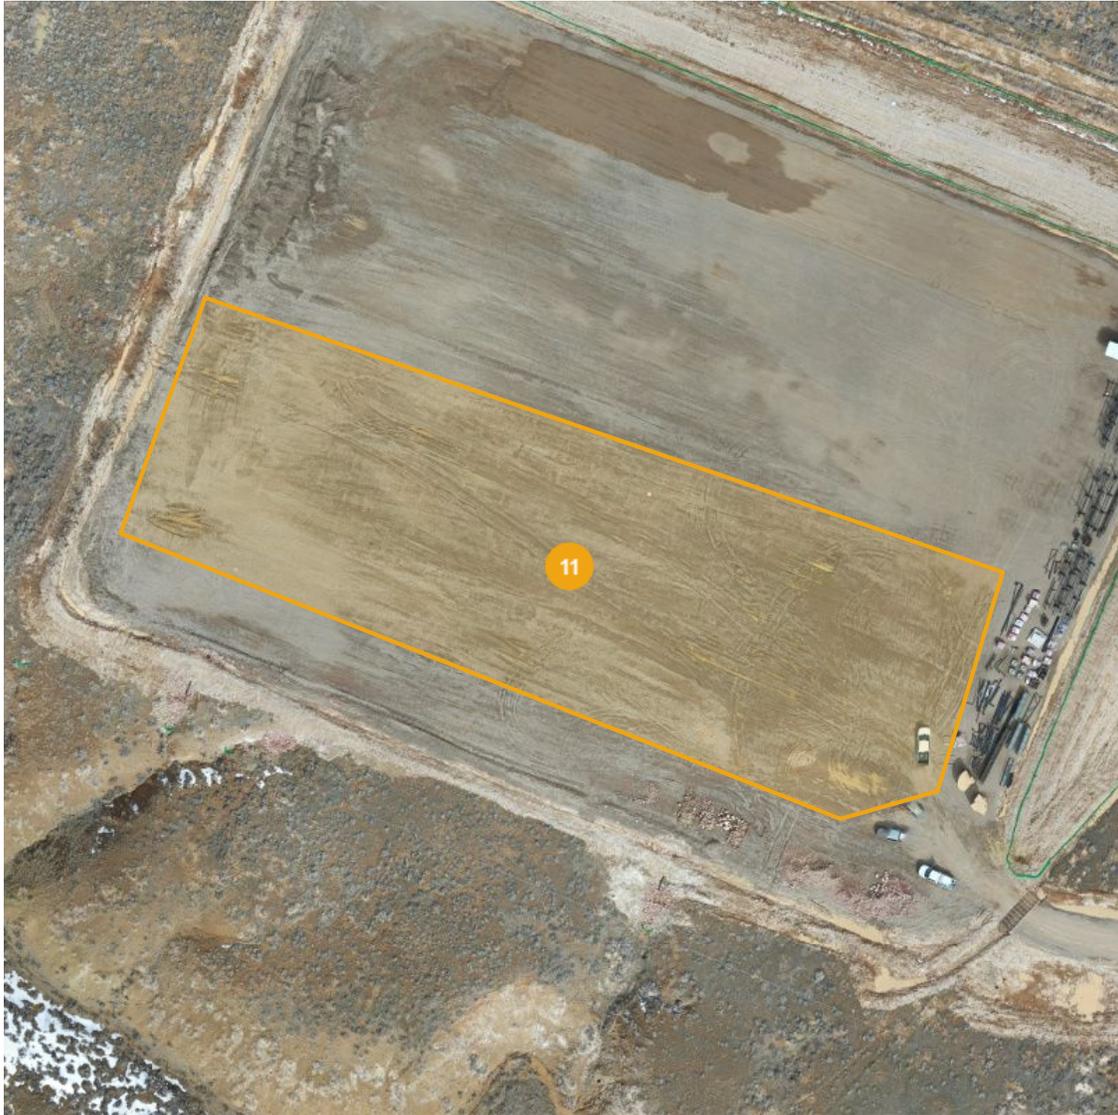
11 - Observation

Summary:	Working pad surface lacks stabilization; tracking observed along southern areas of the pad.
Created:	Mar 13, 2024, 9:38am by Aaron Trujillo
Cost of Repair:	—
Lat/Long:	40.23497, -108.25356
