Inspection Photos
Location Name: Jillson A 1
Location ID: 333156

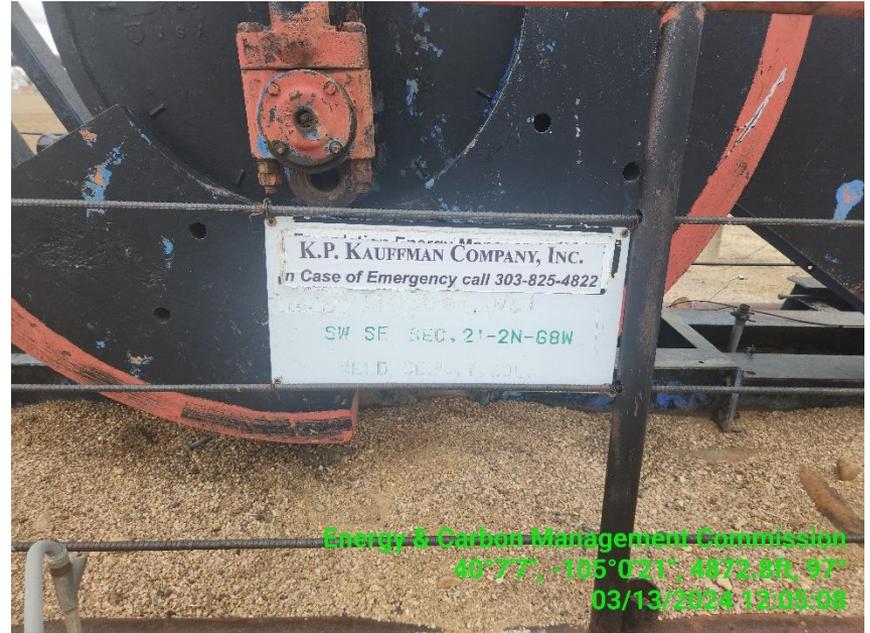
Photo 2 WH information faded.

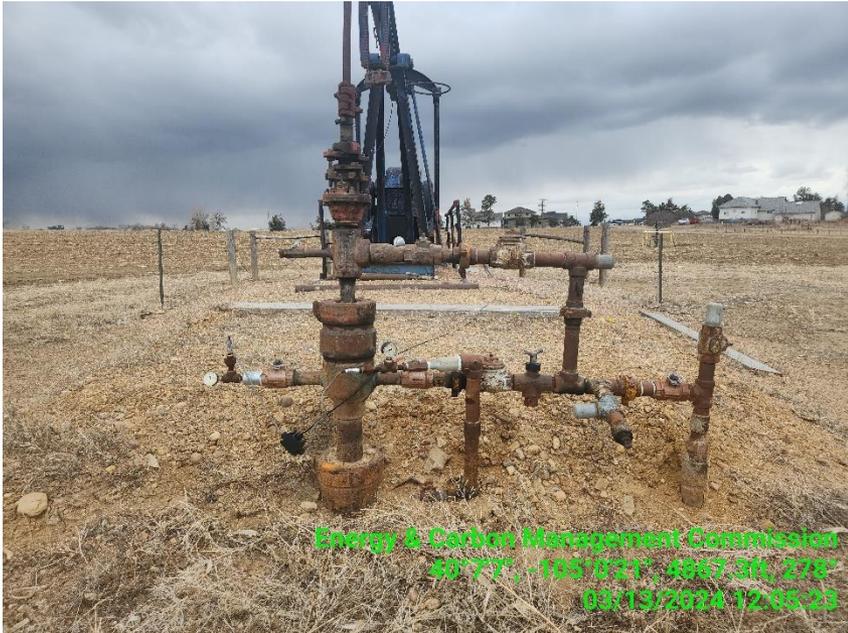
Photo 3 WH is SI.

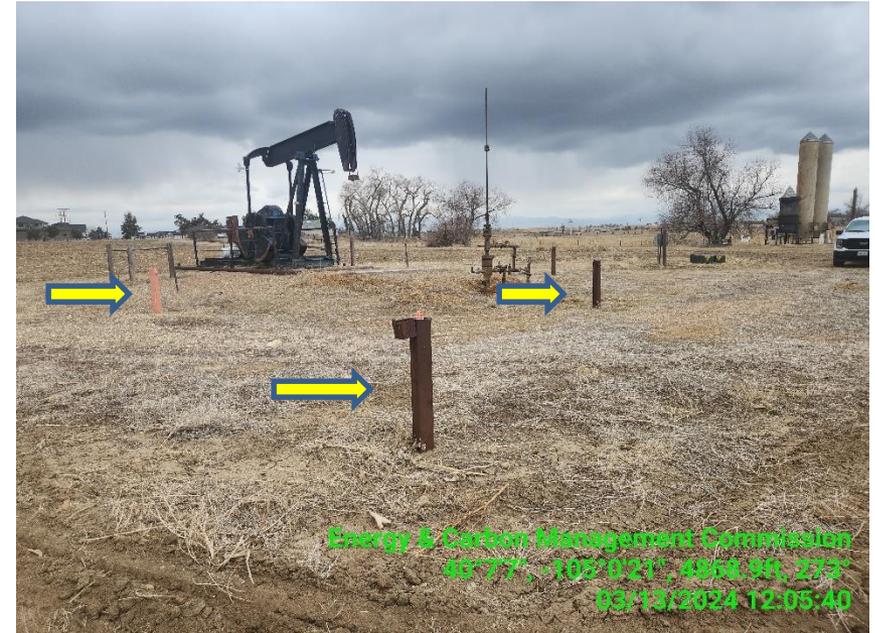
Photo 4 Wellsite, PJ disconnected from Rod, 5 monitor wells
3 are marked in photo.

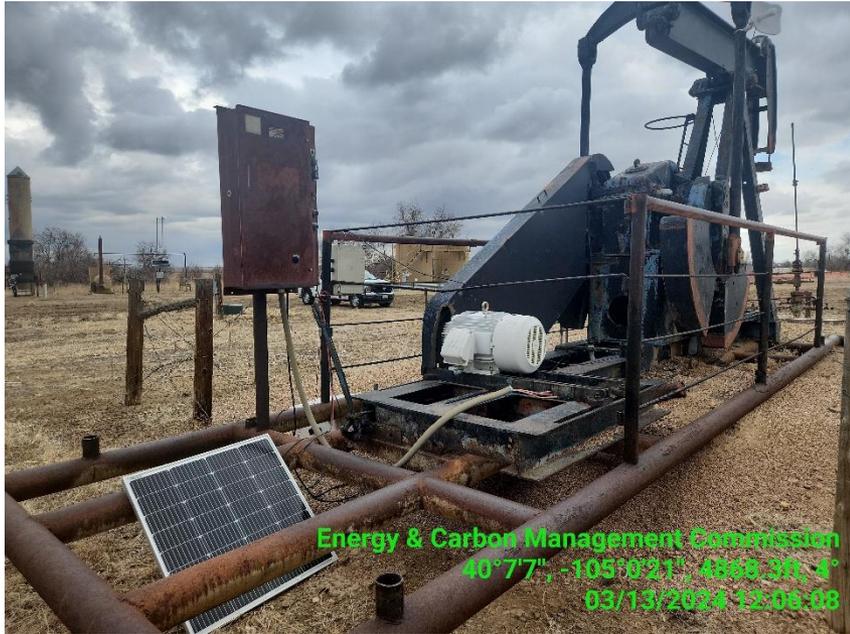
Photo 5 Electric panel for the electric motor is shut off .

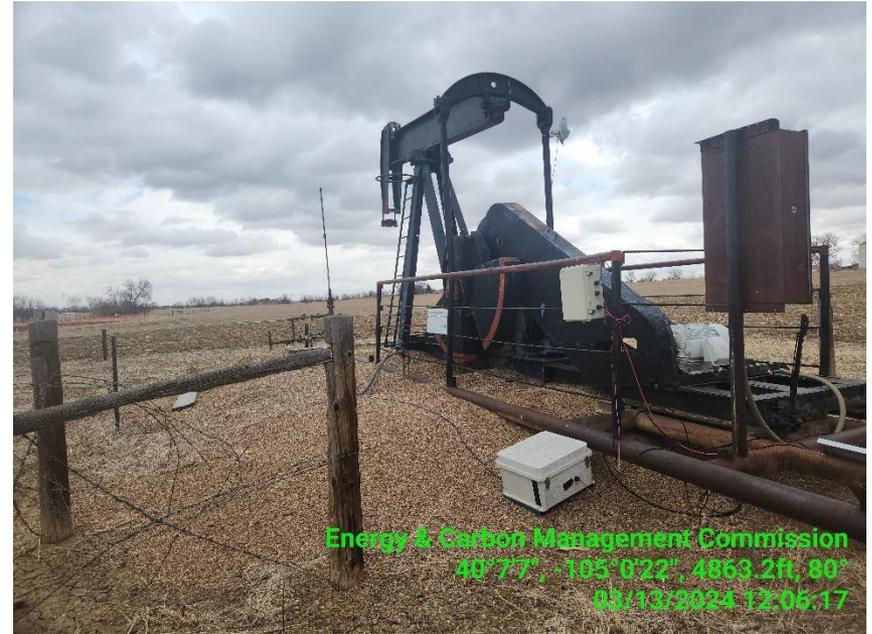
Photo 6 Monitor Well equipment.

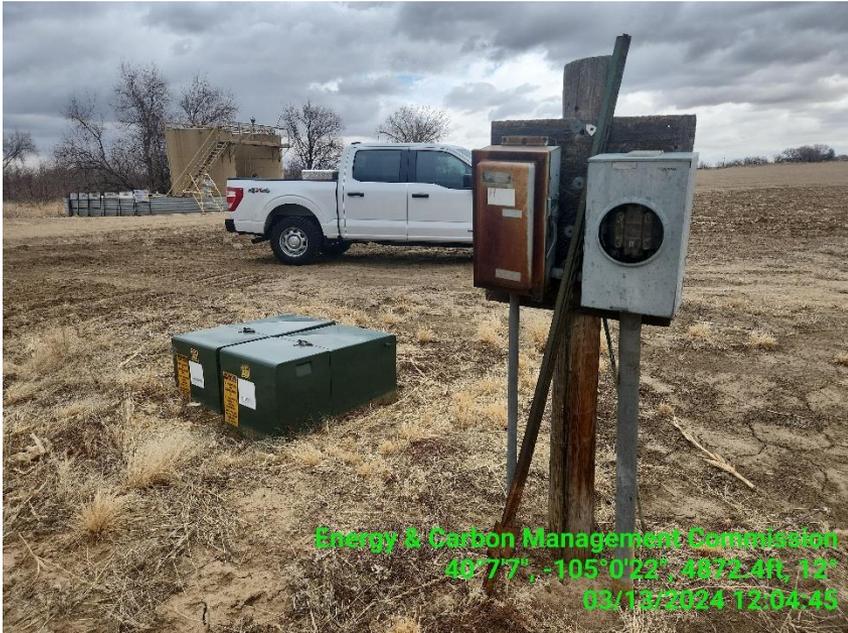
Photo 7 Ancillary equipment is shut off and no meter on the meter box.
