Inspection Photos
Location Name: Wingo C.E. 2
Location ID: 323256

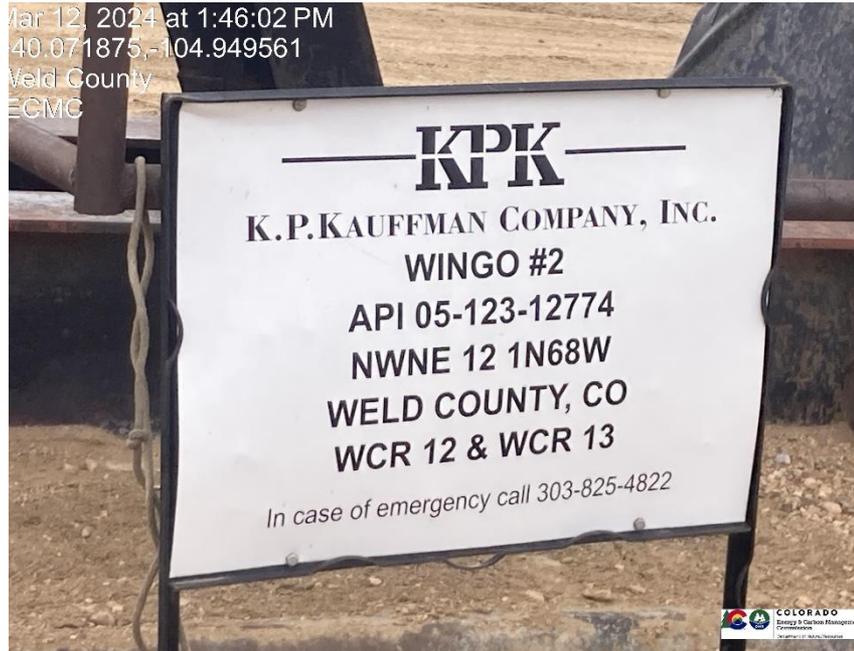
Pic 1 wellhead sign

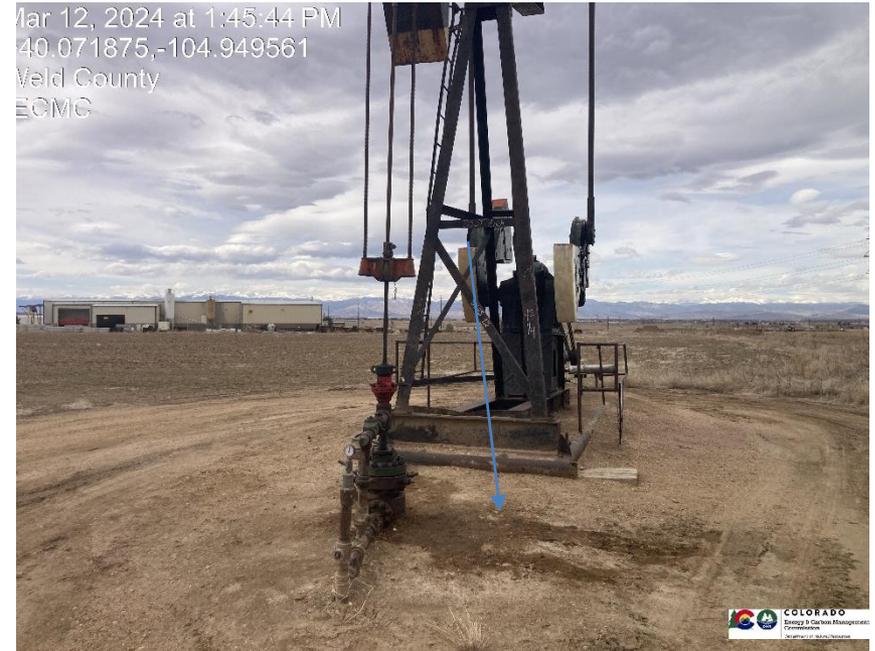
Pic 2 pump jack, stained soil

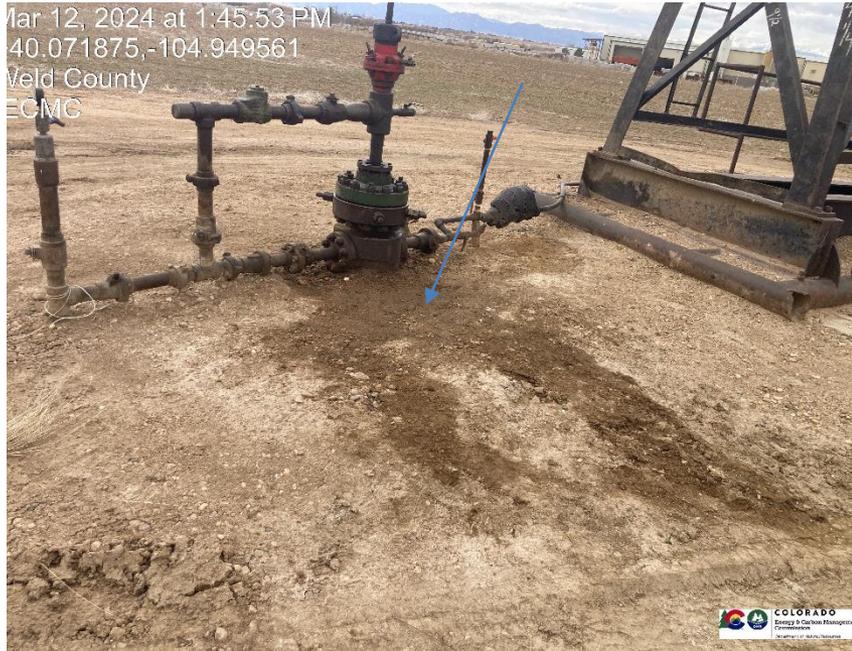
Pic 3 Stained soil / mechanical issue by wellhead. Stained soil needs to be removed.

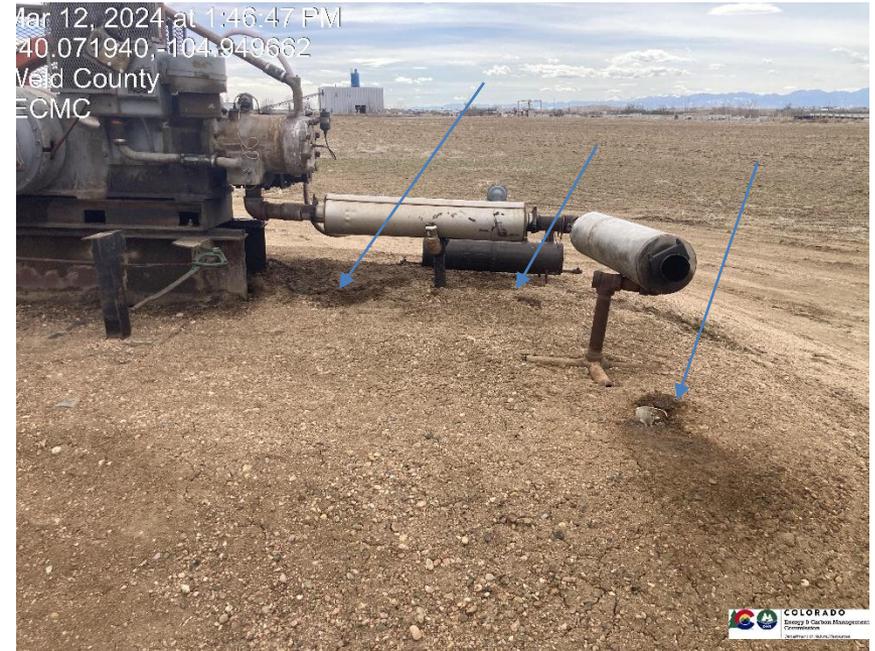
Pic 4 Stained soil / mechanical issue by gas motor

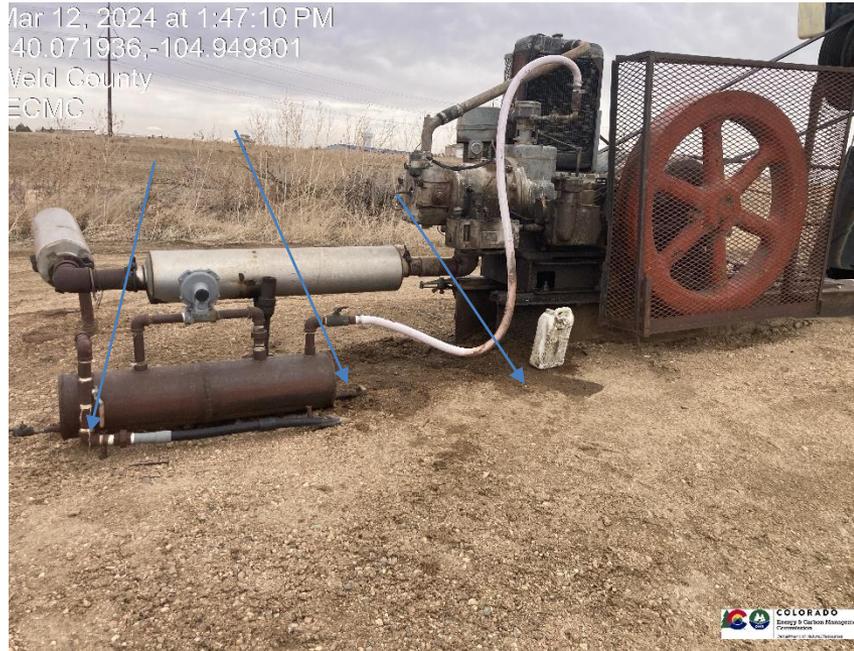
Pic 5 stained soil / mechanical issue
