Inspection Photos and Issue Report

Operator: ANSCHUTZ EXPLORATION CORP

Location ID: 430926

Inspection Doc: 696205676

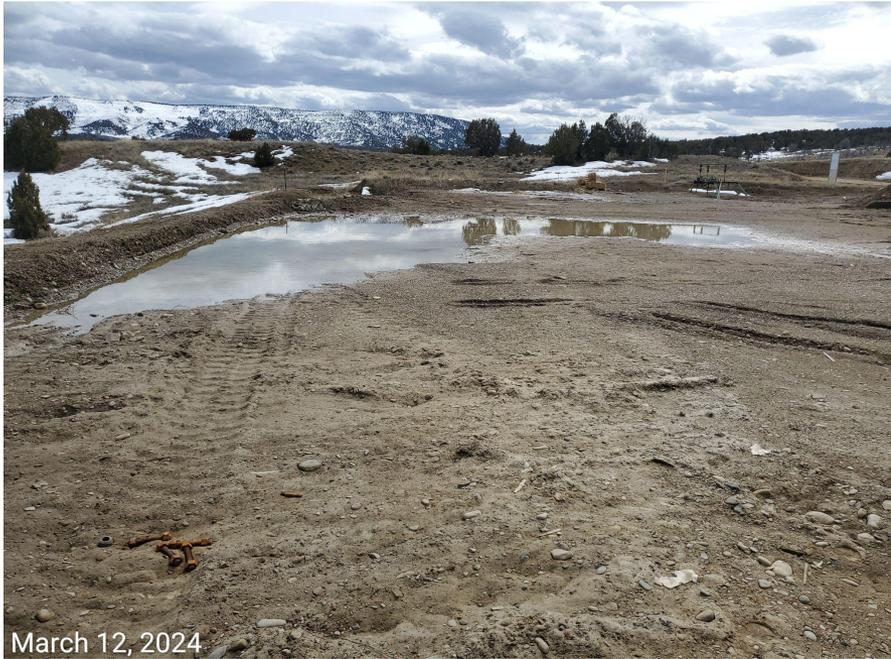
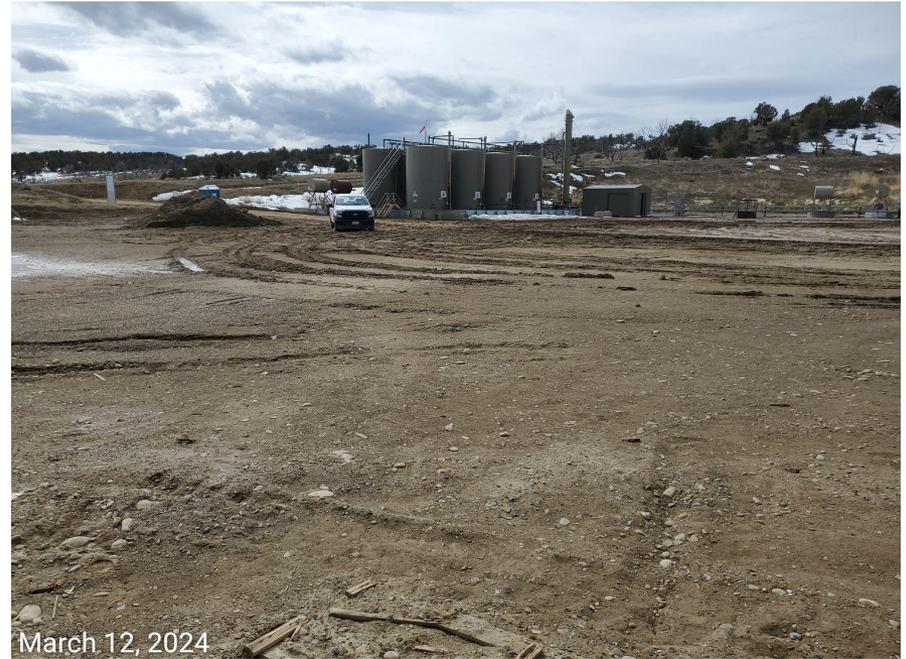
Photo 1: Photos 1-2 taken from the east end of the working pad surface. Photos provide an overview of the Location from south, southwest, northwest to north. Photos also show areas of the Location not needed for production have not been reclaimed pursuant to 1003 Requirements; work including, but not limited to, compaction alleviation, recontouring, regrading and revegetation activities have not been performed.

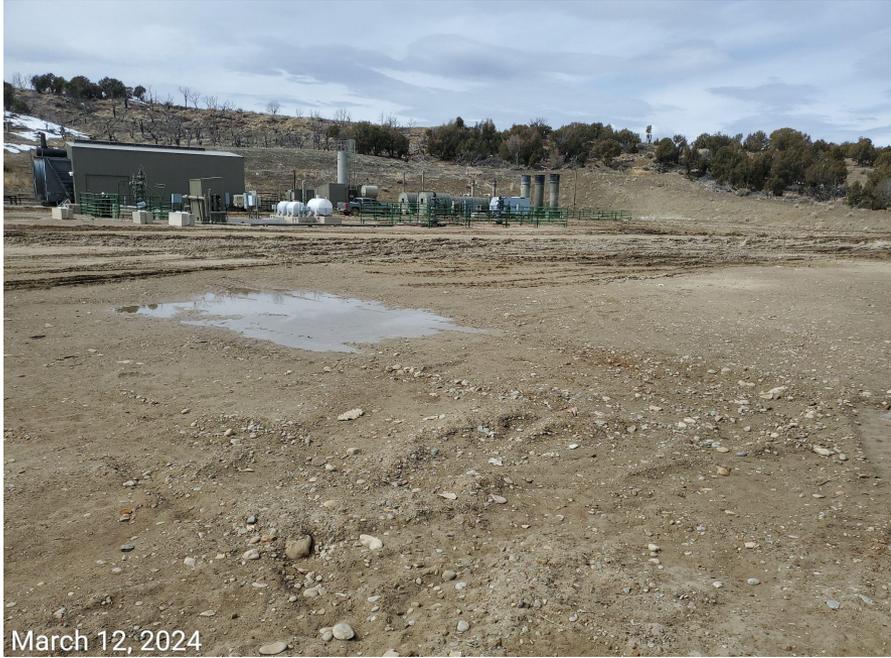
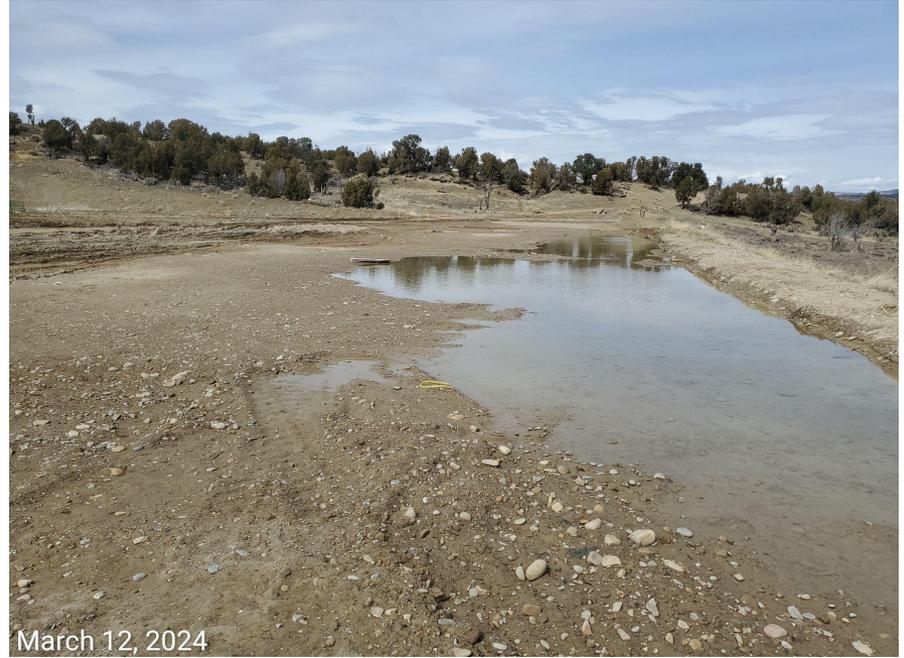
Photo 2: See comments under photo 1.

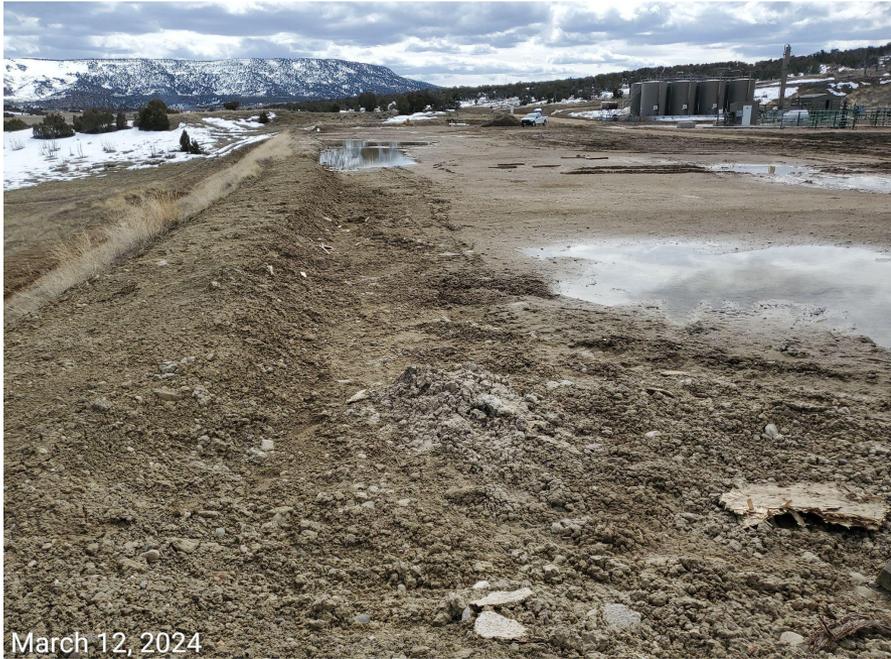
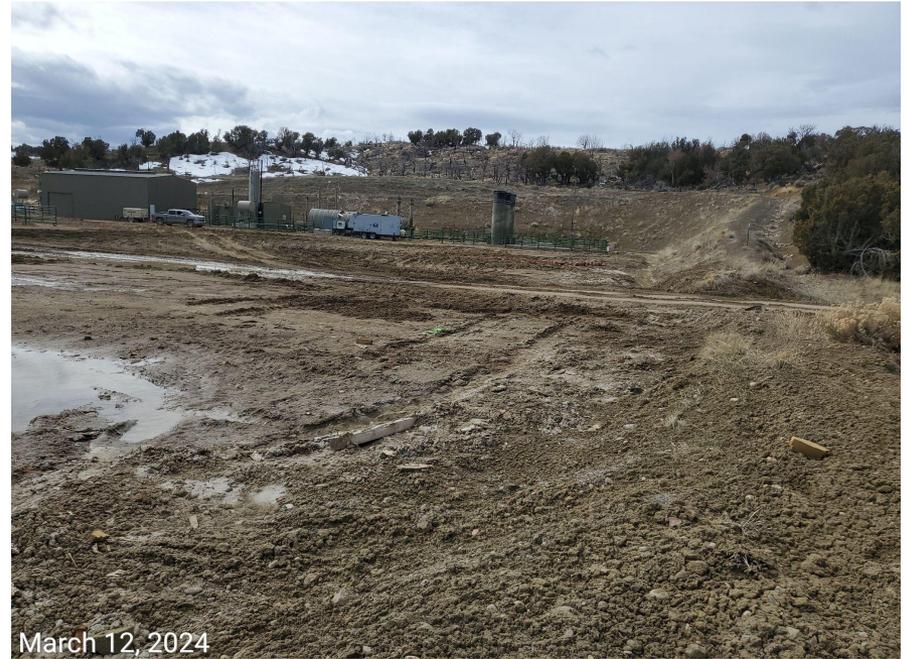
Photo 3: Photos taken from the northeast end of the Location, facing south and west. Photos show areas of the Location not needed for production have not been reclaimed pursuant to 1003 Requirements; work including, but not limited to, compaction alleviation, recontouring, regrading and revegetation activities have not been performed.

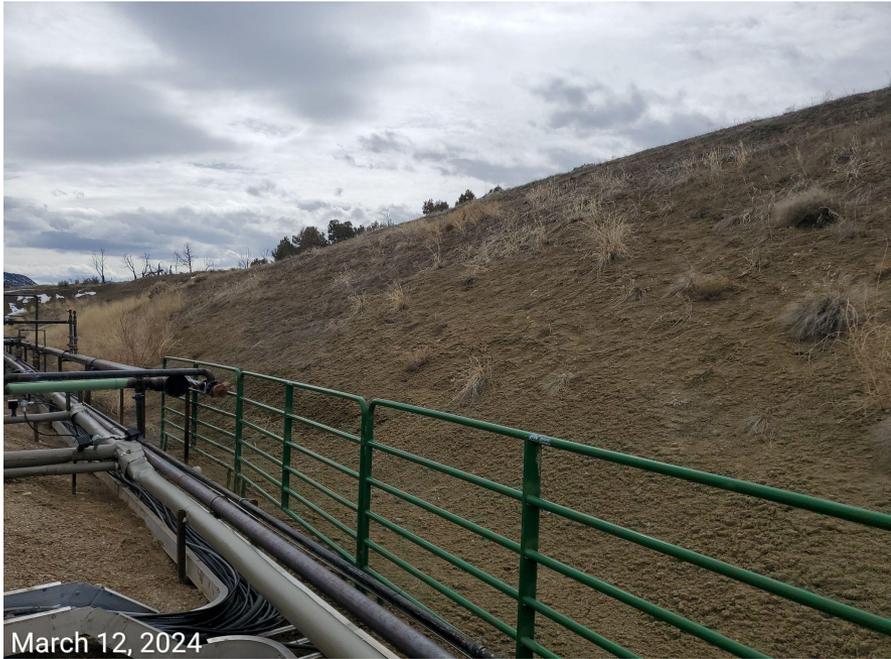
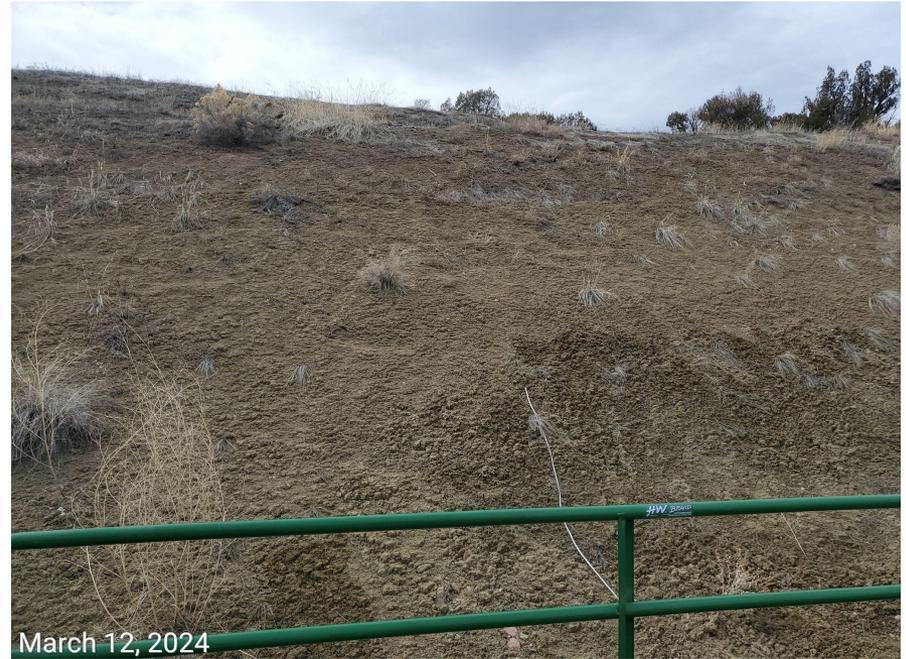
Photo 4: Photos taken from the wet ends of the Location. Photos show slopes are bare and not progressing towards 1003 standards; additional reclamation work required. Photos also show stormwater and erosion control measures to minimize erosion, degradation and sediment transport are missing or insufficient on the slopes. Temporary stormwater and erosion control measures required until long-term stabilization has been achieved.

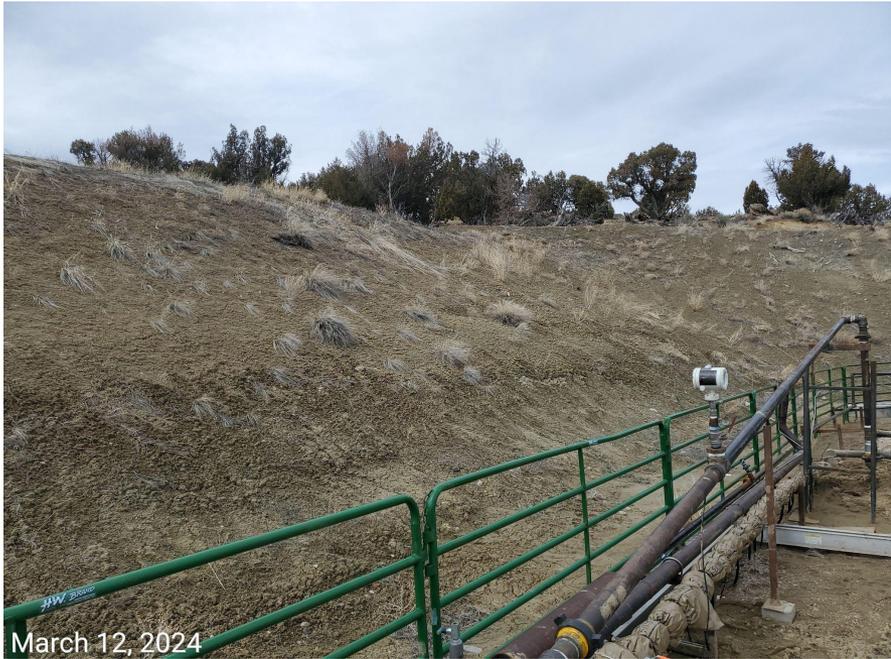
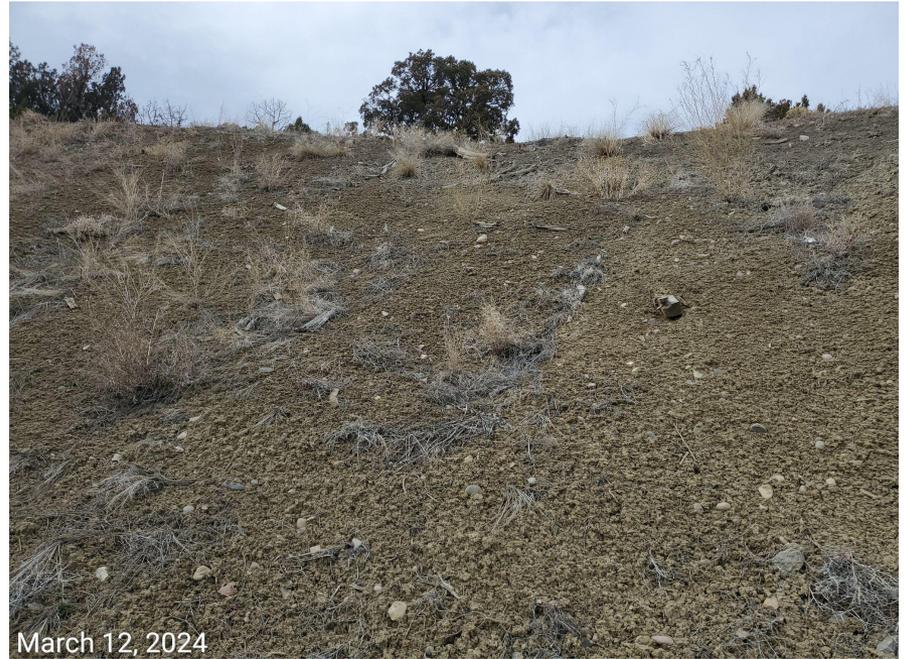
Photo 5: See comments under photo 4.

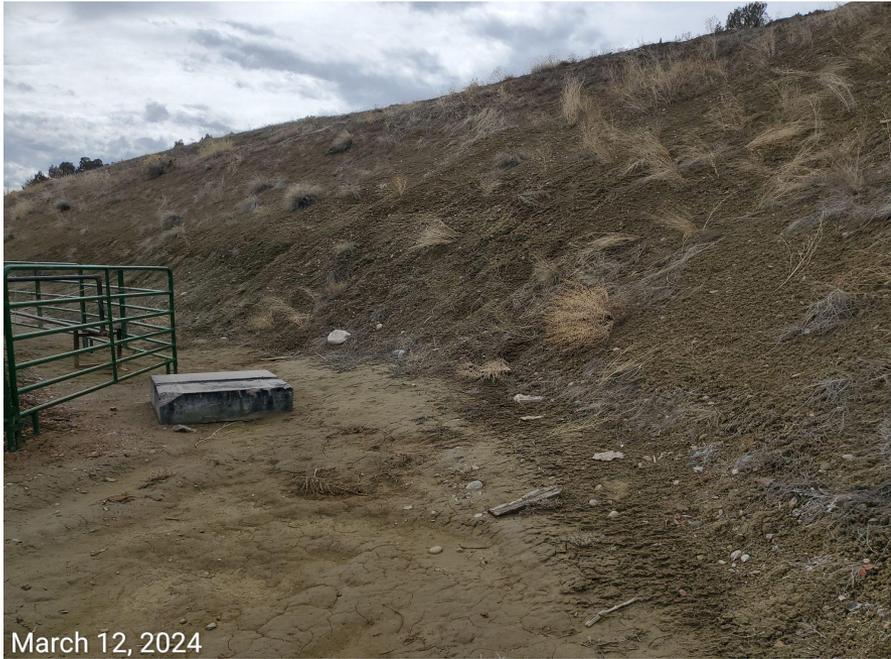
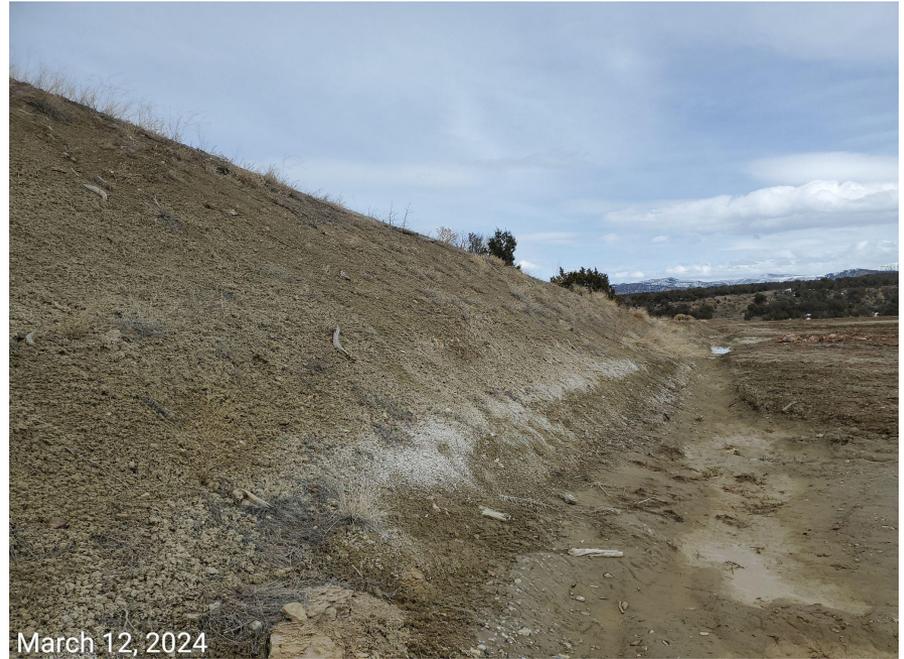
Photo 6: See comments under photo 4.

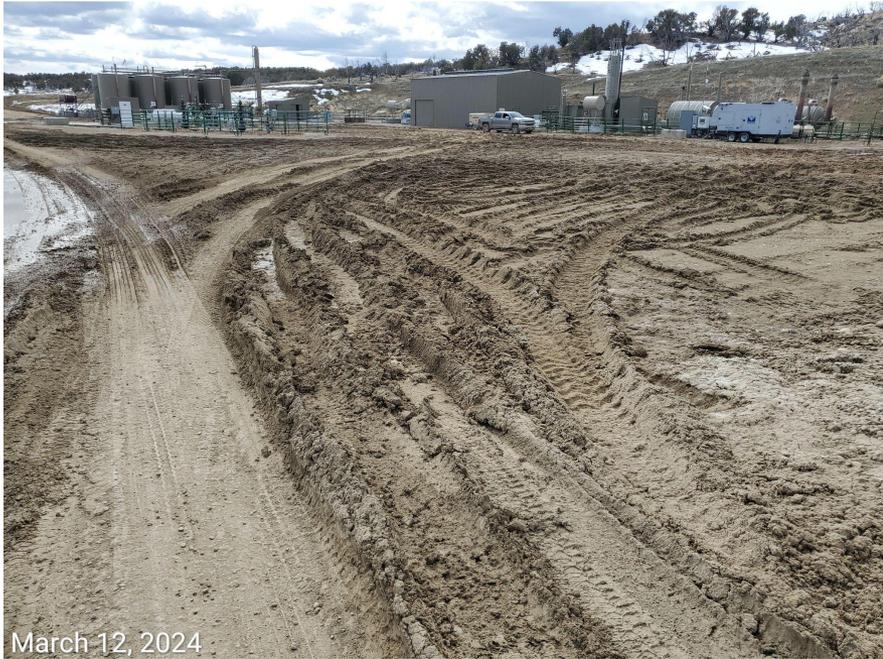
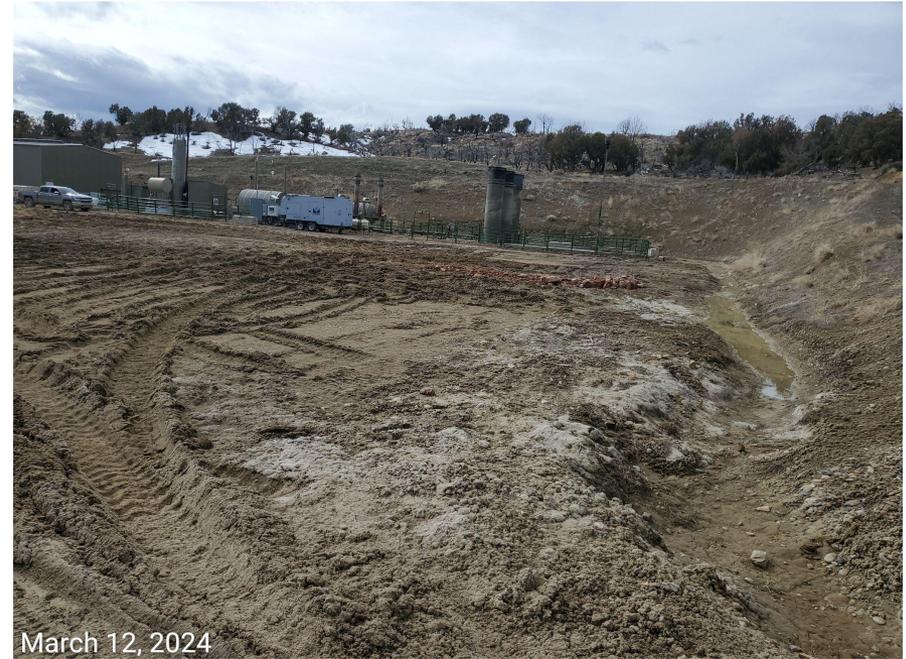
Photo 7: Photos 7-11 taken throughout the working pad surface. Photos examples showing that stormwater and erosion control BMPs to stabilize the working pad surface, as well as to minimize erosion, degradation, tracking and sediment transport are missing or insufficient; pad lacks stabilization. Stormwater ponding on the pad evident and is not being properly discharged, and is contributing to further destabilization of the pad/Location.

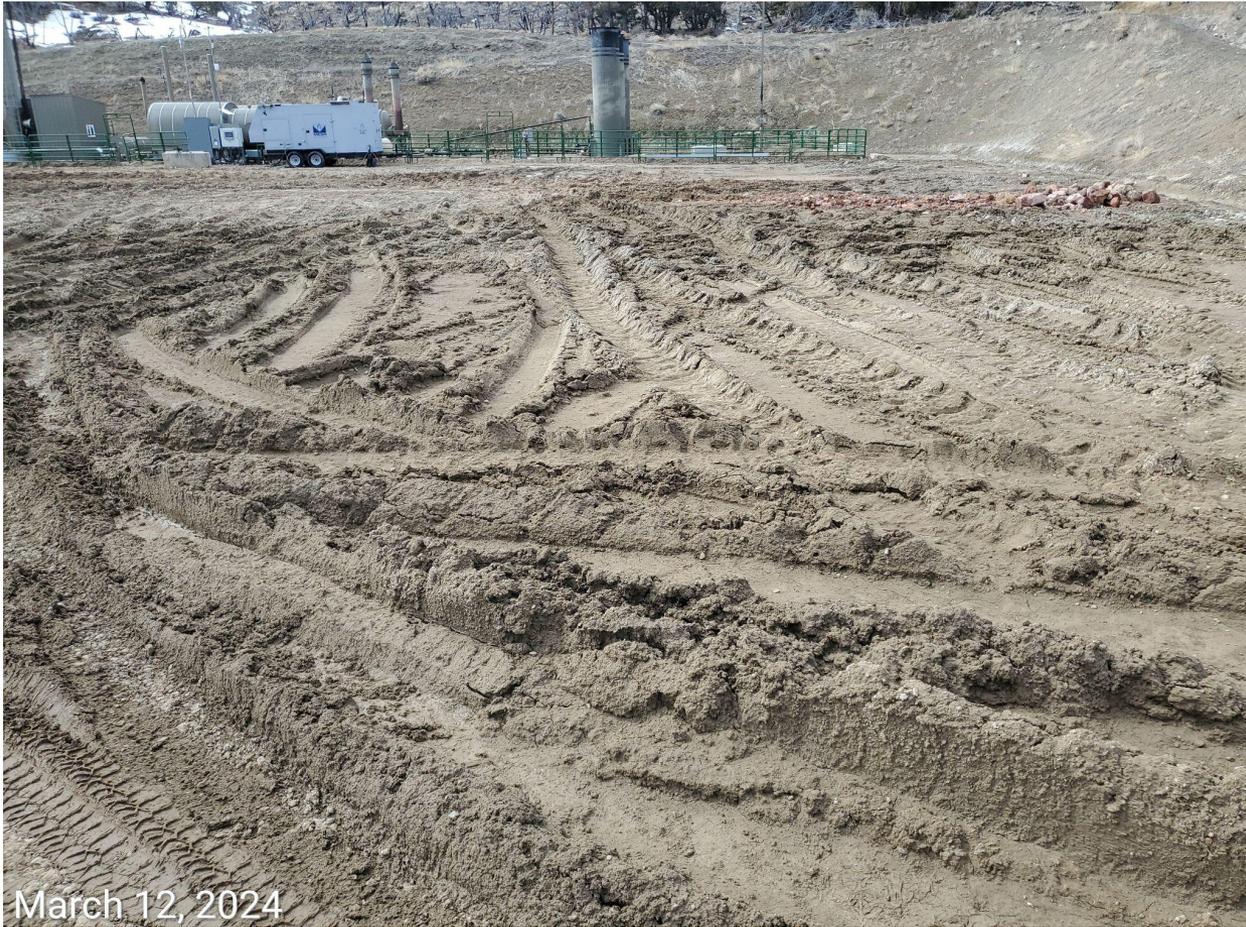
Photo 8: See comments under photo 7.

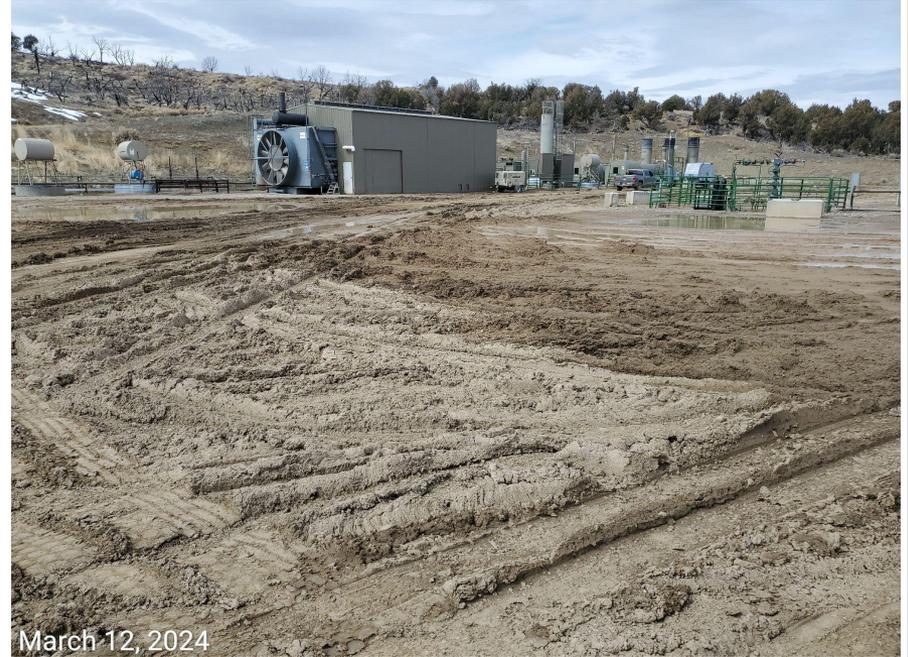
Photo 9: See comments under photo 7.

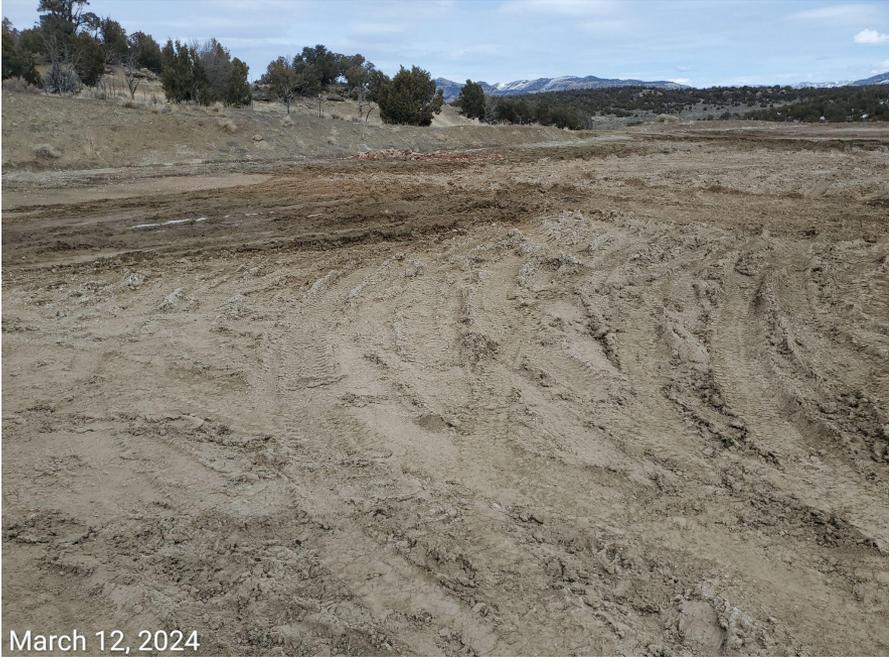
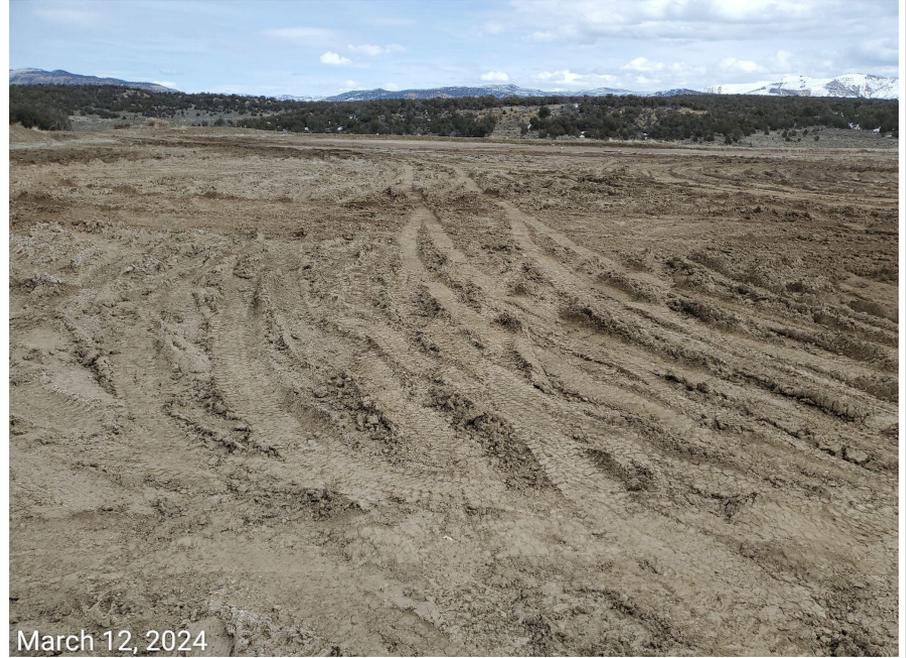
Photo 10: See comments under photo 7.

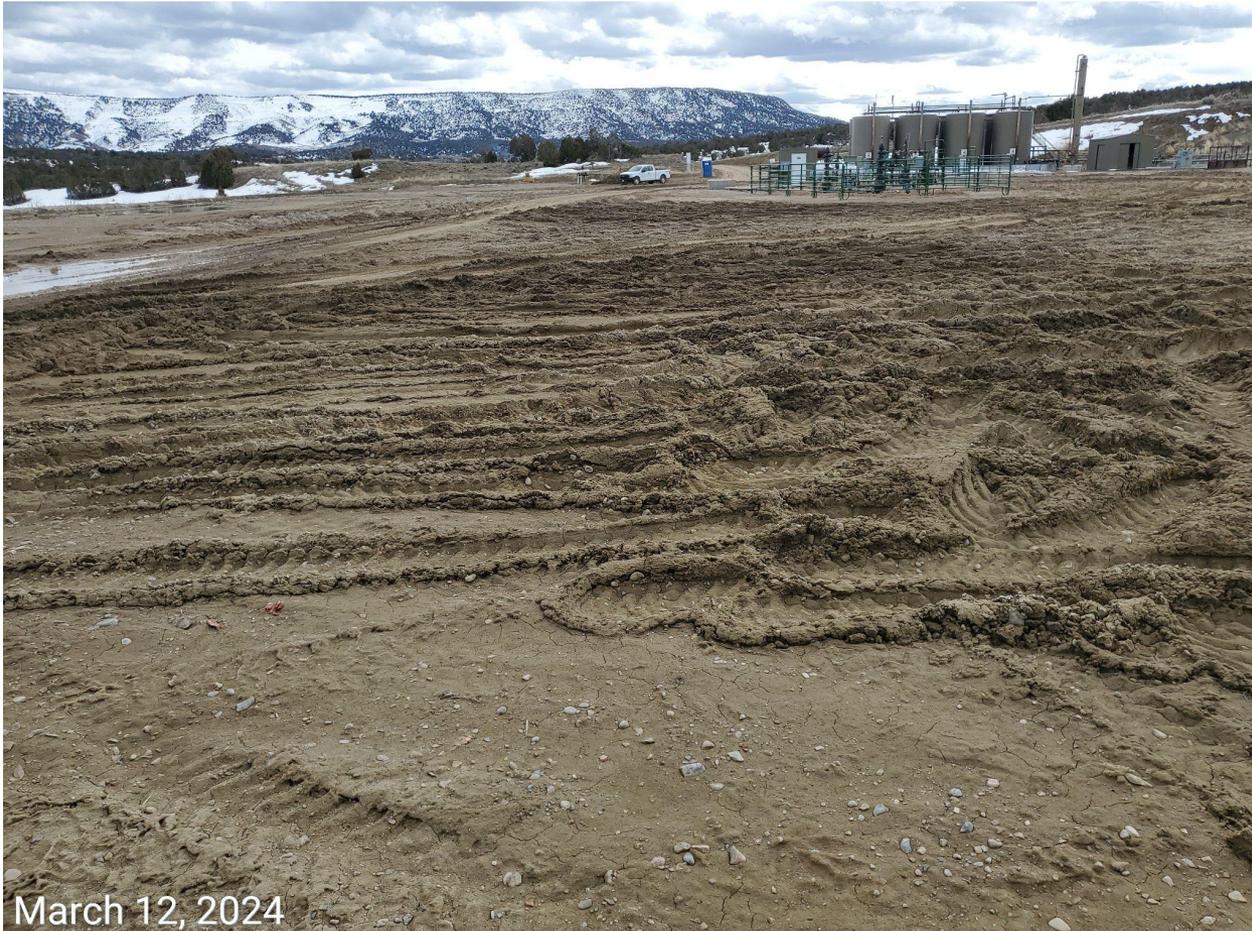
Photo 11: See comments under photo 7.

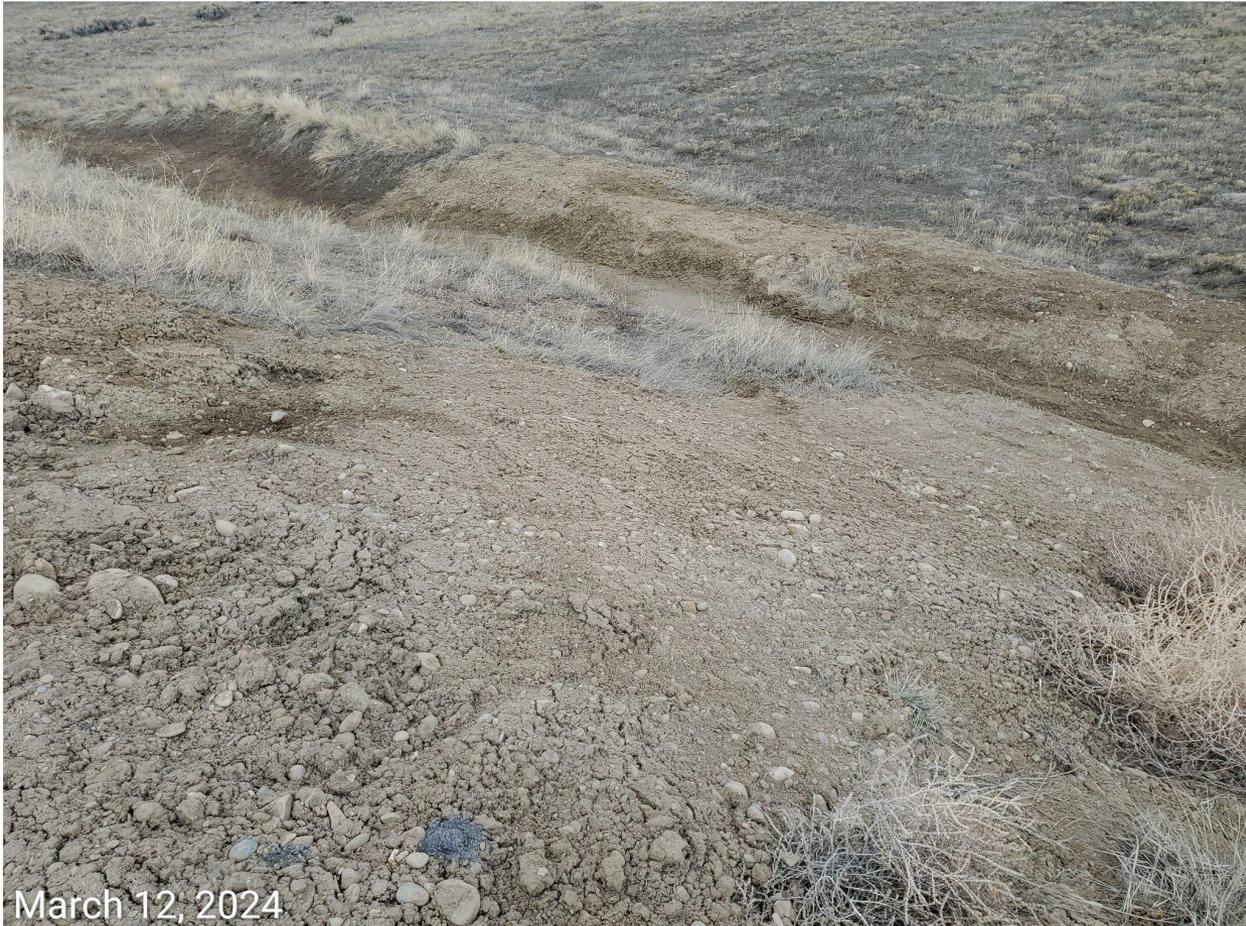
Photo 12: Photo taken from the slopes on the east end of the Location. Photo examples of areas on the fill slope that are bare; stormwater and erosion control BMPs missing or insufficient on slopes of Location. These areas are subject to interim reclamation requirements (recontouring, regrading and revegetation activities). Temporary BMPs required until reclamation work is completed.

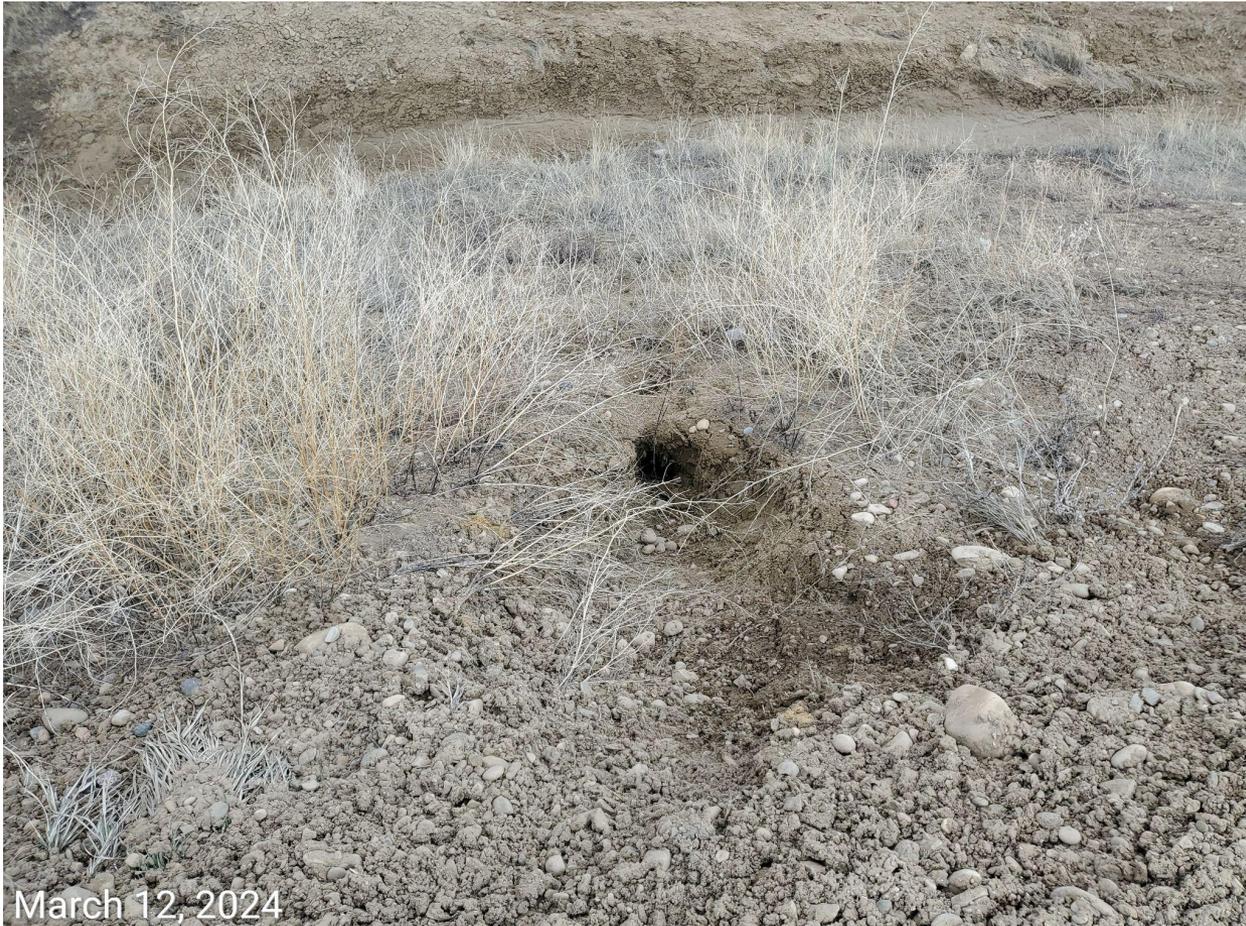
Photo 13: Photo taken from the slopes on the east end of the Location. Photo example showing areas of erosion degradation due to stormwater runoff. Gully evident; stormwater cutting beneath areas of the slopes. These areas are subject to interim reclamation requirements (recontouring, regrading and revegetation activities). Temporary BMPs required until reclamation work is completed.

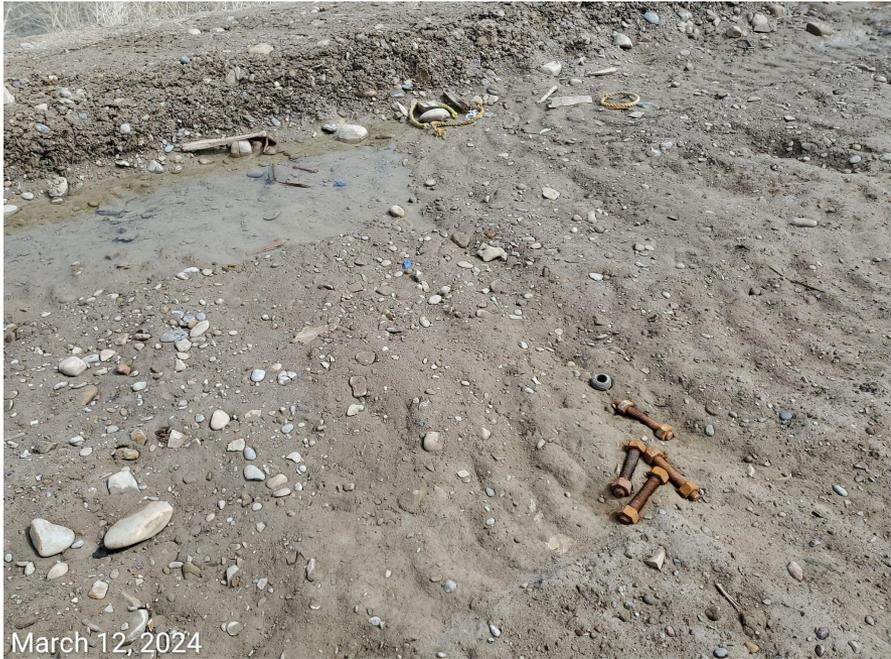
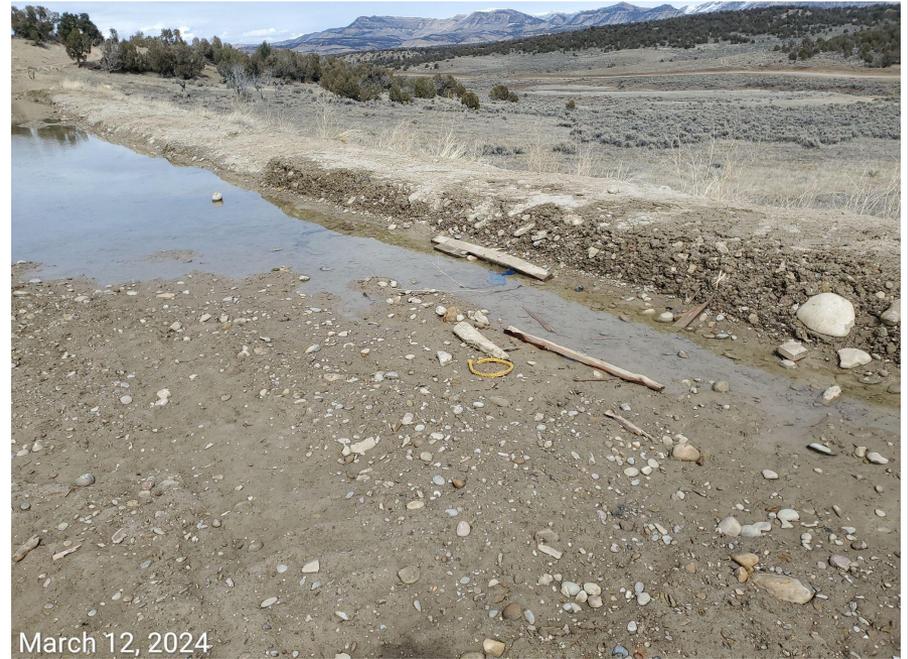
Photo 14: Photos 14-31 taken throughout the working pad surface, interim areas, and around production equipment/facilities of the Location. Photos show various trash/debris/unused equipment/etc... remain improperly stored throughout the entire Location.

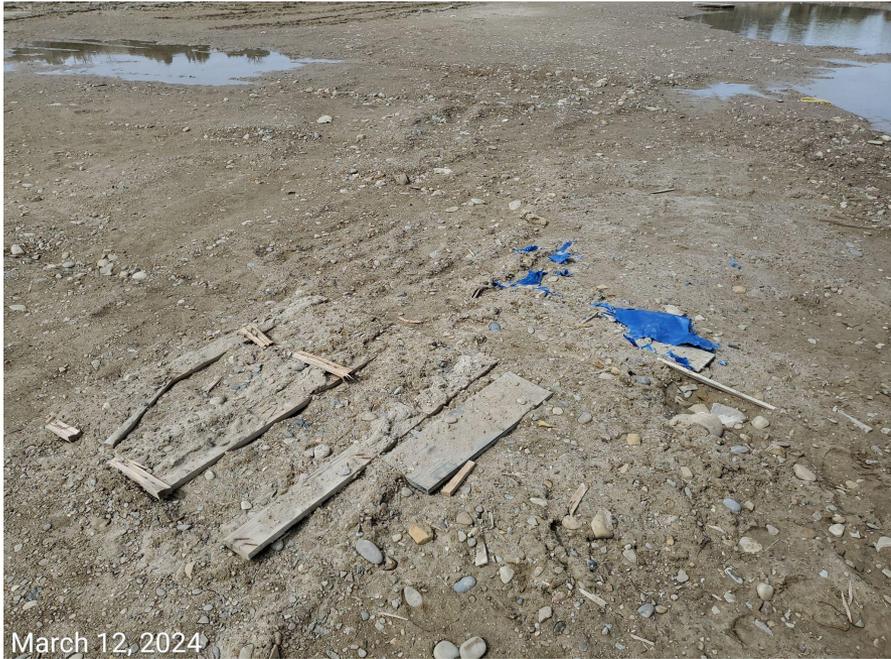
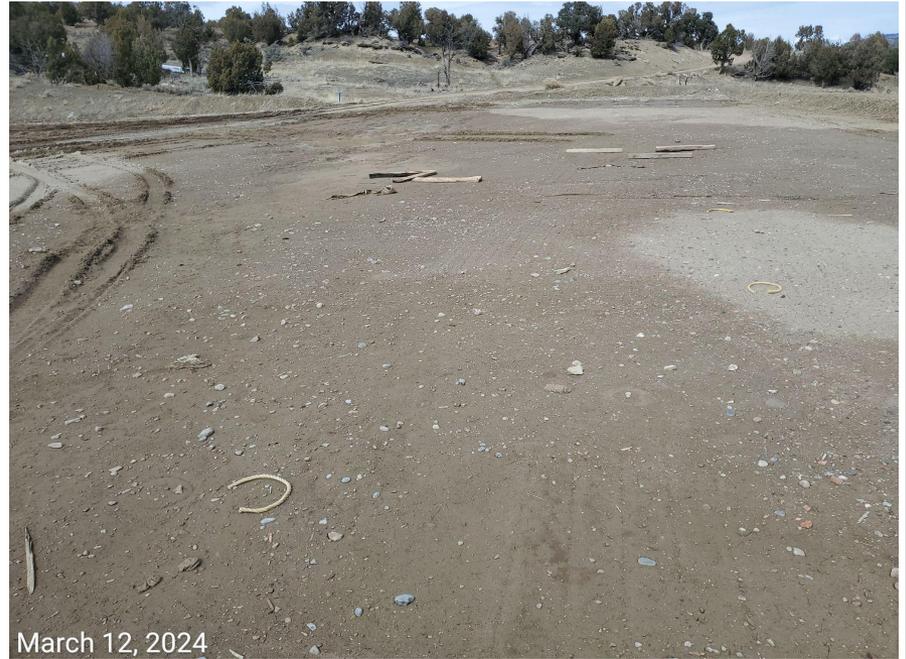
Photo 15: See comments under photo 14.

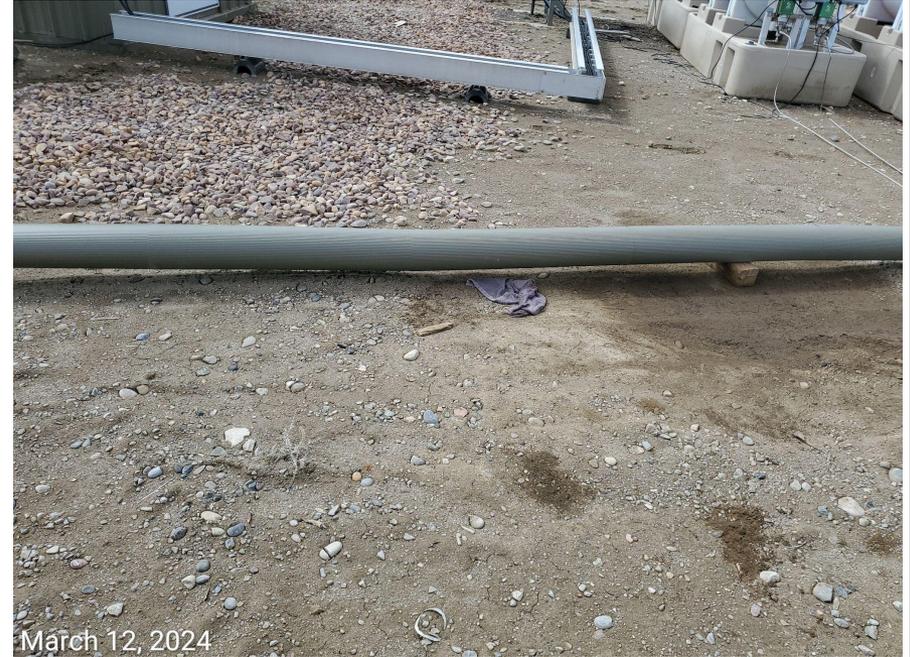
Photo 16: See comments under photo 14.

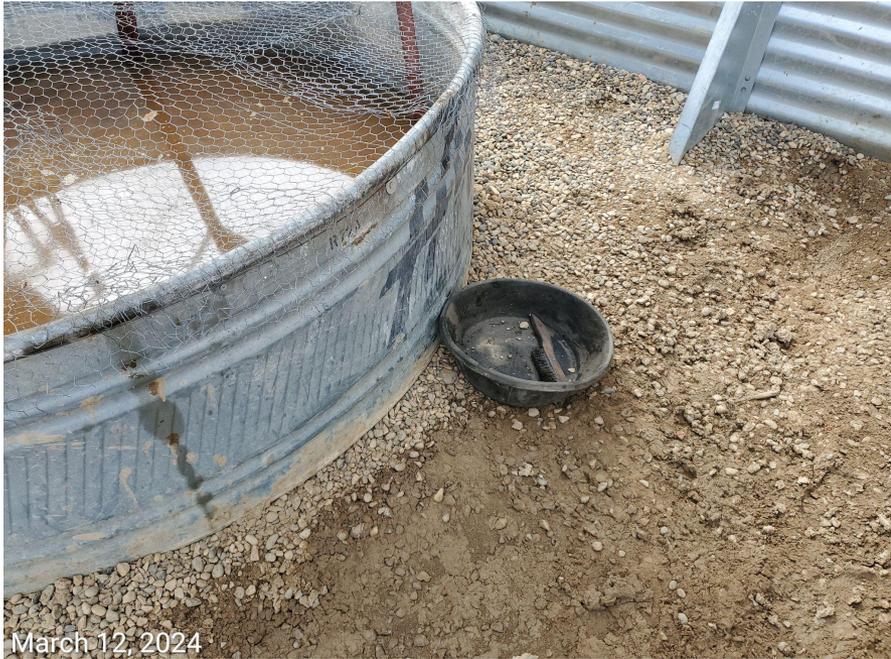
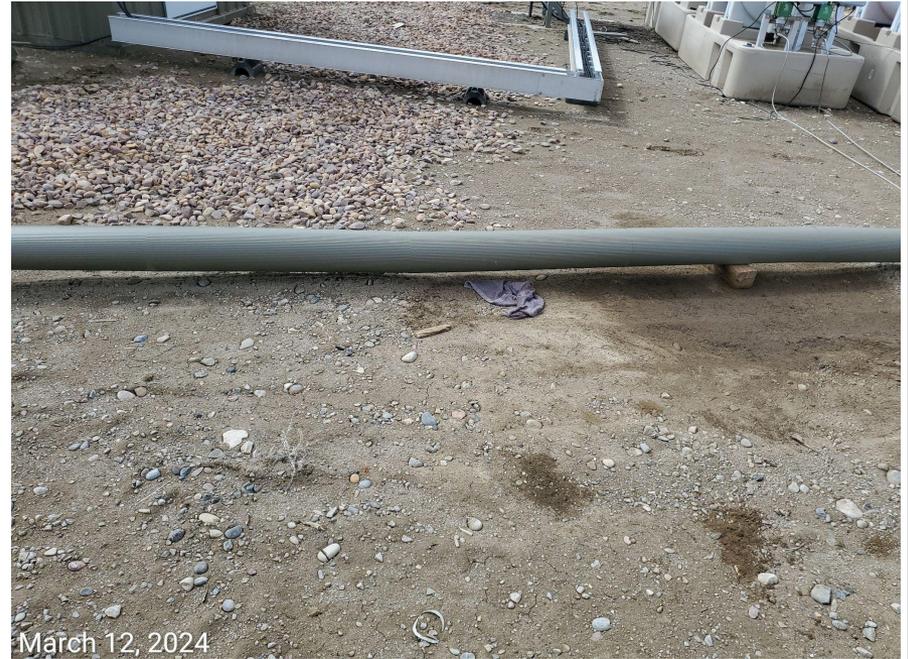
Photo 17: See comments under photo 14.

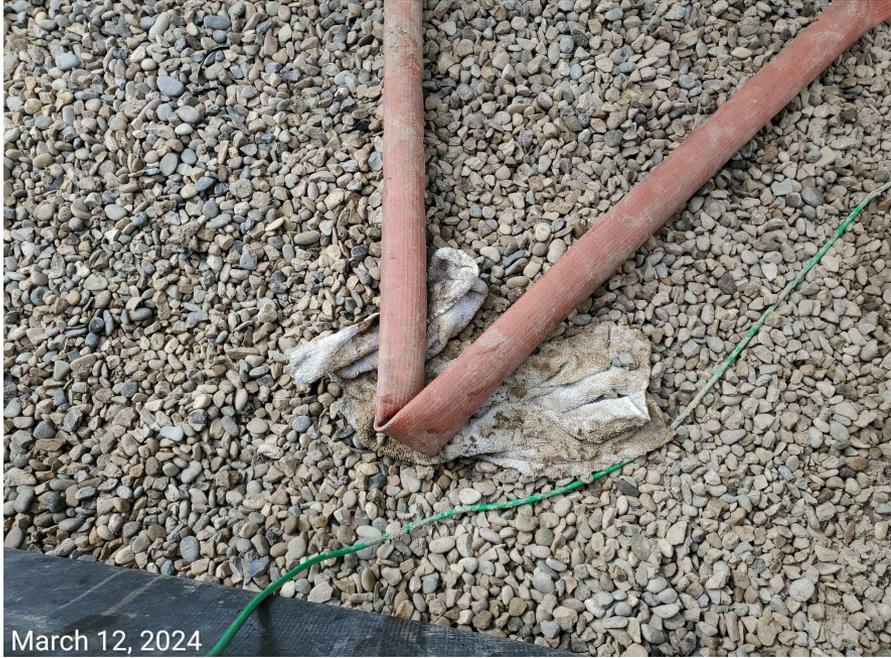
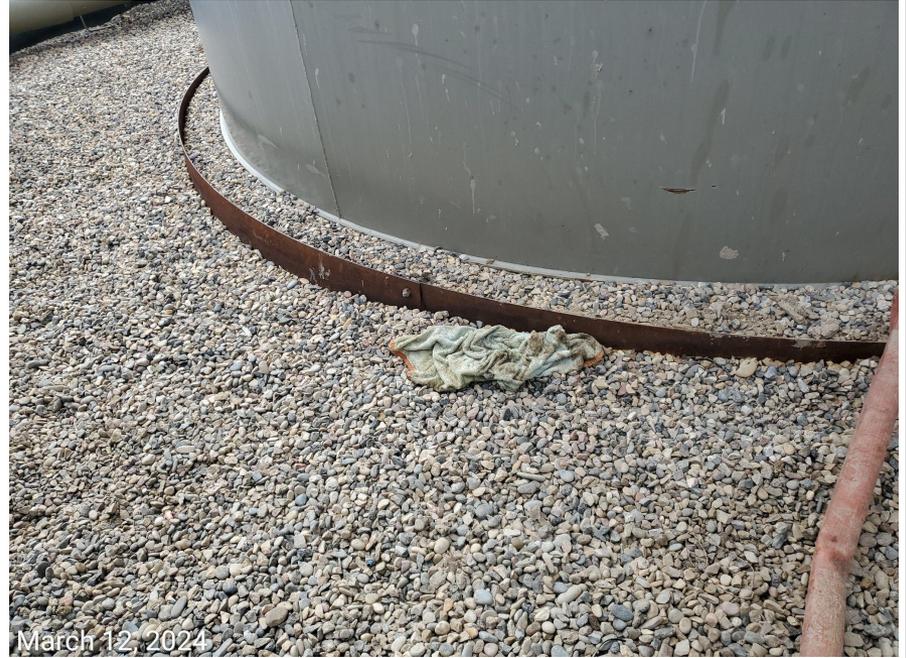
Photo 18: See comments under photo 14.

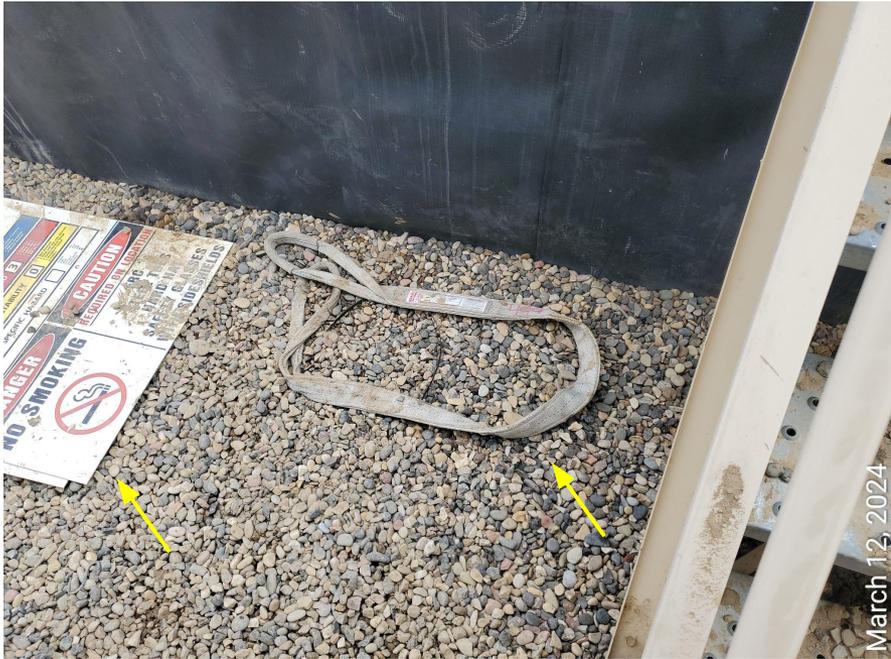
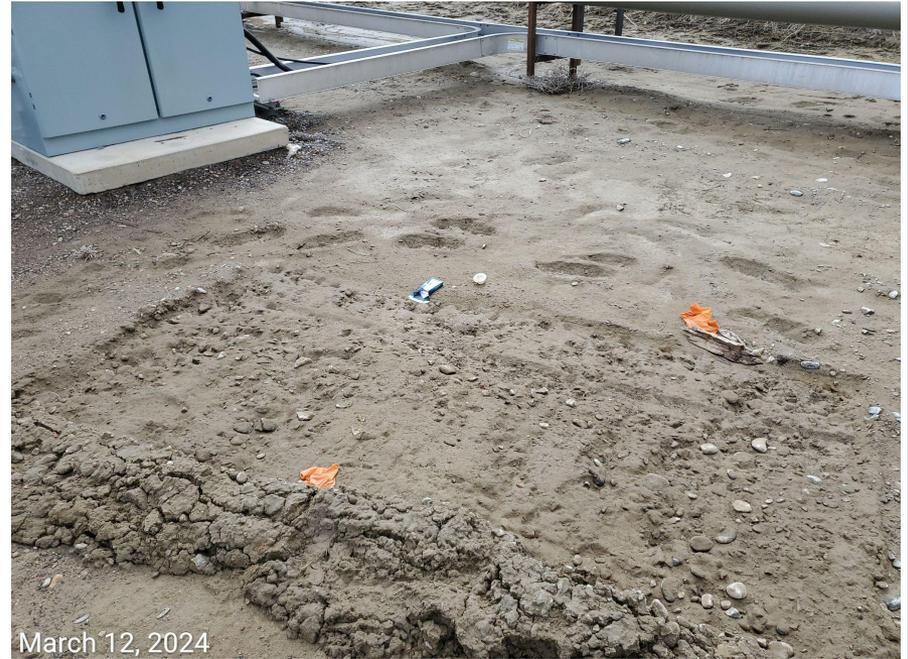
Photo 19: See comments under photo 14.

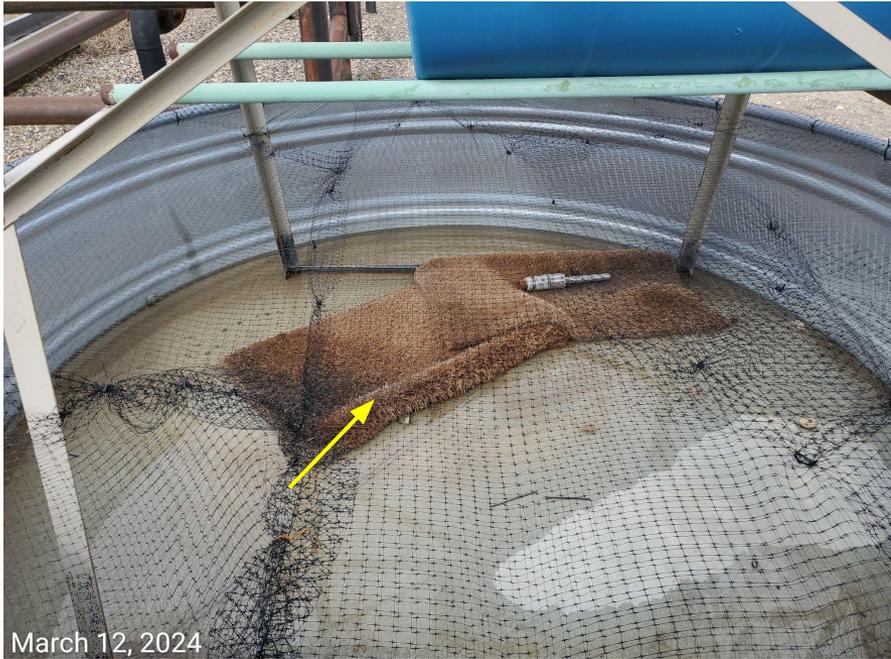
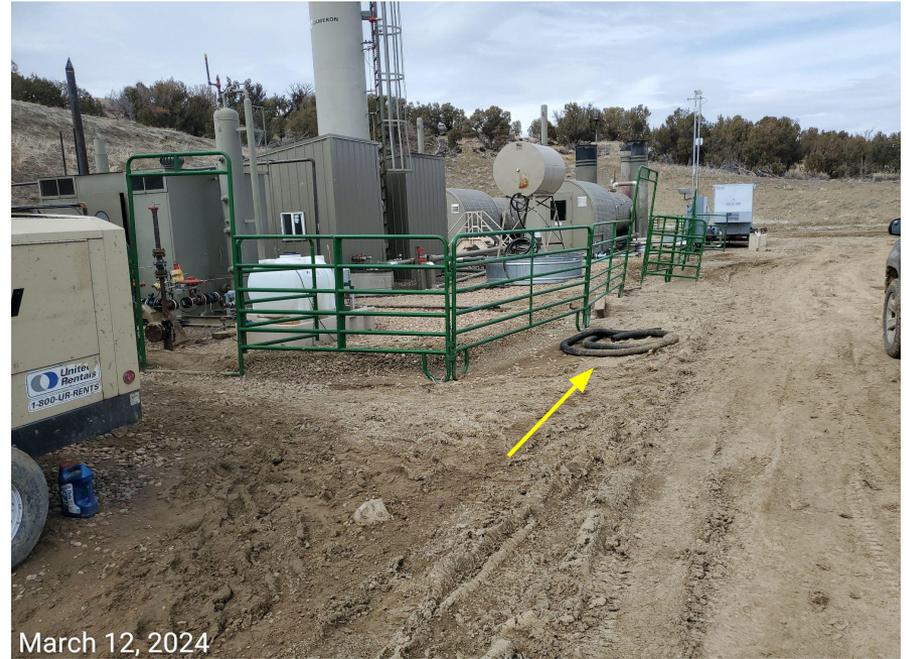
Photo 19: See comments under photo 14.
