Inspection Photos and Issue Report

Operator: ANSCHUTZ EXPLORATION CORP

Location ID: 430926

Inspection Doc: 696205676

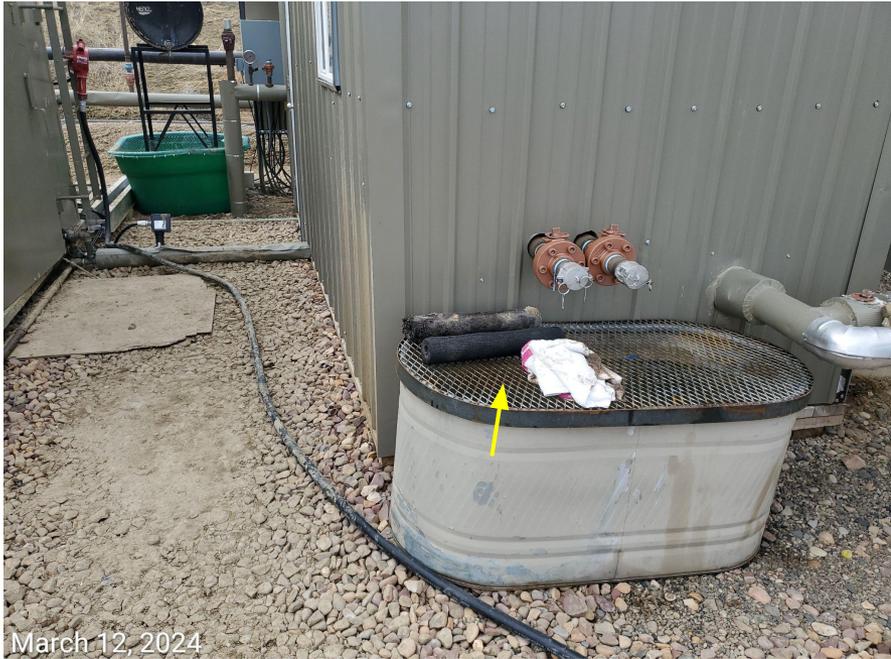
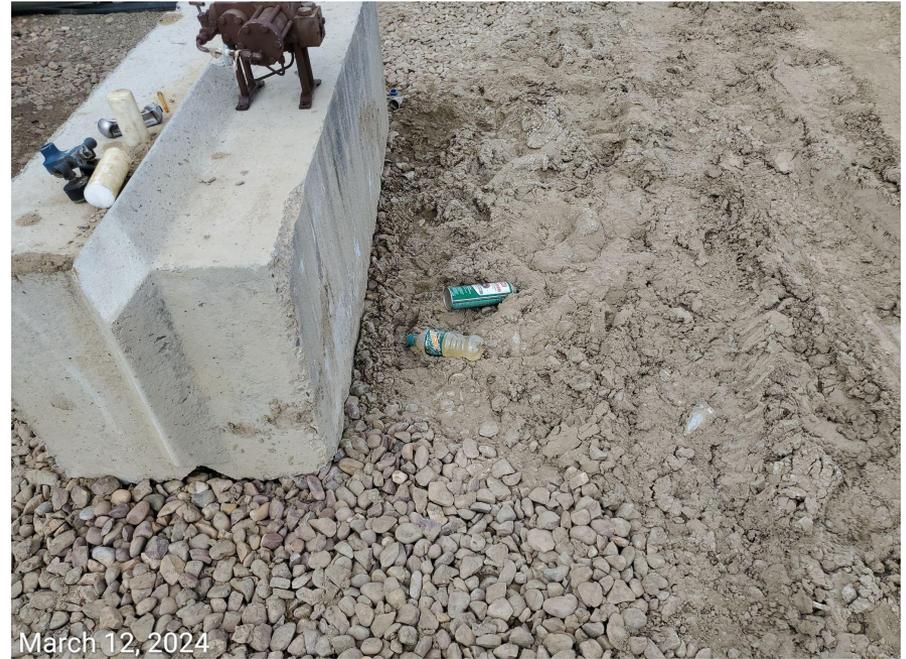
Photo 14: Photos 14-31 taken throughout the working pad surface, interim areas, and around production equipment/facilities of the Location. Photos show various trash/debris/unused equipment/etc... remain improperly stored throughout the entire Location.

Photo 20: See comments under photo 14.

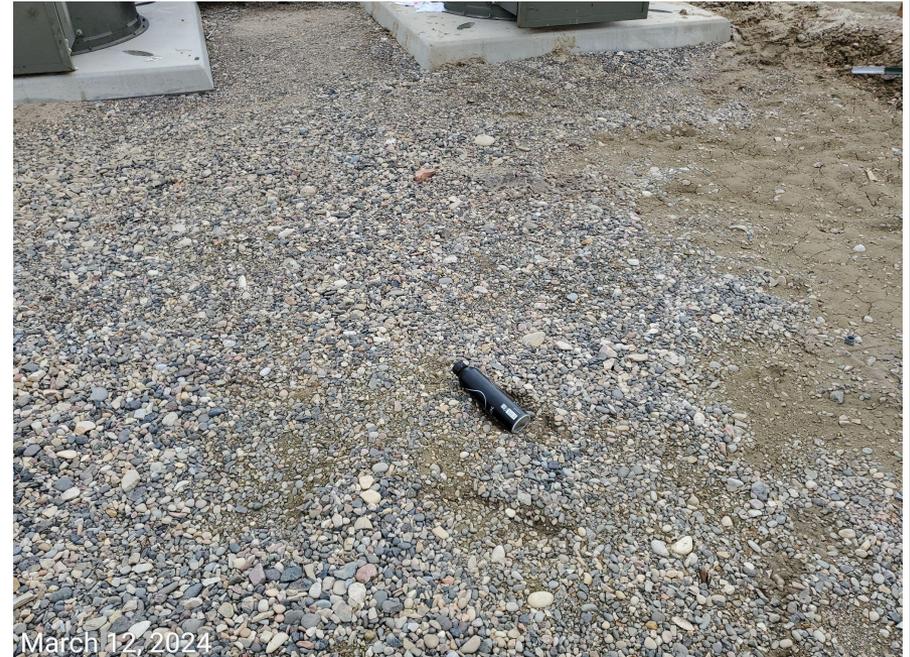
Photo 22: See comments under photo 14.

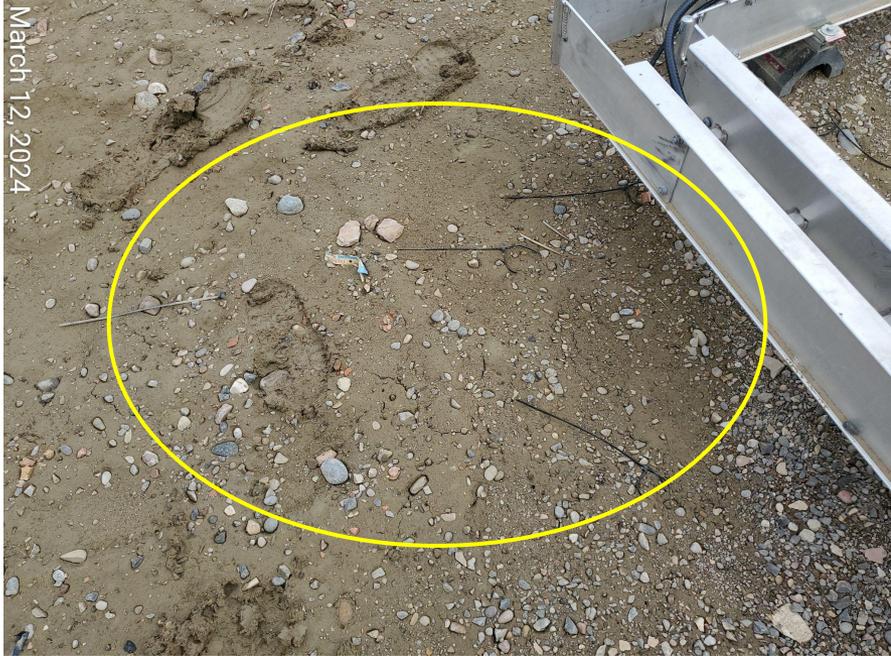
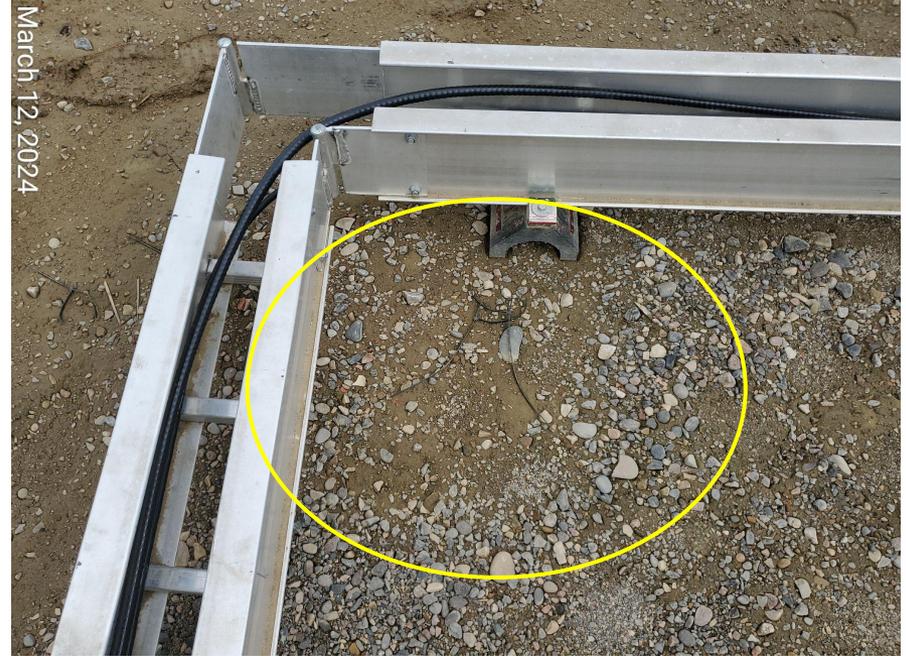
Photo 23: See comments under photo 14. Zip ties

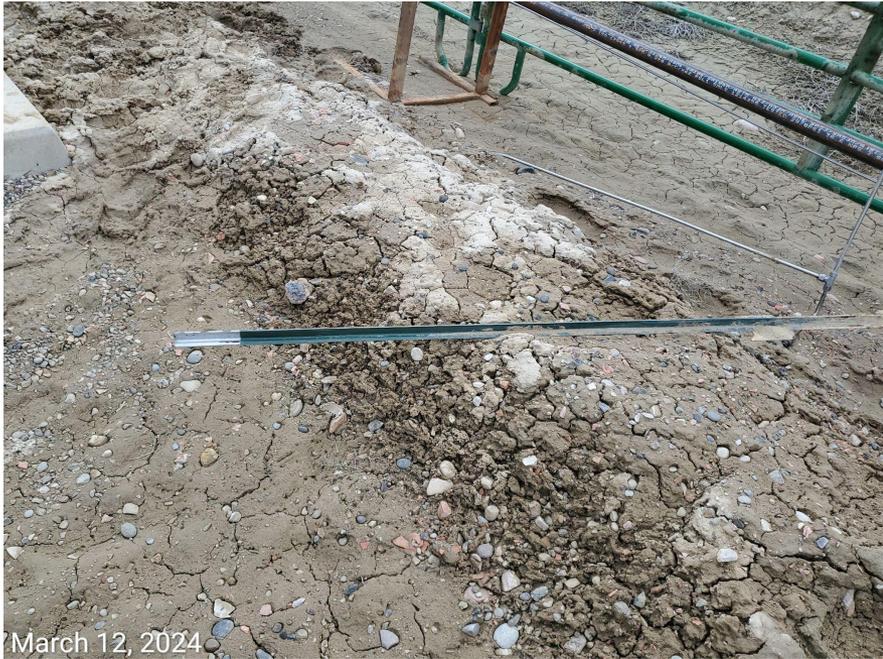
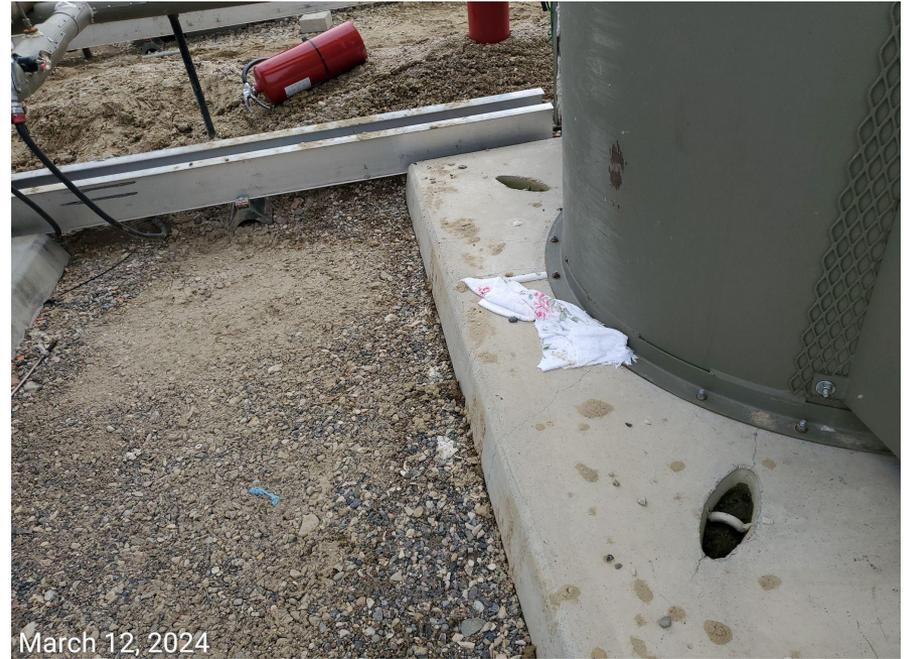
Photo 24: See comments under photo 14.

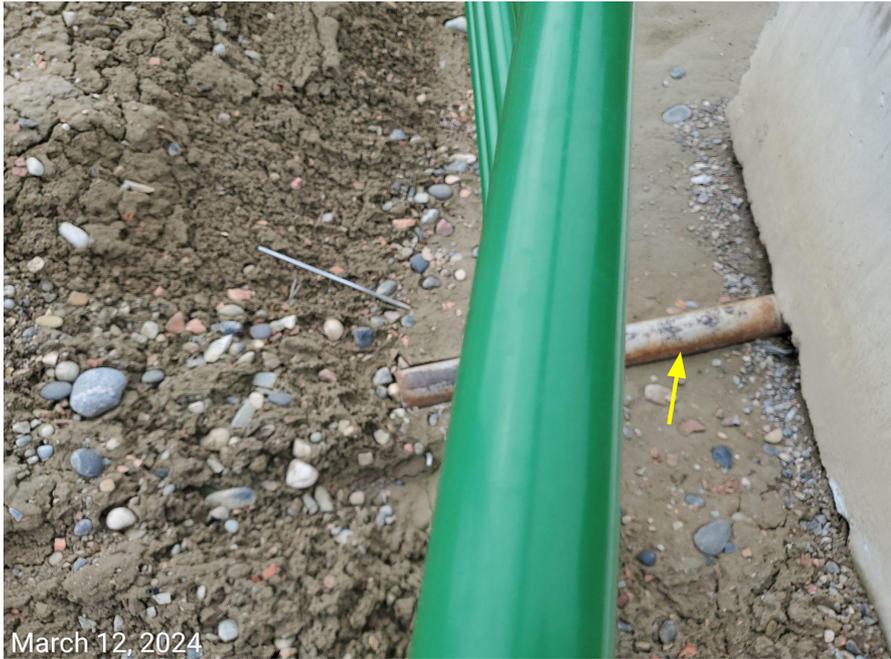
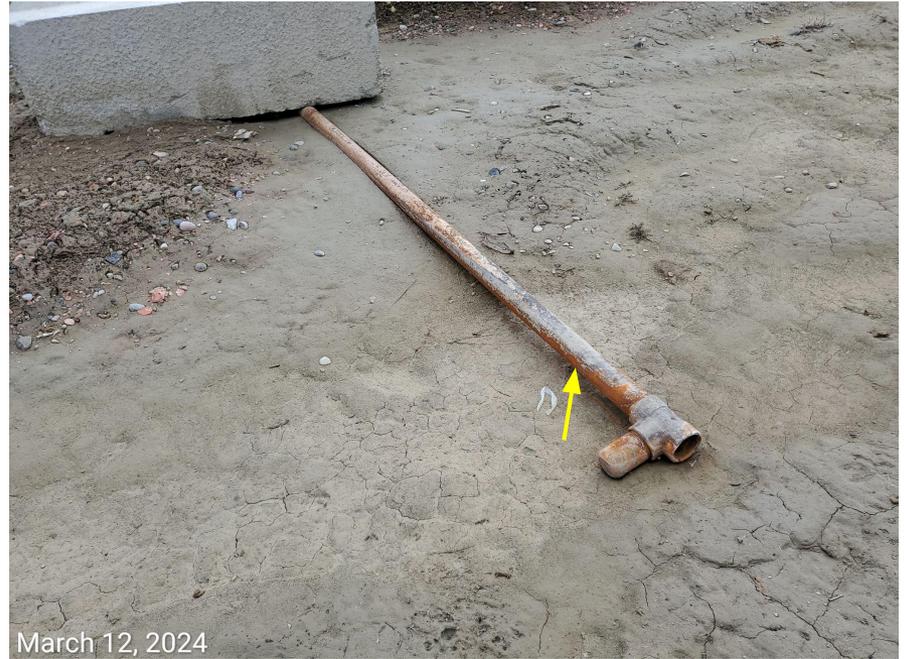
Photo 25: See comments under photo 14.

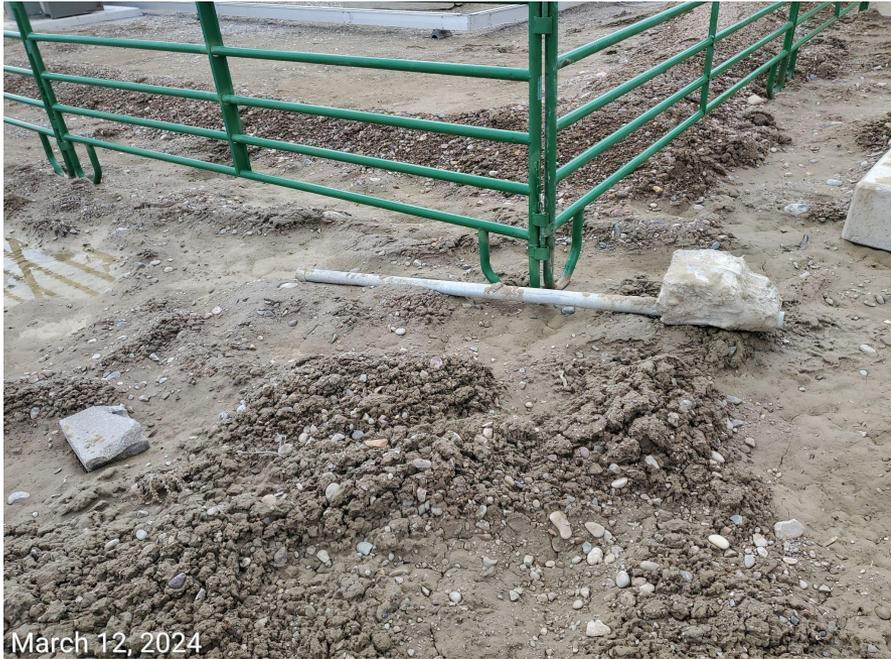
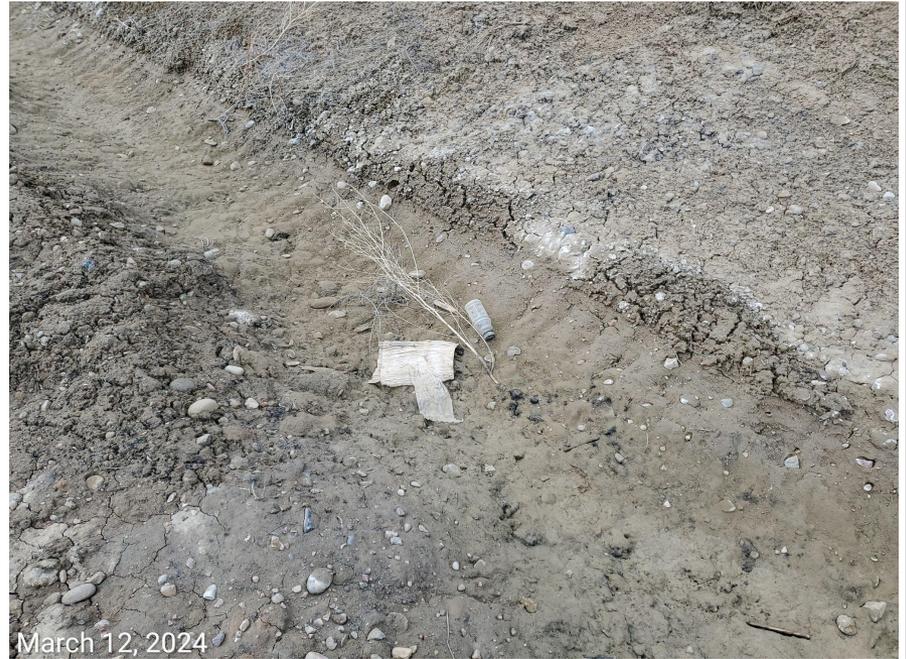
Photo 26: See comments under photo 14.

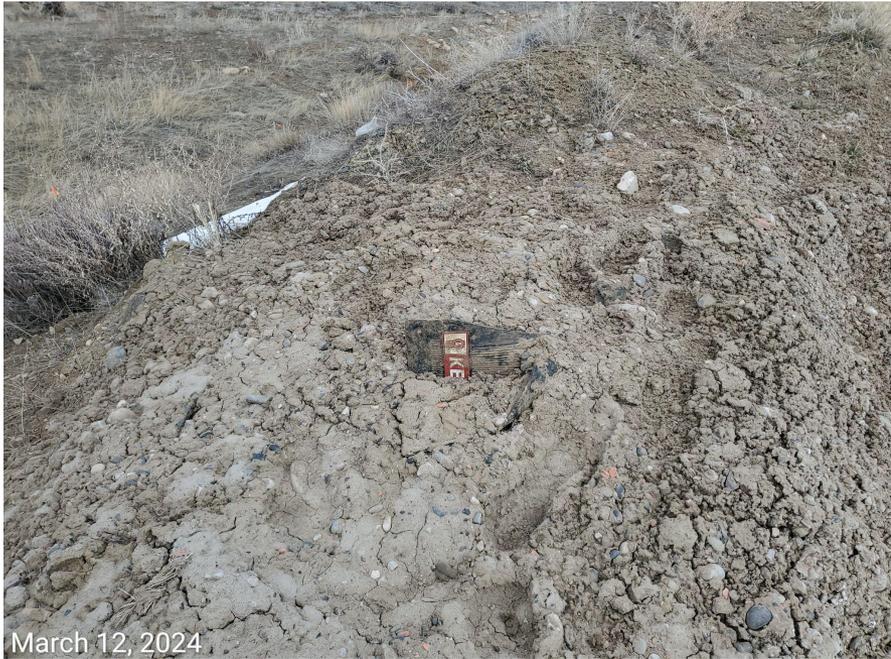
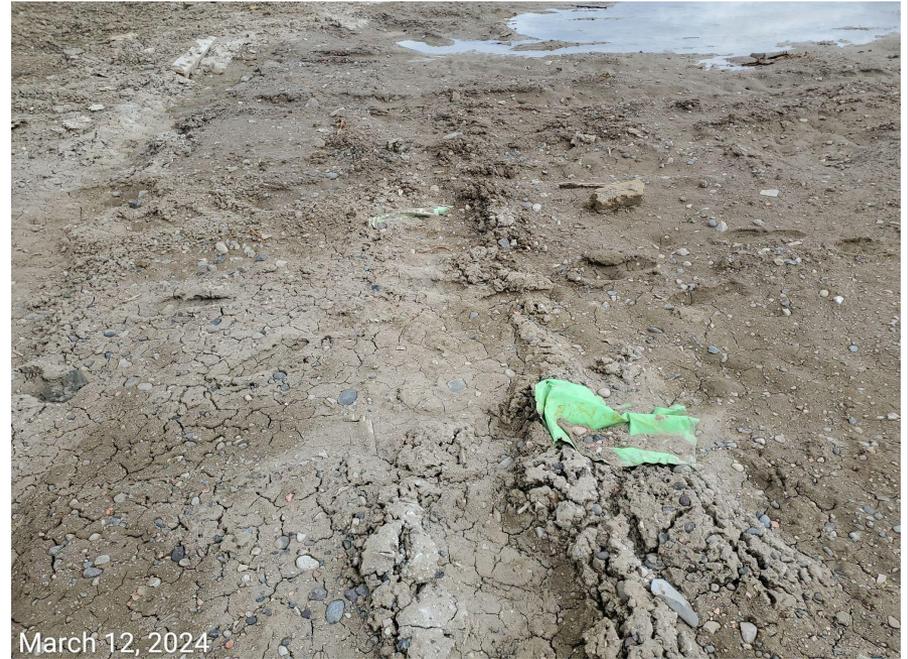
Photo 27: See comments under photo 14.

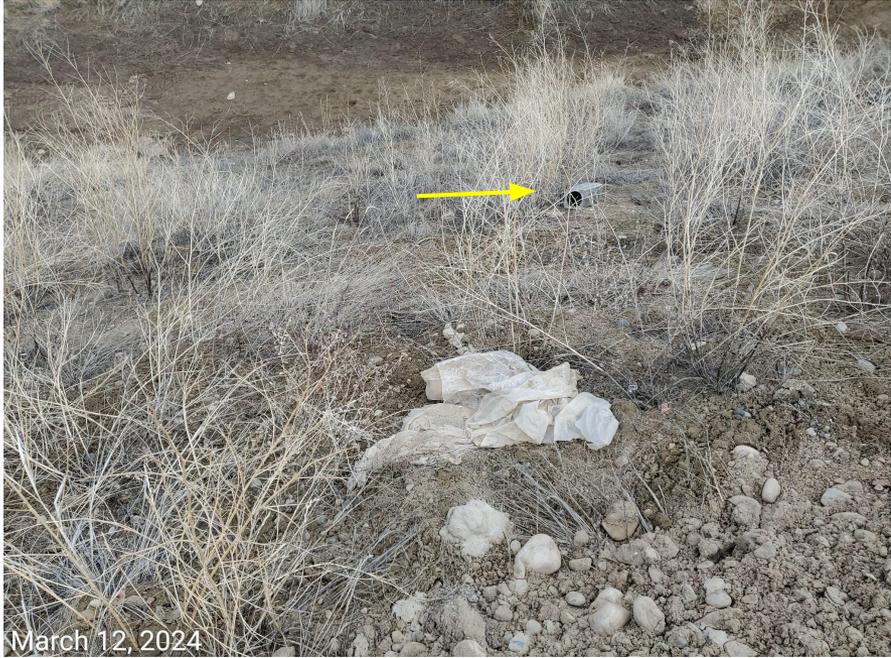
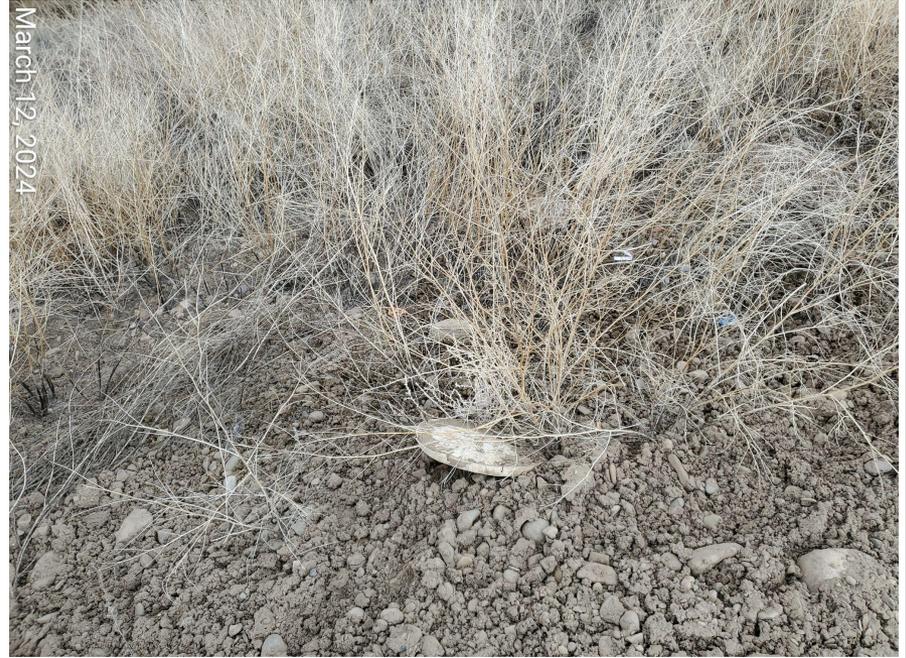
Photo 28: See comments under photo 14.

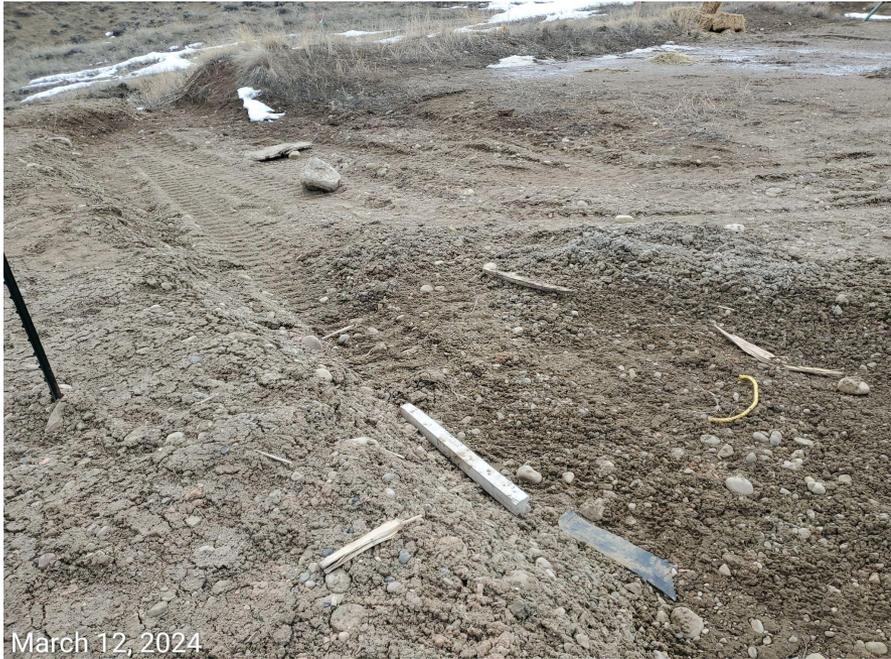
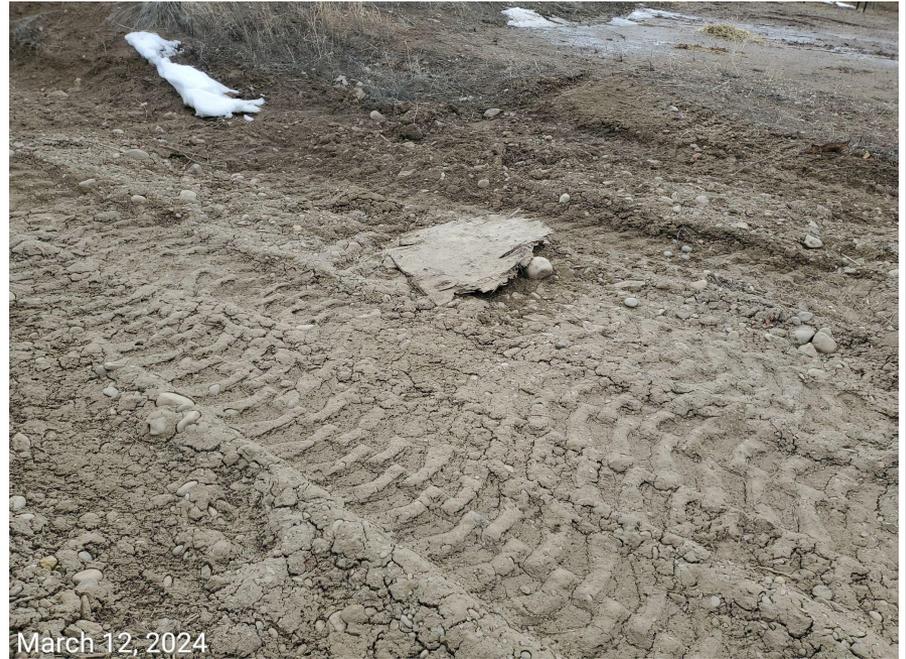
Photo 29: See comments under photo 14.

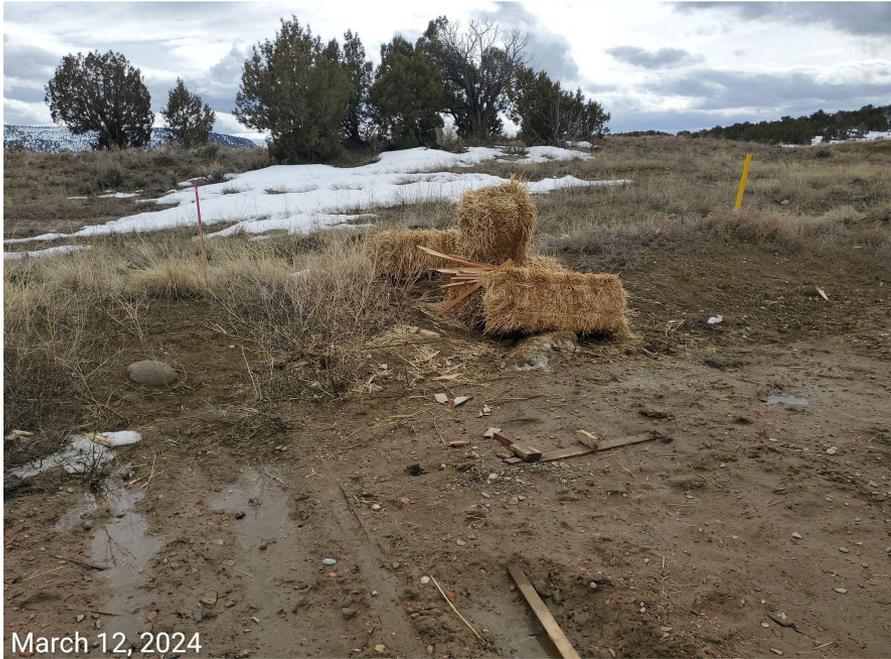
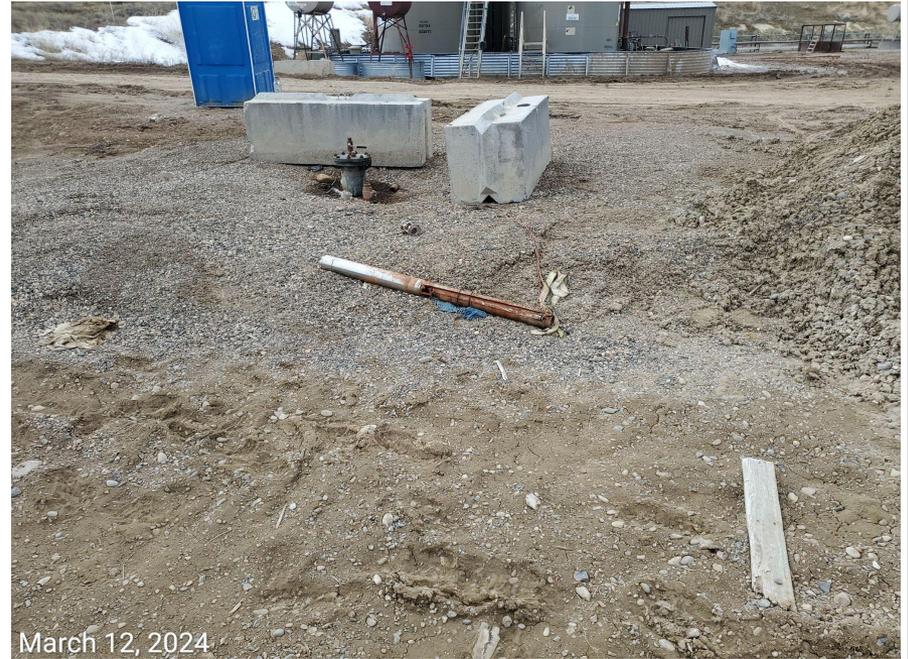
Photo 30: See comments under photo 14.

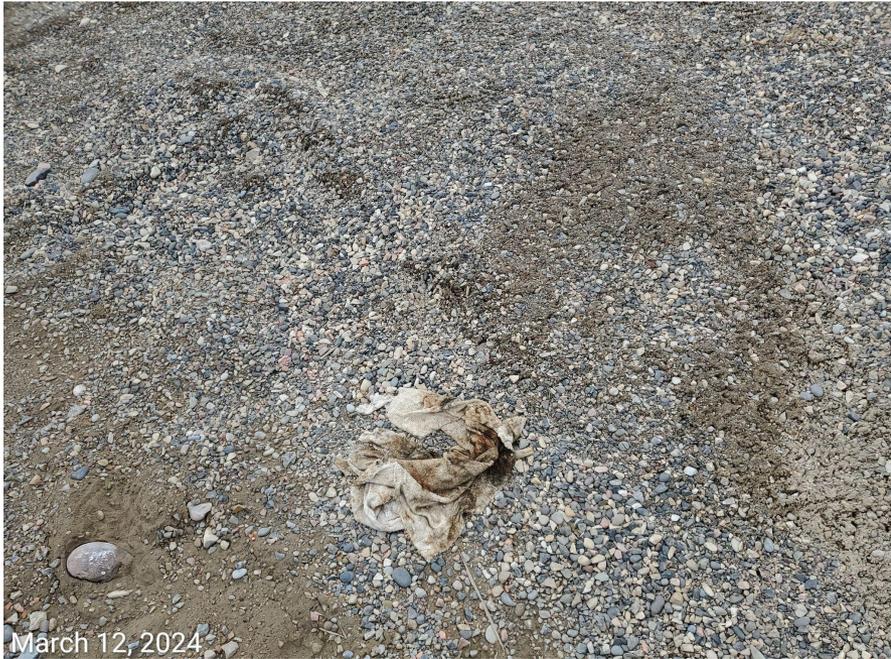
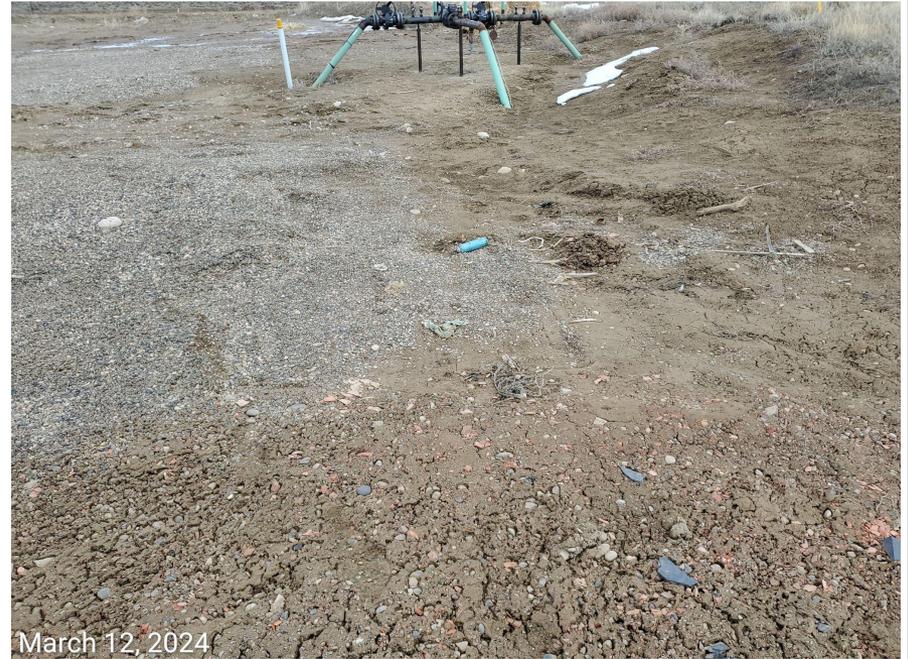
Photo 31: See comments under photo 14.

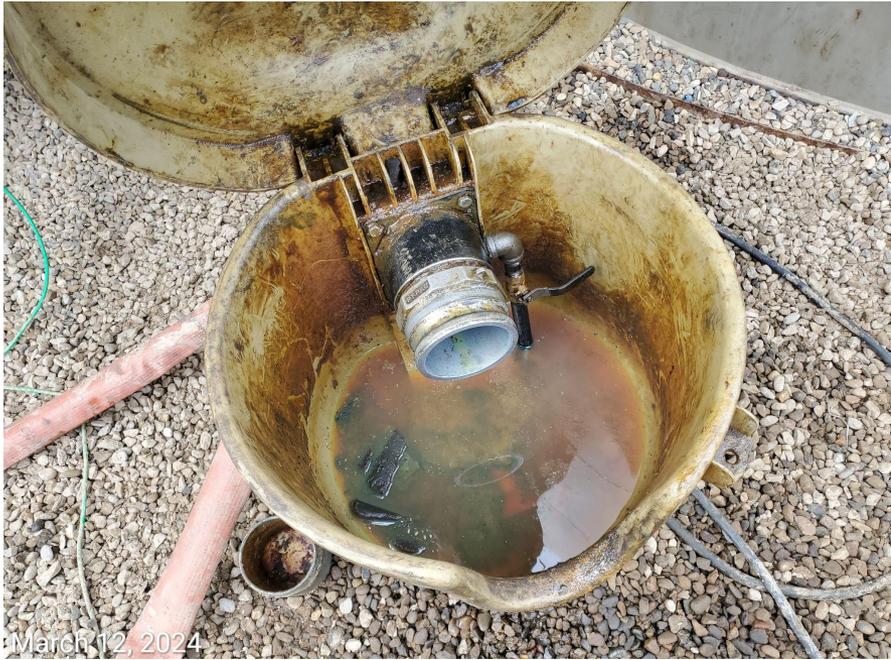
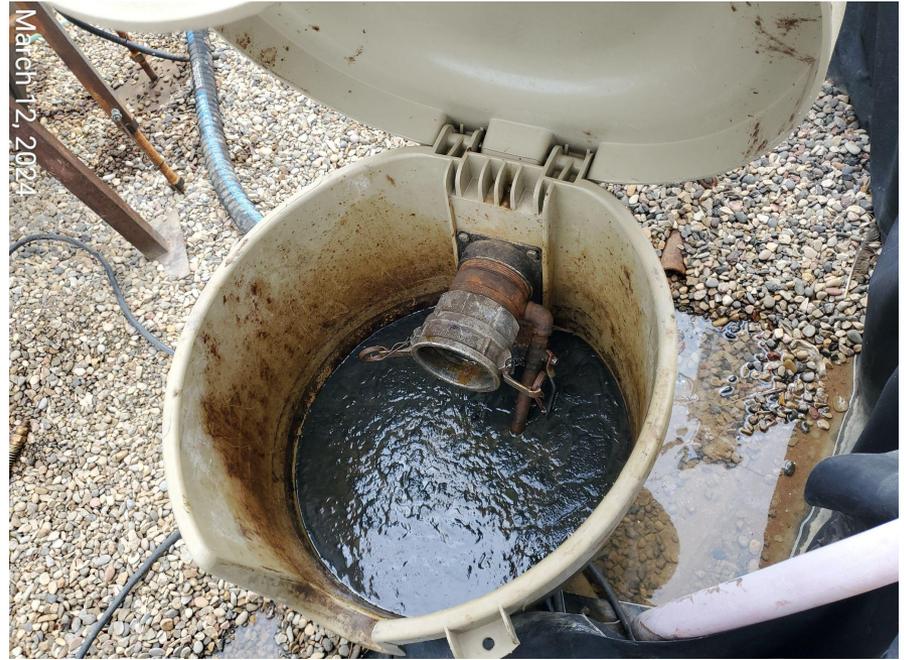
Photo 32: Photos taken from the tank battery facility. Photos show lines at tanks have not been capped/plugged, and produced fluids have not been removed and properly disposed from the honeypots.

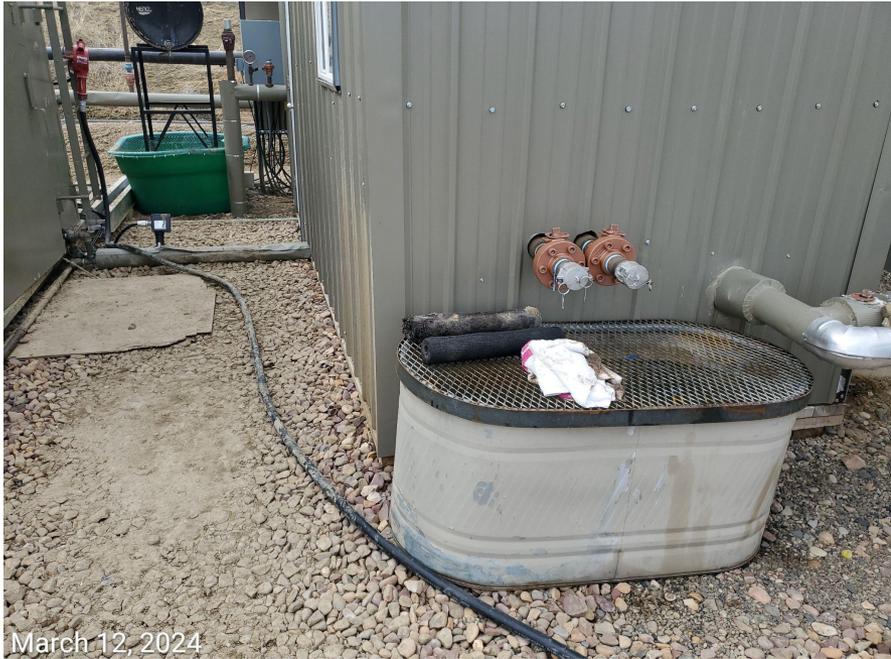
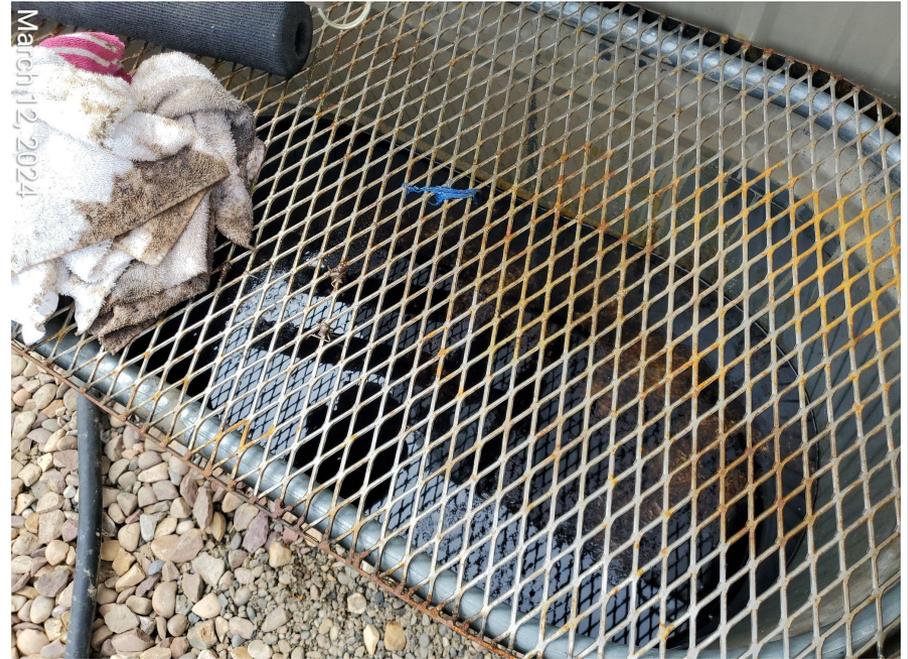
Photo 33: Photos taken from the production equipment on the west end of the Location. Photo shows fluids within containment have not been removed and properly disposed.

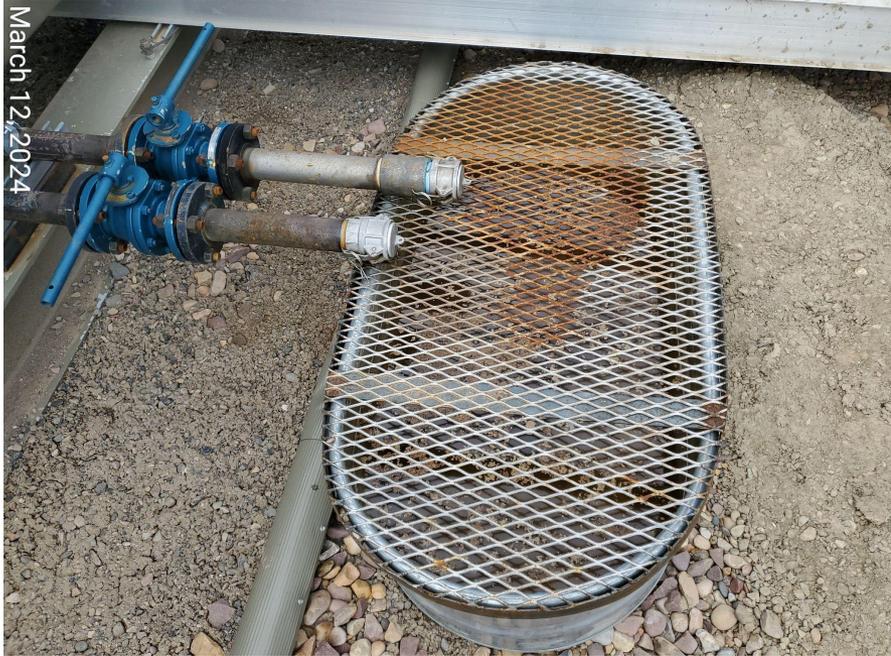
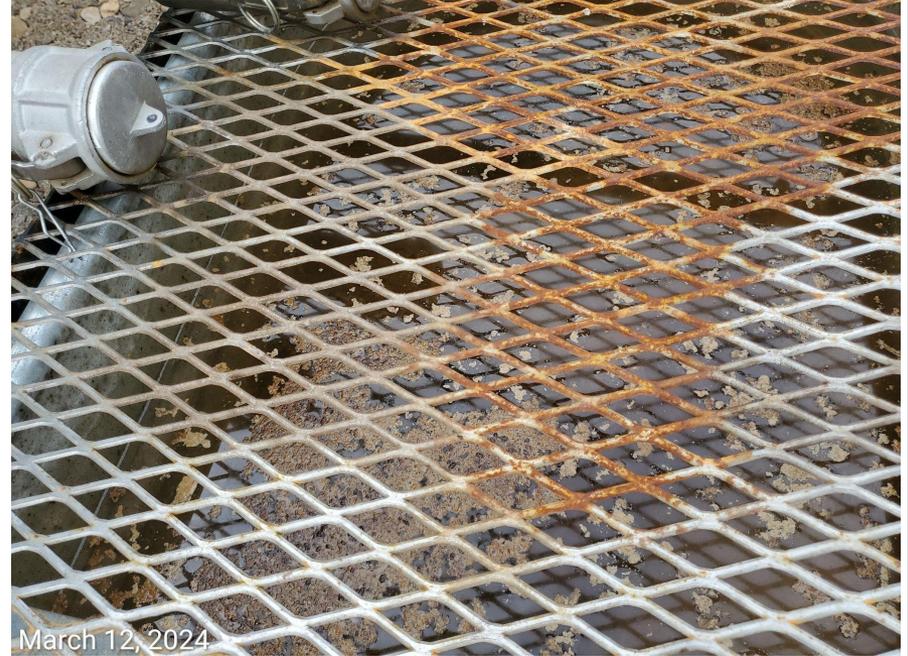
Photo 34: Photos taken from the production equipment on the west end of the Location. Photo shows fluids within containment have not been removed and properly disposed.

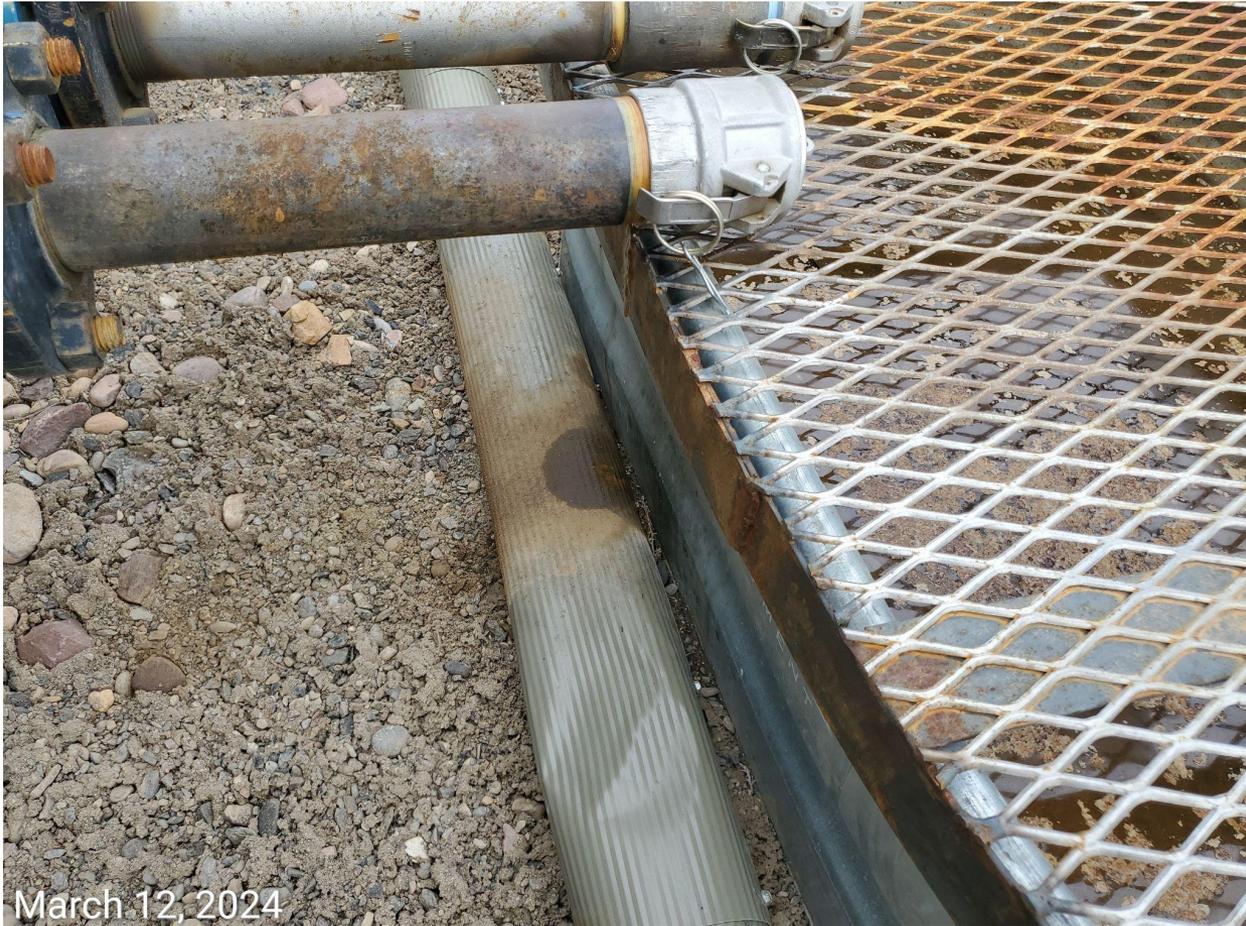
Photo 35: Continued from photo 34. Photo shows containment measure is inadequate to contain a spill or release from the production equipment, resulting in fluids spilled onto the pad surface. BMP will be required to be re-installed. Impacted soils will require cleaning.

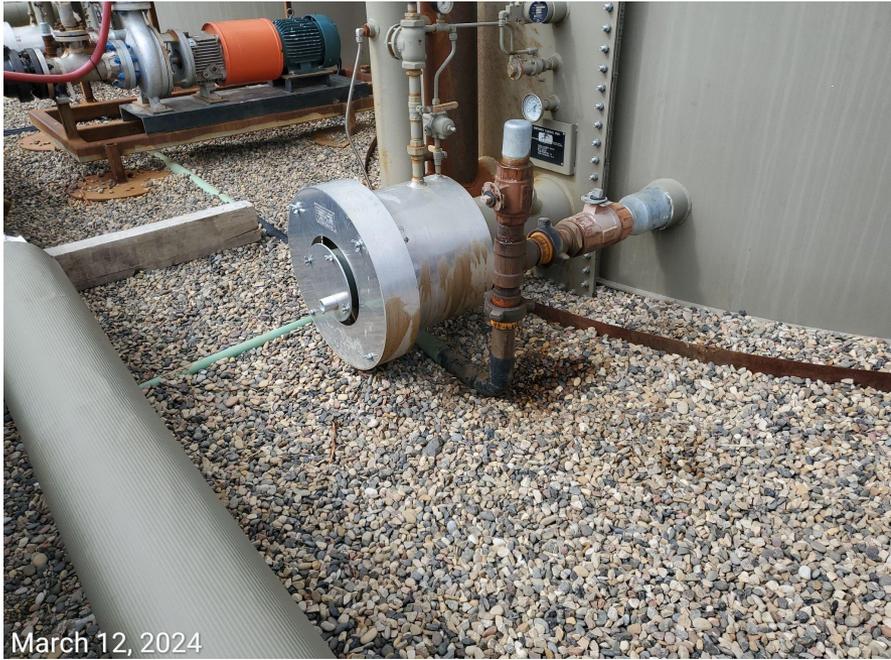
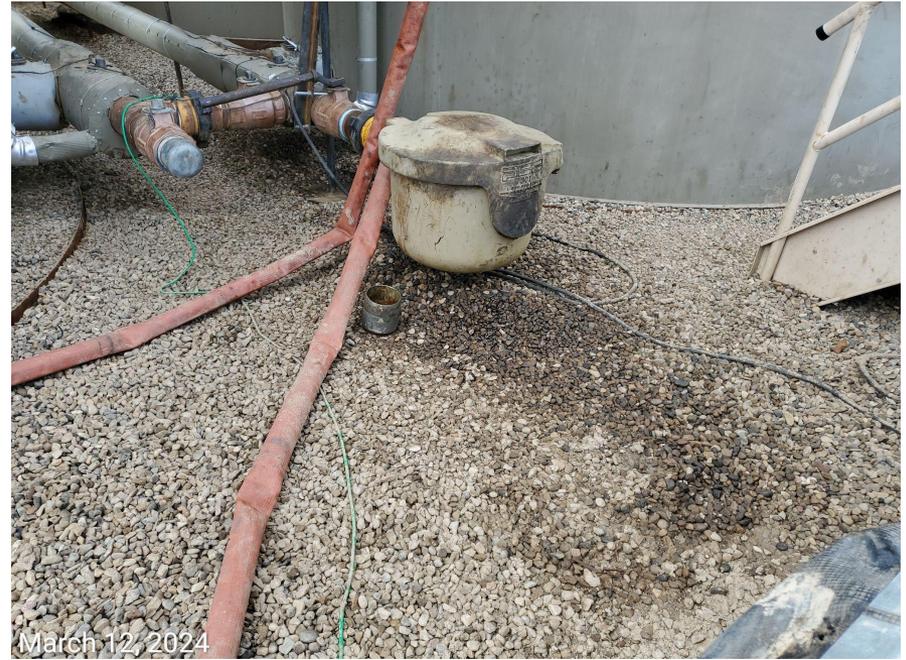
Photo 36: Photos 36-39 examples showing spills/releases and impacted soils/materials observed throughout the entire Location. Operator is being required to Securely fasten all valves, pipes, fittings, and Production Facilities to ensure good mechanical condition to comply with Rule 608.e, to clean up spills and releases per Rule 912.a, and to clean/remediate impacts to Table 915-1

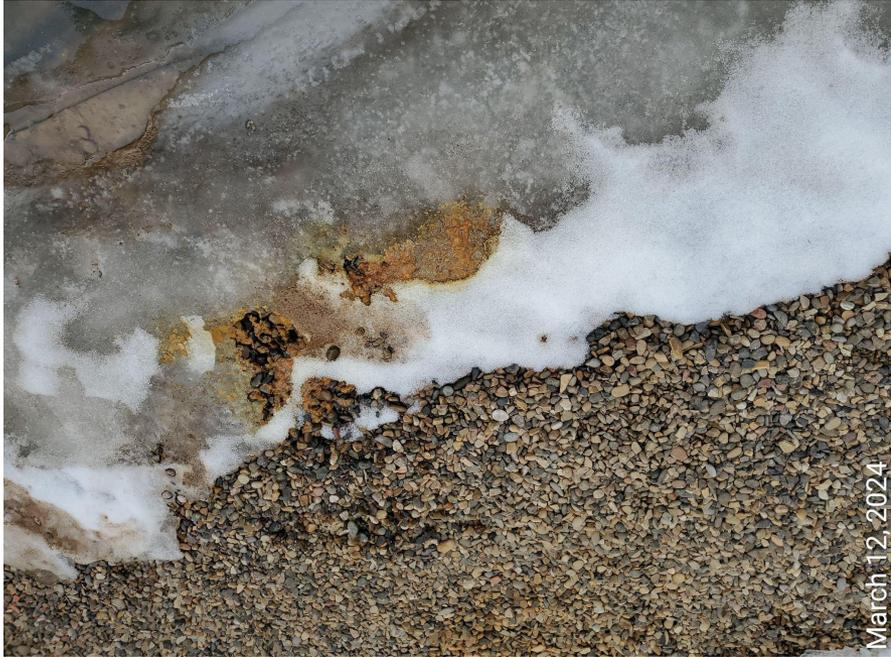
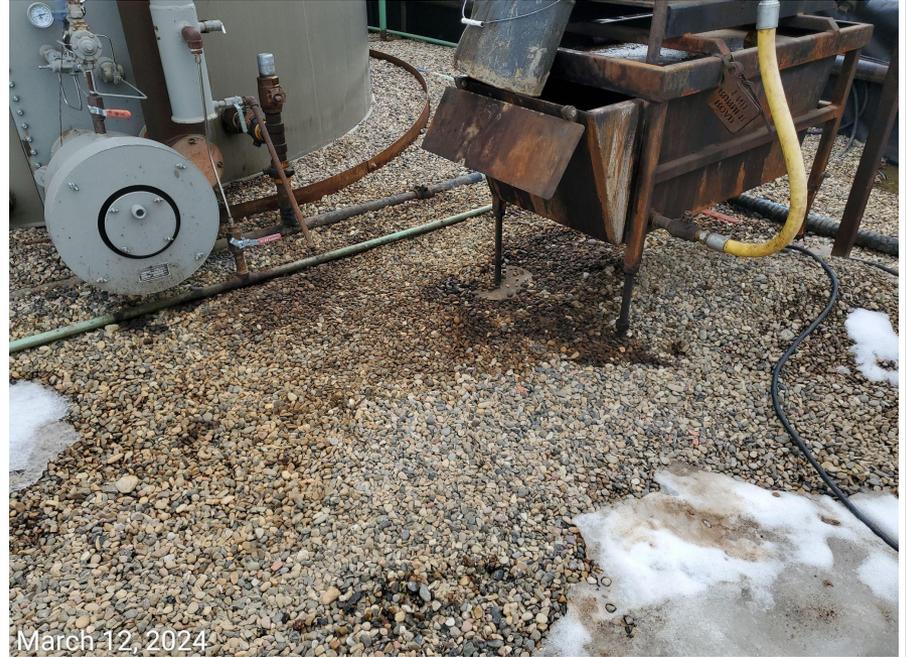
Photo 37: See comments under photo 36.

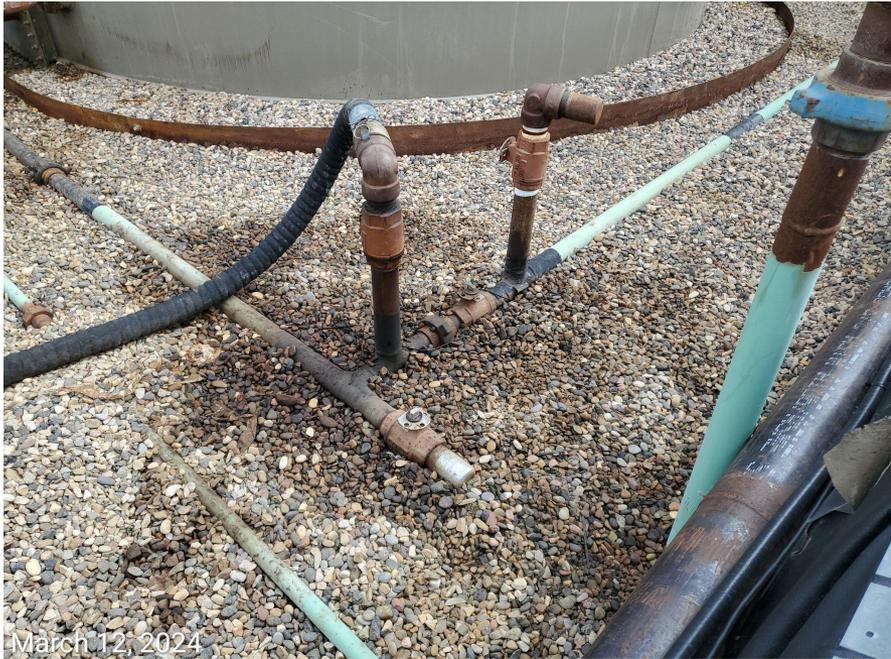
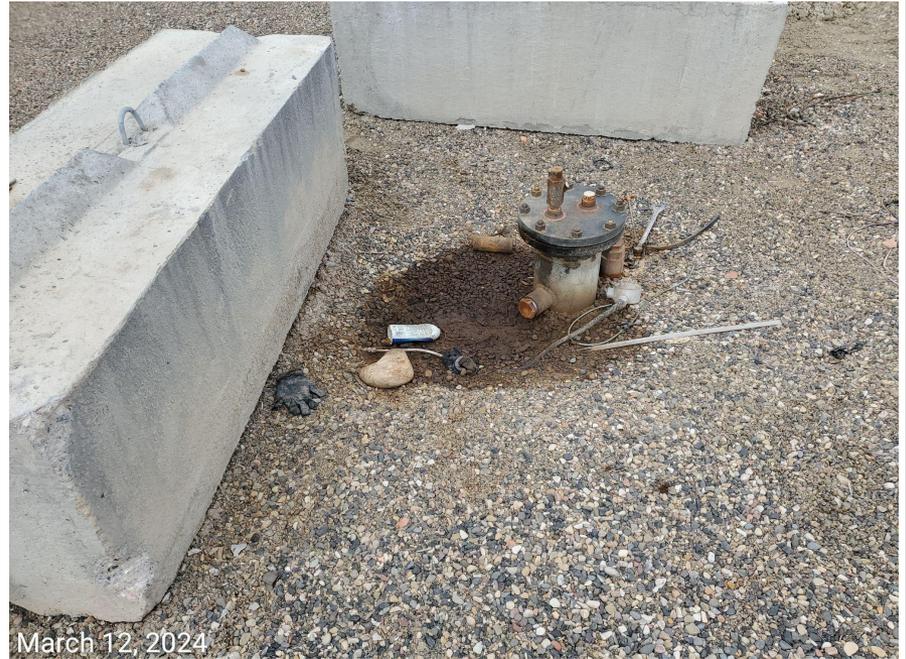
Photo 38: See comments under photo 36.

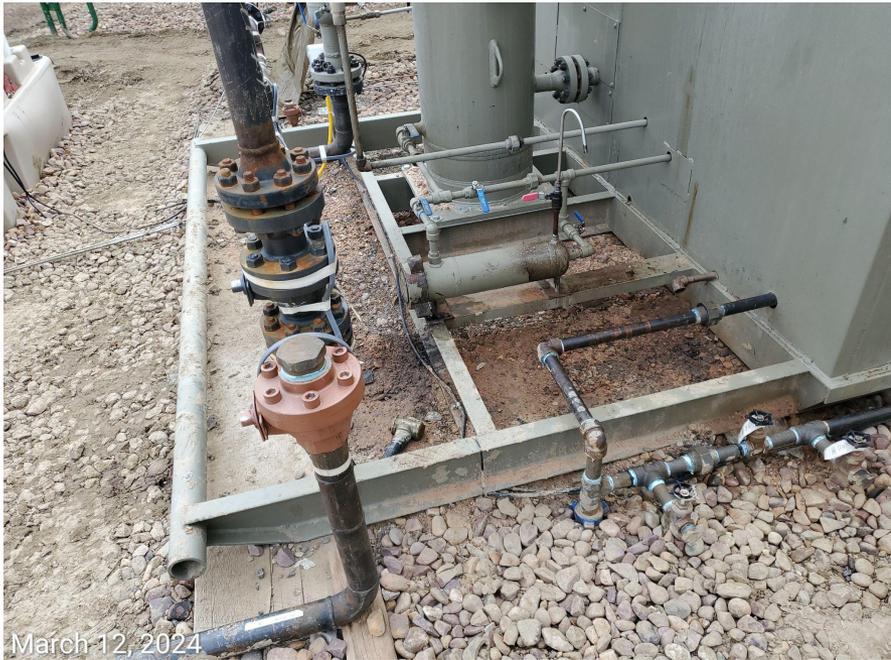
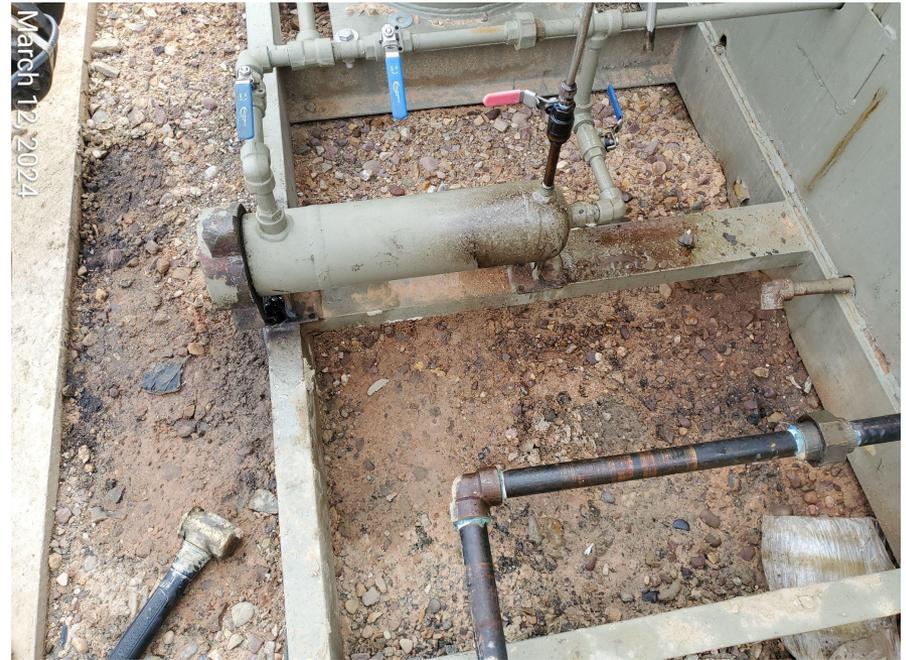
Photo 39: See comments under photo 36.
