Inspection Photos
Location: Foster 14-2
API: 05-123-14822

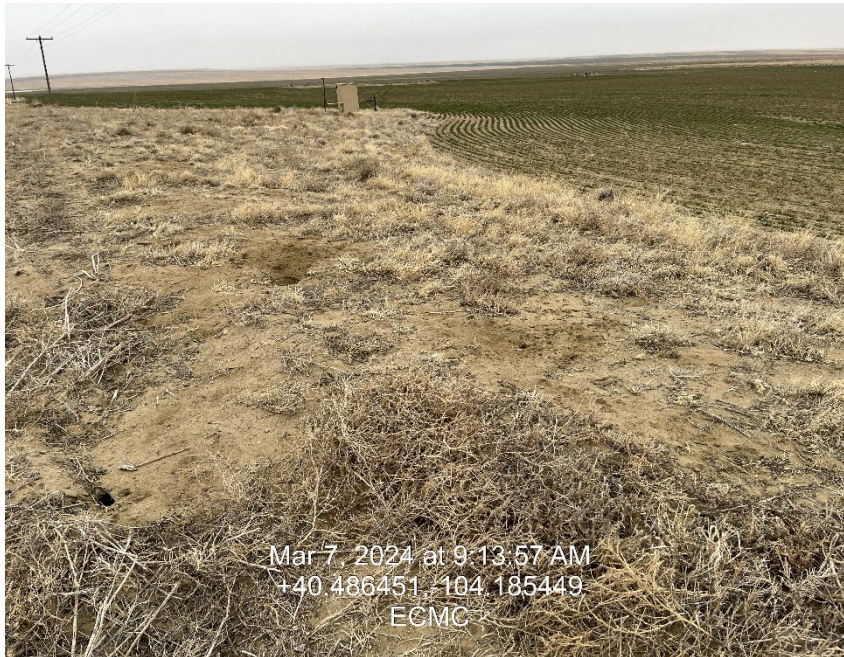
Photo 1 –View looking northeast at former facility

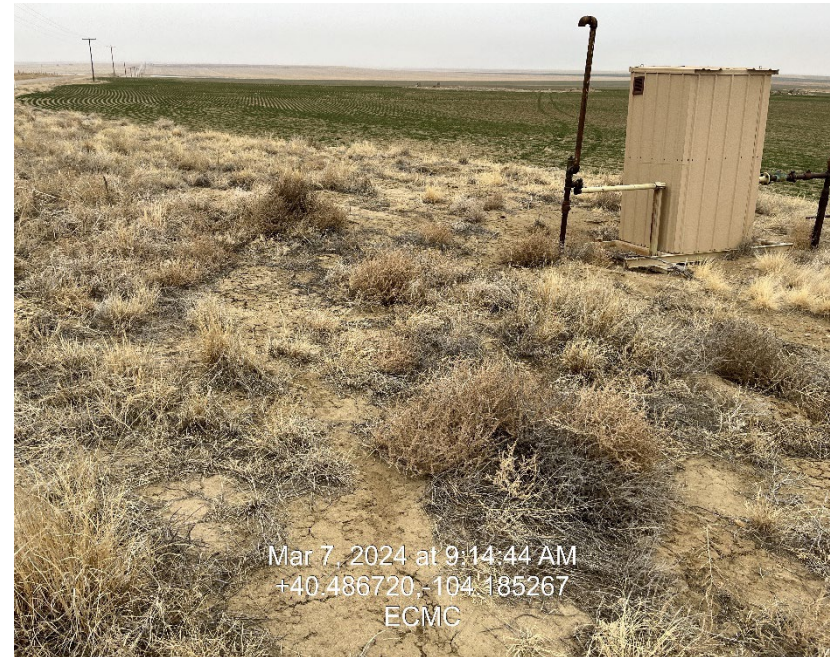
Photo 2 – Unused equipment remaining on site

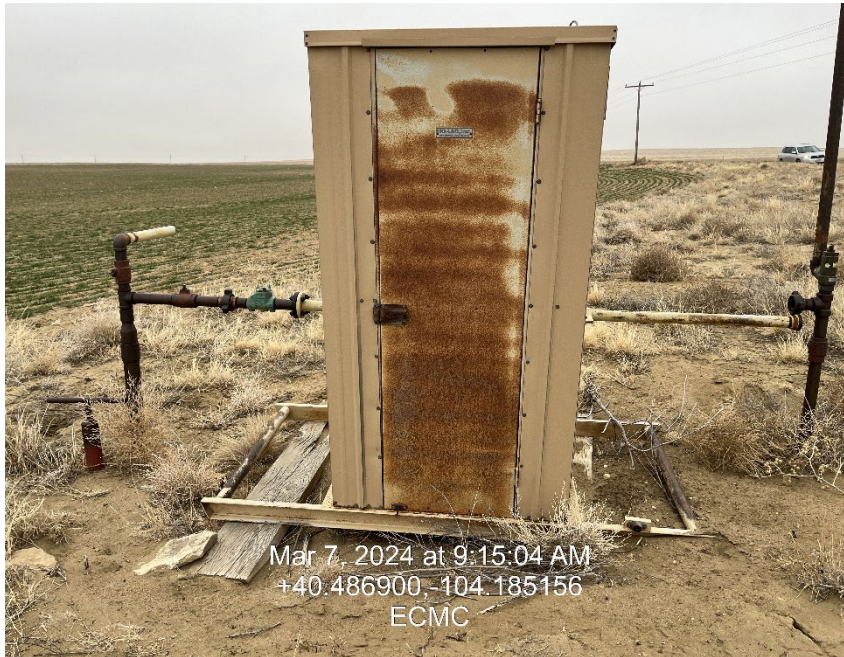
Photo 3 – Unused disconnected equipment on site

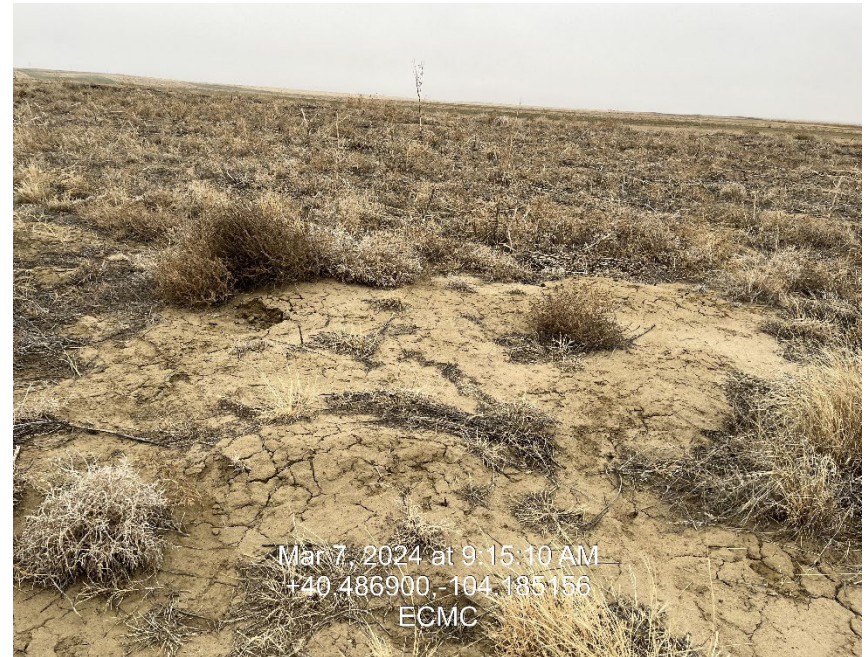
Photo 4 – Undesirable vegetation
