Photographic Log
Ferguson No.2 (OWP) #F-12
ECMC Form 27 Sampling
Colorado Energy & Carbon Management Commission

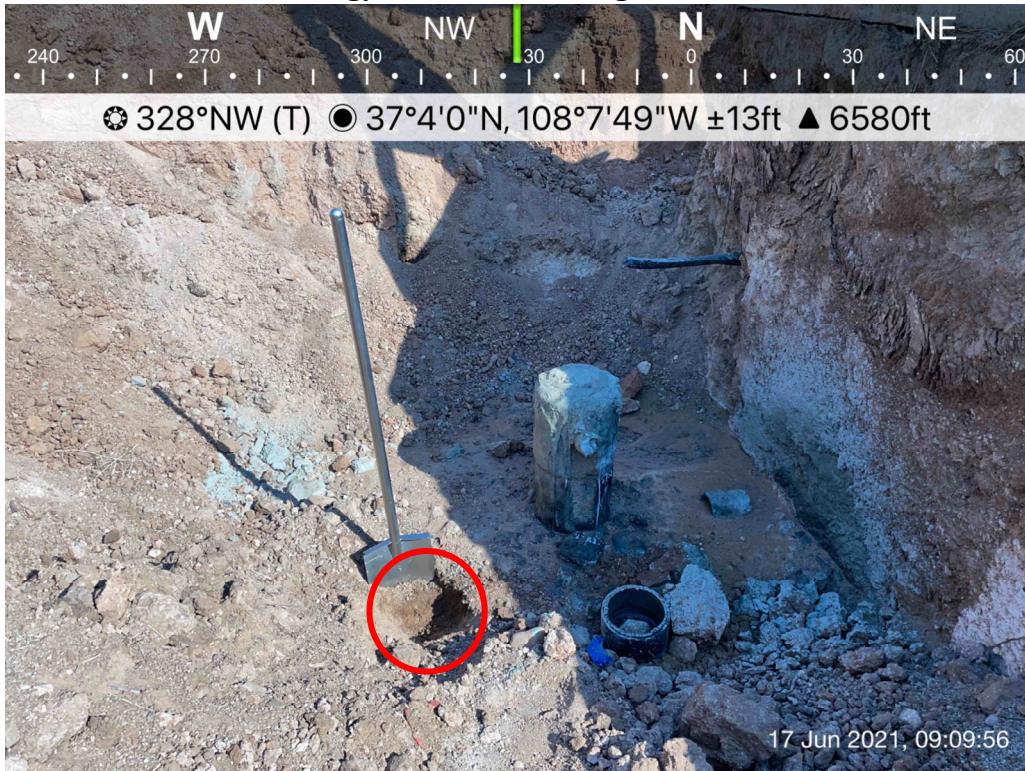
Photo 1: SS01 collected adjacent to Ferguson No. 2 (OWP) F-12 wellhead, 6/17/2021.

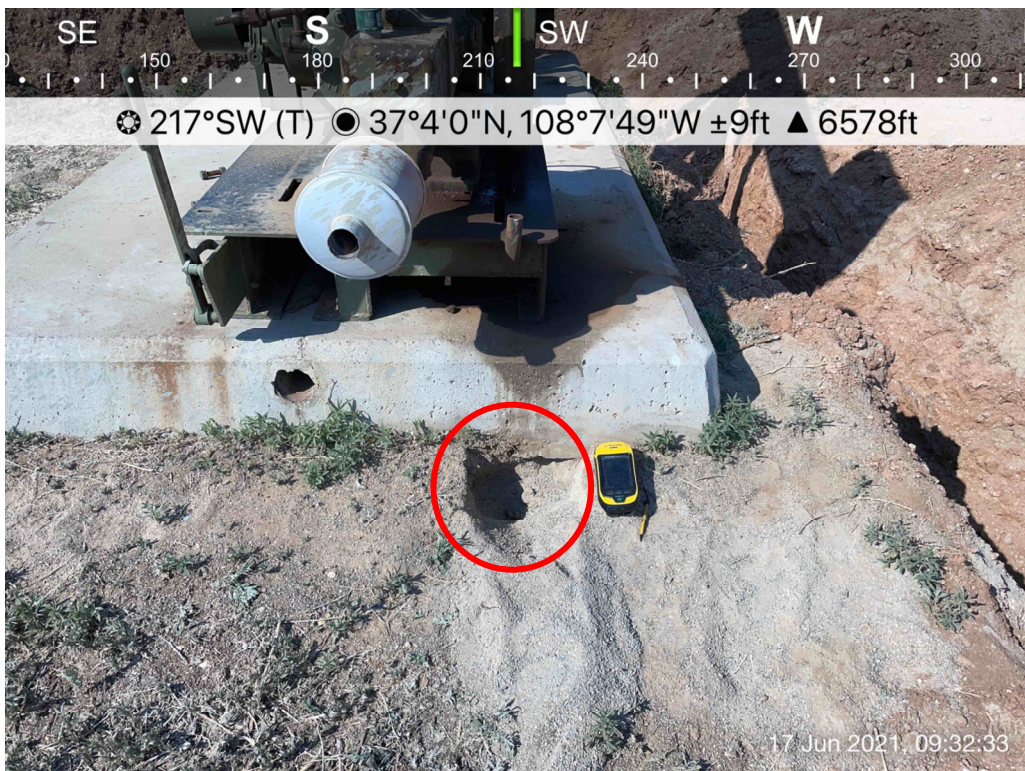
Photo 2: SS02 collected at Ferguson No. 2 (OWP) F-12 pumping unit, 6/17/2021.

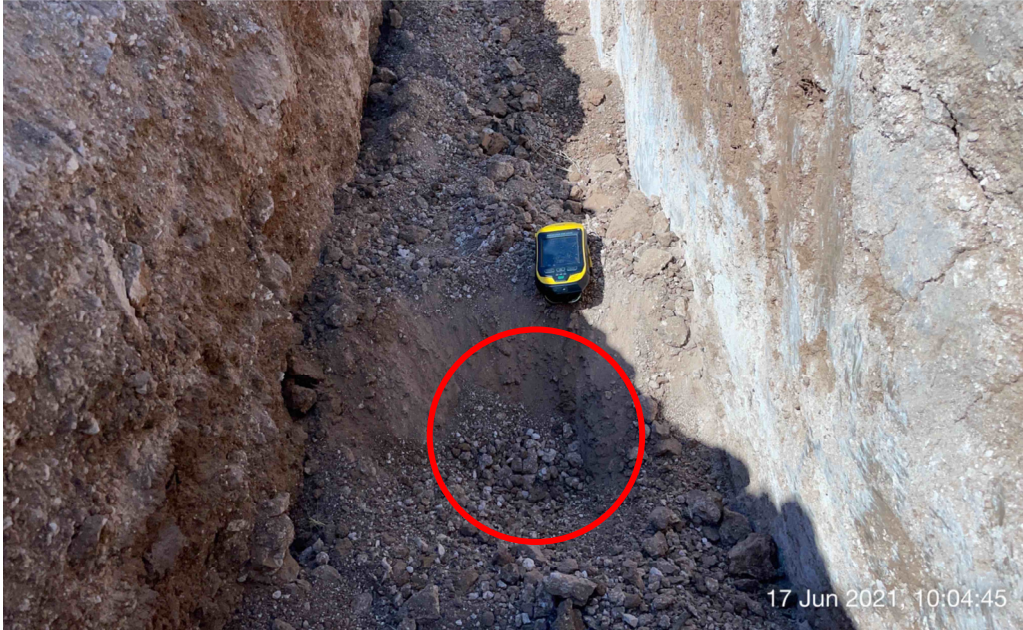
Photo 3: SS03 collected from a flowline segment between wellhead and former meter house at the Ferguson No. 2 (OWP) F-12, 6/17/2021.

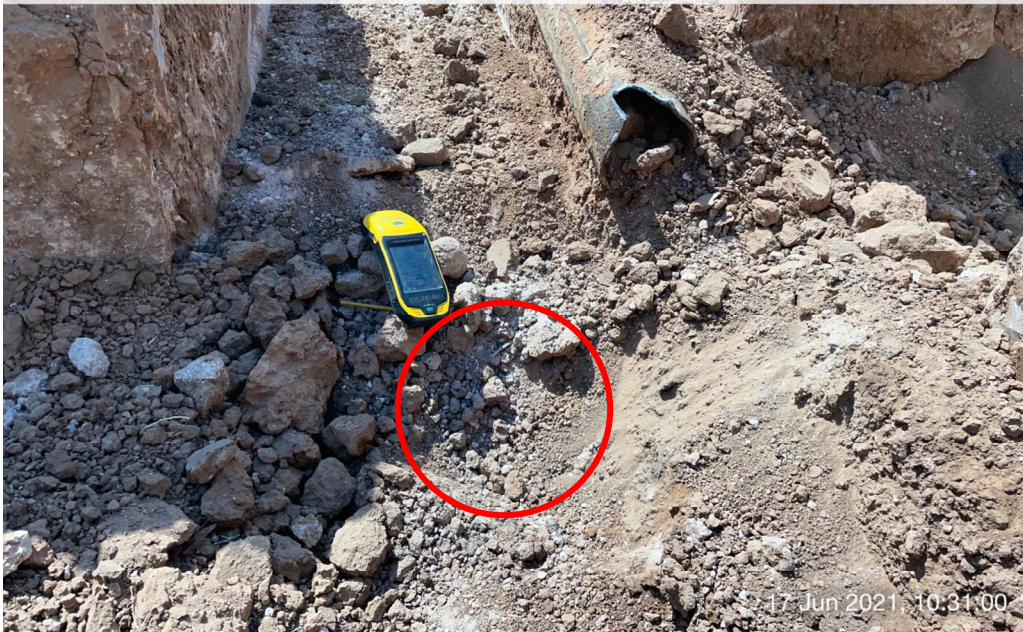
Photo 4: SS04 collected a flowline segment at the Ferguson No. 2 (OWP) F-12, 6/17/2021.

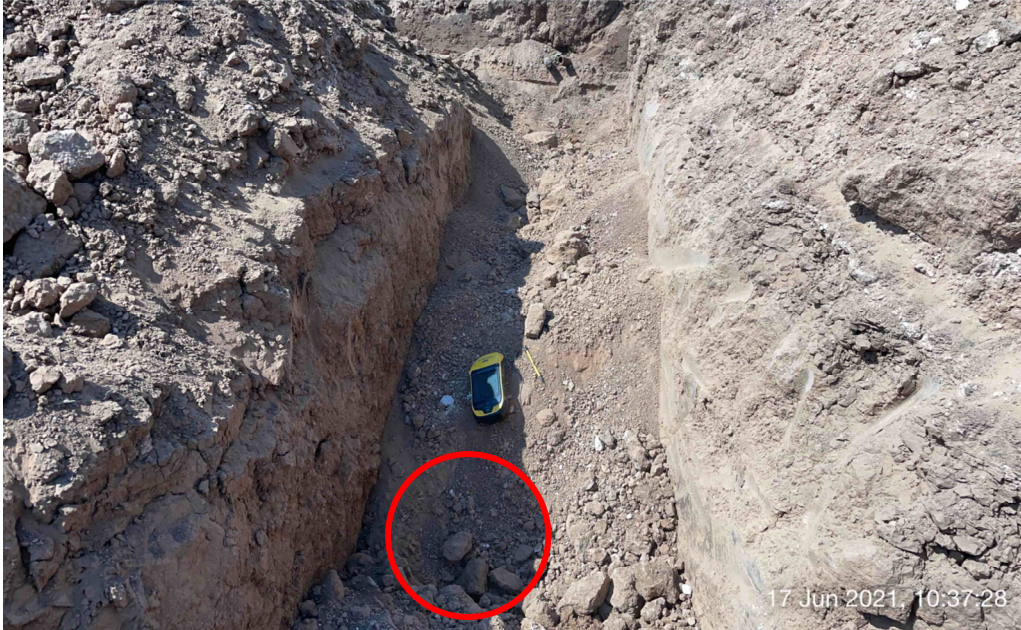
Photo 5: SS05 collected from a flowline segment at the Ferguson No. 2 (OWP) F-12, 6/17/2021.

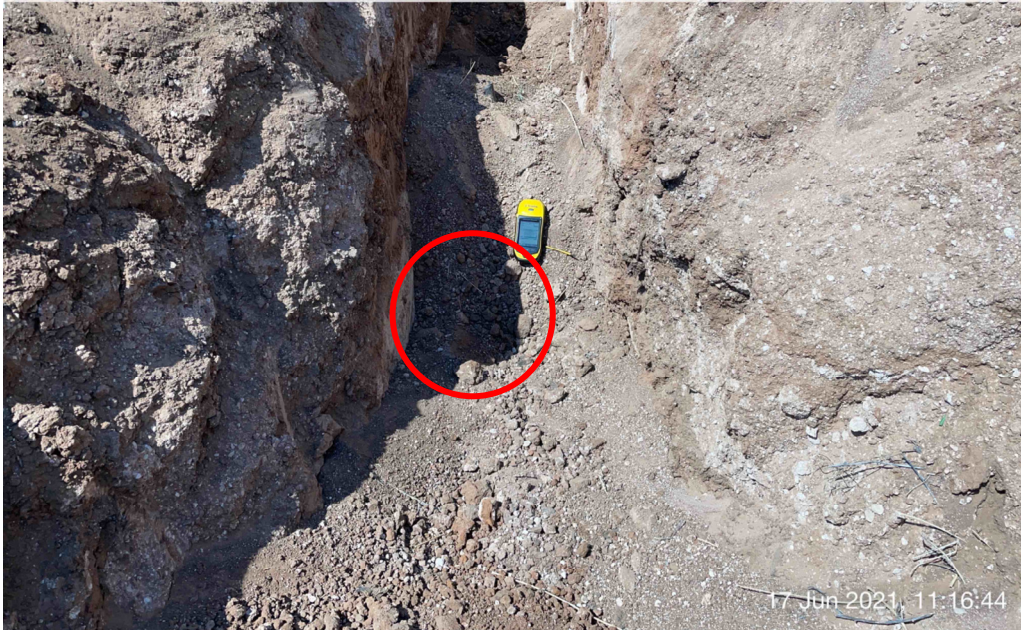
Photo 6: SS06 collected beneath former meter house at the Ferguson No. 2 (OWP) F-12, 6/17/2021.

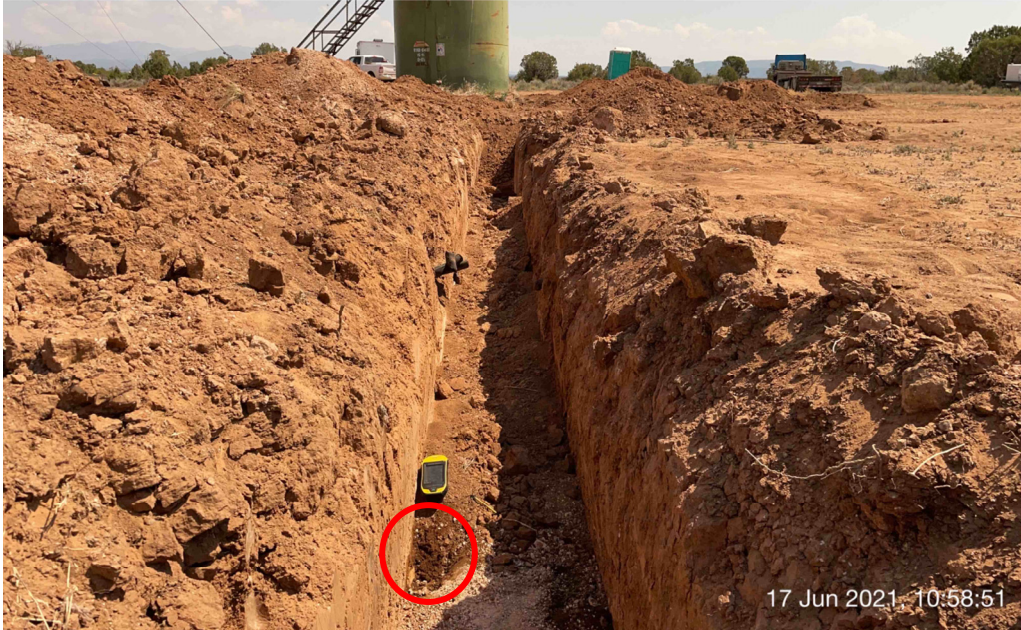
Photo 7: SS07 collected from a flowline segment at the Ferguson No. 2 (OWP) F-12, 6/17/2021.

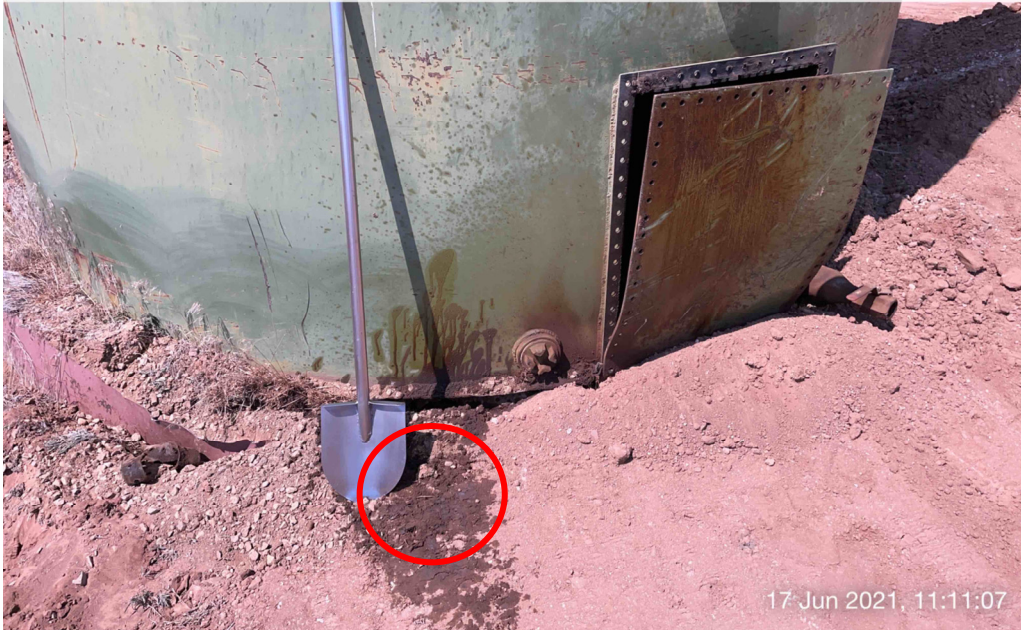
Photo 8: SS08 collected adjacent to AST manway at the Ferguson No. 2 (OWP) F-12, 6/17/2021.

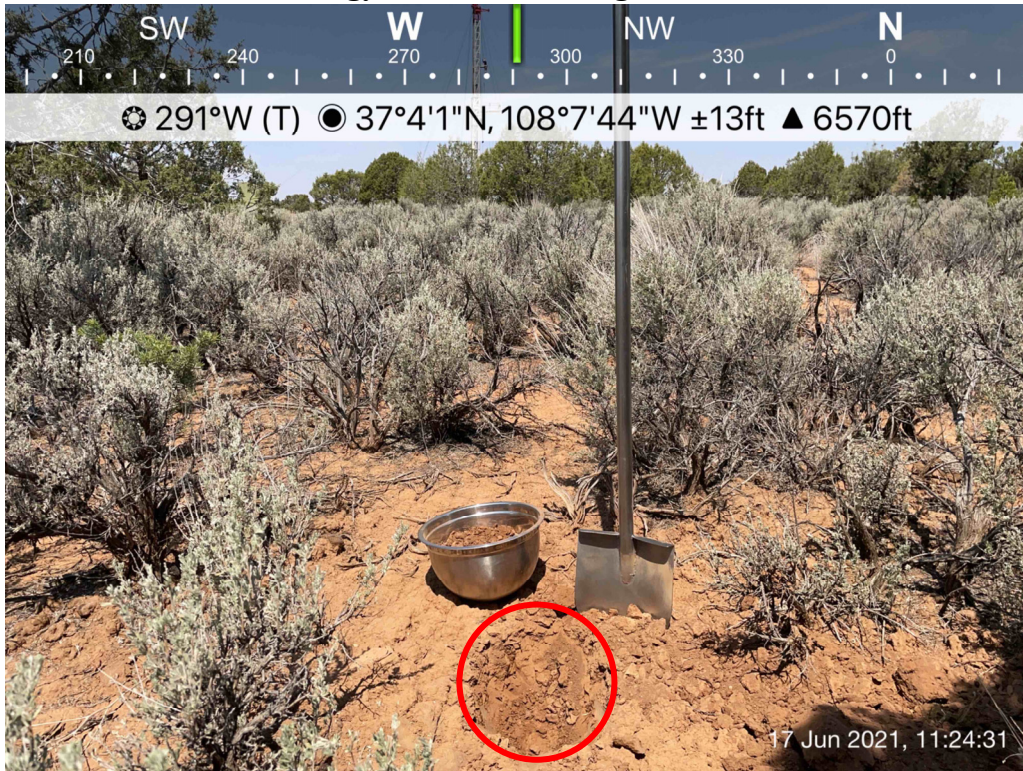
Photo 9: SS09 collected as a background sample in an undisturbed area off-location at the Ferguson No. 2 (OWP) F-12, 6/17/2021.

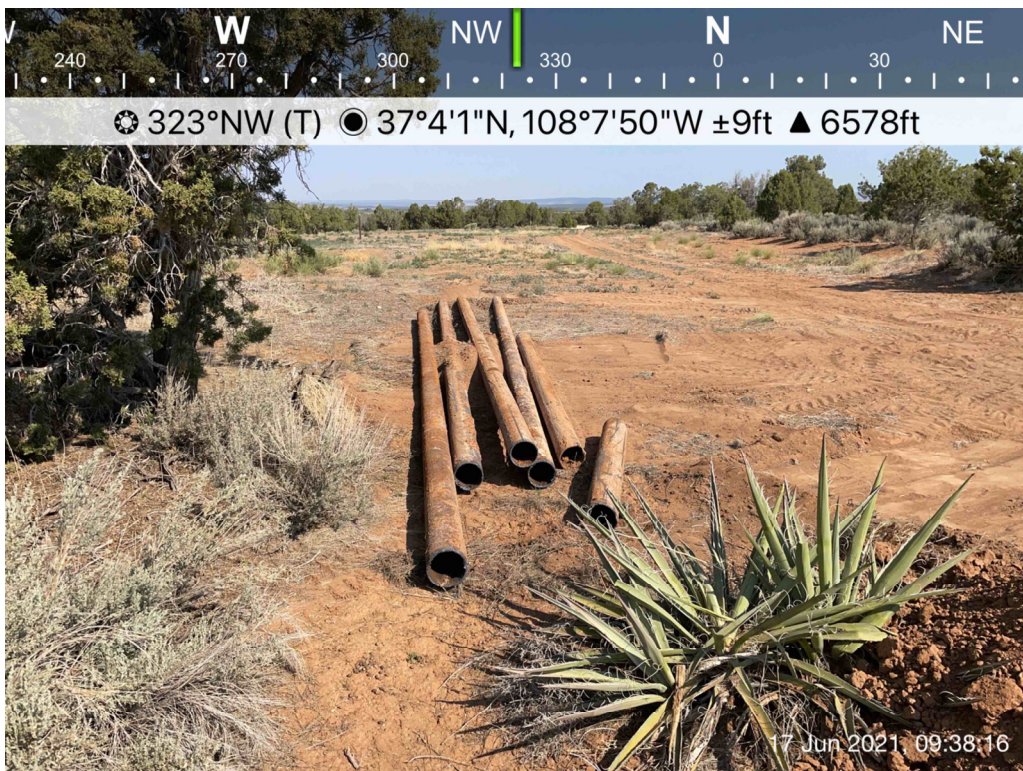
Photo 10: Removed flowlines at the Ferguson No. 2 (OWP) F-12, 6/17/2021.

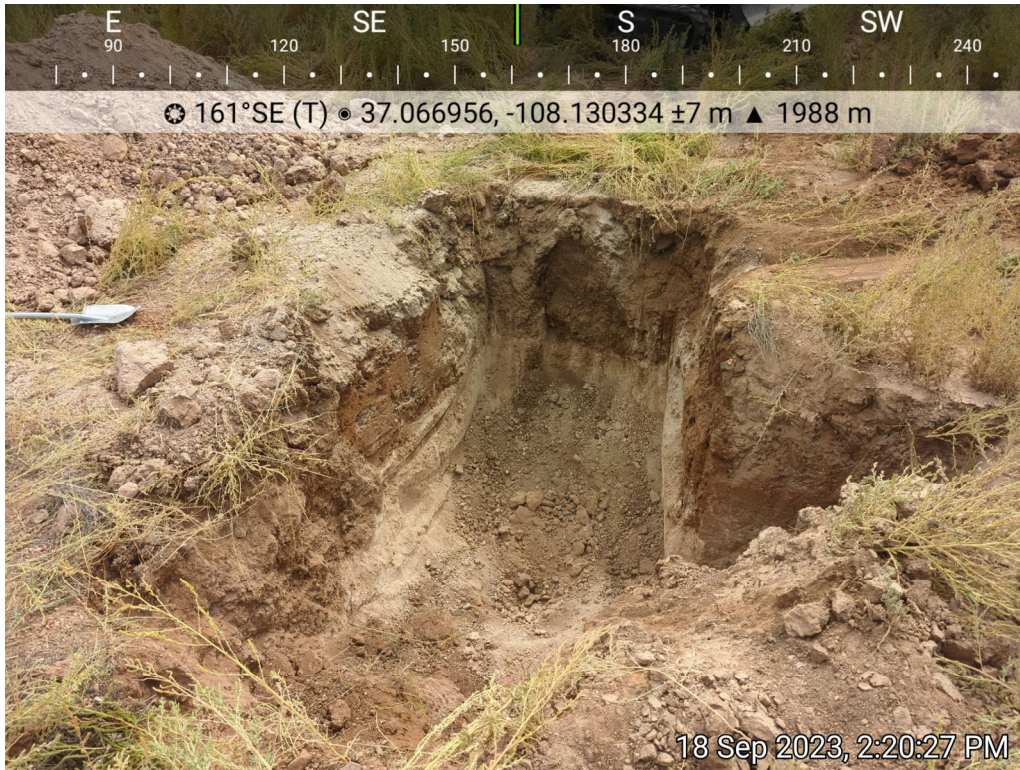
Photo 11: Flowline excavation area, 9/18/2023.

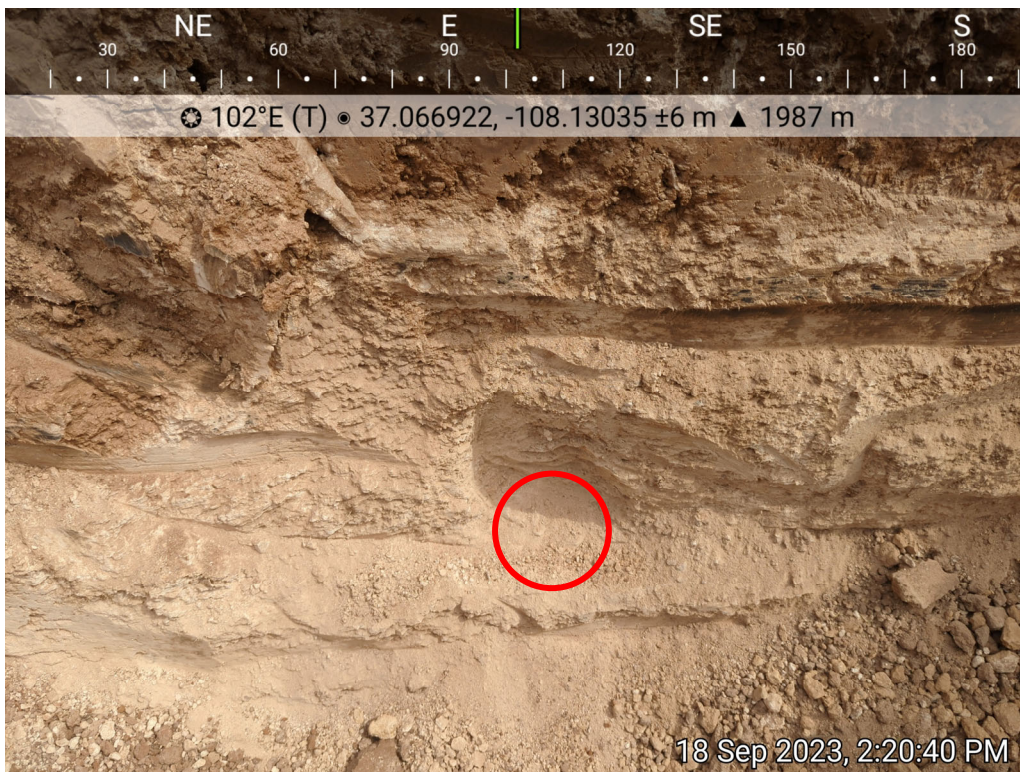
Photo 12: SS10 collected from east sidewall of flowline excavation area, 9/18/2023.

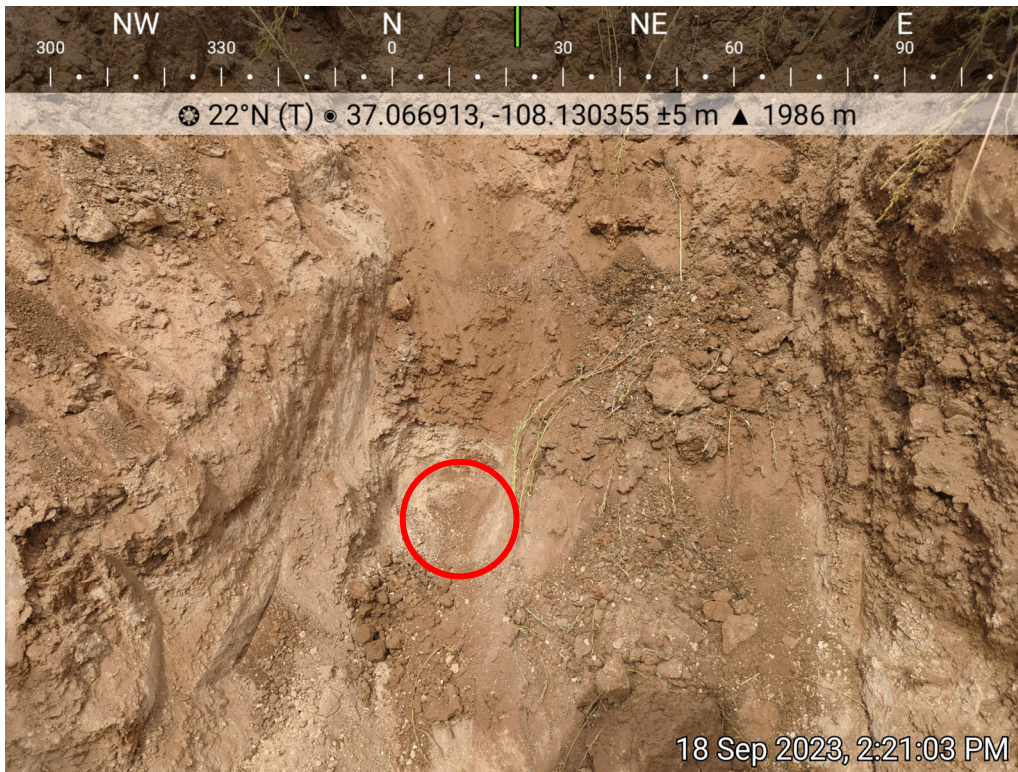
Photo 13: SS11 collected from north sidewall of flowline excavation area, 9/18/2023.

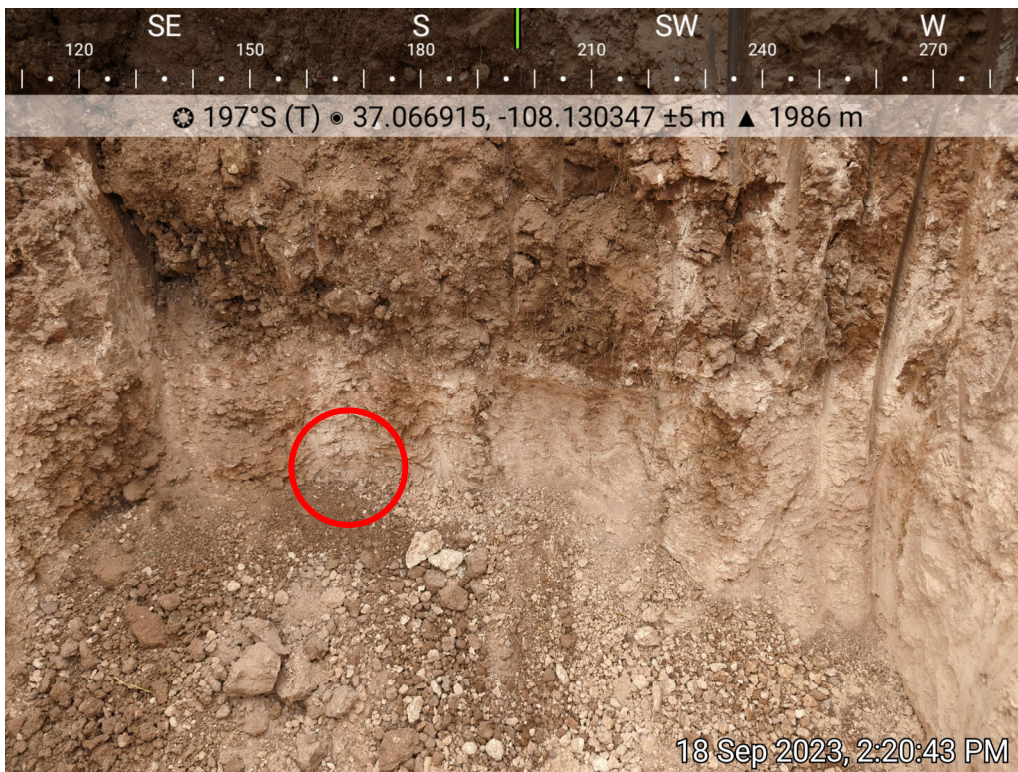
Photo 14: SS12 collected from south sidewall of flowline excavation area, 9/18/2023

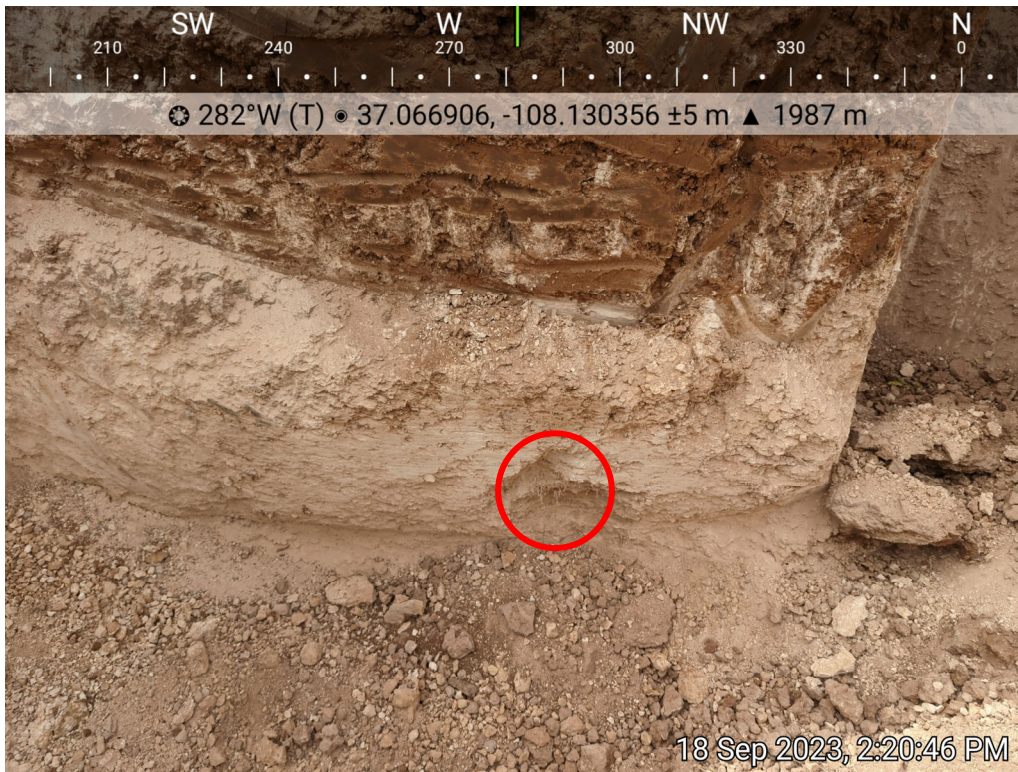
Photo 15: SS13 collected from west sidewall of flowline excavation area, 9/18/2023.

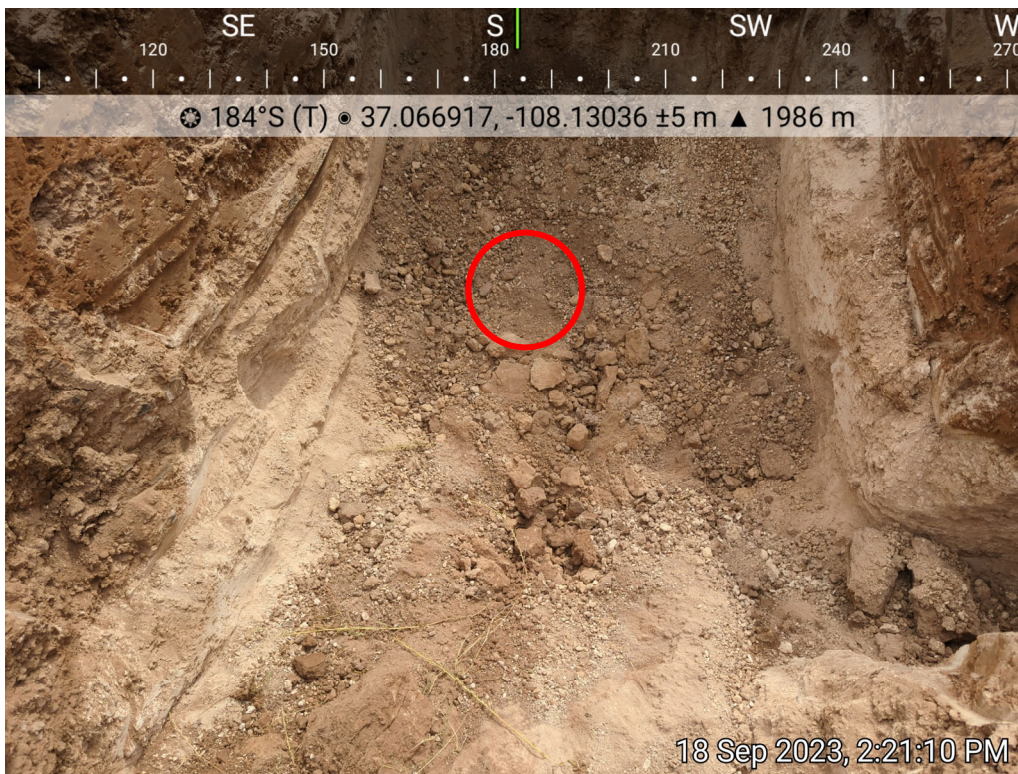
Photo 16: SS14 collected from base of flowline excavation area, 9/18/2023.

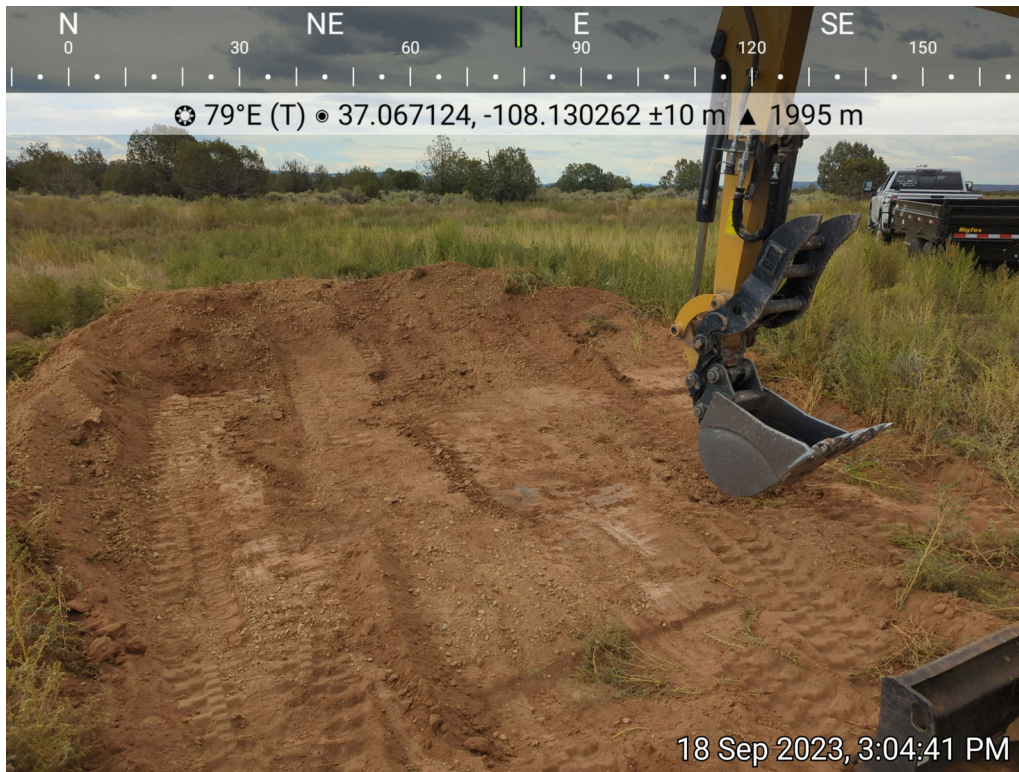
Photo 17: AST excavation area, 9/18/2023.

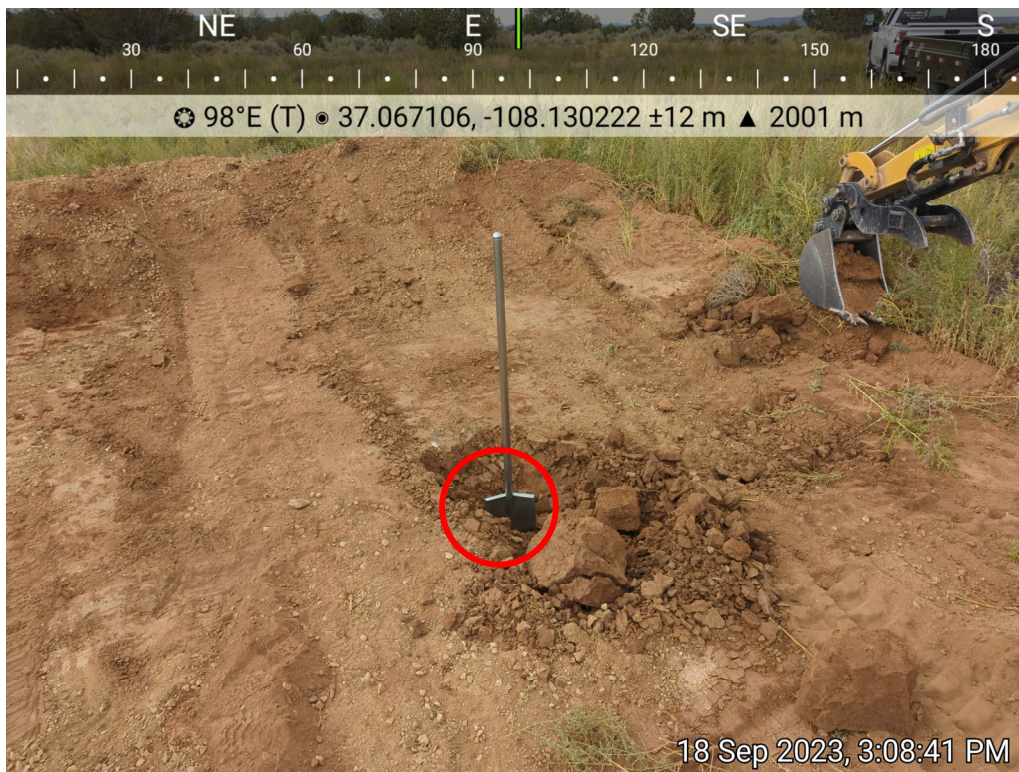
Photo 18: SS15 collected from pothole in the center of AST excavation area, 9/18/2023.

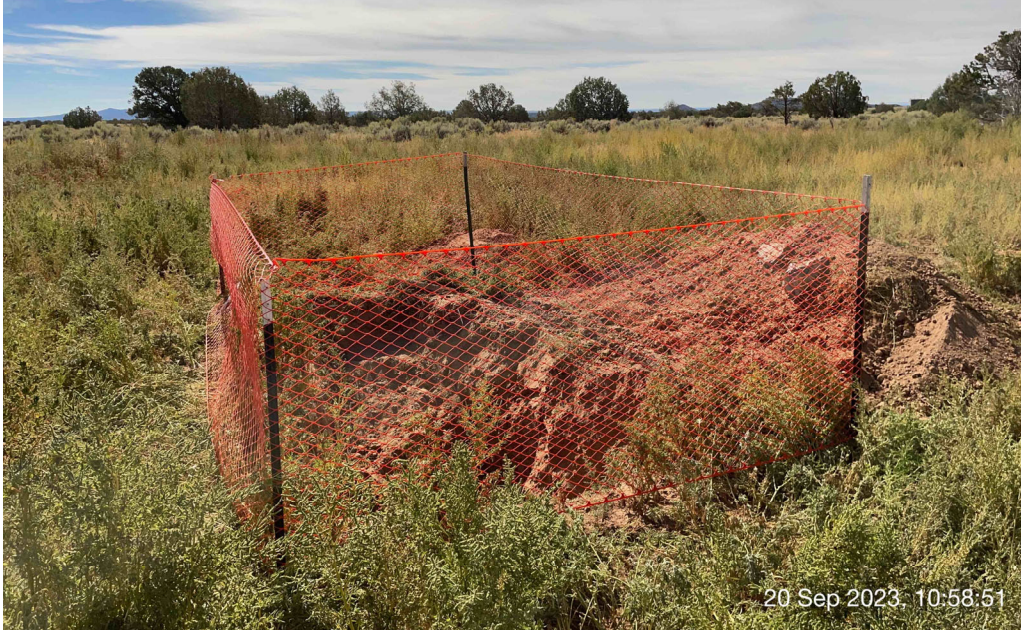
Photo 19: Wellhead excavation area, 9/20/2023.

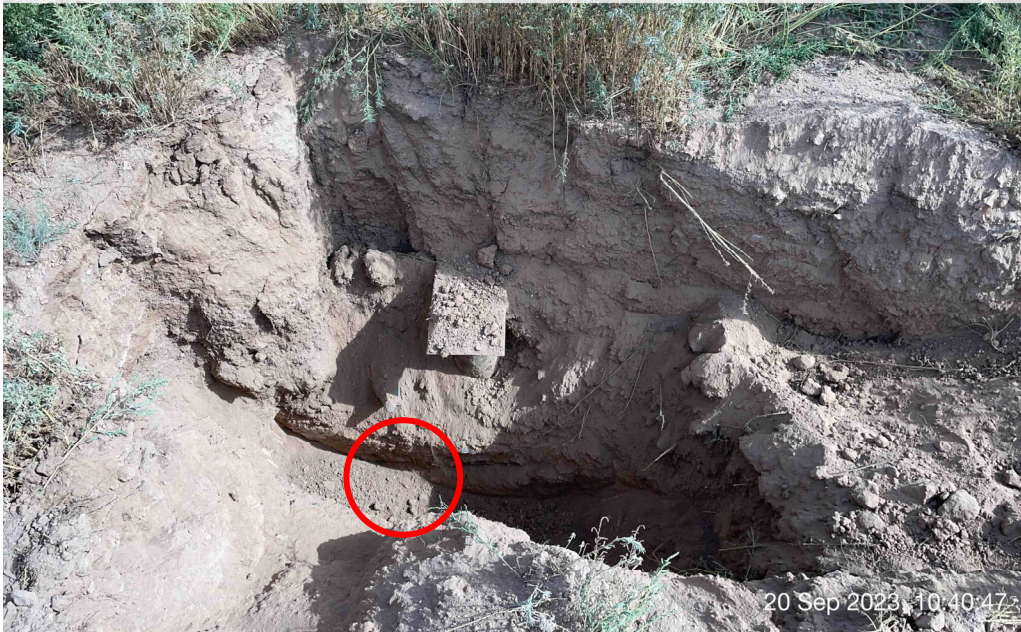
Photo 20: SS09 collected from base of wellhead excavation area, 9/20/2023.
