Inspection Photos

Location Name: CAERUS PICEANCE LLC N. PARACHUTE EF03B19 D19A 595 Pad

Location # 335905

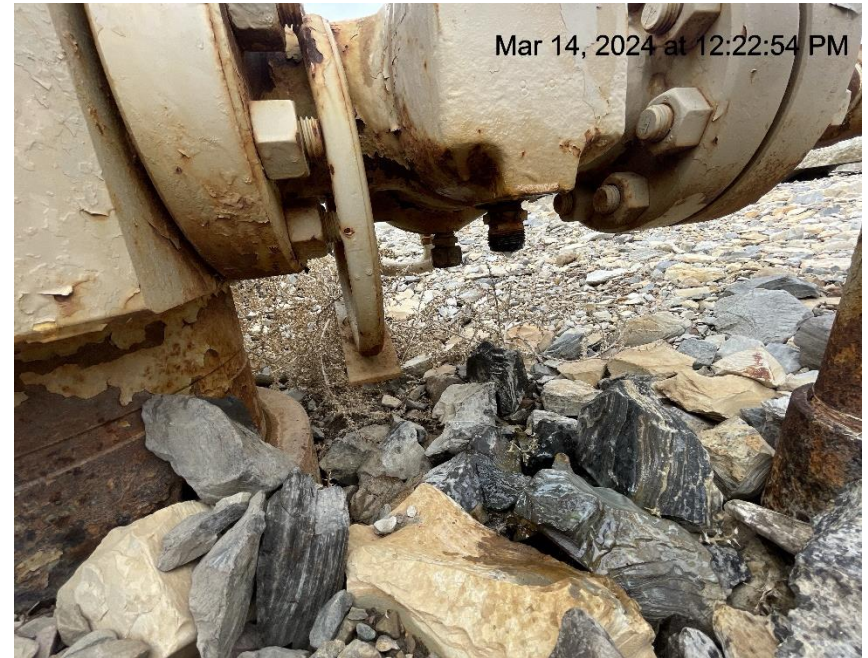
Photo # 85 Mechanical Condition - Casing valve on EF03B-19 well leaking fluid & gas

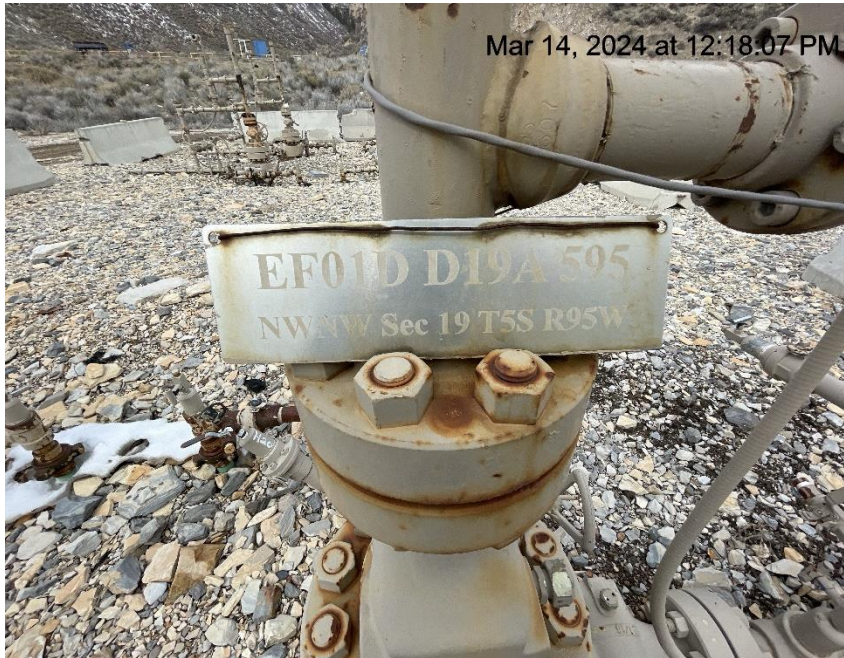
Photo # 86 Wellhead signs lack required info

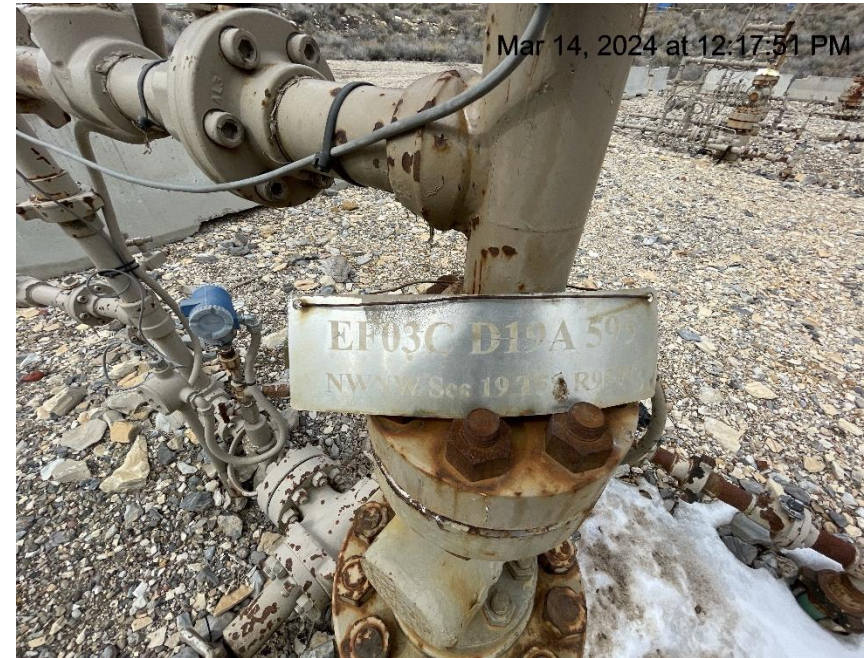
Photo # 87 Wellhead signs lack required info

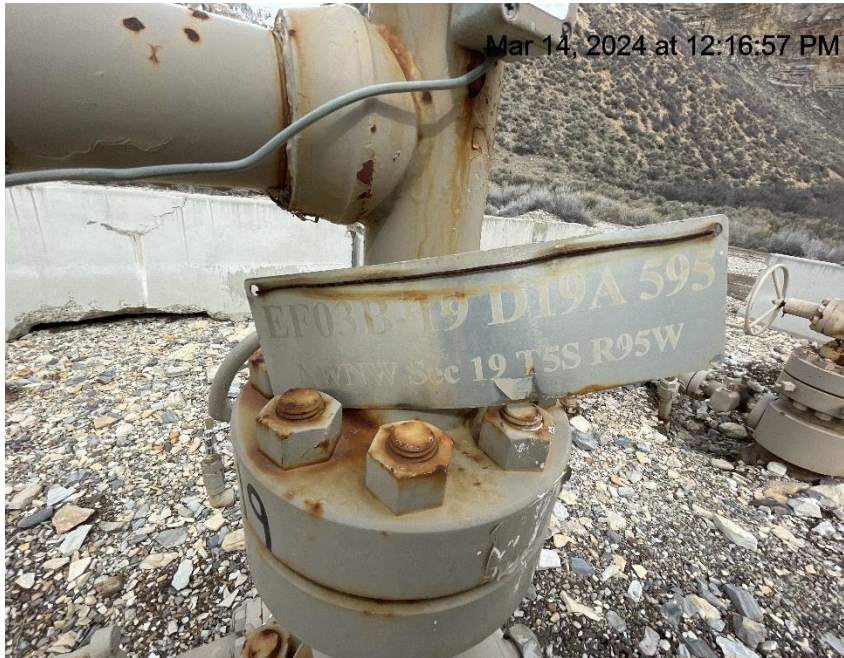
Photo # 88 Wellhead signs lack required info

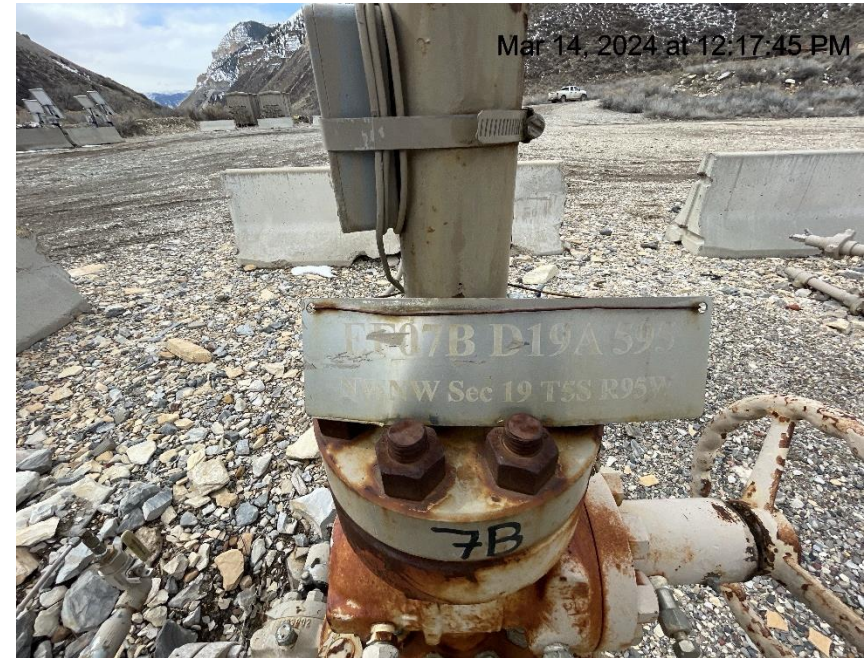
Photo # 89 Wellhead signs lack required info
