Final Reclamation Inspection

March 12th, 2024

Operator: Simcoe LLC - 10749

Location ID: 307017

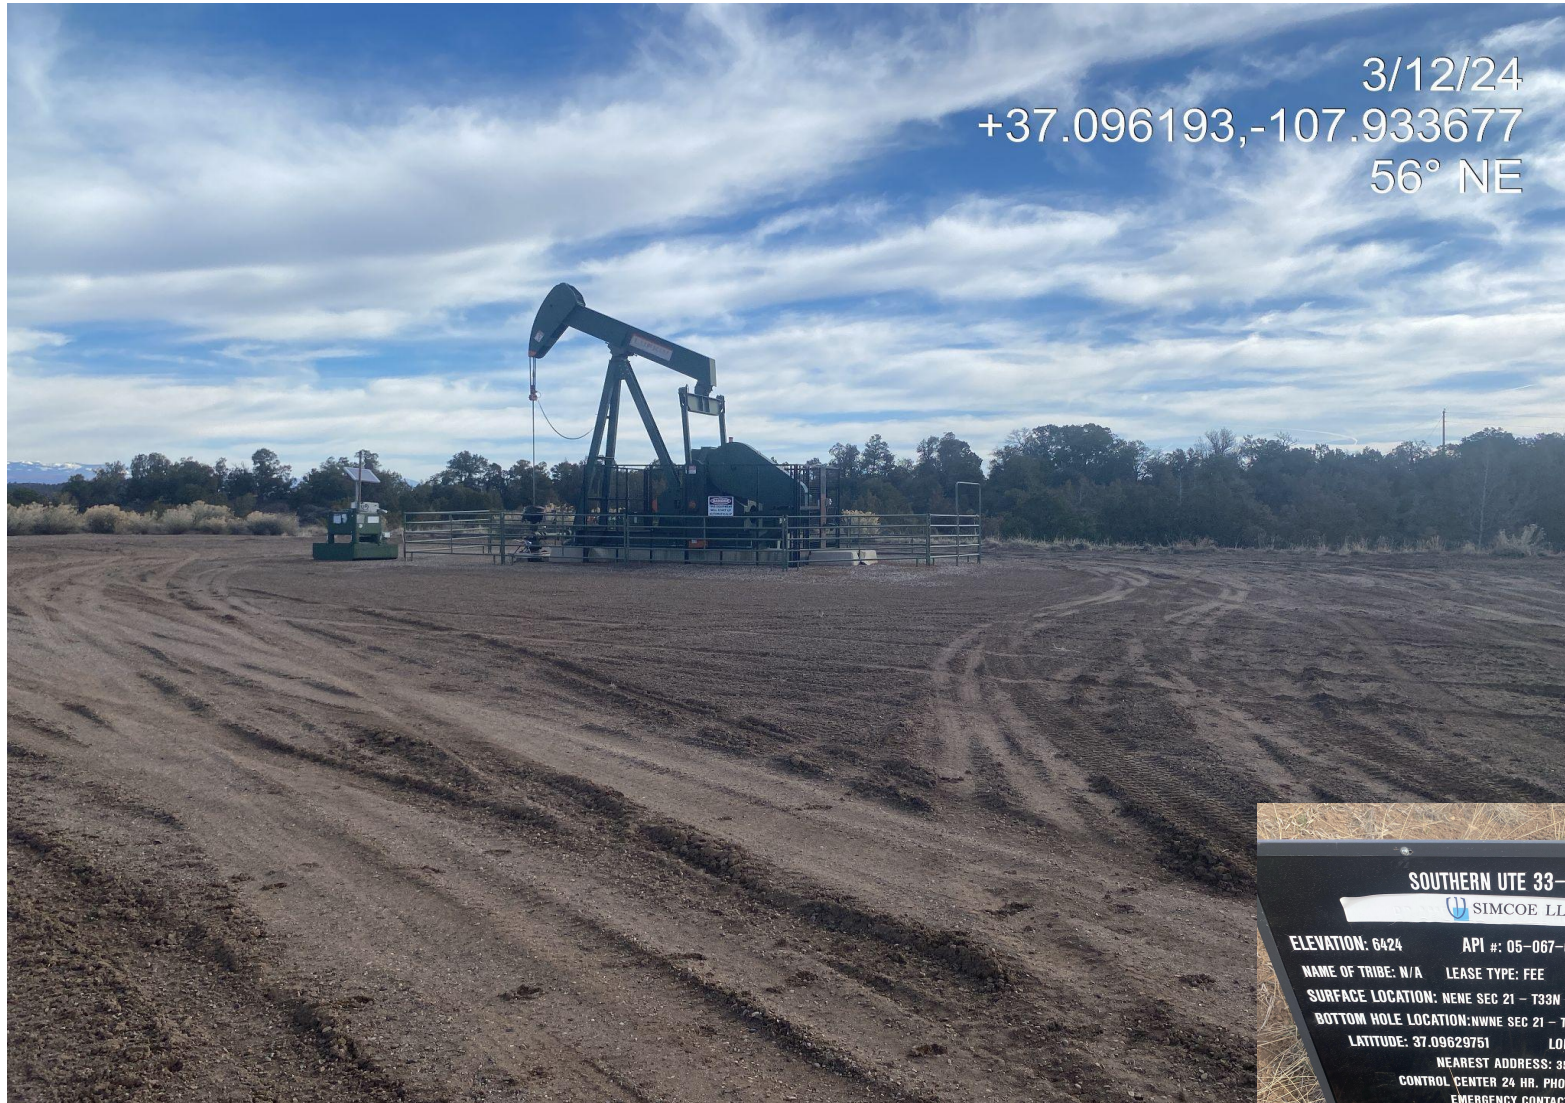
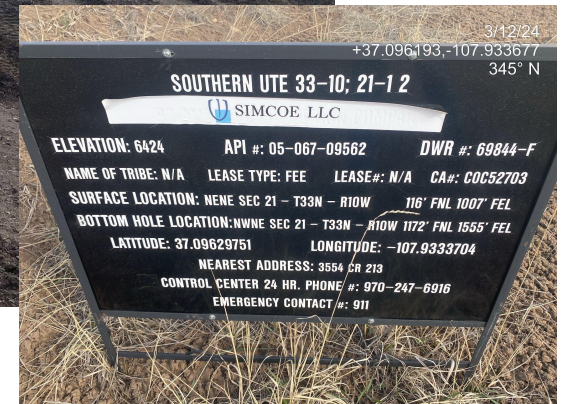
Photo 1. Overview of the disturbance taken from the entrance facing center.

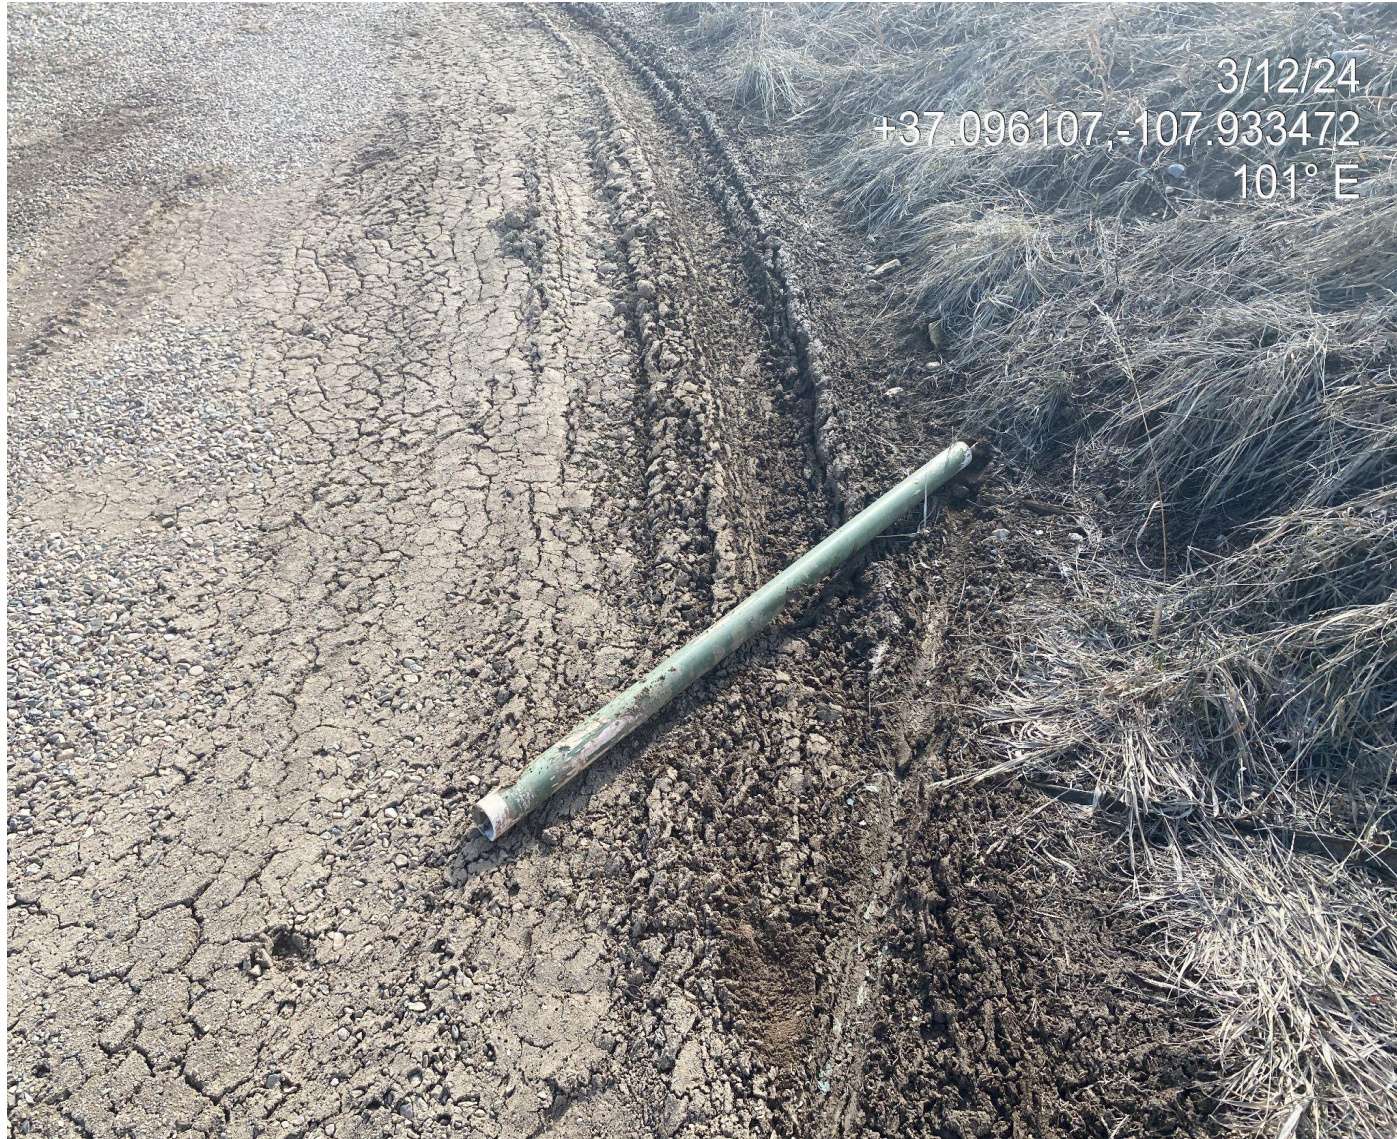
Photo 2. Trash/debris observed on location.

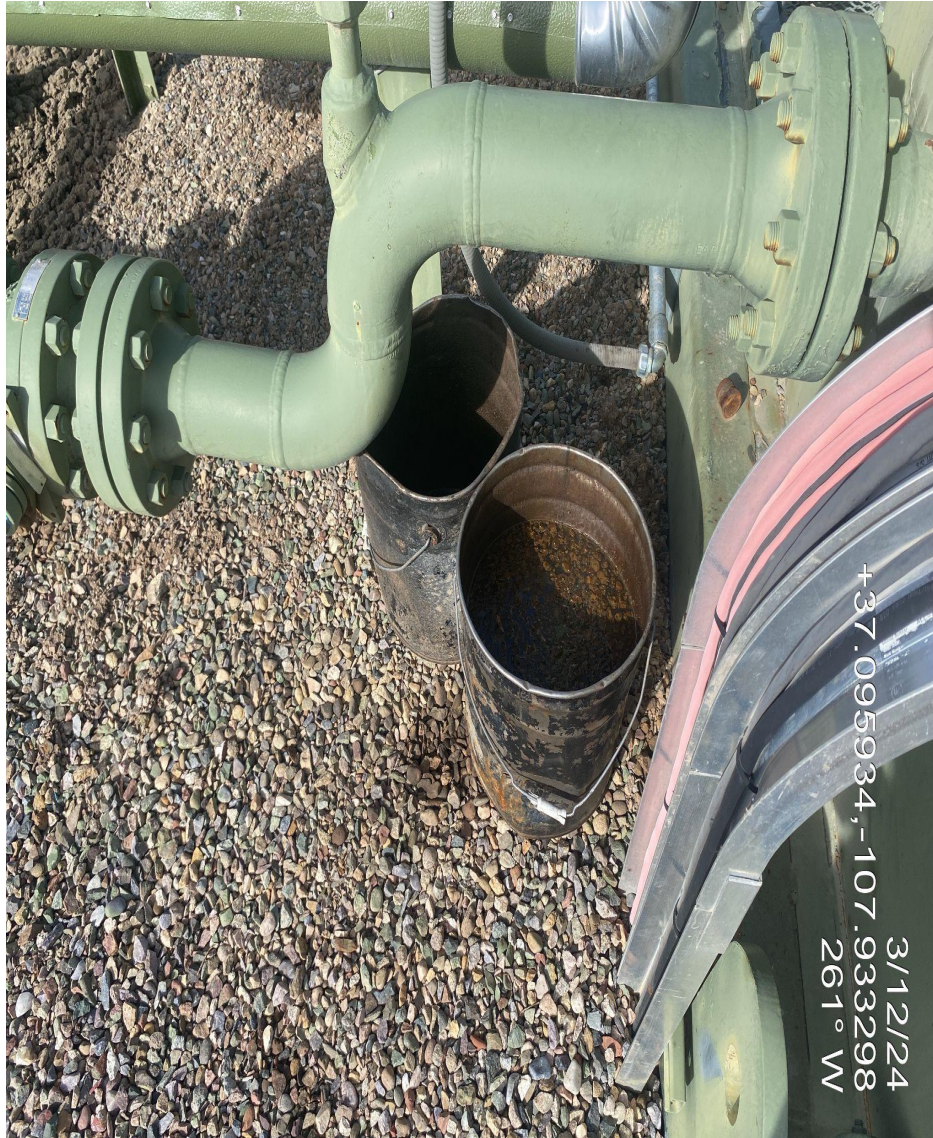
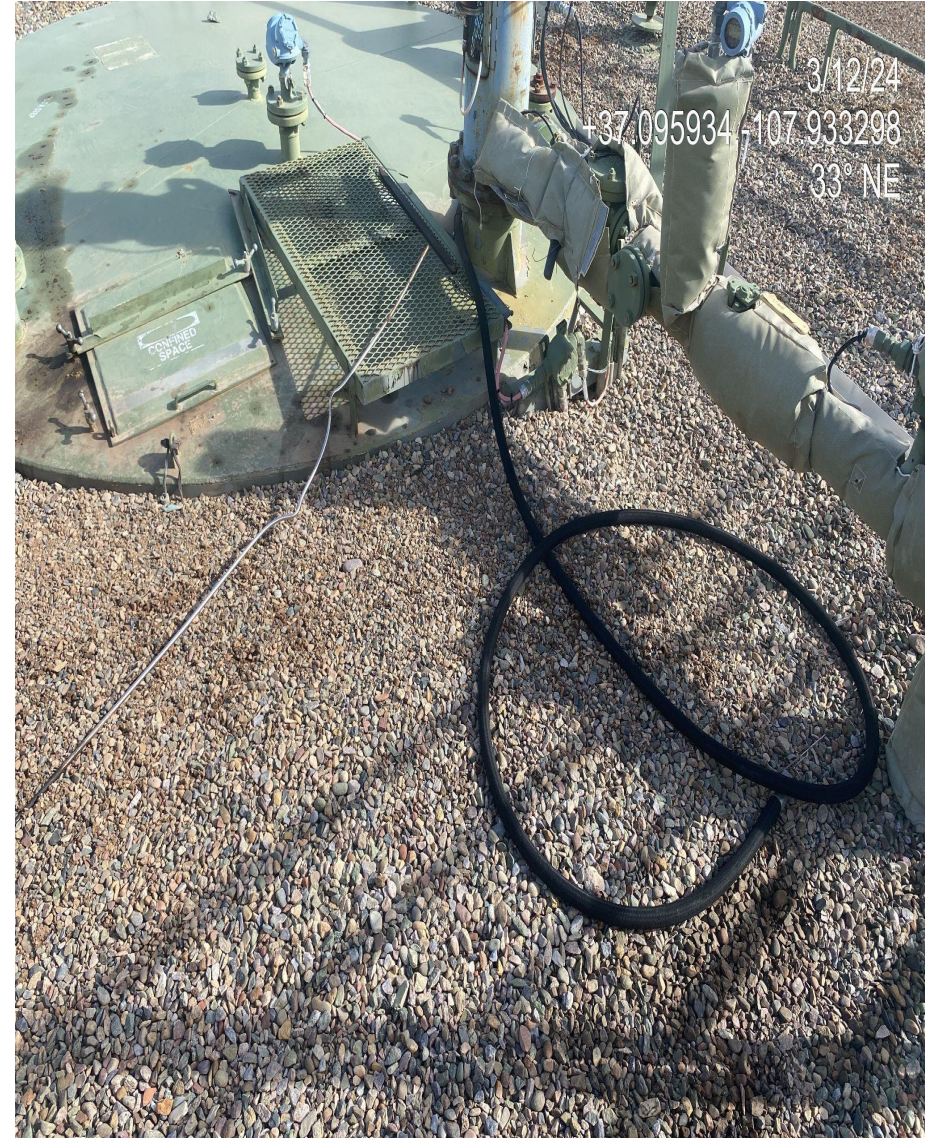
Photo 3. Unused oil and gas equipment observed on location.

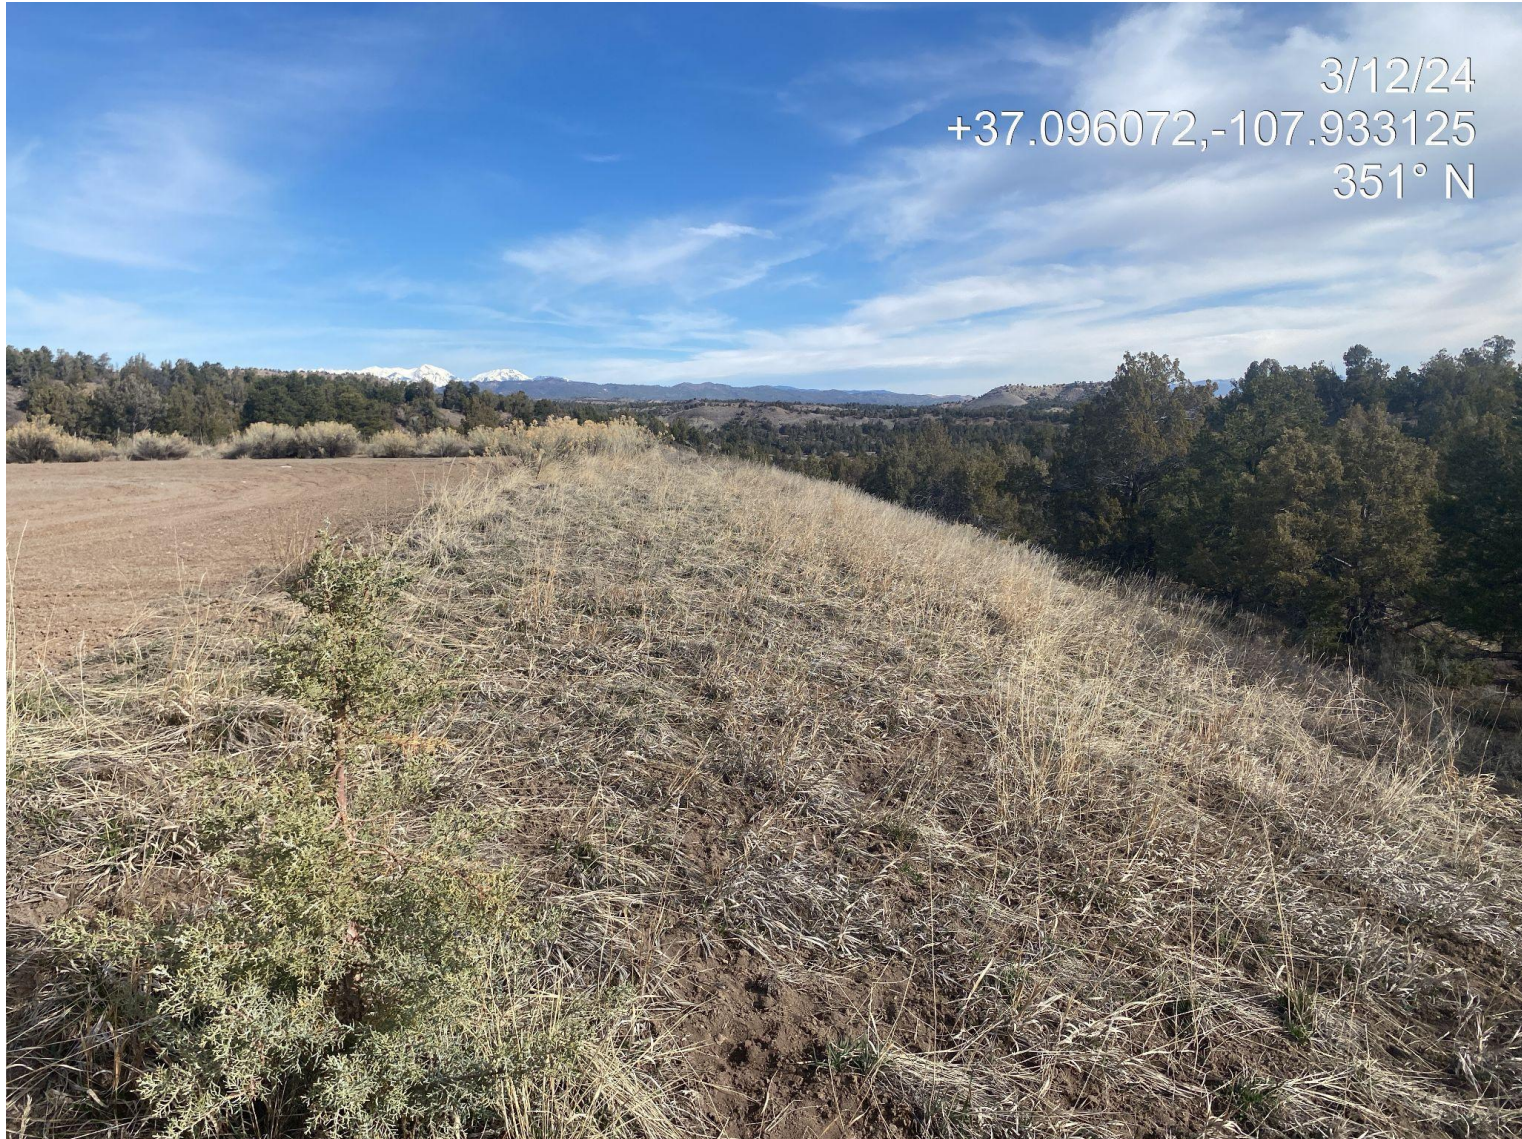
Photo 4. View of eastern interim reclamation area facing north. Vegetation comprised of smooth brome and rabbitbrush.

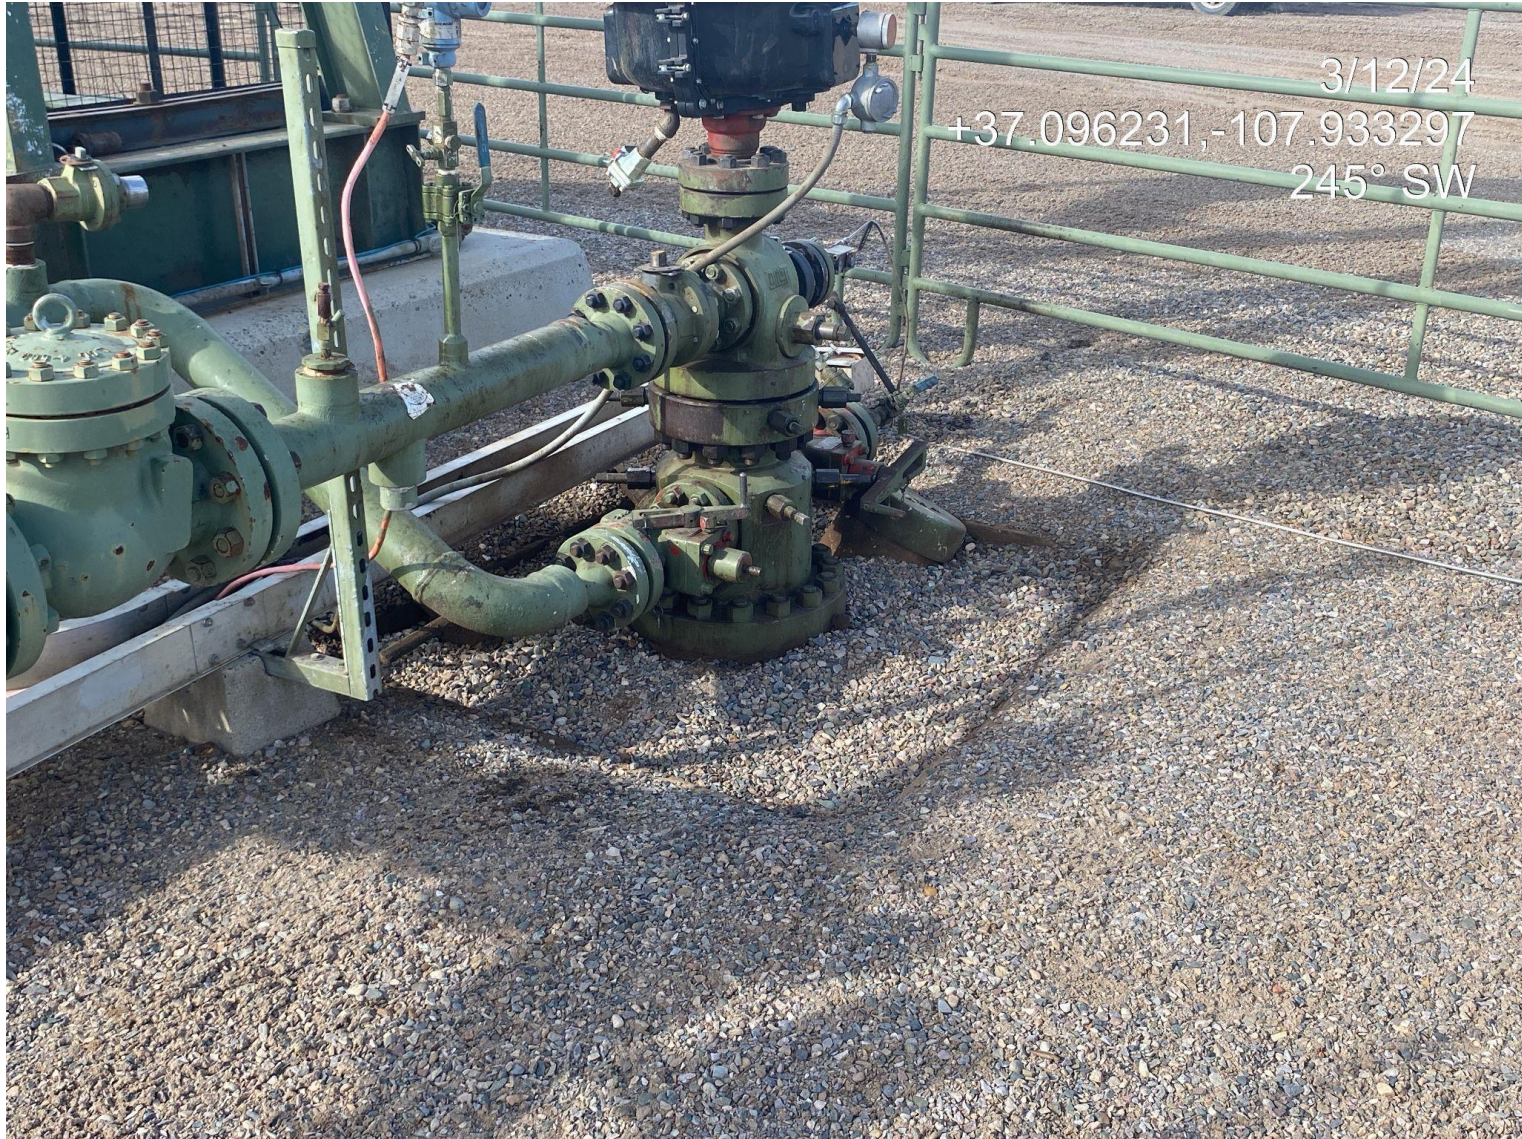
Photo 5. Impacted material at well head corrective action identified in the previous inspection doc #712700262 has been addressed/resolved.

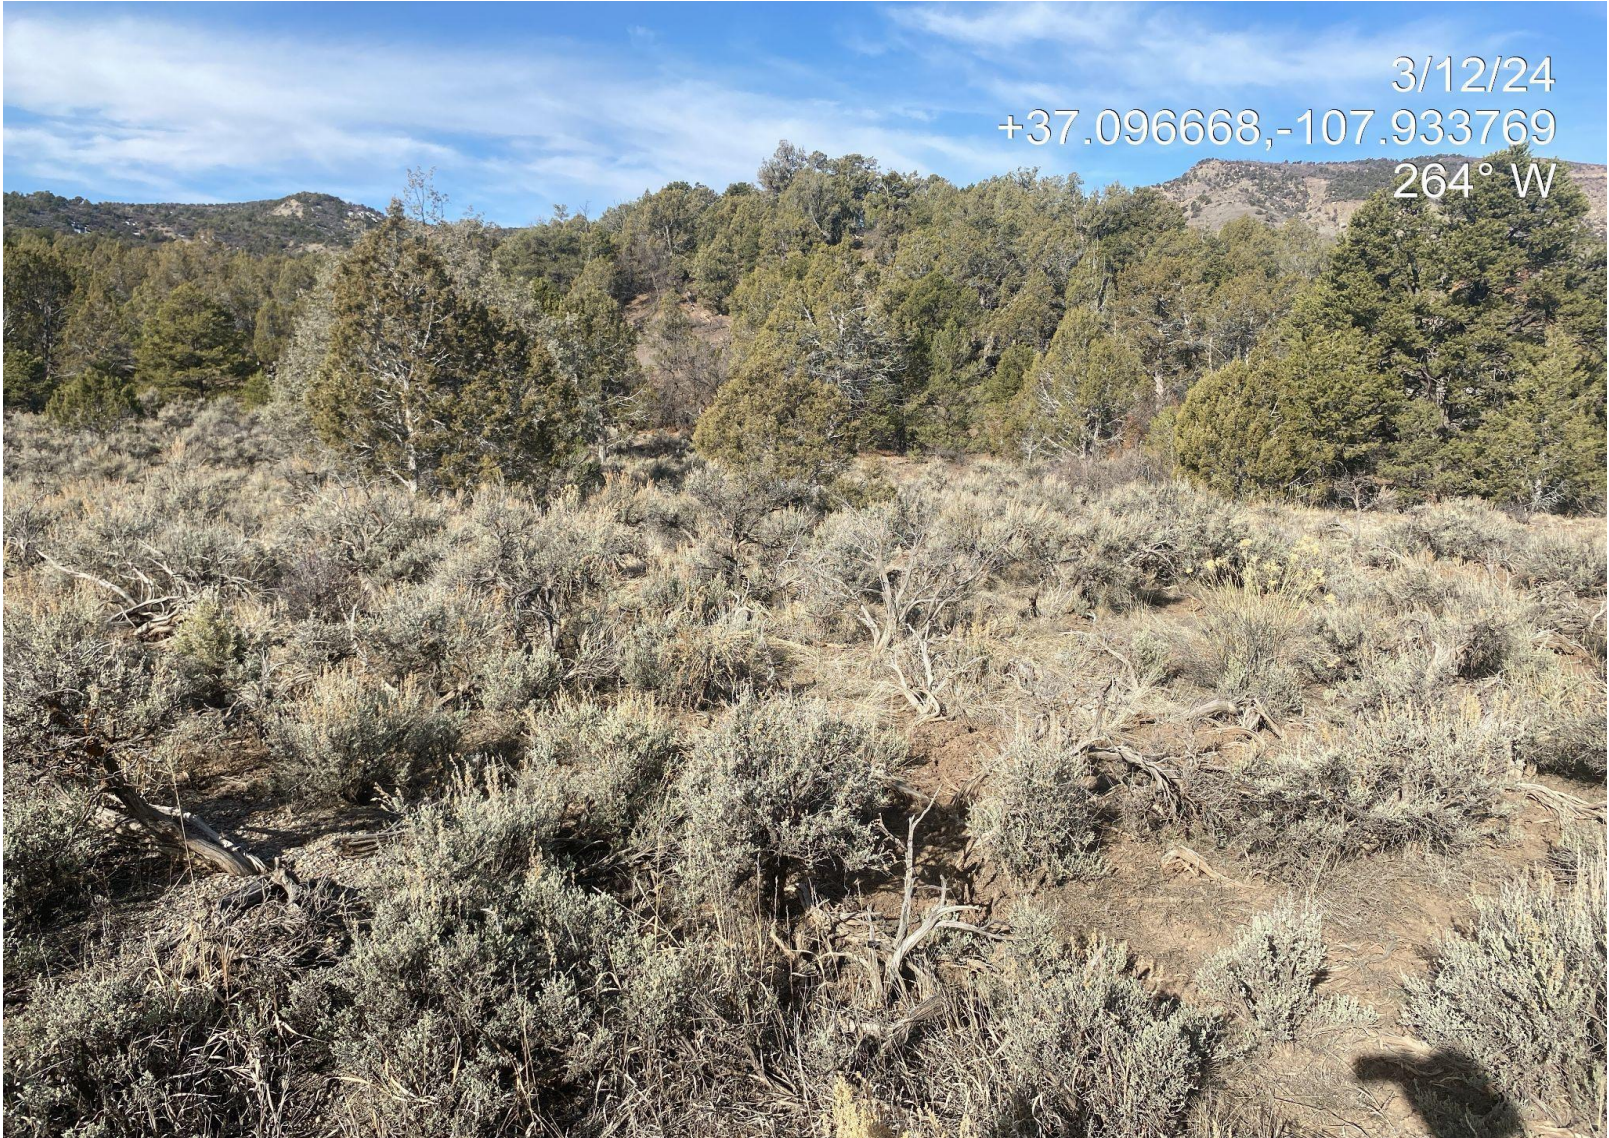
Photo 6. Reference area comprised of Smooth brome, Rabbit brush and sage brush.
