Final Reclamation and Stormwater Inspection

March 4, 2024

Operator: Western Operating Company- #95620

Location ID: 319767

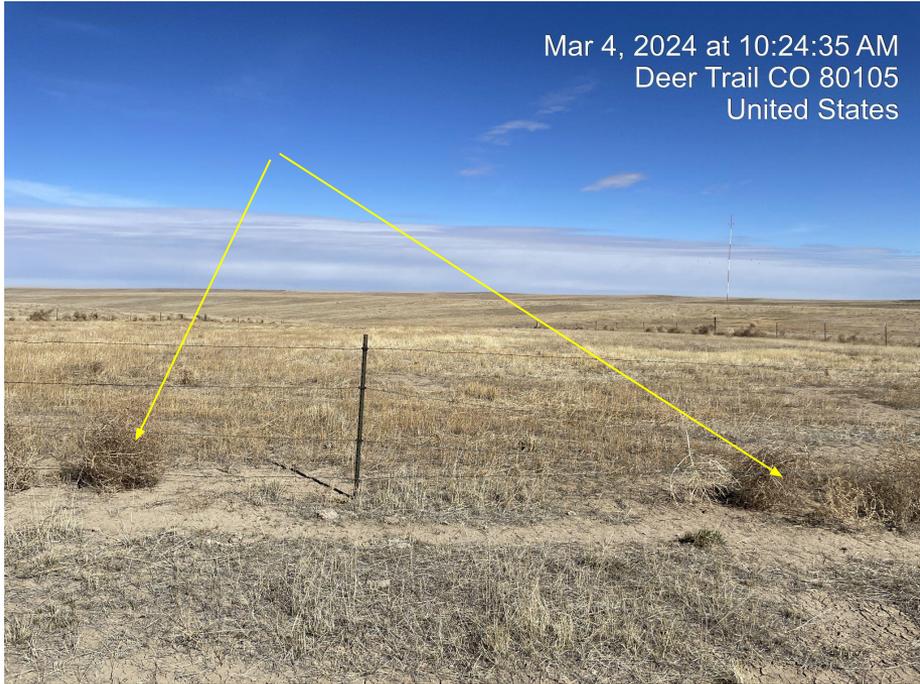
Photo 1. Photo taken facing northeast of perimeter fence of reclamation area. The reclaimed area has been mowed, Russian thistle debris was observed in the fence. Weed debris indicated by yellow arrow.

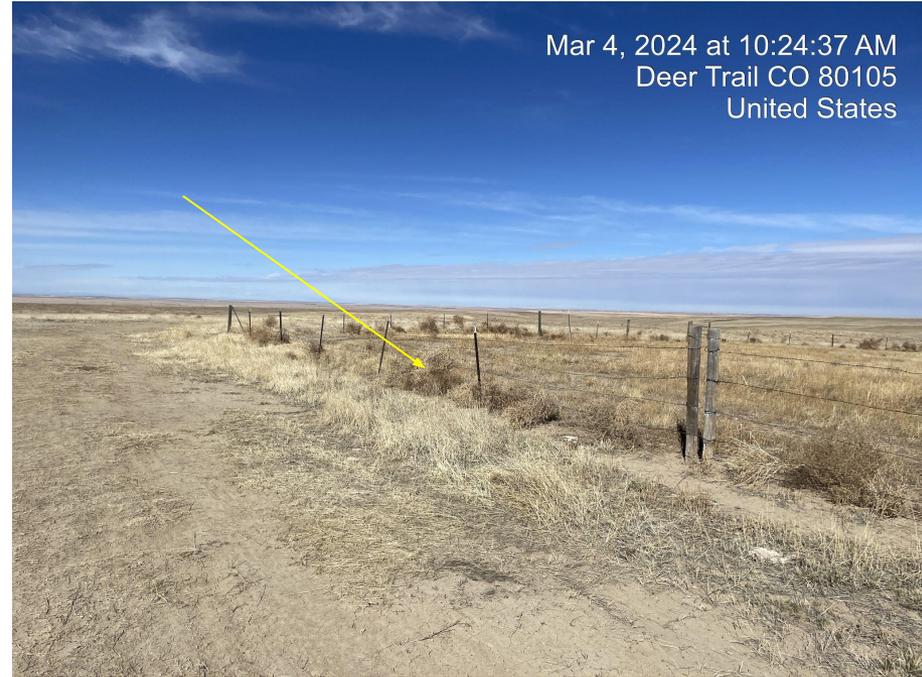
Photo 2. Photo taken facing west of perimeter fence of reclamation area. The reclaimed area has been mowed, Russian thistle debris was observed in the fence. Weed debris indicated by yellow arrow.

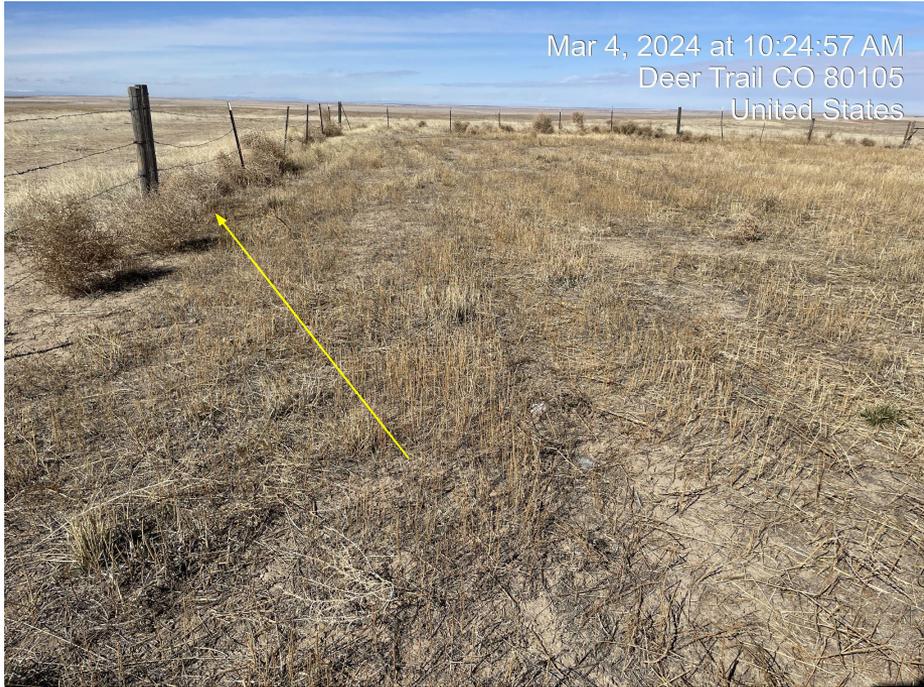
Photo 3. Photo taken facing west of perimeter fence of reclamation area. The reclaimed area has been mowed, Russian thistle debris was observed in the fence. Weed debris indicated by yellow arrow. Perennial vegetation is not apparent.

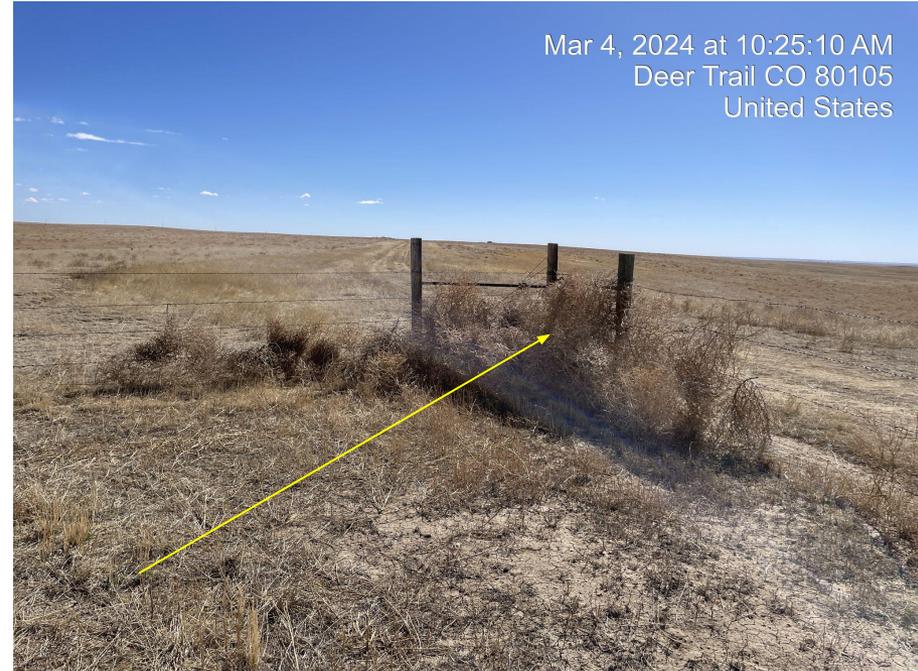
Photo 4. Photo taken facing east of perimeter fence of reclamation area. The reclaimed area has been mowed, Russian thistle debris was observed in the fence. Weed debris indicated by yellow arrow. Perennial vegetation is not apparent.

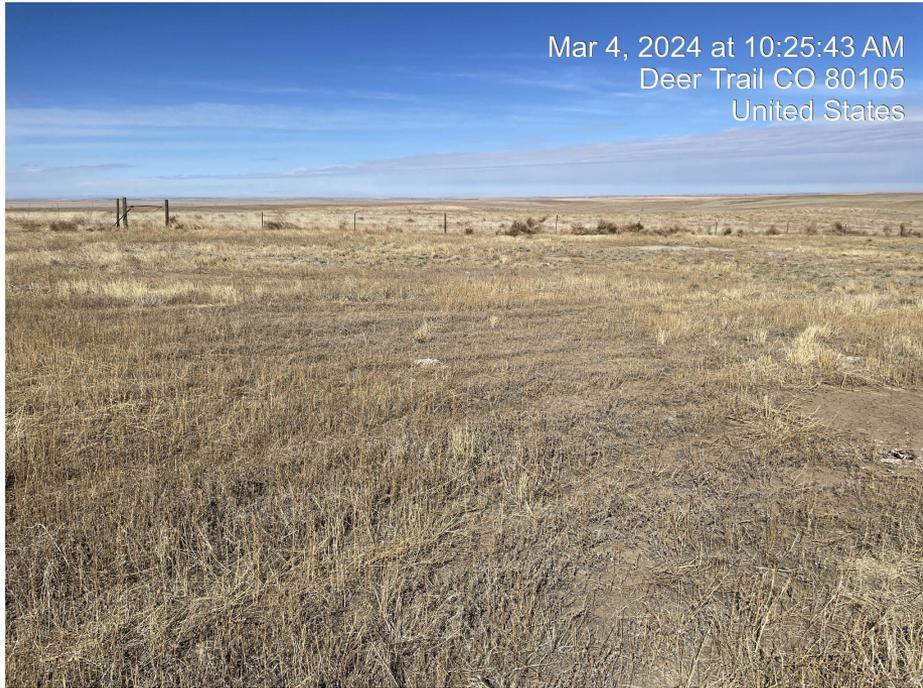
Photo 5. Photo taken facing northwest of mowed vegetation in reclamation area. Perennial vegetation is not apparent.

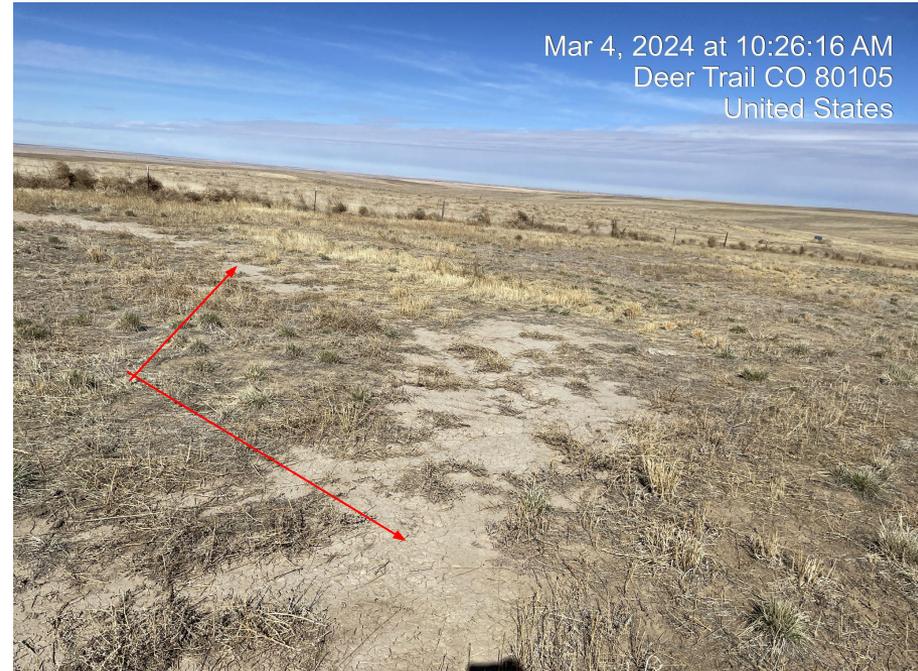
Photo 6. Photo taken facing west of mowed vegetation and bare soil in reclamation area. Red arrow indicates bare soil.

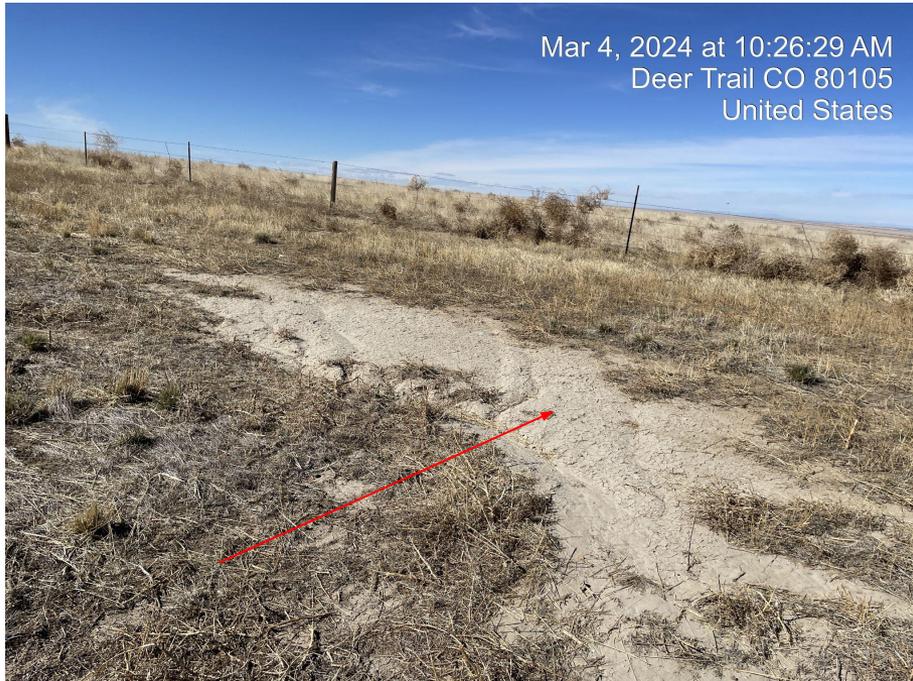
Photo 7. Photo taken facing southwest of mowed vegetation and bare soil in reclamation area. Red arrow indicates bare soil.

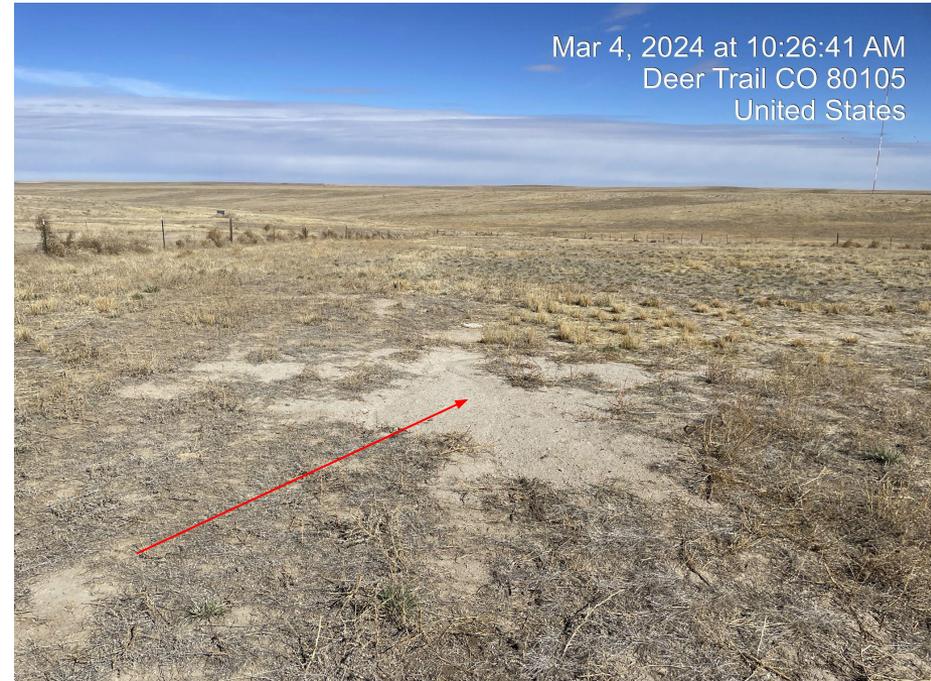
Photo 8. Photo taken facing north of mowed vegetation and bare soil in reclamation area. Red arrow indicates bare soil.

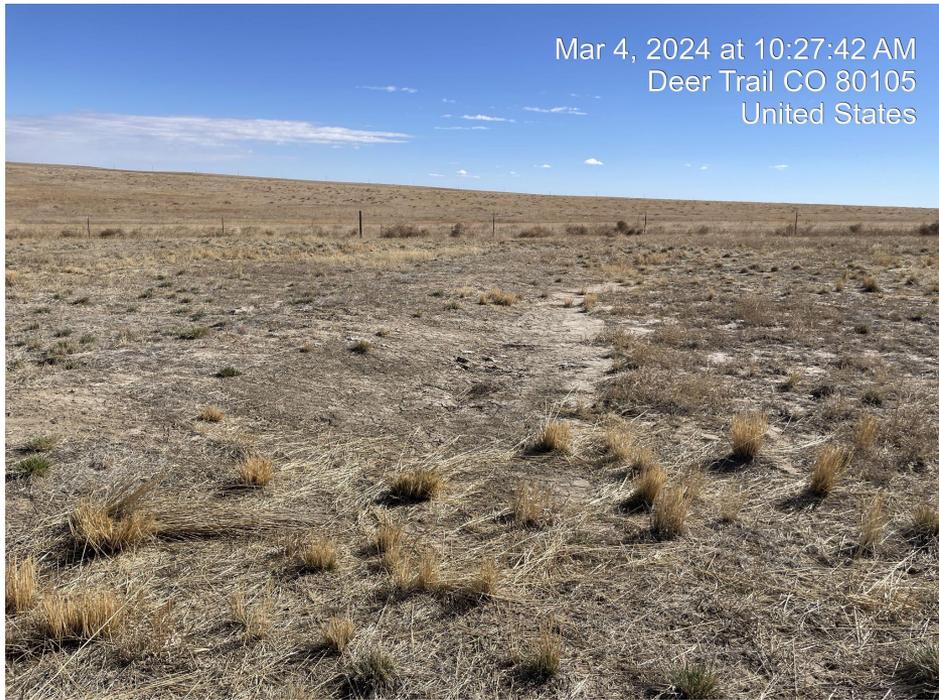
Photo 9. Photo taken facing northwest of mowed vegetation in reclamation area. Perennial vegetation is not apparent.

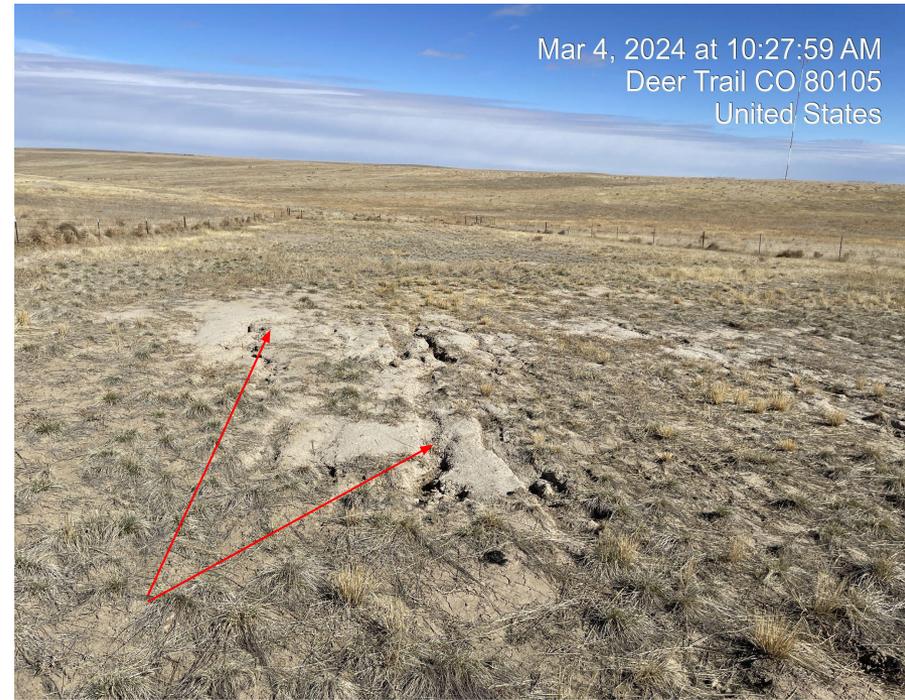
Photo 10. Photo taken facing north of mowed vegetation and eroding bare soil in reclamation area. Red arrow indicates bare soil.

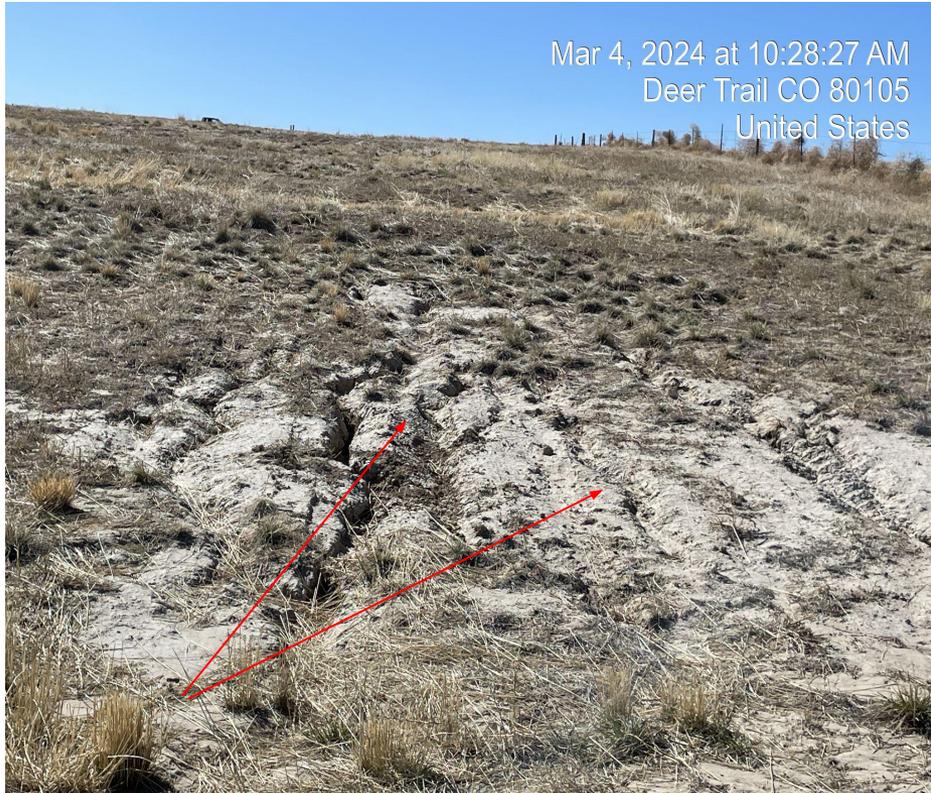
Photo 11. Photo taken facing south of mowed vegetation and eroding bare soil in reclamation area. Red arrow indicates bare soil.

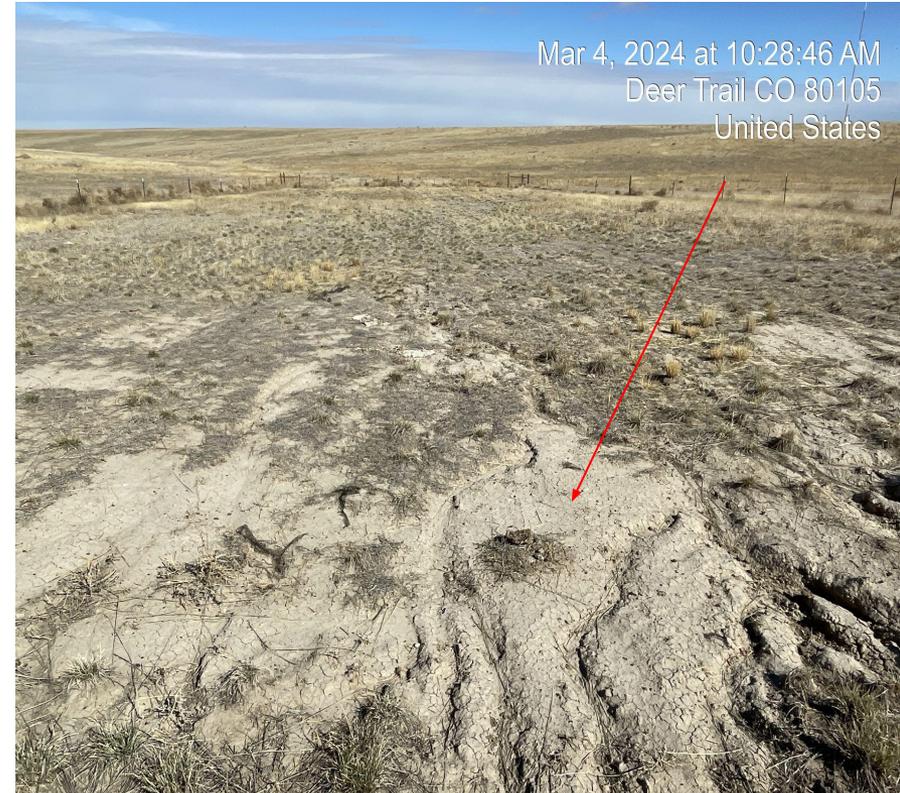
Photo 12. Photo taken facing north of mowed vegetation and eroding bare soil in reclamation area. Red arrow indicates bare soil.

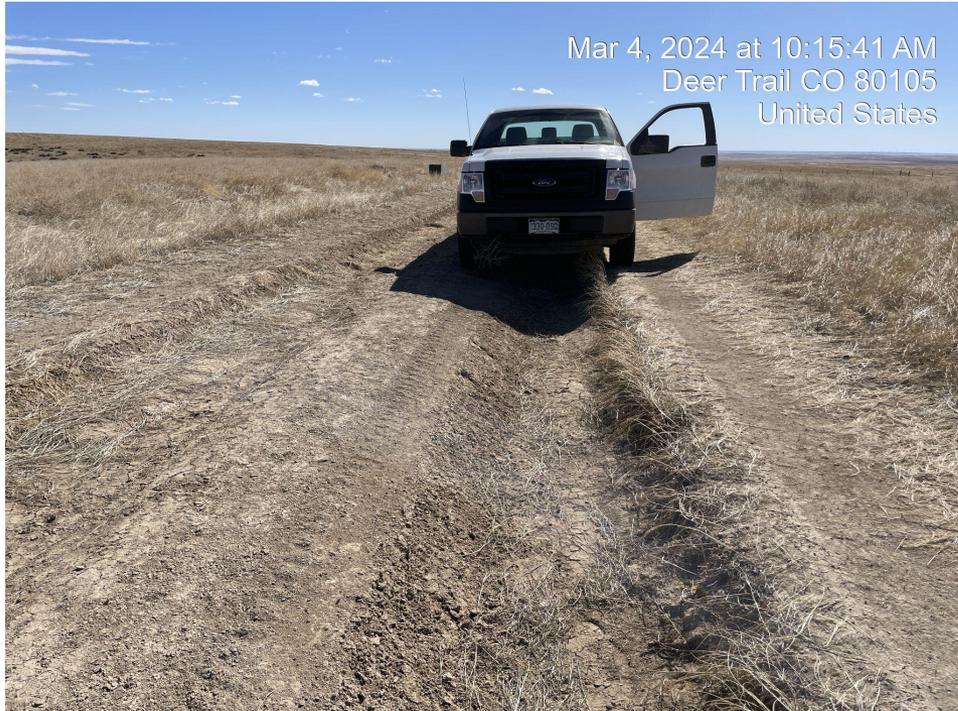
Photo 14. Photo taken facing south of rutted access road.

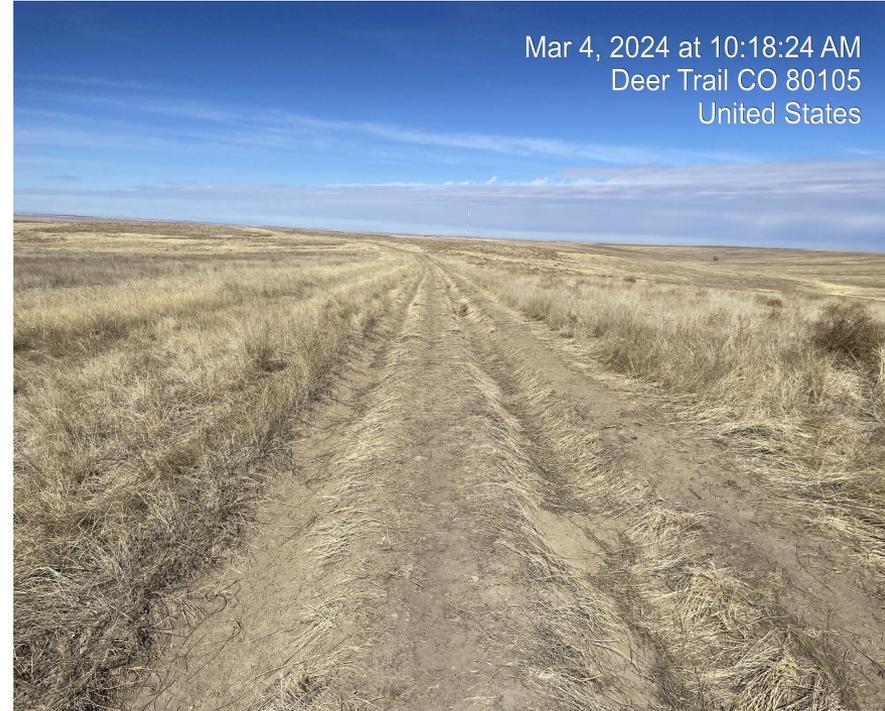
Photo 15. Photo taken facing northwest of rutted access road.
