**Operator: CRESTONE PEAK RESOURCES OPERATING LLC**

**Location Name: ALAUX F UNIT-61N68W 26NWNW**

**Loc ID: 321533**

**Inspection: 714300046**

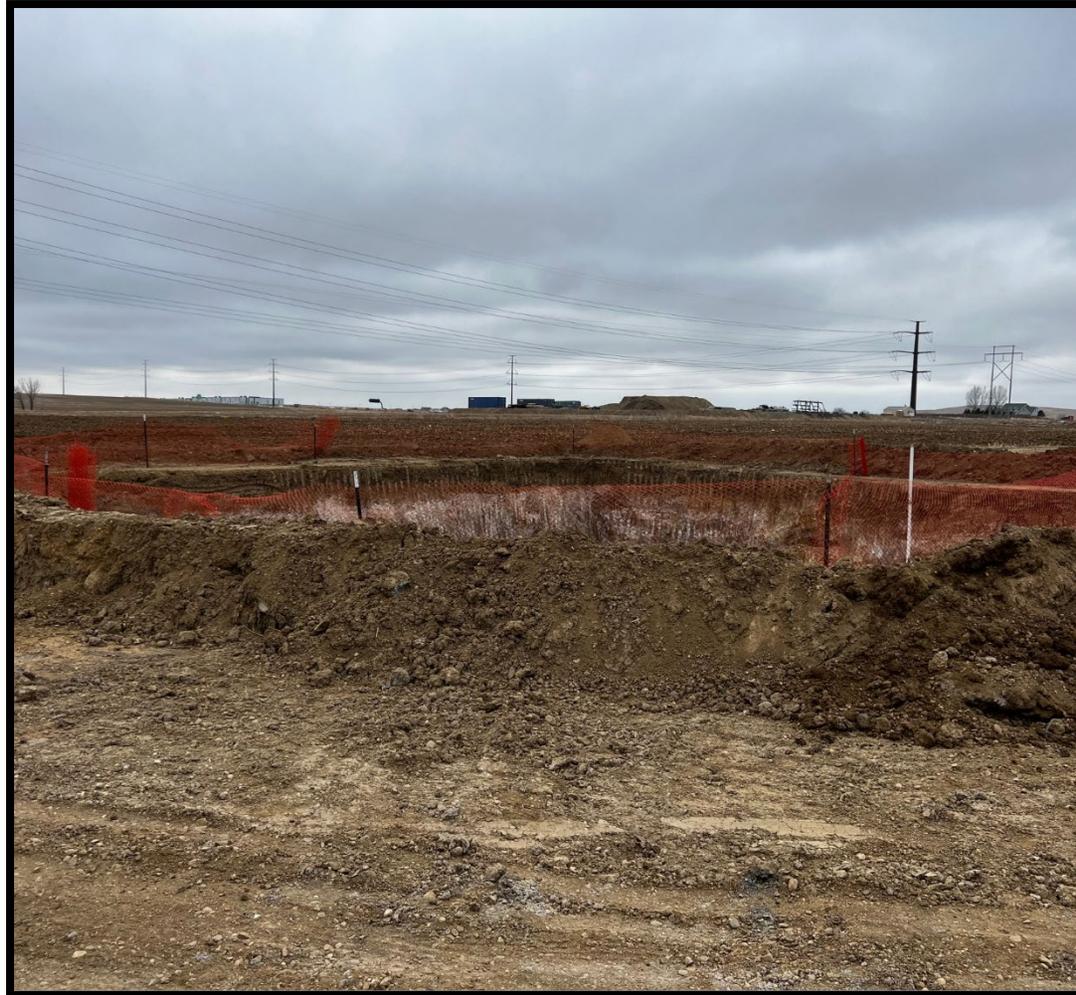
**Exhibit A**

**CA:** No fencing is present around the location. Excavation is surrounded by soil berms which are inadequate for securing the excavation. Secure access to excavation in compliance with Rule 913.b.(5).B.i and ECMC Guidance 913.b.(5)B i-v

**CA Resolution:** Operator has appropriately installed fencing around the excavation to comply with Rule 913.b.(5).B.i.
