Inspection Photos

Location Name: TEP ROCKY MOUNTAIN LLC MCLAUGHLIN 42A-27 Pad

Location ID: 335082

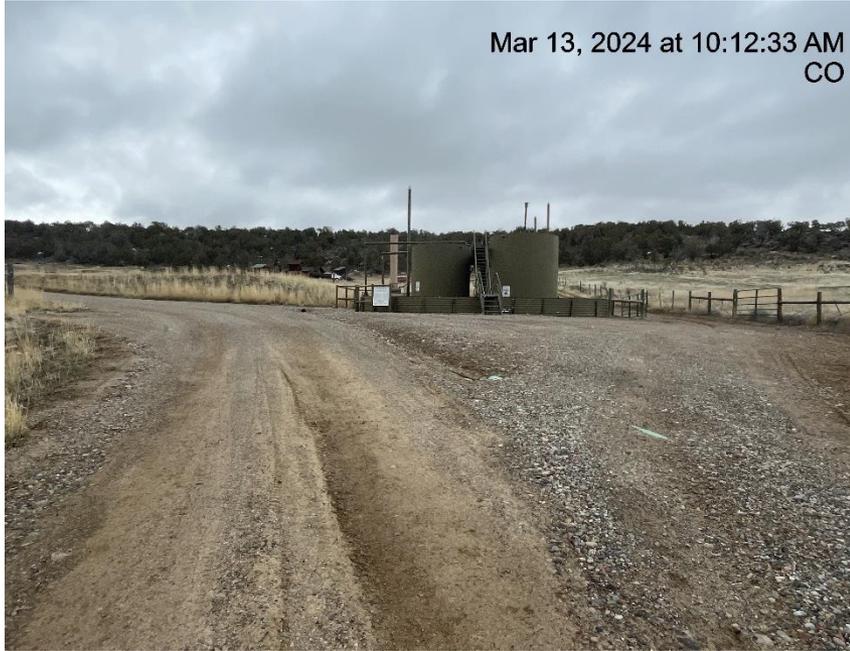
Photo # 9614 From entrance to location

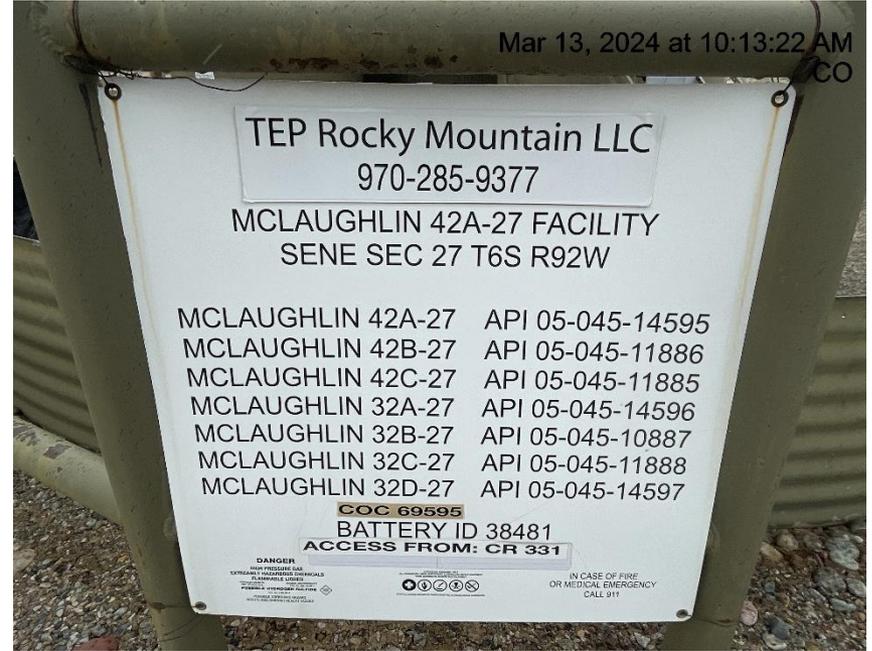
Photo # 9615 Location

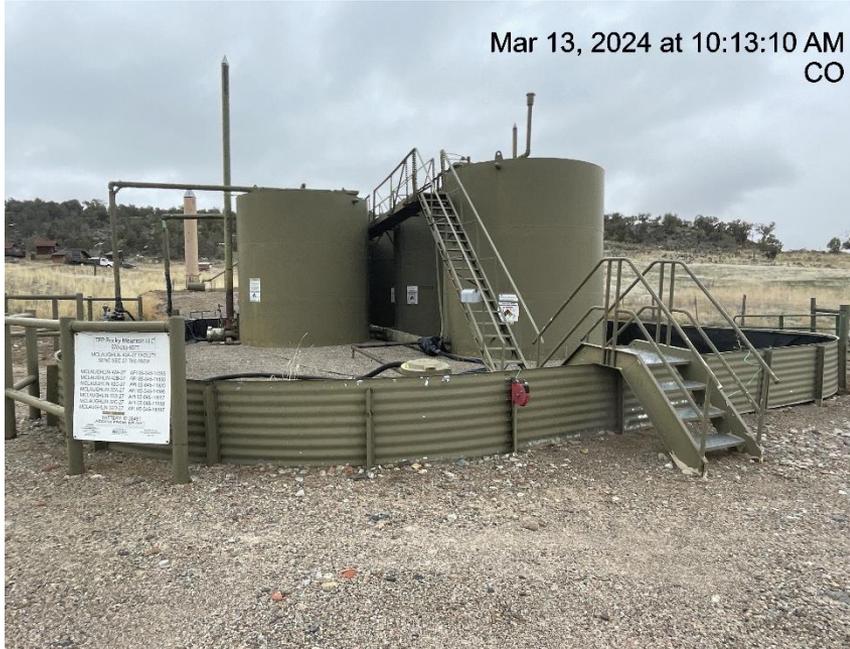
Photo # 9616 Location

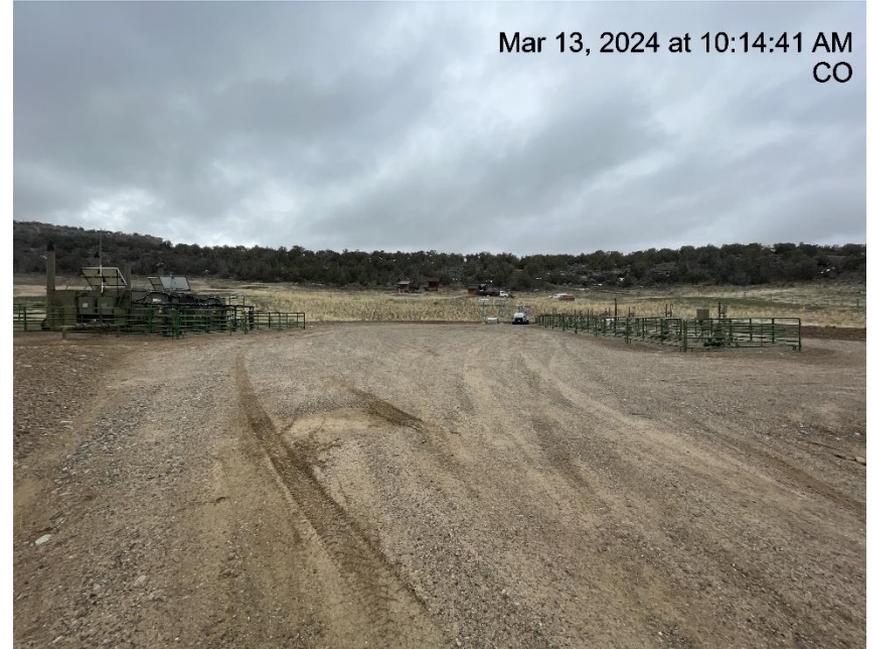
Photo # 9617 Location

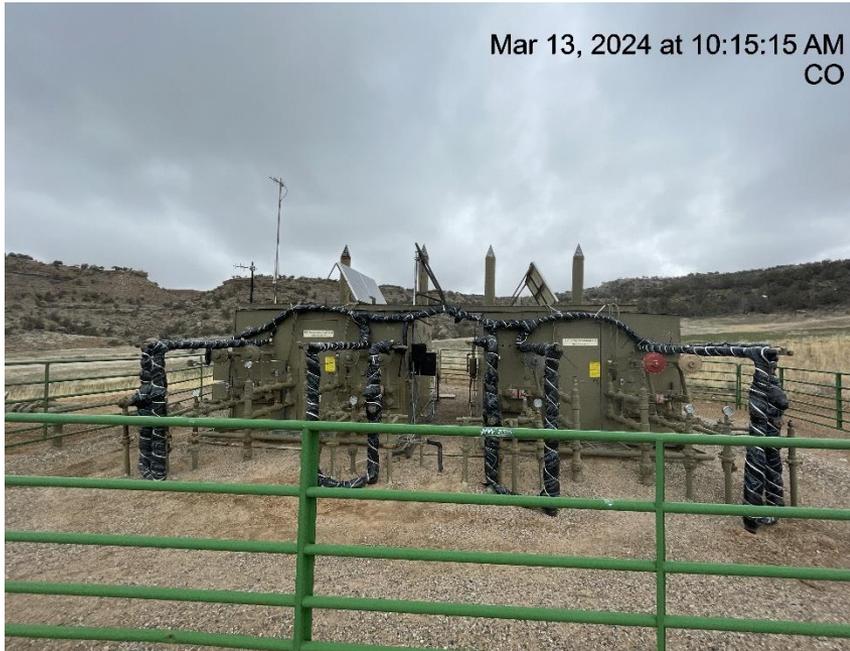
Photo # 9618 Location

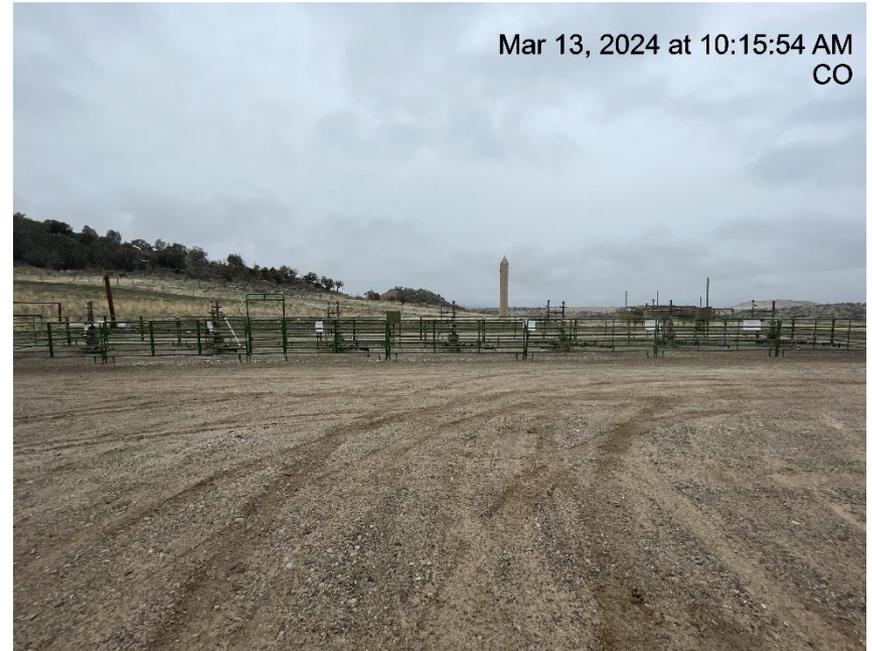
Photo # 9619 Location

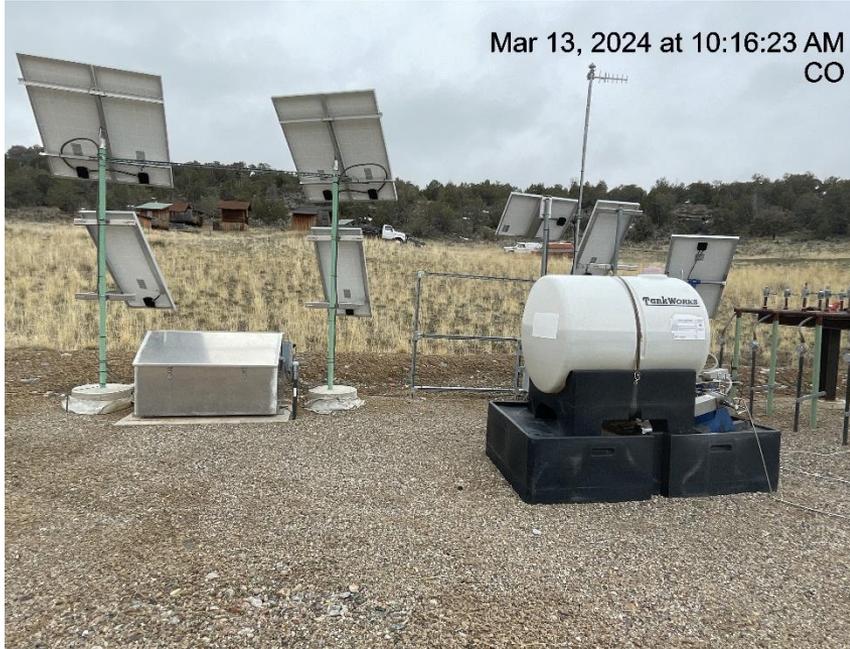
Photo # 9620 Location

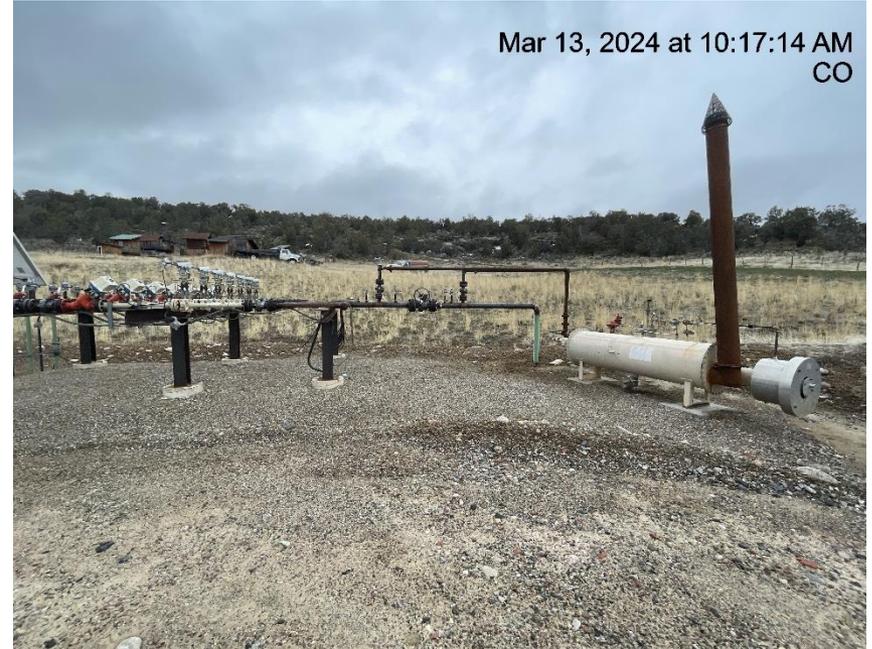
Photo # 9621 Location

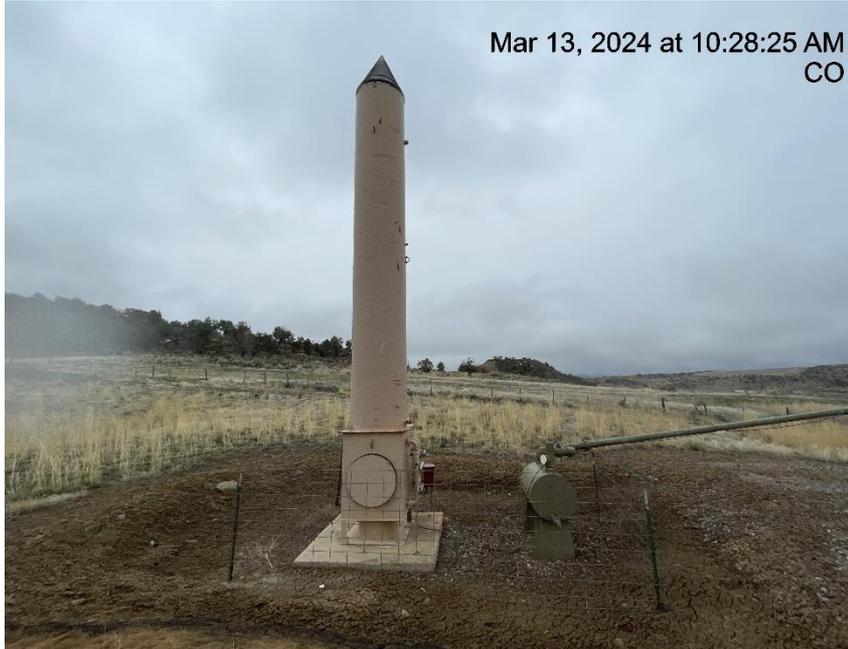
Photo # 9622 Unused equipment

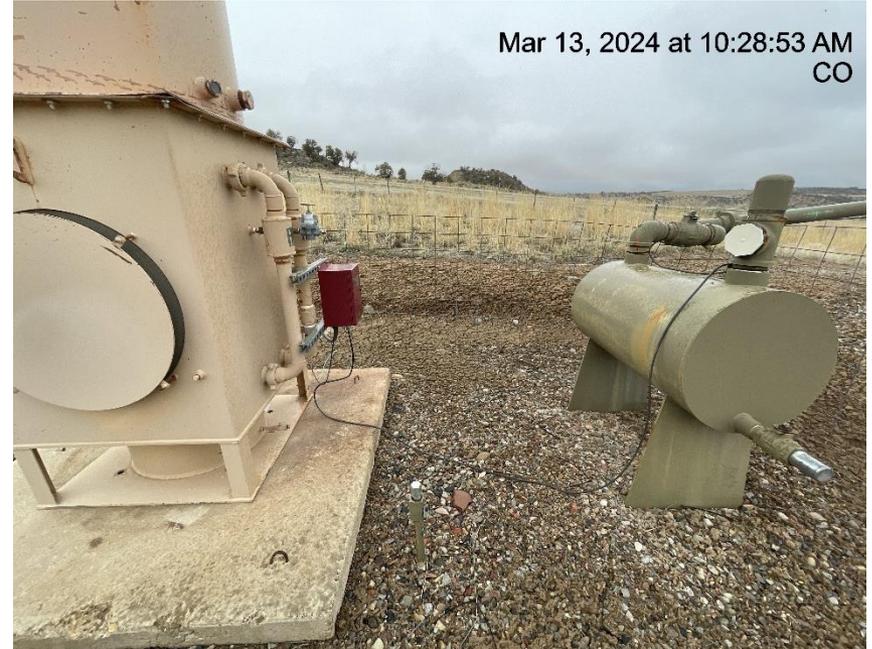
Photo # 9623 Unused equipment/ECD disconnected & not in use

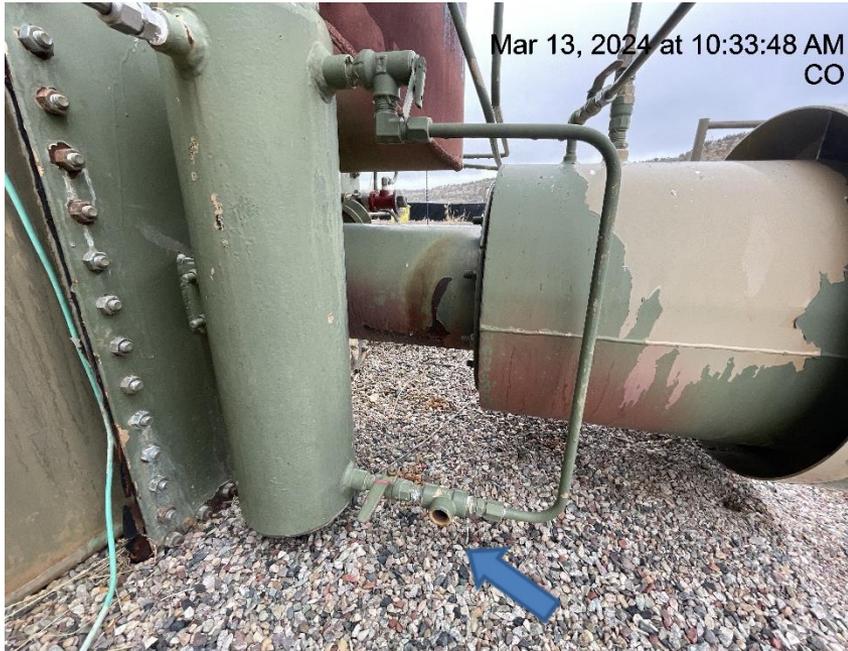
Photo # 9624 PRV vent line on tank burner terminates in an unsafe manner/does not comply with CECMC pressure safety device rules & general safety rules.

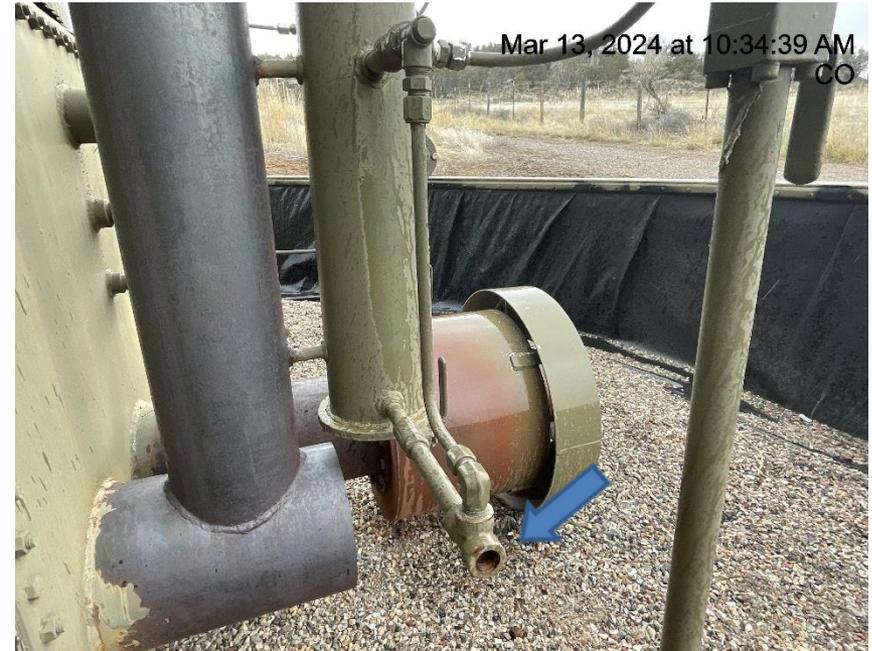
Photo # 9625 PRV vent line on tank burner terminates in an unsafe manner/does not comply with CECMC pressure safety device rules & general safety rules.

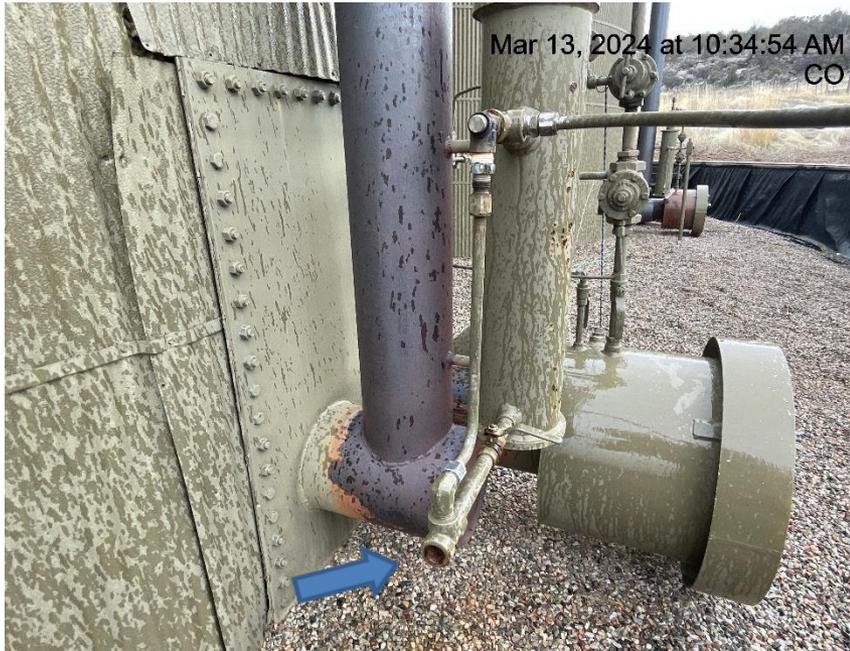
Photo # 9626 PRV vent line on tank burner terminates in an unsafe manner/does not comply with CECMC pressure safety device rules & general safety rules.

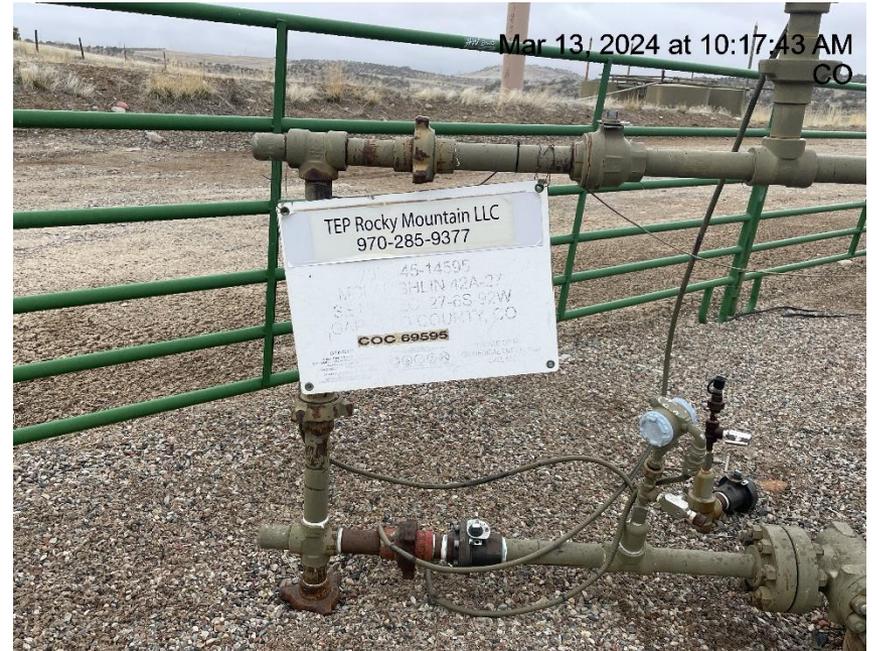
Photo # 9627 42A-27 wellhead sign faded & illegible

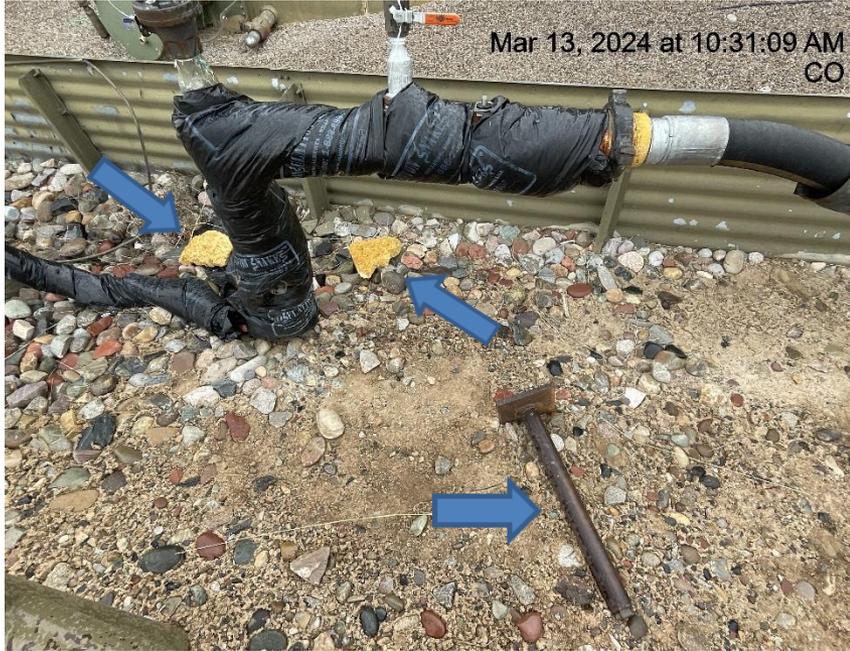
Photo # 9628 Debris

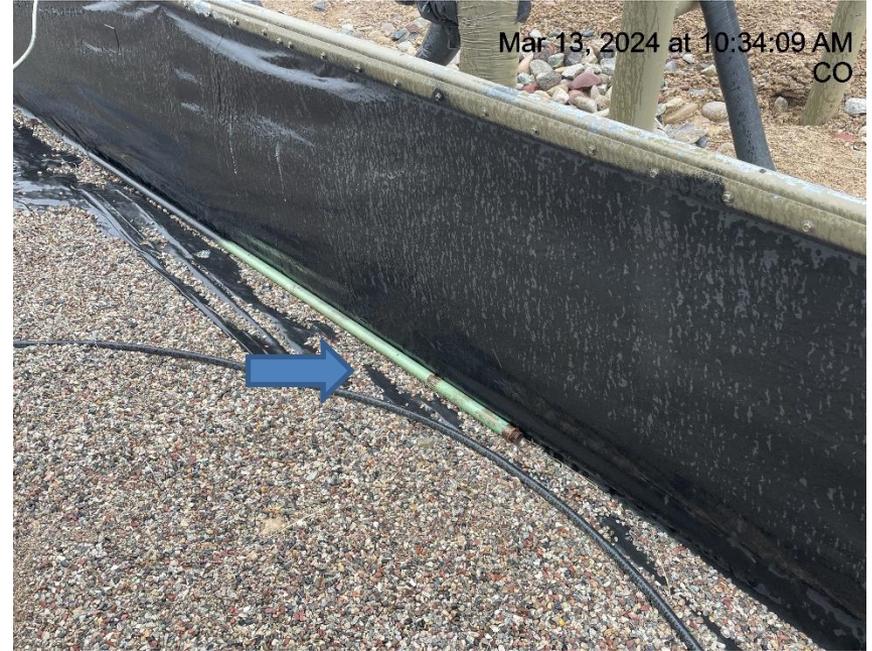
Photo # 9629 Debris
