Inspection Photos

API: 099-06045

Operator: RENEGADE OIL & GAS COMPANY LLC

Inspection Date: 3/15/2024

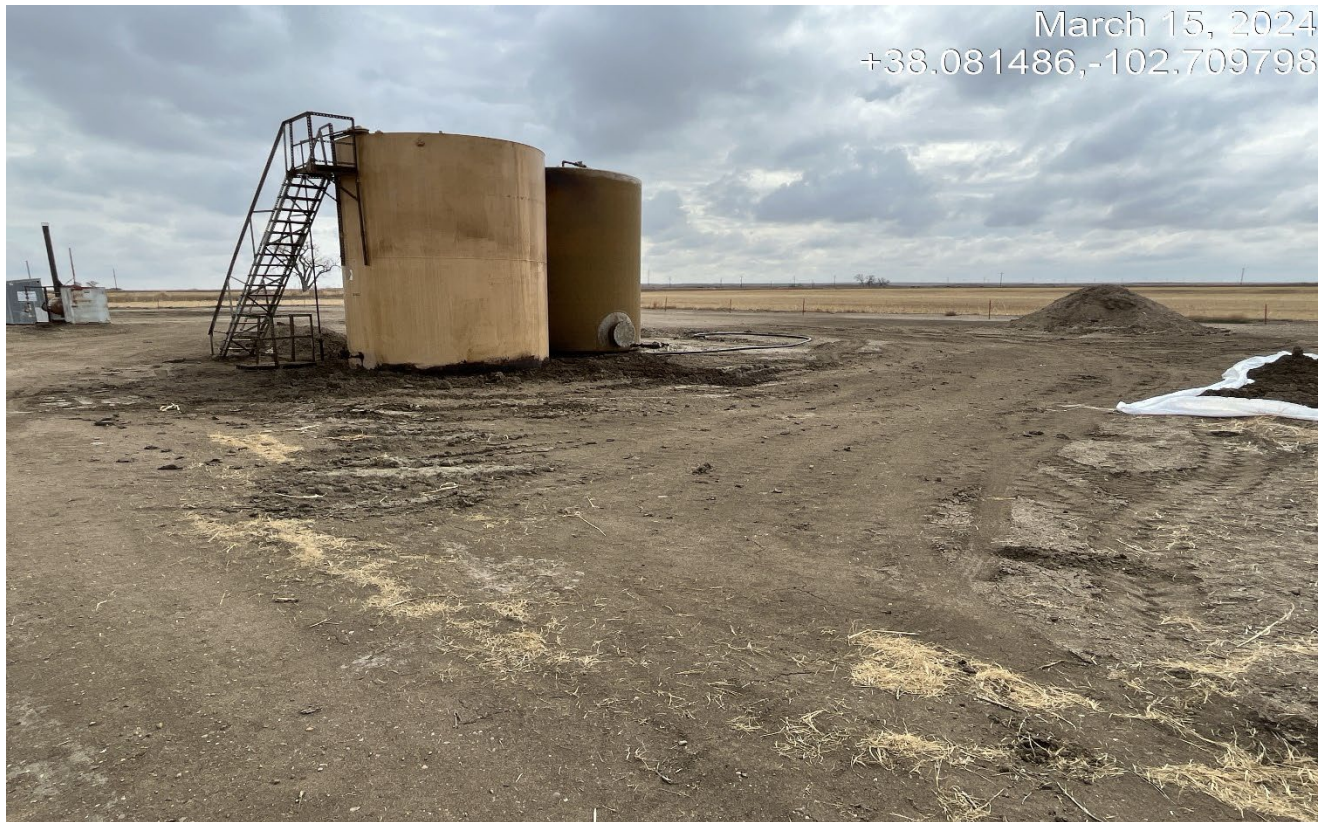
Photo 1. Facing southeast toward the tank battery. There is a new tank being installed which will need to follow the 603.k.o. requirements. Previous corrective action was not completed.

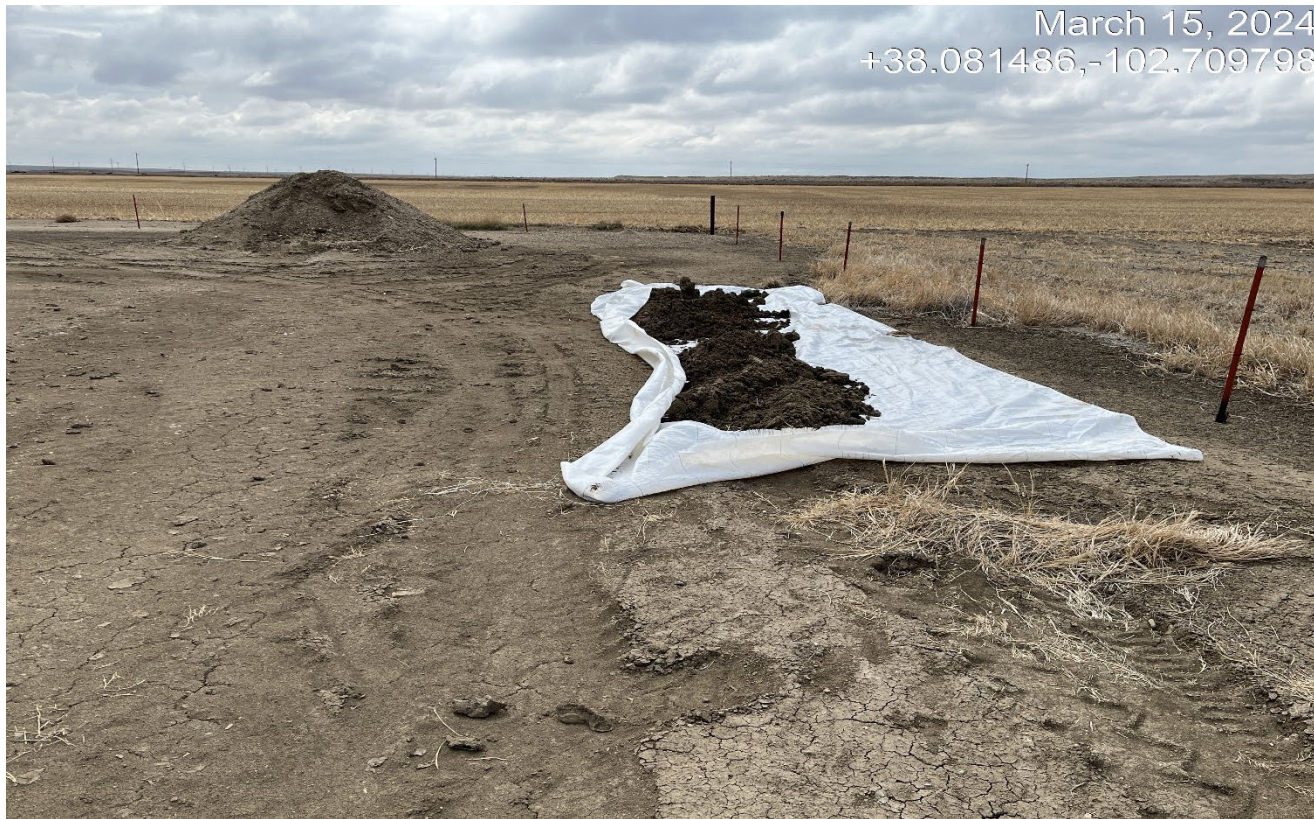
Photo 2. There is impacted oily material stored on a liner at the west side of the location. This is not properly stored to prevent stormwater from transporting the contaminated soil off the liner.

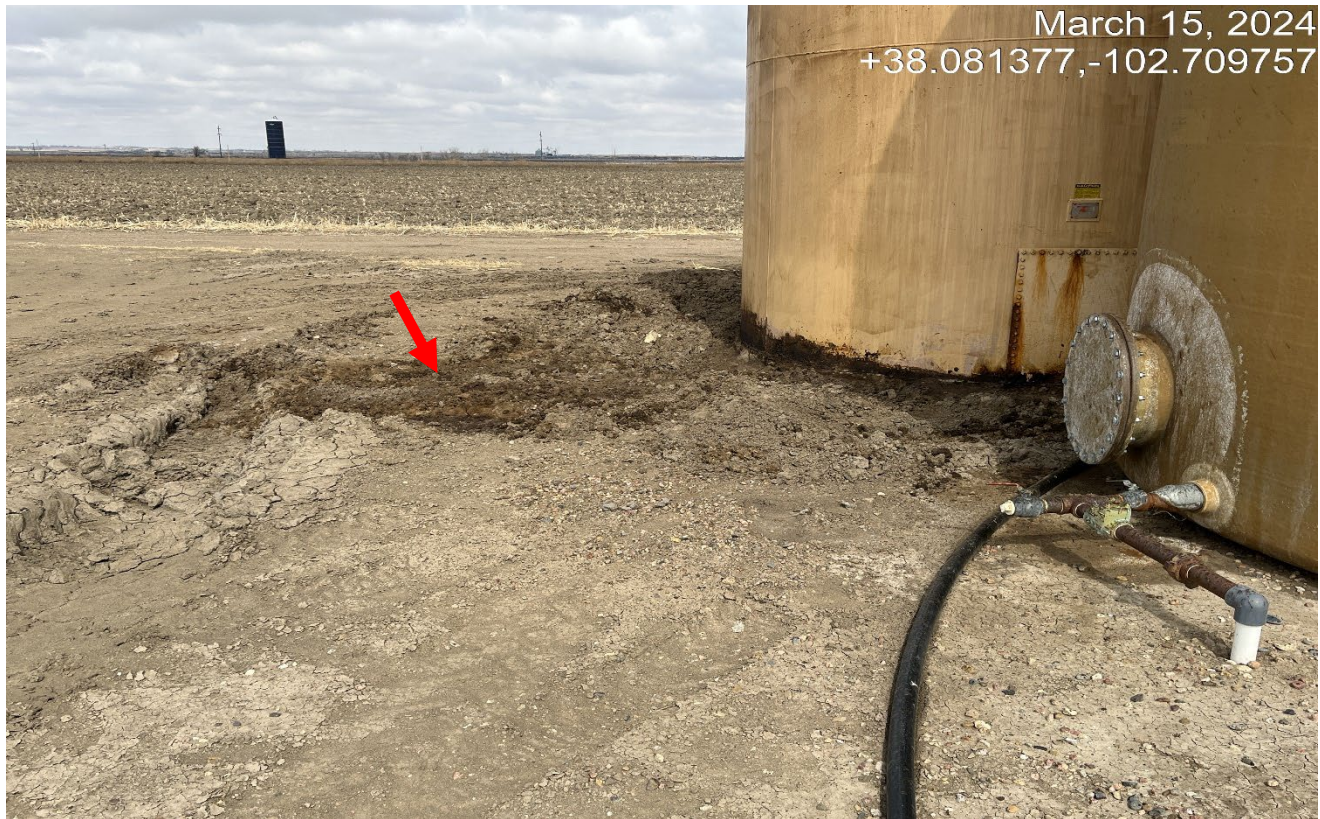
Photo 3. Facing northeast toward the tank battery where leak was previously observed. It appears the impacted material was partially scrapped away however there is still dark oily soil still evident around the tanks that extends out shown by red arrow.

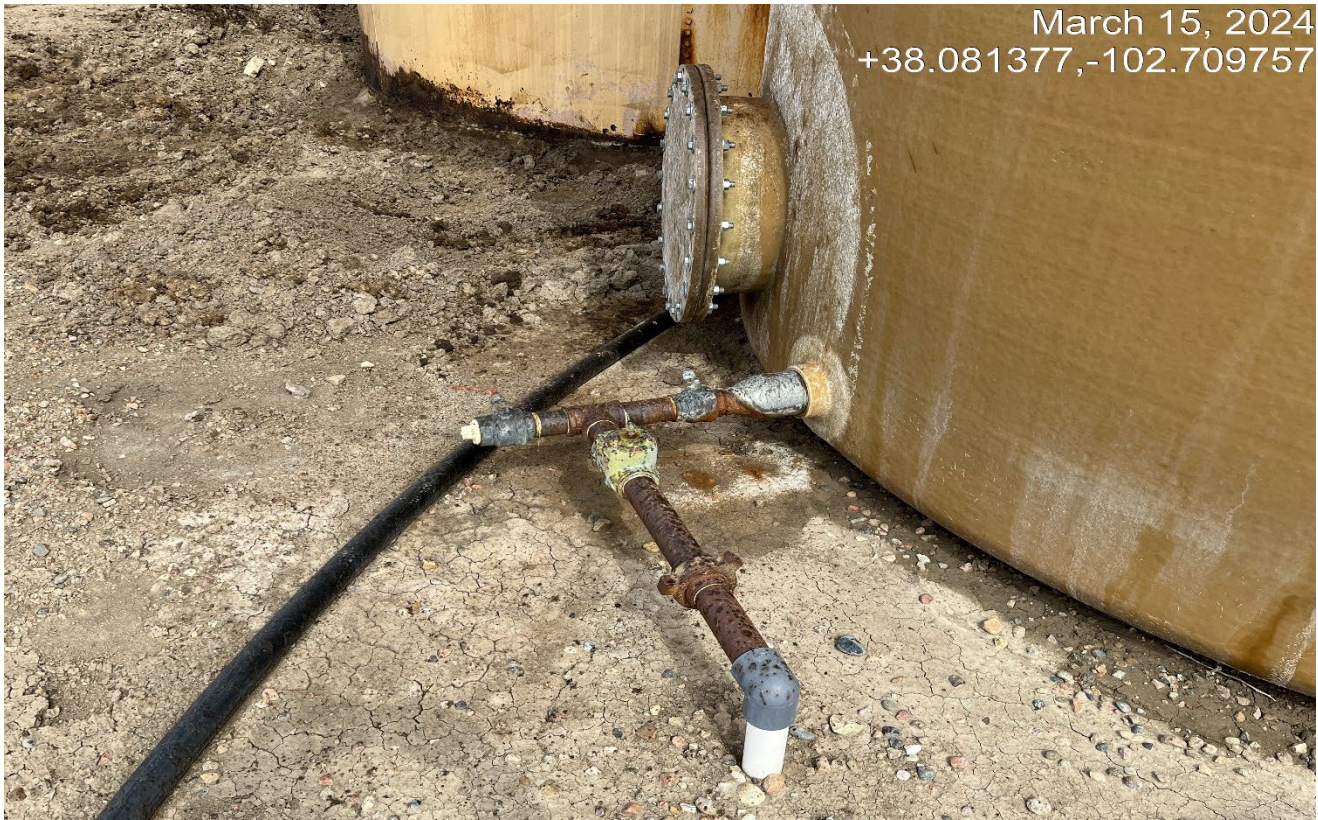
Photo 4. Closer view at the tanks. It appear the produce water tank has a dripping leak. The oily soils around the crude oil tank have not been properly cleaned up.

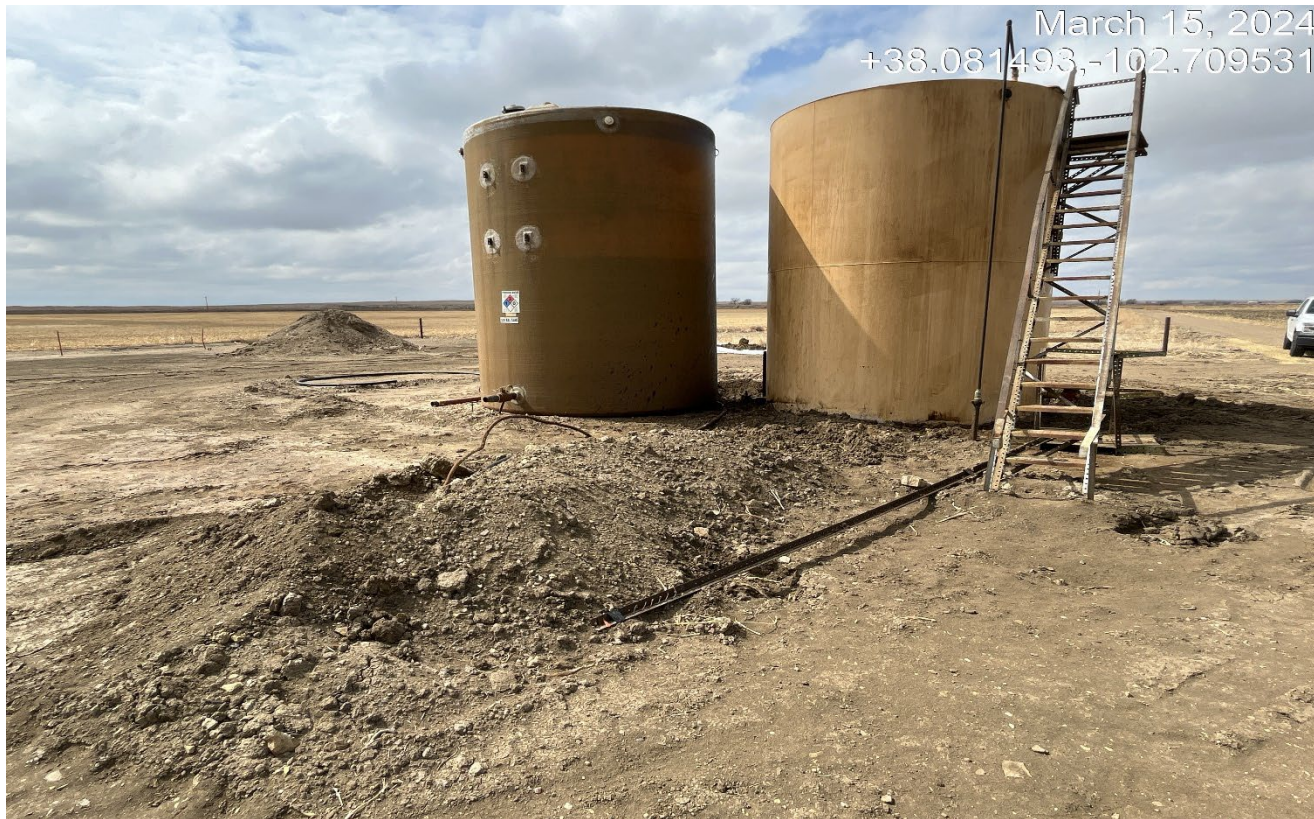
Photo 5. Facing west toward the tank battery which had been significantly remodified and requires secondary containment per Rule 603.o. There is also no labeling of the crude oil tank at the right side of the photo. The produced water tank is labeled at the left tank.

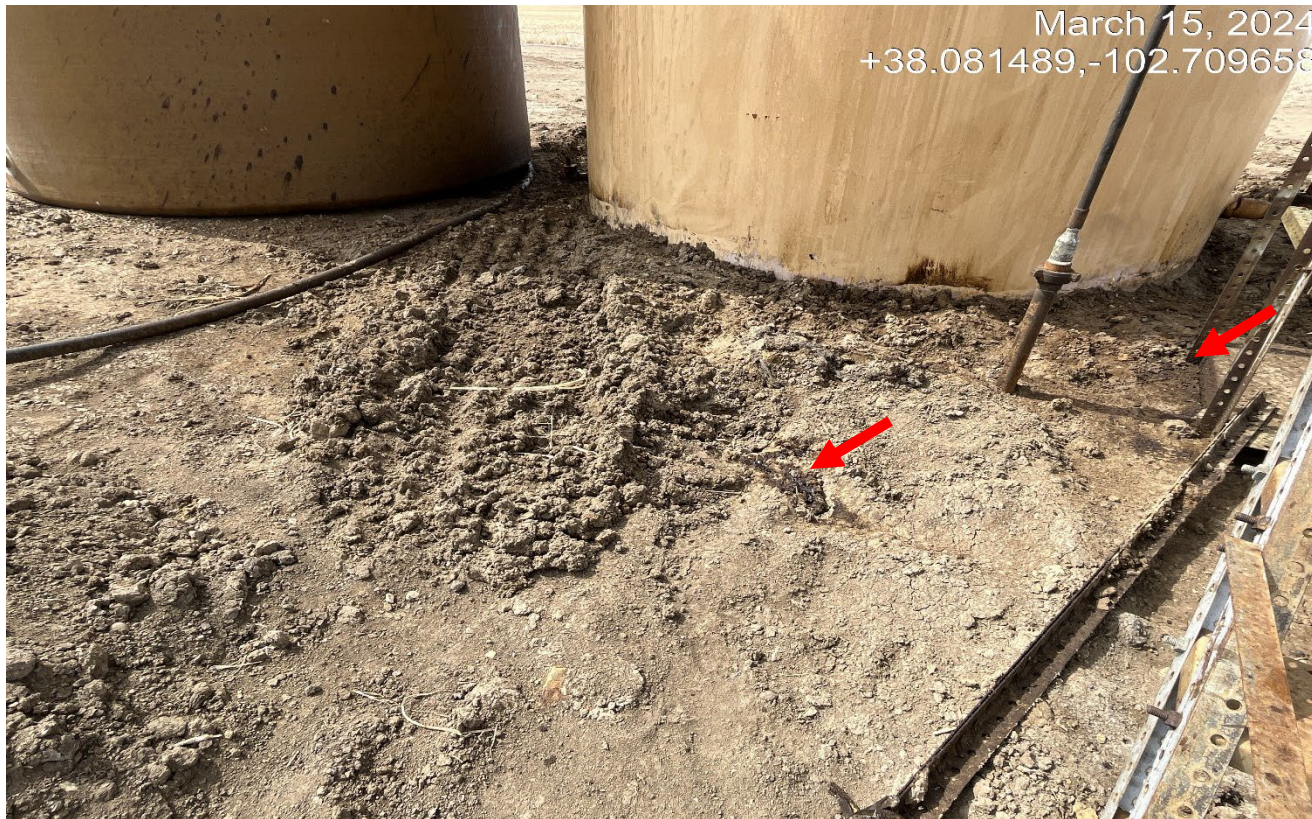
Photo 6. Facing west toward the tank battery where leak was previously observed. It appears the impacted material was partially scrapped away however there is still dark oily soil still evident around the tanks. Tanks will need to be removed for proper clean up.

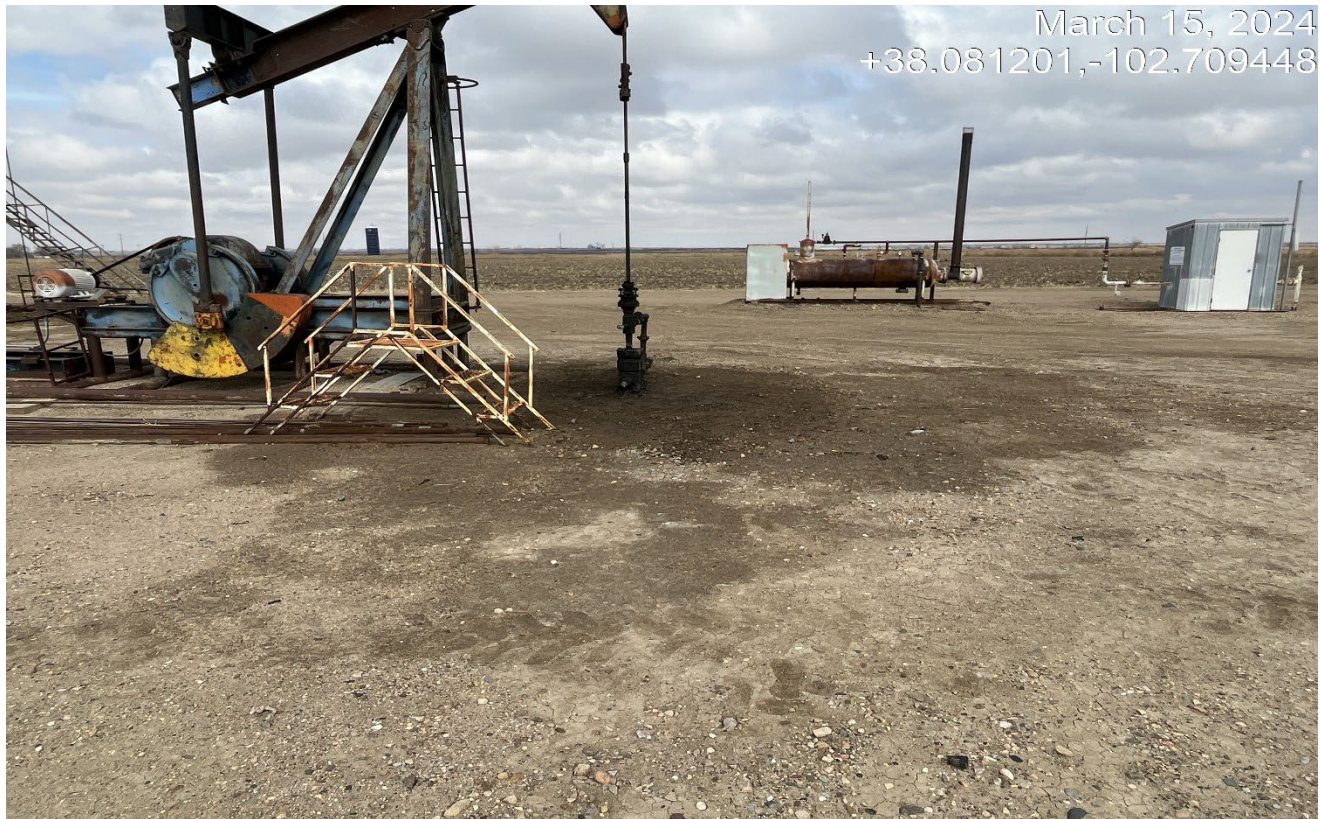
Photo 7. Facing north toward the wellhead. There is oil that has leak and sprayed out of the wellhead that needs to be cleaned up. Previous corrective action has not been completed.

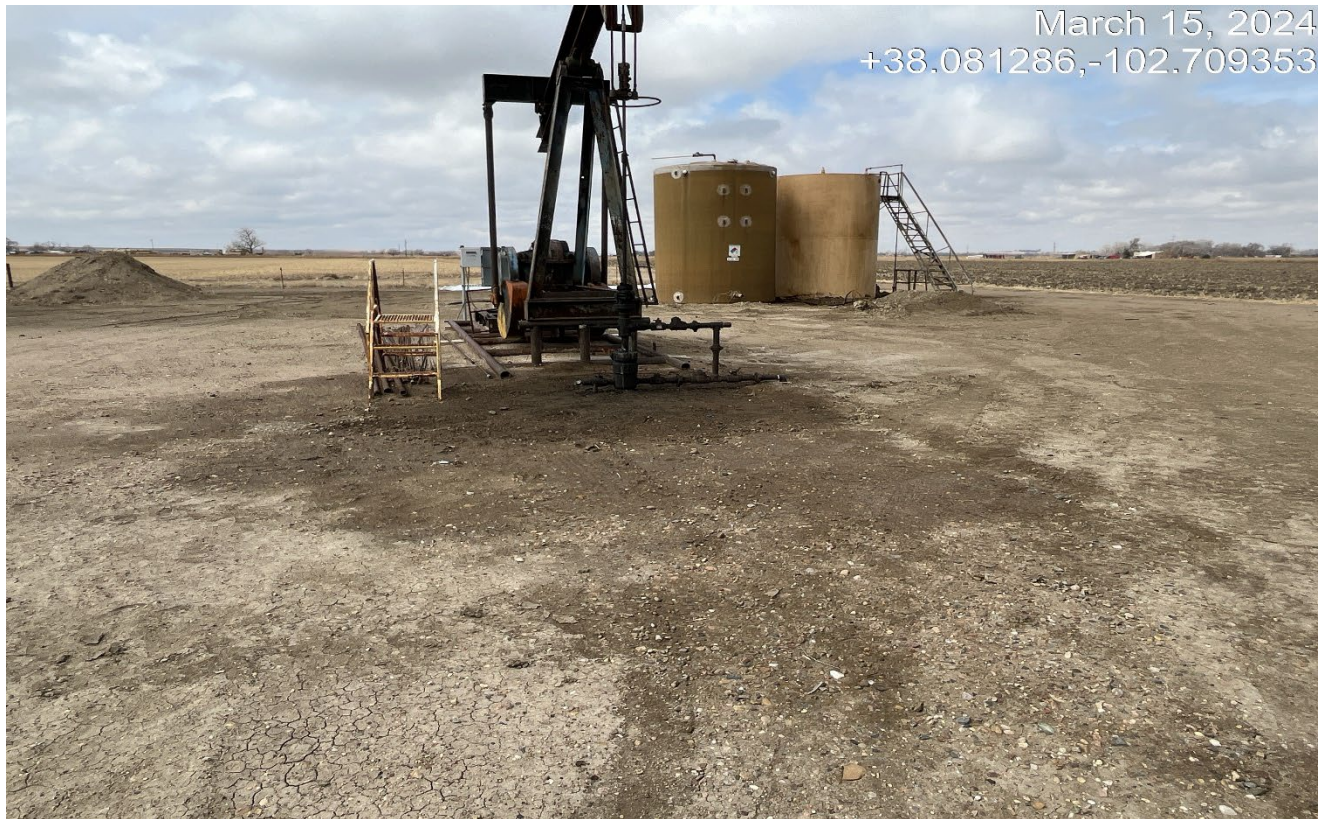
Photo 8. Facing west toward the wellhead. There is oil that has leak and sprayed out of the wellhead that needs to be cleaned up. Previous corrective action has not been completed.

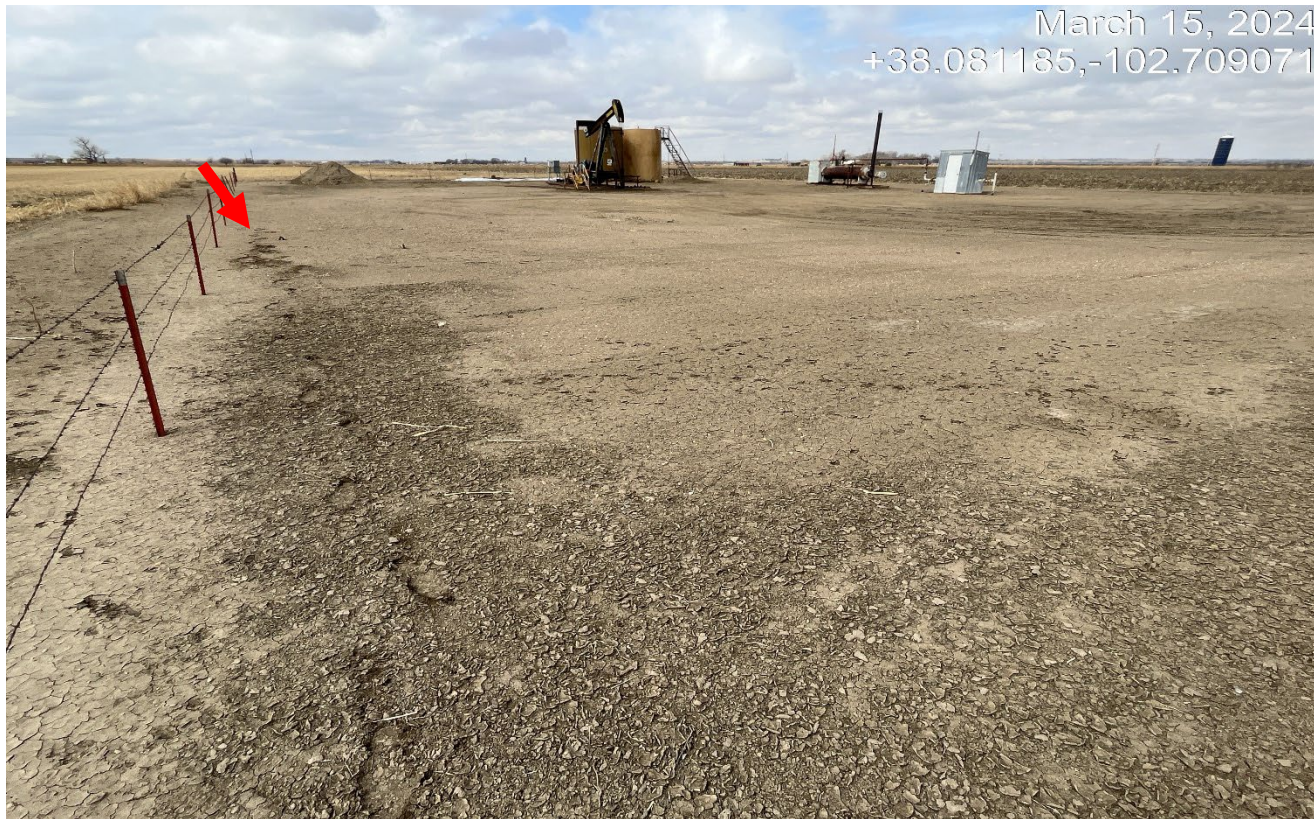
Photo 9. Facing west at the south side of the location. Red arrow points to the unmarked guyline anchor. Unused areas of the location are not reclaimed.

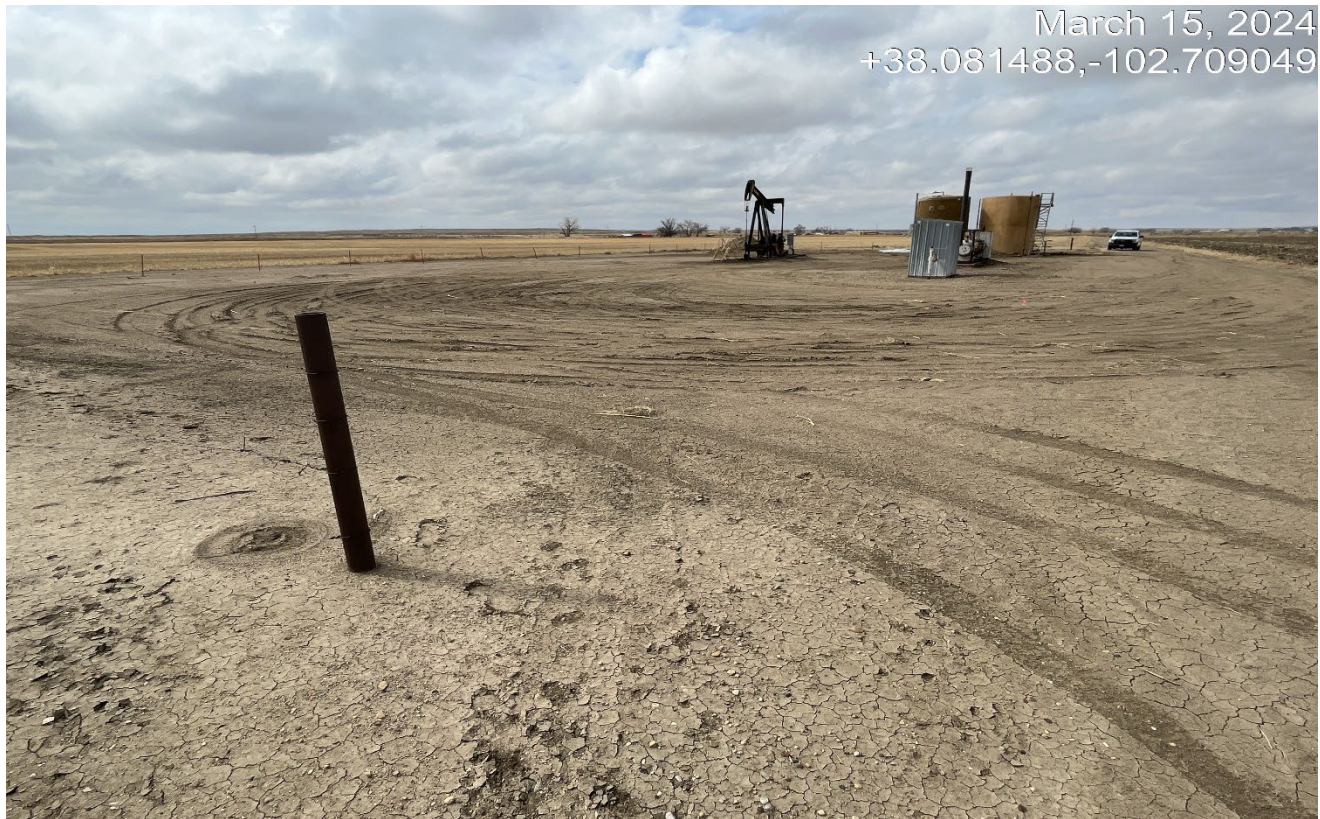
Photo 10. Facing southwest at the location. Unused areas of the location are not reclaimed. Fence is only up on the sides and does not prevent livestock entry.

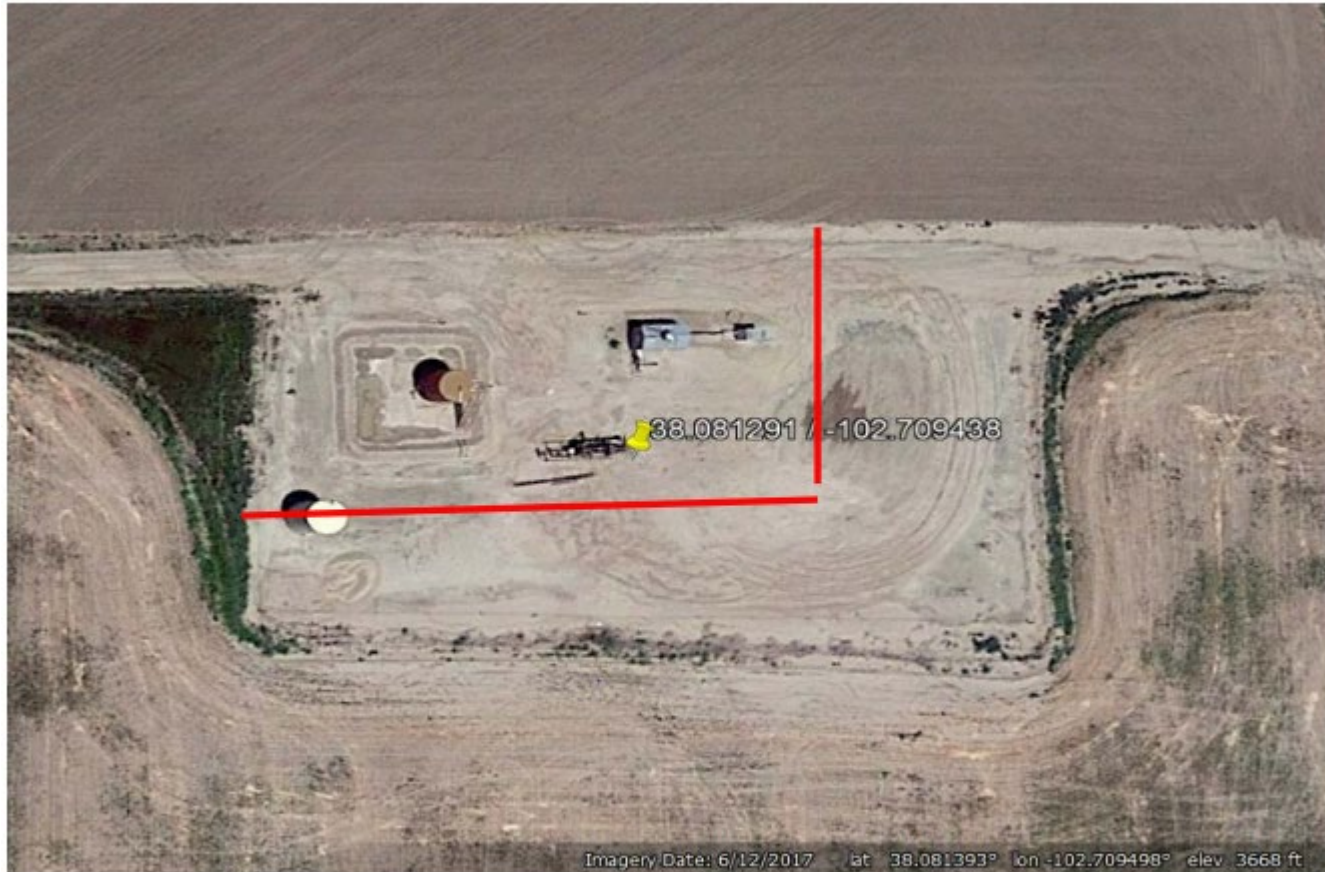
Photo 4. Aerial view of the location shows unused areas of the location below and to the right of red line could be put back into cropland.
