Inspection Photos
Location Name: Caster 4-36-9-59 PAD
Location ID: 434893

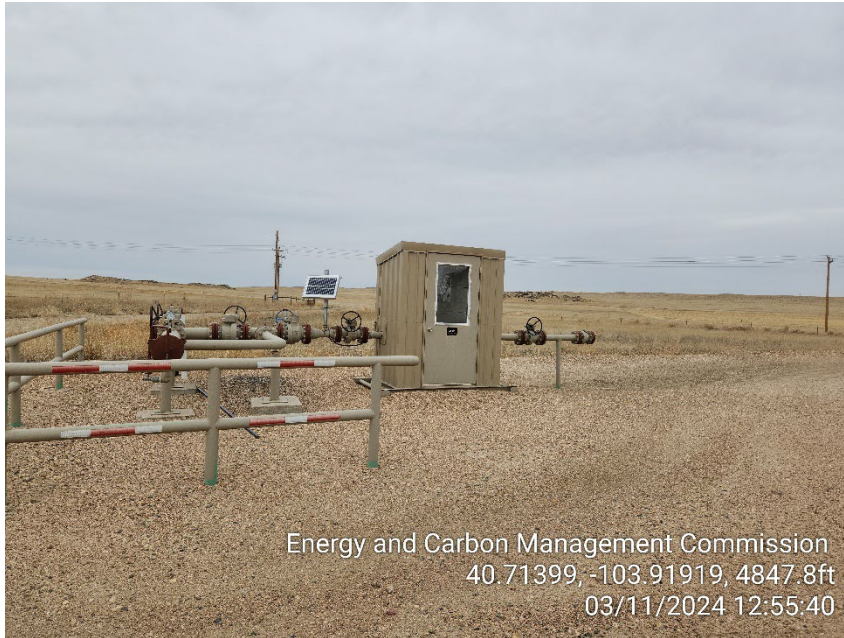
Photo 1 – Gas Meter

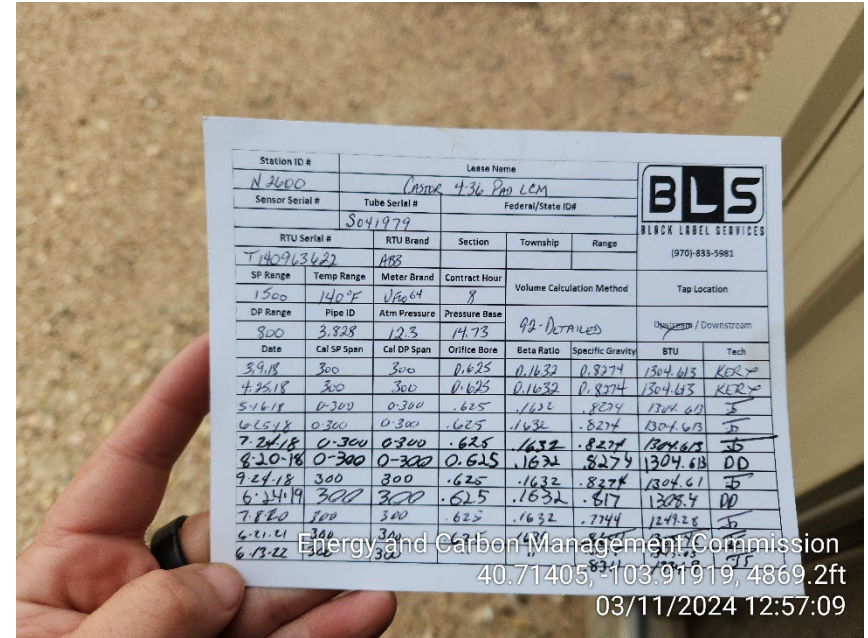
Photo 2 – Gas Meter Calibration Card

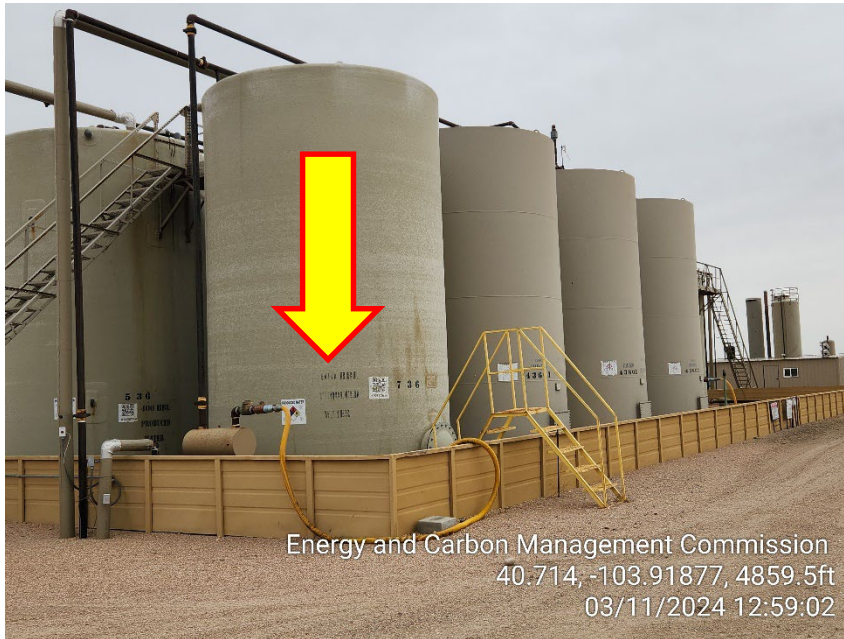
Photo 5 – Tank Battery – Capacity Label

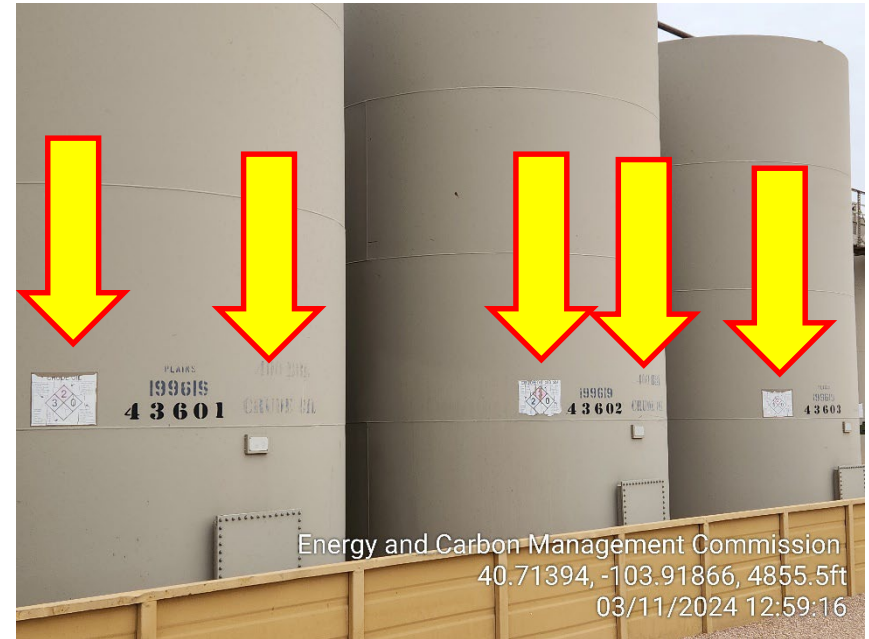
Photo 6 – NFPA, Content and Capacity Labels

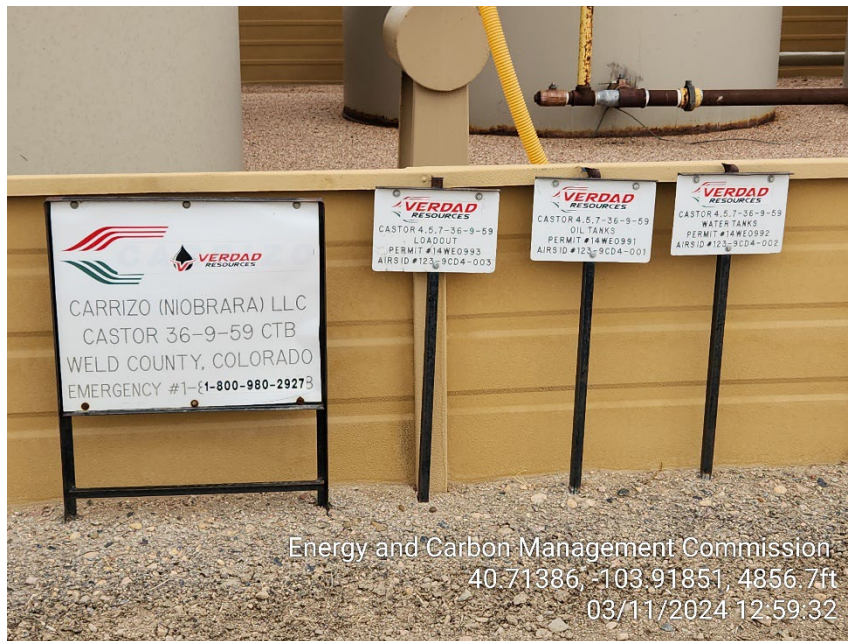
Photo 7 – Tank Battery Signs

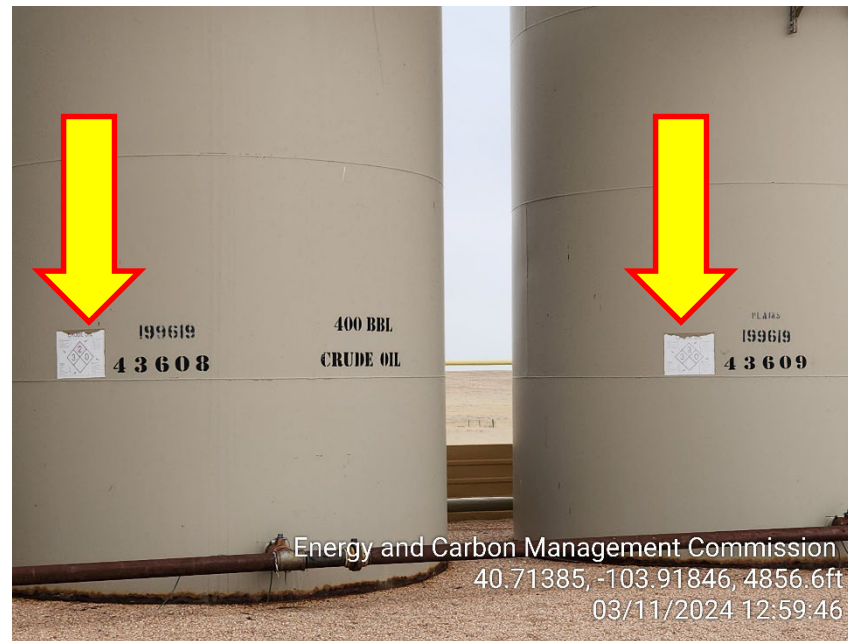
Photo 8 – NFPA Labels are fading

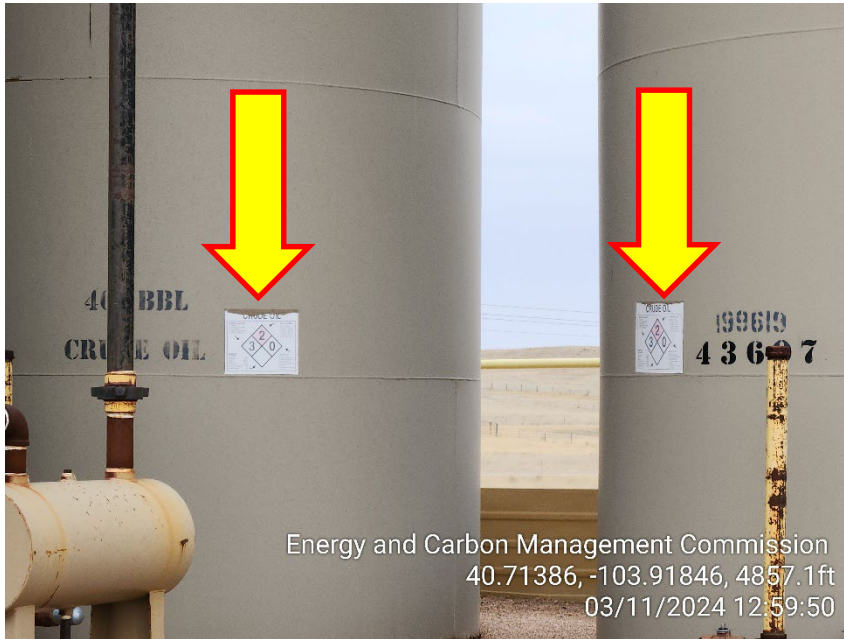
Photo 9 – NFPA Labels – Fading

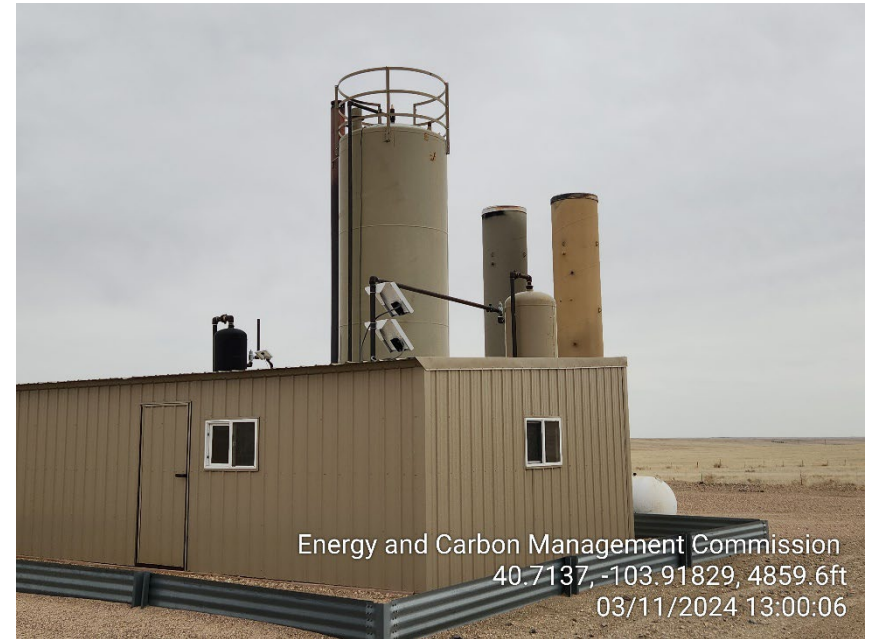
Photo 10 – Heater Treater and ECDs

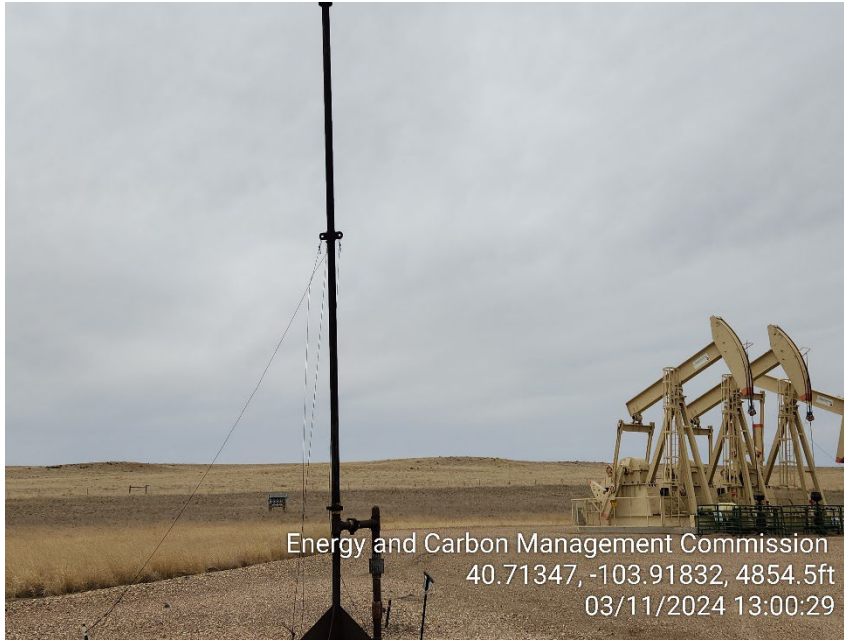
Photo 11 – Flare

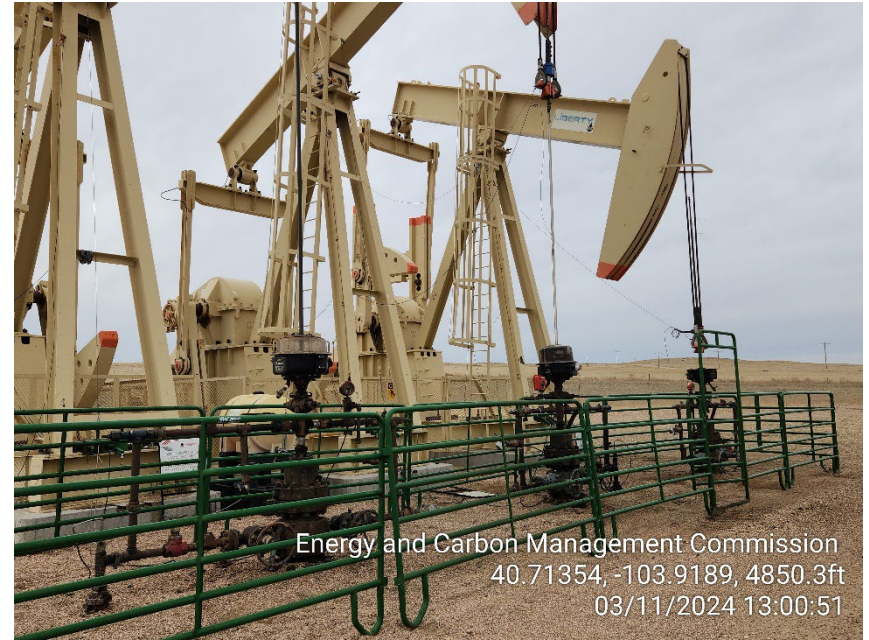
Photo 12 – Pumping Units

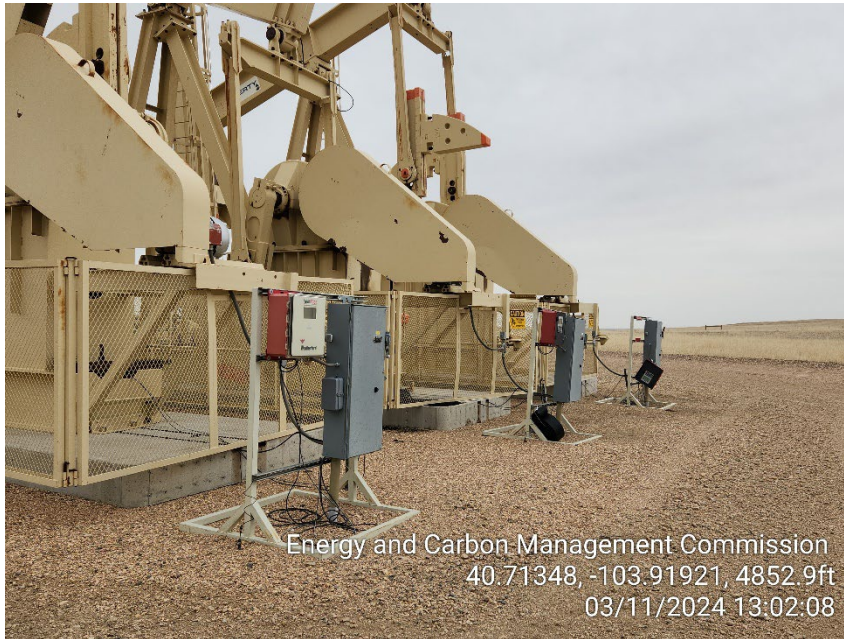
Photo 13 – Electric Motors

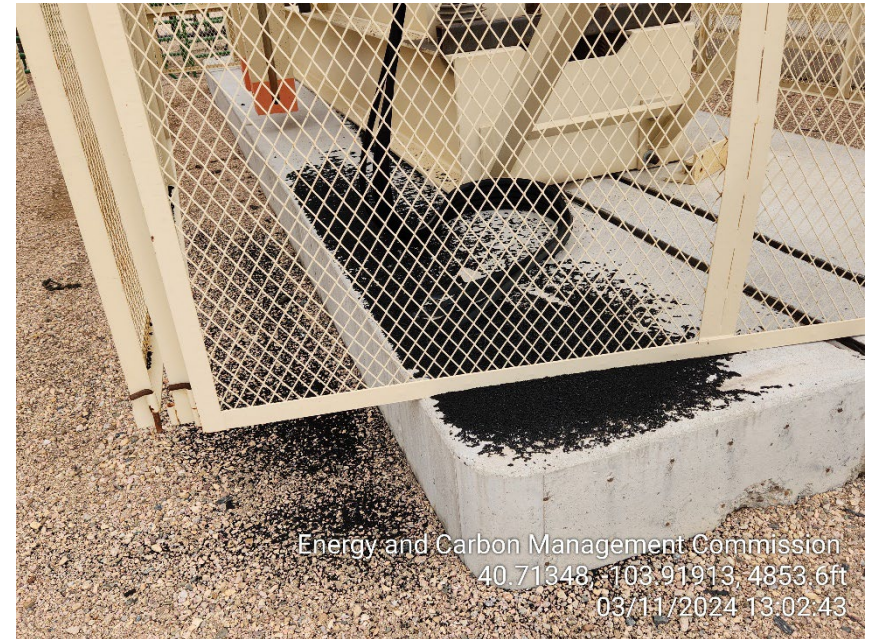
Photo 14 – Belt Debris
