Final Reclamation and Stormwater Inspection

March 4, 2024

Operator: Western Operating Company- #95620

Location ID: 319759

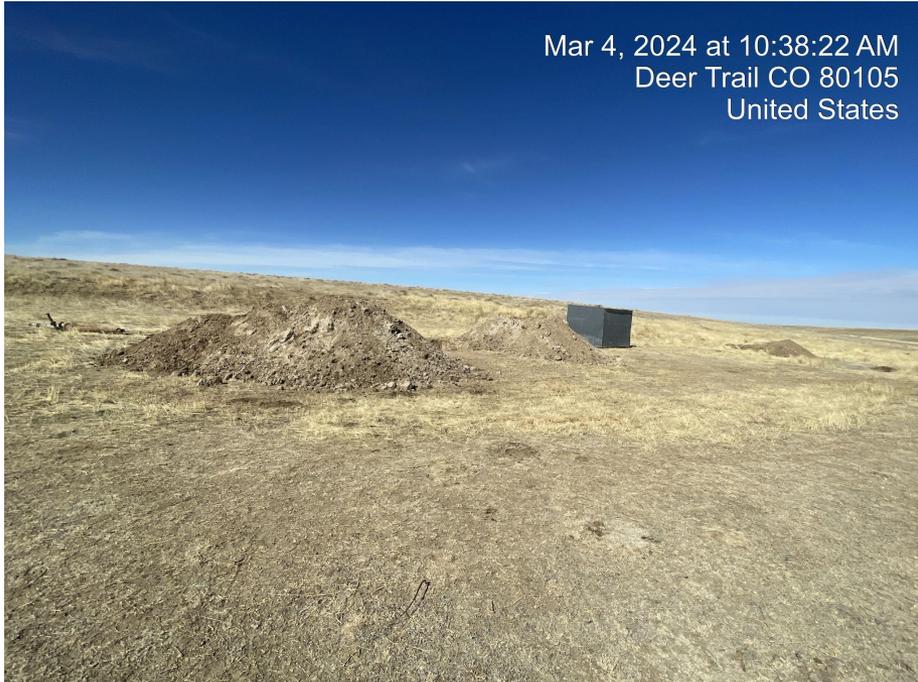
Photo 1. Photo taken facing northwest of excavation of removed well head and location.

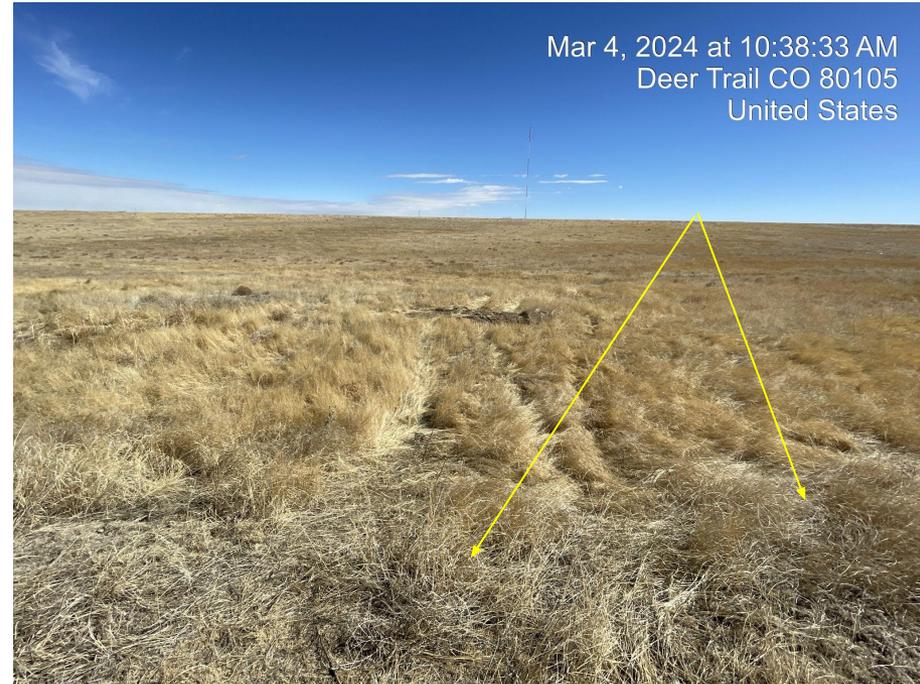
Photo 2. Photo taken facing west of reclamation area vegetation and weeds(Russian thistle). Weeds indicated by yellow arrow.

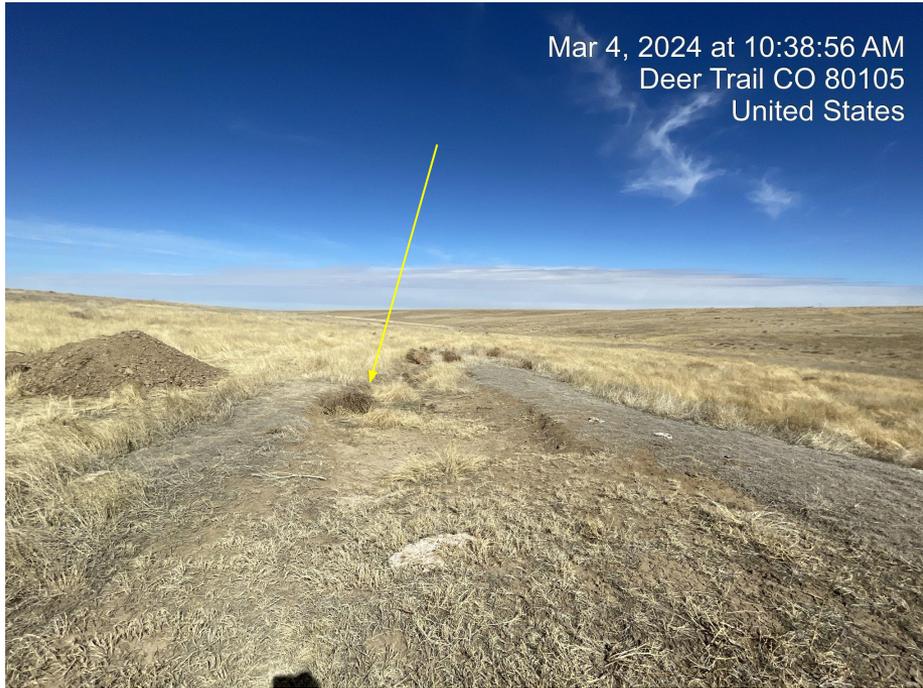
Photo 3. Photo taken facing northeast of reclamation area, weeds (russian thistle) and access road. Weeds indicated by yellow arrow.

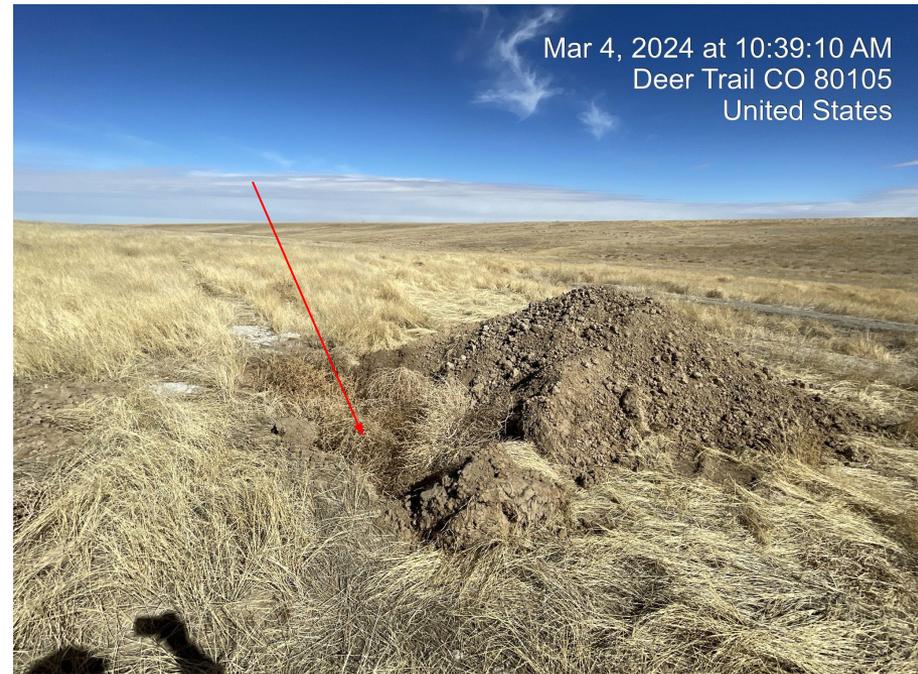
Photo 4. Photo taken facing west of excavation of anchor removed onsite. , Red arrow indicates excavation.

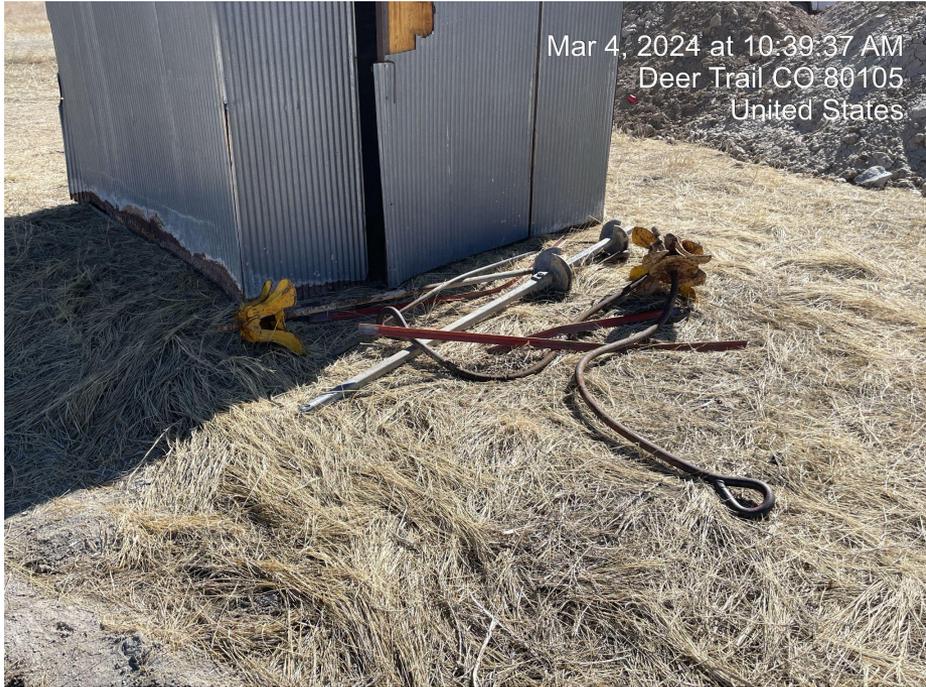
Photo 5. Photo taken facing southeast of removed anchors.

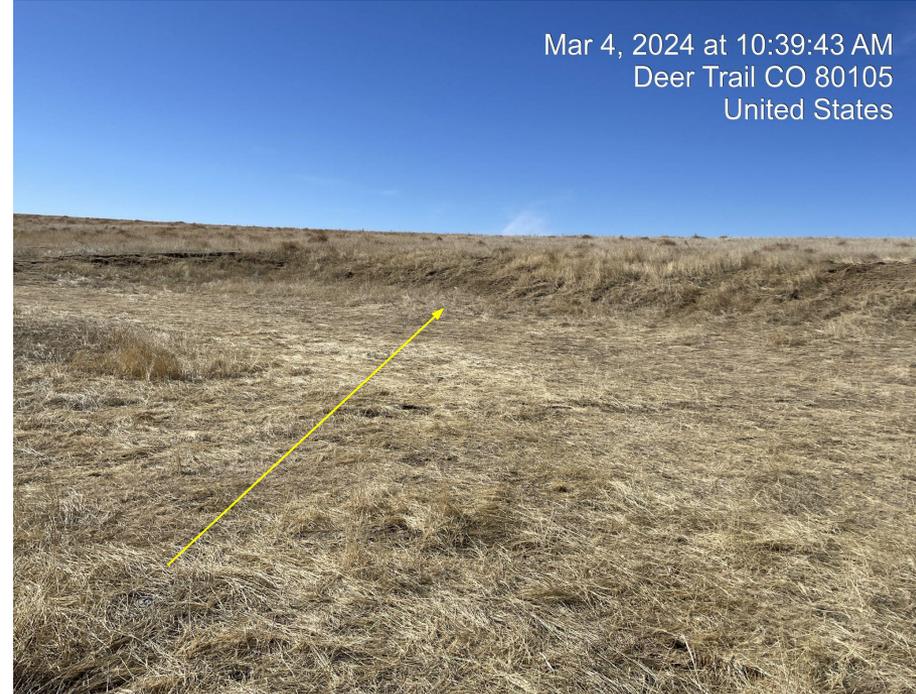
Photo 6. Photo taken facing southwest of vegetation and cut slope that has not been recontoured in reclamation area. Yellow arrow indicates cut slope.

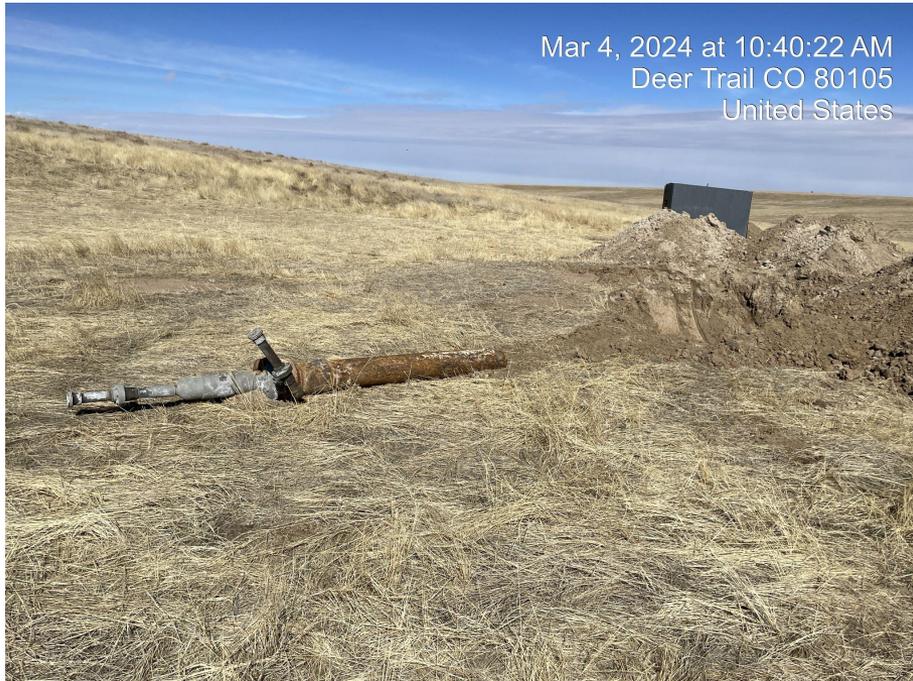
Photo 7. Photo taken facing north of removed well head and excavation on site.

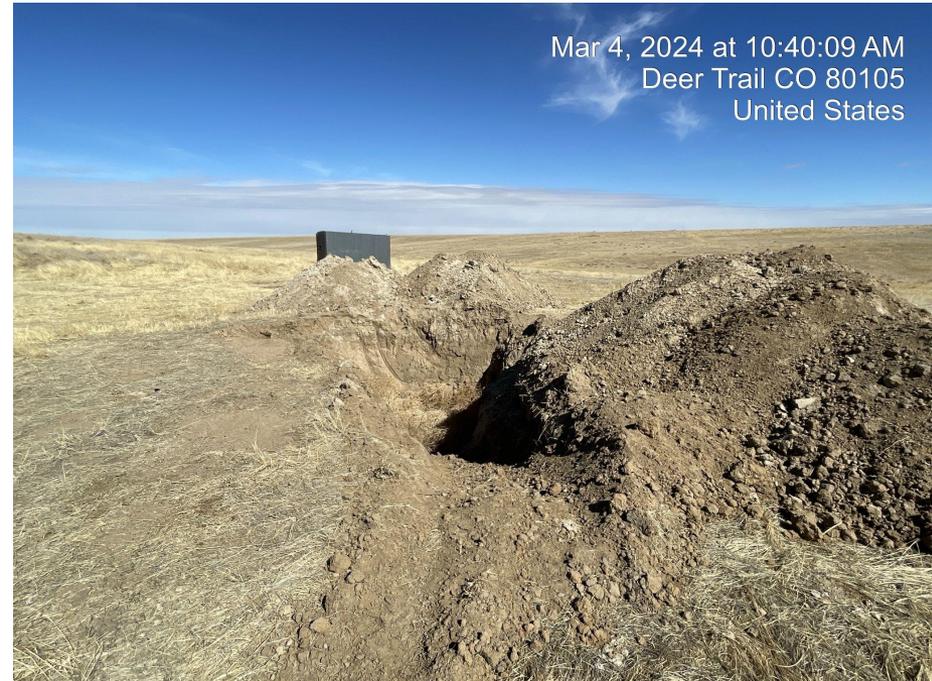
Photo 8. Photo taken facing north of removed well head excavation on site.

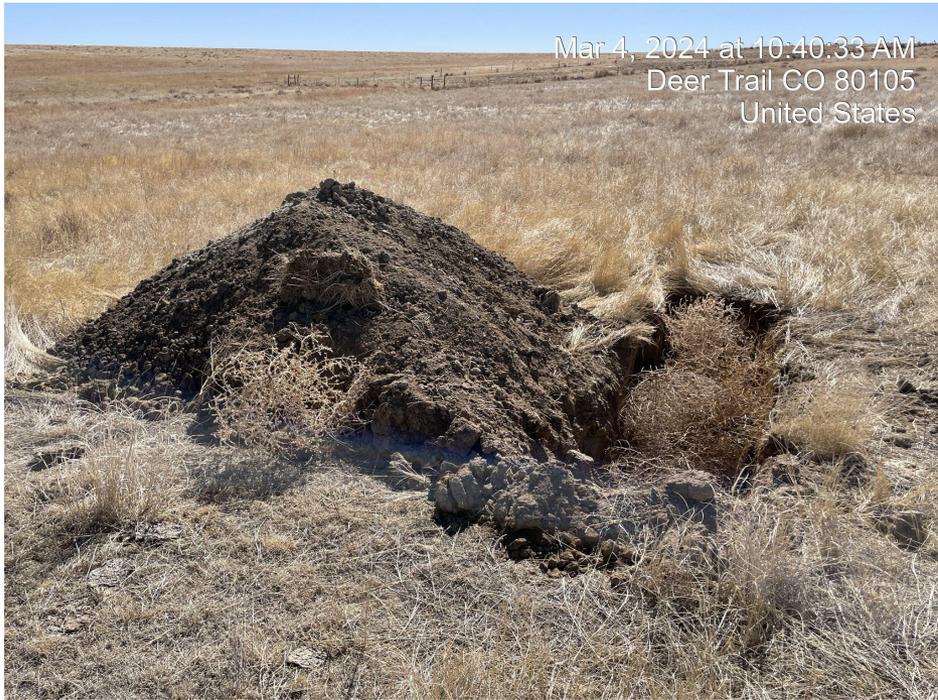
Photo 9. Photo taken facing southwest of excavation of anchor on southwest side of site in reclamation area.

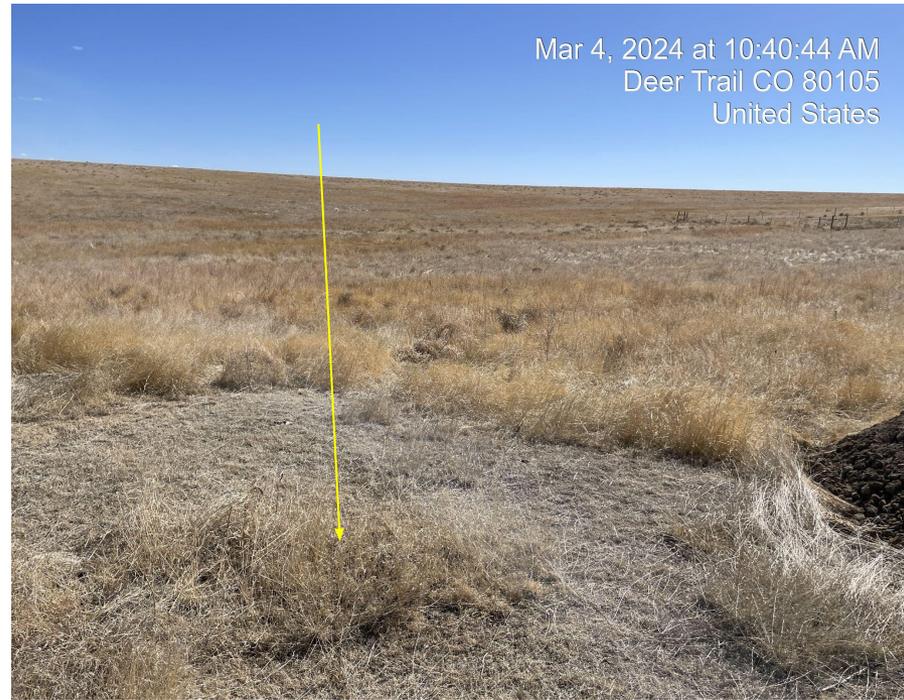
Photo 10. Photo taken vegetation and weeds (russian thistle) soil in reclamation area. Weeds indicated by yellow arrow.

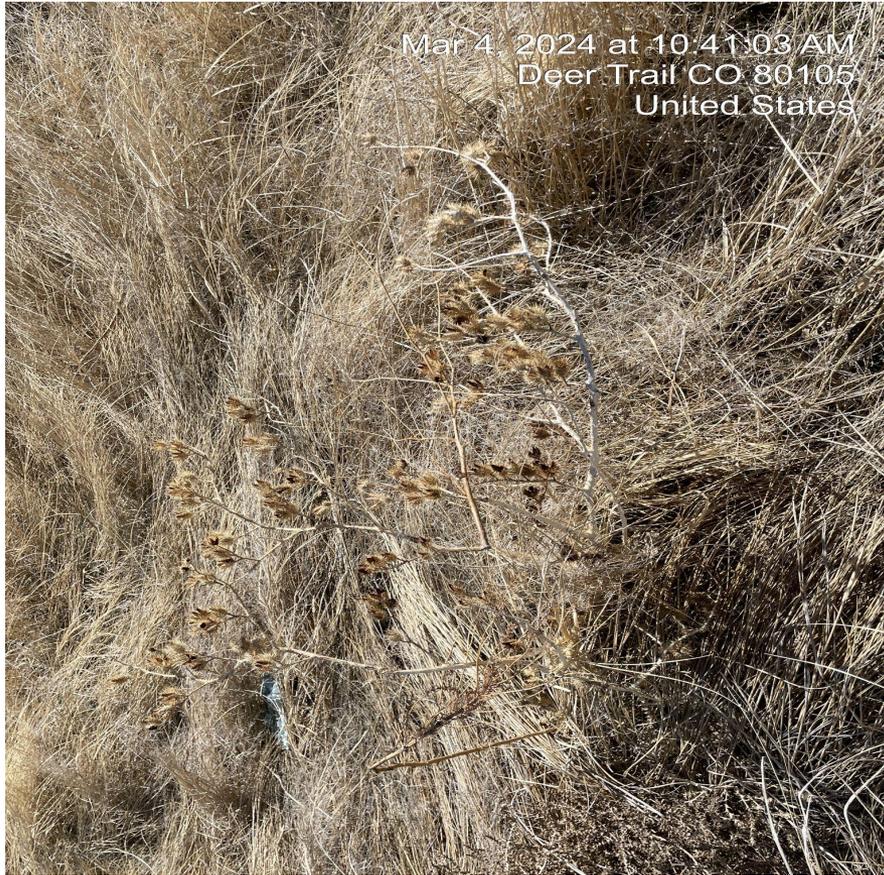
Photo 11. Photo taken facing south of bull thistle in reclamation area.

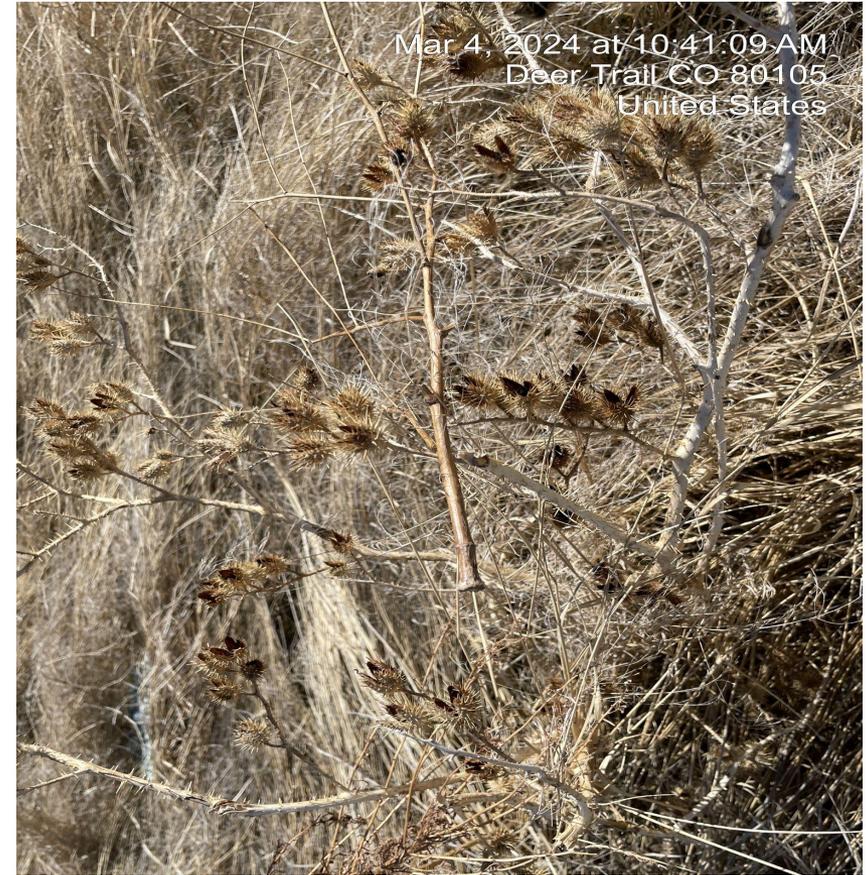
Photo 12. Photo taken facing south of bull thistle in reclamation area.

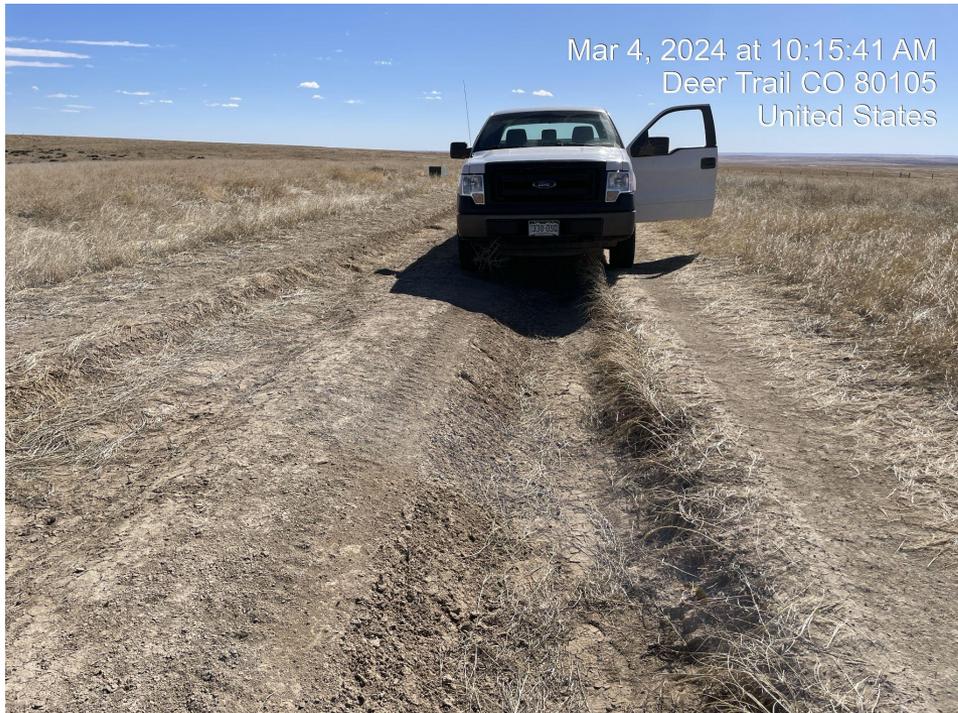
Photo 14. Photo taken facing south of rutted access road.

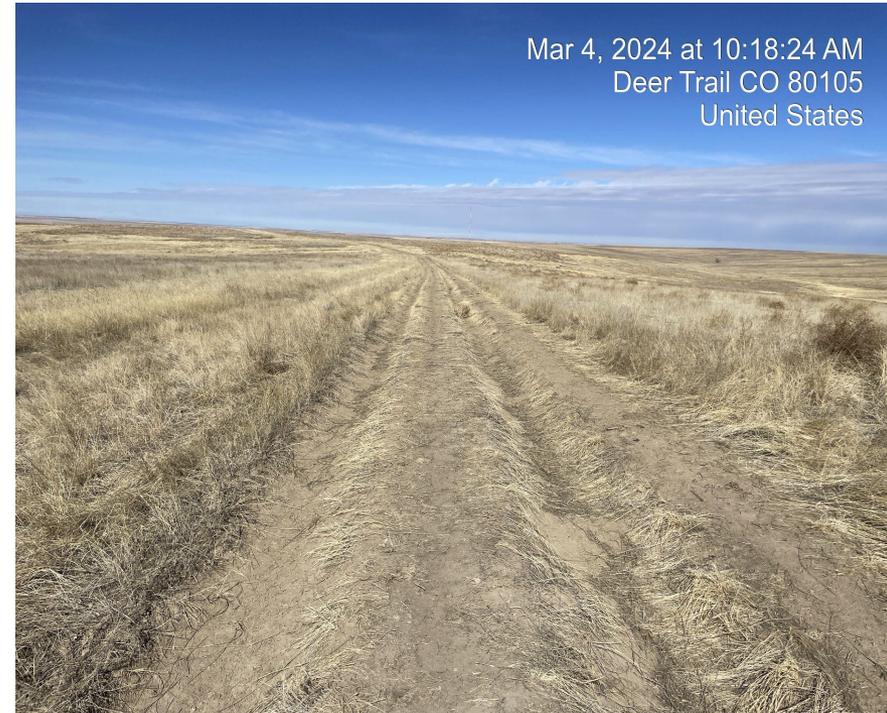
Photo 15. Photo taken facing northwest of rutted access road.
