Inspection Photos

Location Name: ROUSE USX AB-67N64W/33SWSW

Location #: 302629

Rouse USX AB 33-13 (123-29500) Wellsite

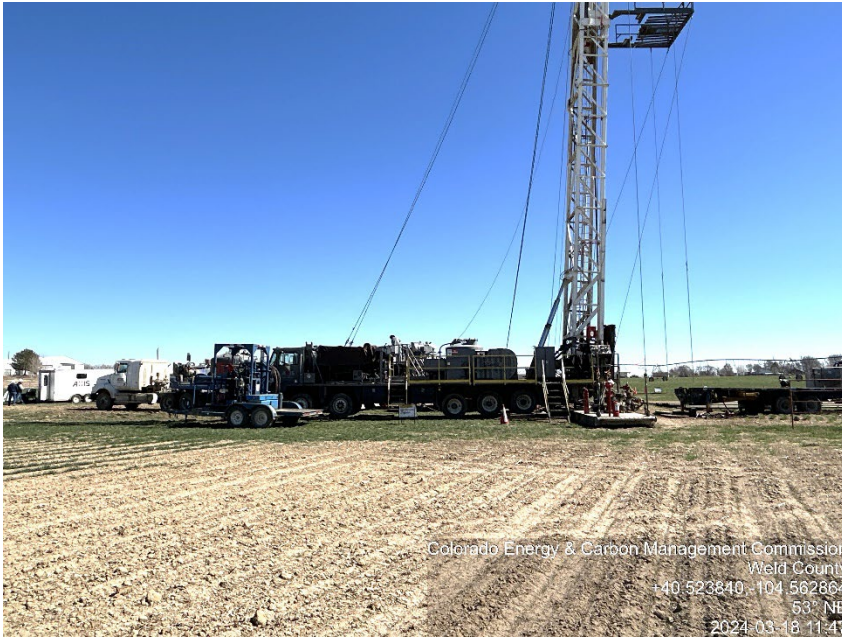
Photo #1

Plugged & Abandoned | PA

Plugging Ops; Cementing: cmt-surf

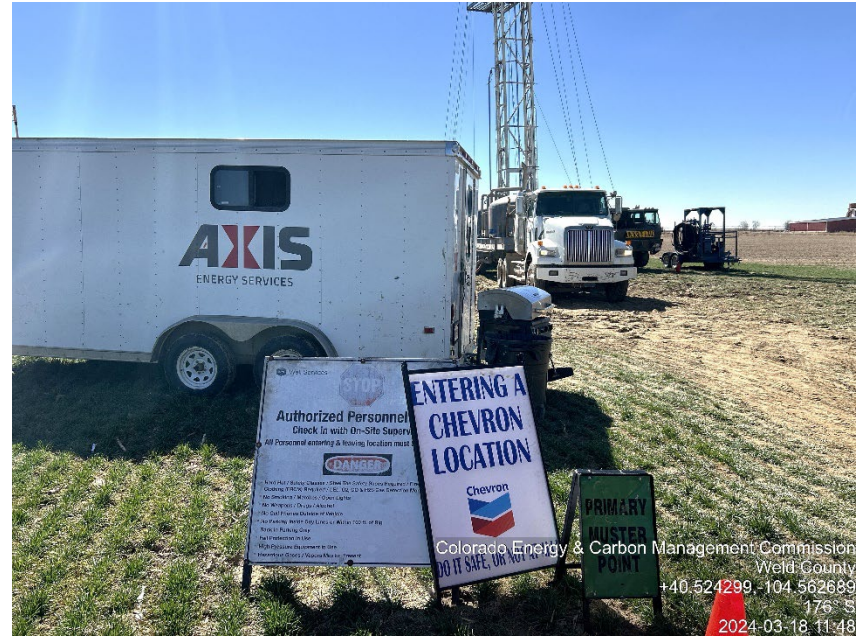
Photo #2

Rouse USX AB 33-13 Wellsite

Plugged & Abandoned | PA

Plugging Ops; Cementing: cmt-surf

Site safety signage

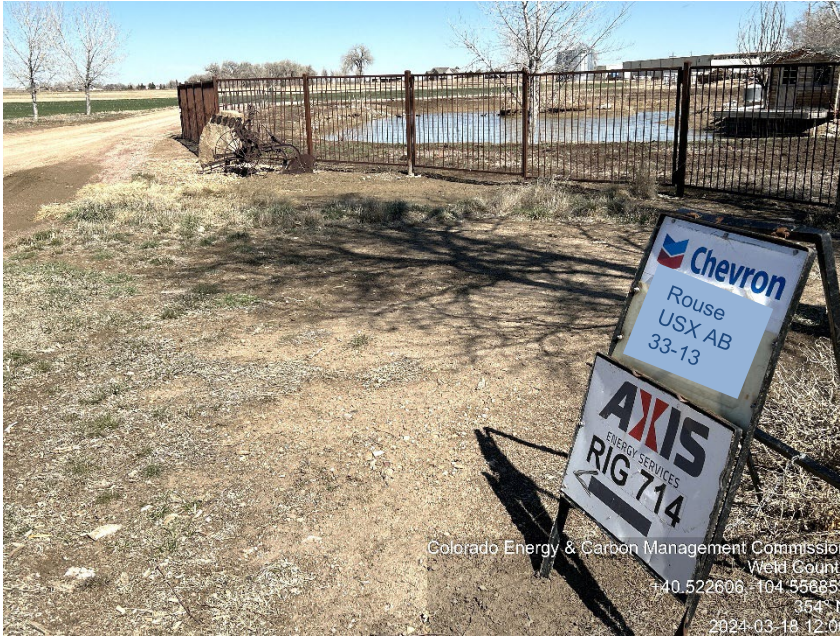
Photo #3
Rouse USX AB 33-13 Wellsite
Plugged & Abandoned | PA
Plugging Ops; Cementing: cmt-surf
Wellsite entrance

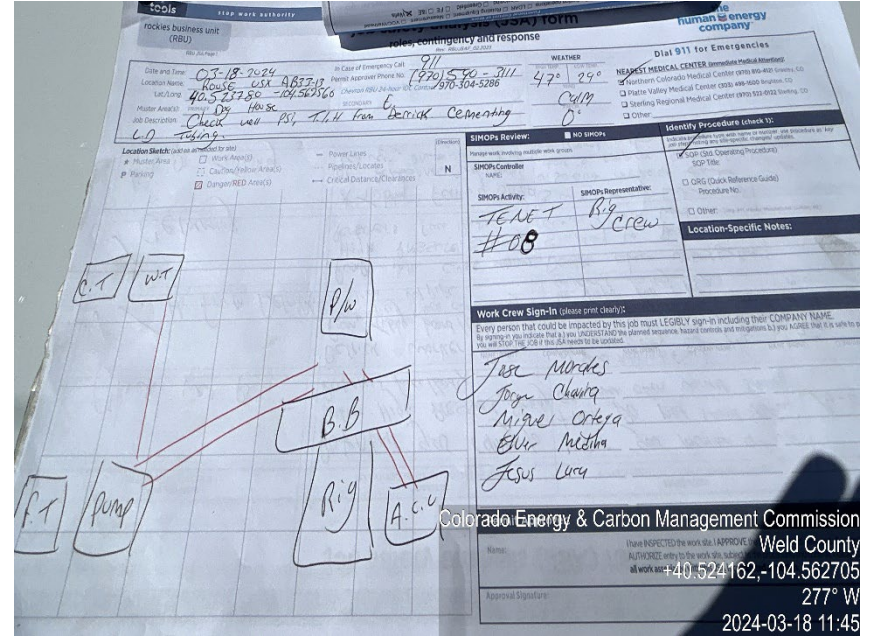
Photo #4
Rouse USX AB 33-13 Wellsite
Plugged & Abandoned | PA
Plugging Ops; Cementing: cmt-surf
JSA: 2024-03-12

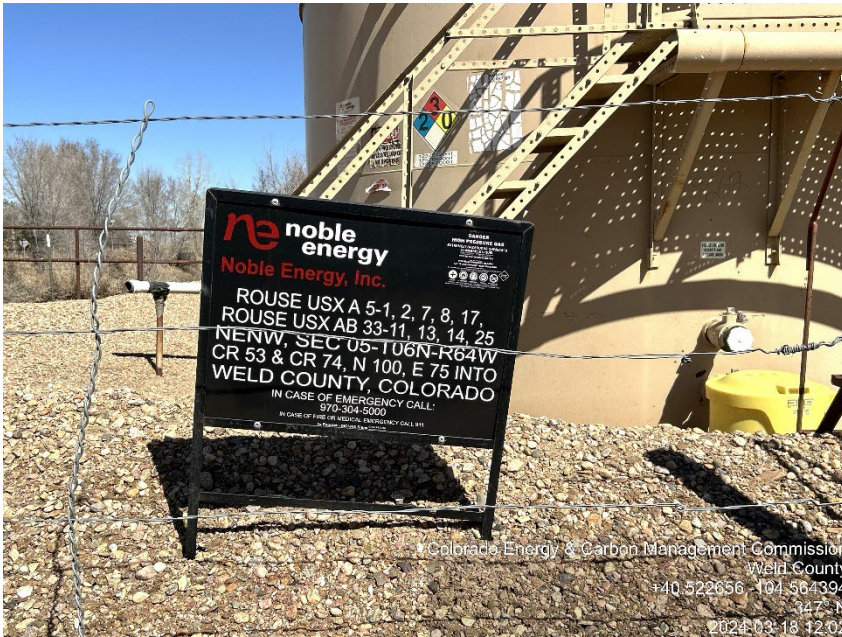
Photo #5

Rouse USX AB 33-13 Battery site

Plugged & Abandoned | PA

Plugging Ops; Cementing: cmt-surf

Battery sign
