Inspection Photos

API: 099-06872

Operator: STRACHAN EXPLORATION INC

Inspection Date: 3/15/2024

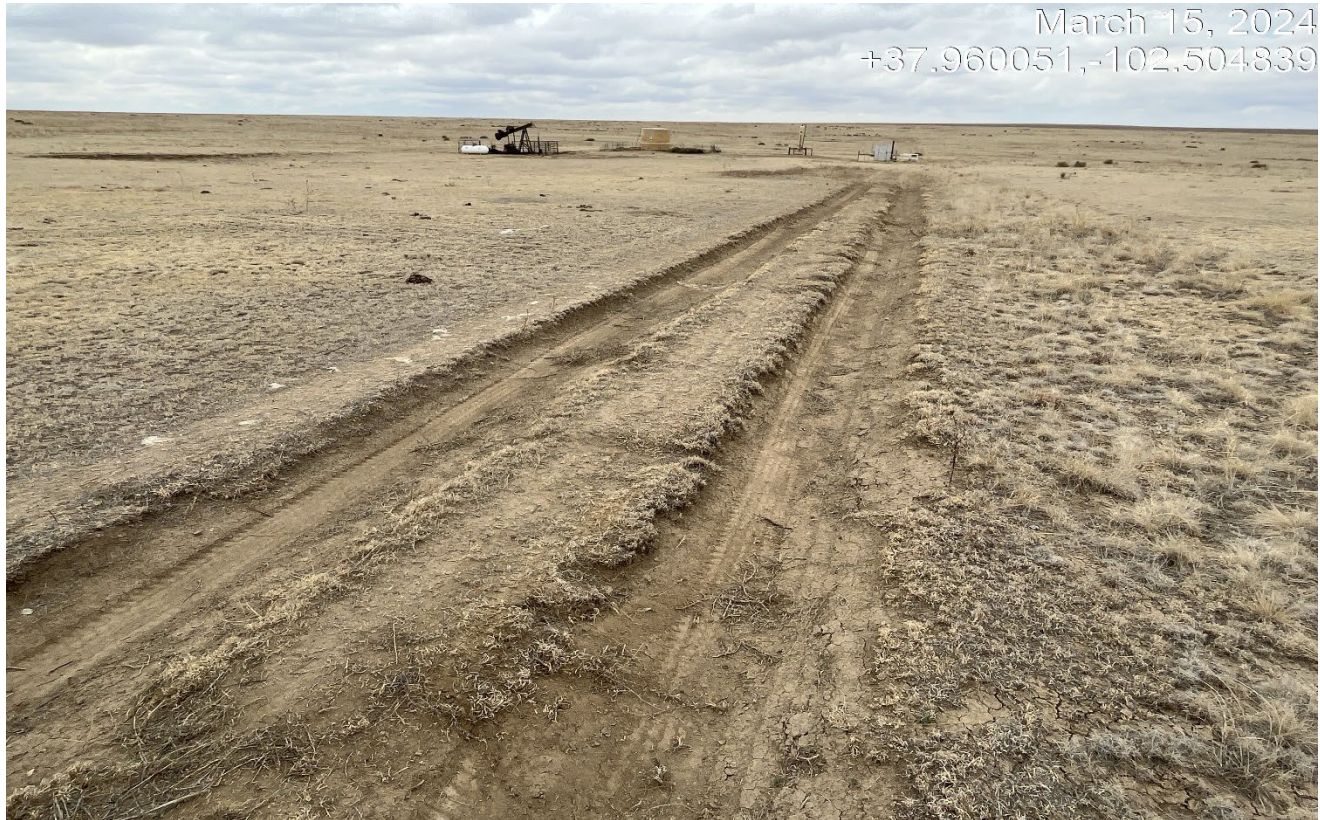
Photo 1. Facing northeast toward the wellsite location.

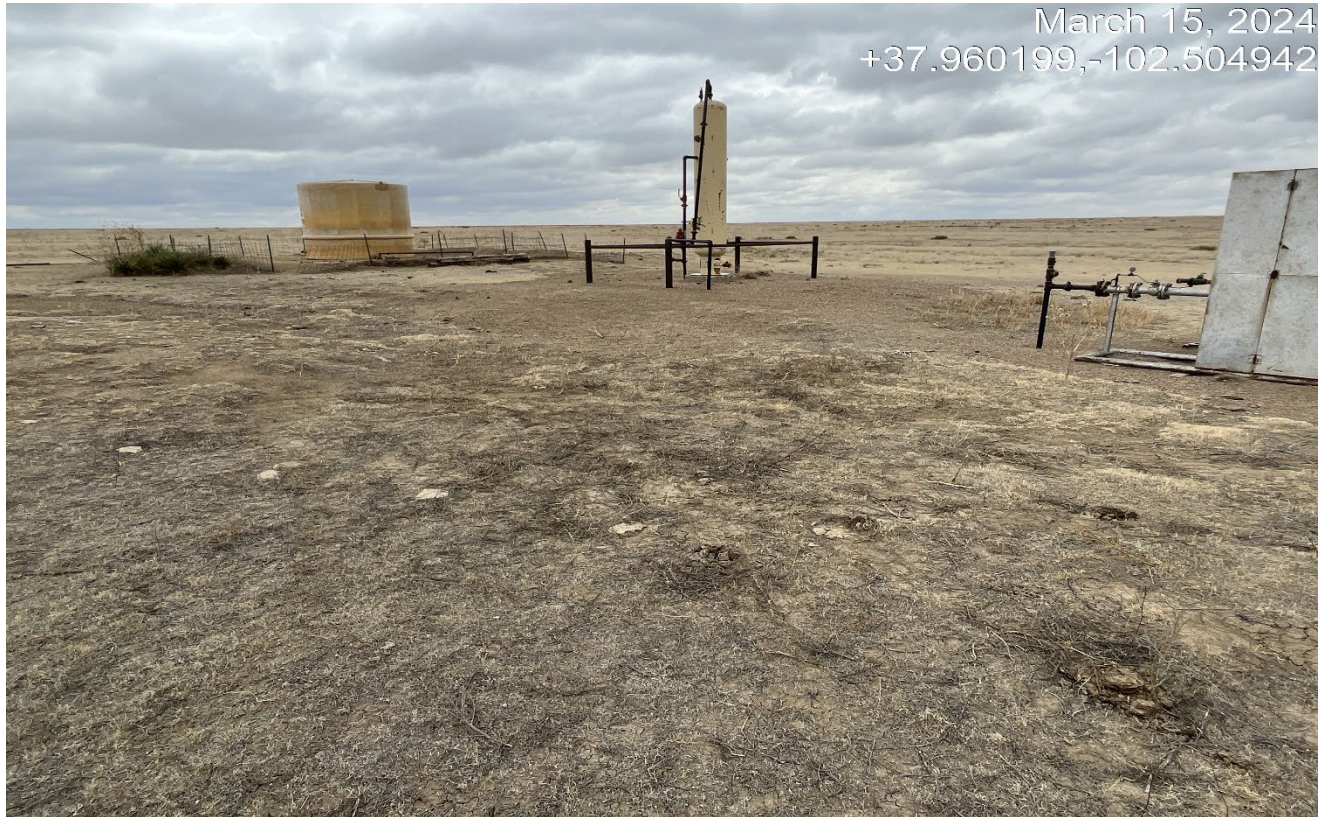
Photo 2. Facing southwest at the wellsite. There was no sign posted at the wellsite.

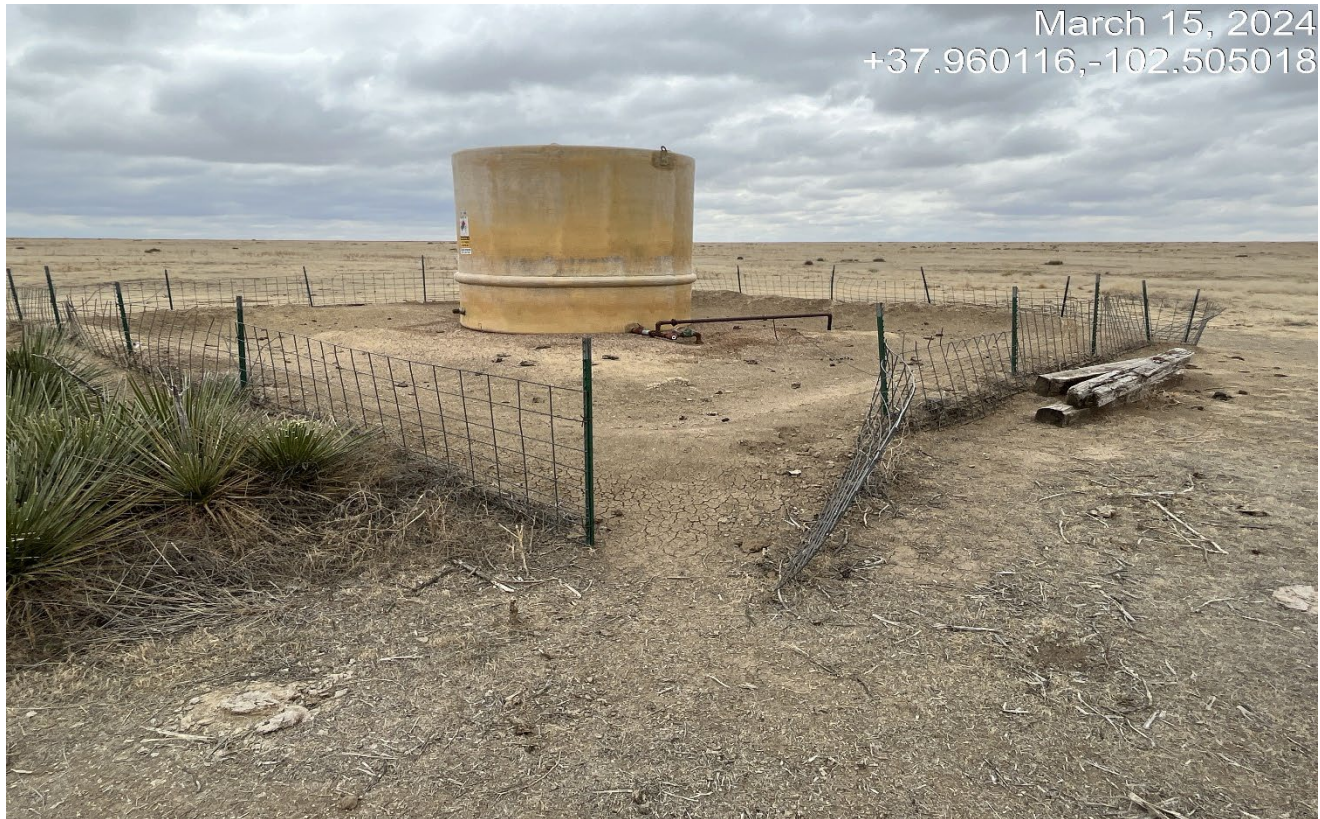
Photo 3. Facing toward the fiberglass tank. The fence around the tank is not maintained to prevent livestock entry.

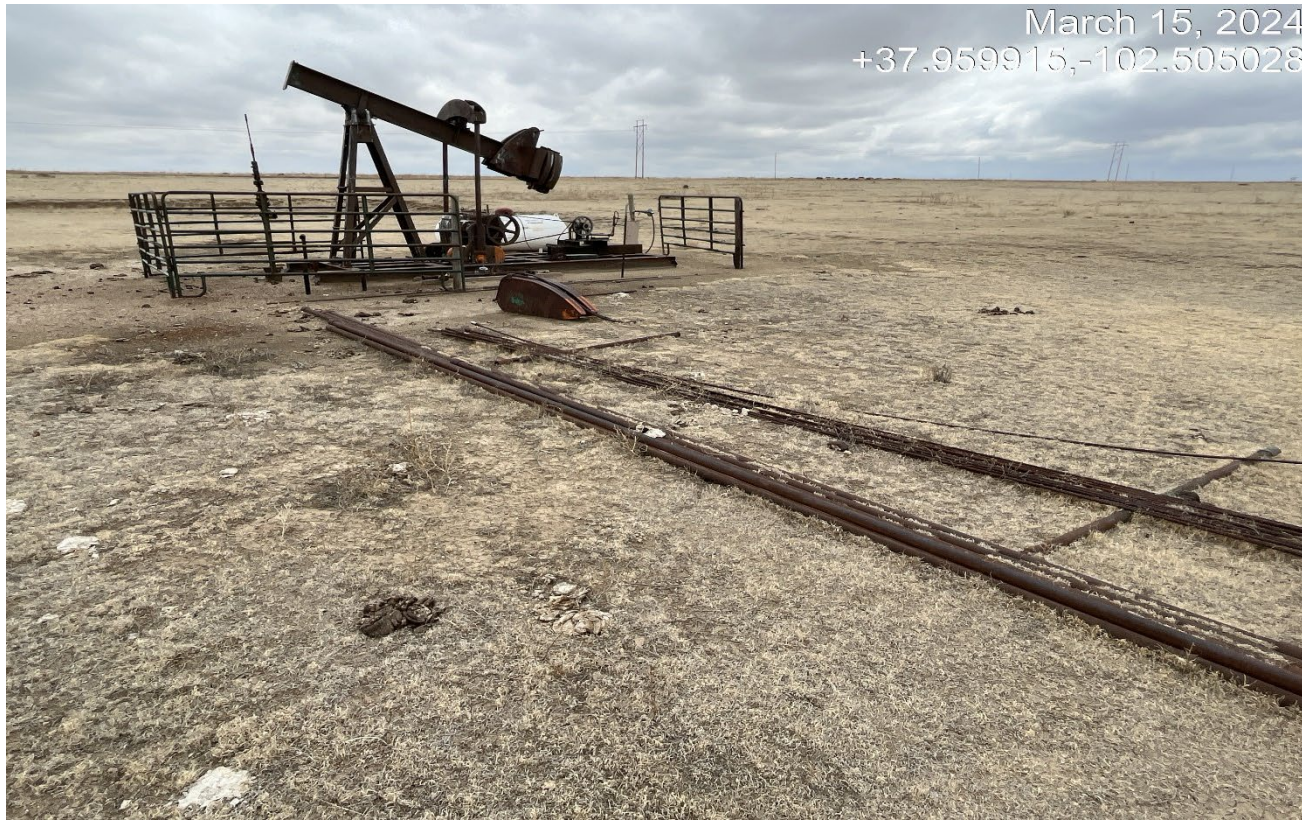
Photo 4. Facing toward the well. There is unused equipment and drilling pipe that needs to be removed..

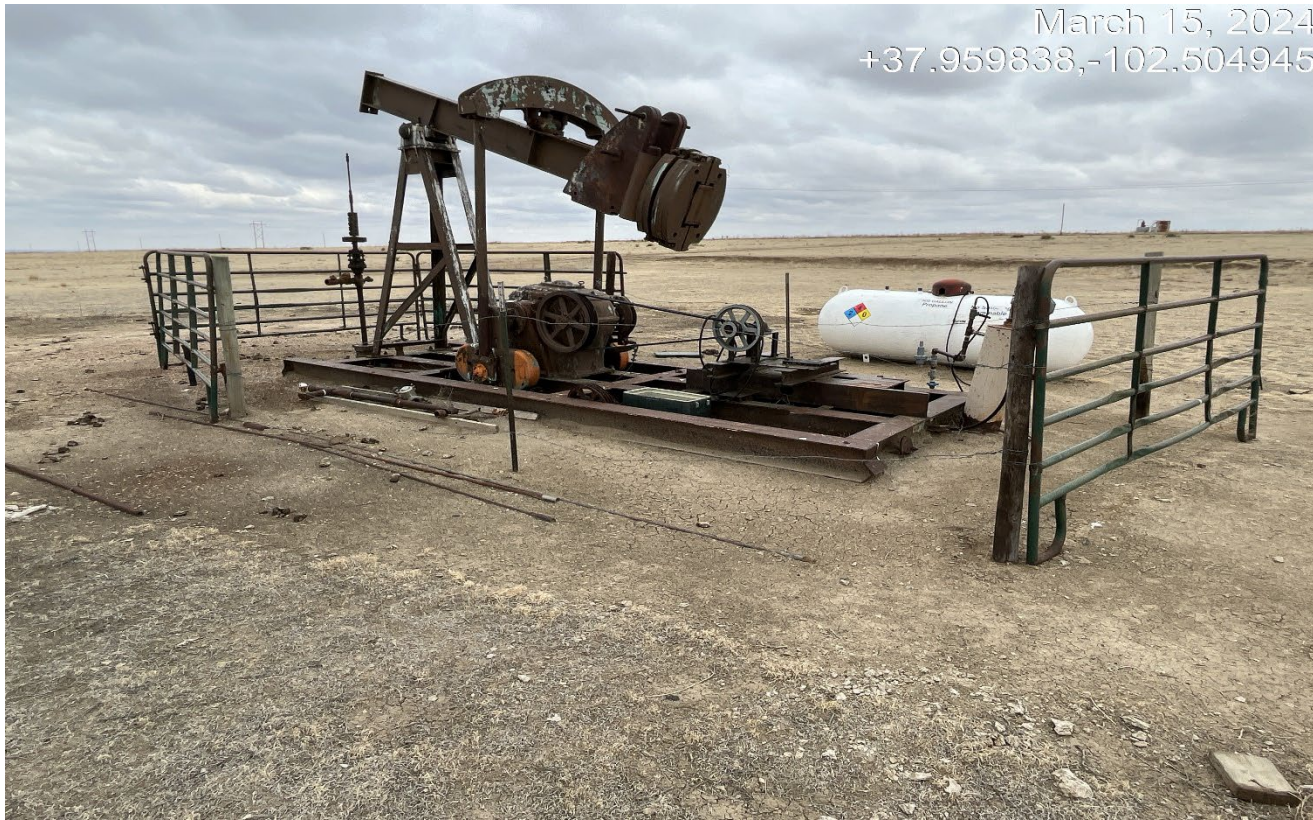
Photo 5. The fence around the pumpjack is insufficient to prevent livestock entry.

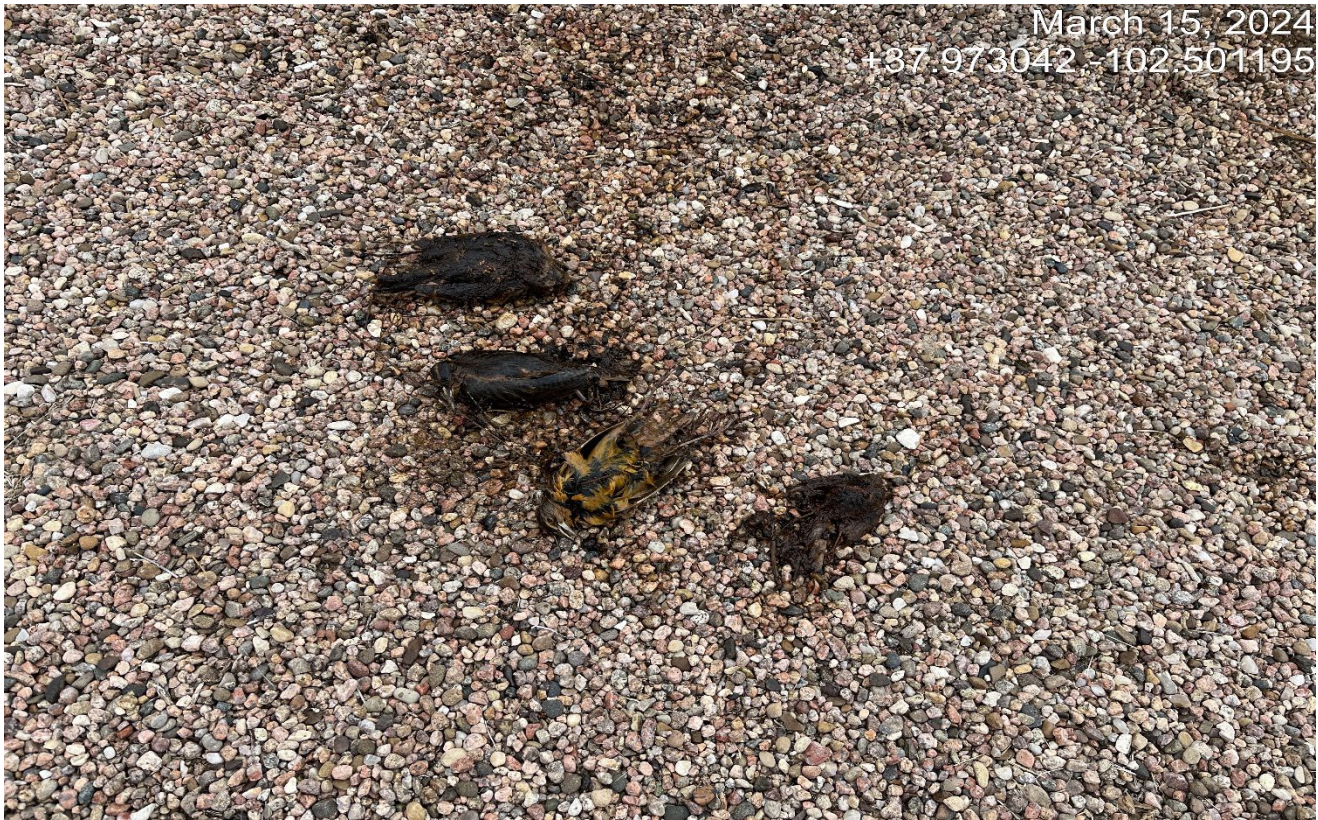
Photo 6. There were 4 dead birds pulled out of the tank.
