Inspection Photos

API: 099-06328

Operator: BERRY* WALTER V DBA BERRY ENERGY INC

Inspection Date: 3/15/2024

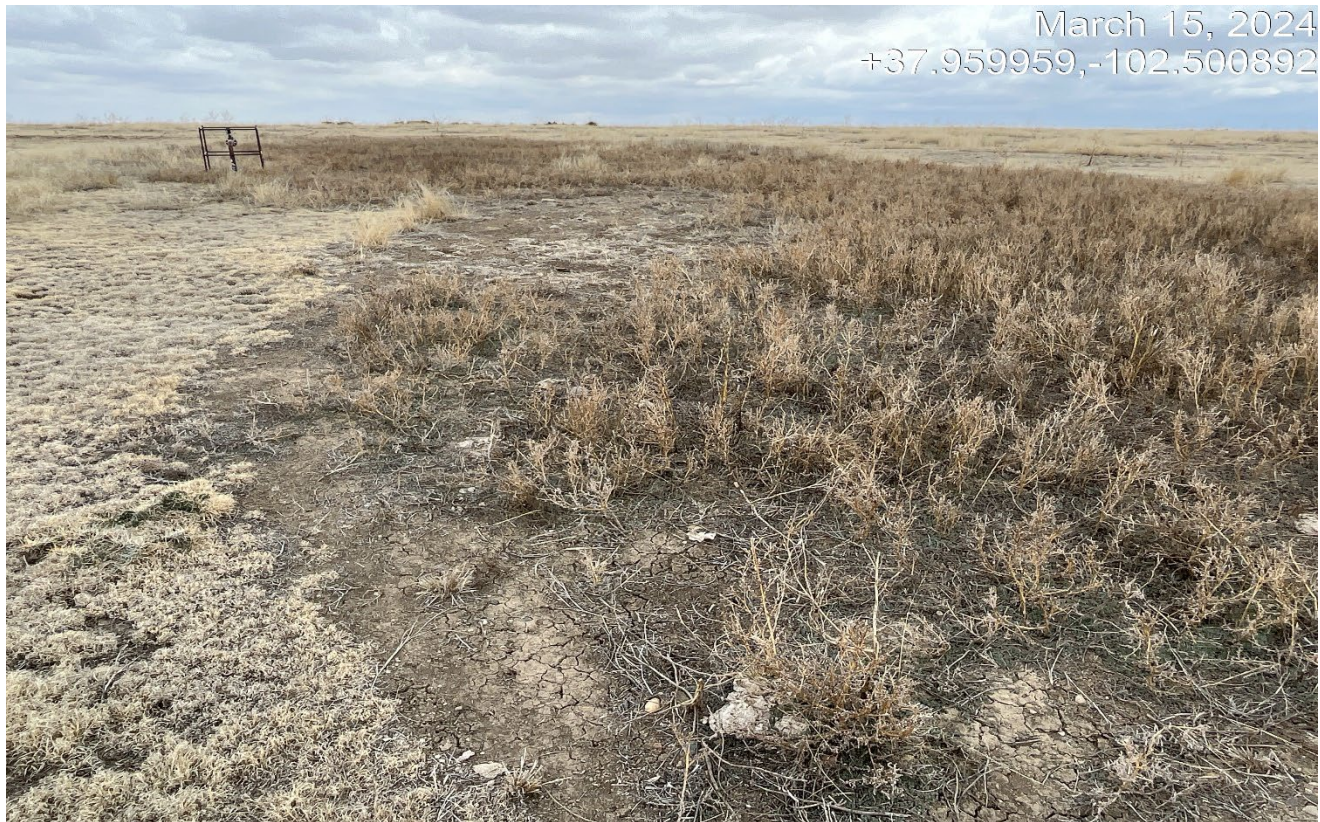
Photo 1. Facing east toward the location. This area has not established a perennial uniform cover and consists mostly of undesirable weeds.

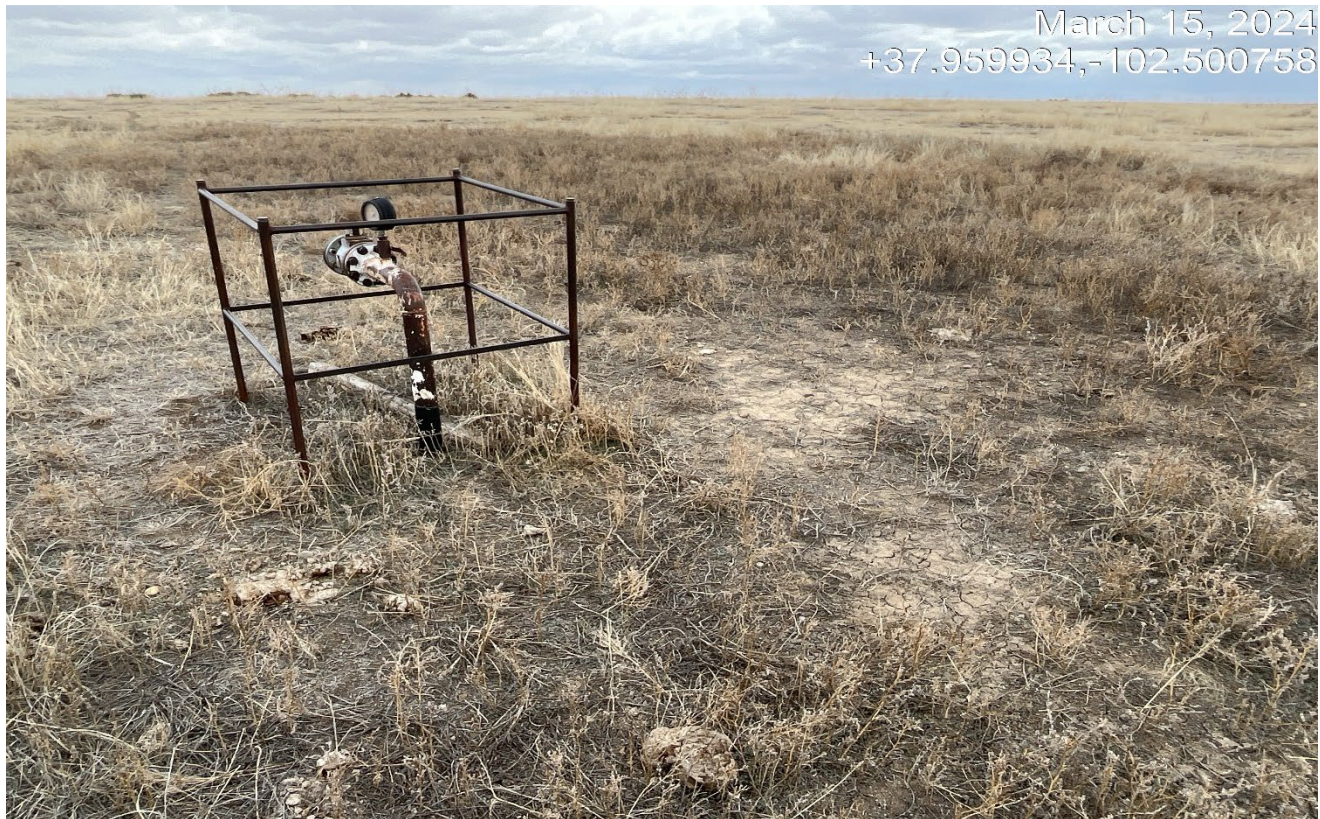
Photo 2. There is an abandoned pipe riser that remains on location that was never removed..

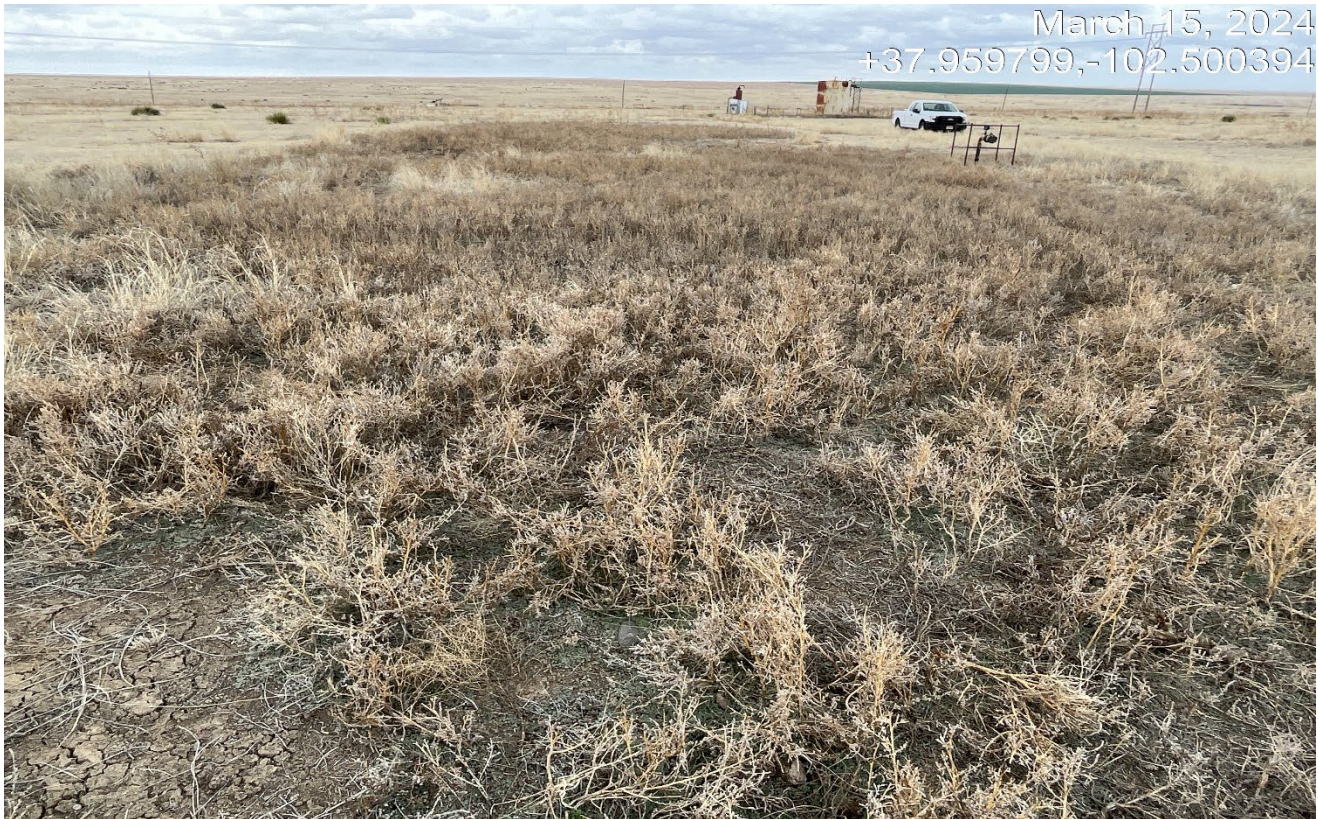
Photo 3. Facing west at the location. This area (approx. 200'x60') has not established a perennial uniform cover and consists mostly of undesirable weeds.

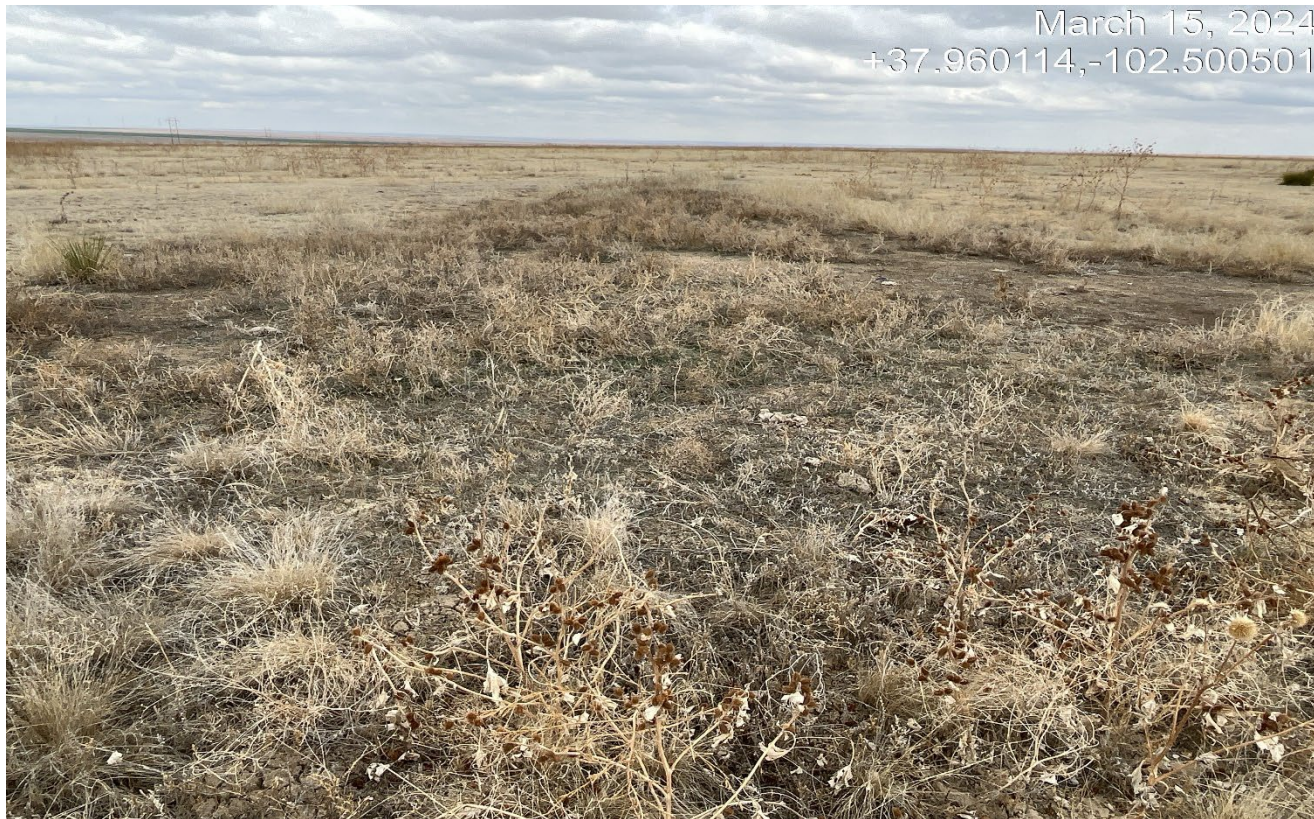
Photo 4. Facing north at the location. This area (approx. 100'x40') has not established a perennial uniform cover and consists mostly of undesirable weeds.

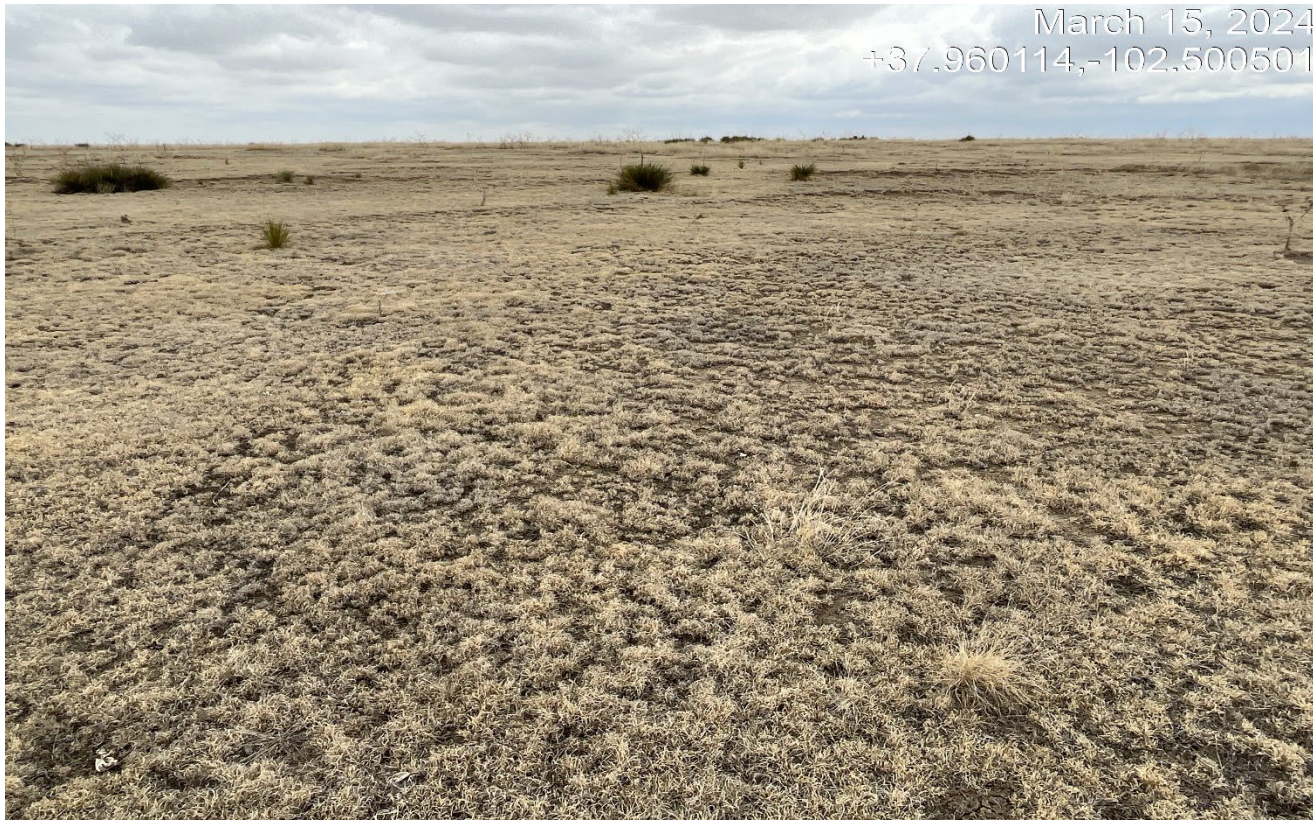
Photo 5. Facing east at the undisturbed surrounding reference area shows a uniform native Blue grama prairie with no weeds.
