Inspection Photos

ID: 444661

Operator: STRACHAN EXPLORATION INC

Inspection Date: 3/15/2024

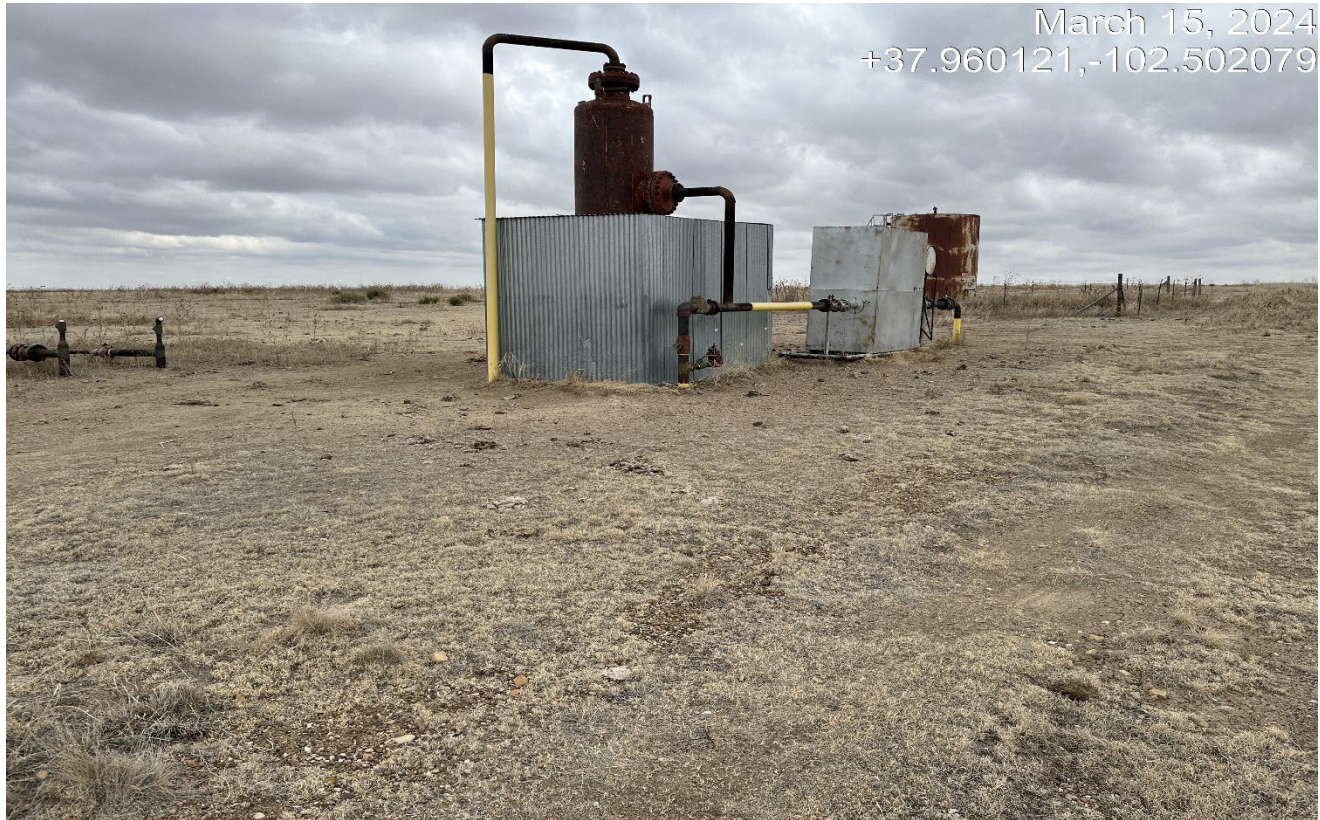
Photo 1. Facing northeast toward the compressor facility.

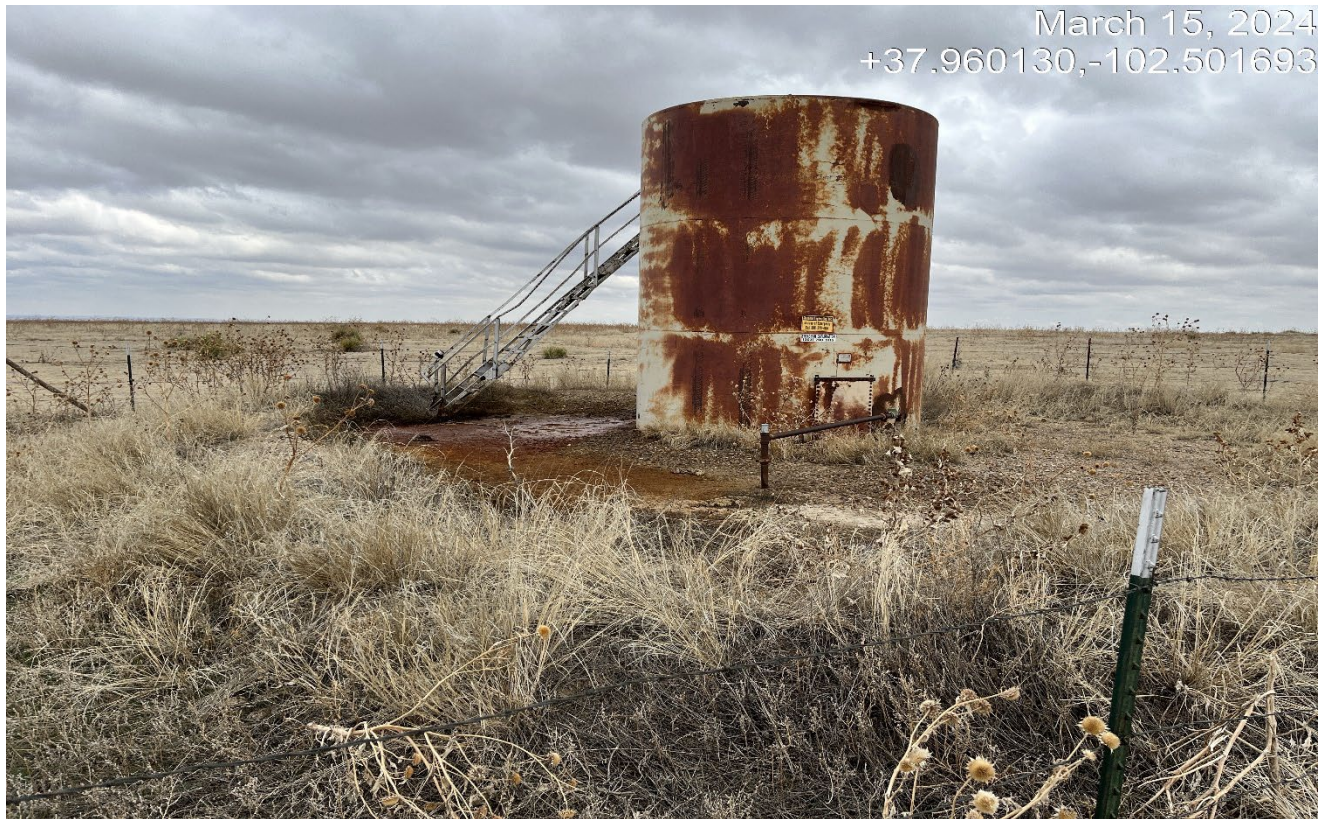
Photo 2. Facing northeast toward the tank. There is a leak that occurred at the tank within the secondary containment. There is insufficient labeling and signage at the tank .

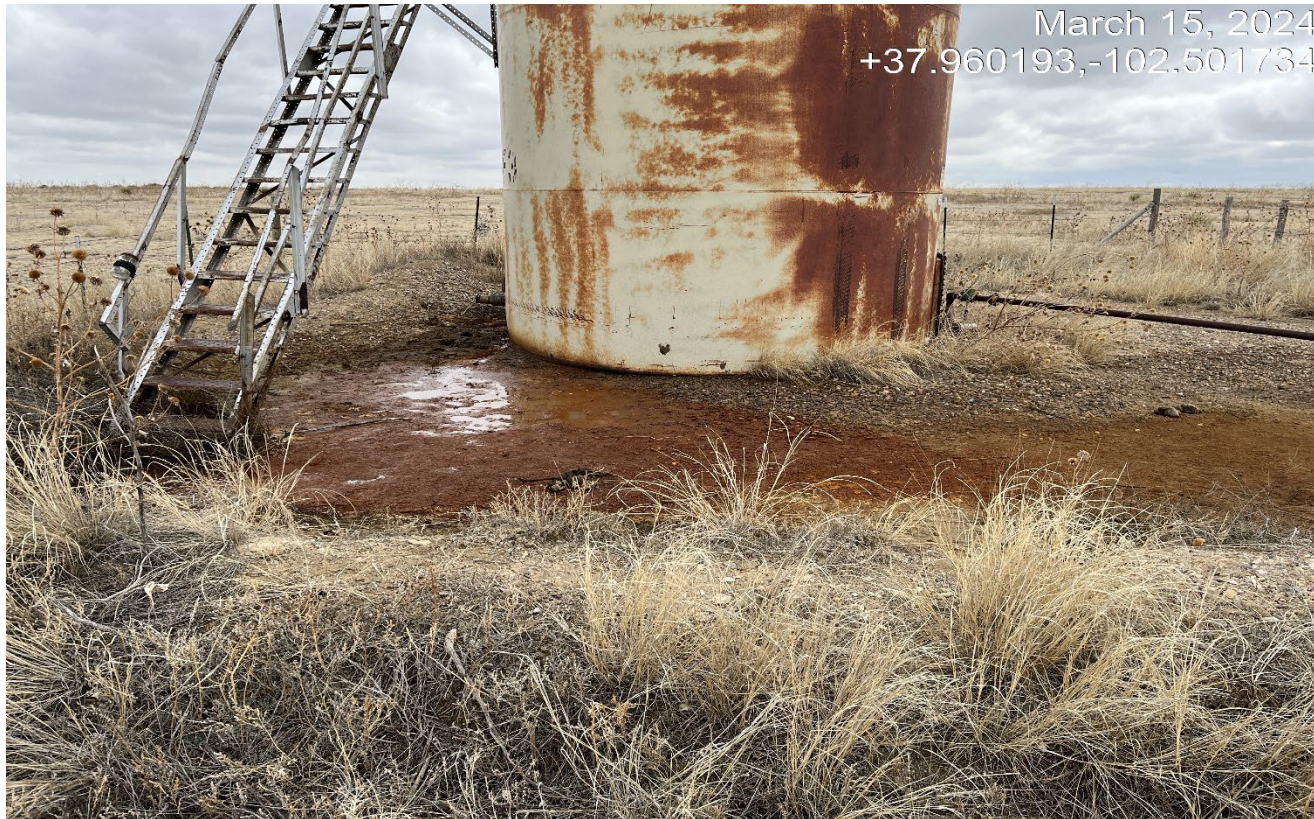
Photo 3. Facing east toward the tank. There is a leak that occurred at the tank within the secondary containment. There is insufficient labeling and signage at the tank .

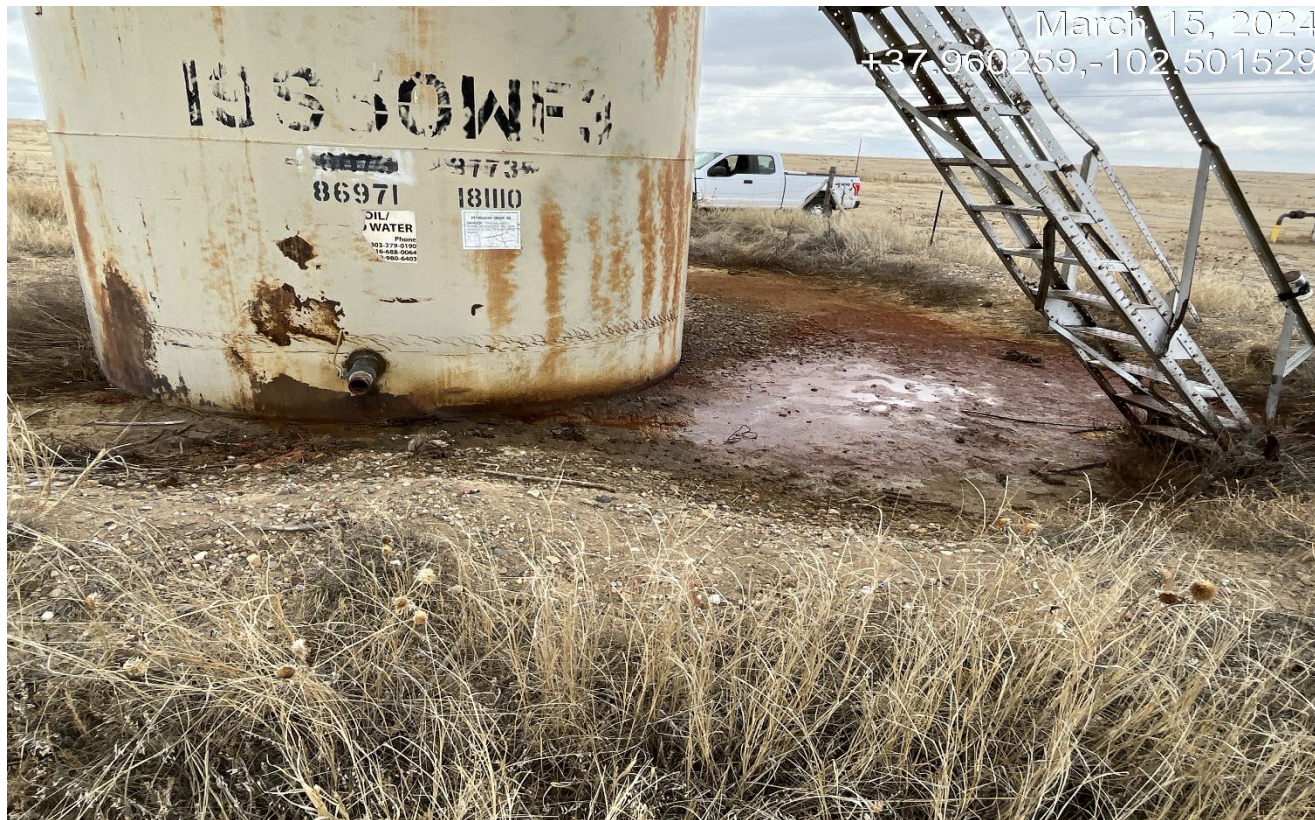
Photo 4. Facing toward the tank. There is a leak that occurred at the tank within the secondary containment. There is insufficient labeling and signage at the tank .

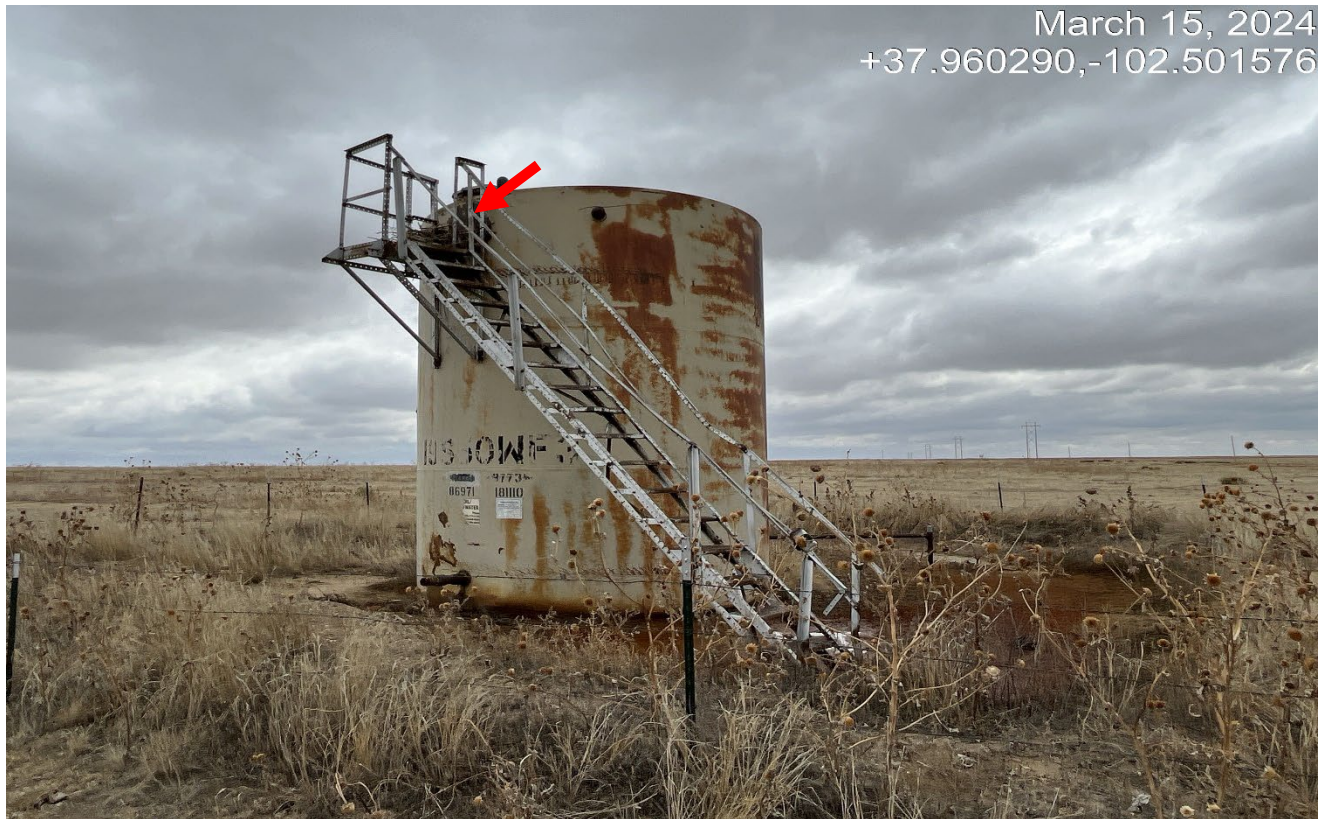
Photo 5. There is a bird nest at the top of the tank that should not be disturbed. Operator will need to contact CPW or USFS regarding bird nest.

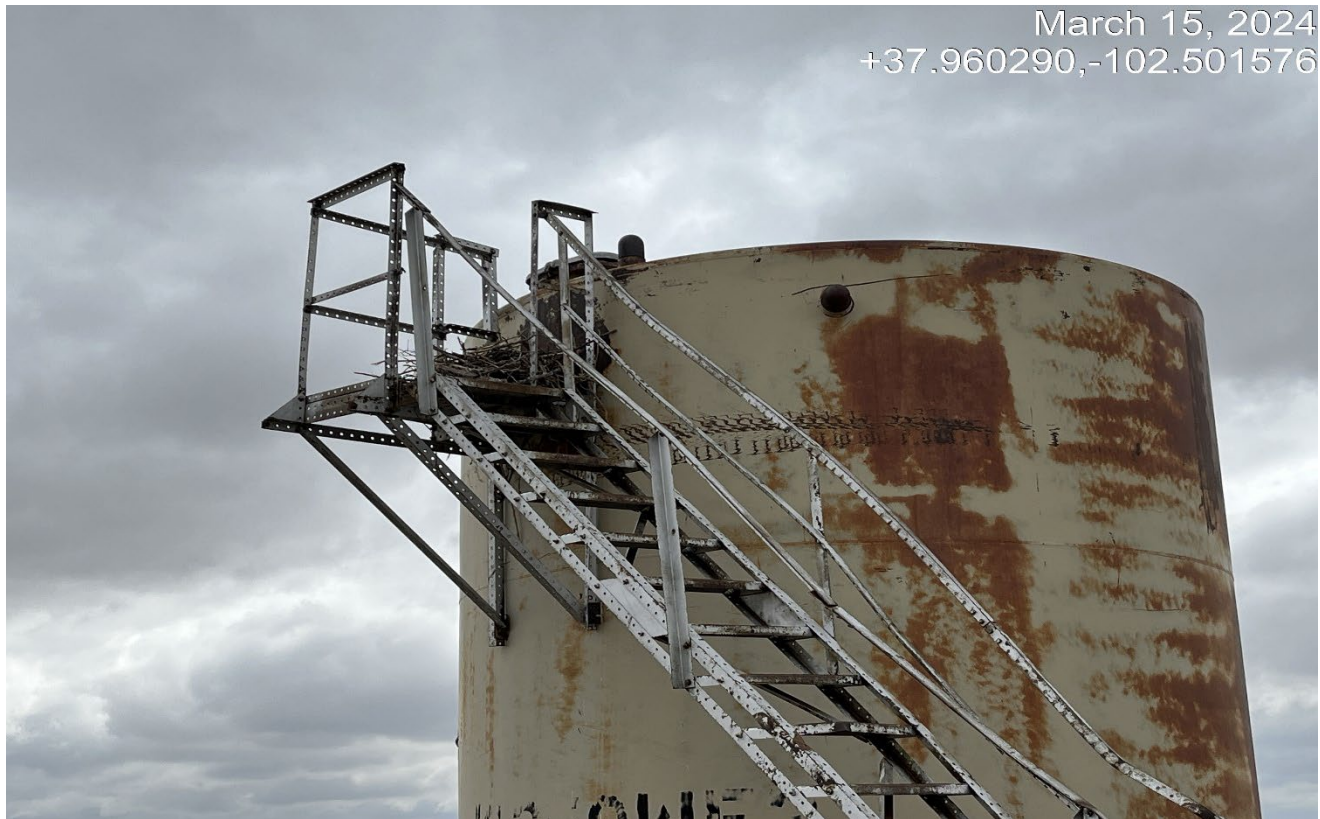
Photo 6. There is a bird nest at the top of the tank that should not be disturbed. Operator will need to contact CPW or USFS regarding bird nest.
