Inspection Photos and Issue Report

Operator: TEP ROCKY MOUNTAIN LLC #96850

Location ID: 486086

Inspection Doc: 696205680

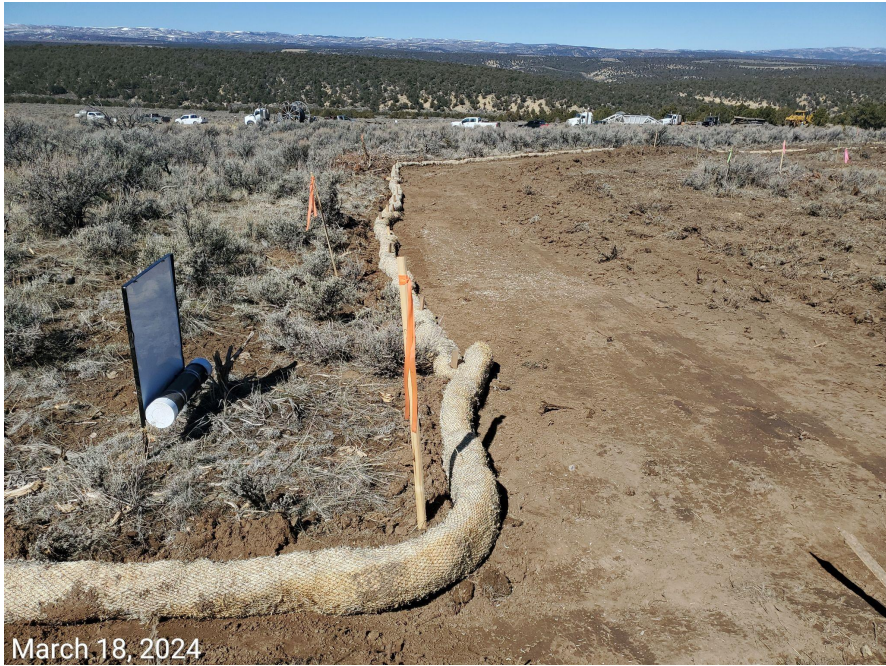
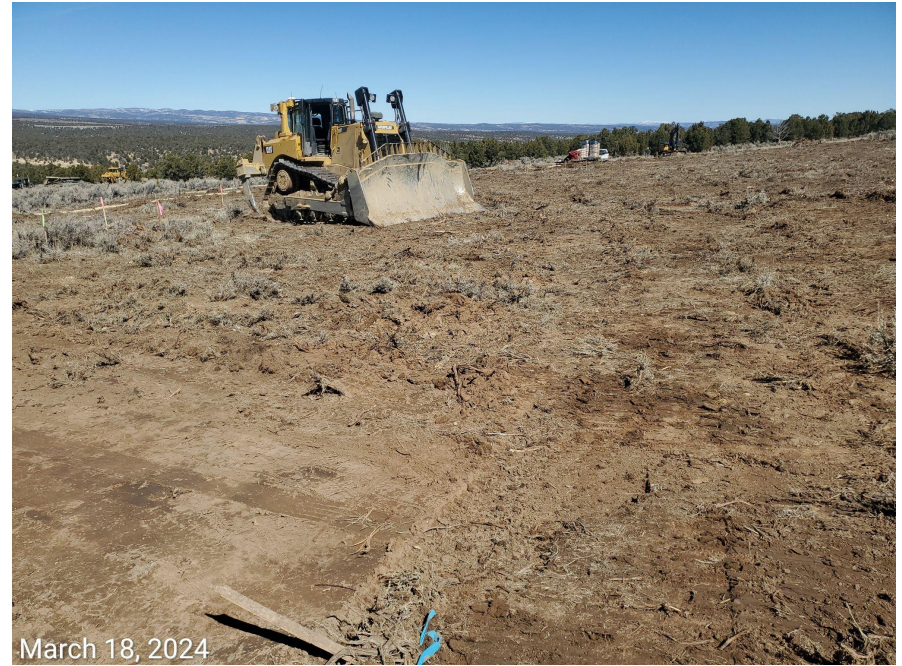
Photo 1: Photos 1-2 taken from the Location entrance on the southwest end of the site. Photos provide an overview of the Location from northwest, north, northeast to east. Photo shows grubbing activities have commence / been completed. Operator in process of installing erosion logs along the western perimeter of the Location; stormwater and erosion control BMPs remain missing along remaining disturbance perimeter.

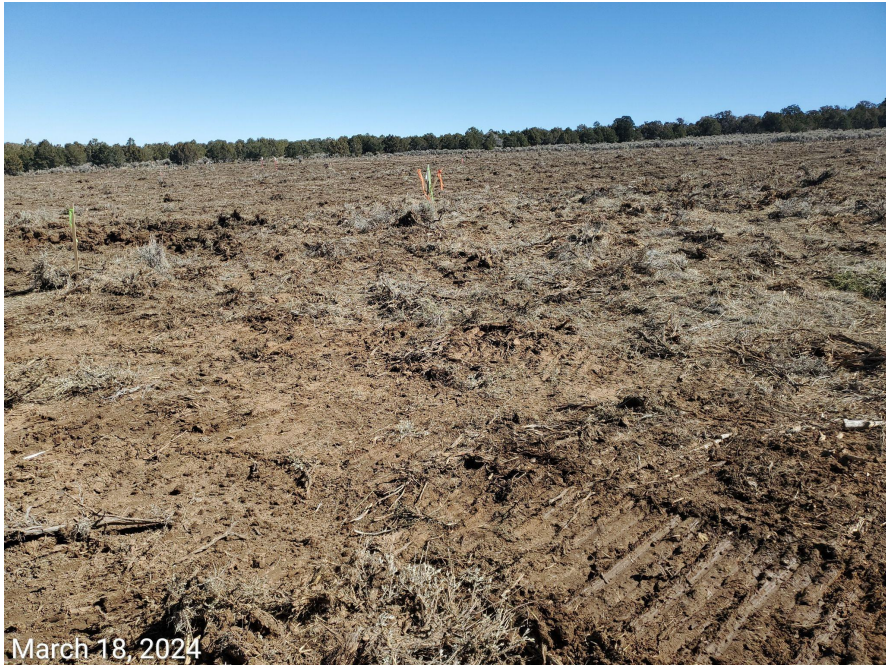
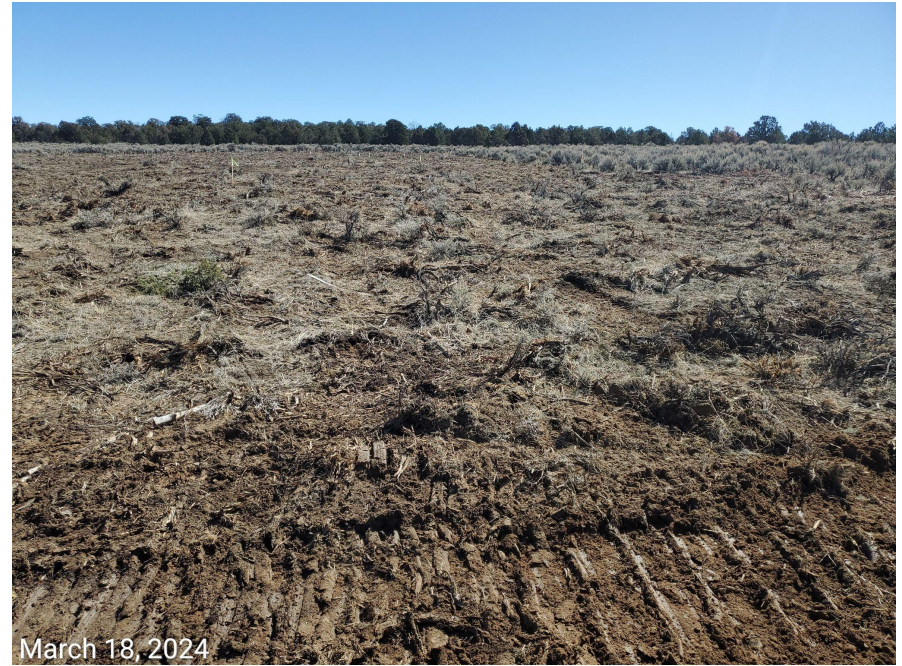
Photo 2: See comments under photo 1.

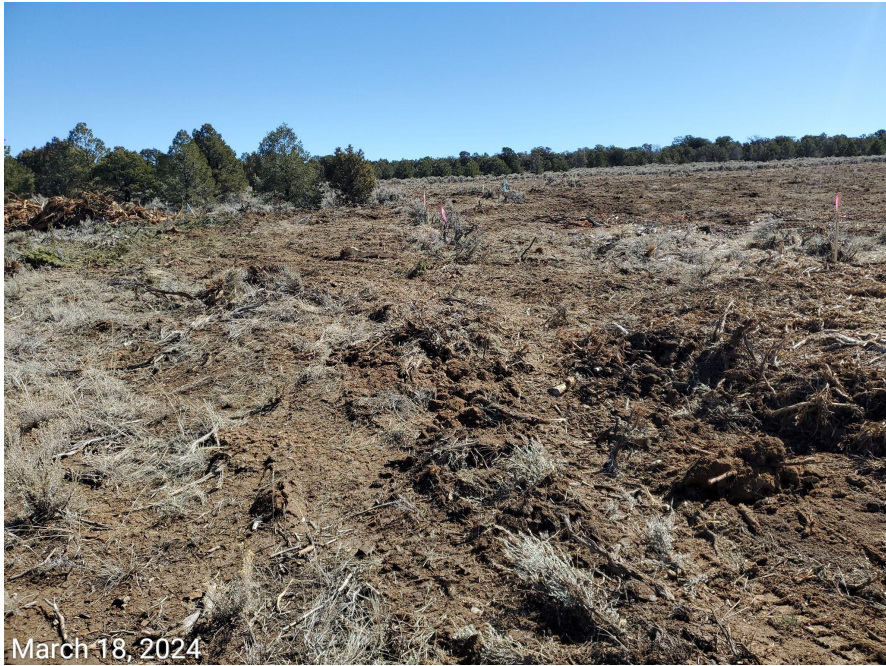
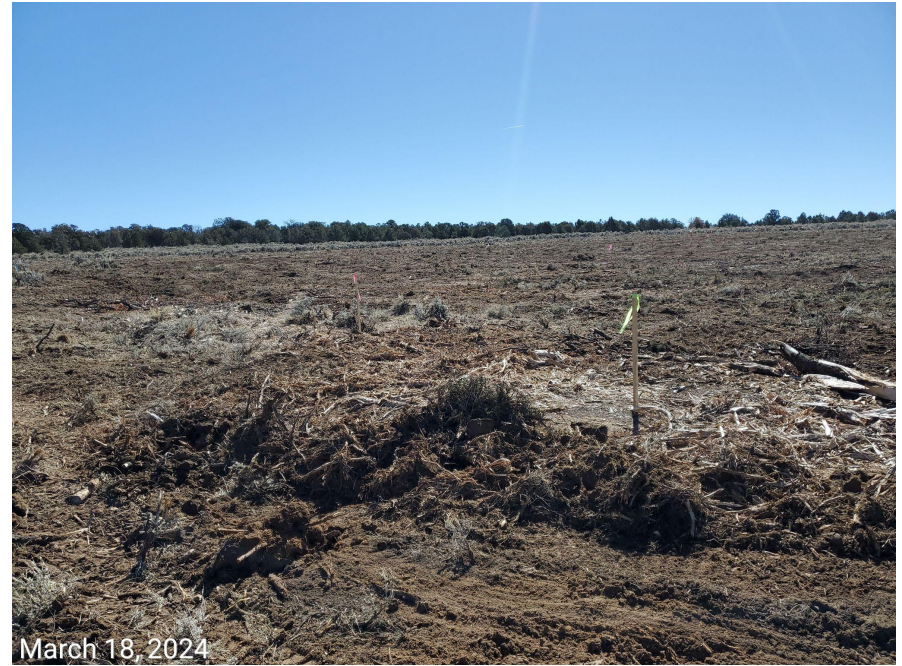
Photo 3: Photos 3-4 taken from the North end of the Location. Photos provide an overview of the Location from east, southeast, southwest to west. Photo shows grubbing activities have commence / been completed. Operator in process of installing erosion logs along the western perimeter of the Location; stormwater and erosion control BMPs remain missing along remaining disturbance perimeter.

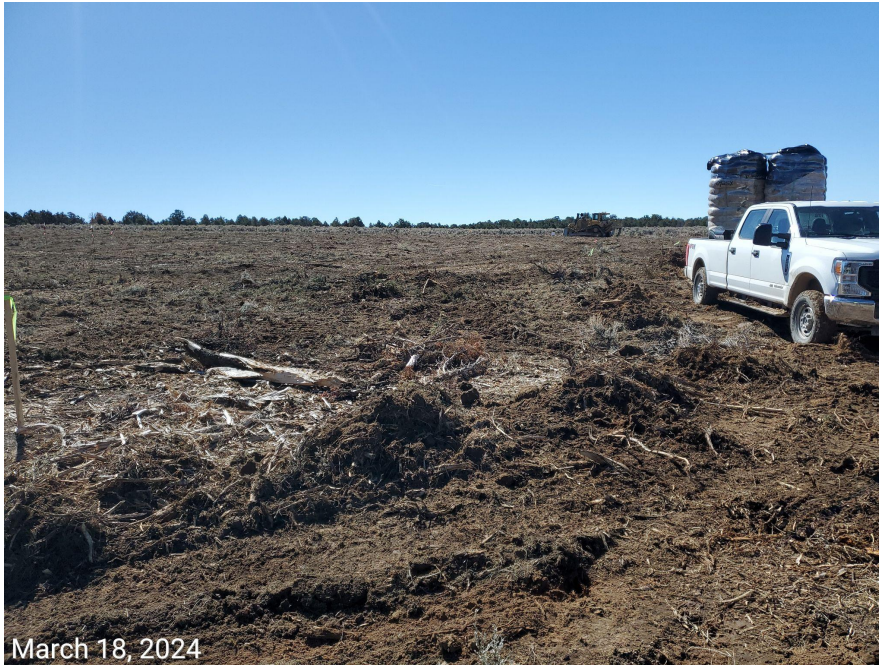
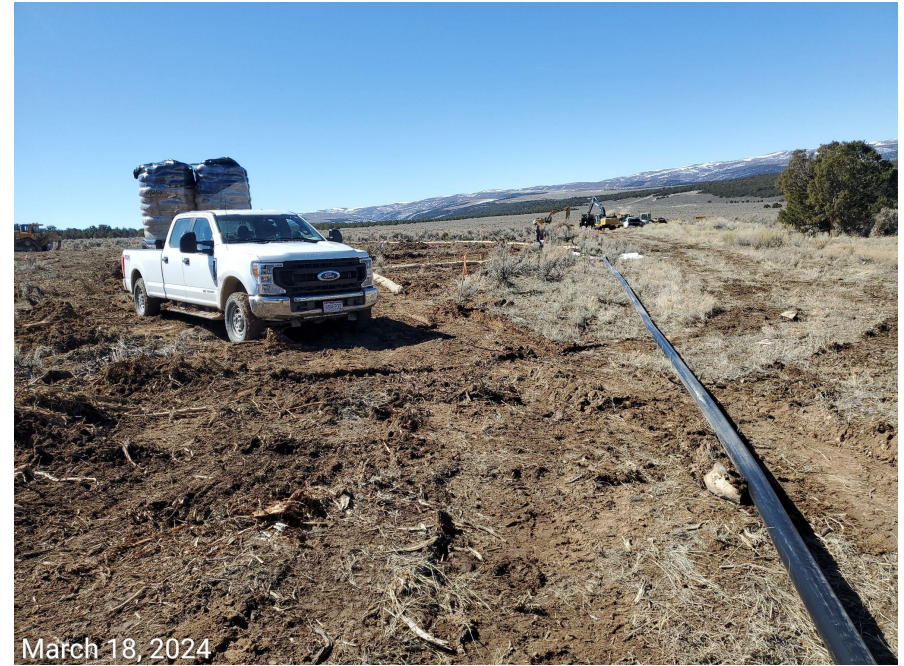
Photo 4: See comments under photo 3.

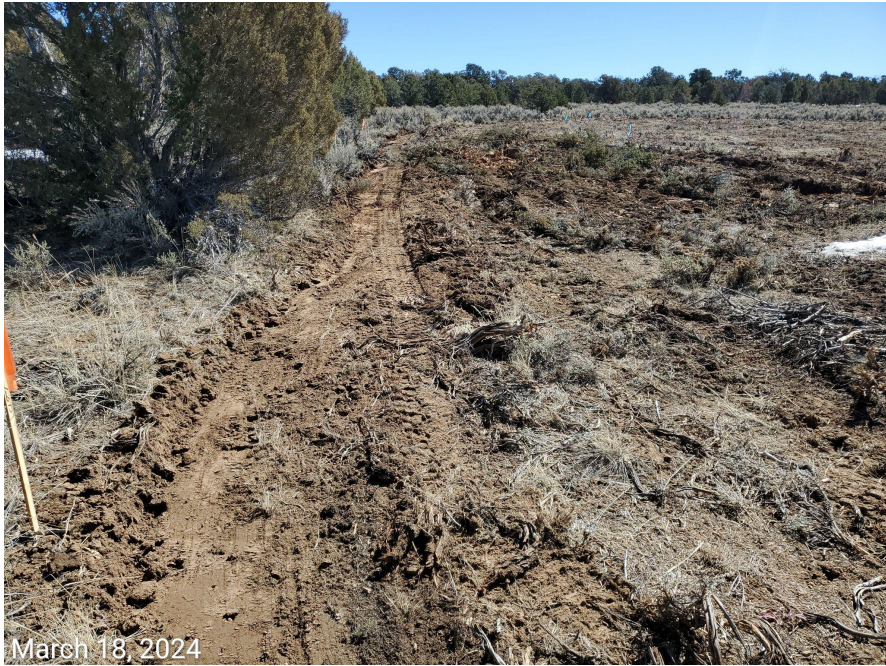
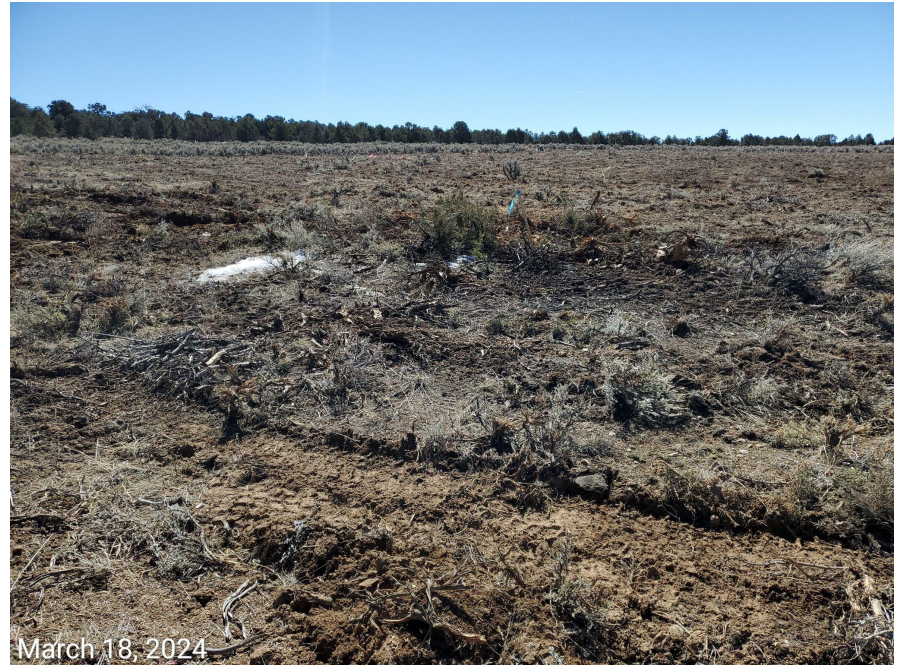
Photo 5: Photos 5-6 taken from the Northeast end of the Location. Photos provide an overview of the Location from east, southeast, southwest to west. Photo shows grubbing activities have commence / been completed. Operator in process of installing erosion logs along the western perimeter of the Location; stormwater and erosion control BMPs remain missing along remaining disturbance perimeter.

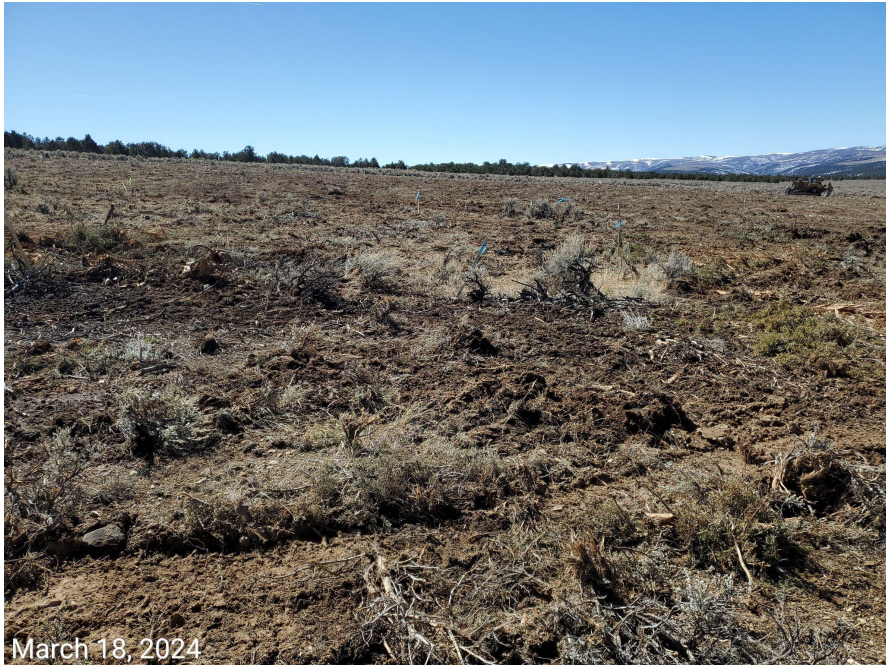
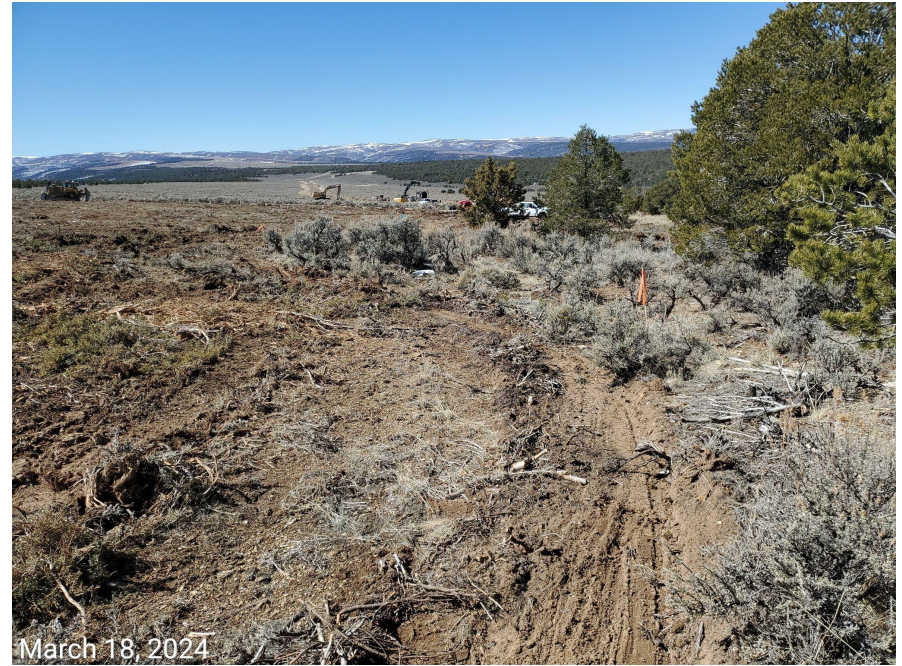
Photo 6: See comments under photo 5.

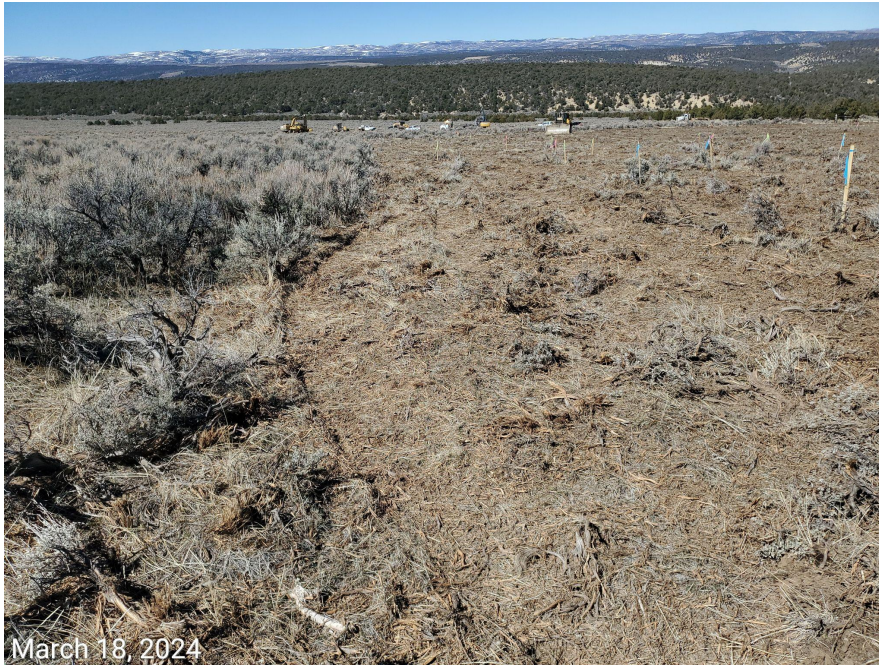
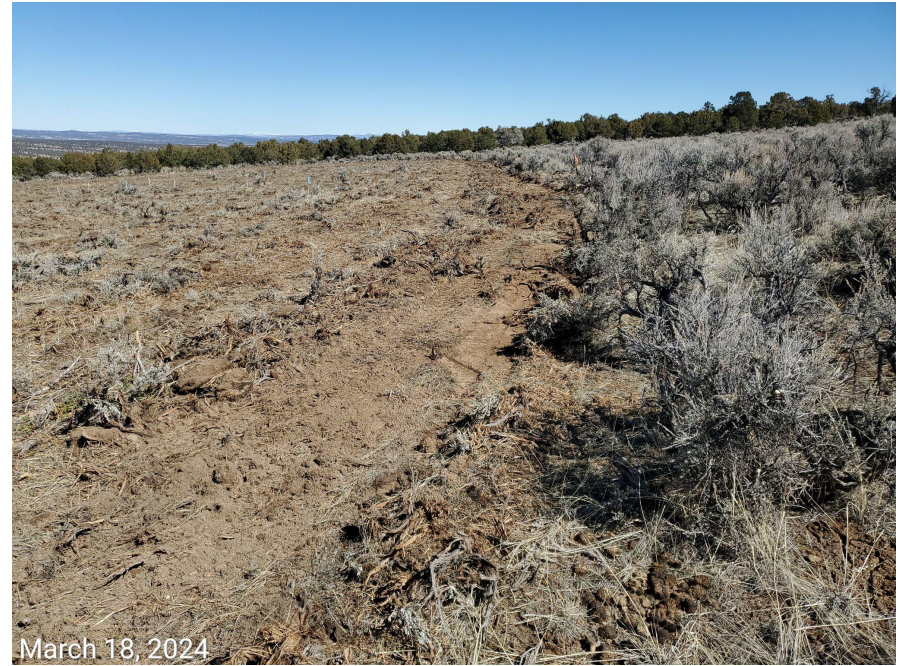
Photo 7: Photos taken from the southeast end of the Location. Photos provide an overview of the Location from northwest to northeast. Photo shows grubbing activities have commence / been completed. Operator in process of installing erosion logs along the western perimeter of the Location; stormwater and erosion control BMPs remain missing along remaining disturbance perimeter.

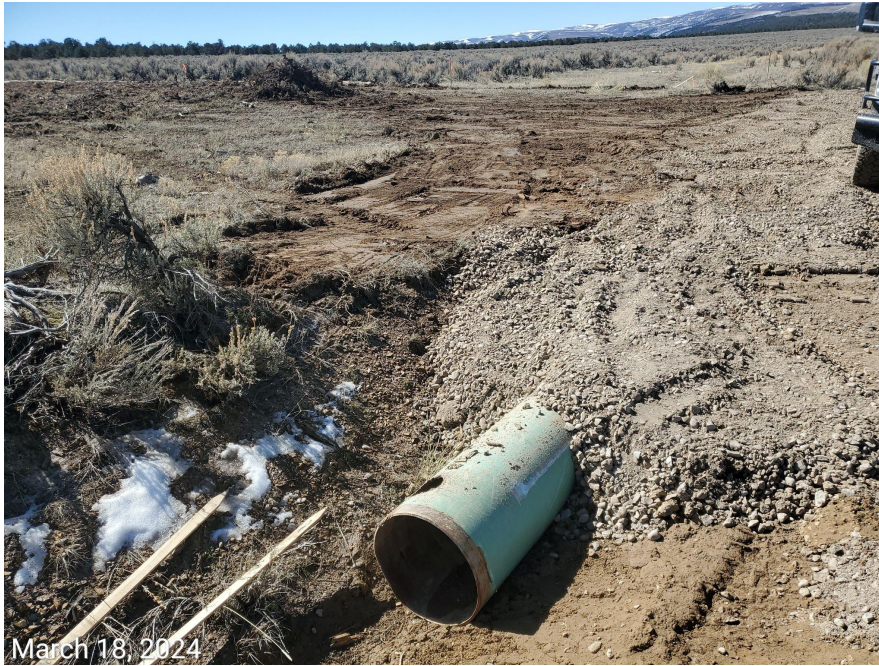
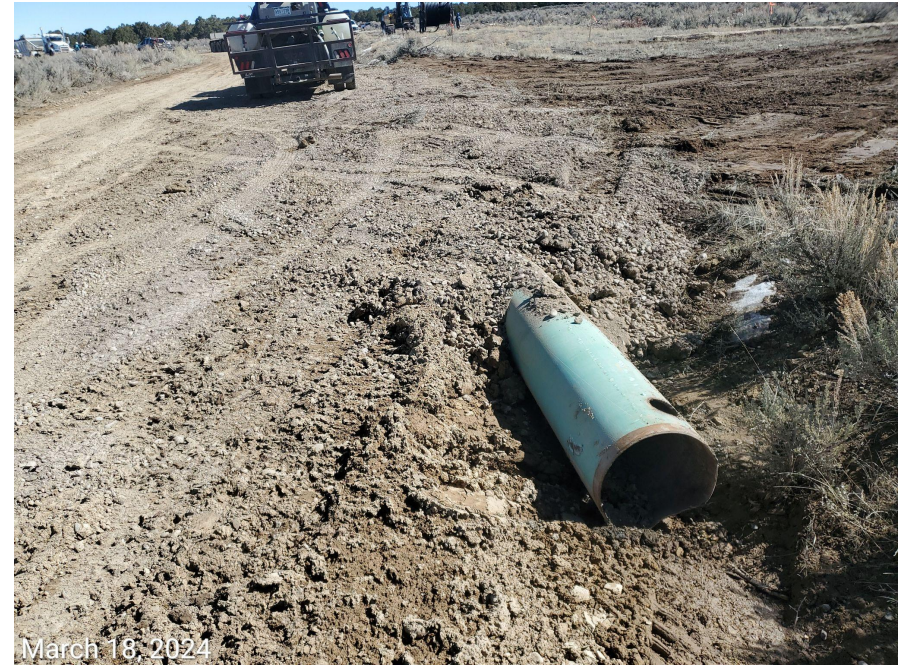
Photo 8: Photos taken from the access road entrance and CR 68. Photo shows culvert installation along access road.

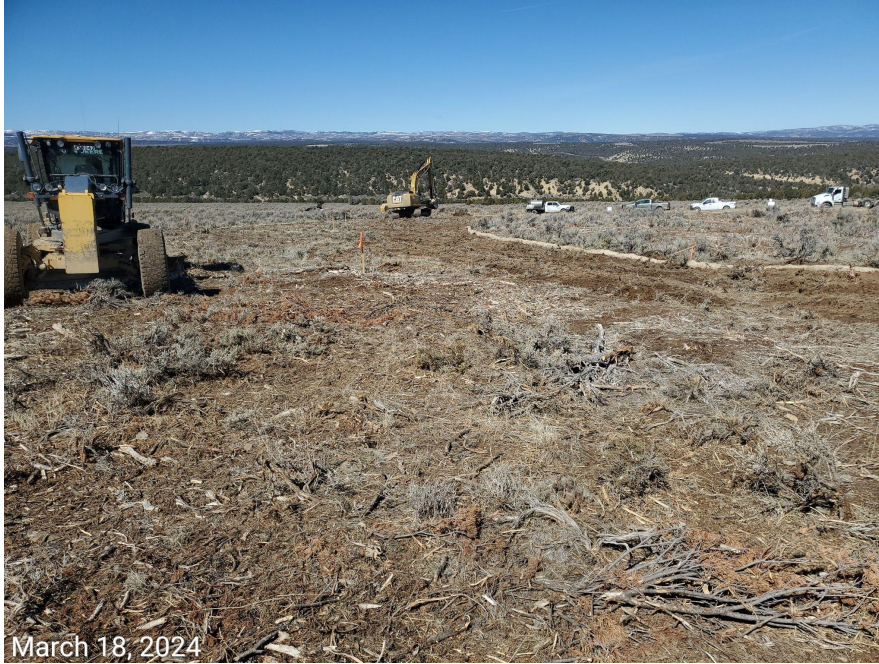
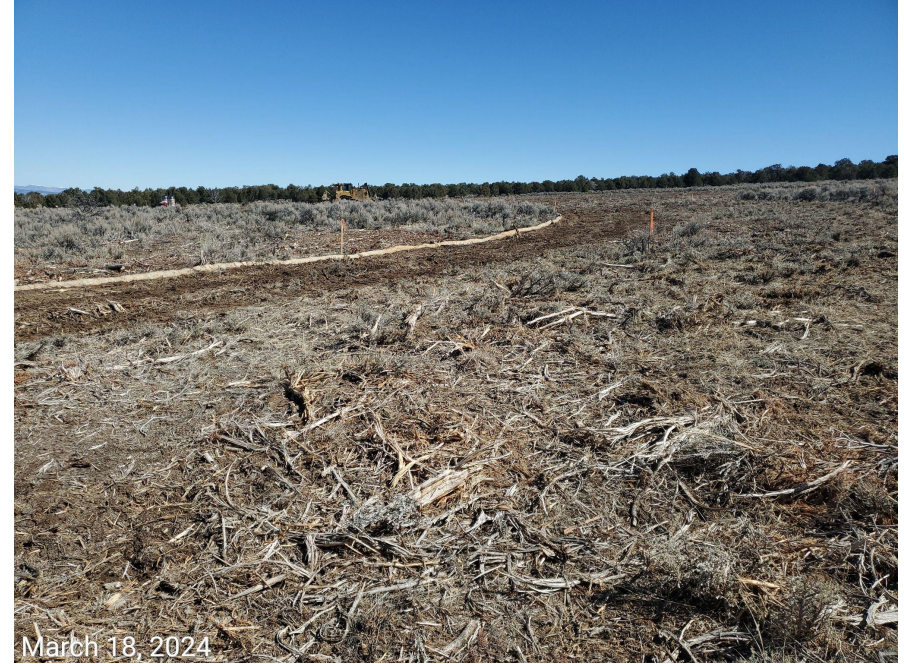
Photo 9: Photos show disturbance area of the access road.
