KT Resources LLC
 Ant Hill Unit 8-32
 Location ID: 316321

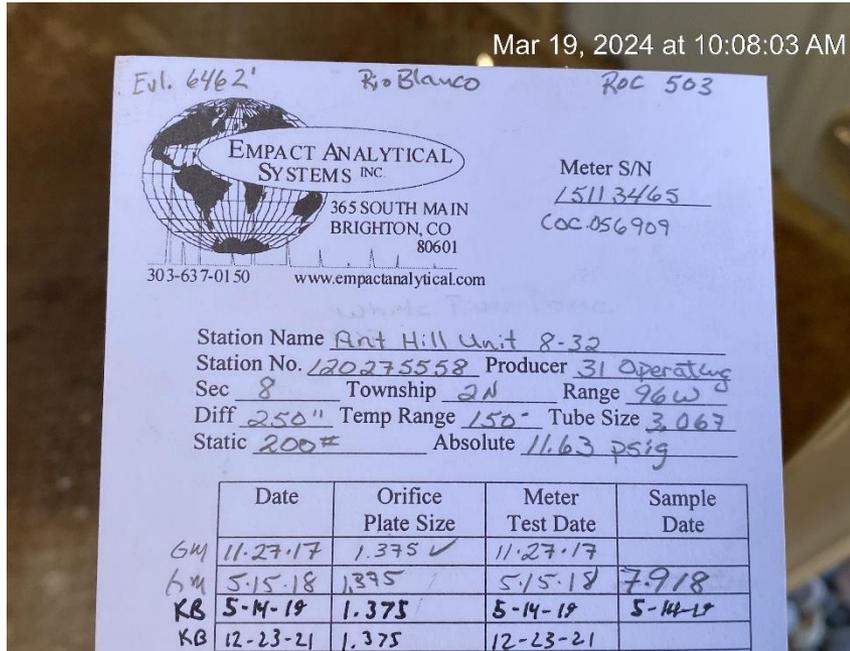
Calibration out of compliance

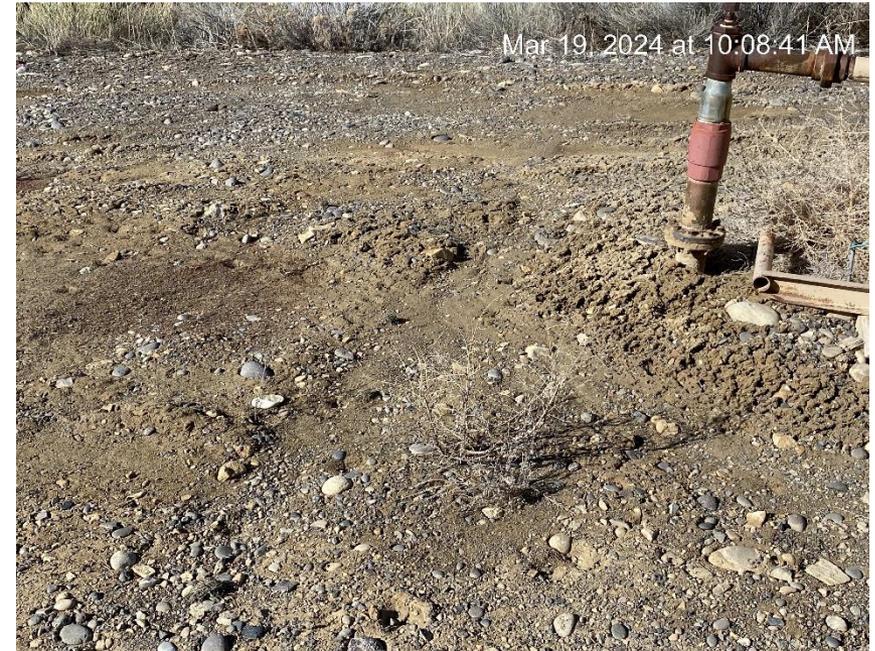
Erosion and sediment migration

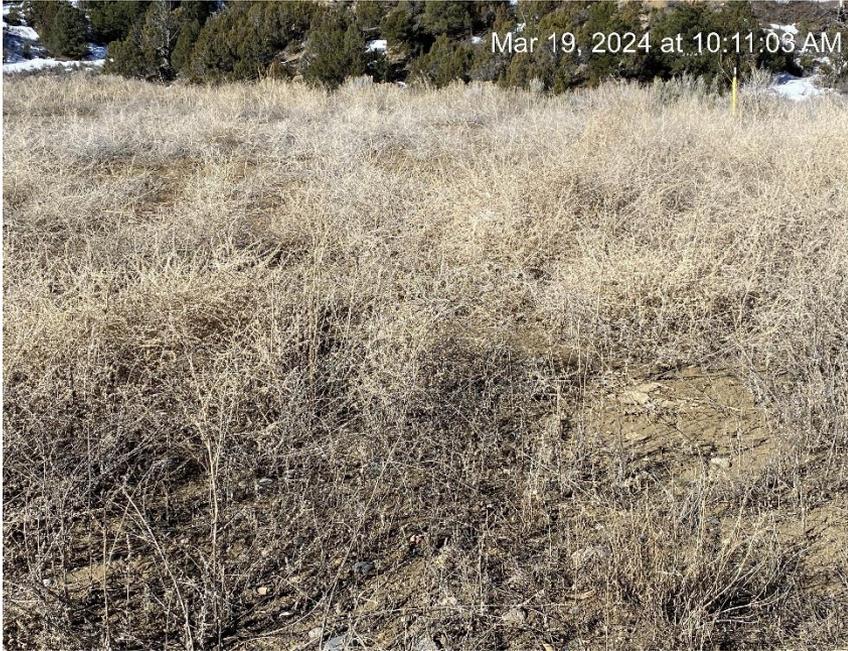
Previous year weed debris

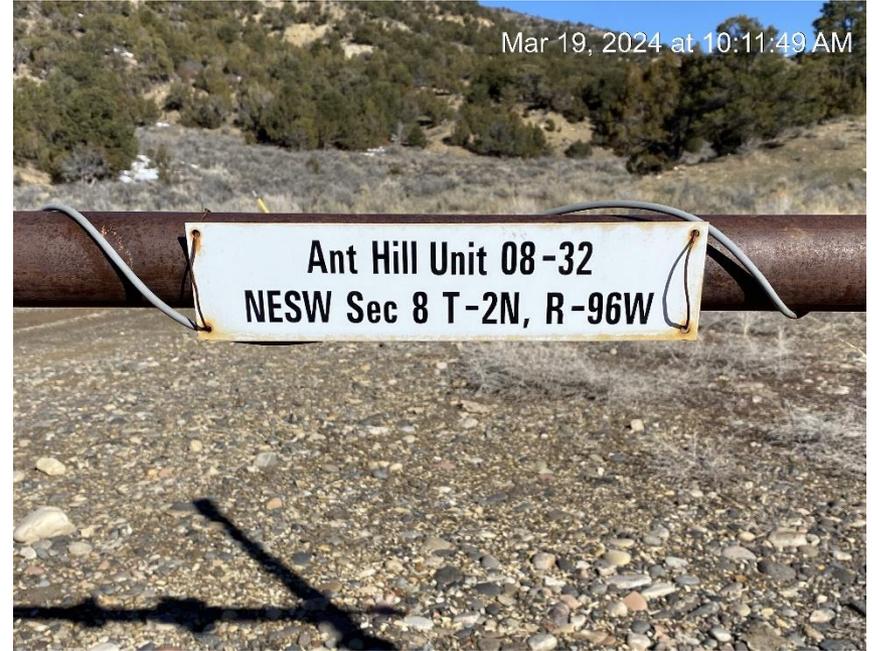
As signs are replaced additional information is required

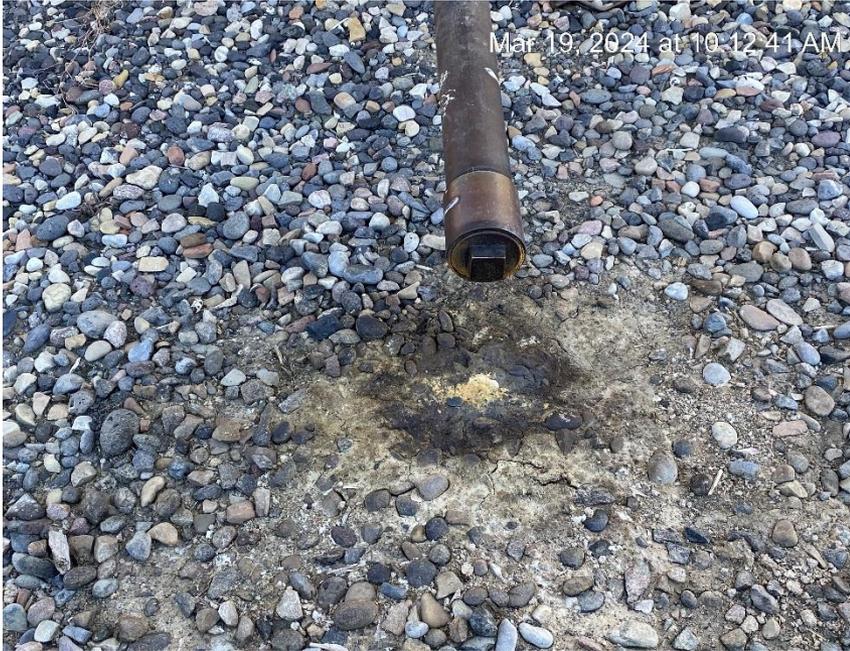
Stained soil

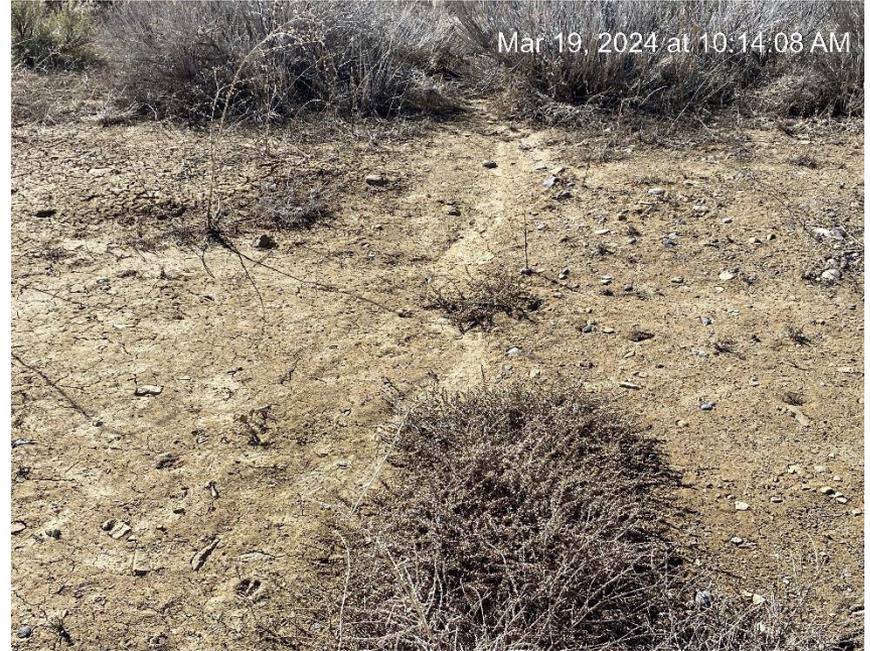
Erosion and sediment migration
