Caerus
H34NW
Location ID: 334959

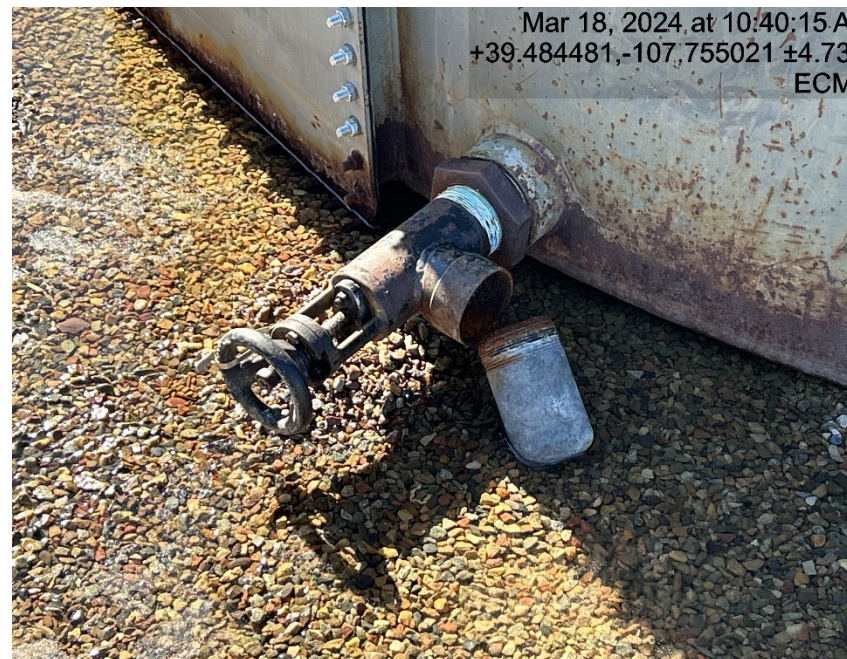
Cap not installed properly

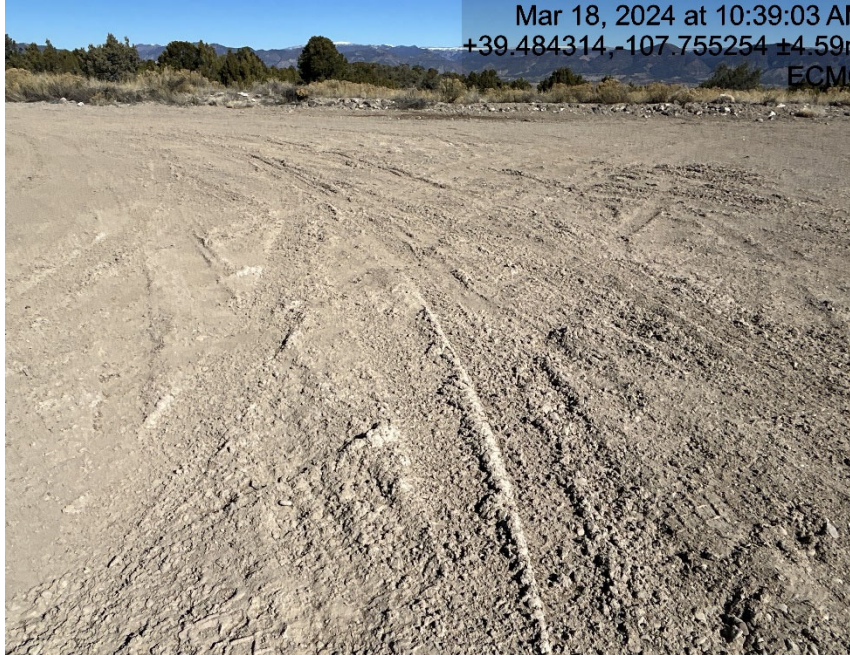
Lack of stabilization/compaction

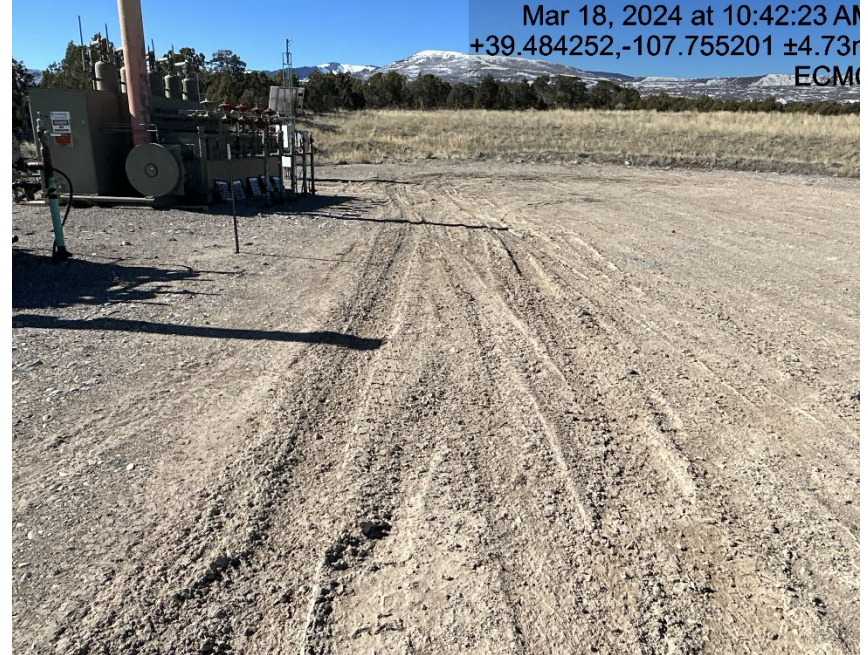
Lack of stabilization/compaction

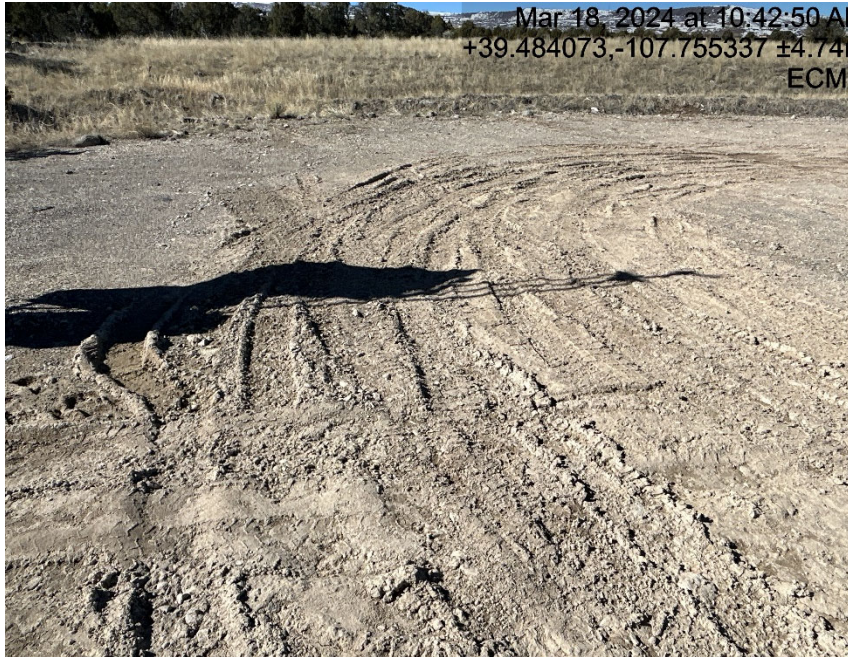
Lack of stabilization/compaction

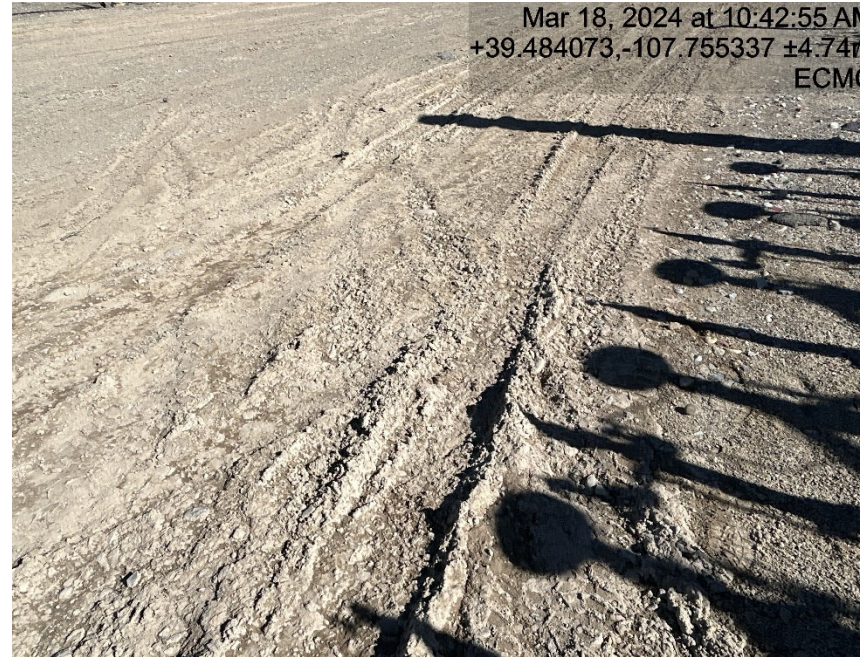
Lack of stabilization/compaction

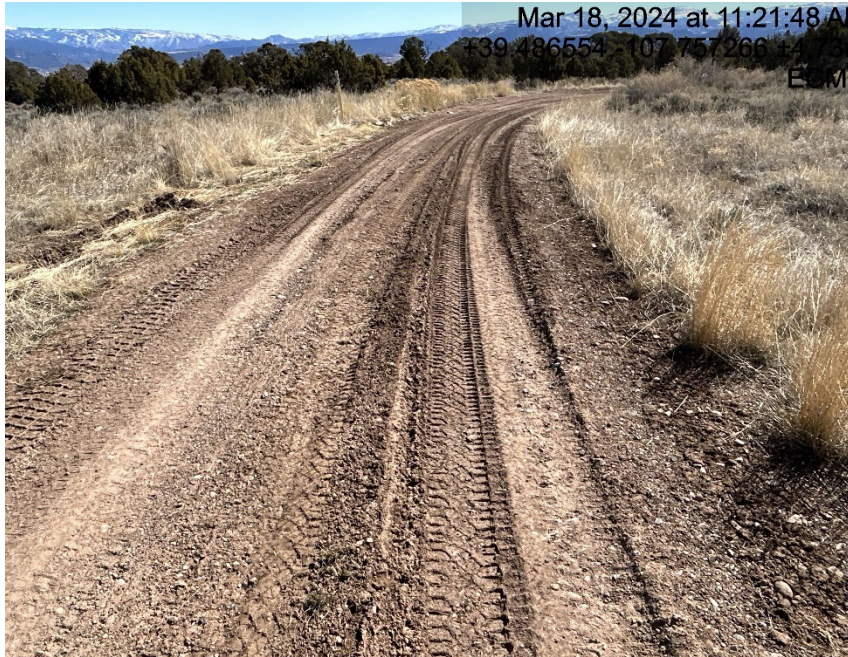
Lack of stabilization/compaction

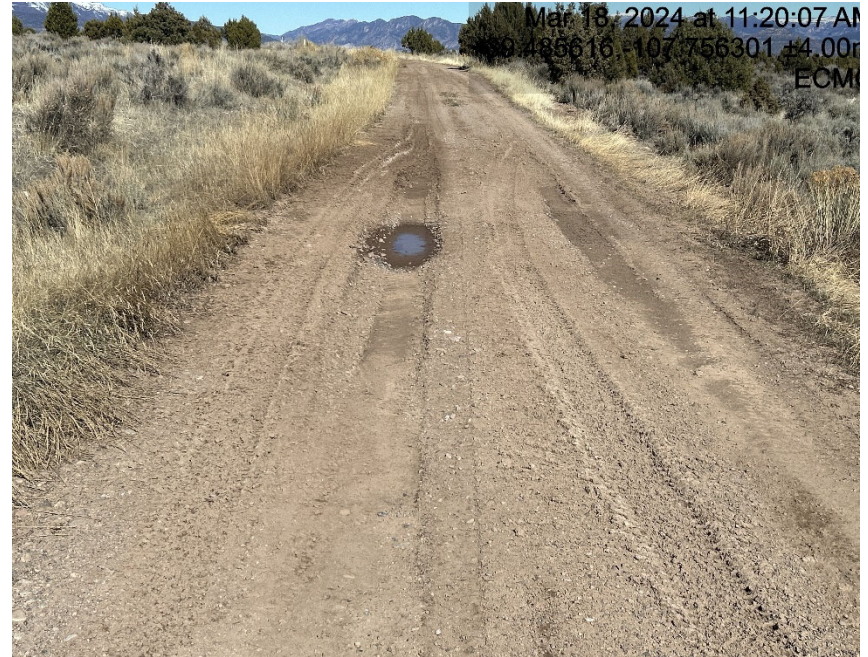
Lack of stabilization/compaction
