Final Reclamation Inspection

Operator: Enduring Resources LLC - 10663

Location ID: 326276

Inspection Document #: 714000571

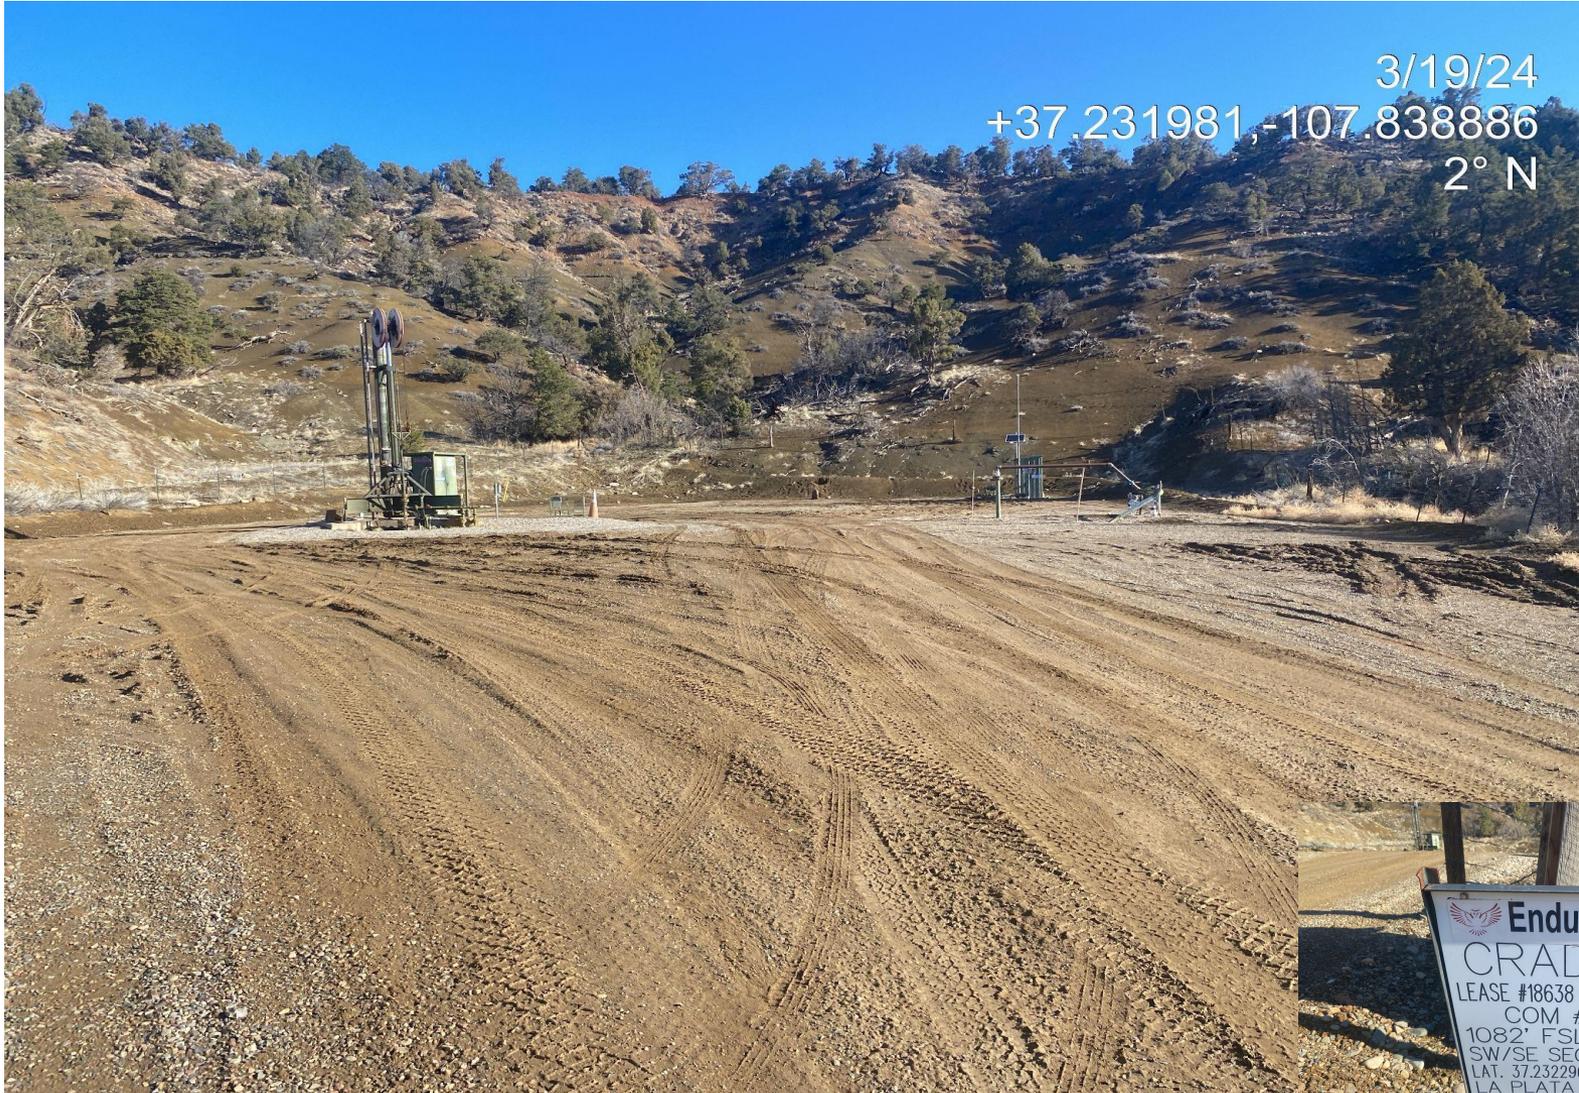
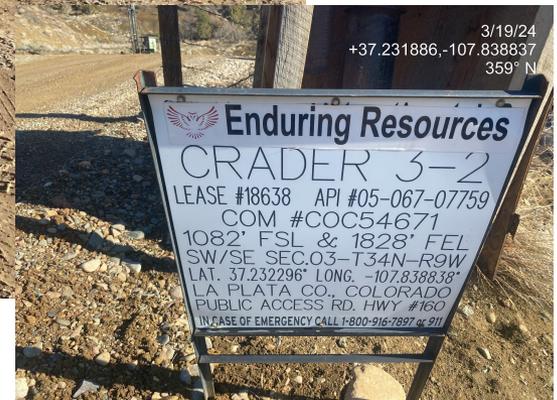
Photo 1. Overview of the disturbance taken from the entrance facing center.

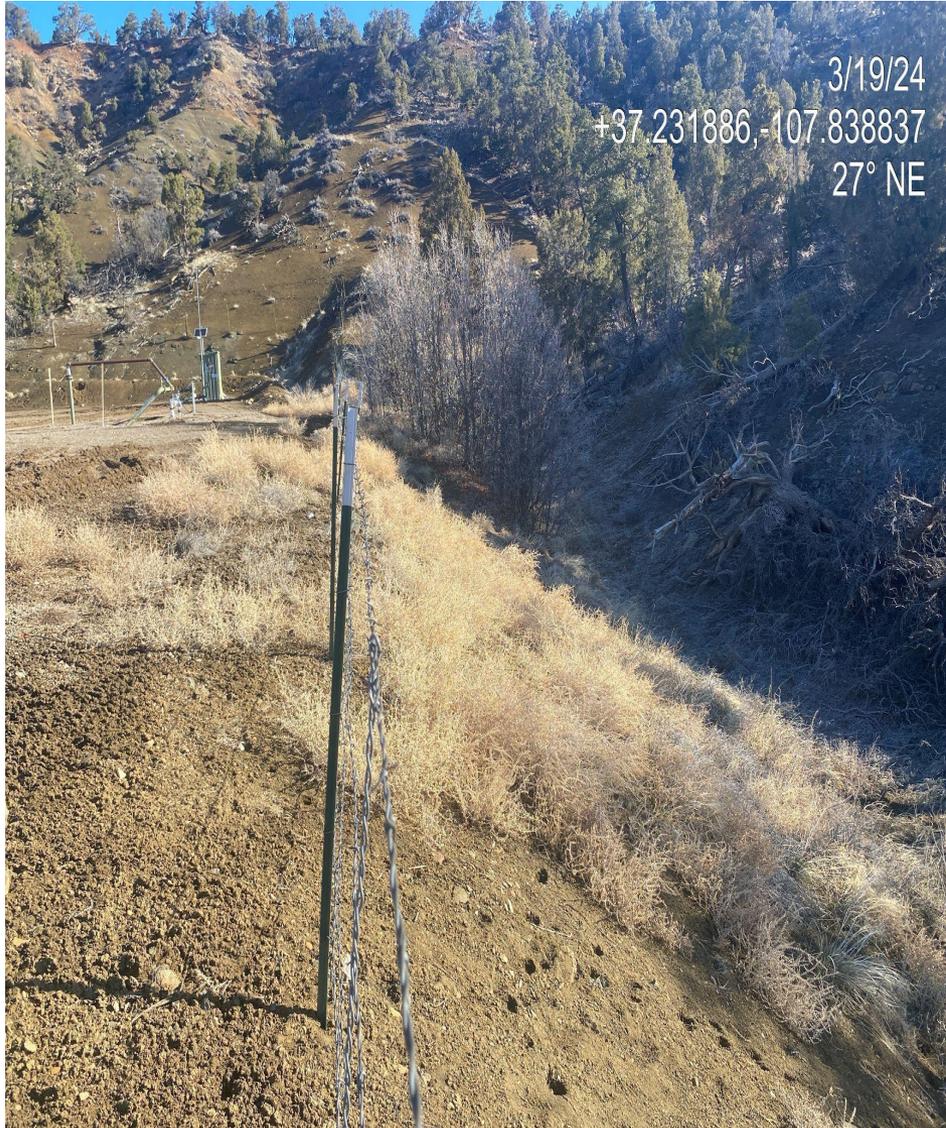
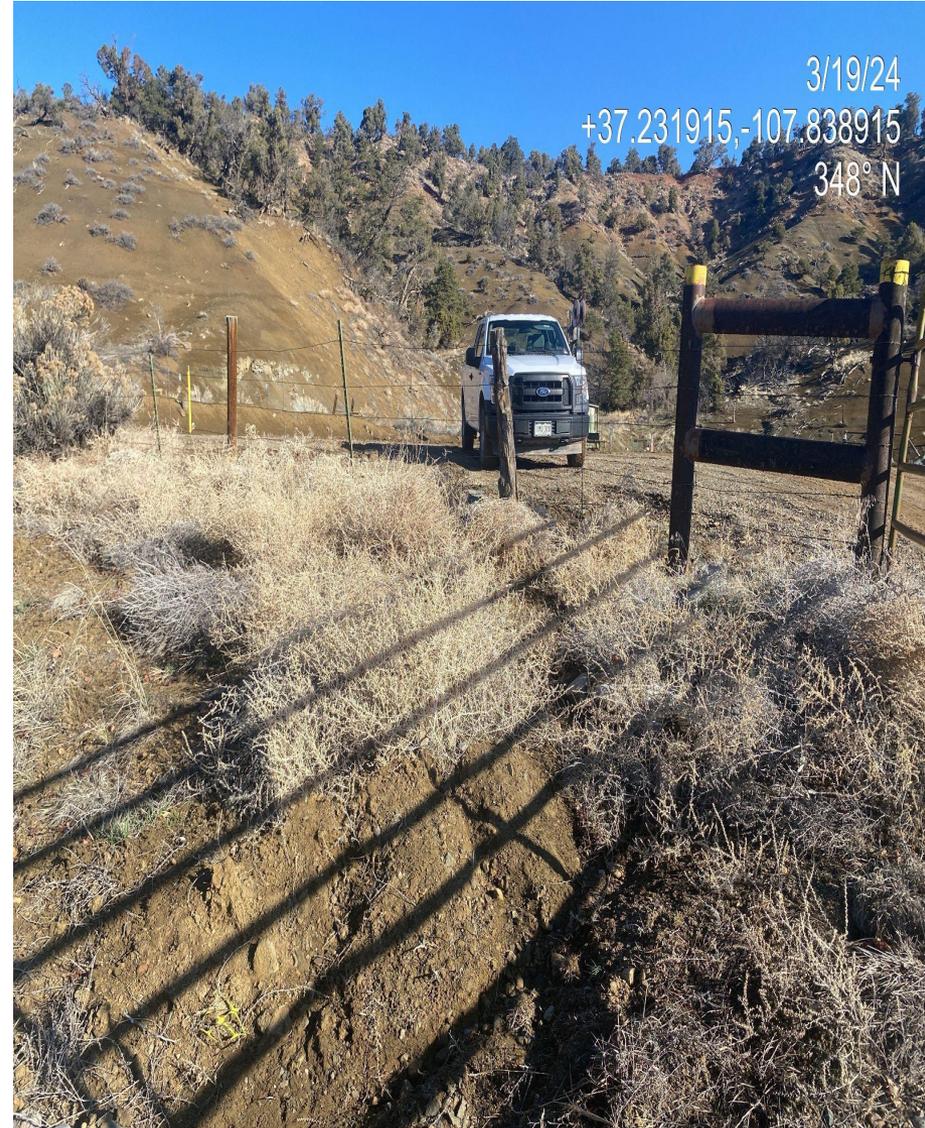
Photo 2. Weedy debris observed in the eastern interim reclamation fill slope and in the southern interim reclamation area at the access point. Fill slope lacks desirable vegetation and needs to be stabilized.

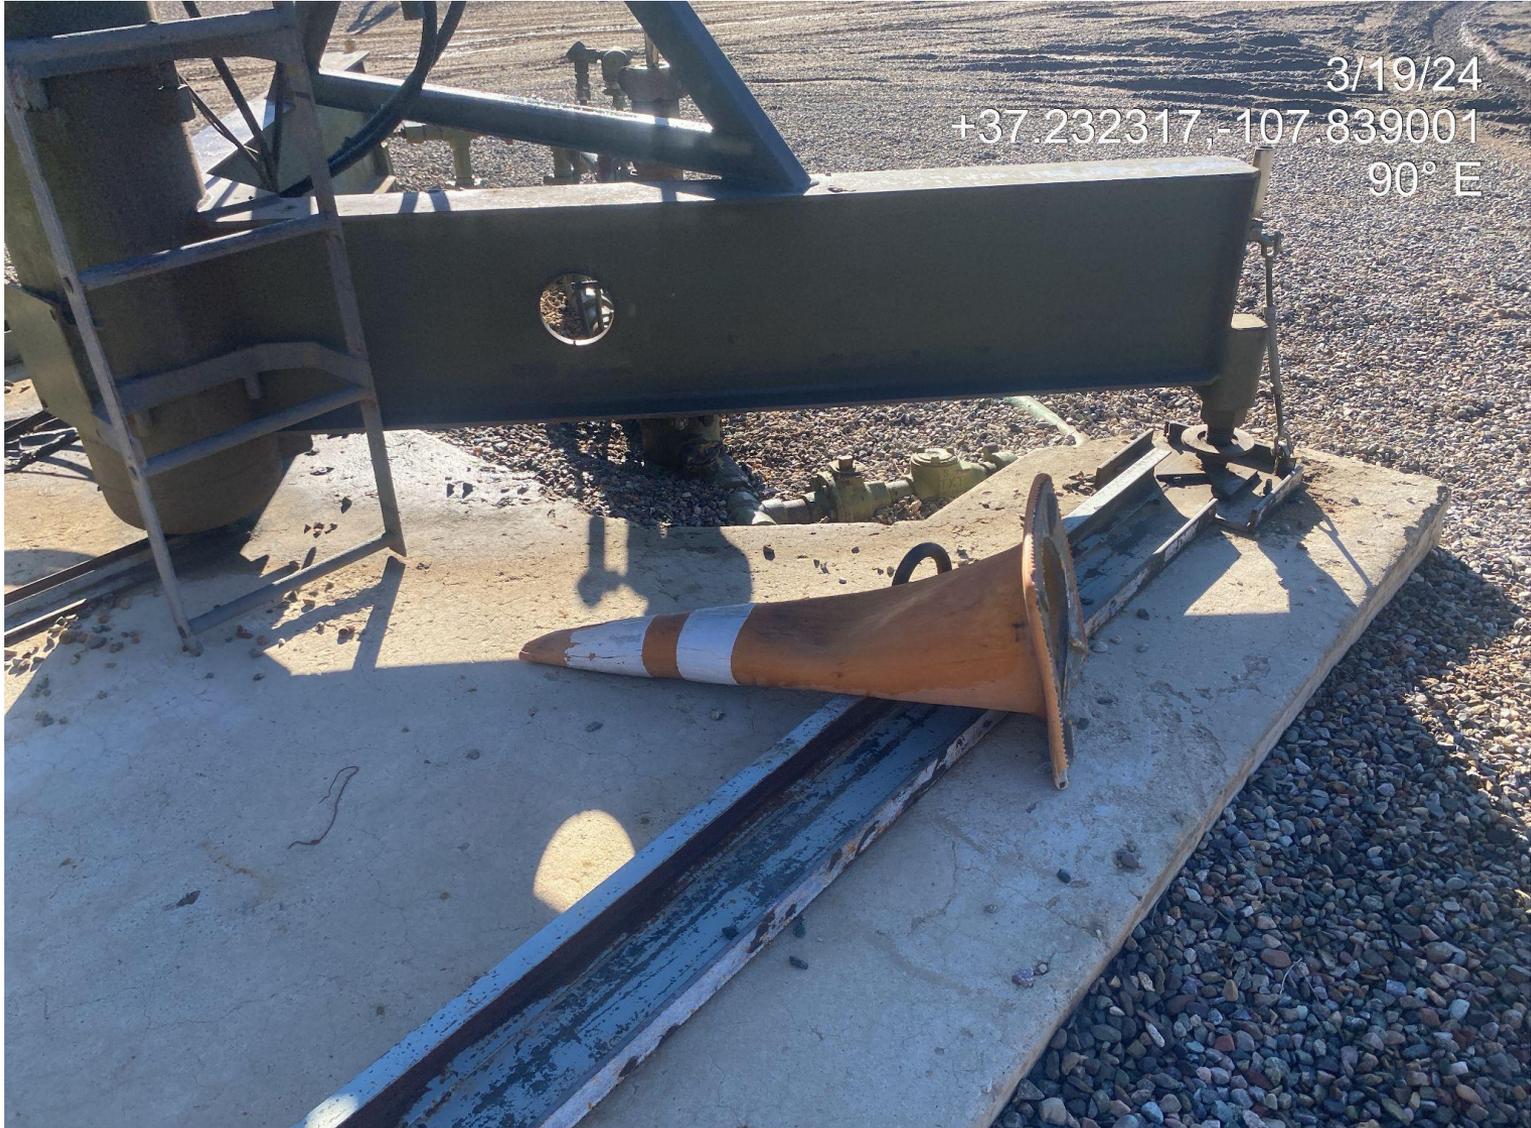
Photo 3. Unused cone observed on location.

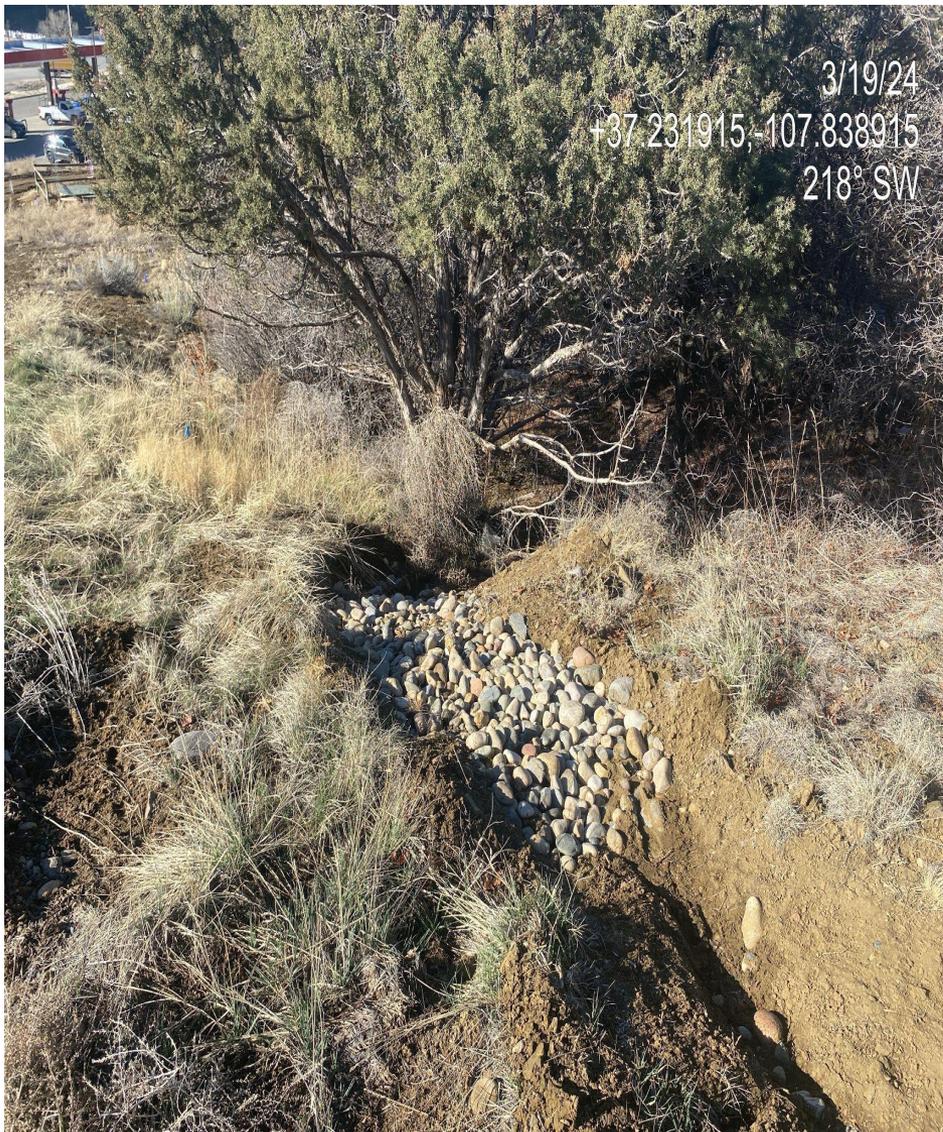
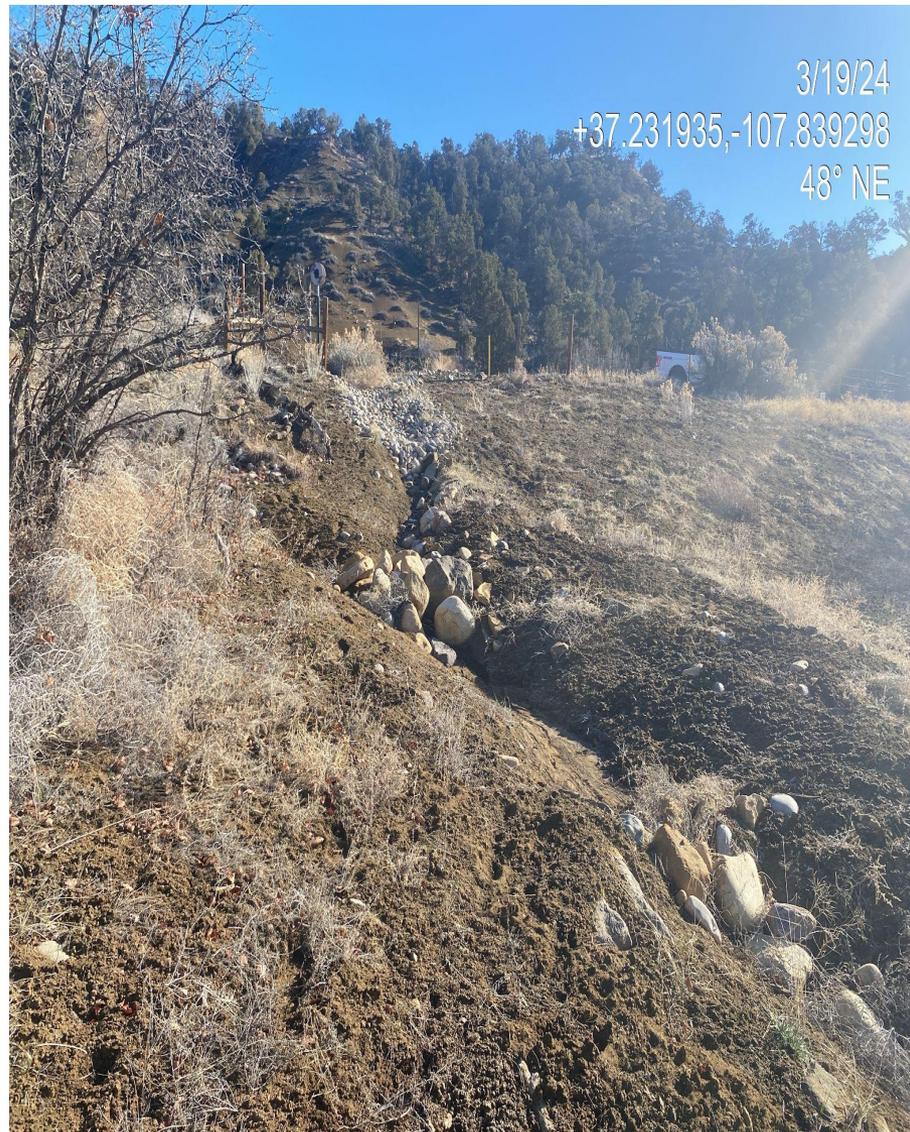
Photo 4. Stormwater corrective action identified in the previous inspection doc #714000031 has been addressed/resolved.

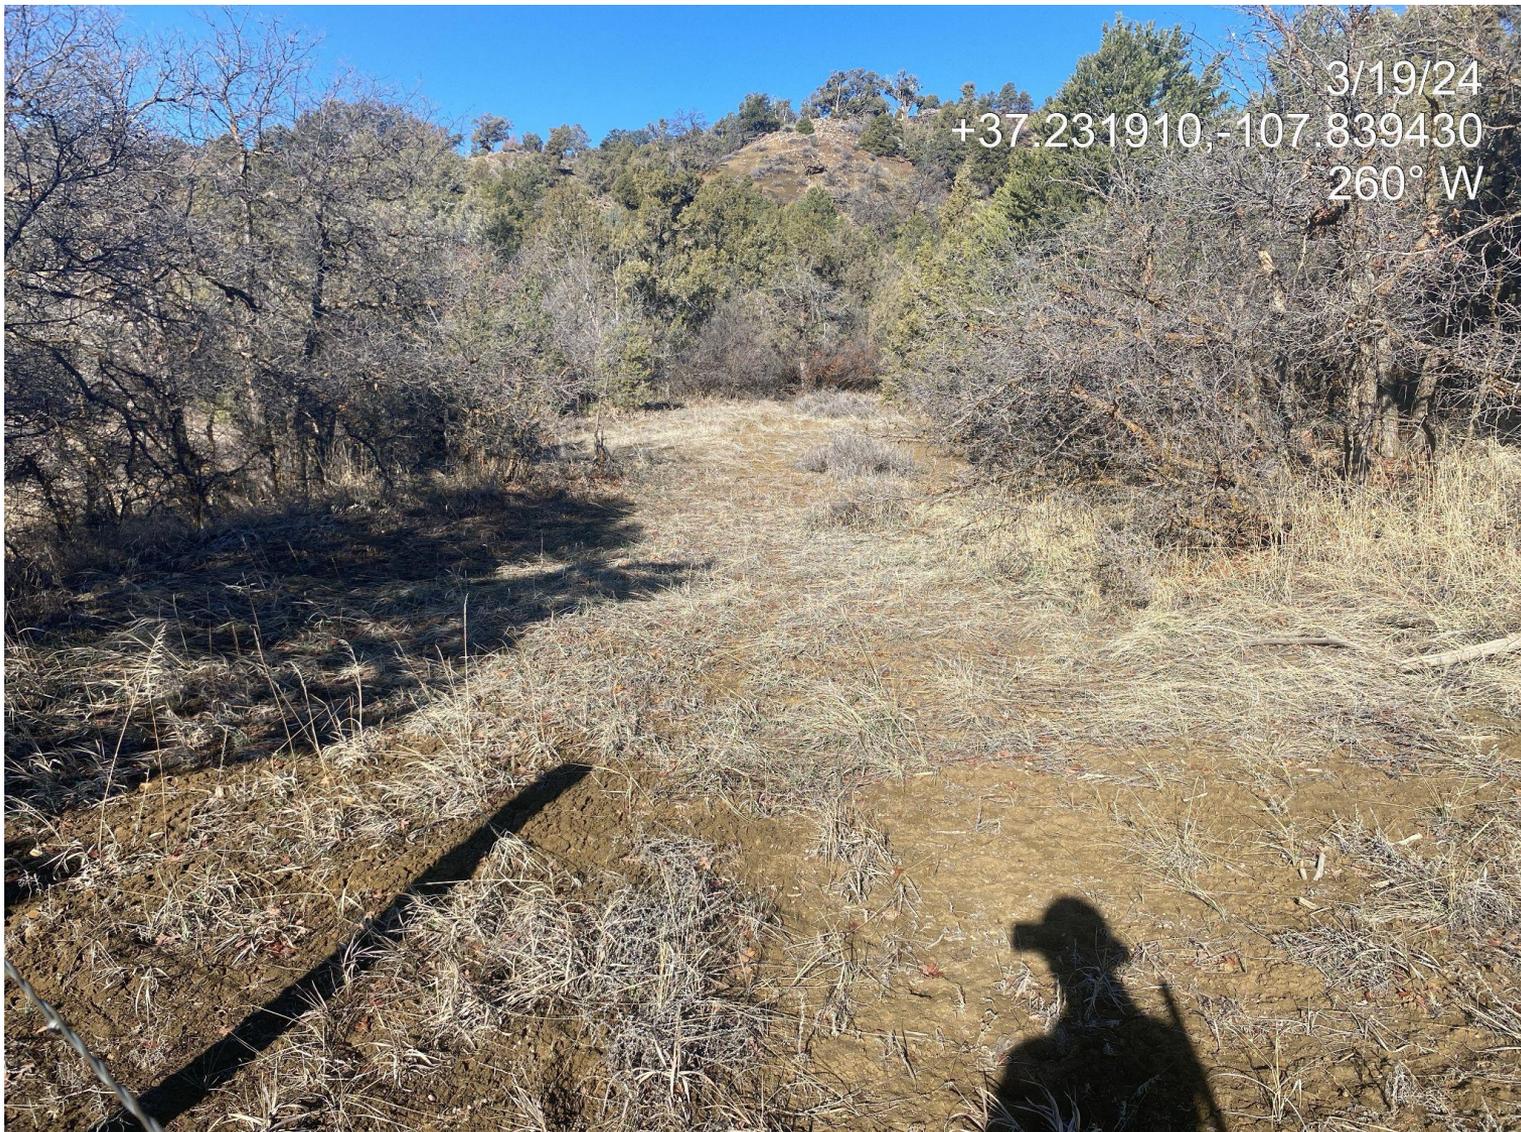
Photo 5. Reference area comprised of smooth brome, indian rice grass, gambel oak and juniper.
