Inspection Photos
Location Name: Castor LC 26-75HN
Location ID: 422629

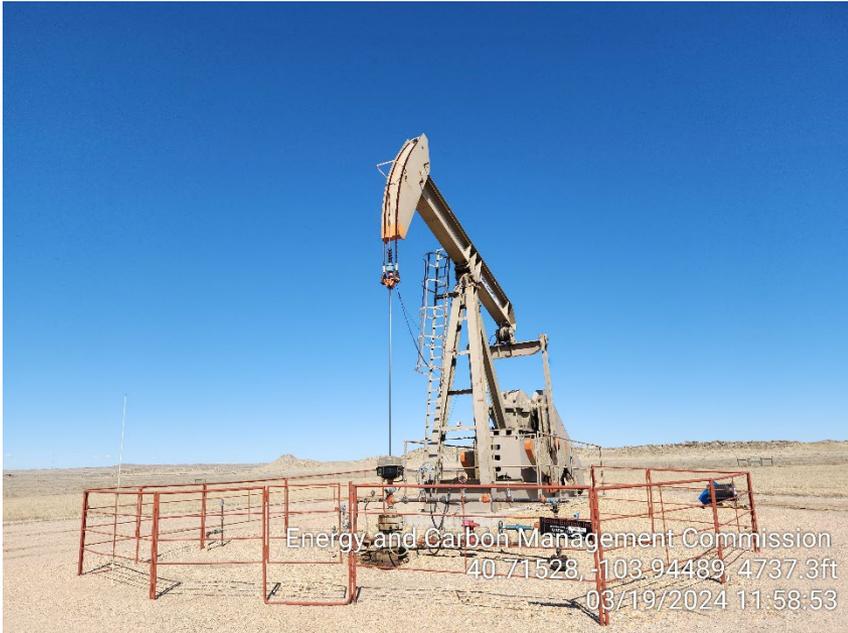
Photo 1 – Pumping Unit

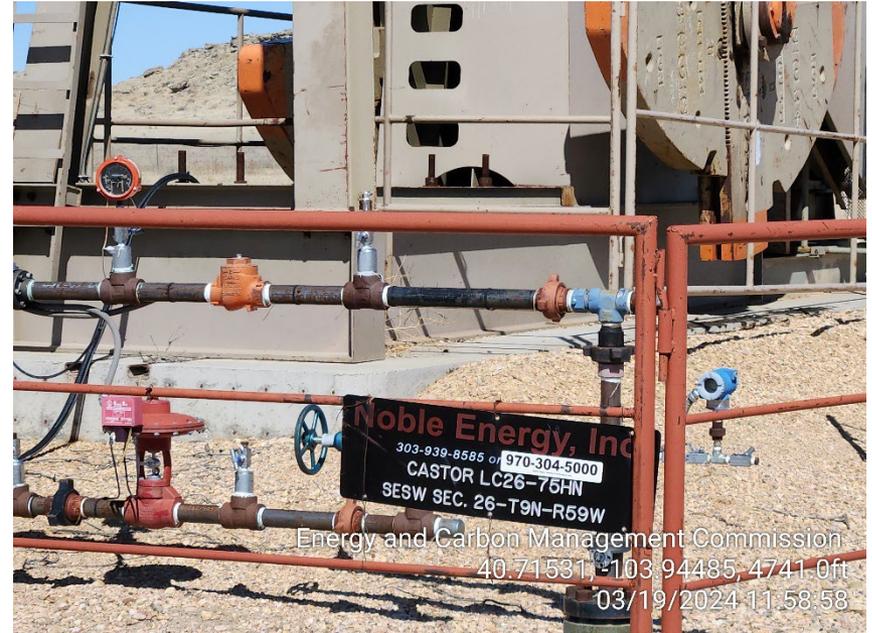
Photo 2 – Wellhead Sign

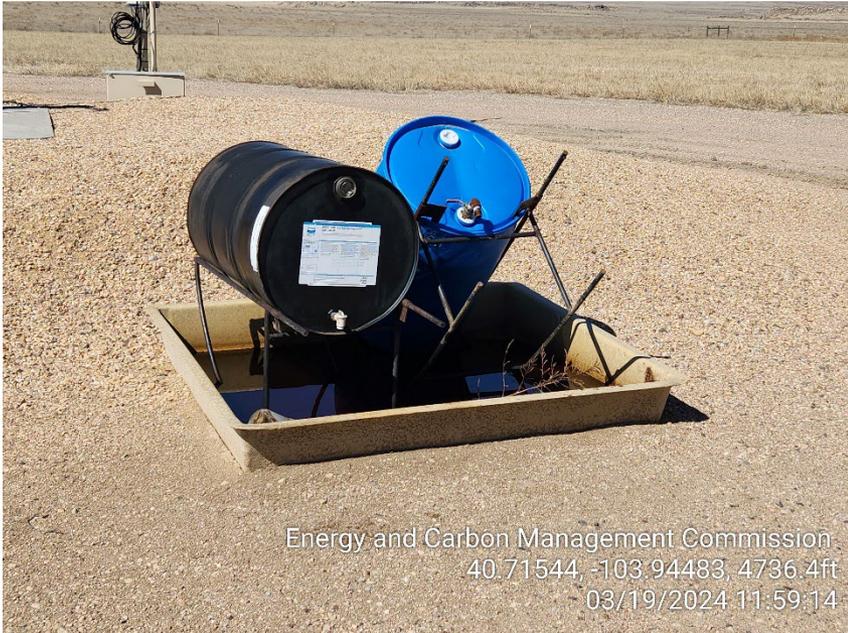
Photo 3 – Oily Waste in Containment

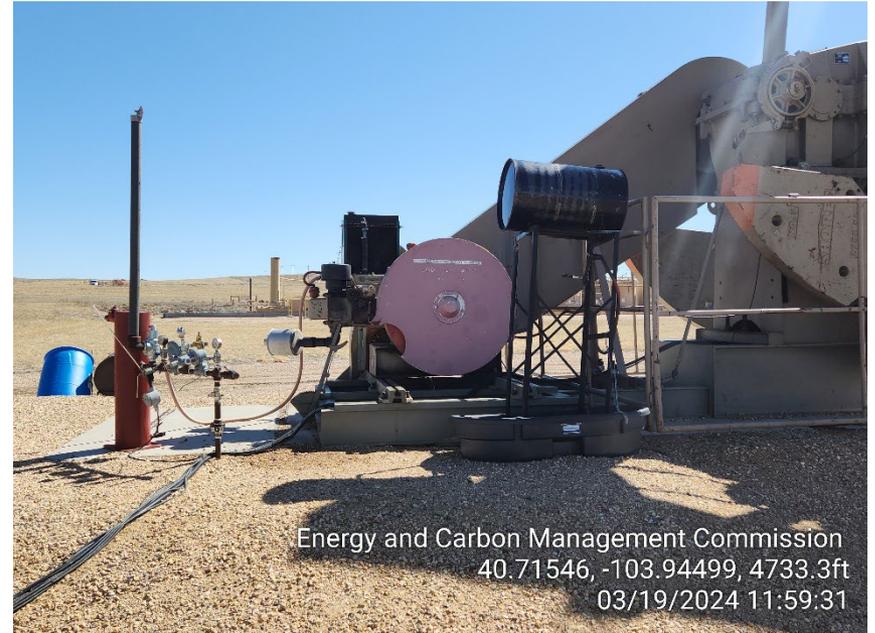
Photo 4 – Gas Engine

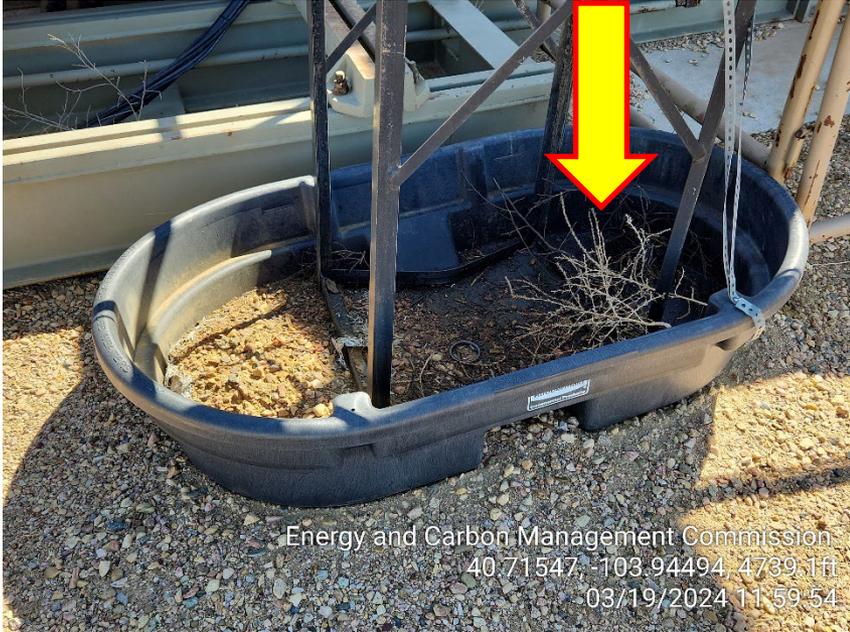
Photo 5 – Oily Waste in Containment

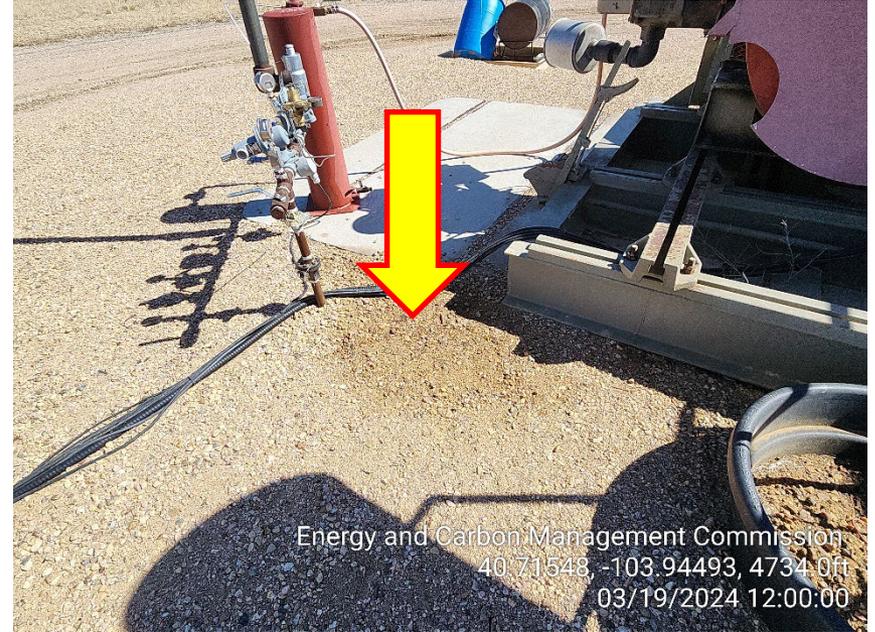
Photo 6 – Stained Soil

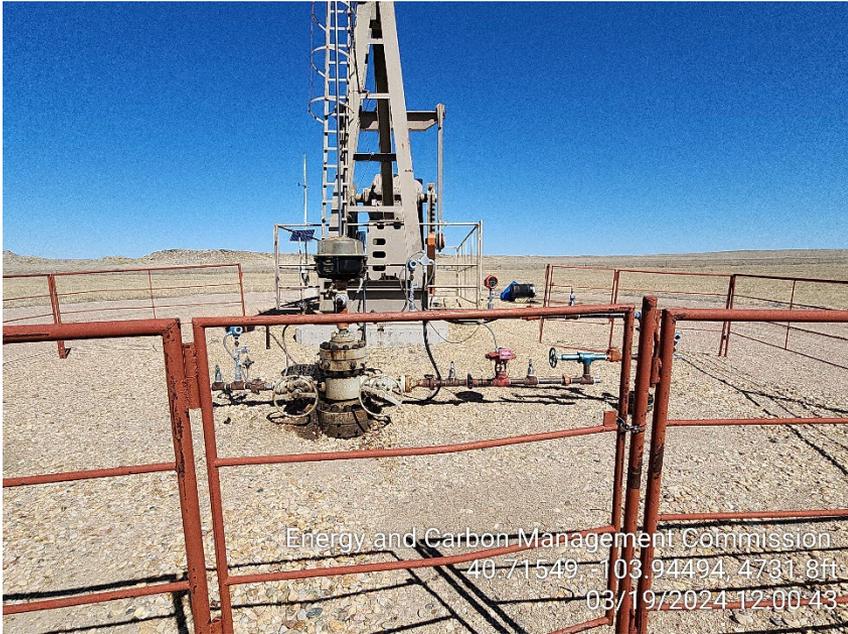
Photo 7 – Wellhead

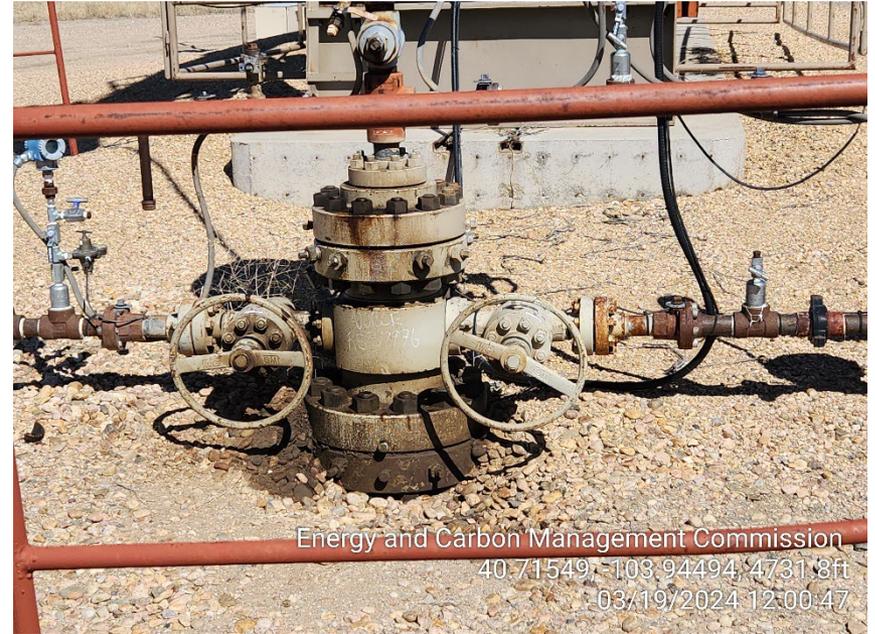
Photo 8 – Stained Soil at Wellhead

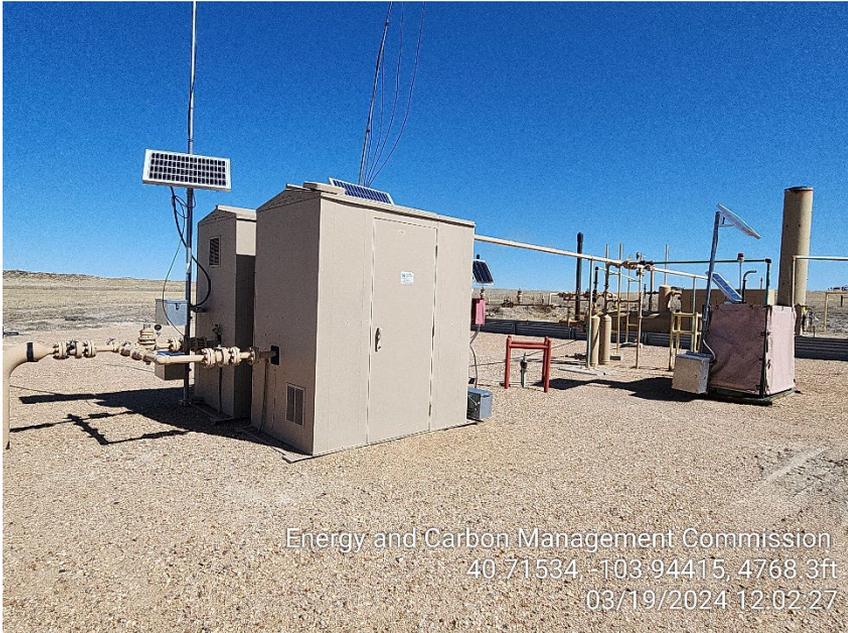
Photo 9 – Gas Meters and VRU

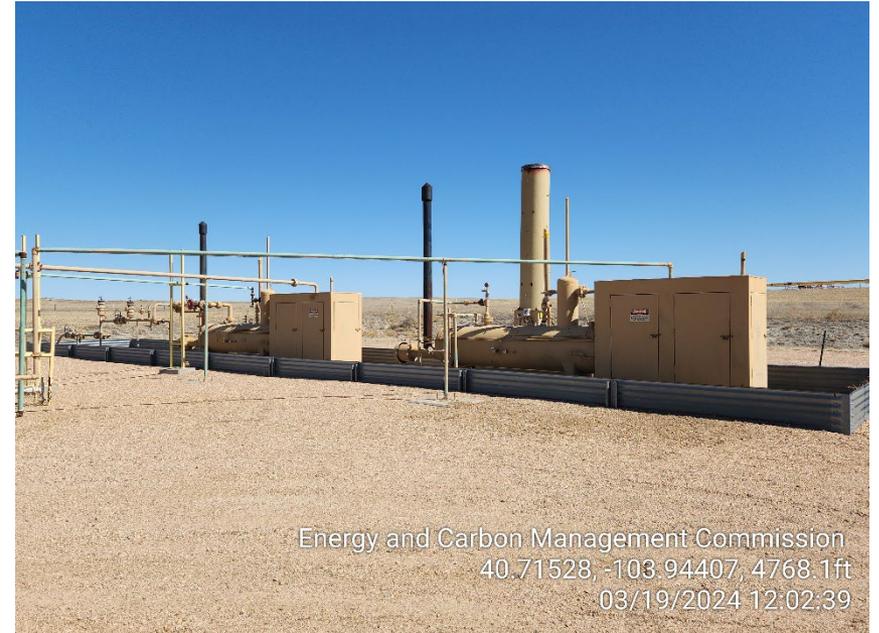
Photo 10 – Separators

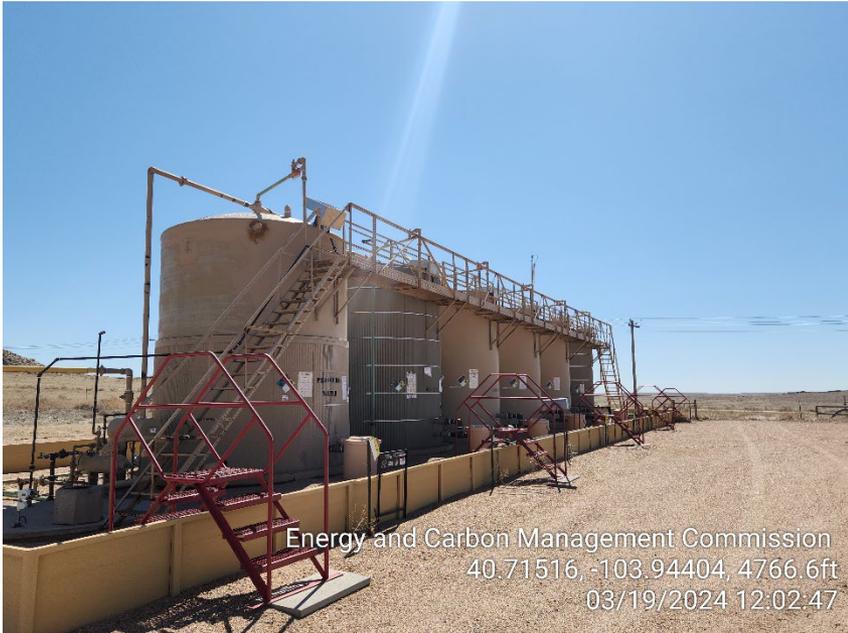
Photo 11 – Tank Battery

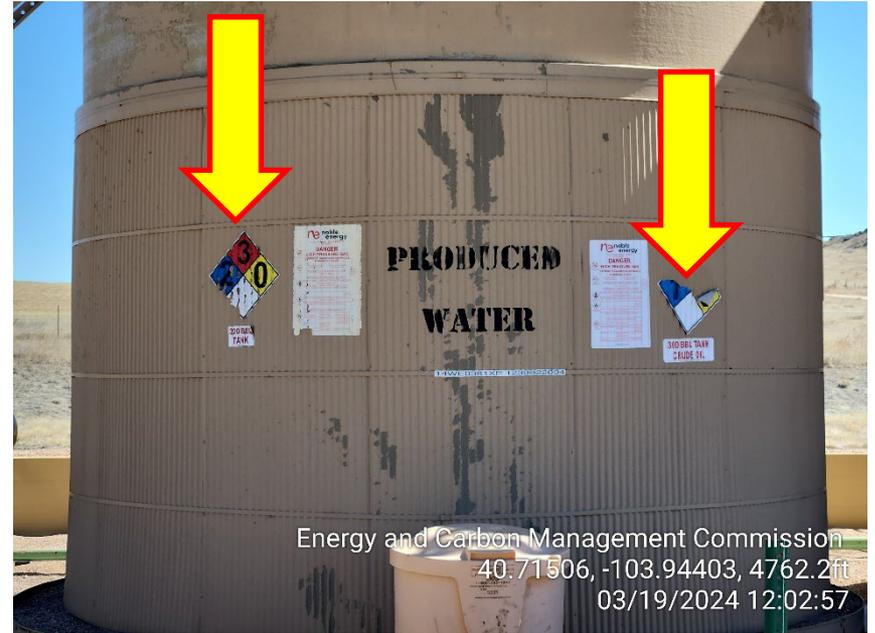
Photo 12 – NFPA Labels

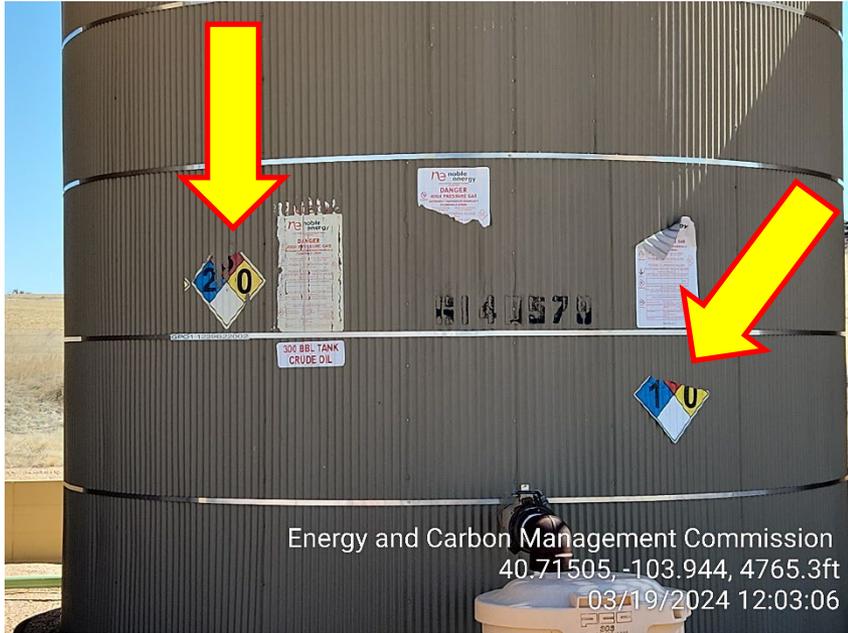
Photo 13 – NFPA Labels

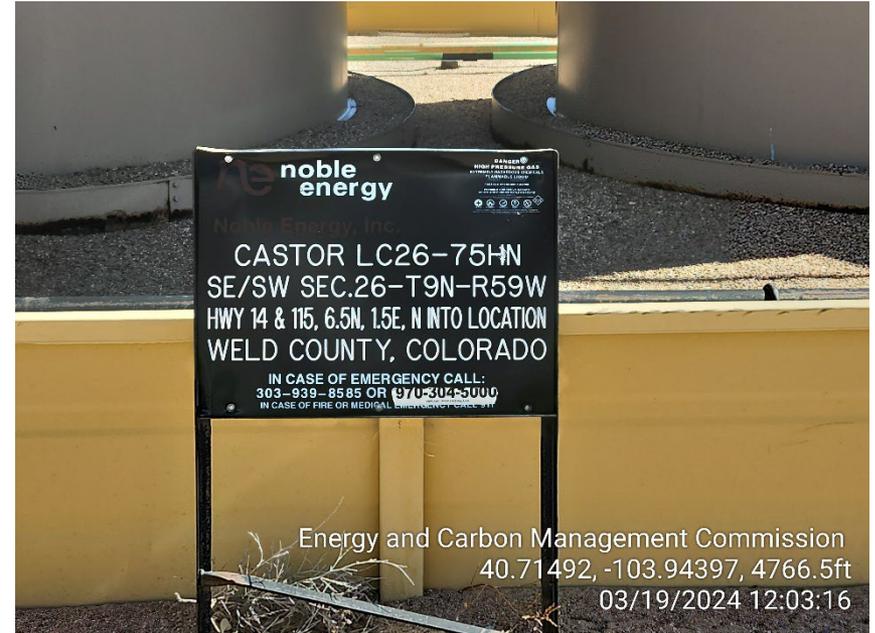
Photo 14 – Tank Battery Sign

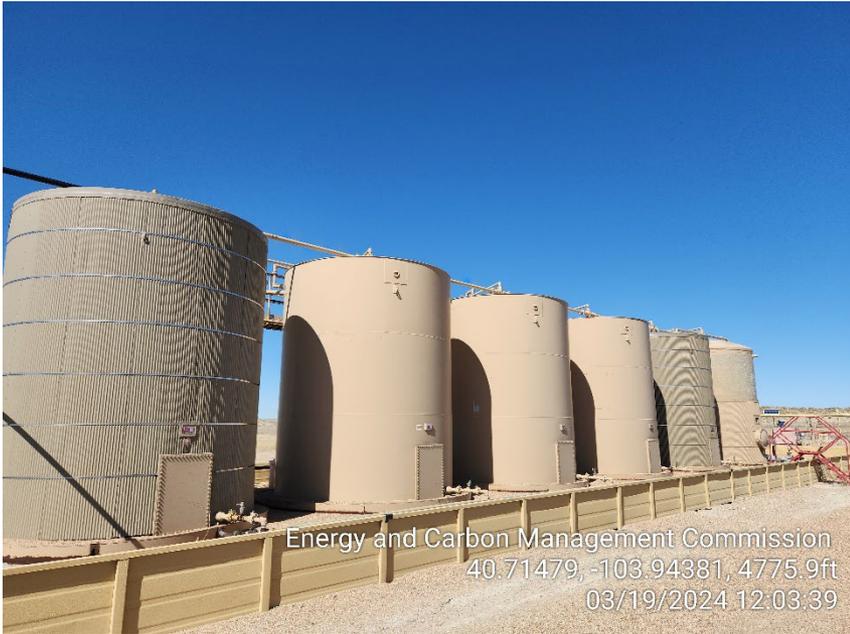
Photo 15 – Tank Battery – Backside

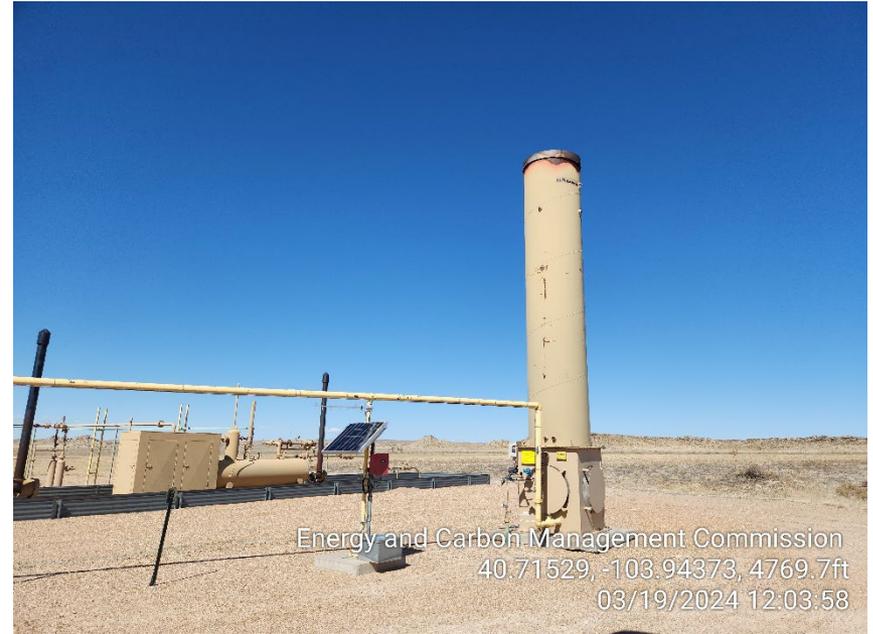
Photo 16 – ECD
