Inspection Photos
Location Name: Douglas LC 35-785 PAD
Location ID: 440068

Inspection Photos
Location Name: Lynn LC 35-765 PAD
Location ID: 440072

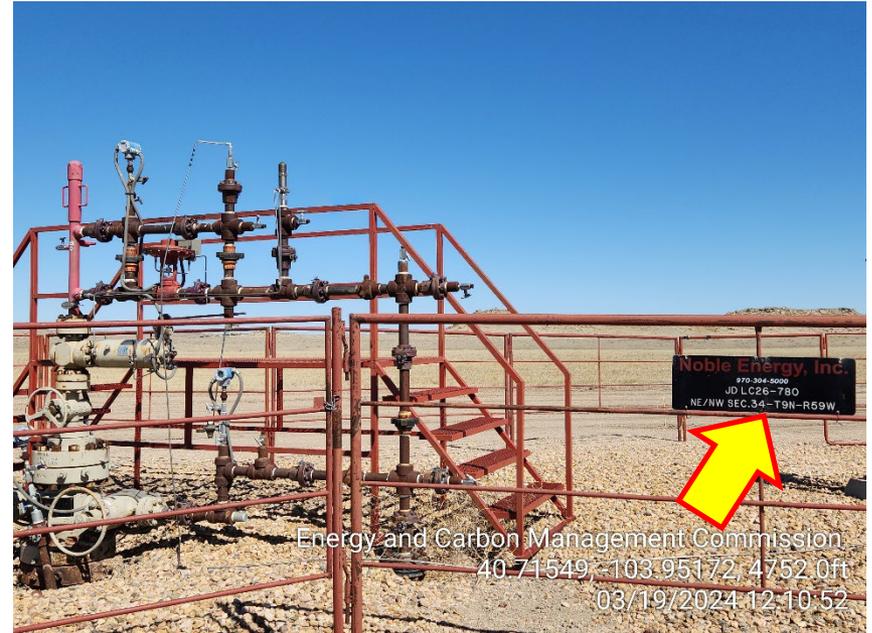
Photo 2 – LC26-780 Wellhead – Sec. # not adequate Well is in Sec. 26 not Sec. 34

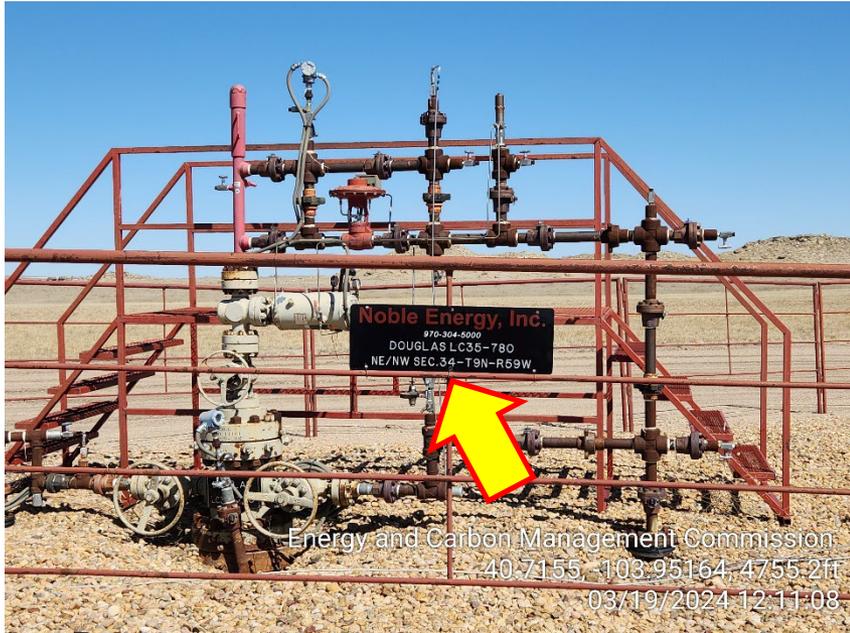
Photo 3 – LC35-780 Wellhead – Sec. # not adequate Well is in Sec. 26 not Sec. 34

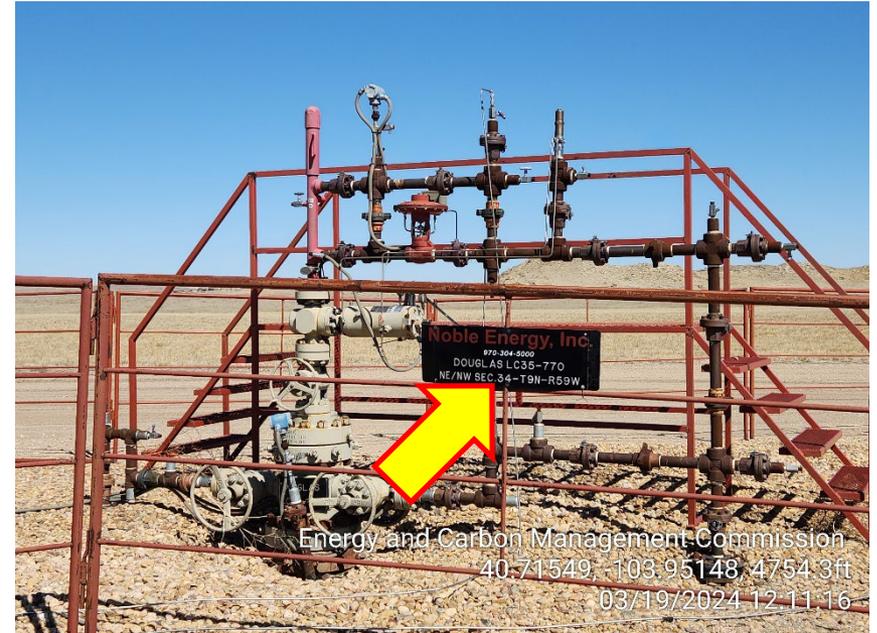
Photo 4 – LC35-770 Wellhead – Sec. # not adequate Well is in Sec. 26 not Sec. 34

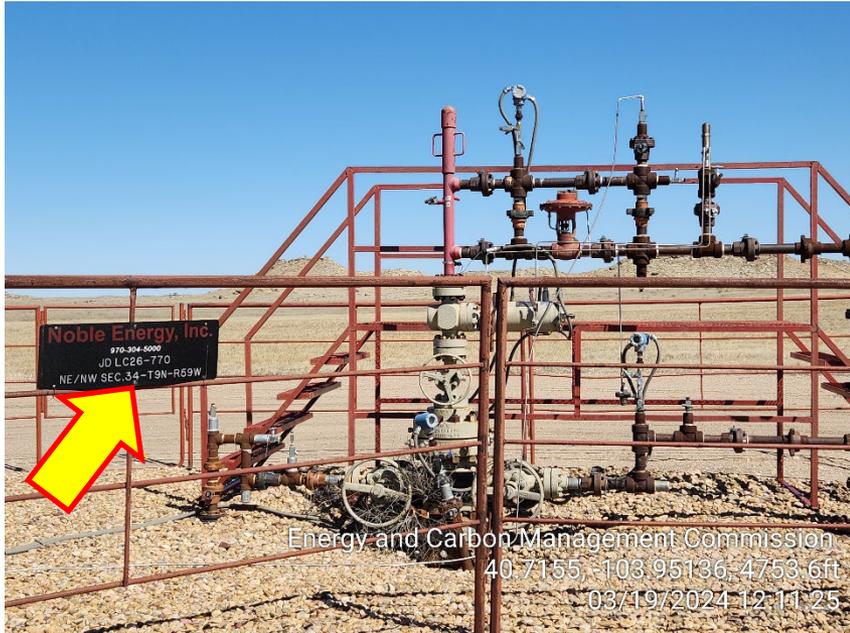
Photo 5 – LC26-770 Wellhead – Sec. # not adequate Well is in Sec. 26 not Sec. 34
