Inspection Photos

Location Name: TEP ROCKY MOUNTAIN LLC SOUTH LEVERICH 18-13 Pad

Location ID: 335049

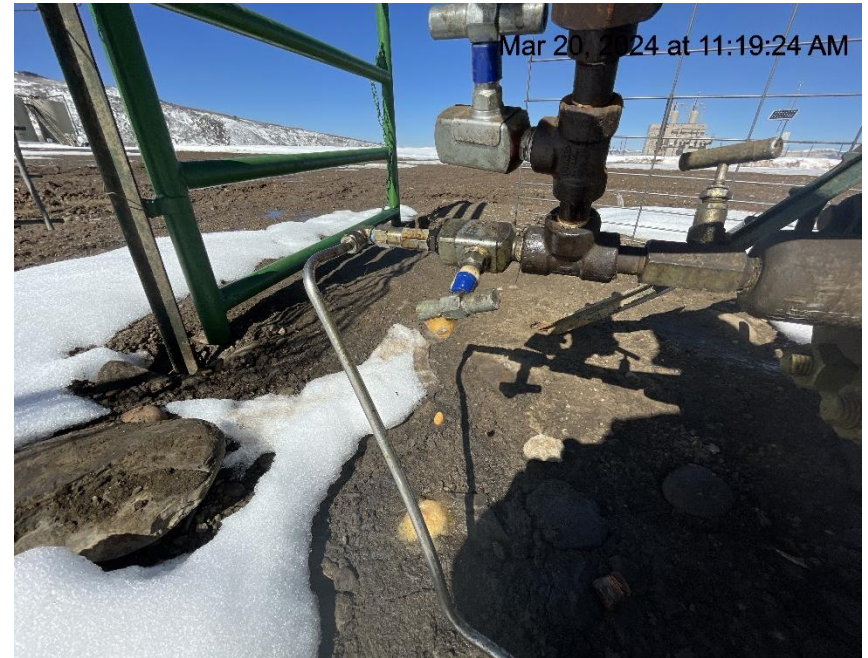
Photo # 611 Mechanical condition/Fluid leaking onto the ground from S. Leverich 13-16C wellhead

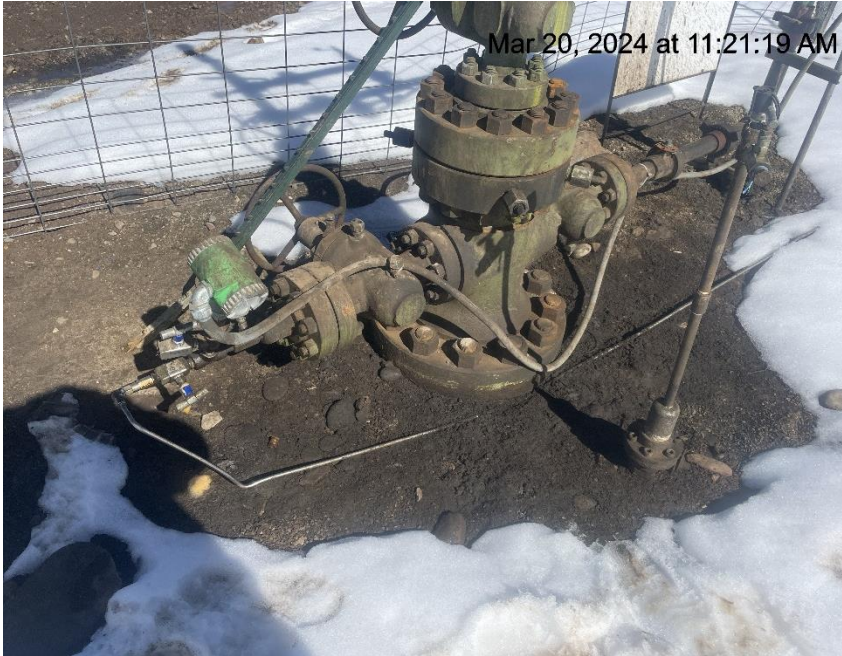
Photo # 612 Stained soils & gravel around S. Leverich 13-16C wellhead

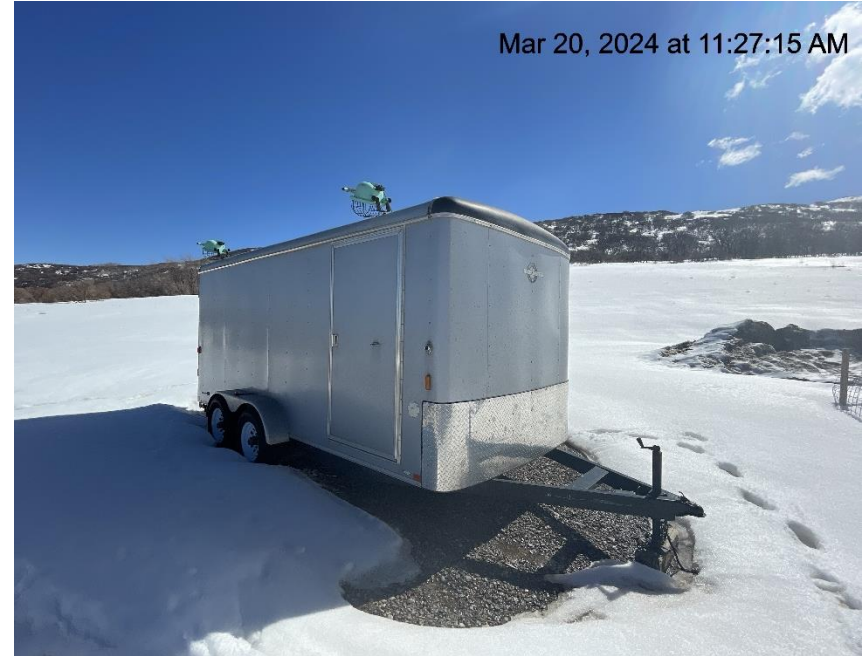
Photo # 613 Stored trailer/unused equipment

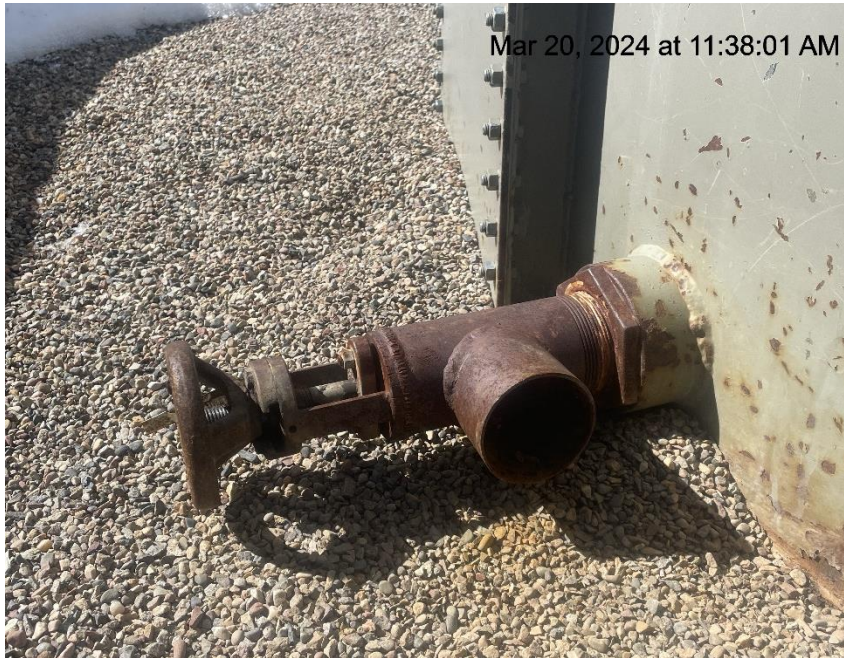
Photo # 614 Open ended load line

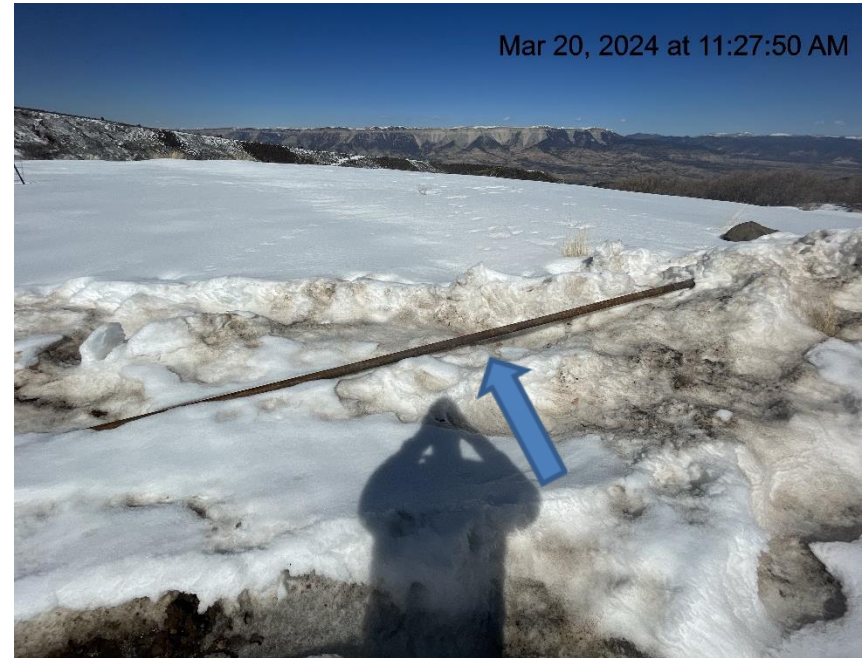
Photo # 615 Debris

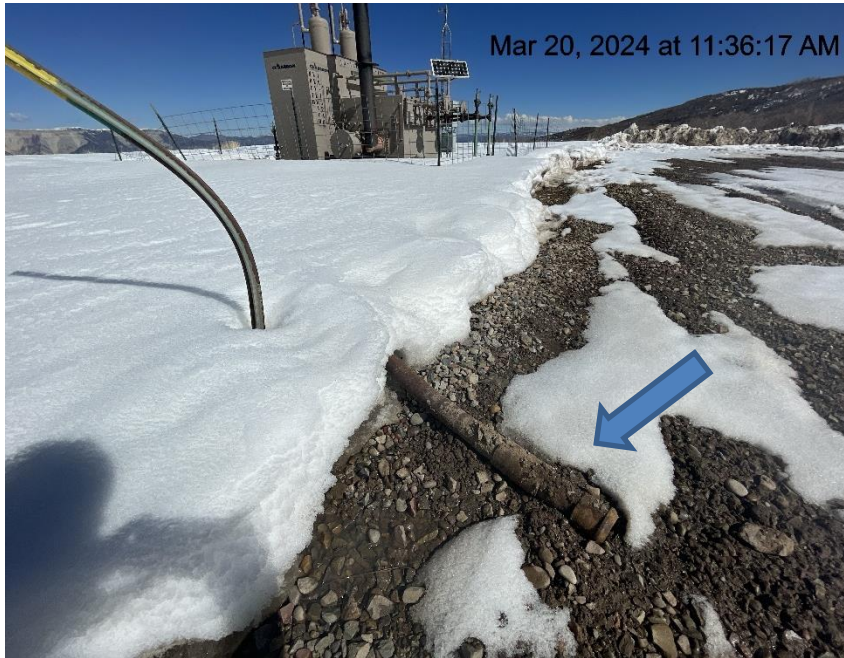
Photo # 616 Debris
