Inspection Photos
Location Name: James a Damiana #1
Location ID: 336455

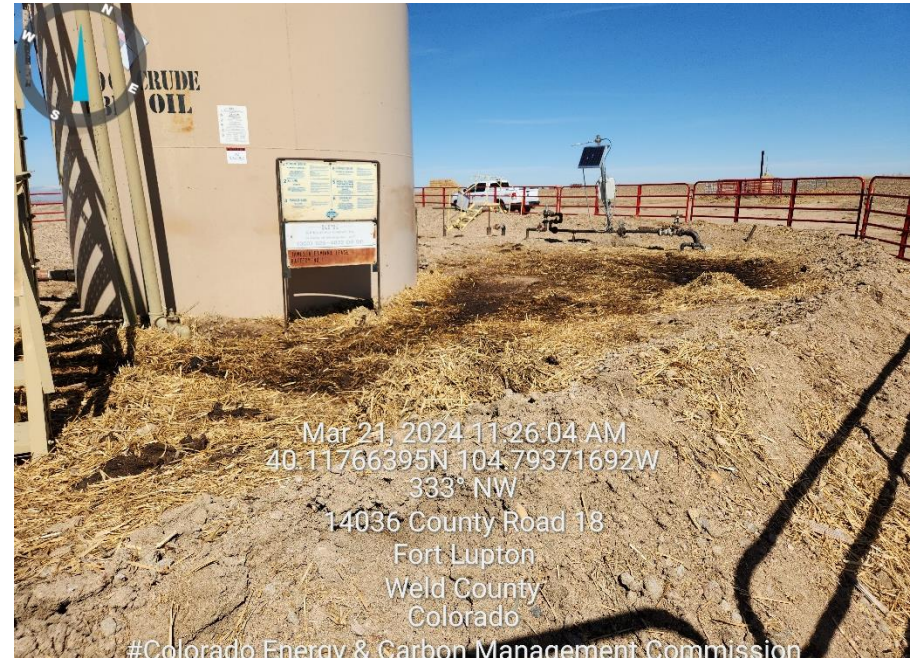
Photo 2 TNK BTRY sign rusted and not legible

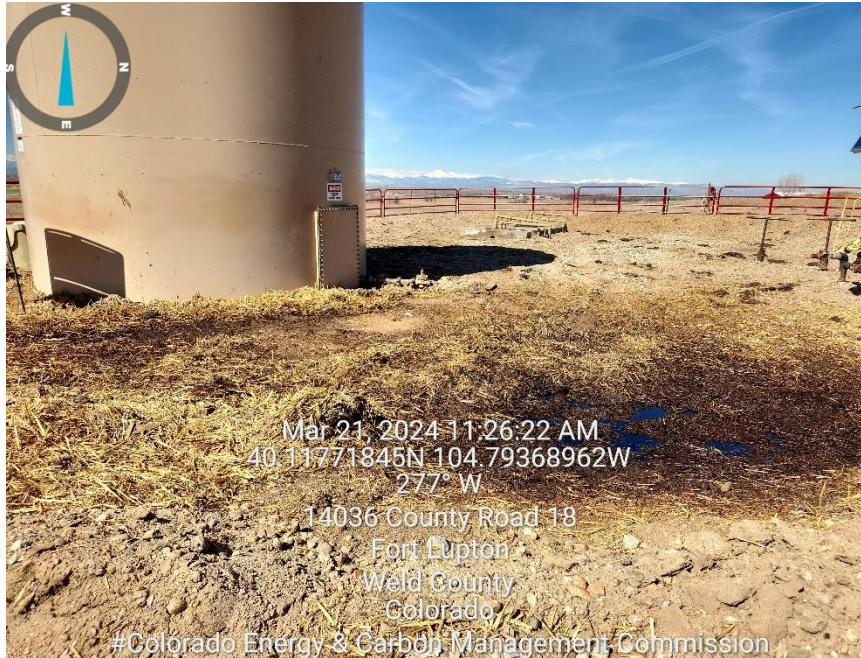
Photo 3 Debris in containment

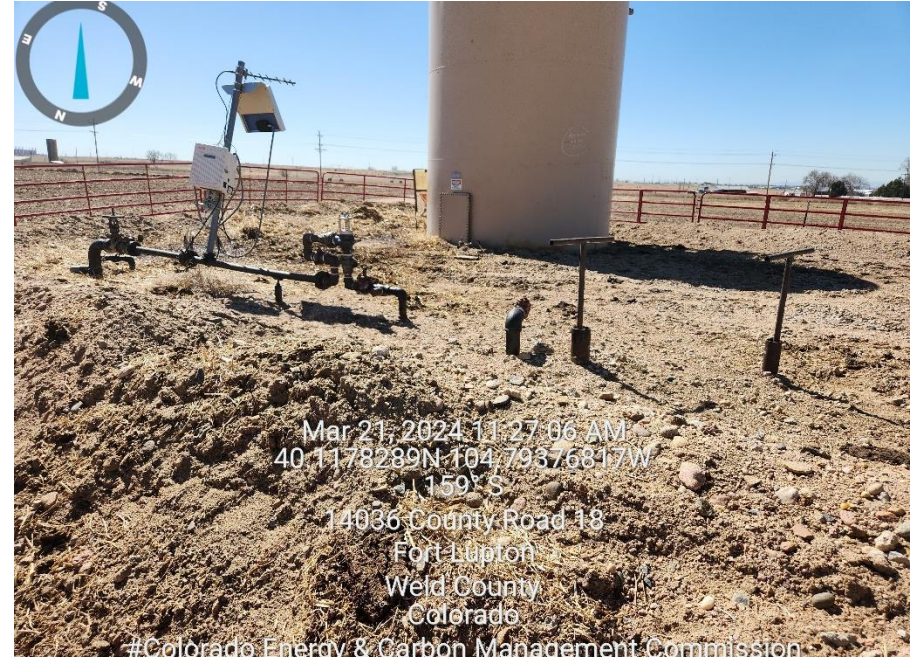
Photo 4 risers not ooslat tagged. Meter no card and meter is non operational

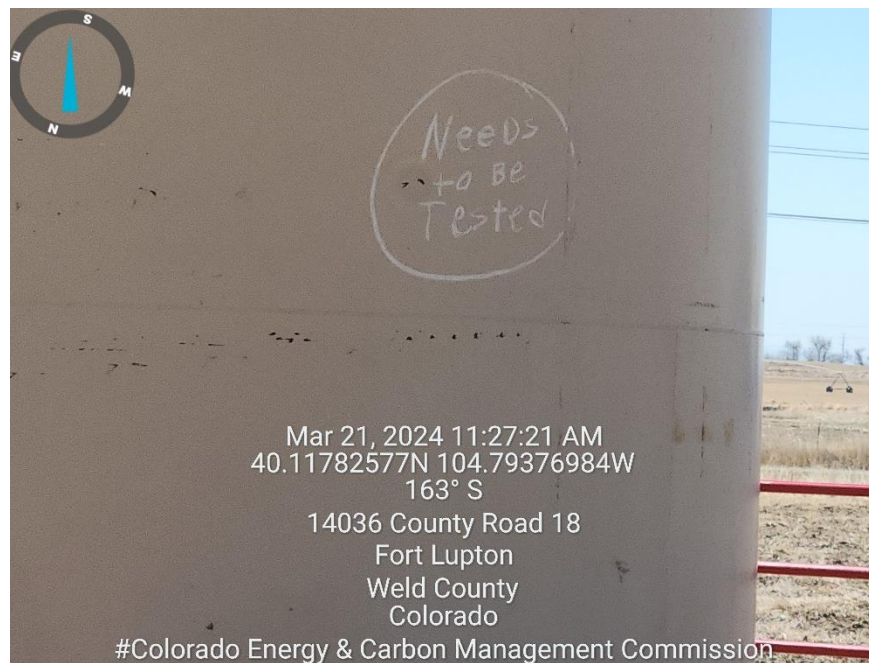
Photo 5 writing on crude oil tank

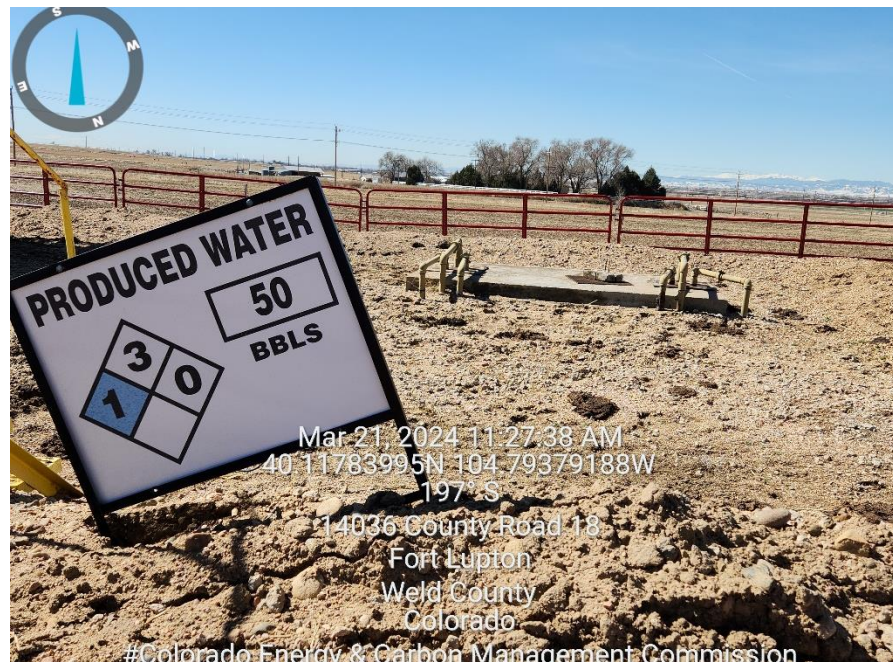
Photo 6 Produced water vault NFPA Placard faded.

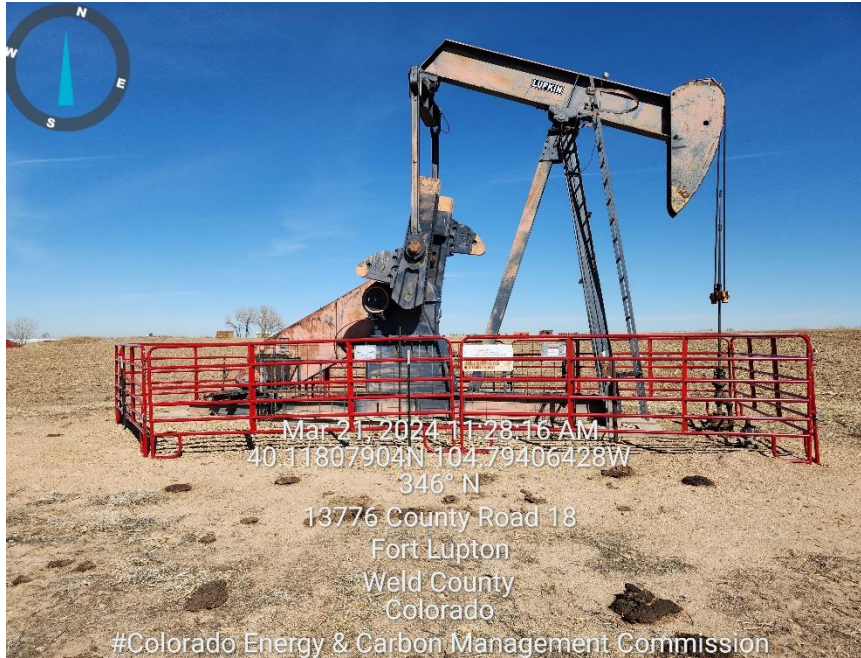
Photo 7 Well head sign faded not legible

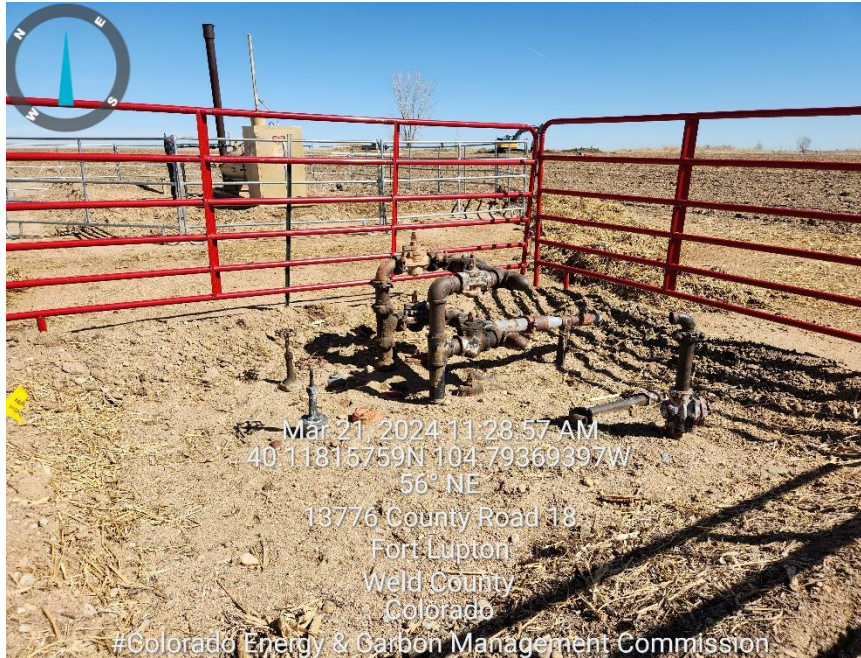
Photo 9 piping has not OOSLAT tags

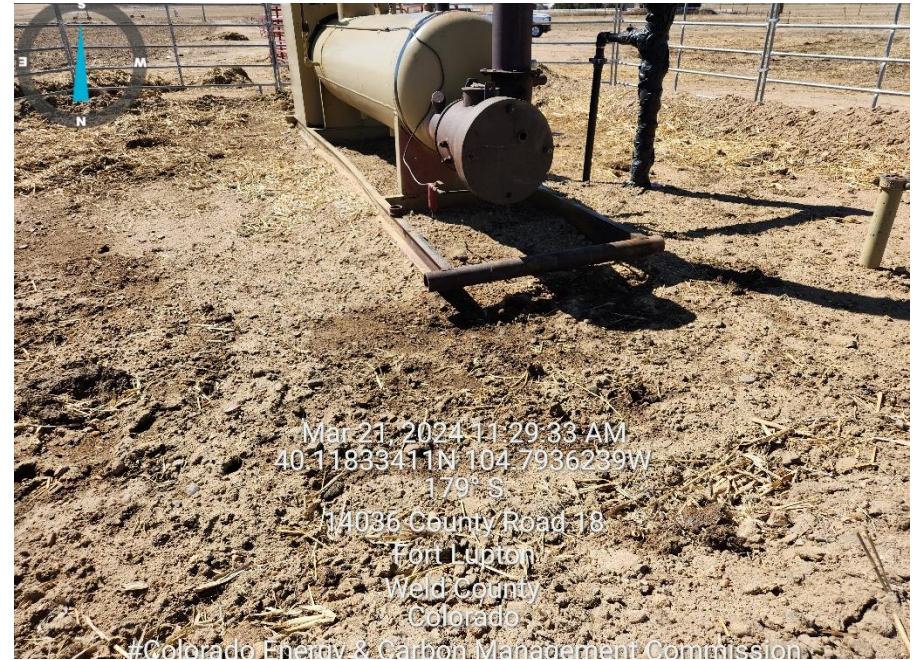
Photo 10 Mechanical issue and stained soil on ground of Hoz sep.
