Inspection Photos
Location Name: Coan 17-33#17-33
Location ID: 331435

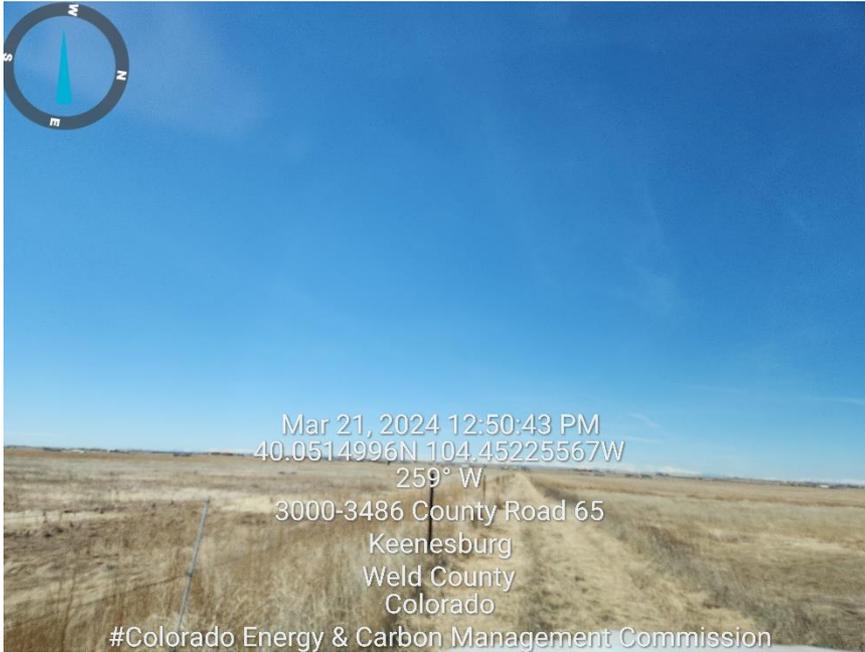
Photo 1 Access road mowed not maintained

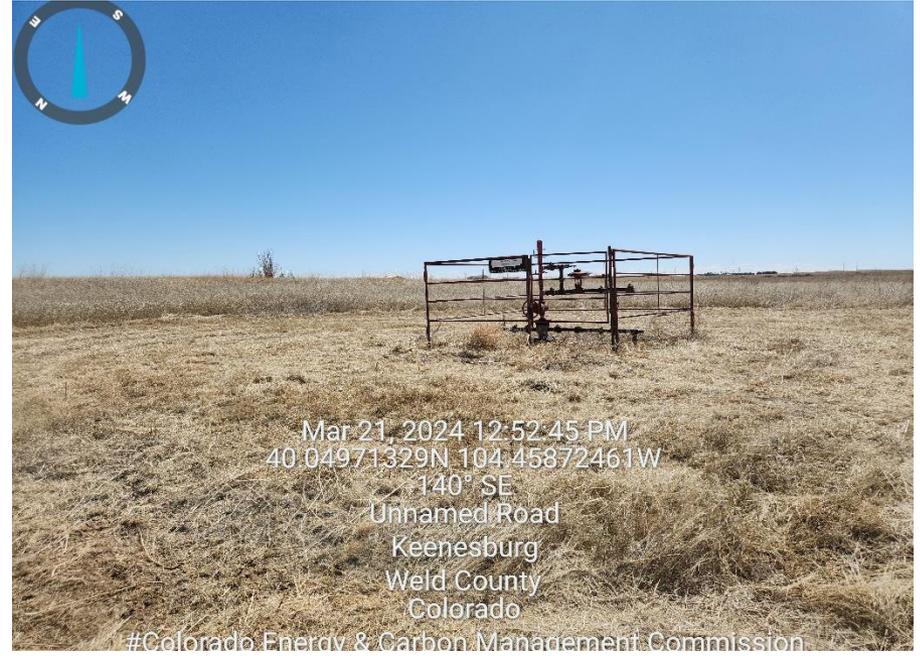
Photo2 Well head Dead vegetation around well head

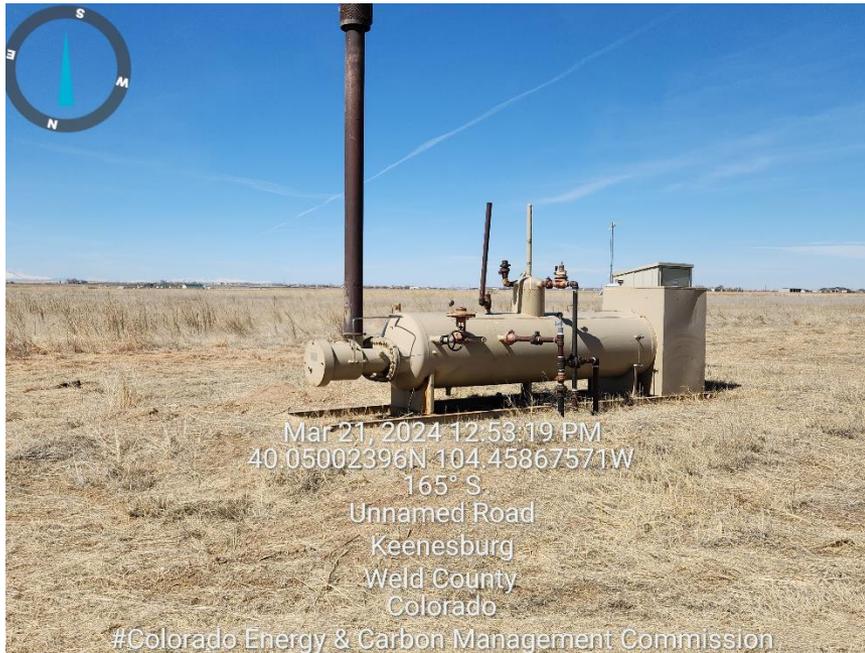
Photo 3 Heater stack installed Dead vegetation around separator

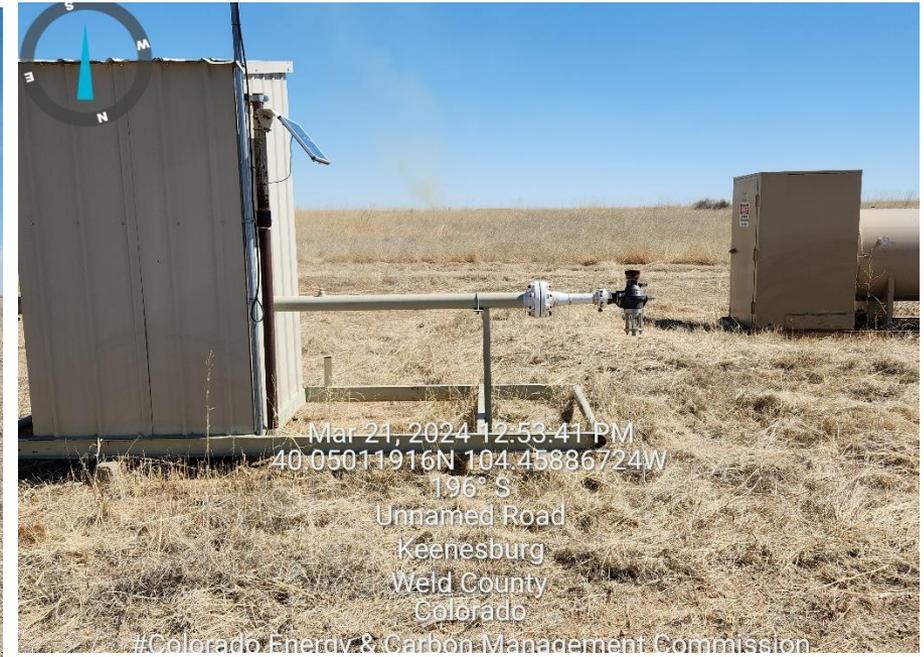
Photo 4 Meter house not connected to sales flow line not operational

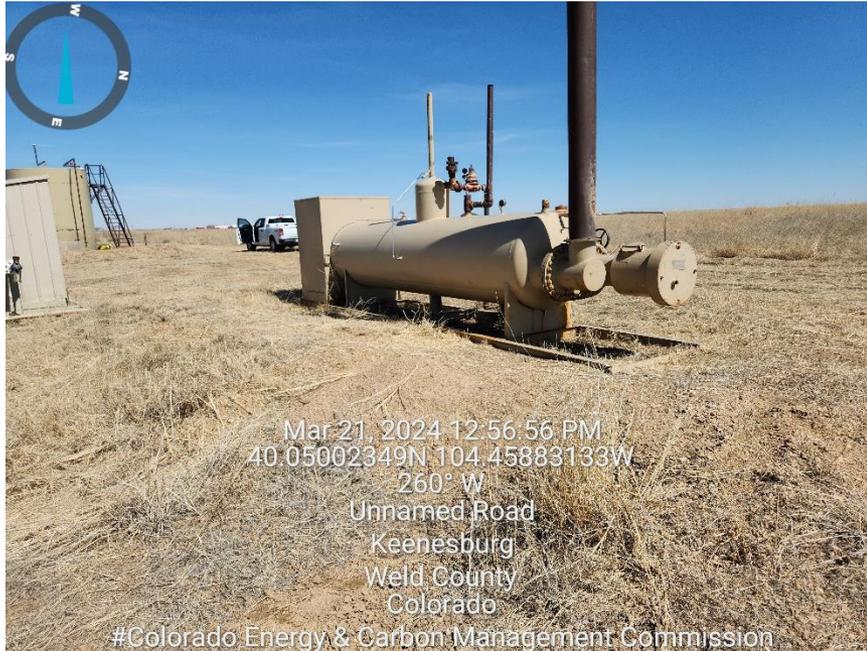
Photo 5 Dead vegetation around equipment

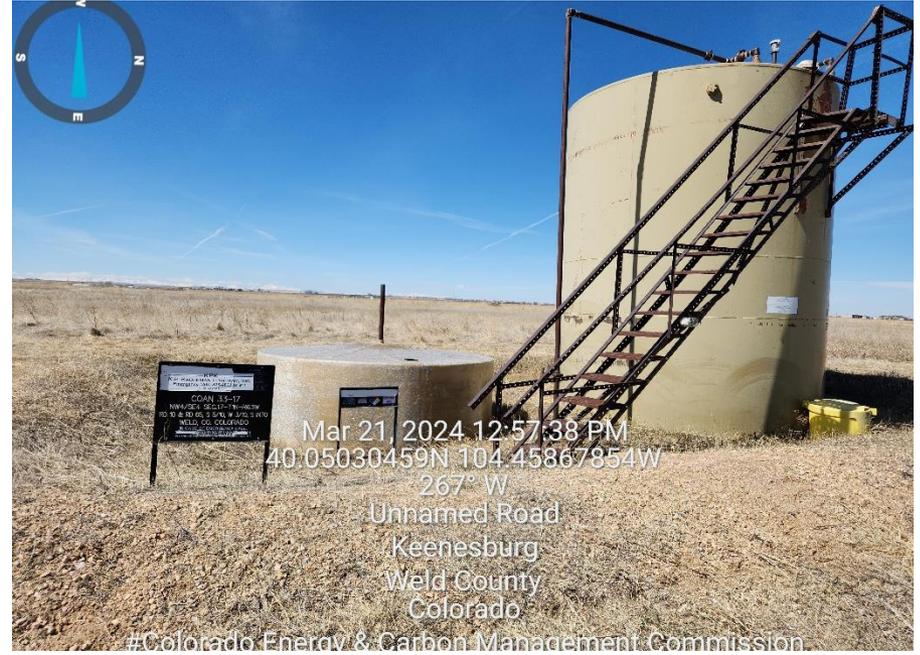
Photo 6 Battery sign not replaced no volume on produced water tank

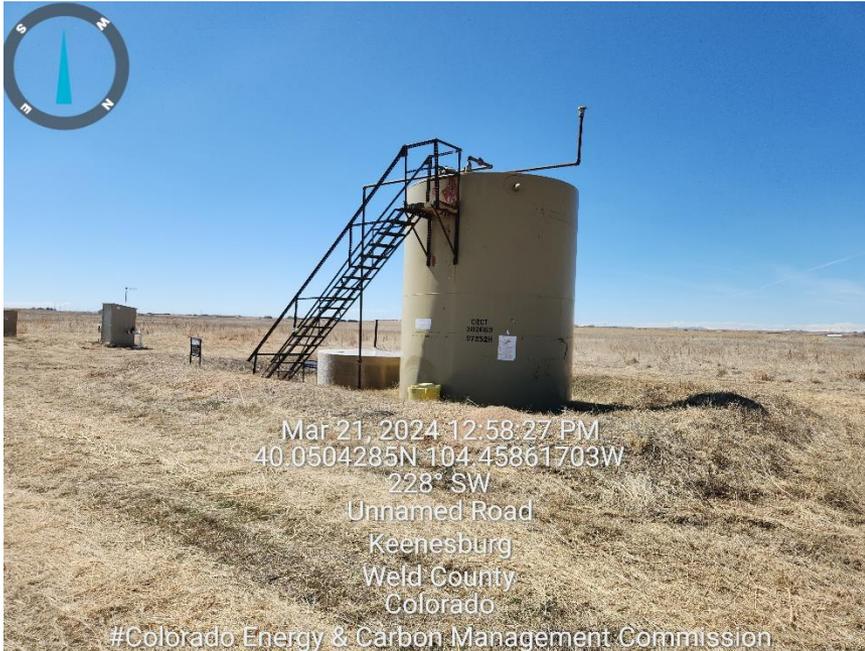
Photo 7 Oil tank has no placards or volume signs

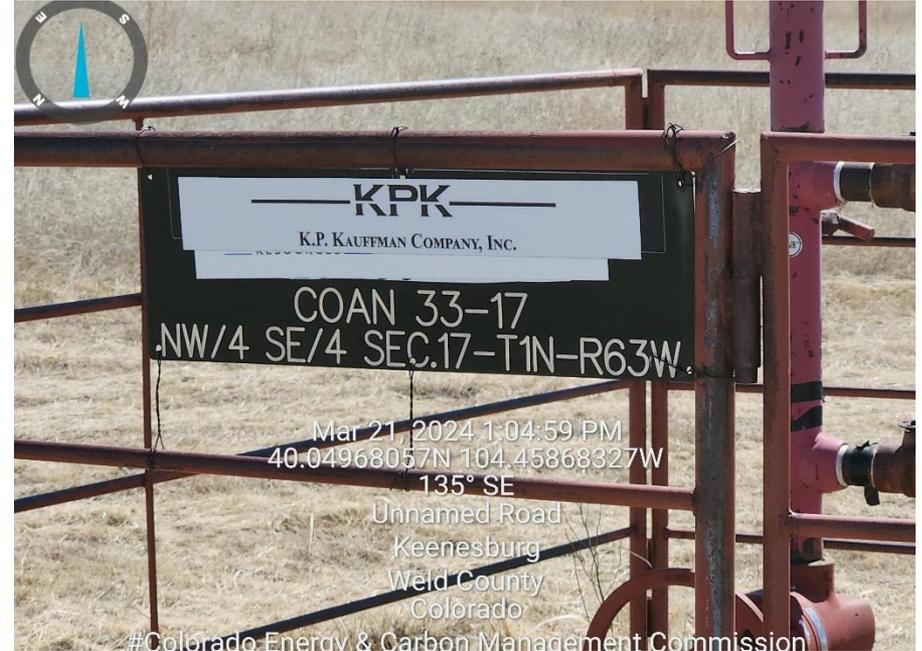
Photo 8 well head sign has not been replaced with correct well number

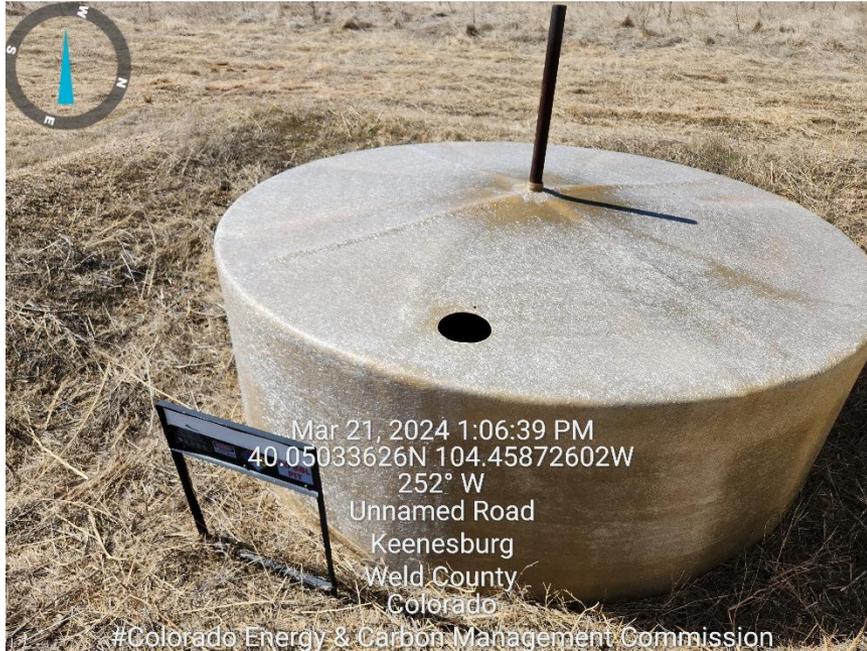
Photo 9 Wildlife protection hole in produced water tank

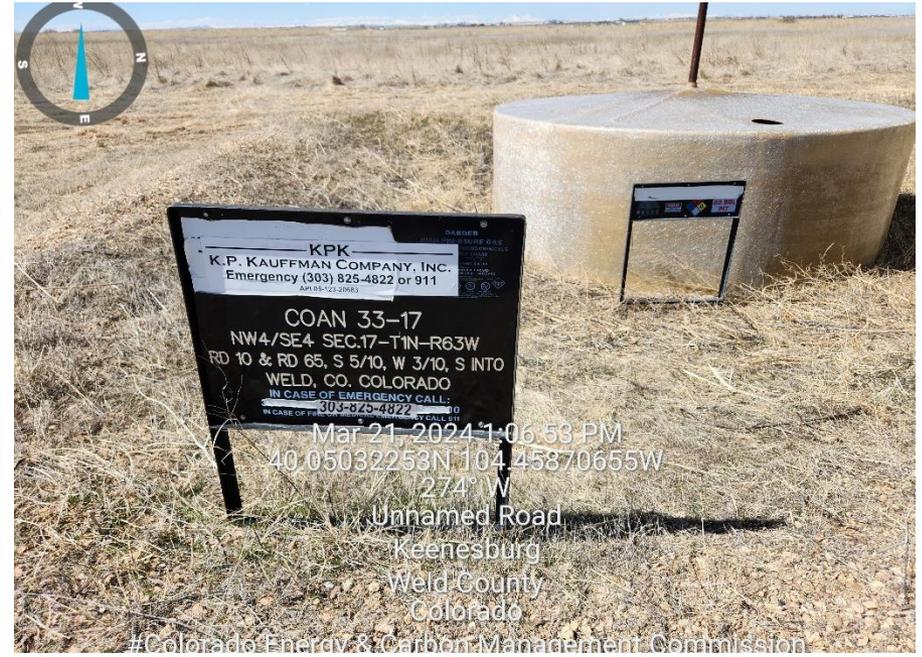
Photo 10 TNK BTRY sign does not reflect correct well number

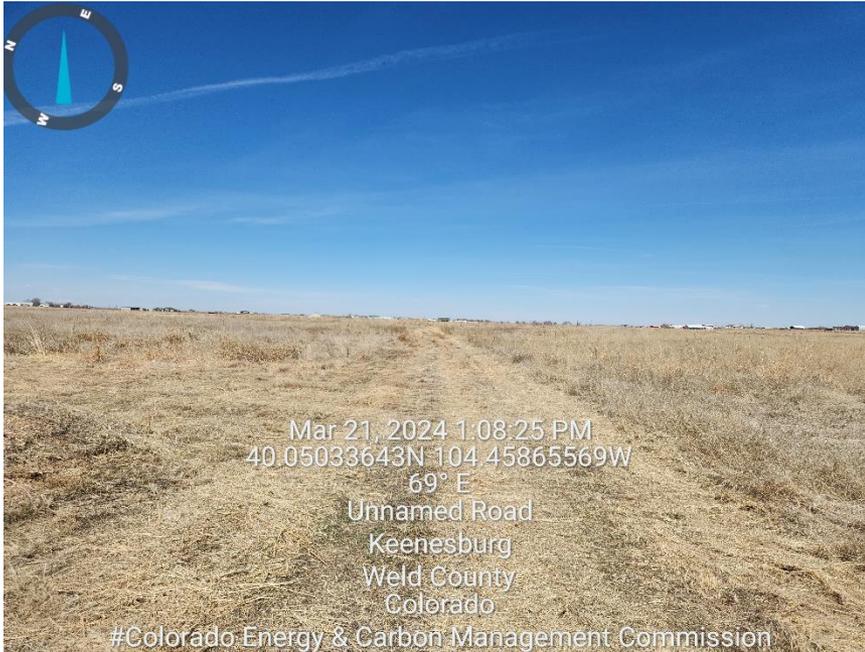
Photo 11 access road mowed not maintained

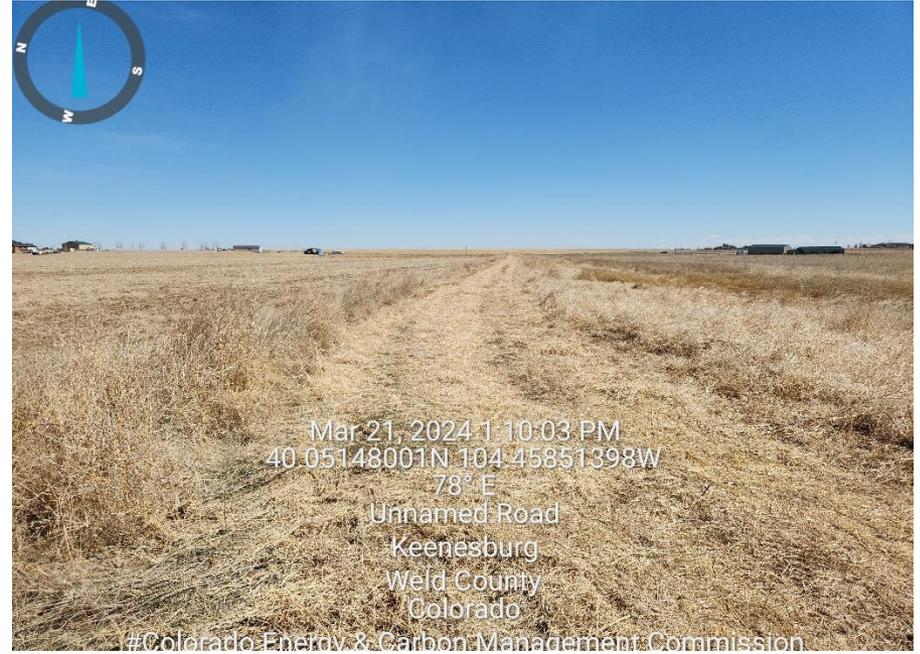
Photo 12 Access road mowed not maintained

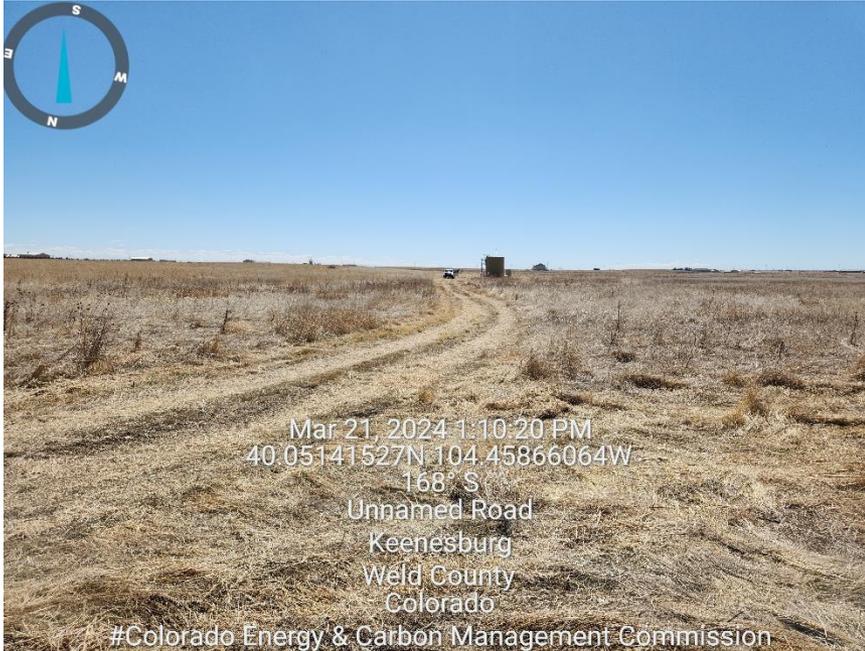
Photo 13 Access road mowed not maintained

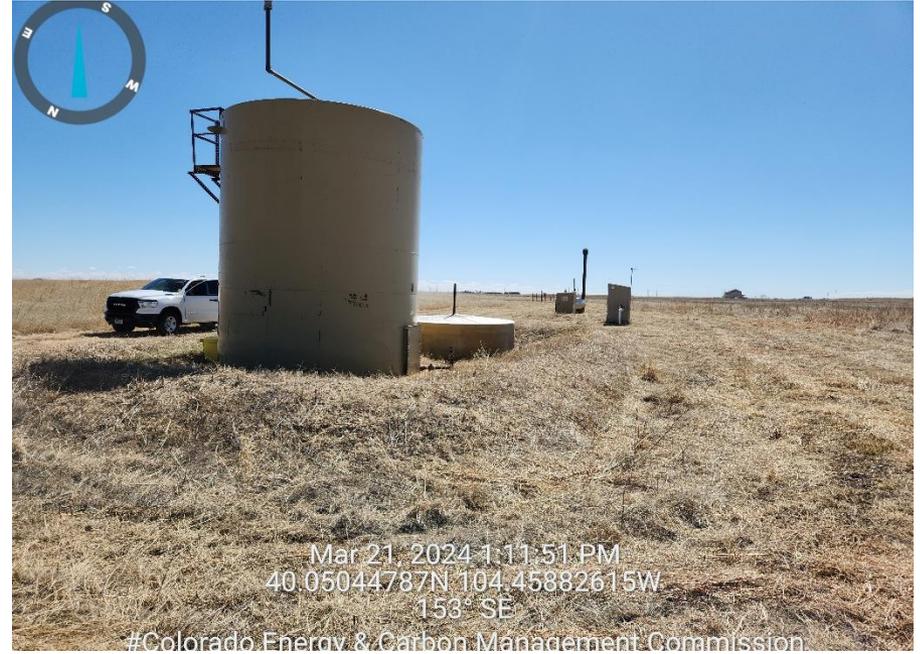
Photo 14 Debris cut down in and around secondary containment but not removed

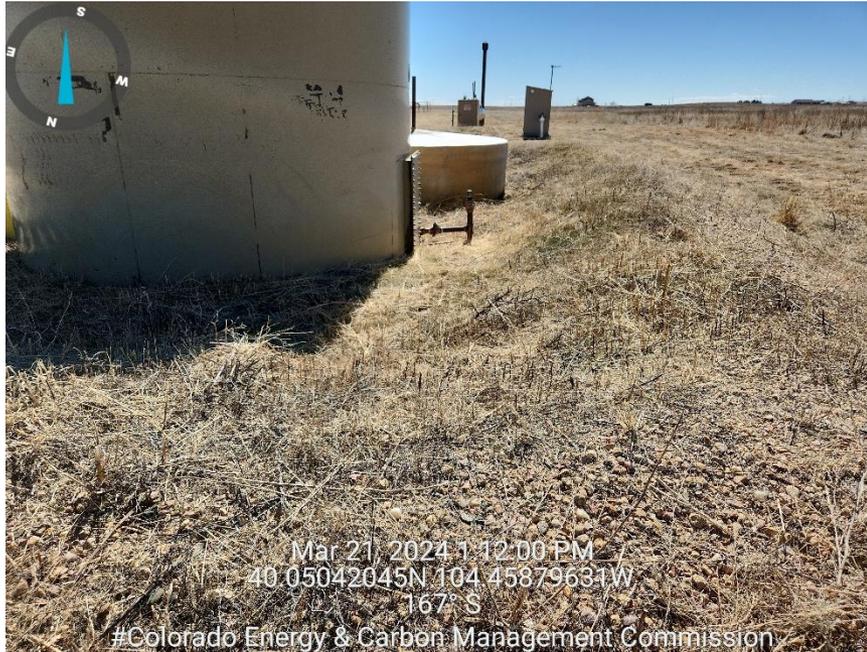
Photo 15 Dead vegetation in secondary containment

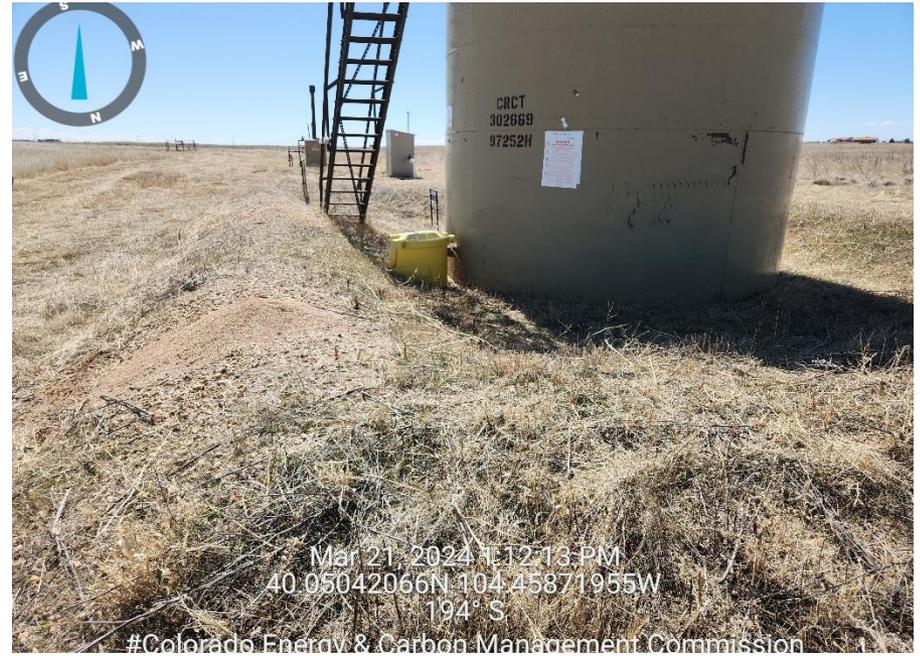
Photo 16 Dead vegetation in secondary containment
