Inspection Photos

Loc: 322234

Operator: **INCREMENTAL OIL & GAS (FLORENCE) LLC**

Inspection Date: 3/20/2024

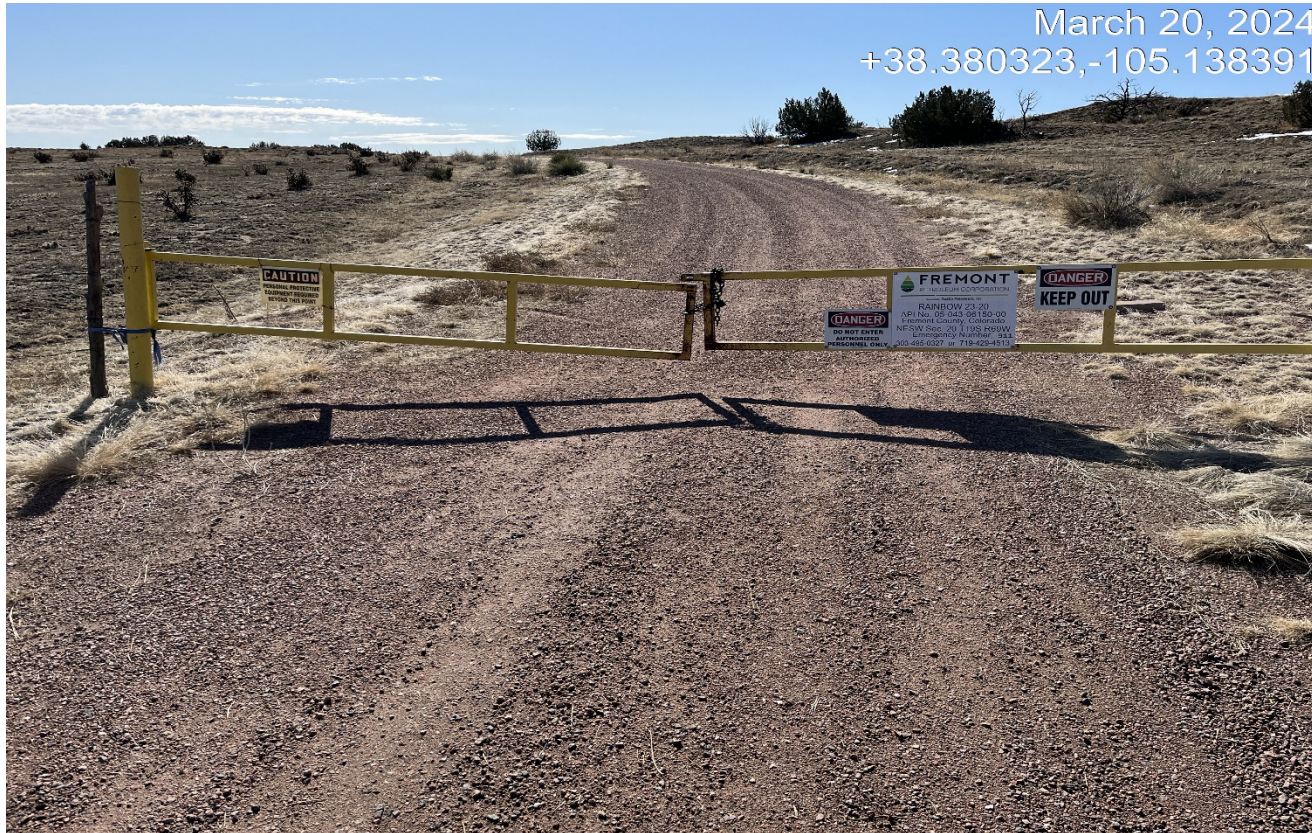
Photo 1. Facing southeast at the beginning of the access road. The access road has not been reclaimed.

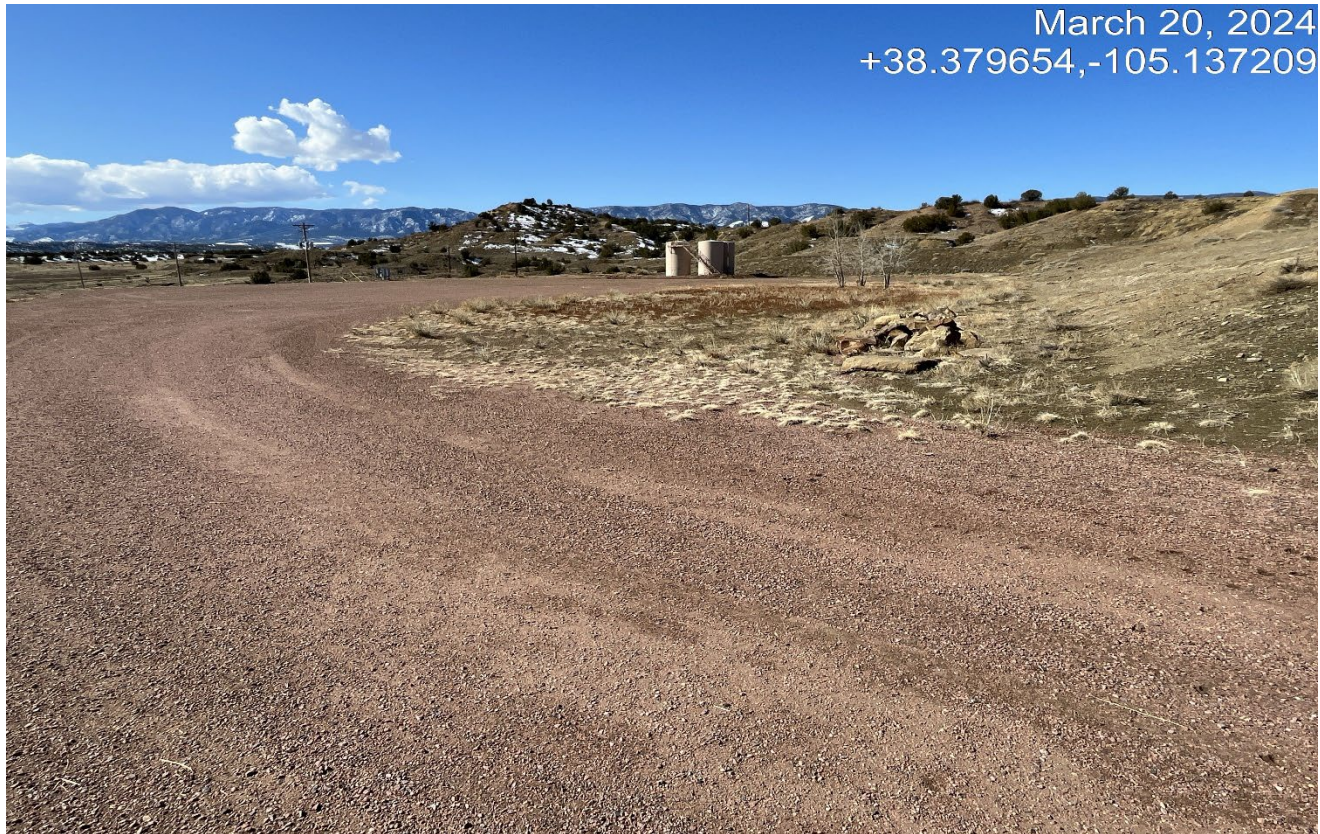
Photo 2. Facing south toward the location. The well has been plugged and abandoned however final reclamation has not yet been completed.

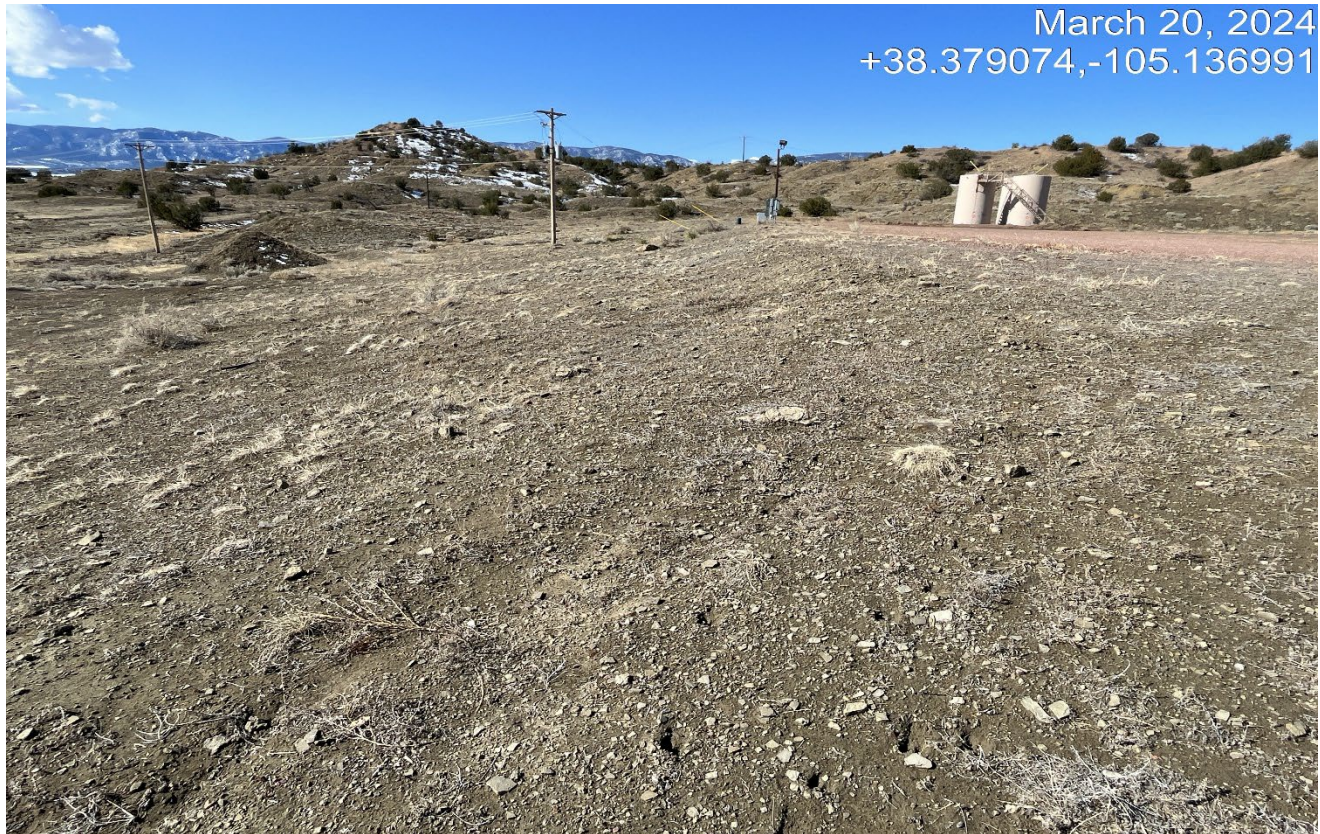
Photo 3. Facing southwest along the fill slope. The location will need to be recontoured back to the original slopes

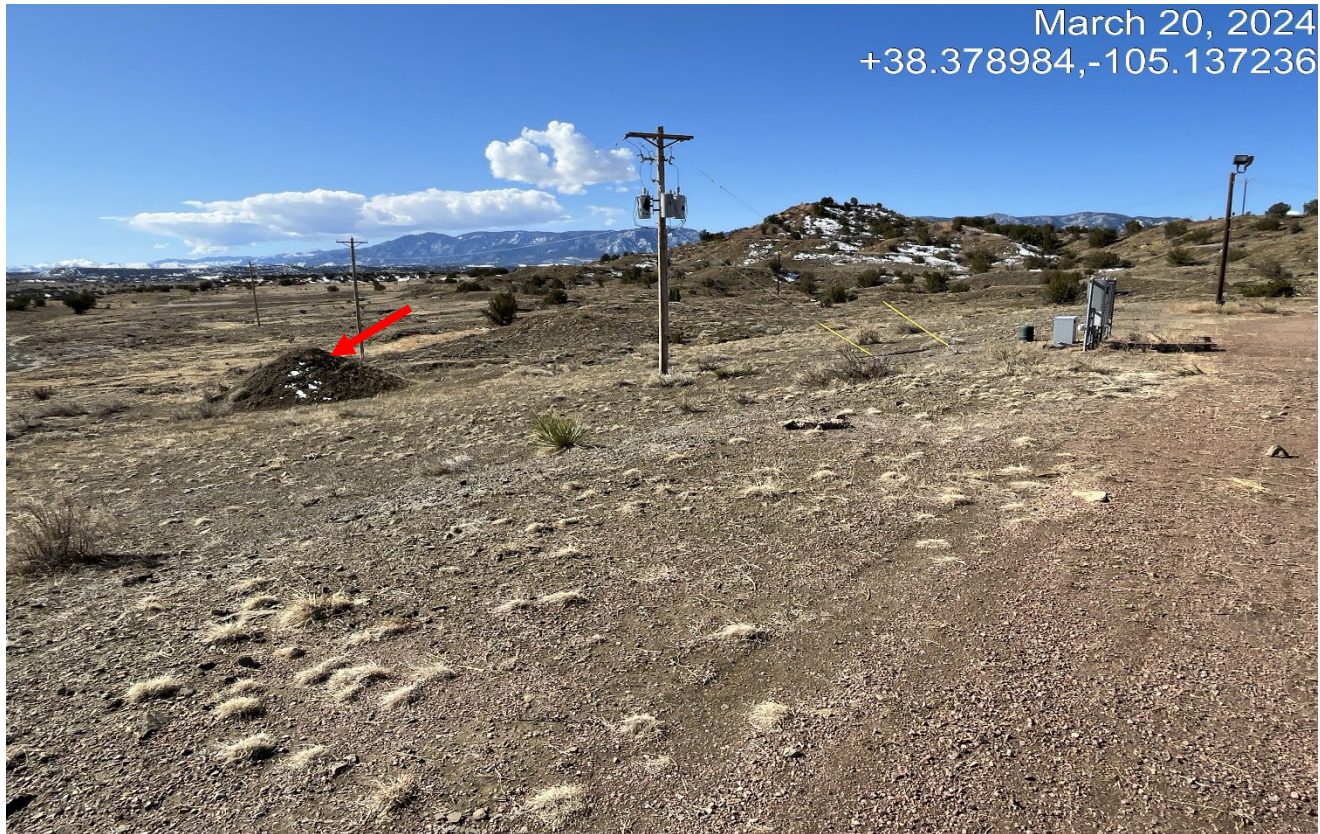
Photo 4. The electric utilities remain at the location and should have been removed with 3 months of abandonment. The entire powerline and poles servicing this location must be removed. There is a topsoil pile shown at red arrow.

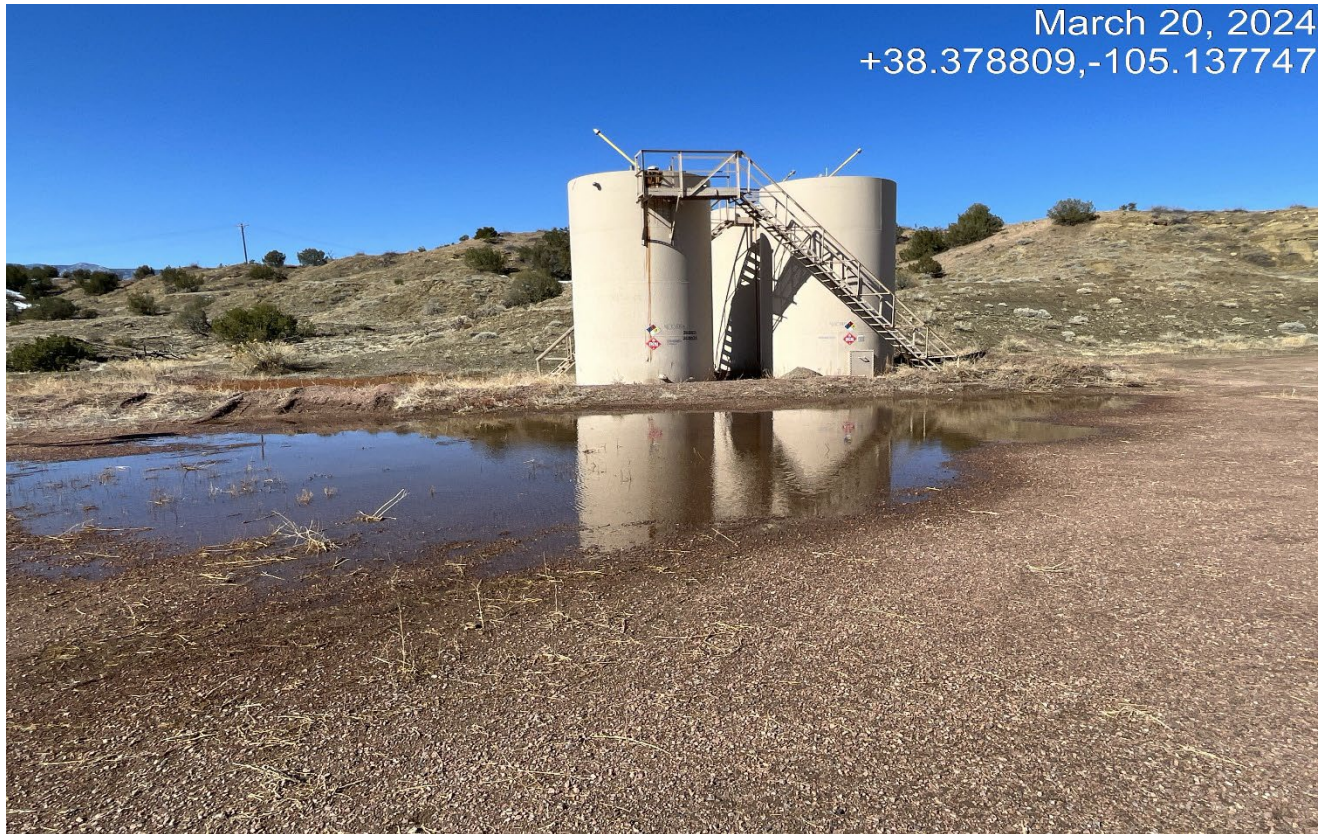
Photo 5. Facing toward the south side of the location. There are tanks that have not been removed. All equipment should have been removed within 3 months of abandonment.

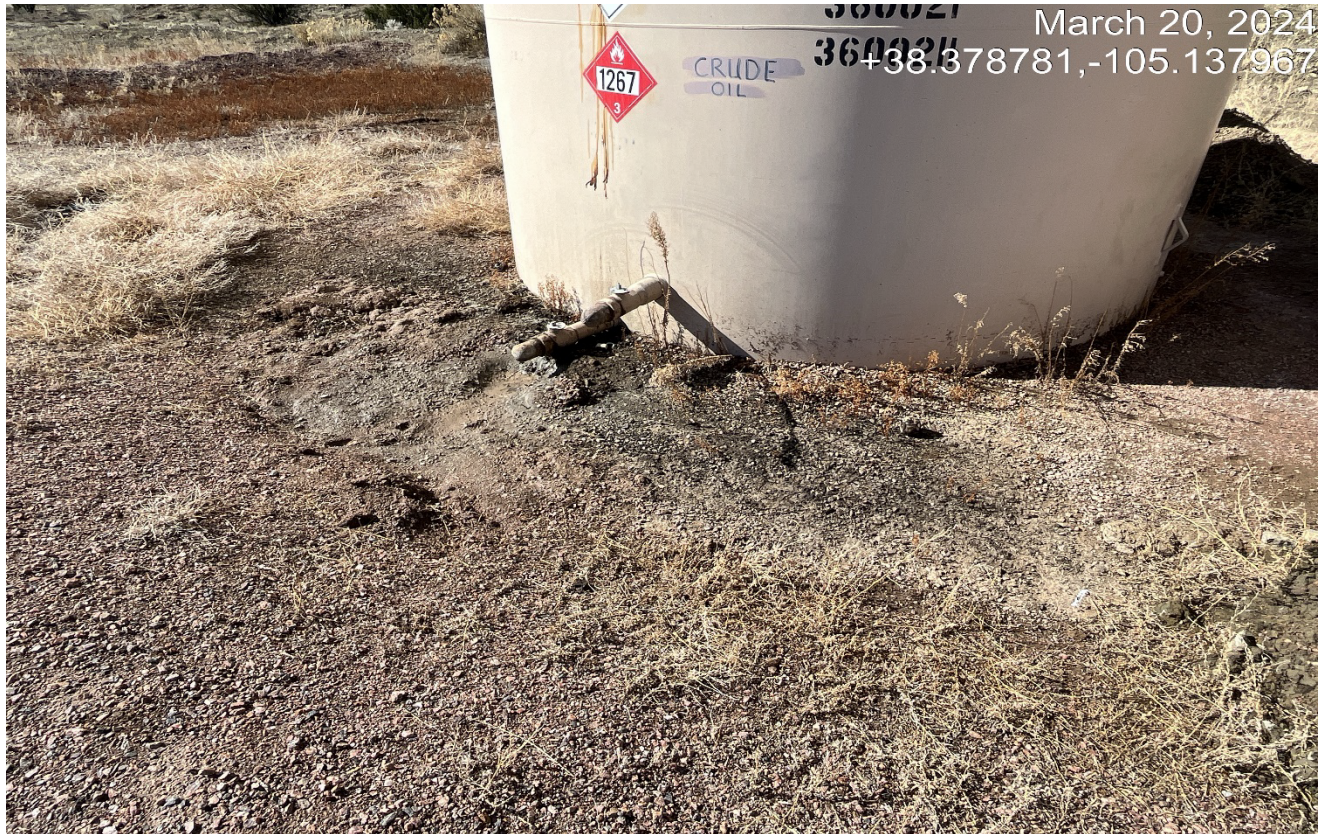
Photo 6. Upon closer inspection of the tanks there is a spill that had occurred at the tank outlet. Immediate clean up needs to be performed.

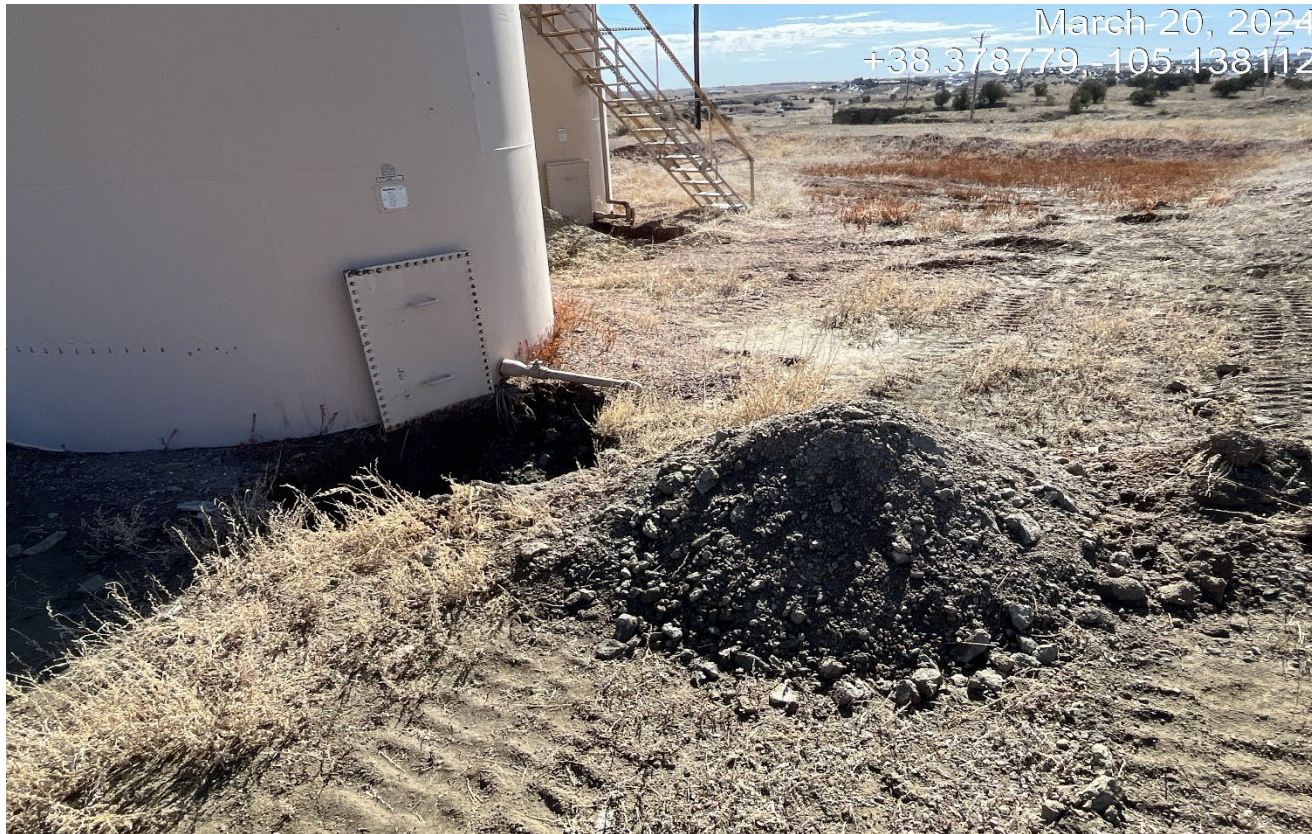
Photo 7. Facing toward the backside of the tanks. There has been digging at the backside of the tanks.

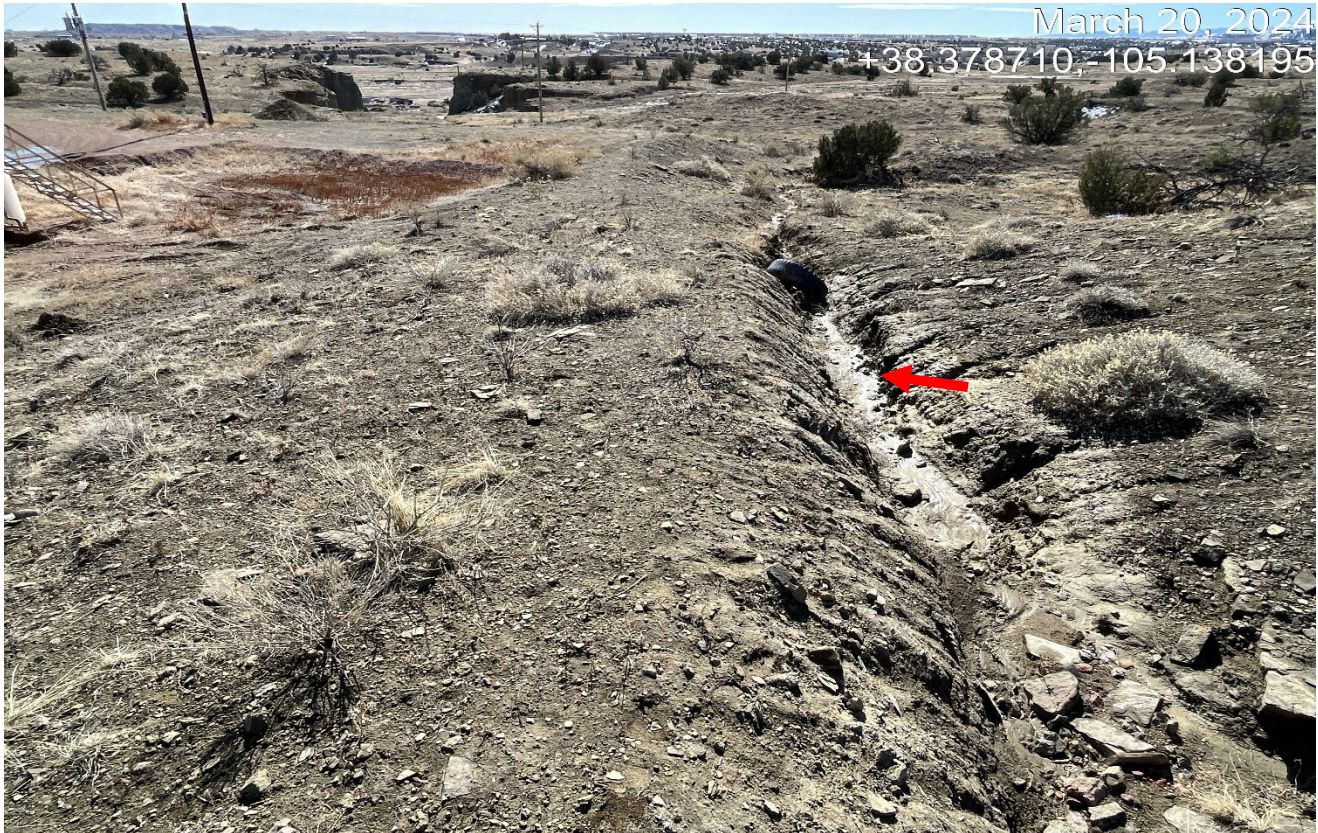
Photo 8. Facing southeast at the south side of the location. There is an erosion channel shown at red arrow which will need to be repaired and stabilized.

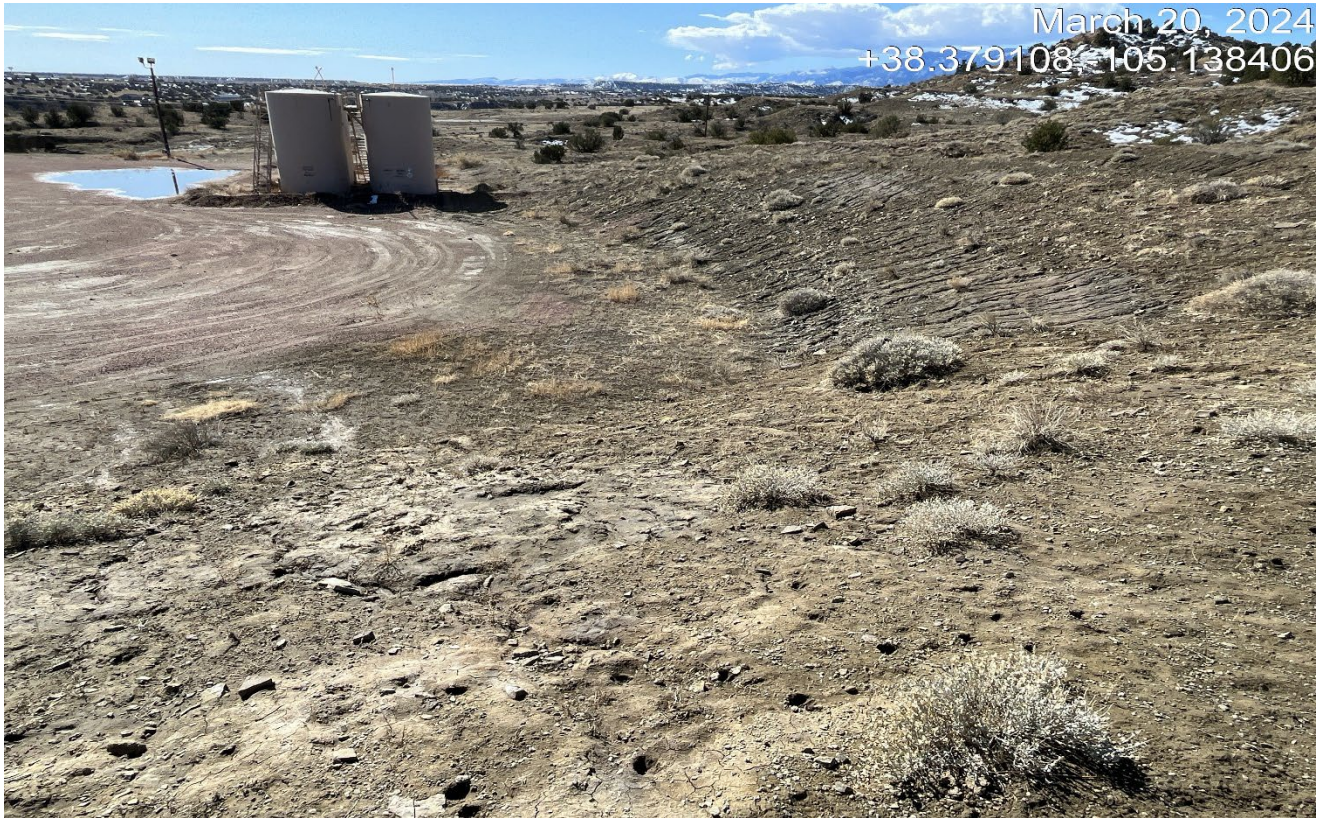
Photo 9. Facing east along the cut slope. There are rilling erosion along the cut slope.

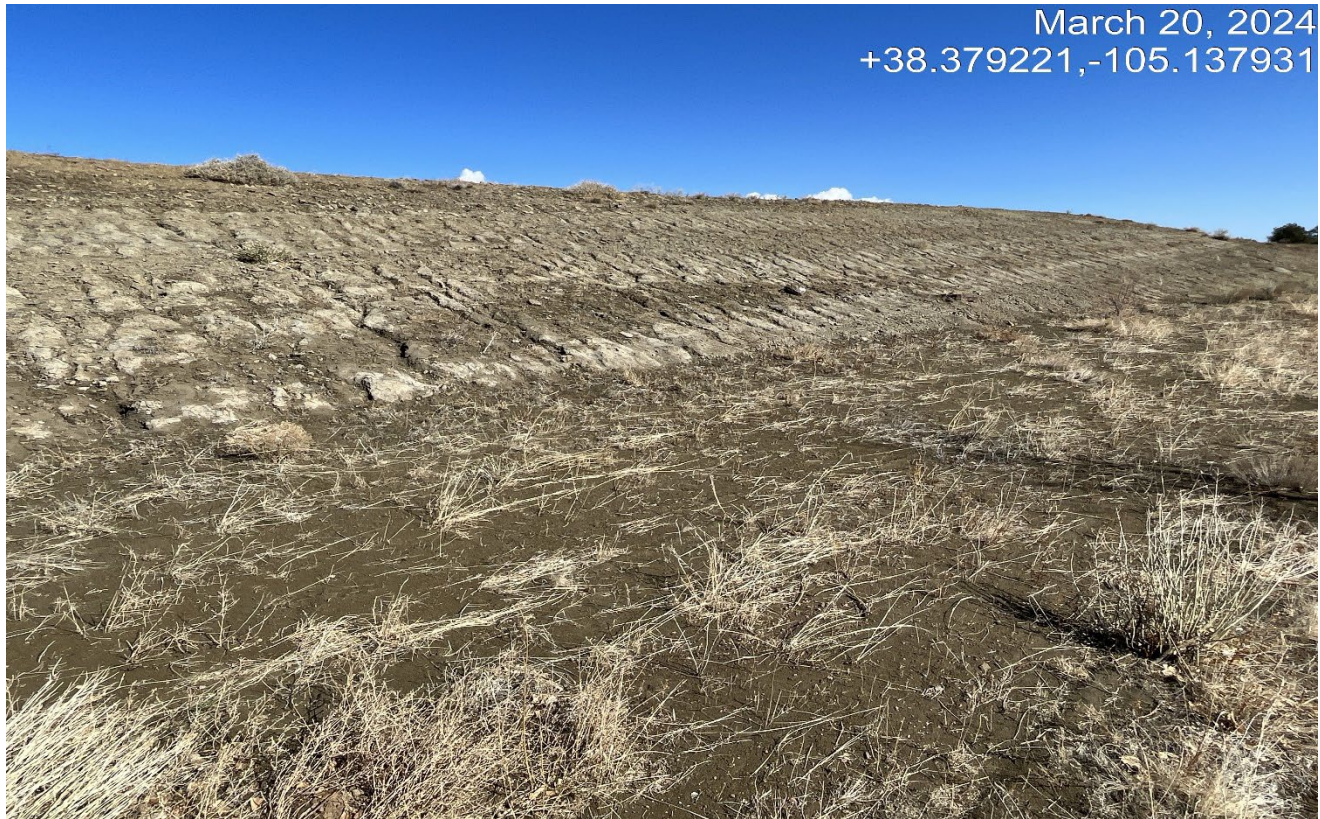
Photo 10. Facing northwest along the cut slope. There cut slope is not stabilized.

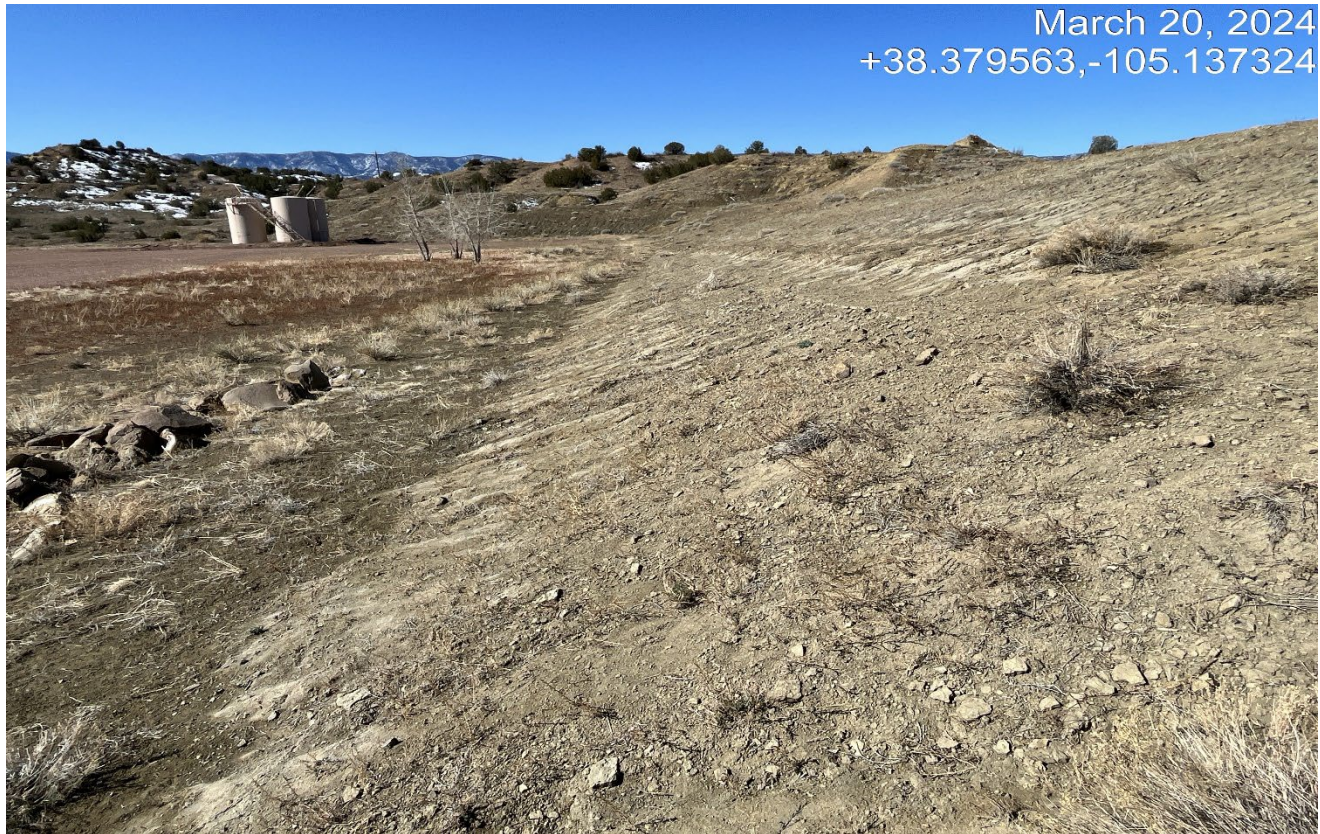
Photo 11. Facing south at the location standing from base of the cut slope.
