# Inspection Photos

API: 043-06157

Operator: **INCREMENTAL OIL & GAS (FLORENCE) LLC**

Inspection Date: 3/20/2024

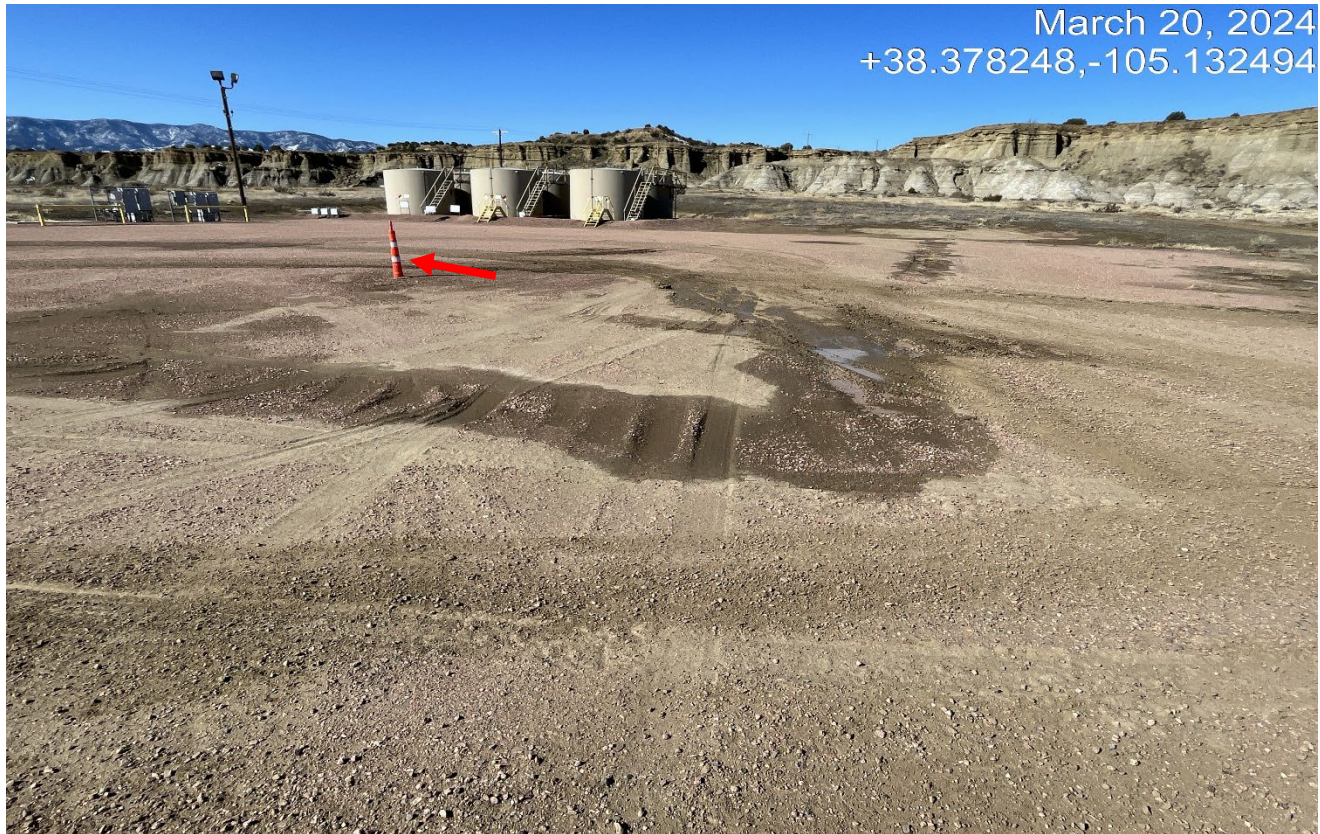
**Photo 1.** Facing west at the location. There is a orange safety cone placed at the wellhead. All unused areas of the location must be reclaimed.

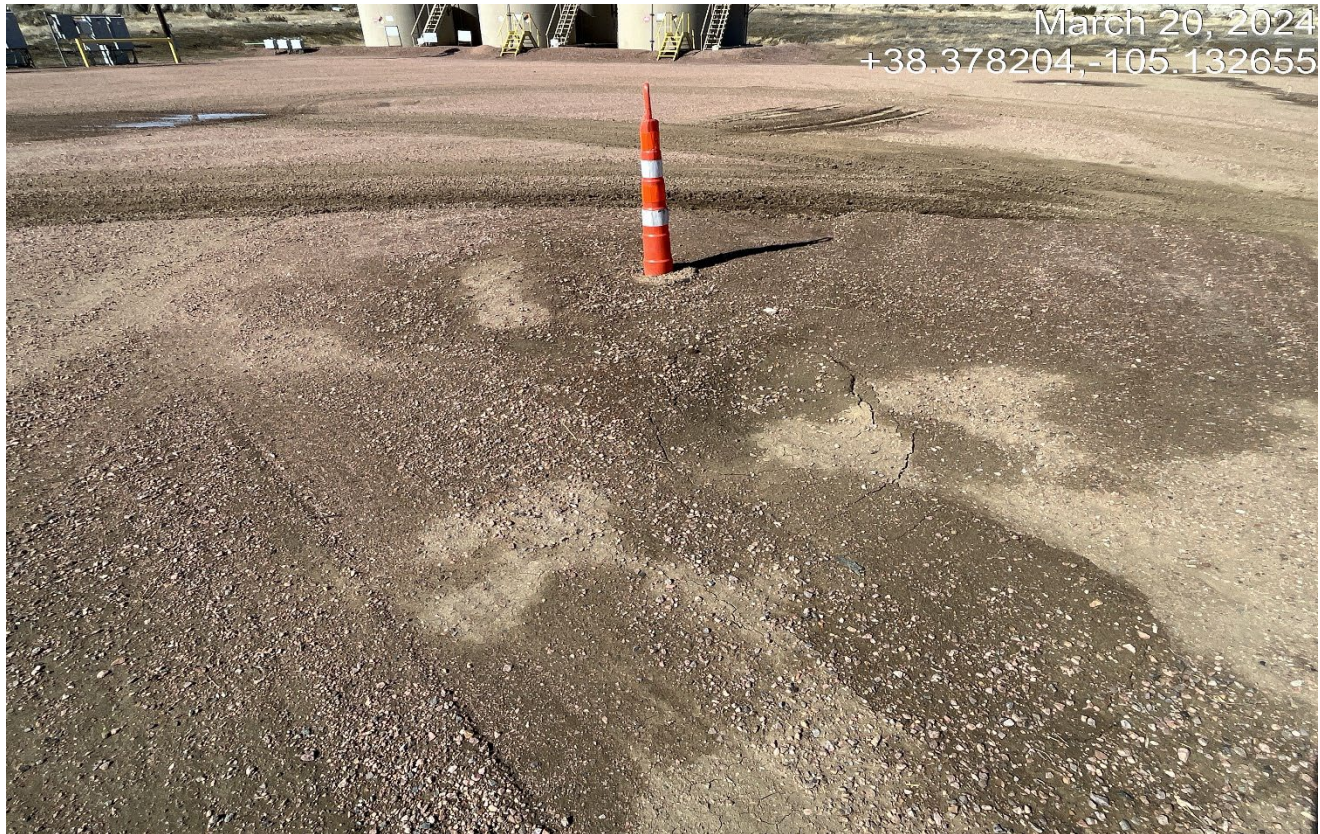
**Photo 2.** Facing back east at the location. There is a plastic bucket covering an open wellbore at red arrow.

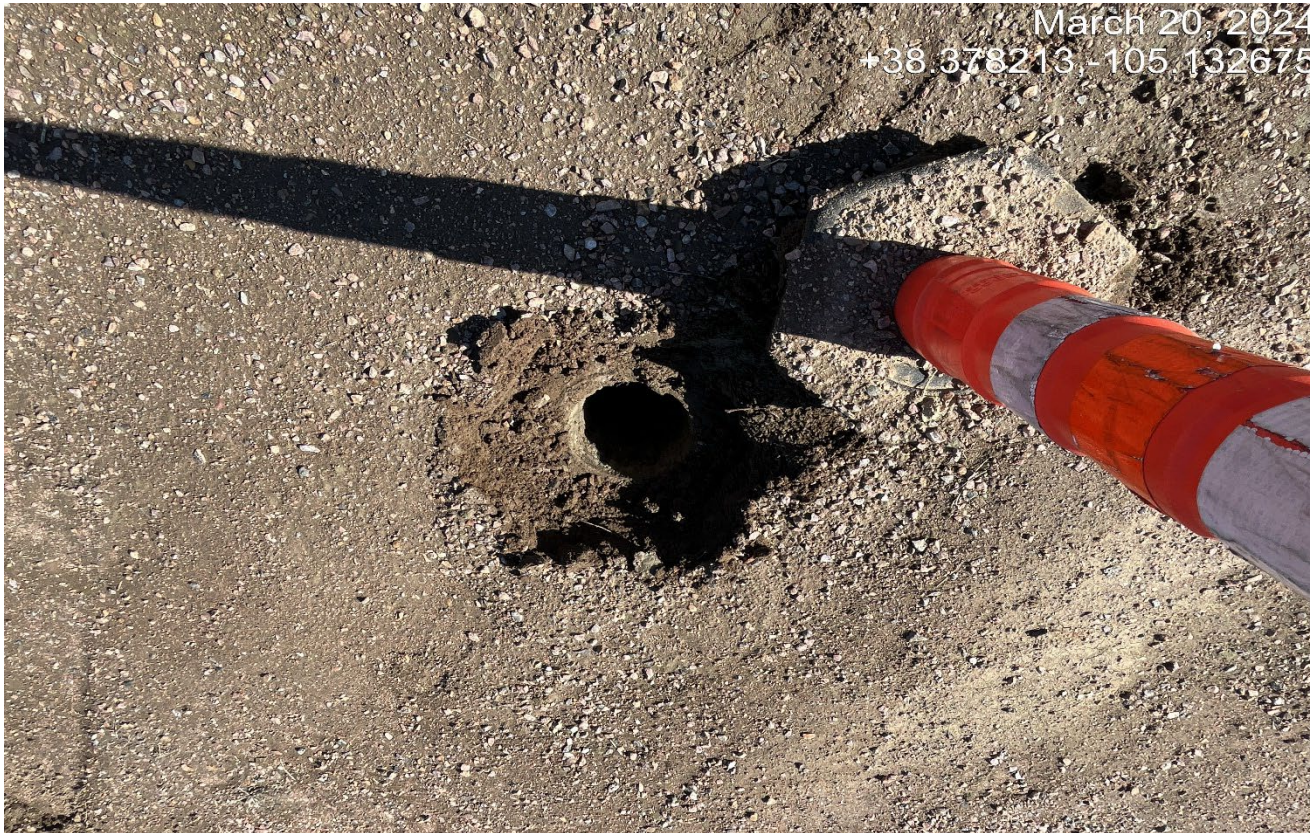
**Photo 3.** There is a well casing and deep wellbore which the safety cone is covering the well but is not secure. A proper steel cap should be placed and secured on the open wellbore.

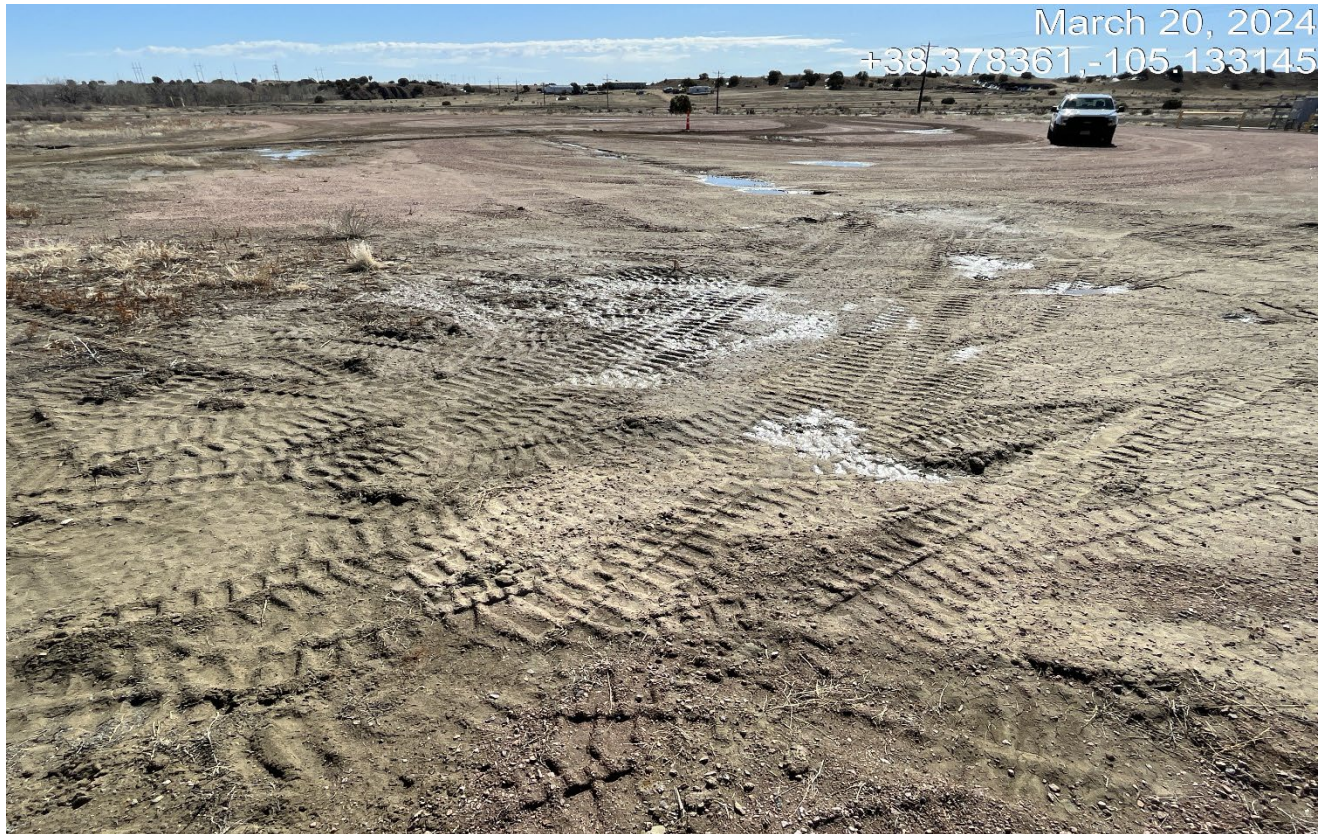
**Photo 4.** Facing east at the northwest side of the location. The pipe risers and utility appear to have been removed. All unused areas of the location must be reclaimed.
