Inspection Photos

Loc: 424805

Operator: **JAVERNICK OIL**

Inspection Date: 3/20/2024

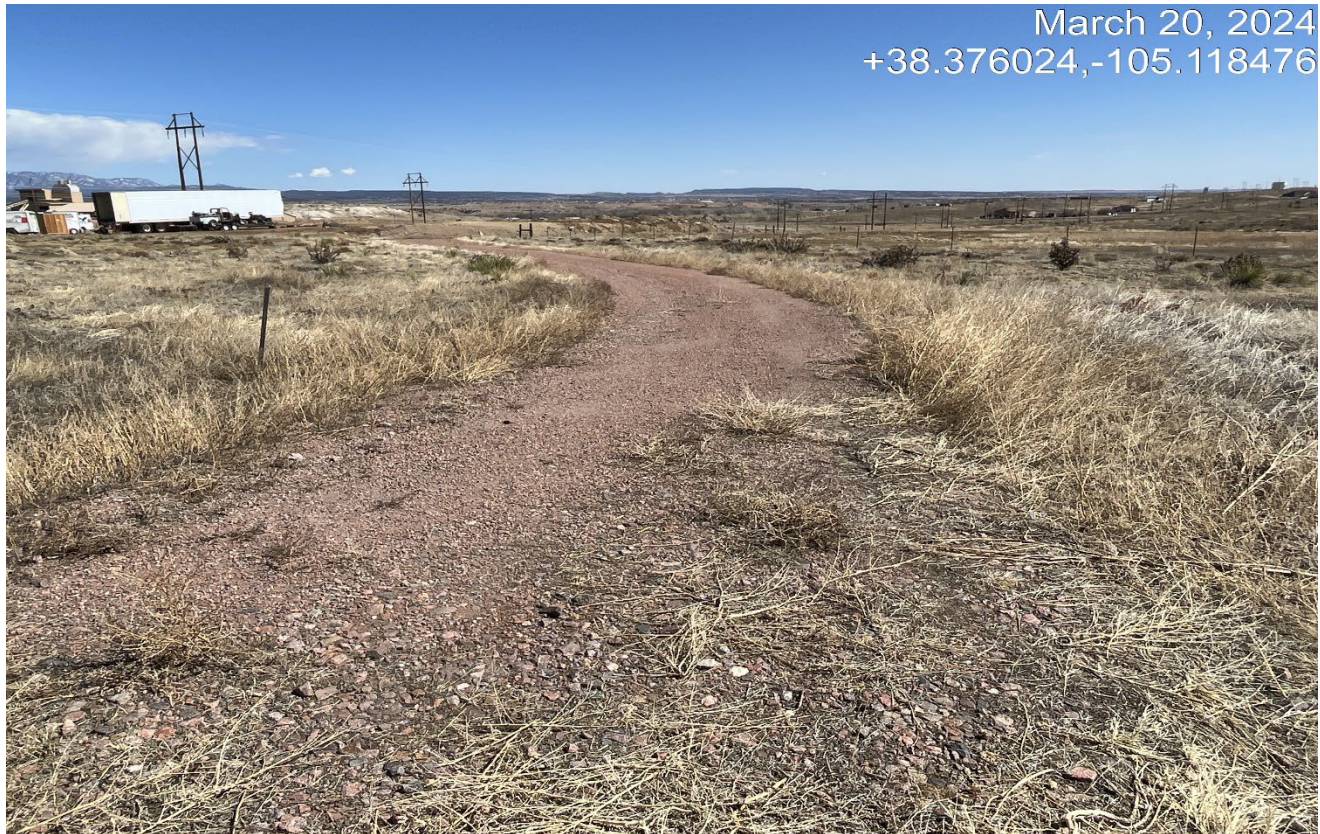
Photo 1. Facing northwest at the beginning of the access road. There is undesirable weeds along the access and the access road has not been reclaimed..

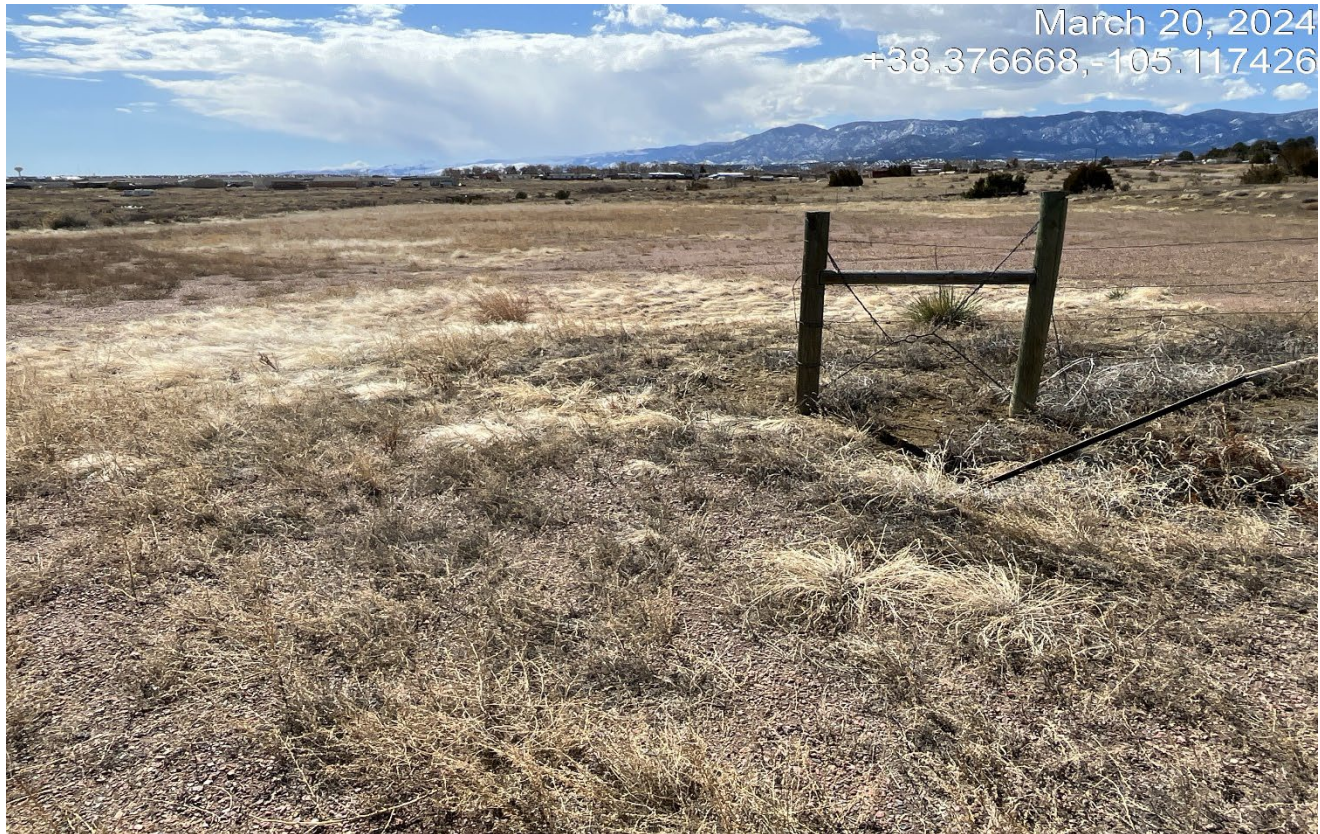
Photo 2. Facing south toward the location which has not been reclaimed per 1004 Rules. The fence remains around the location and is not maintained.

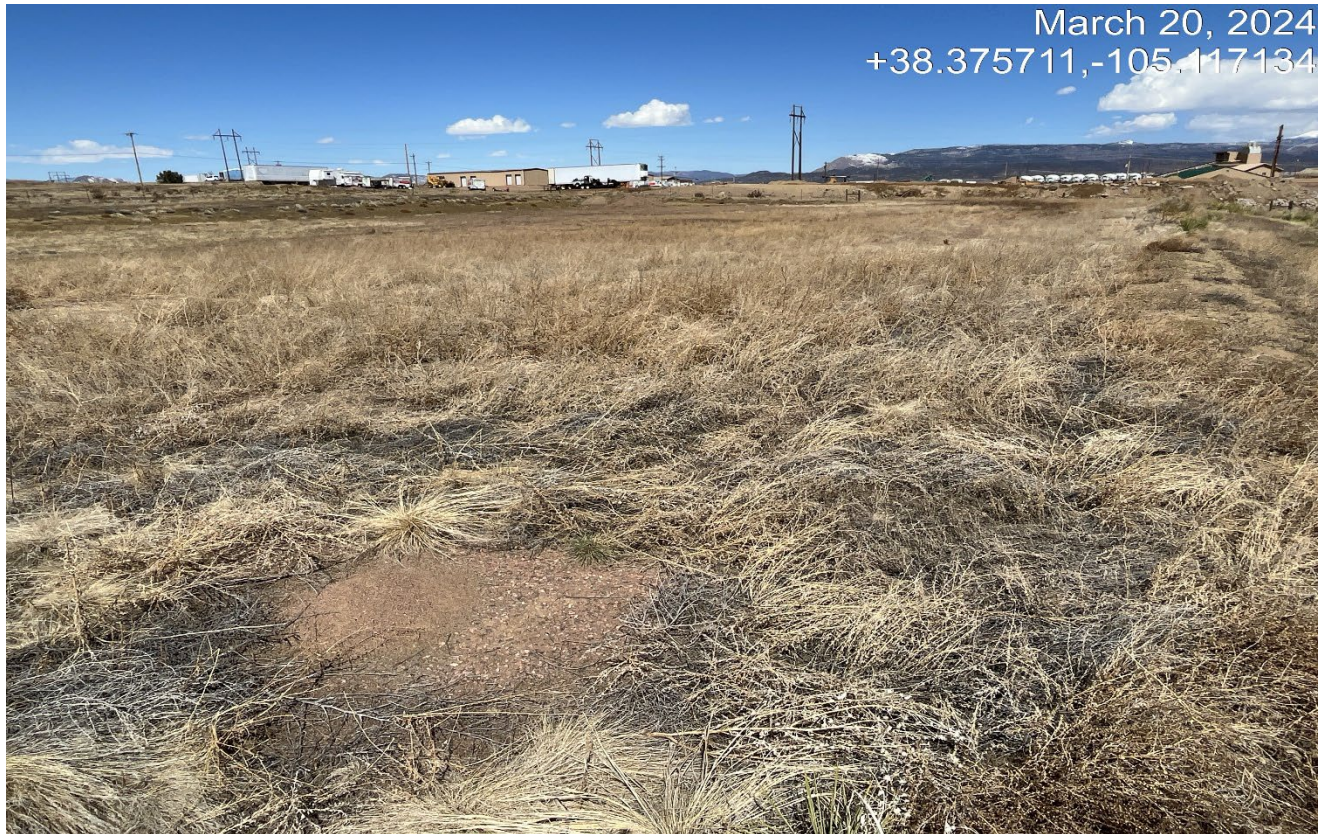
Photo 4. Facing northwest at the location. There is tall dry undesirable weeds throughout the location which is a fire hazard.

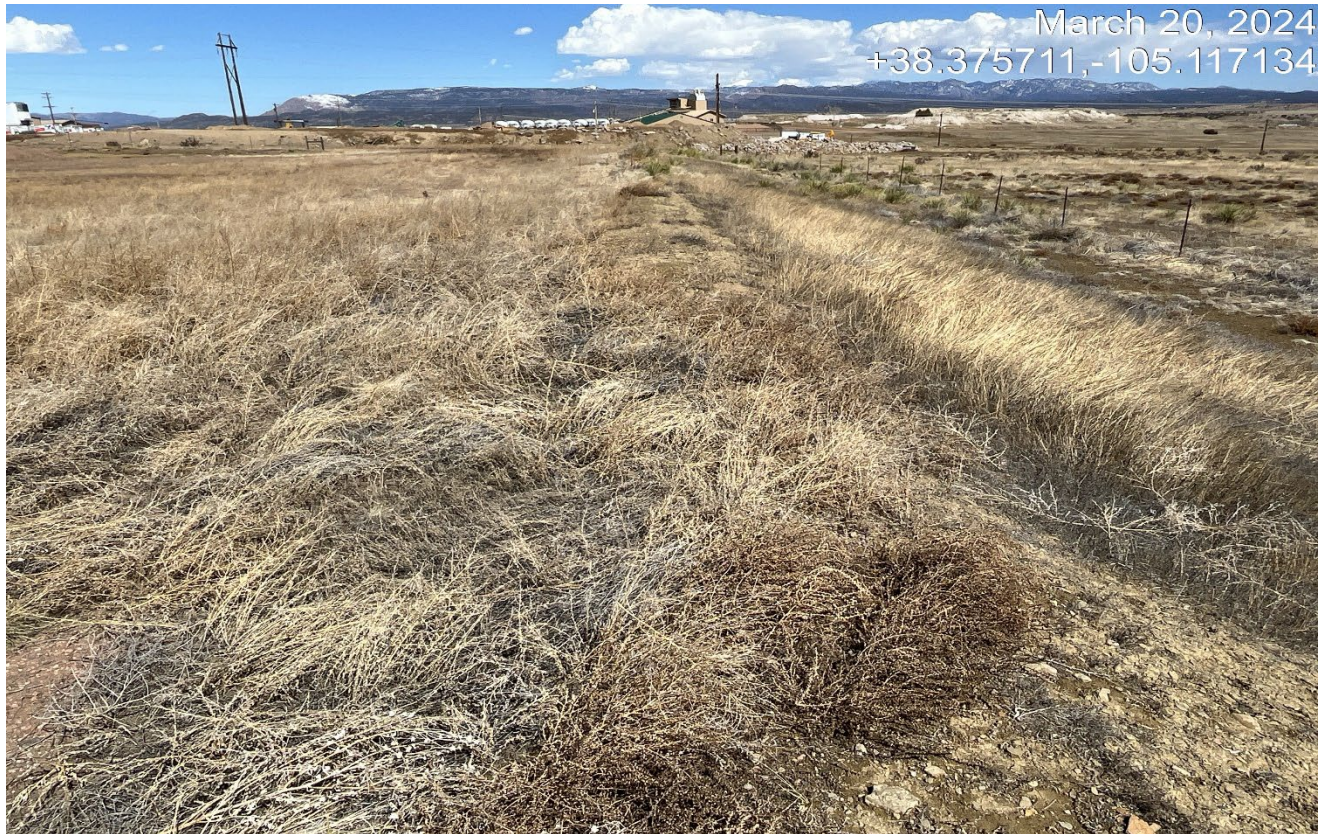
Photo 5. Southeast corner of the location facing north along the fill slope. There are undesirable growing along the fill slope that need to be controlled. The location has not been recontoured. Previous corrective action was not completed.

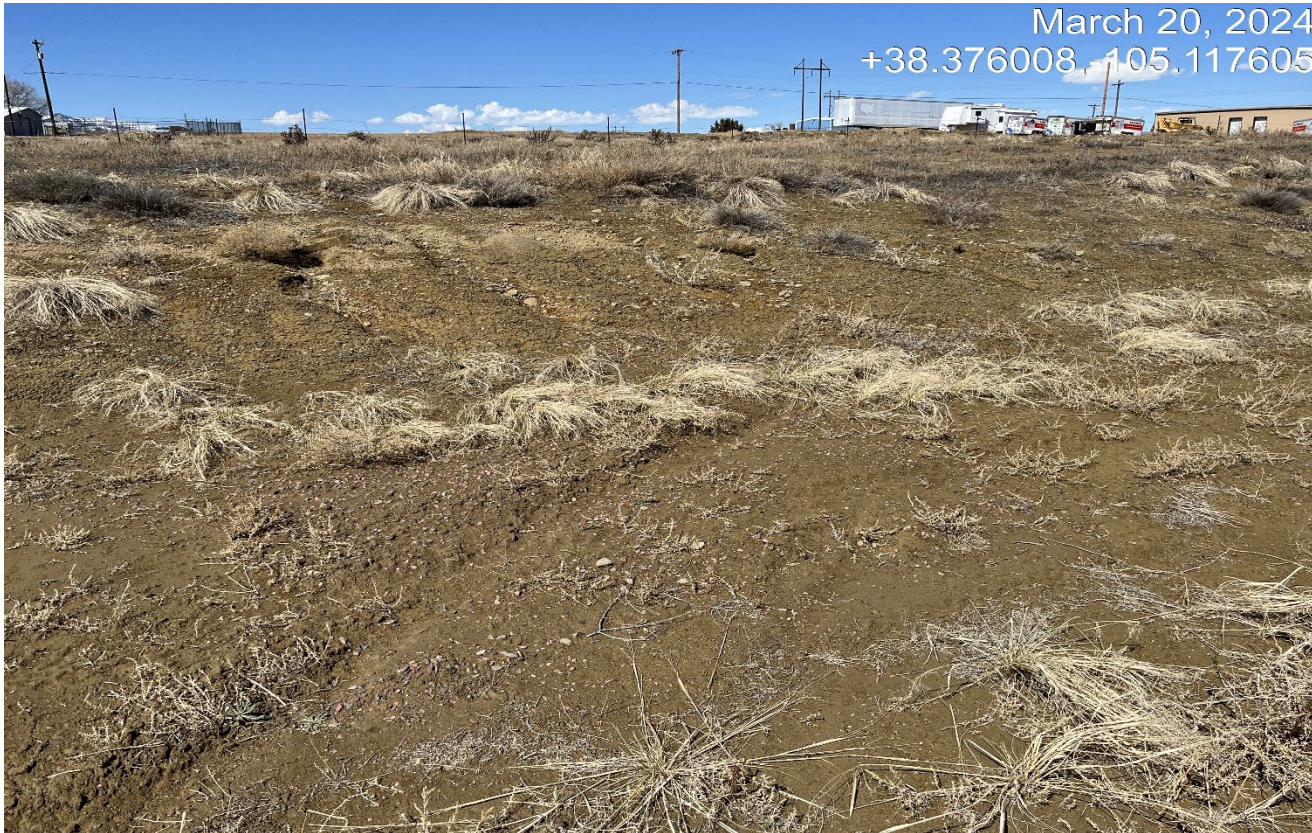
Photo 6. Facing northwest along the cut slope. There is rilling erosion along the cut slope which is not stabilized. Previous corrective action was not completed.

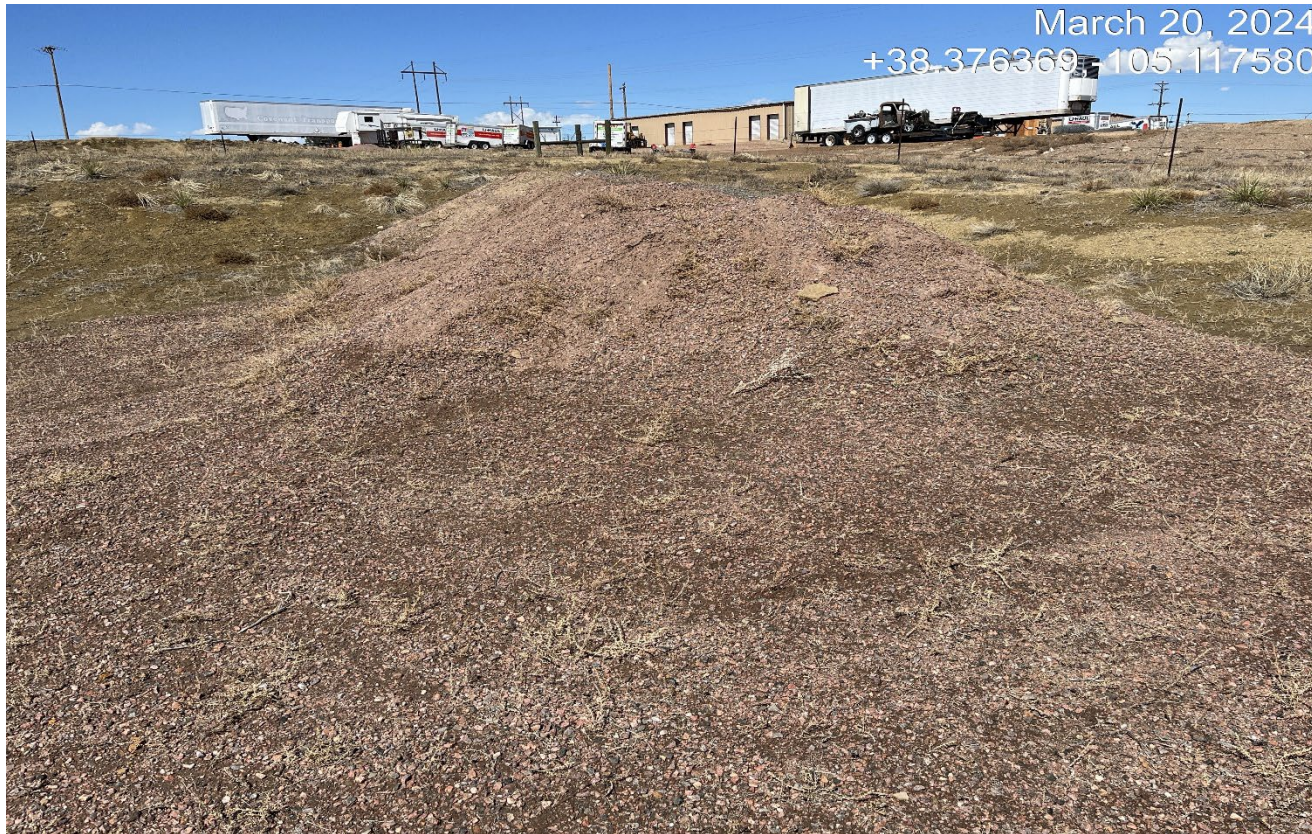
Photo 6. There are two gravel pile at the remain at the northwest corner of the Location. Previous corrective action was not completed.

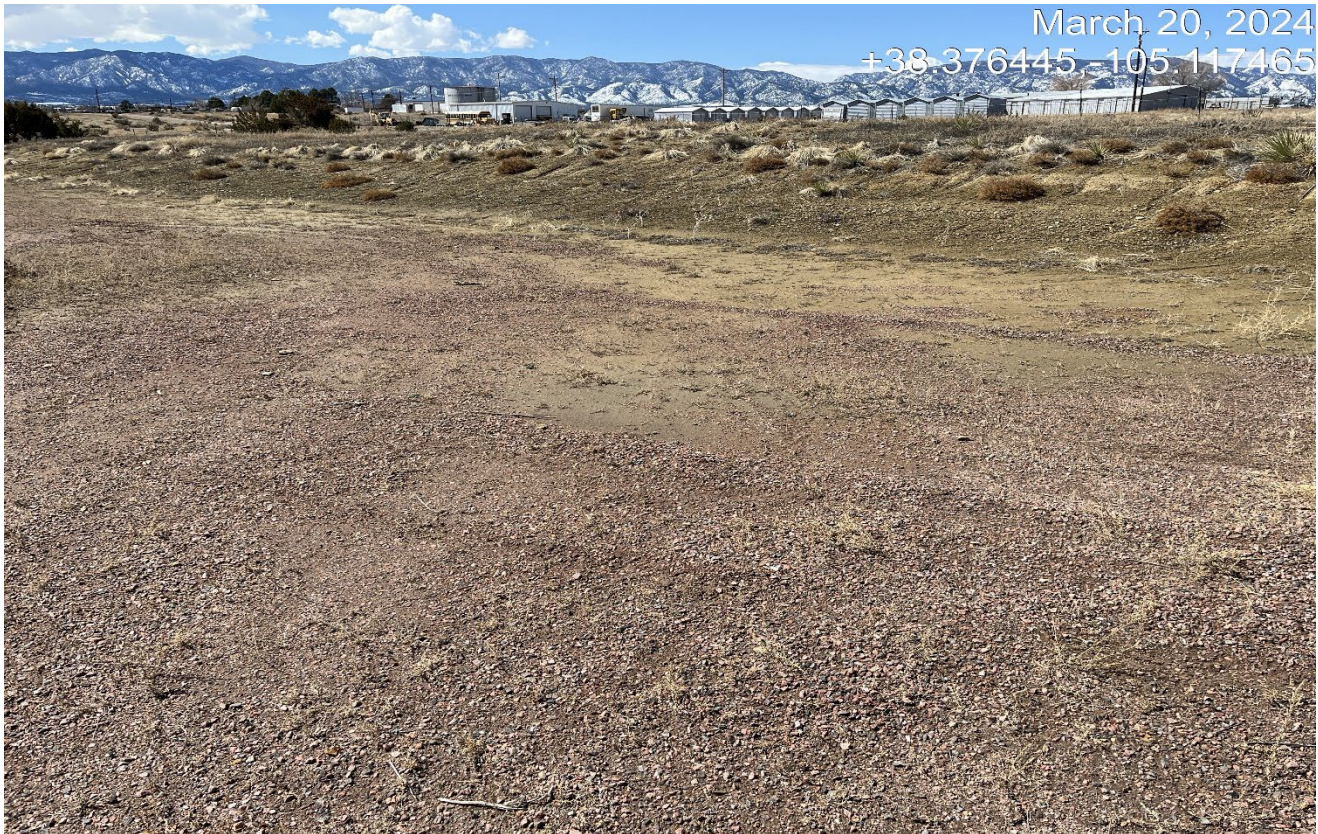
Photo 7. Facing southwest toward the cut slope.

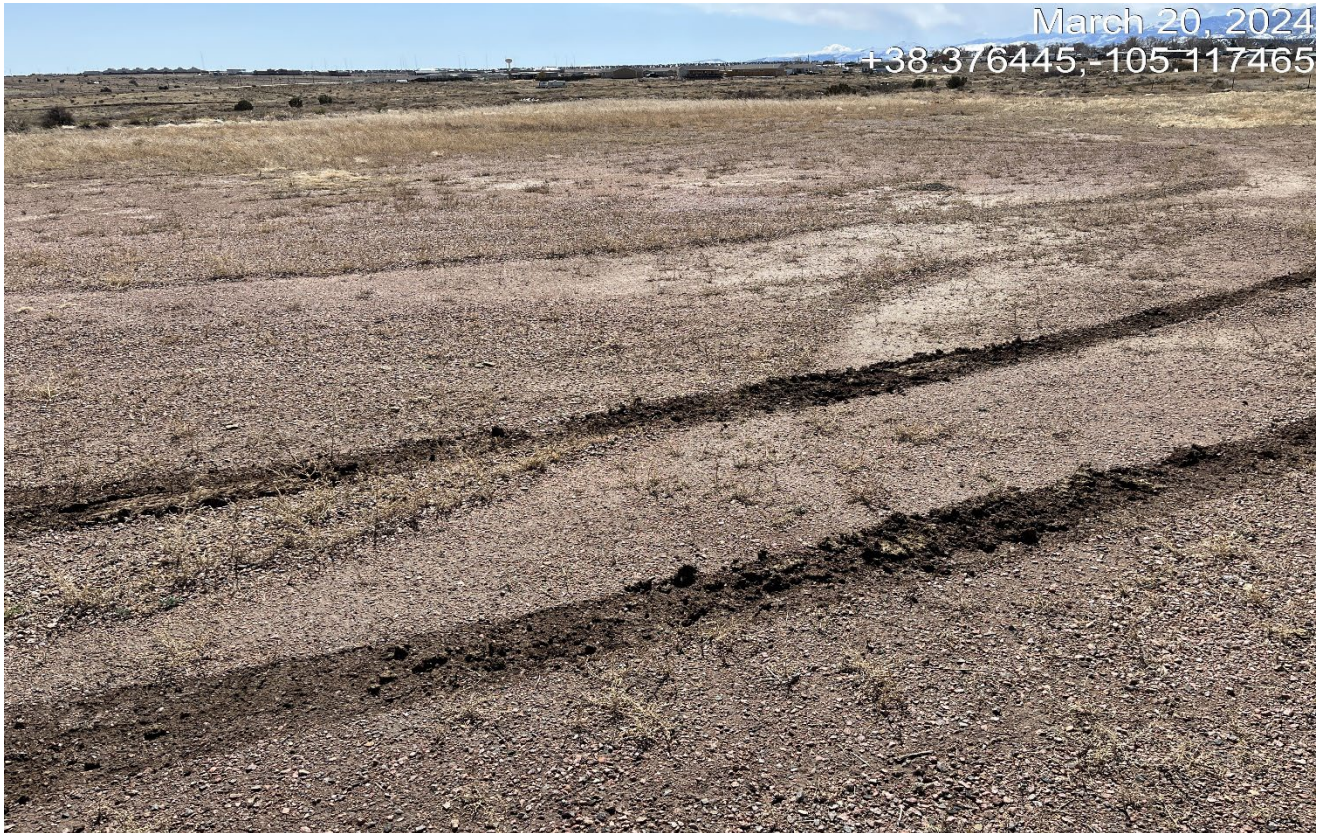
Photo 8. Facing south at the location.
