Prospect Energy - ECMC Inspection Photos
Location: PW Injection Line between MSSU 3-6 & 30-7 Flowline Release
Spill ID #485394 Date 03/20/2024

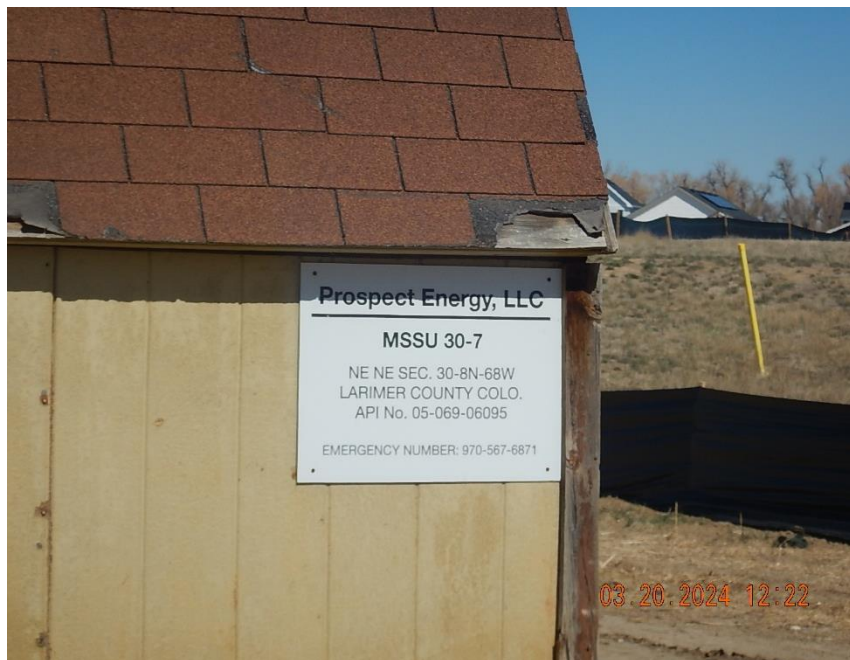
Signage at MSSU 30-7 well

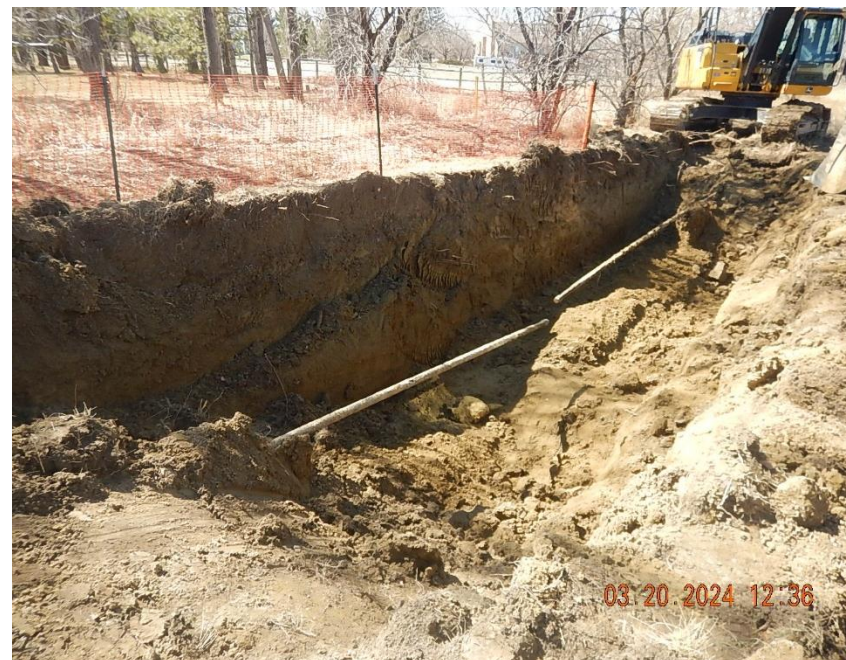
Excavation at point of release. Off location flowline pipe exposed; 2" OD Sch 80 Carbon Steel pipe with external coating (damaged in areas). Pipe failure section cut out for inspection; cut pipe ends collared and bullplugged.

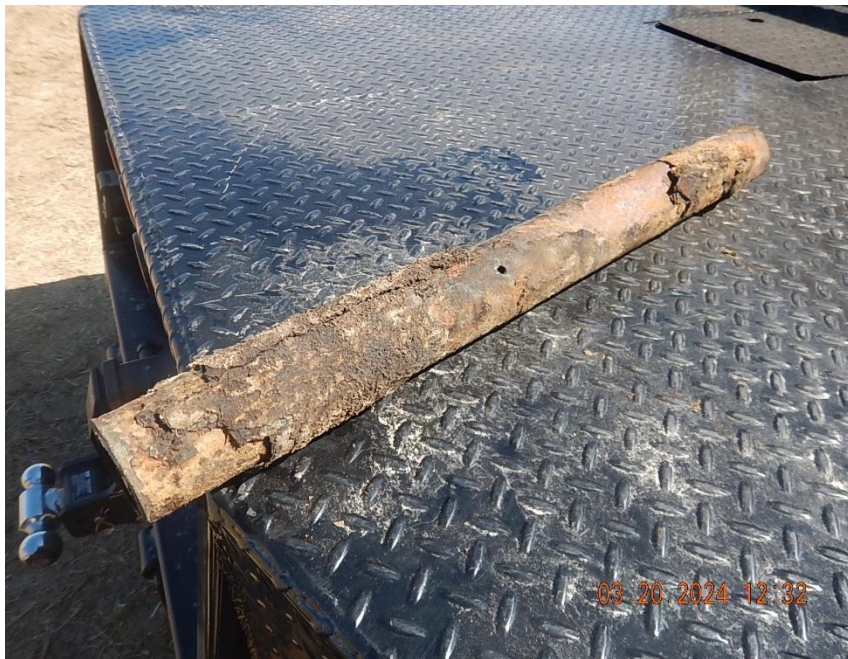
Hole identified on outside of flowline pipe; 6'Oclock position. External coating damage in area of failure.

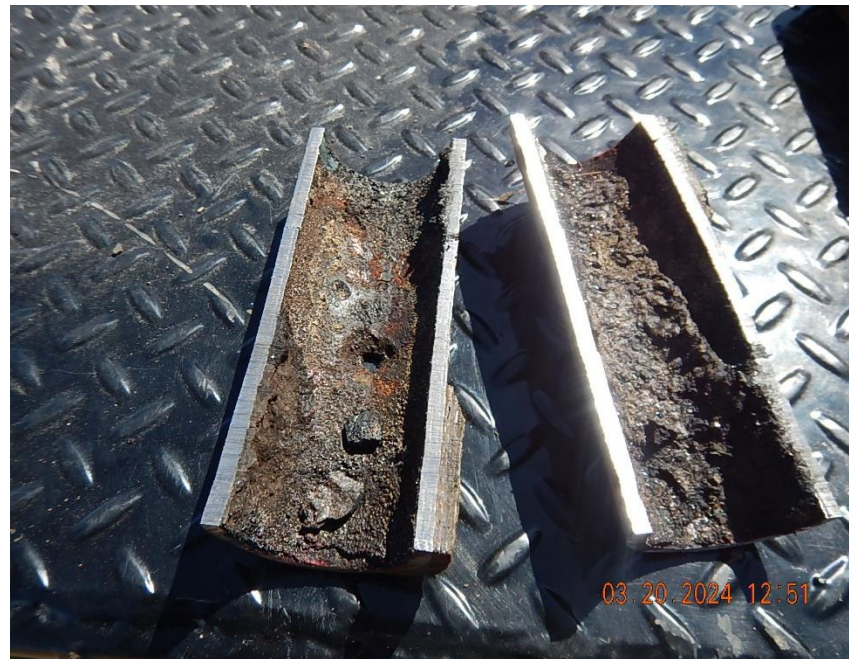
Flowline pipe cut in half for internal inspection. Black scale/sludge deposits can be seen on inside of pipe. (2) localized corrosion pits can be seen inside the pipe (left); one of the pits resulted in the hole in pipe.
