## Inspection Photos

Location Name: CAERUS PICEANCE LLC SAVAGE 1-13 (RB1) Pad

Location #: 334637

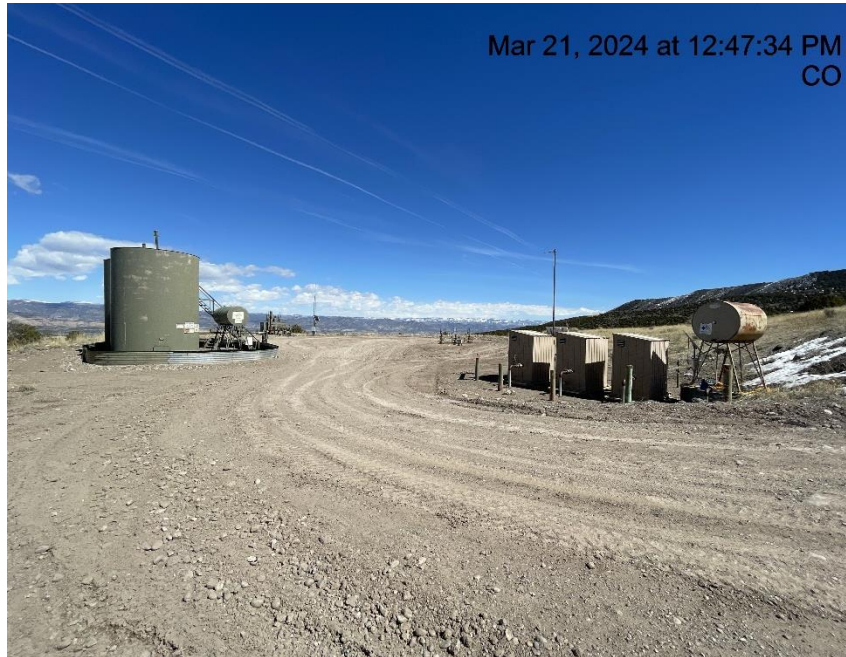
Photo # 975 From entrance to location

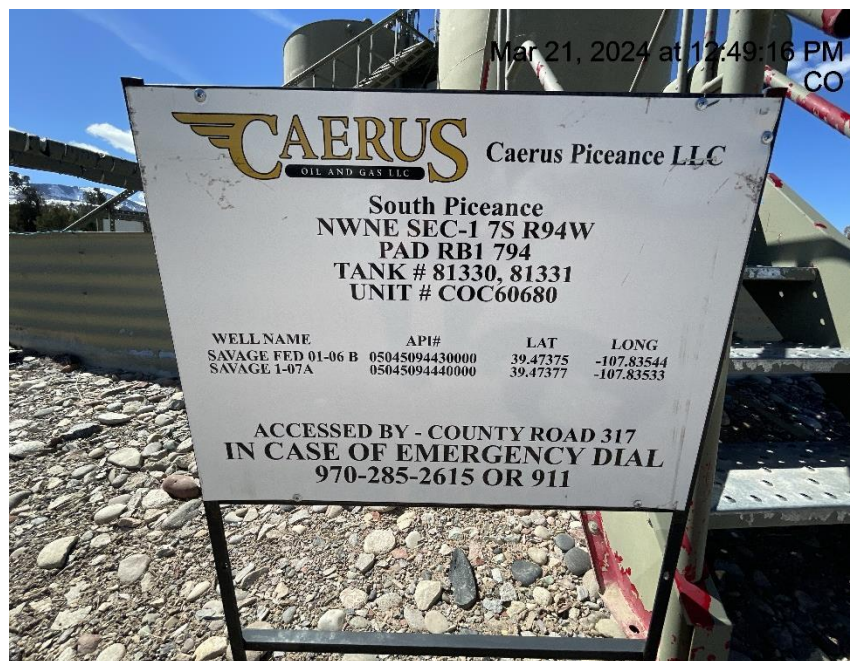
Photo # 981 Tank battery sign lacks required information

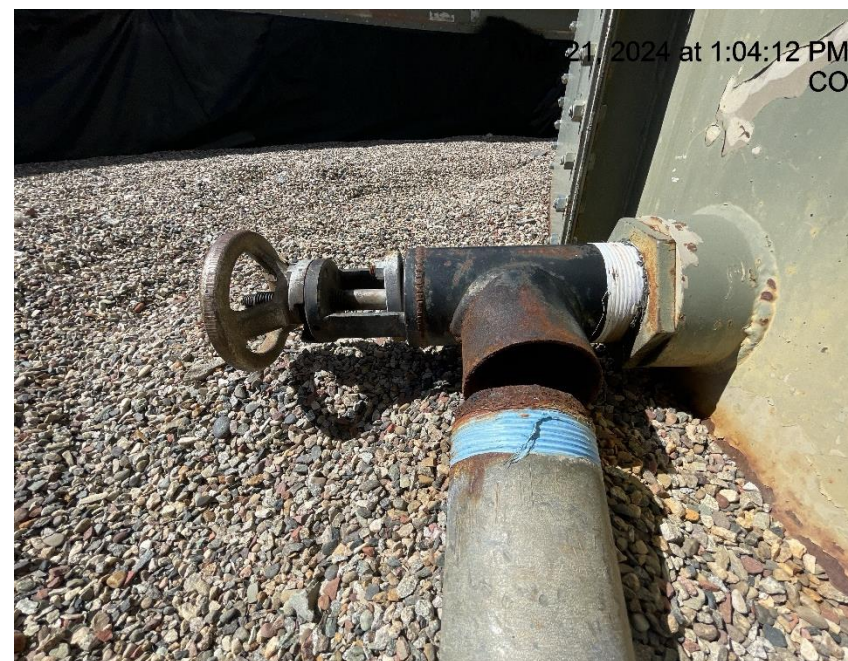
Photo # 982 Open ended load line

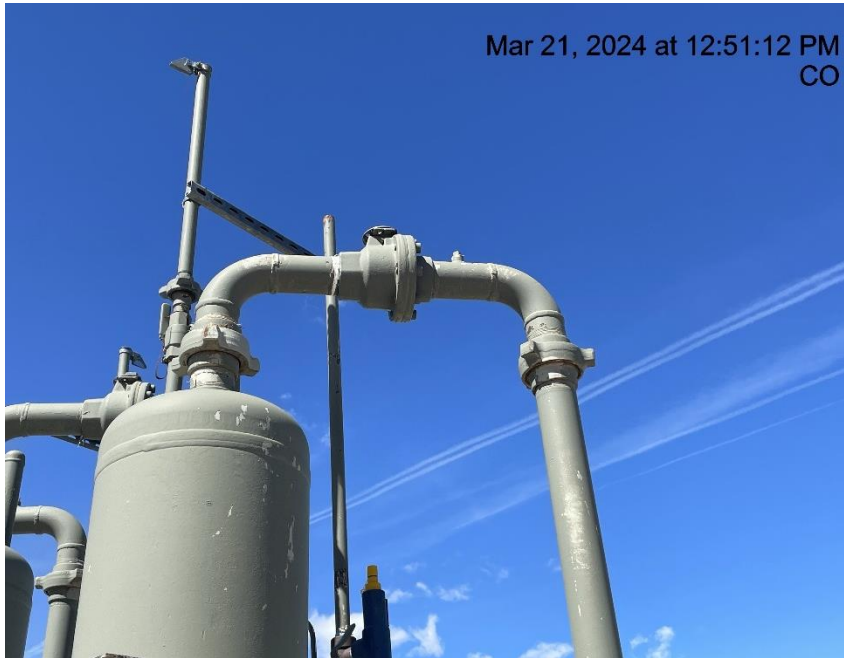
**Photo # 983 PRV vent line lacks cap/does not comply with CECMC pressure safety device rules**

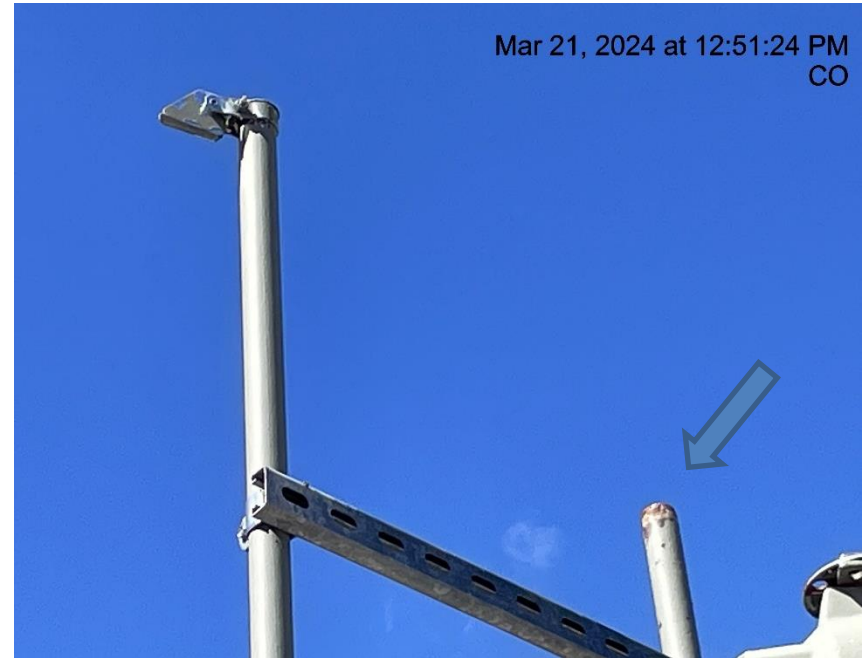
**Photo # 984 PRV vent line lacks cap/does not comply with CECMC pressure safety device rules**

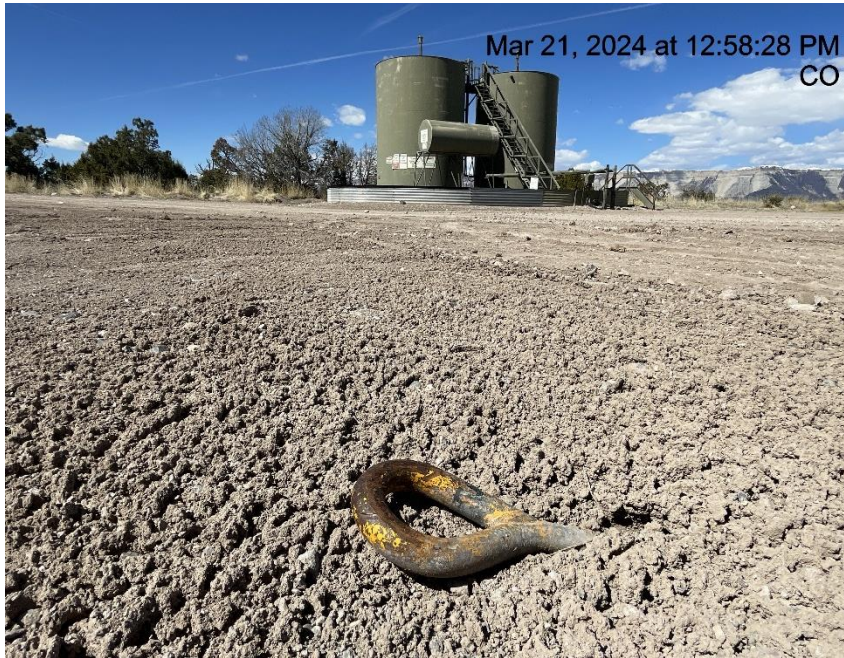
Photo # 985 Unmarked deadman

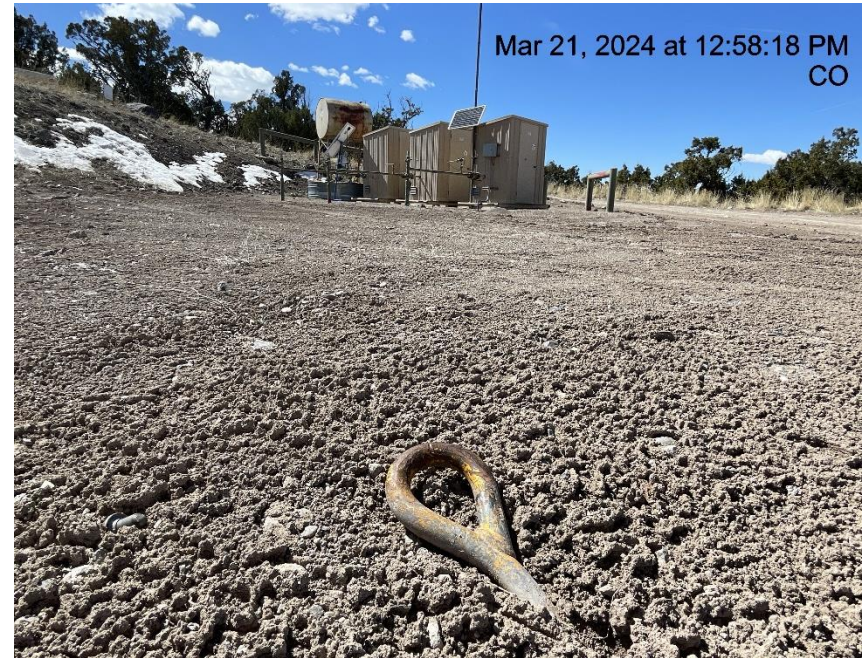
Photo # 986 Same unmarked deadman from a different angle

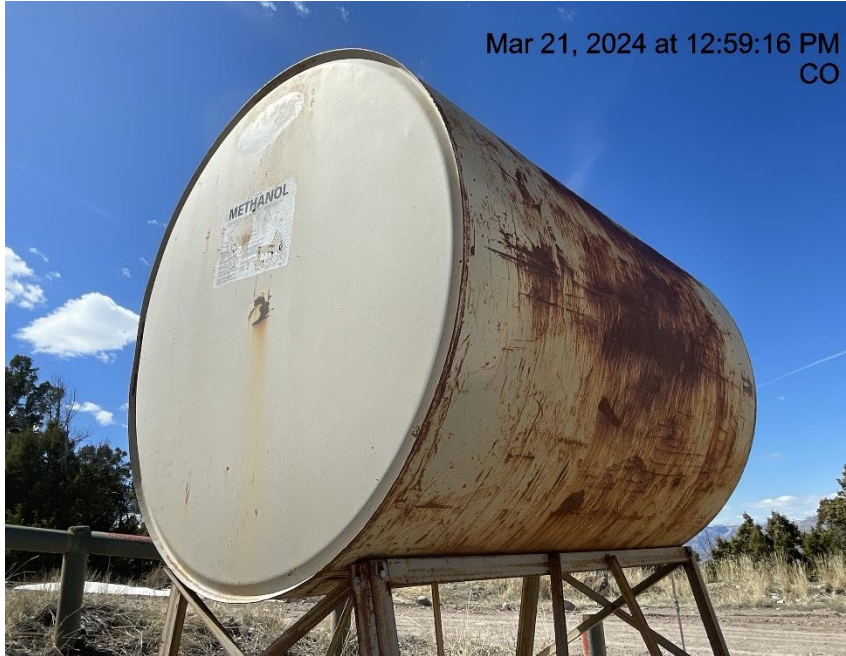
**Photo # 987 Methanol tank improperly labeled/lacks required information**

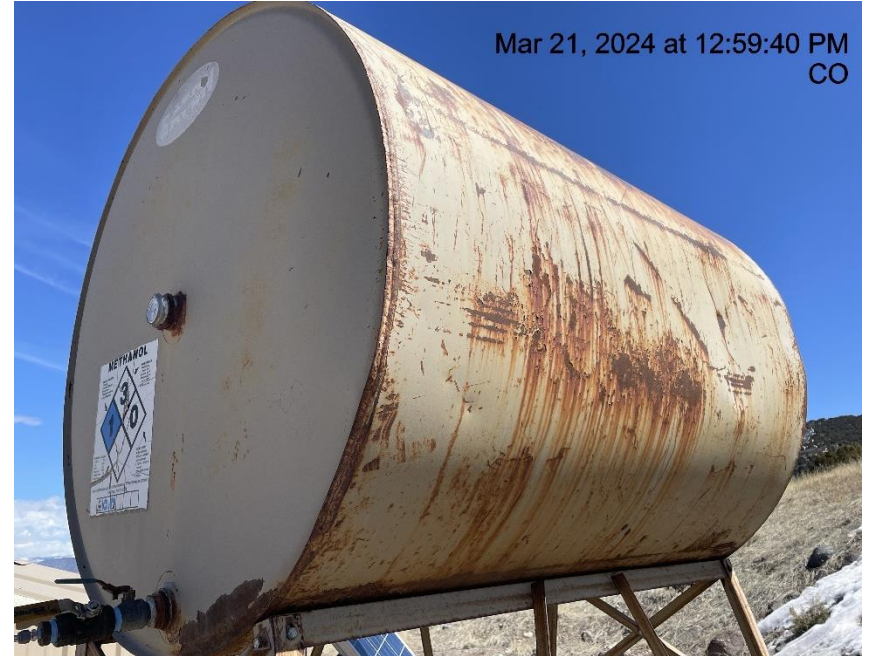
**Photo # 988 Methanol tank improperly labeled/lacks required information**
