Interim Reclamation and Stormwater Inspection

March 19, 2024

Operator: Arch Oil & Gas LLC- #10528

Location ID: 317921

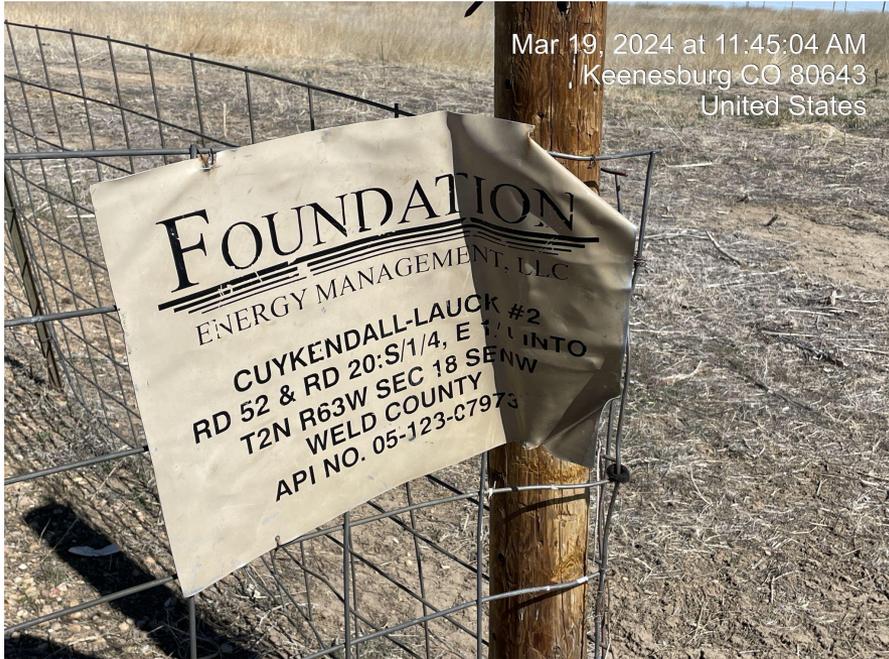
Photo 1. Photo taken facing north of location sign from previous operator. New signage needed. .

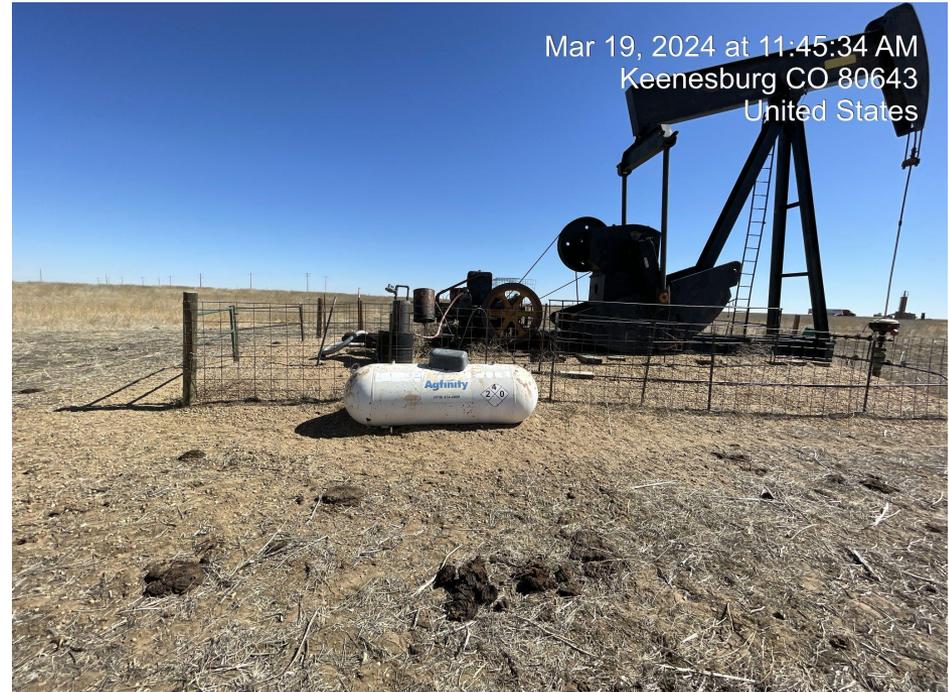
Photo 2. Photo taken facing east of of wellhead.

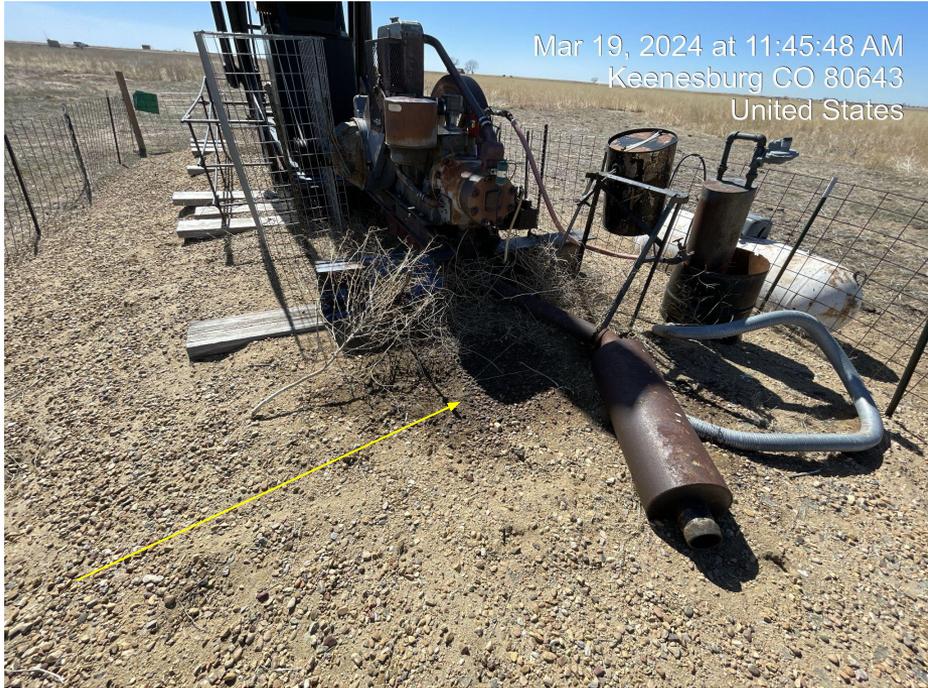
Photo 3. Photo taken facing south of stained soil under pumpjack engine.

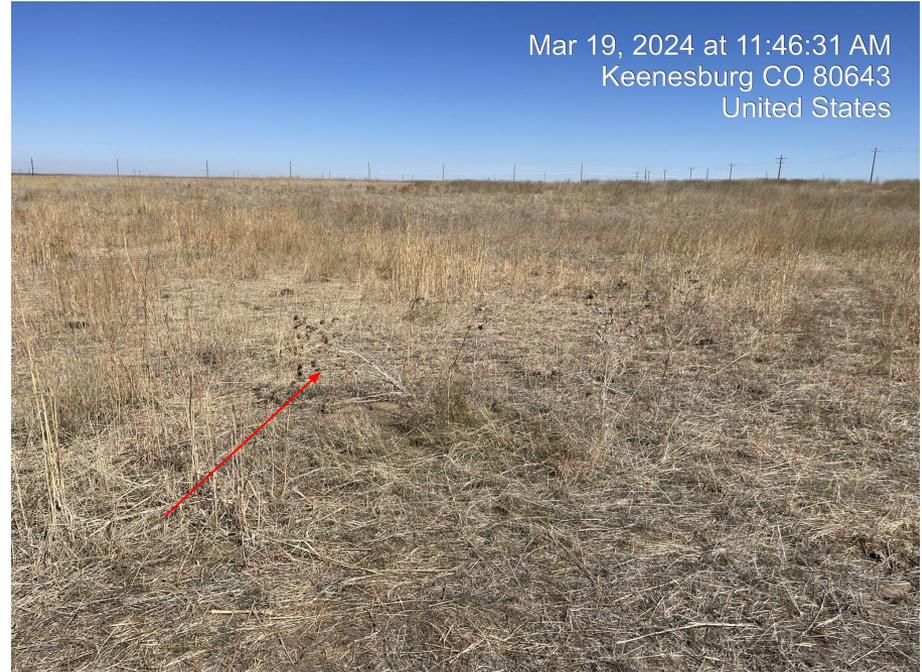
Photo 4. Photo taken facing northwest of interim reclamation area, Canada thistle is present.

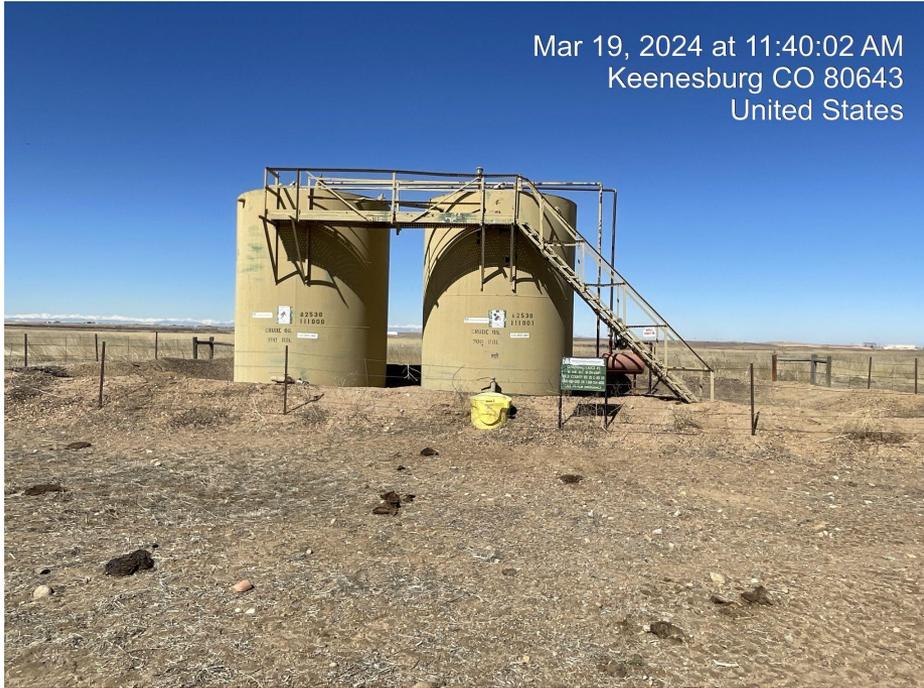
Photo 5. Photo taken facing west of tank battery.

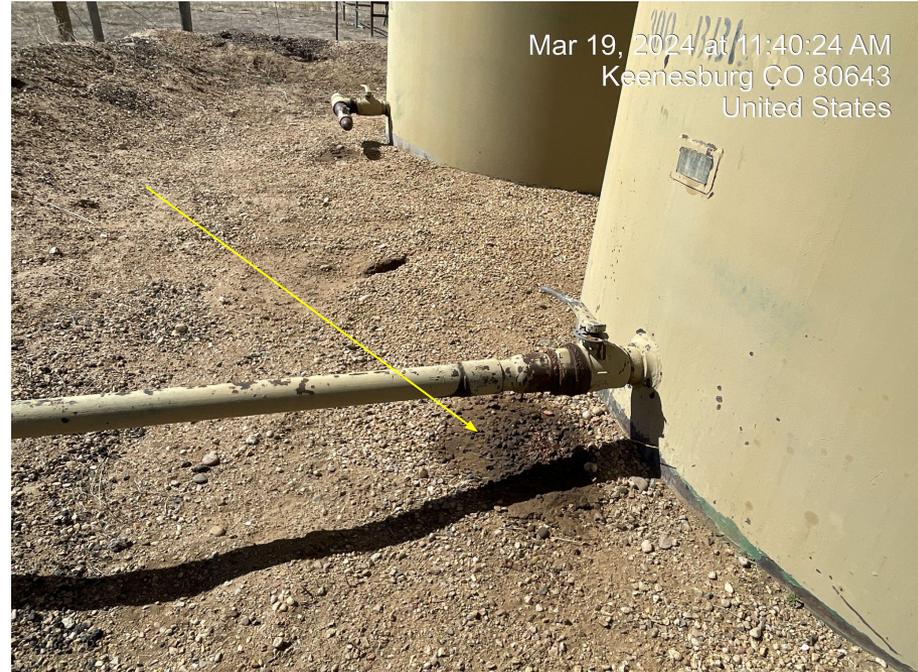
Photo 6. Photo taken facing south of stained soil under tank loadout pipe connection.

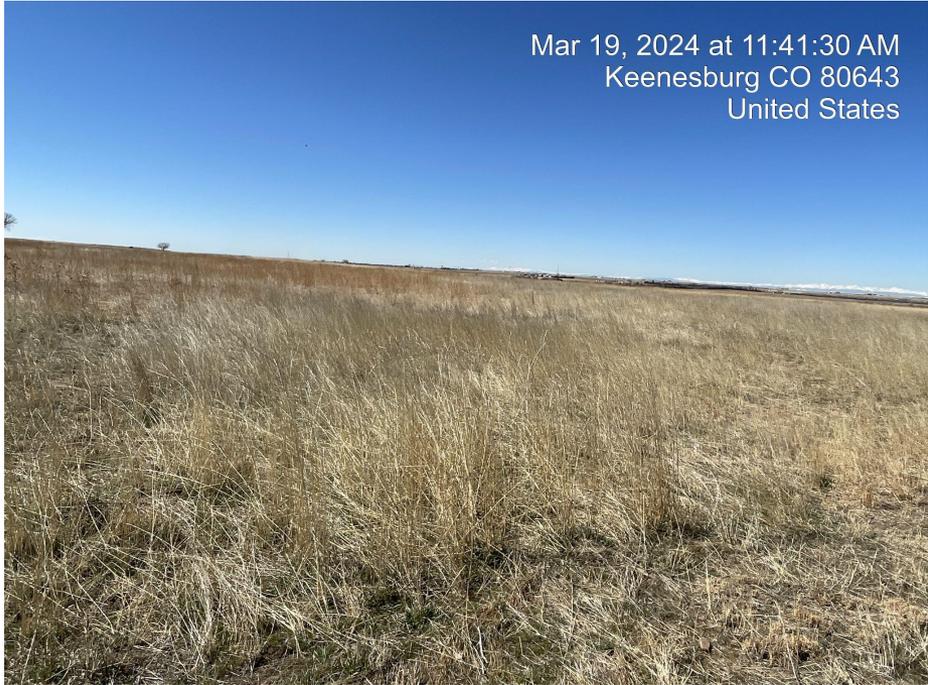
Photo 7. Photo taken facing south of interim reclamation area.

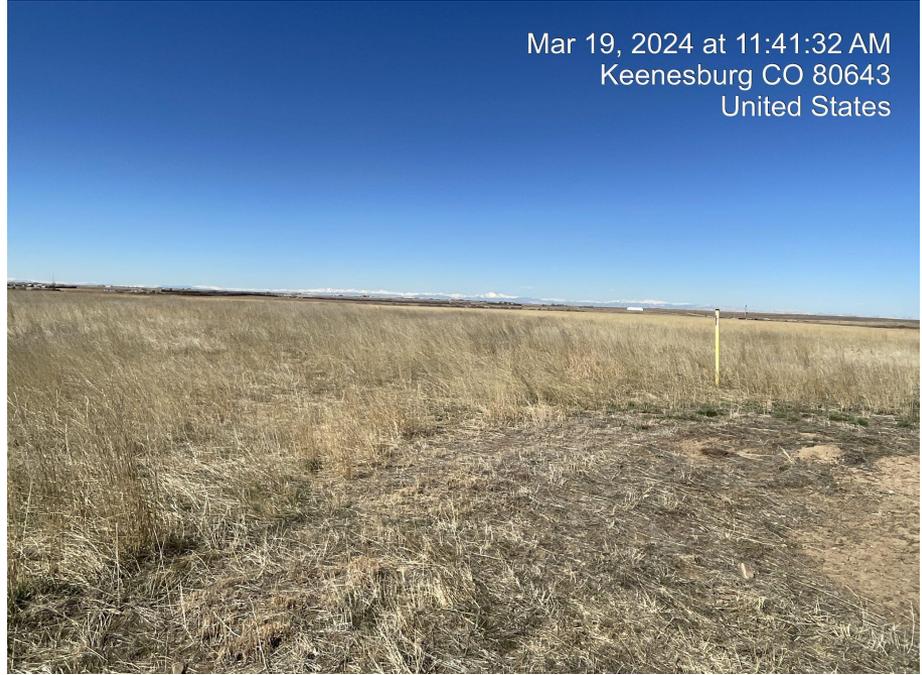
Photo 8. Photo taken facing west of interim reclamation area.

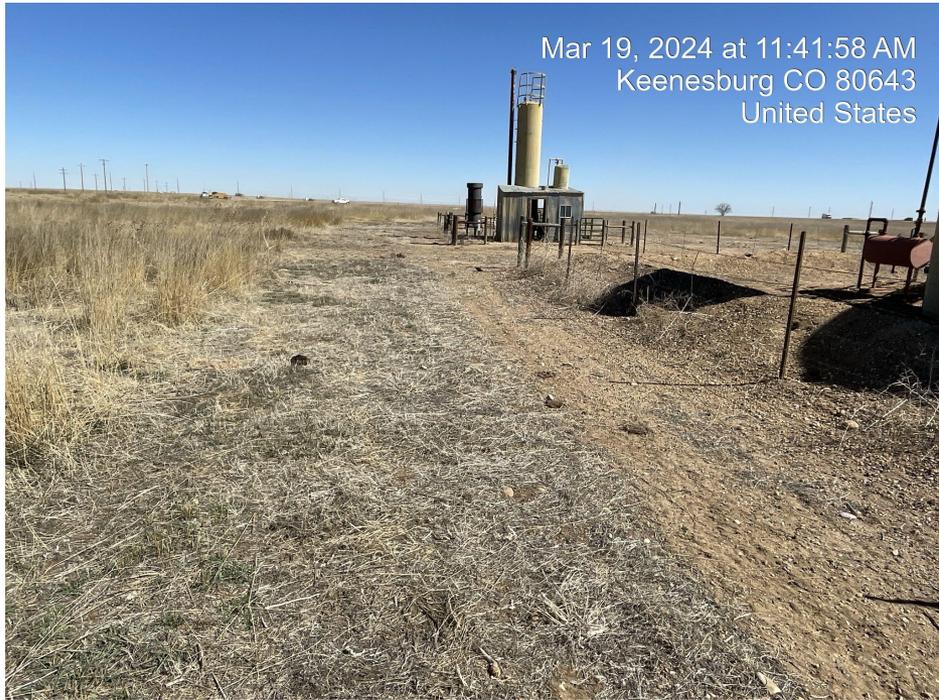
Photo 9. Photo taken facing north of interim reclamation area and mowed vegetation around equipment.

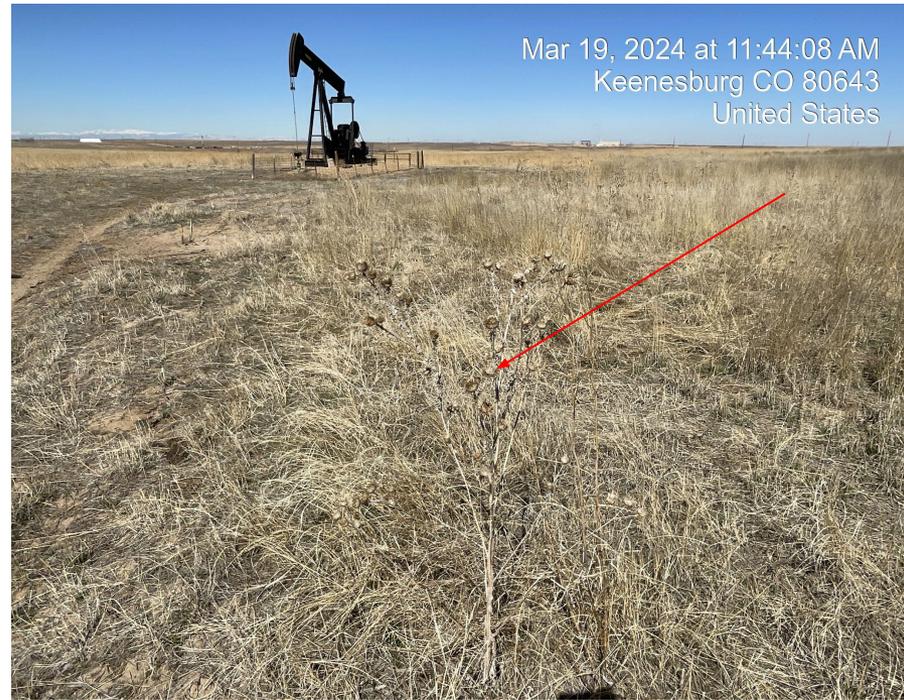
Photo 10. Photo taken facing west of interim reclamation area and weeds (canada thistle).
