Inspection Photos

Operator: TEP ROCKY MOUNTAIN LLC - 96850

Location ID: 311852

Inspection Doc: 696205699

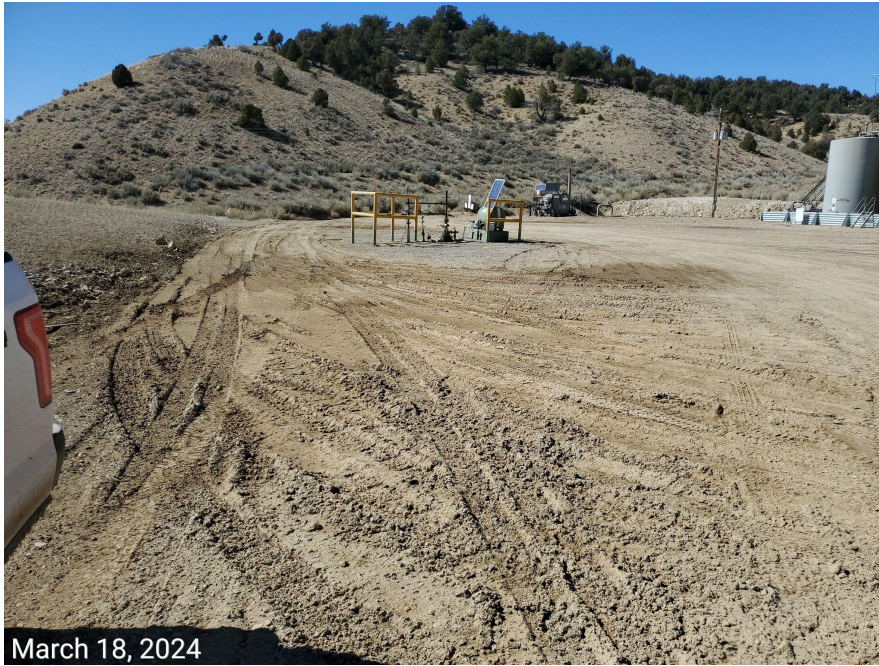
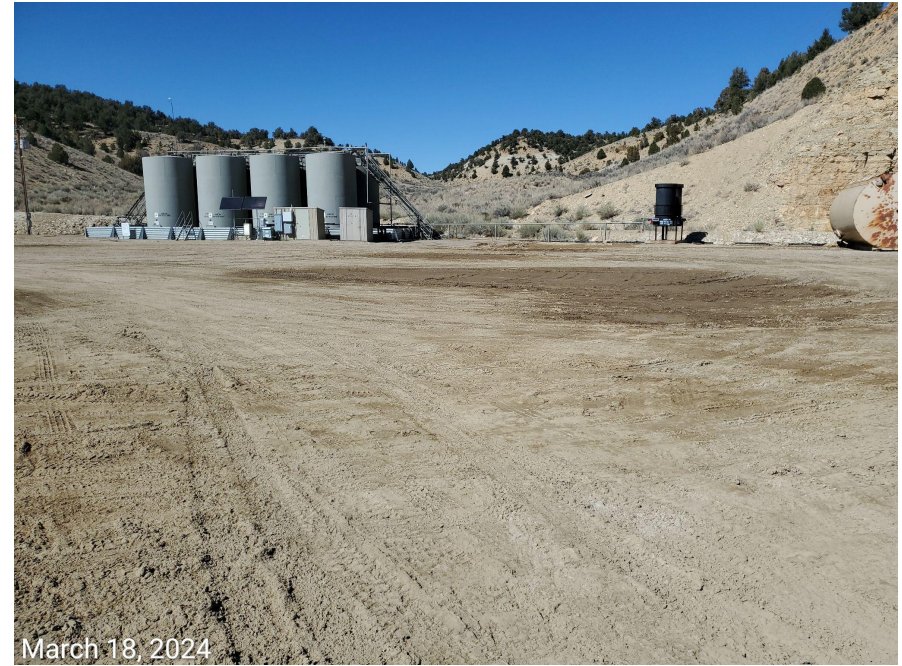
Photo 1: Photos 1-2 taken from the south end of the Location. Photos provide an overview of the Location from west, northwest, northeast to east.

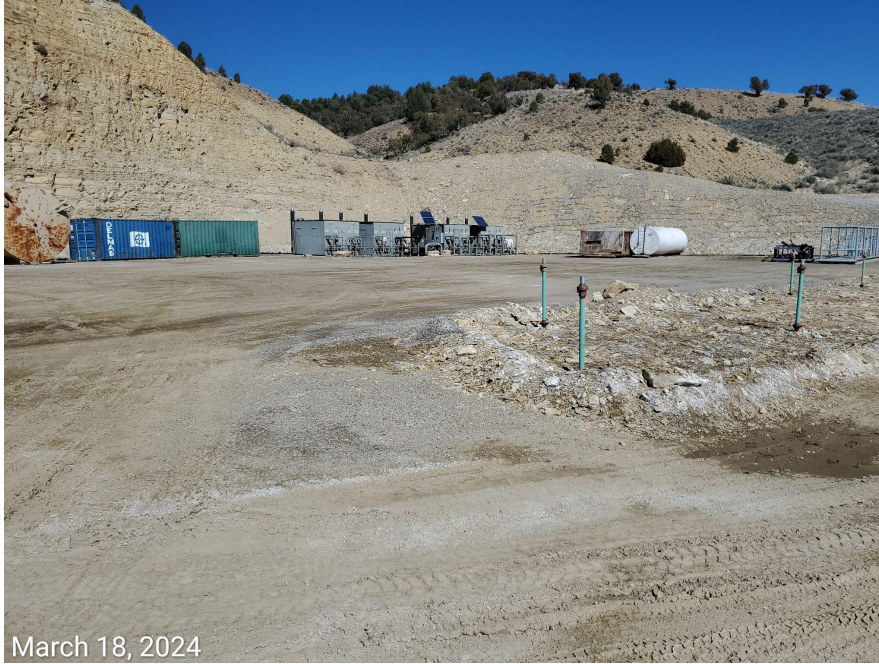
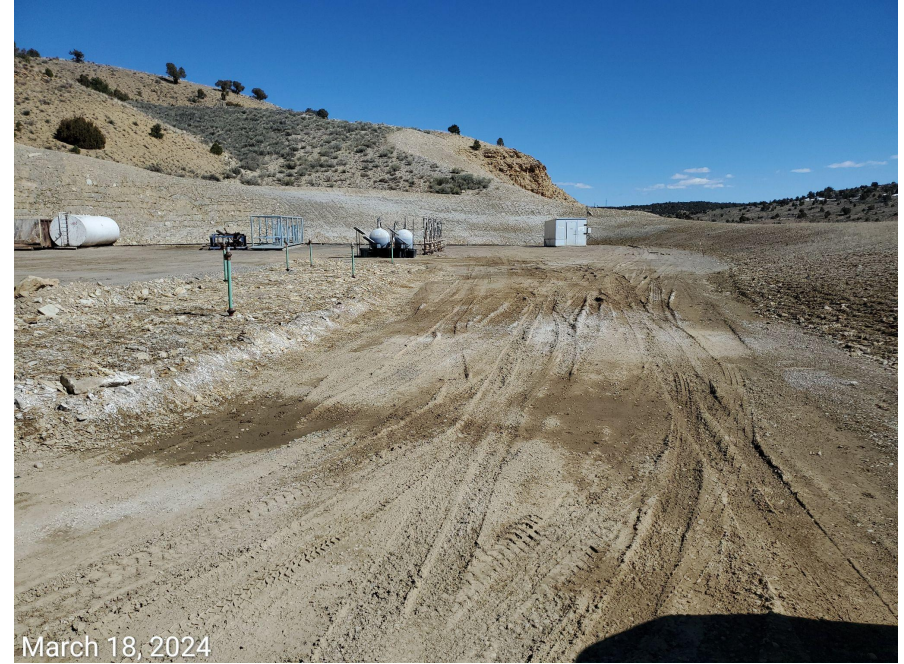
Photo 2: See comments under photo 1.

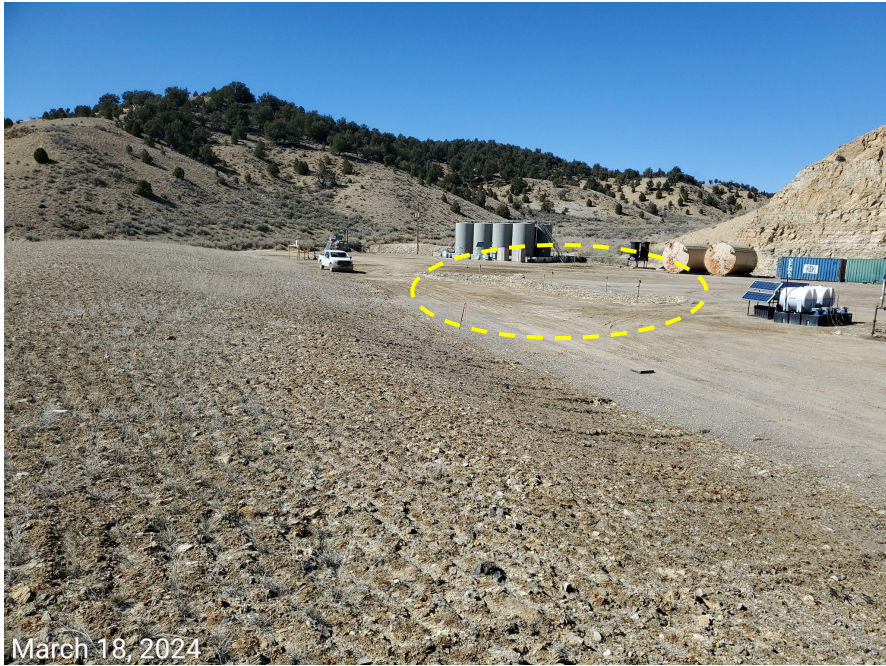
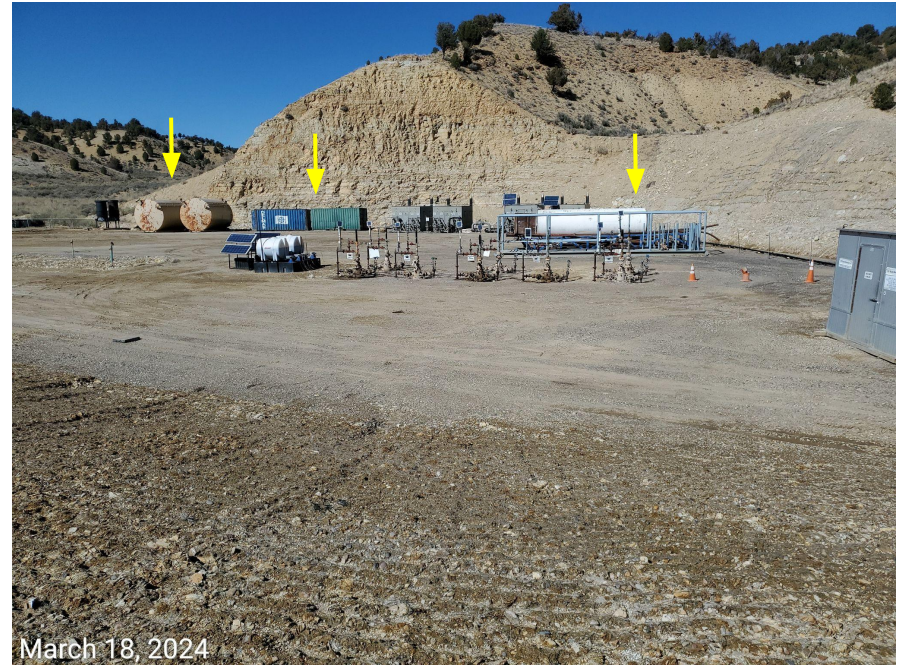
Photo 3: Photos taken from the southeast end of the Location, facing northwest and north. Photos provide an overview of the Location. Photo also shows Location of unused risers associated with Abandoned wells remain on the Location (Yellow circle), as well as unused equipment being stored onsite (arrows).

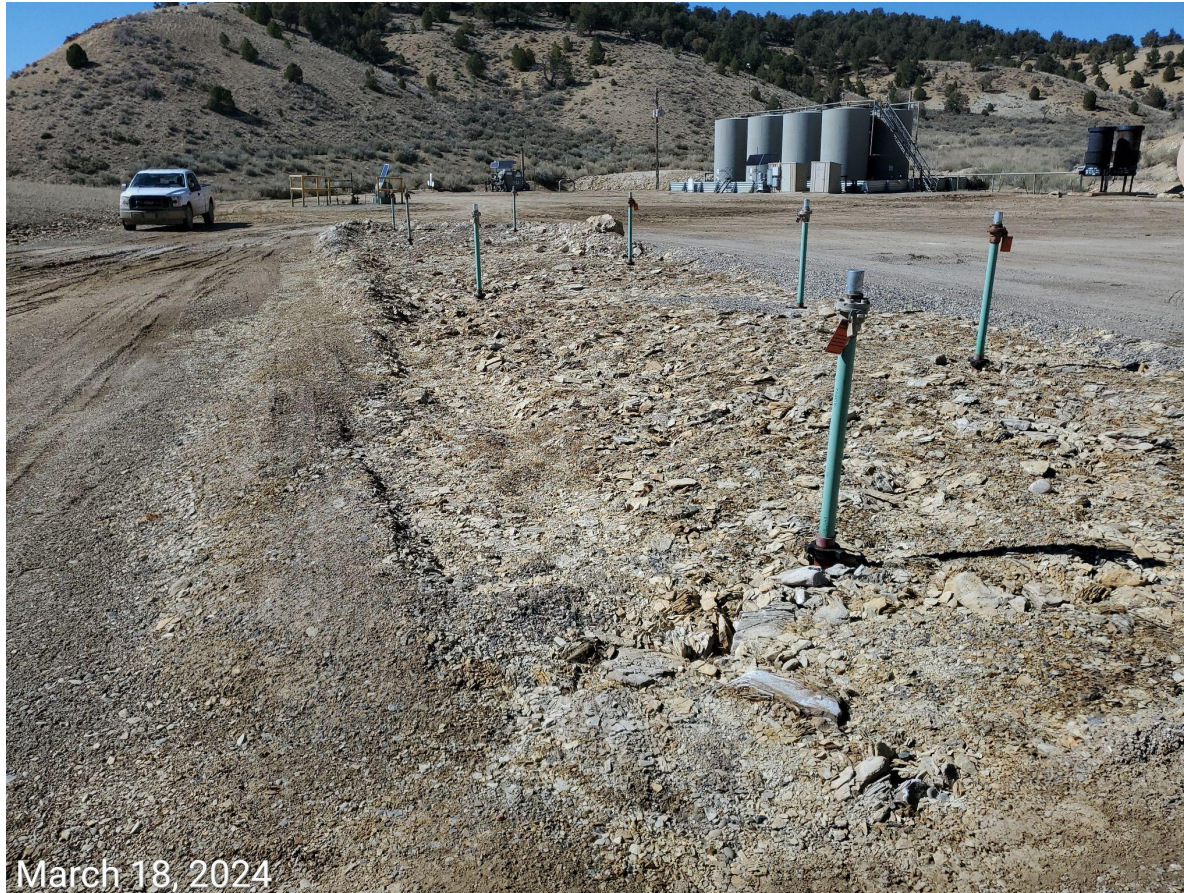
Photo 4: Photo shows riser equipment. Riser equipment is associated with Abandoned, undrilled wells, are unused, not necessary for production, and require removal.

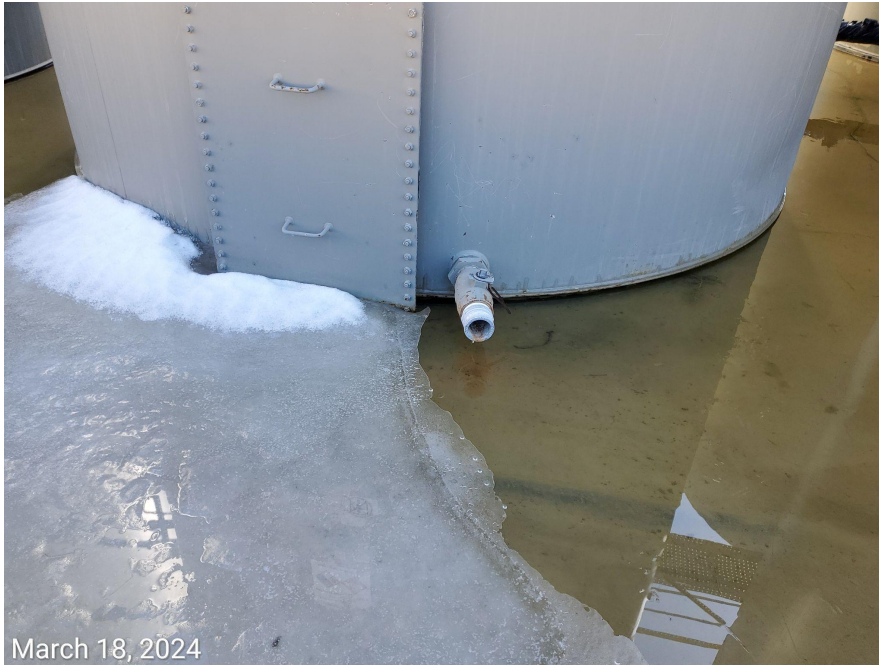
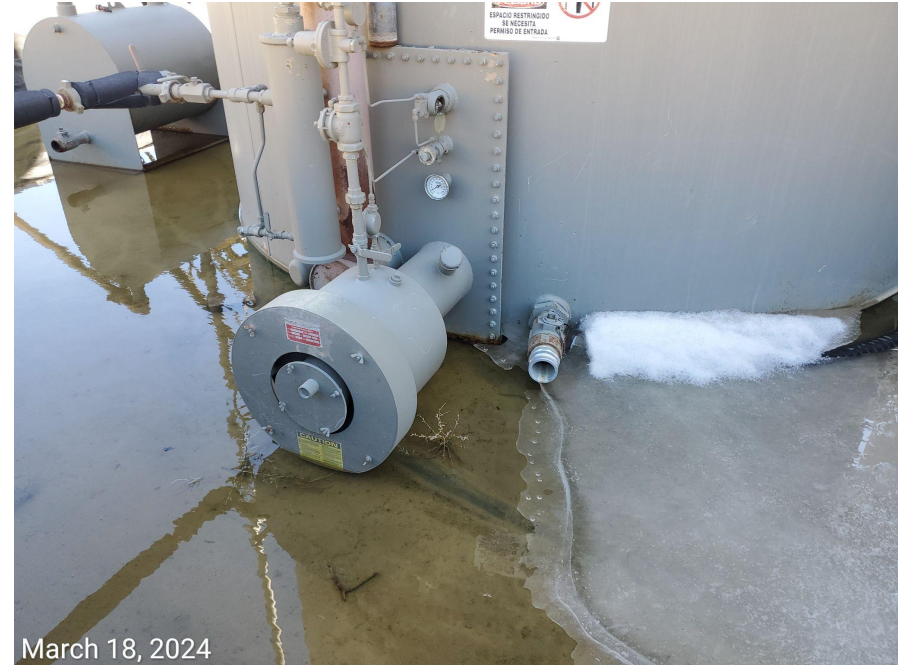
Photo 5: Photos examples showing lines at tanks missing required cap/plug.

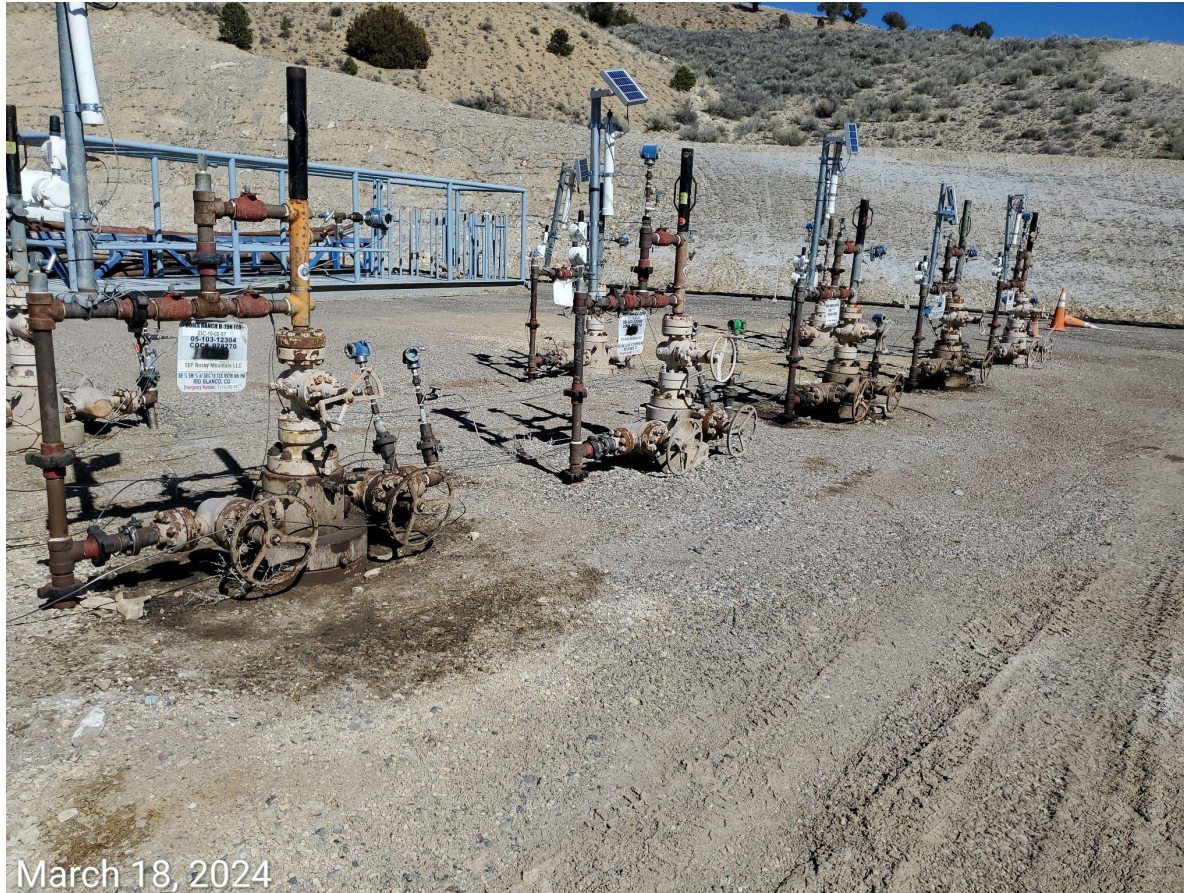
Photo 3: Active wells on the Location.

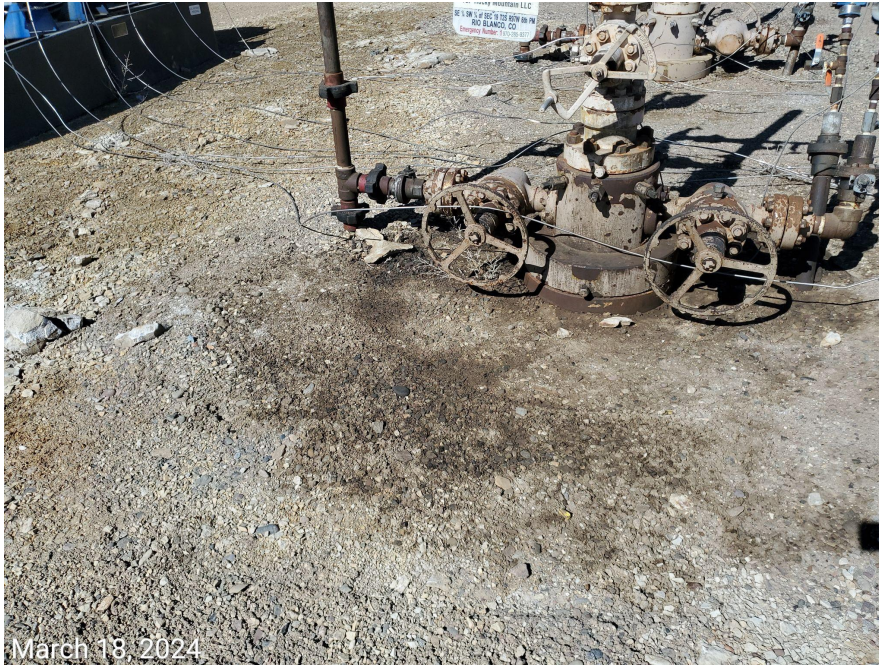
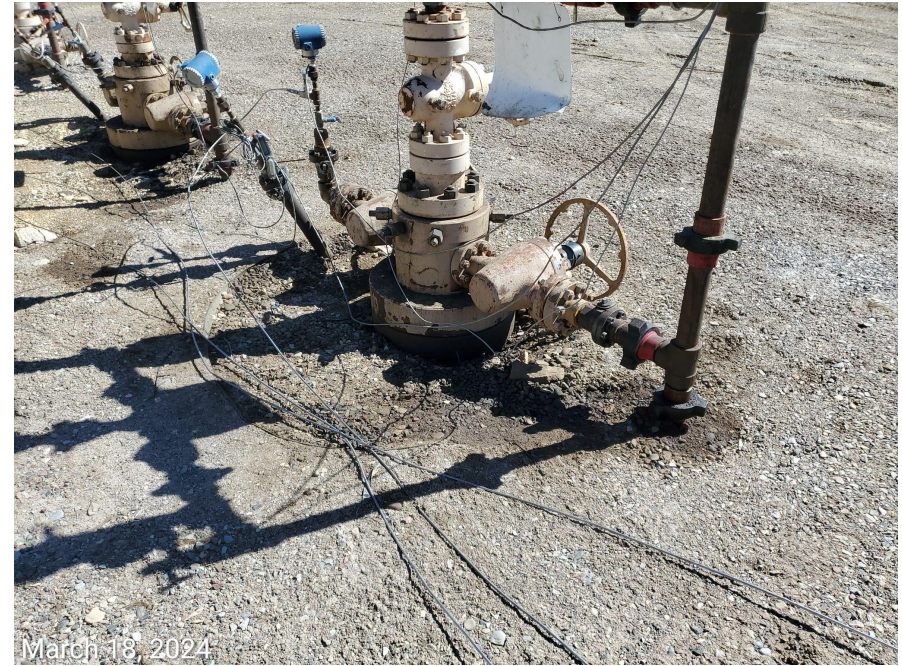
Photo 7: Photos example showing stained soils remaining around the wells.

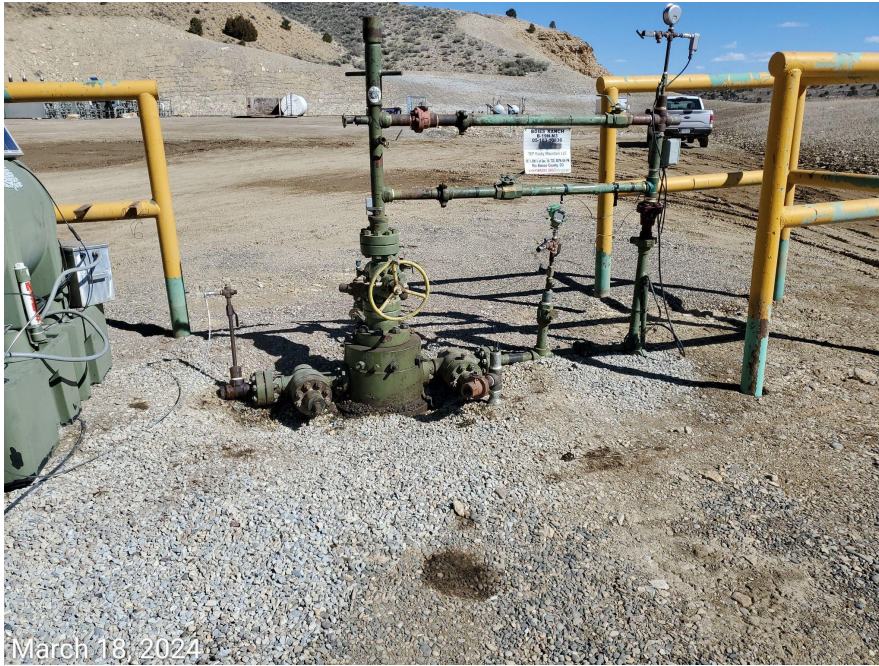
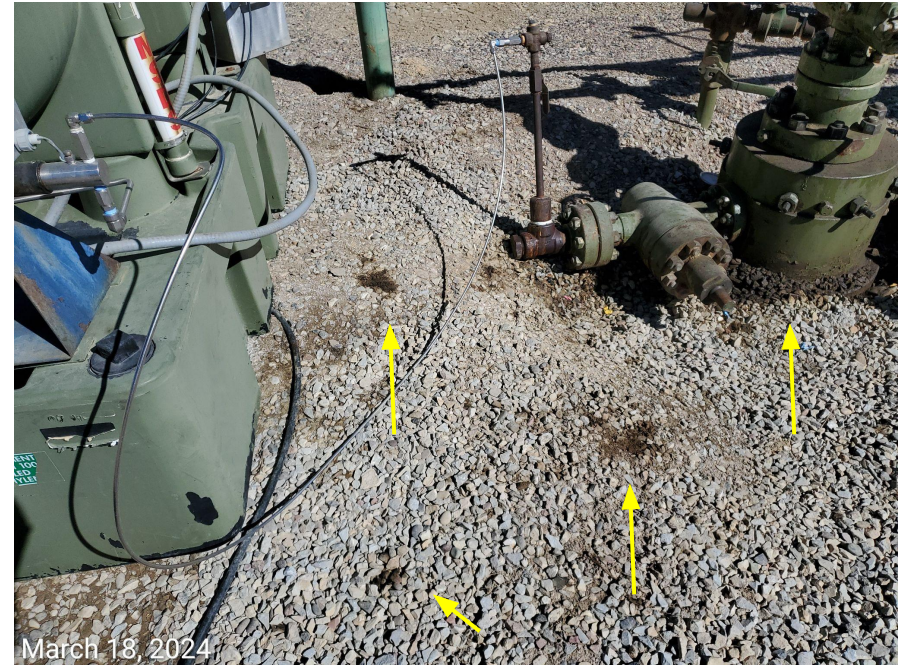
Photo 8: Photos show stained soils at the B-19N-N3 well (API 103-10836)

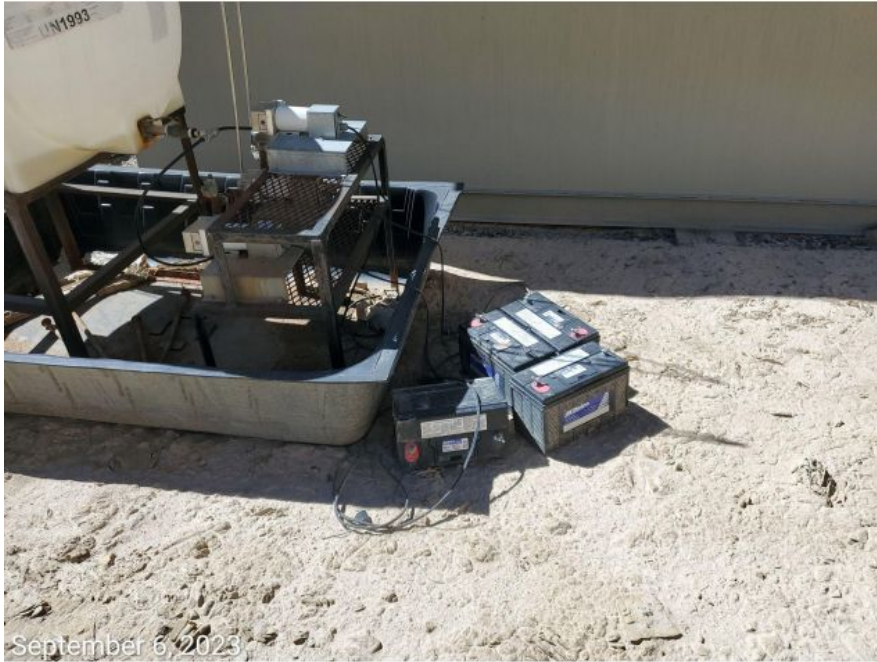
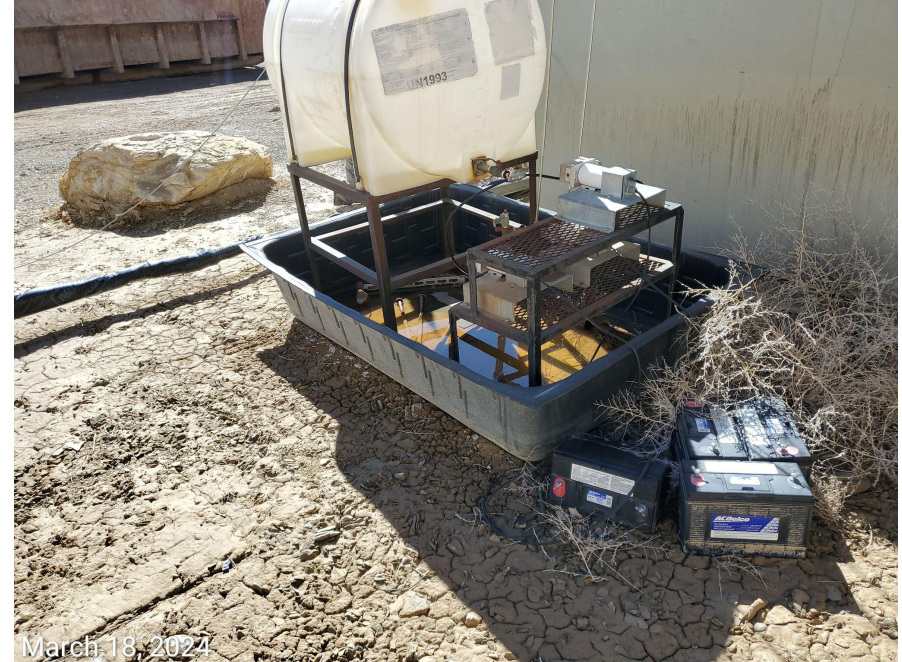
Photo 9: Photo left taken from the 9/6/2023 inspection; photos shows unused tank and batteries improperly stored next to the separator equipment. Photo right dated 3/18/2024 and shows tank and batteries remain improperly stored on the Location.

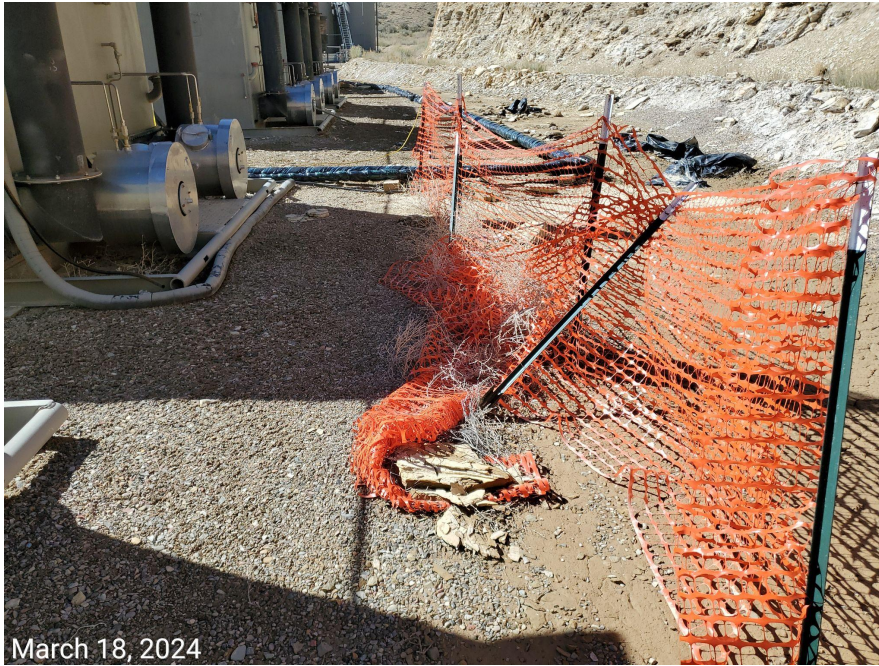
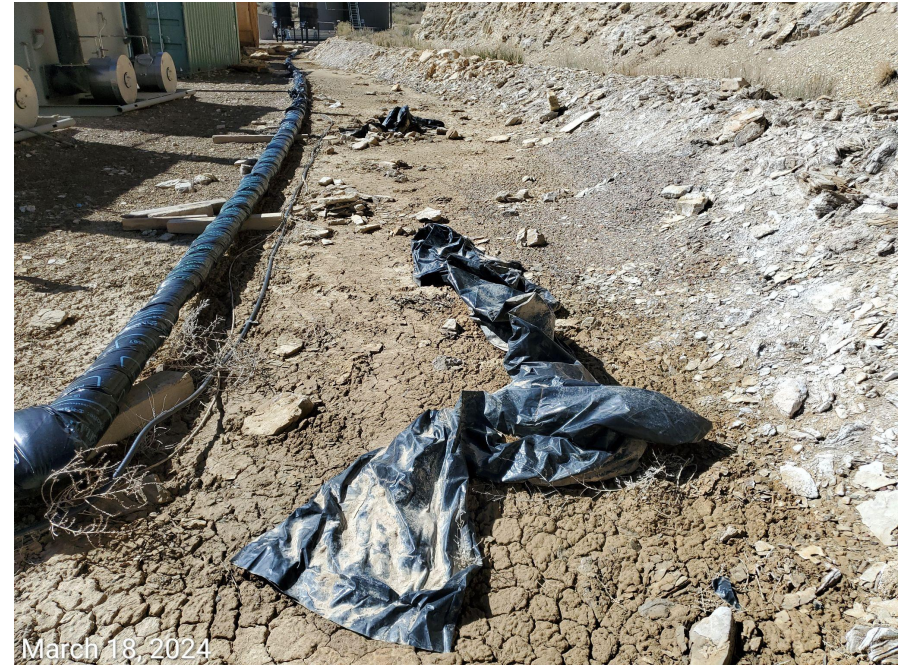
Photo 10: Photos examples of additional trash/debris observed behind the separator equipment.

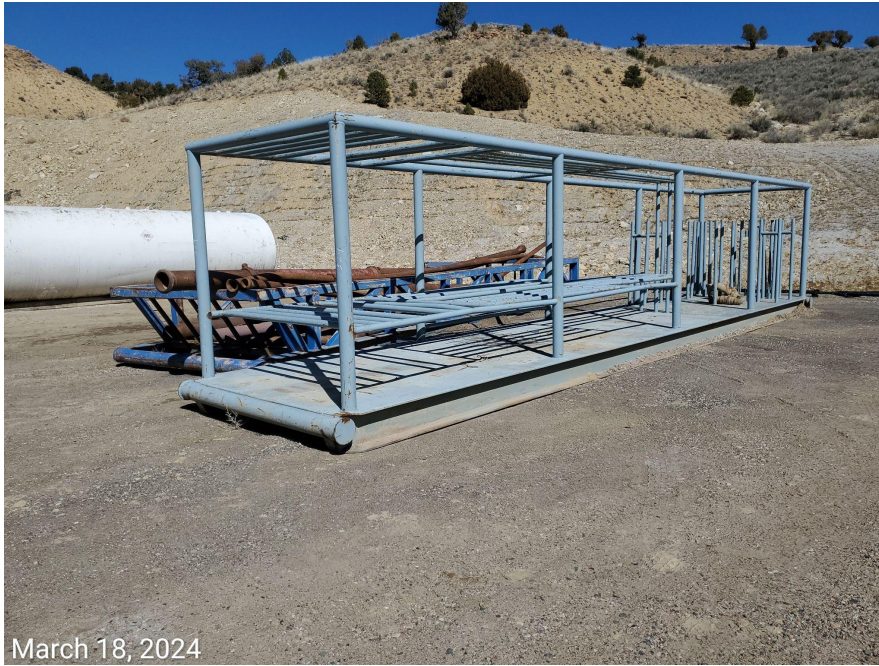
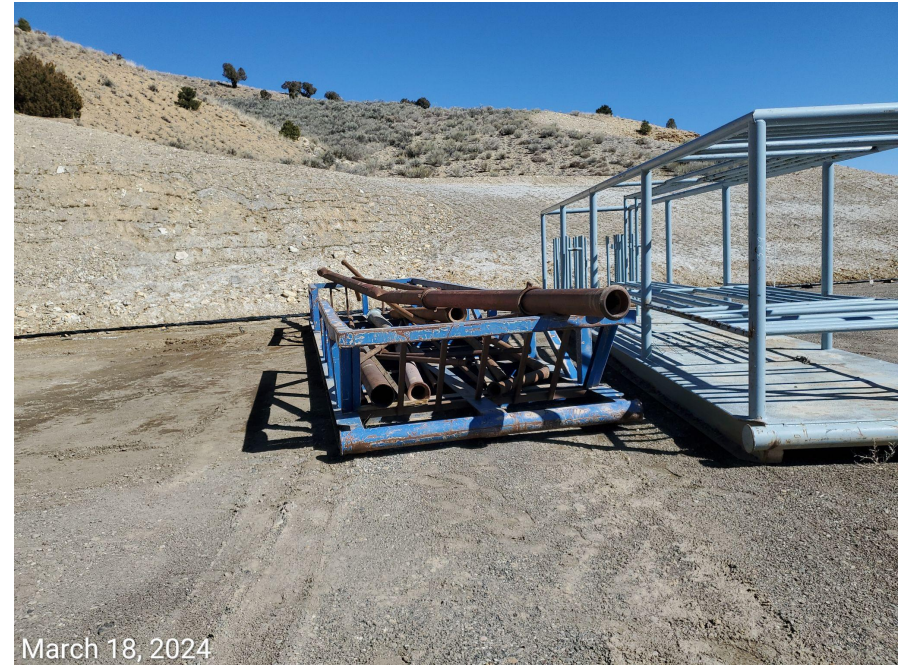
Photo 11: Photos 11-13 examples showing various equipment not necessary for production being stored on the Location.

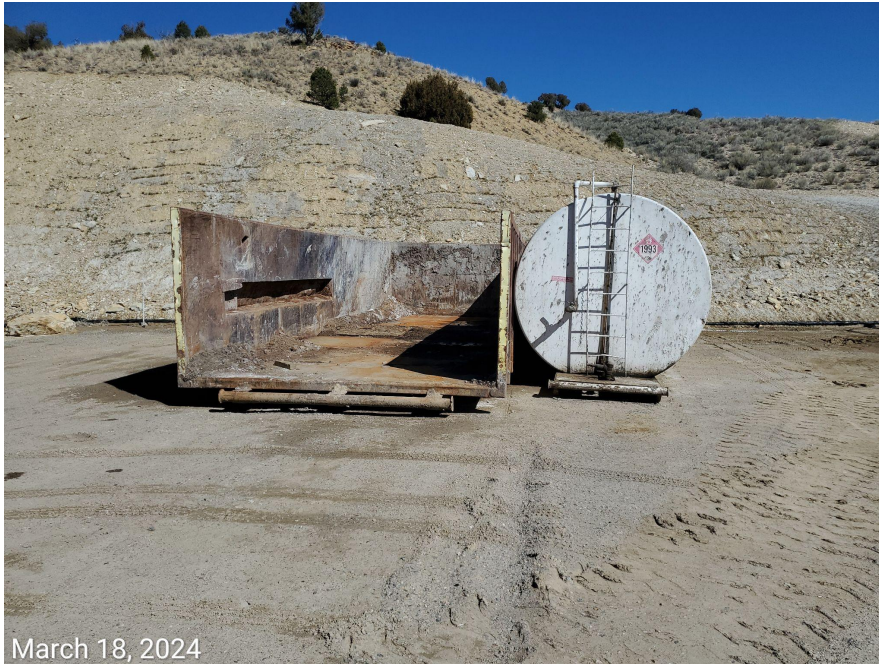
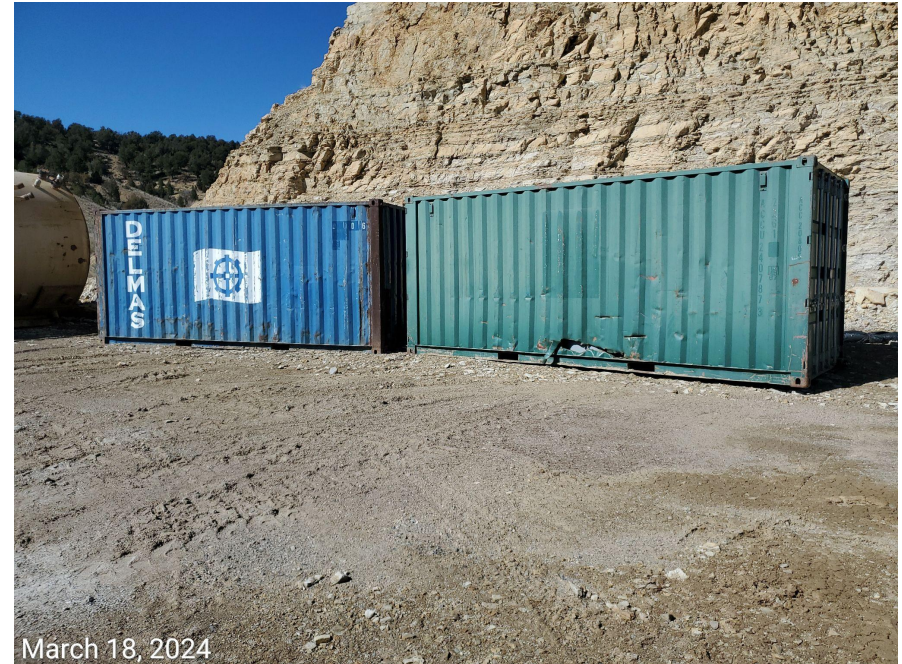
Photo 12: See comments under photo 11.

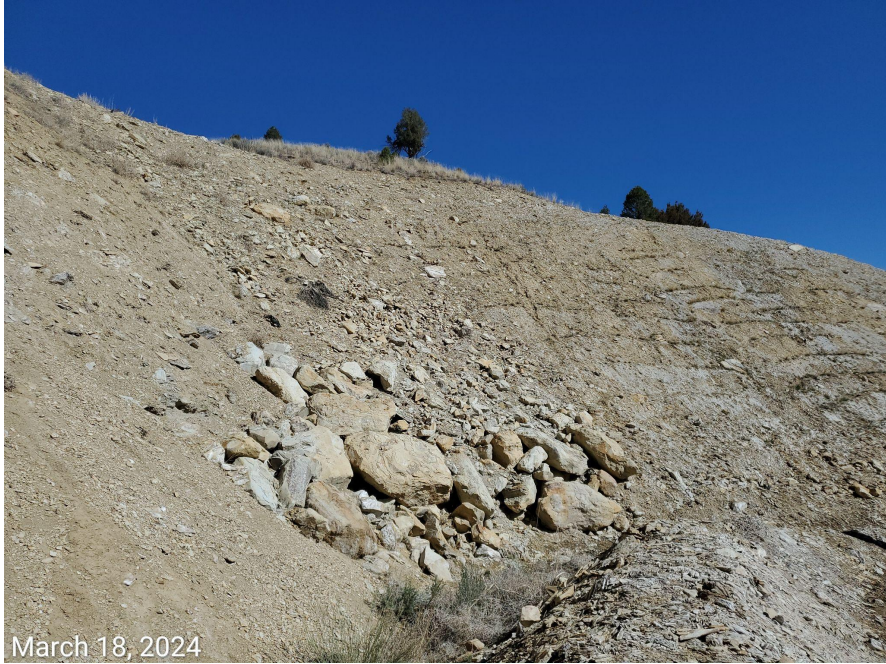
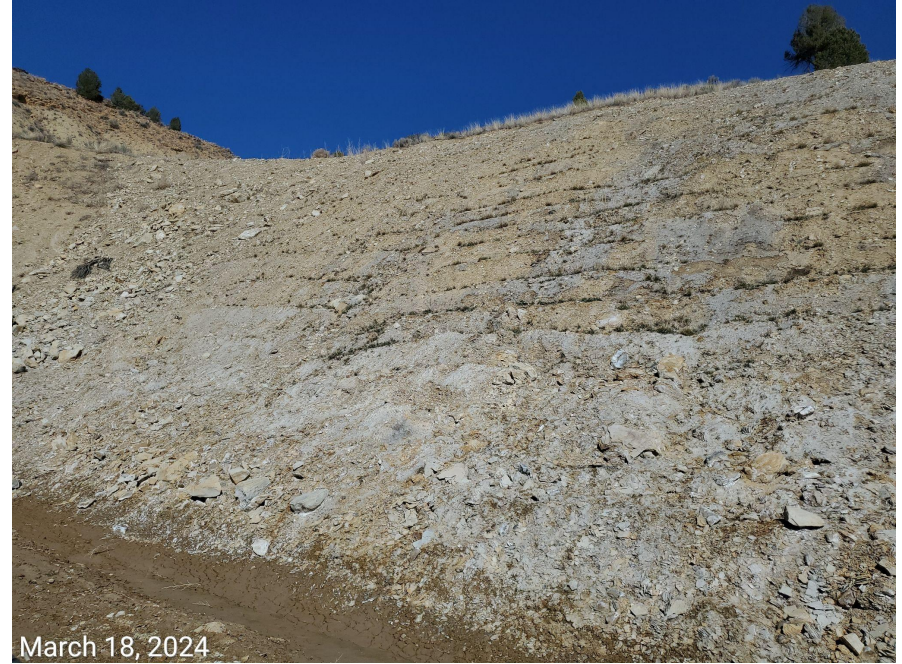
Photo 14: Photos taken from the cut slopes of the Location. Hydromulch no longer in proper functioning condition. BMPs to minimize erosion, degradation and sediment transport remain missing or insufficient on the cut slopes of the Location.

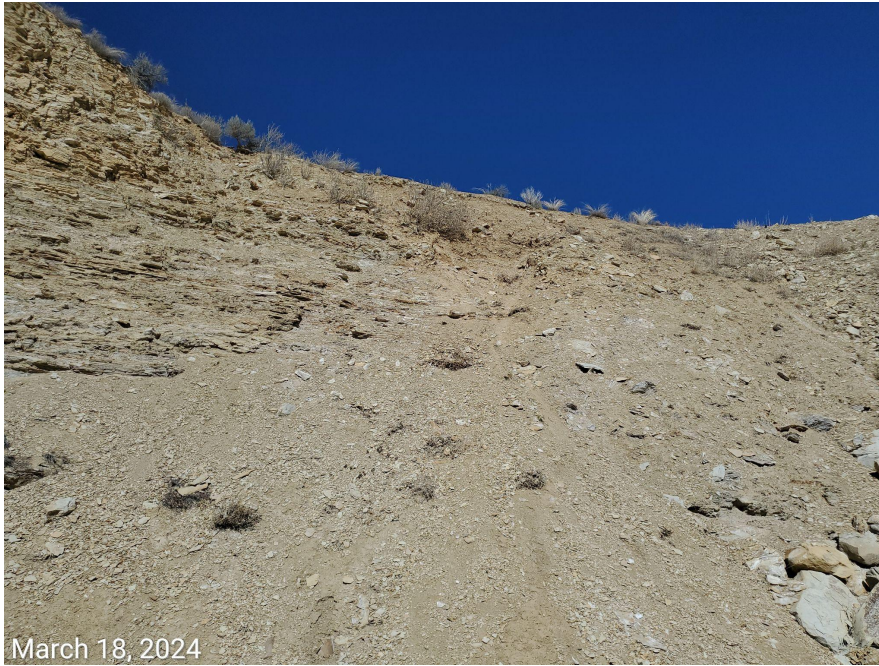
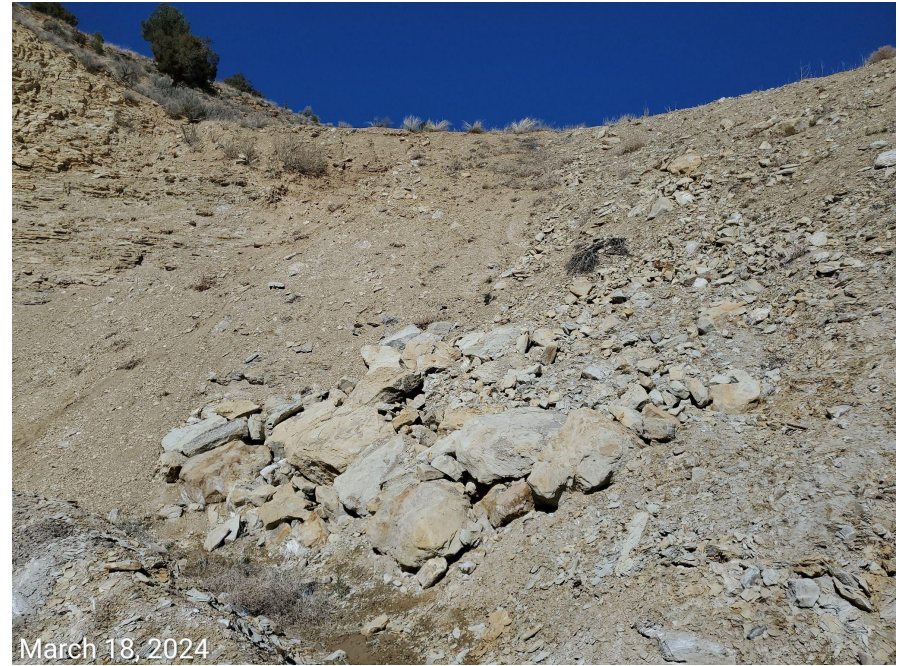
Photo 15: Photos taken from the cut slopes of the Location. BMPs to minimize erosion, degradation and sediment transport remain missing or insufficient on the cut slopes of the Location. Erosion degradation has persisted.

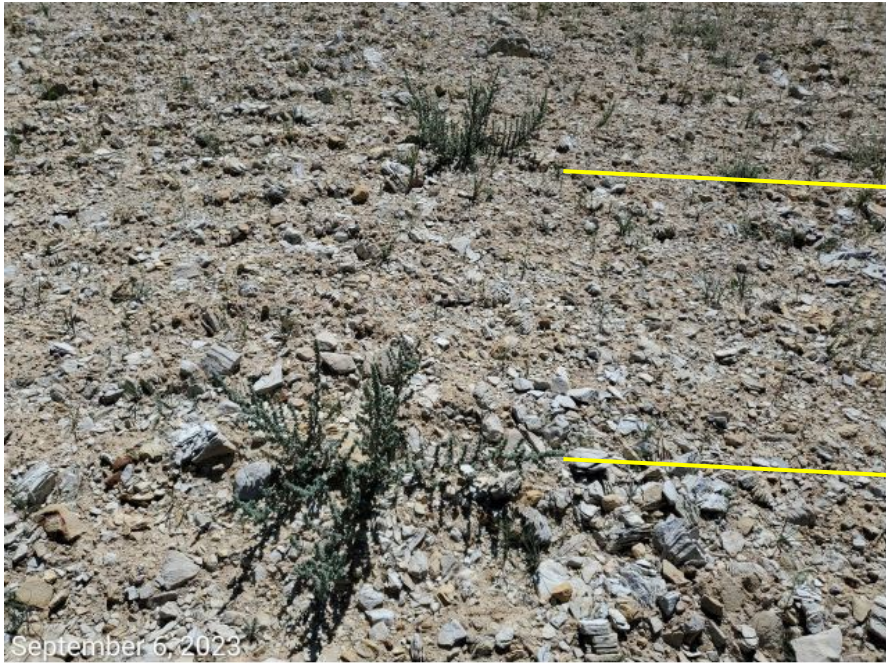
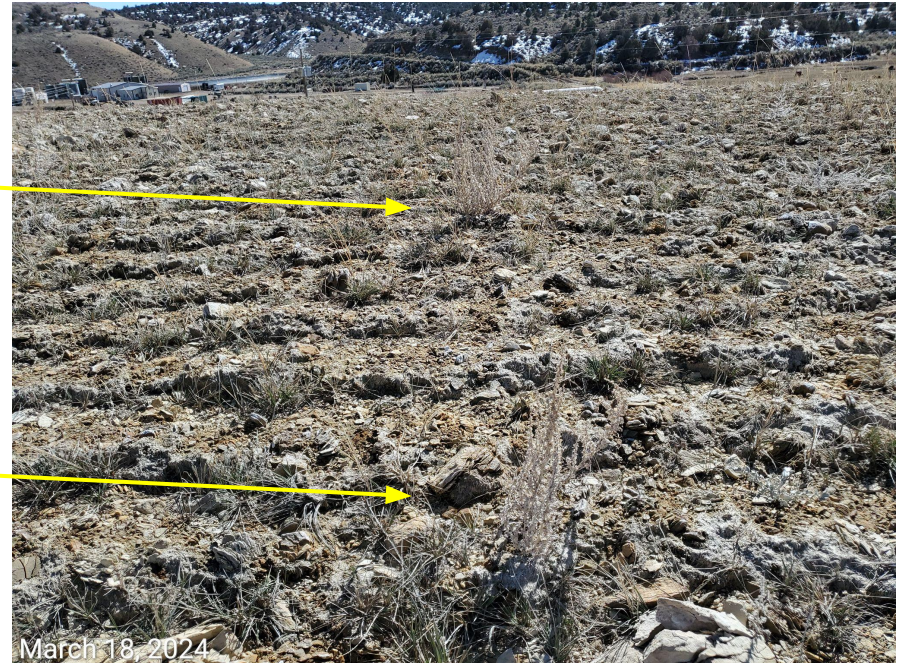
Photo 17: Photo left taken from the 9/6/2023 inspection; photo right shows Noxious weeds (Halogeton) observed during the 9/6/2023 inspection remain, and appear to have matured during the 2023 growing season. Unable to find evidence that weed management activities had been performed on the Location prior to maturation, flowering and seed dispersal; Halogeton evident throughout the entire interim area. Additional and ongoing weed management efforts required.
