Inspection Photos

Operator: TEP ROCKY MOUNTAIN LLC - 96850

Location ID: 335678

Inspection Doc: 696205701

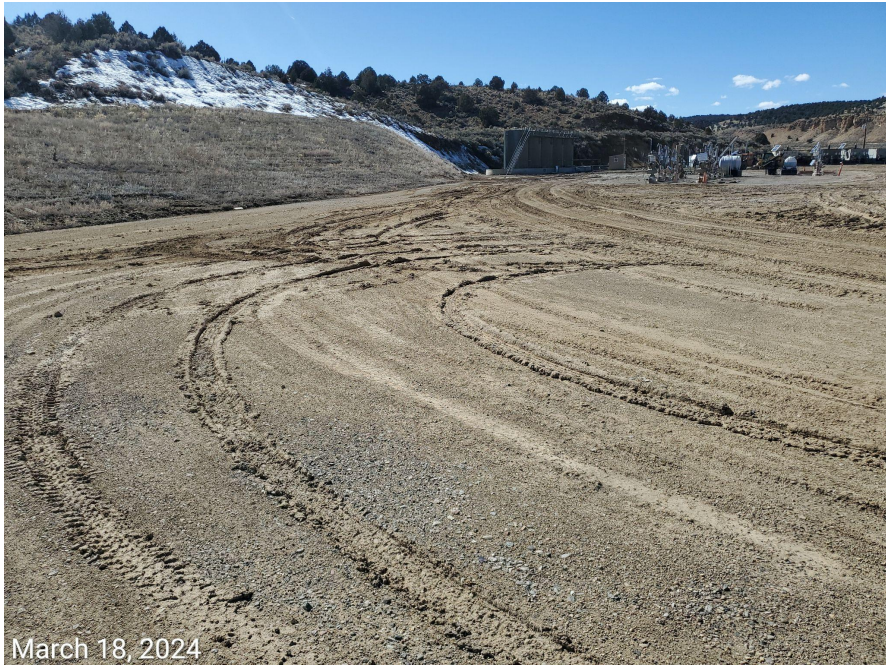
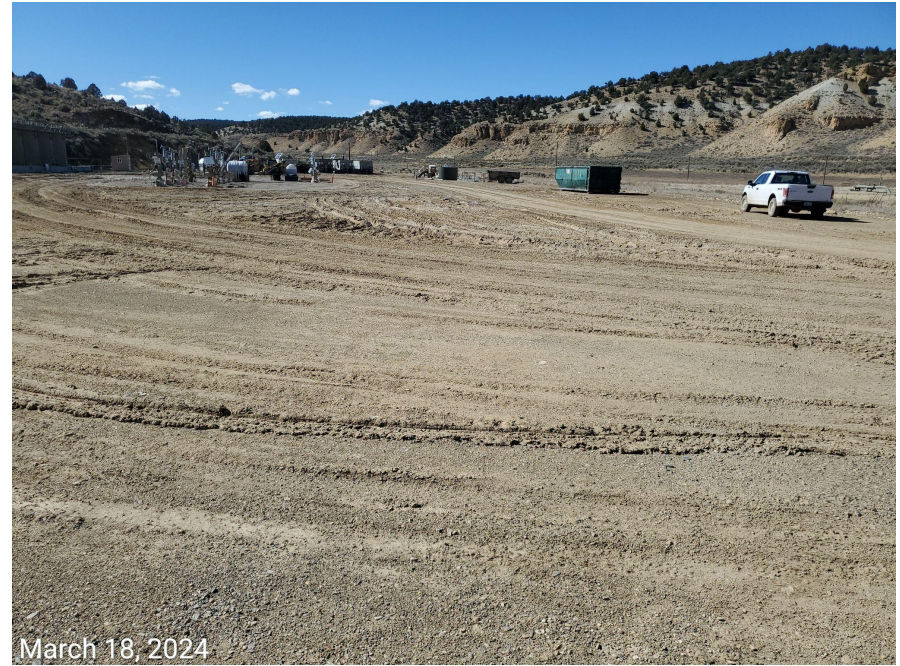
Photo 1: Photos taken from the east end of the Location. Photos provide an overview of the Location from west to northwest. Photo also shows that BMPs to stabilize the working pad surface are missing or insufficient; tracking and degradation evident.

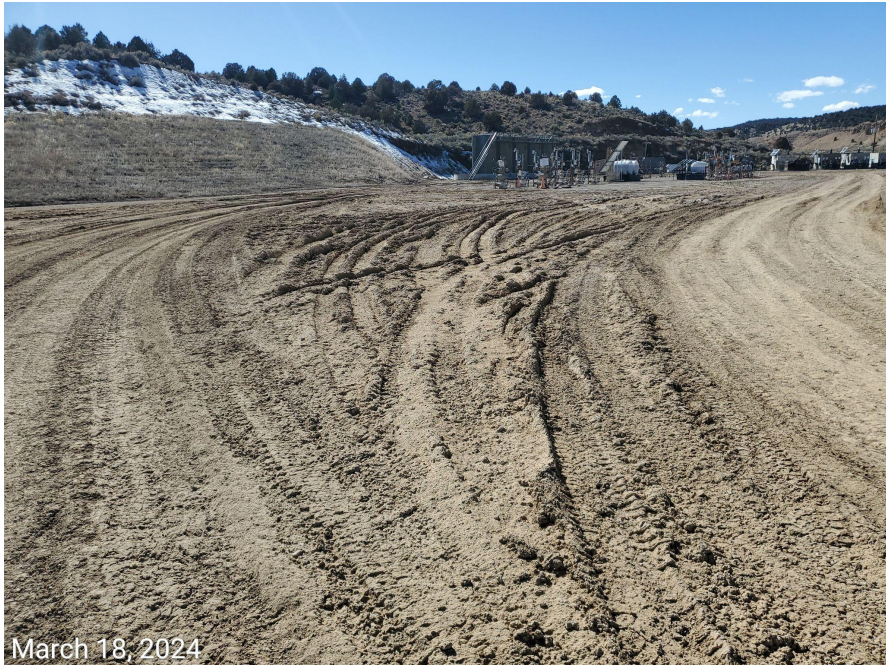
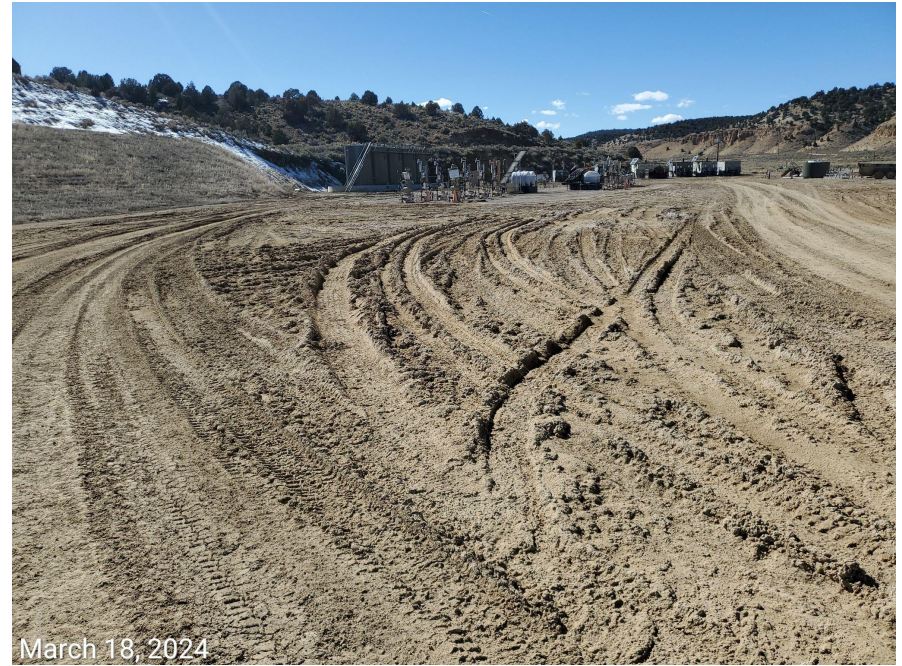
Photo 2: Photos examples showing that BMPs to stabilize the working pad surface are missing or insufficient; tracking and degradation evident.

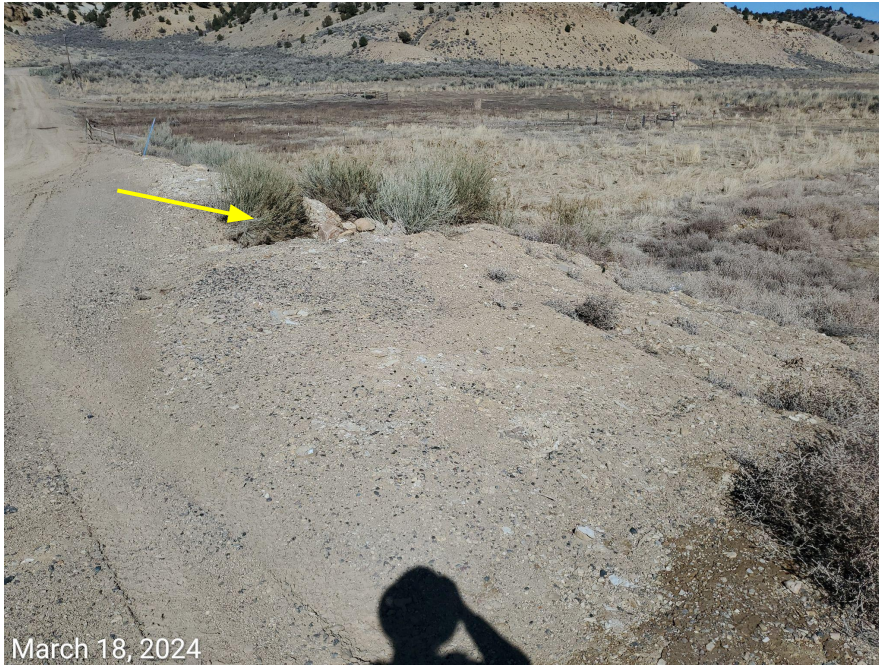
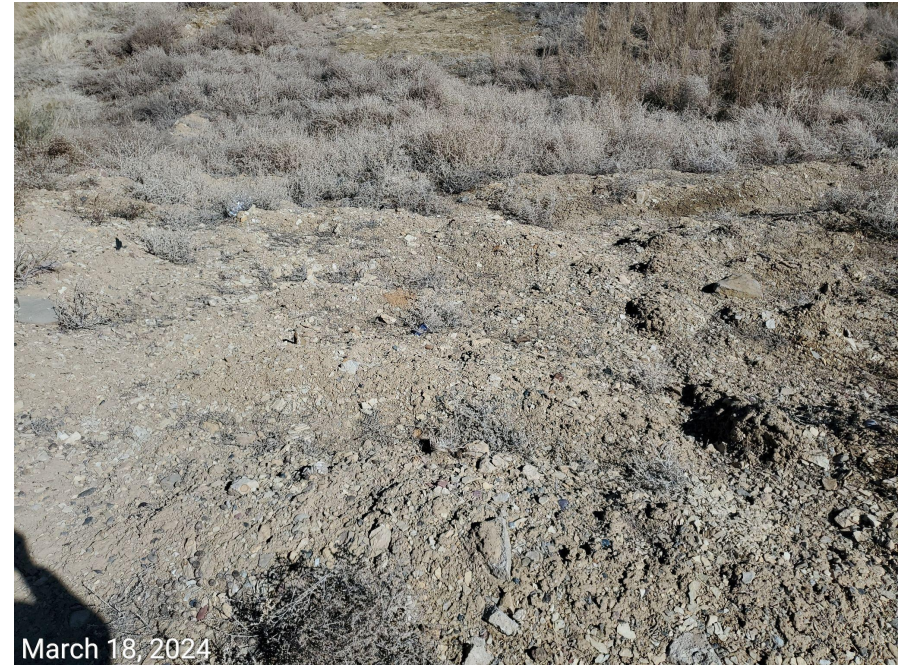
Photo 3: Photos taken from the east end of the Location, facing northeast and east. Arrow shows Location of sediment trap. Photo right shows slopes off the working pad surface adjacent to sediment trap. Photos show control measures to properly divert runoff into the sediment trap remains insufficient; runoff has continued to travel down the slopes on the north end of the Location; degradation has persisted; BMPs to minimize erosion and degradation to the slopes remain missing or insufficient.

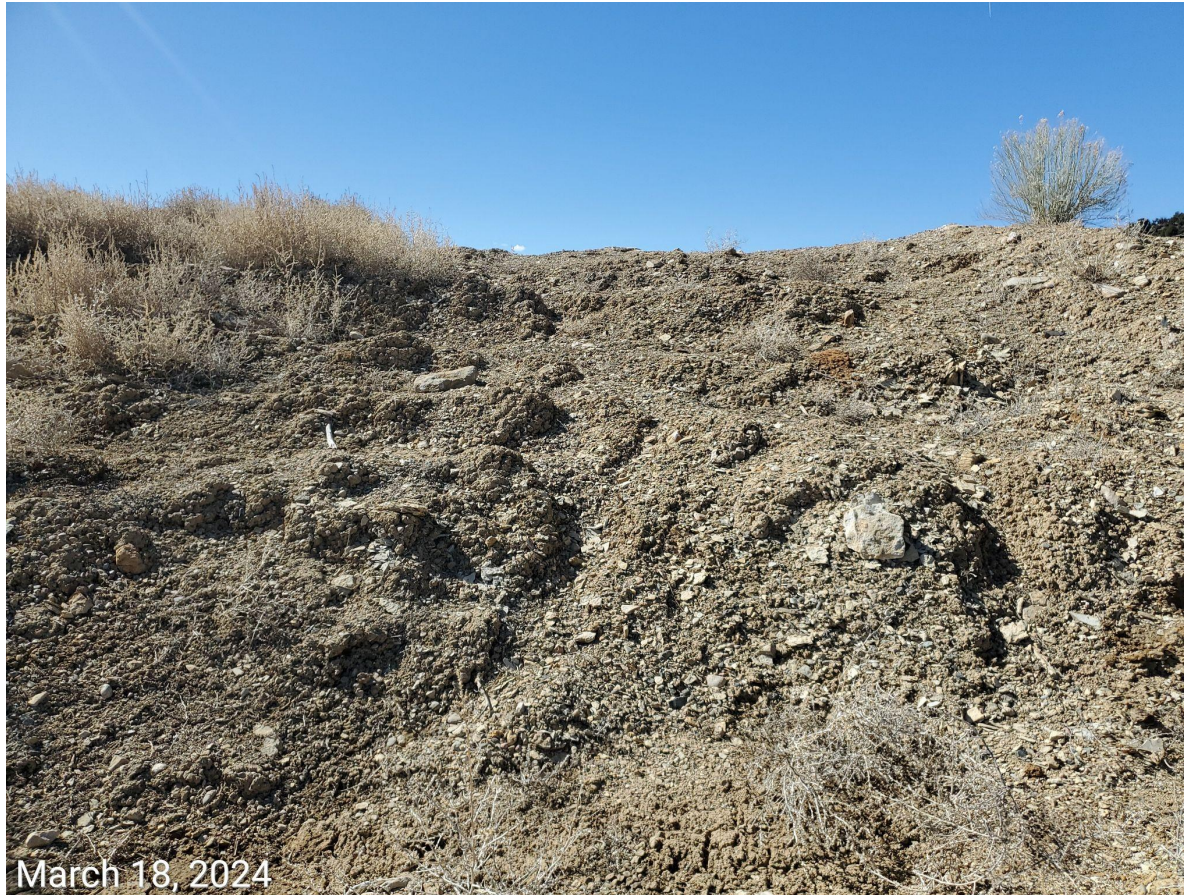
Photo 4: Photo taken downslope from photo 3, facing west. See comments under photo 3.

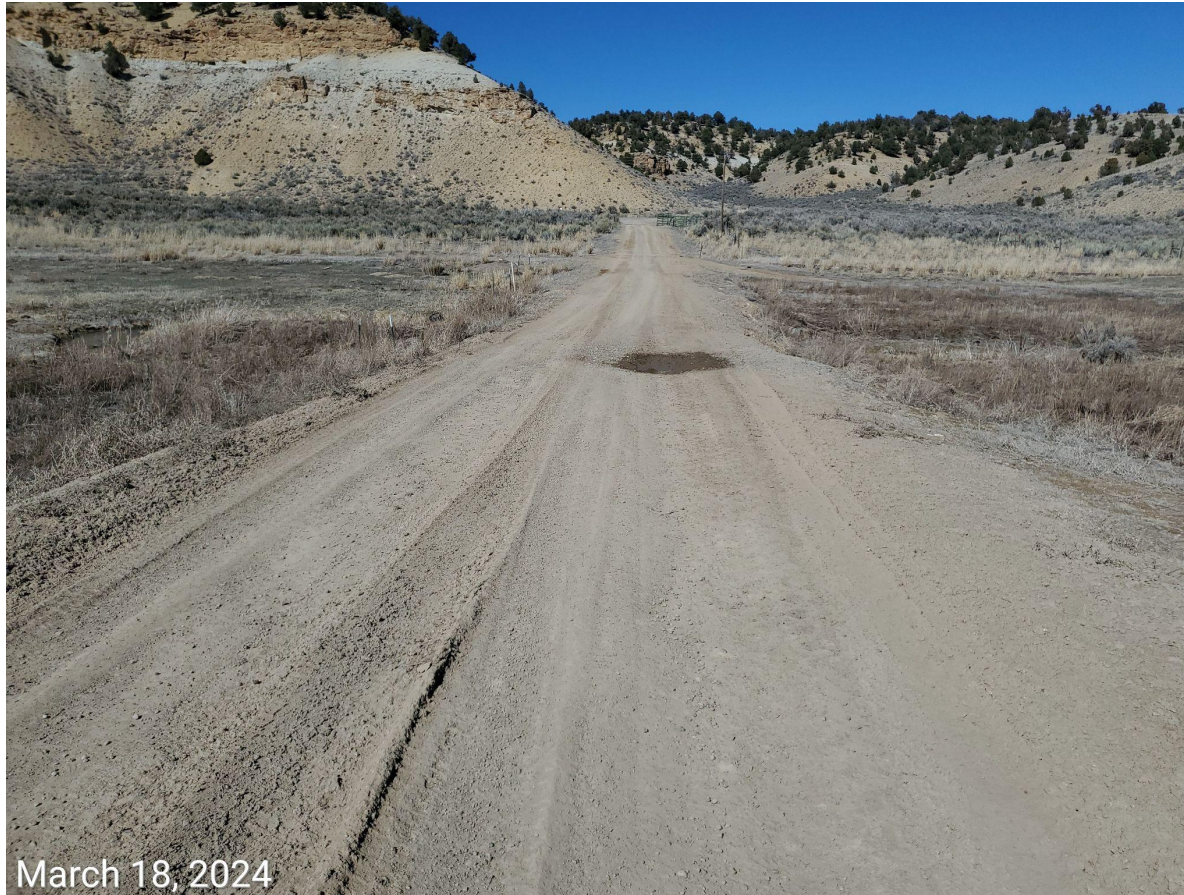
Photo 5: Photo taken from access road, facing north. Road crosses “Black Sulphur Creek” an Aquatic Native Species Conservation Waters. Erosion degradation and sediment transport observed throughout the road.

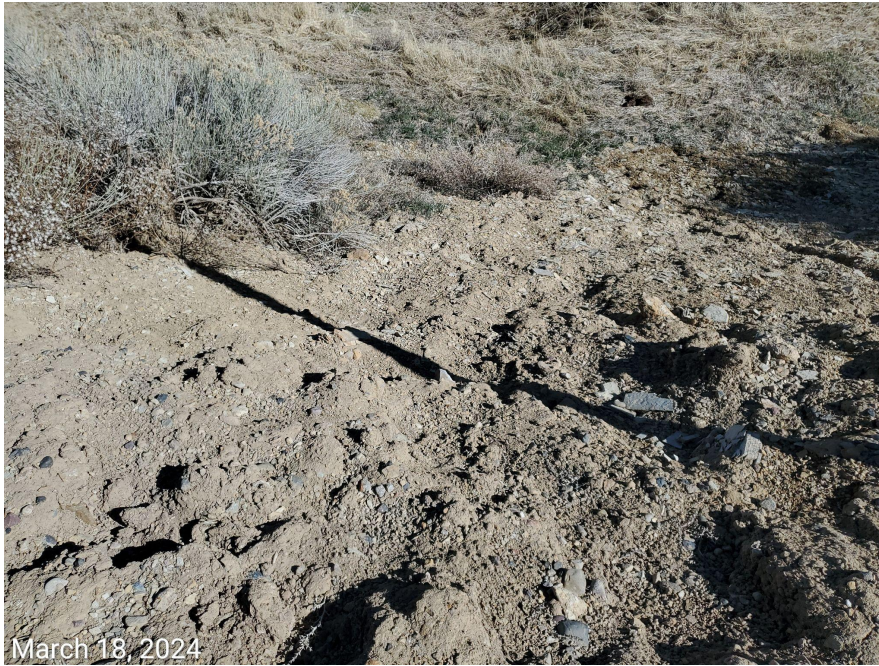
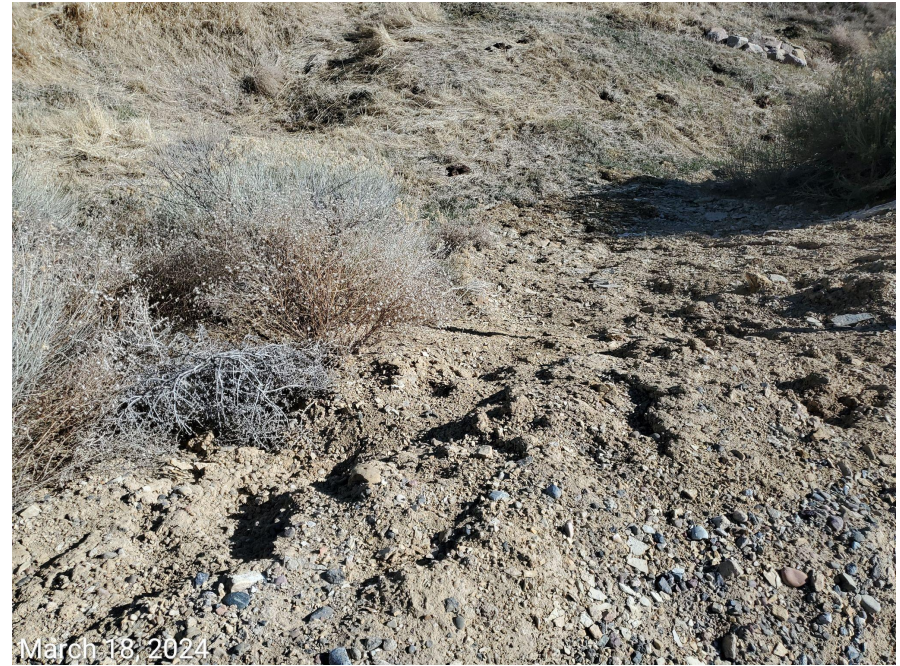
Photo 6: Photos taken from along the access road. Photo shows erosion degradation due to inadequate stormwater and erosion control BMPs at the access road has persisted.

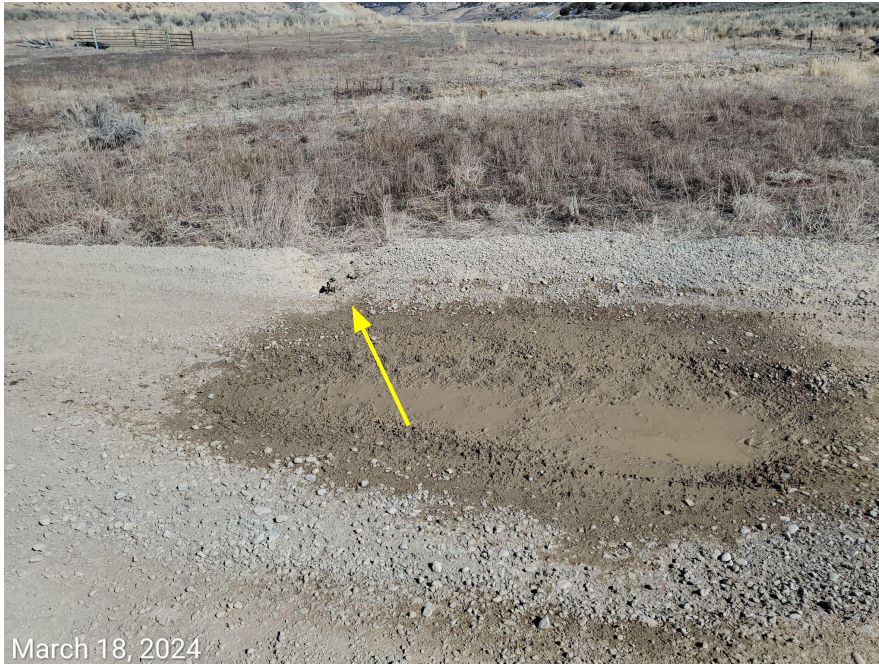
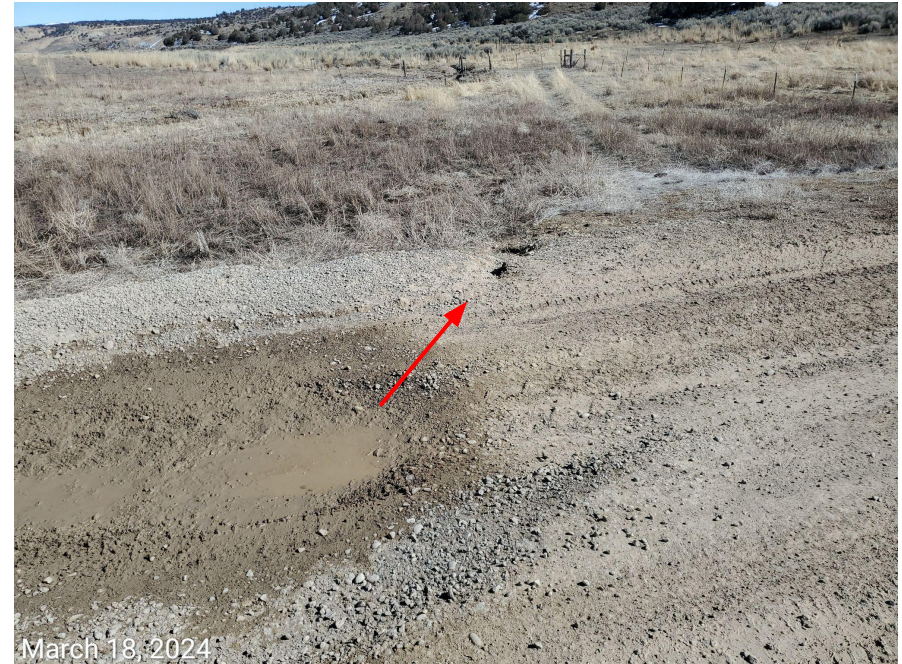
Photo 7: Photos taken from along the access road. Photo shows erosion degradation due to inadequate stormwater and erosion control BMPs at the access road has persisted.

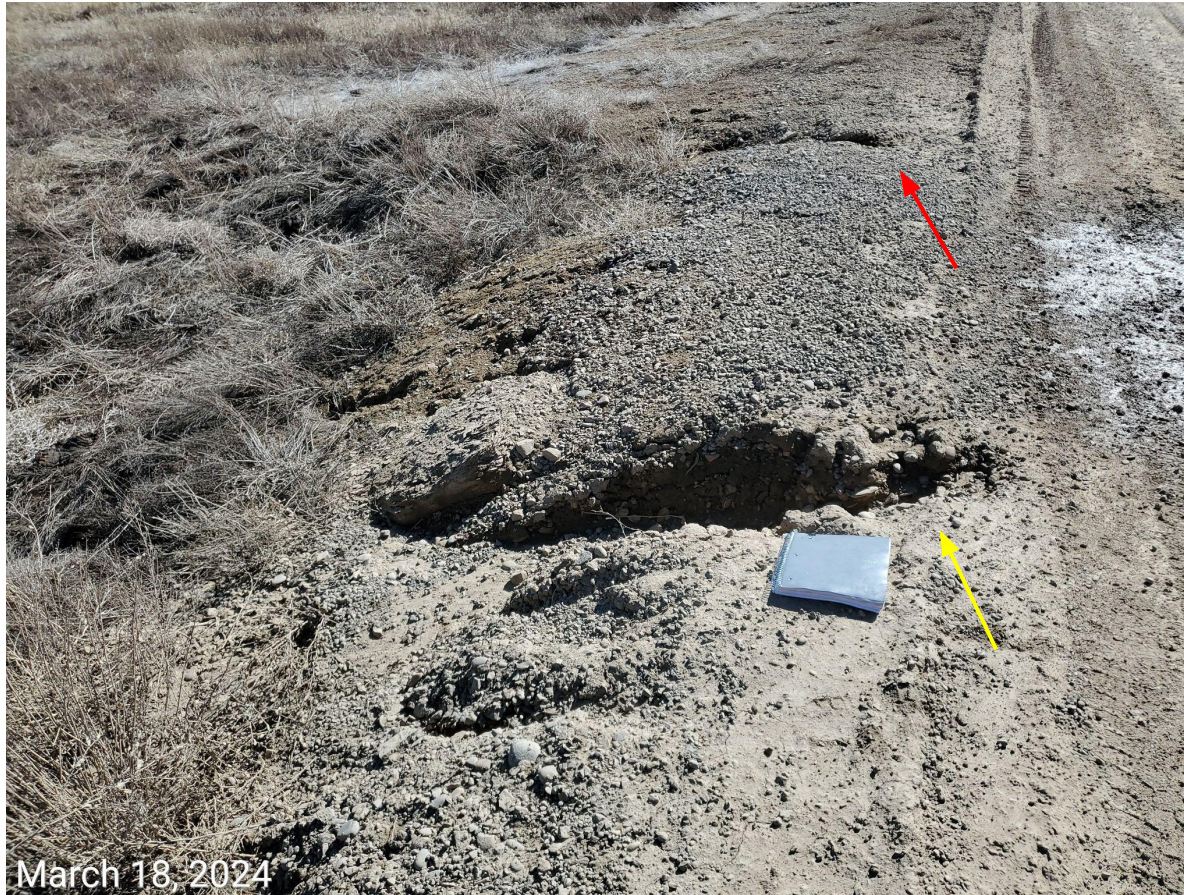
Photo 8: Continued from photo 7. Notebook in photo used for reference.

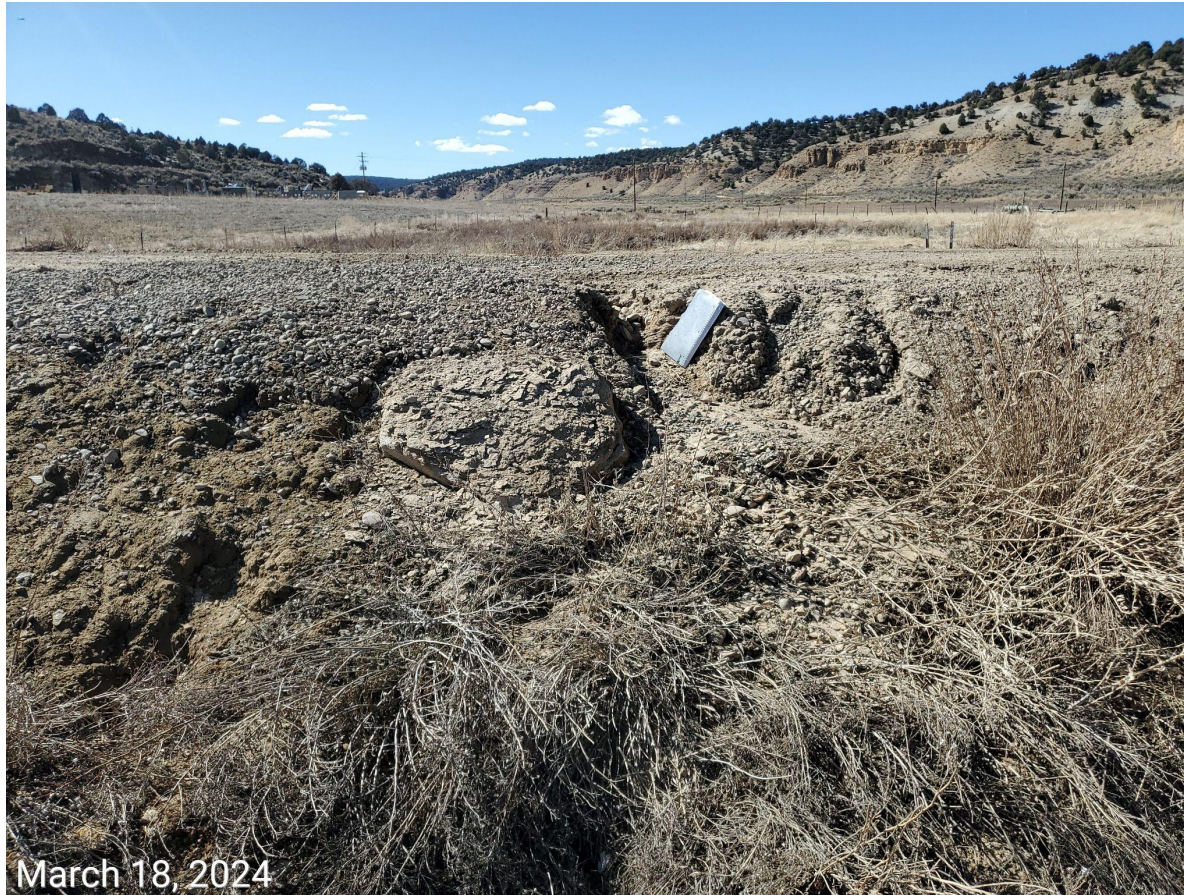
Photo 9: Continued from photo 7. Notebook in photo used for reference.

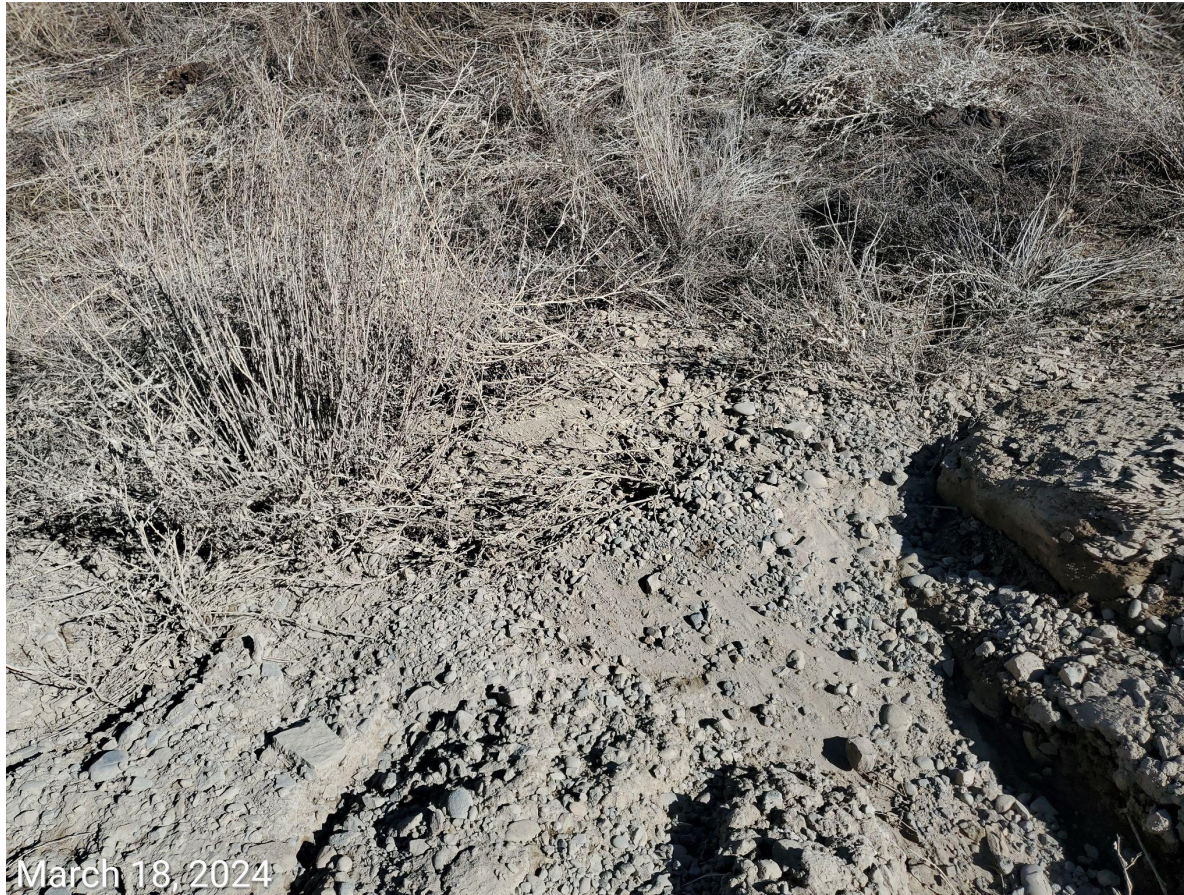
Photo 10: Sediment transport and deposition due to runoff and erosion degradation at the access road.

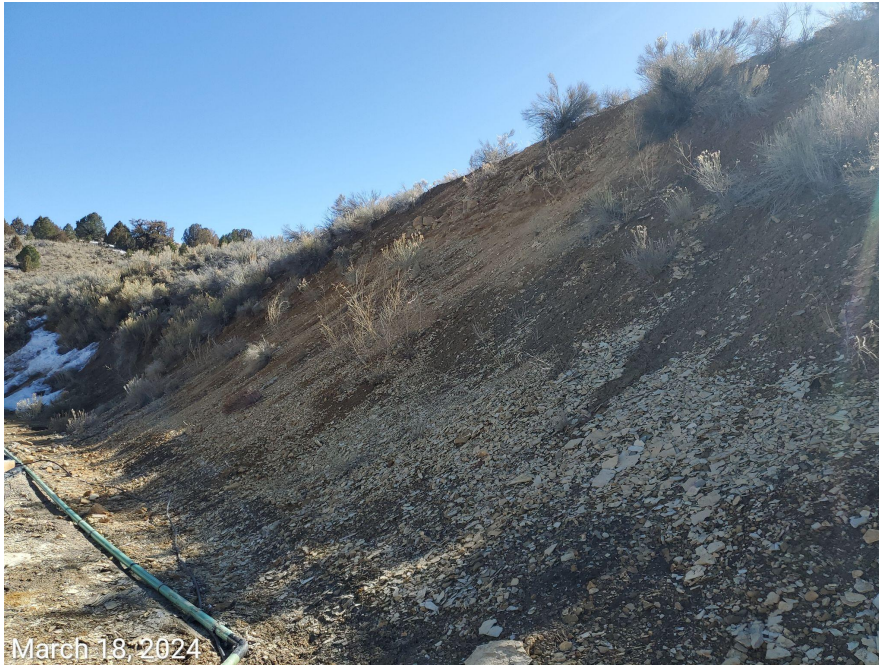
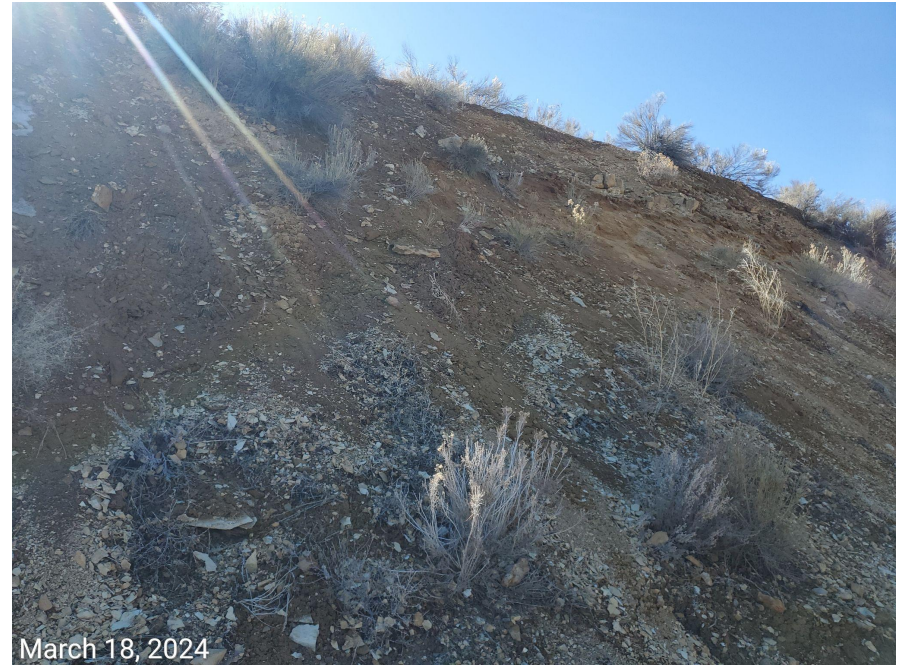
Photo 11: Photos 11-12 taken from the cut slopes of the Location. Photos examples showing control measures at the cut slopes remain missing or insufficient resulting in persisting erosion and degradation.

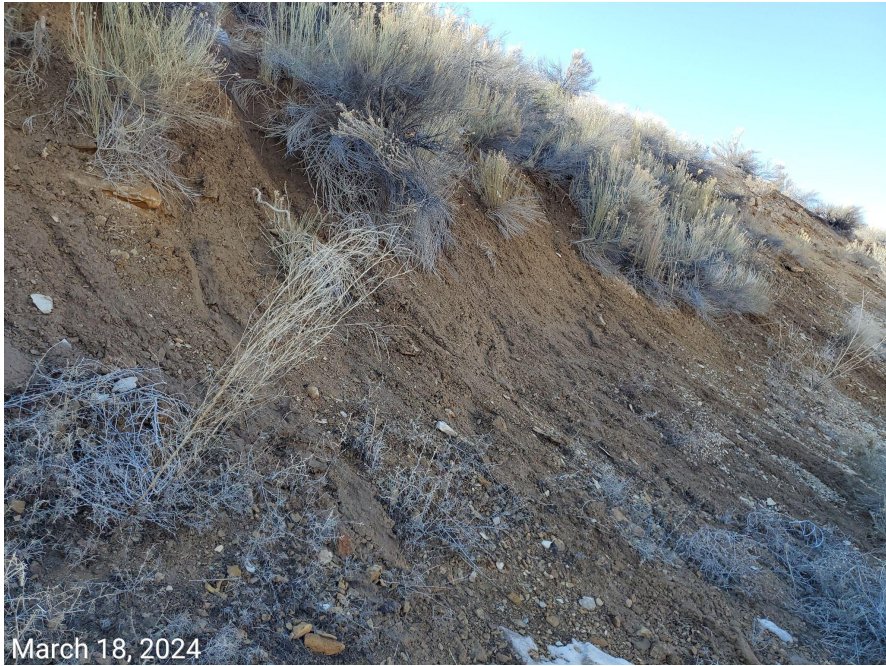
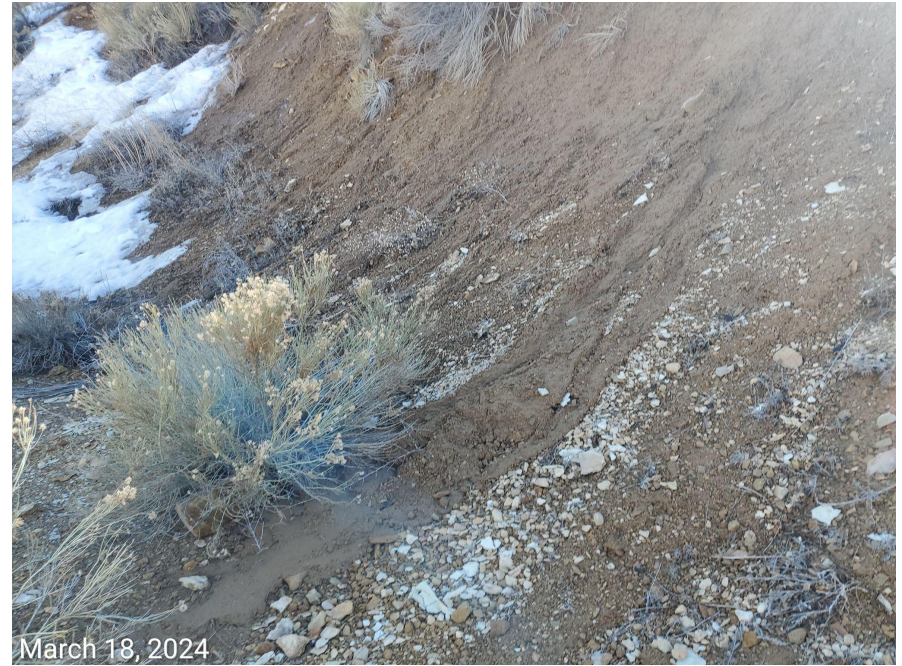
Photo 12: See comments under photo 11.

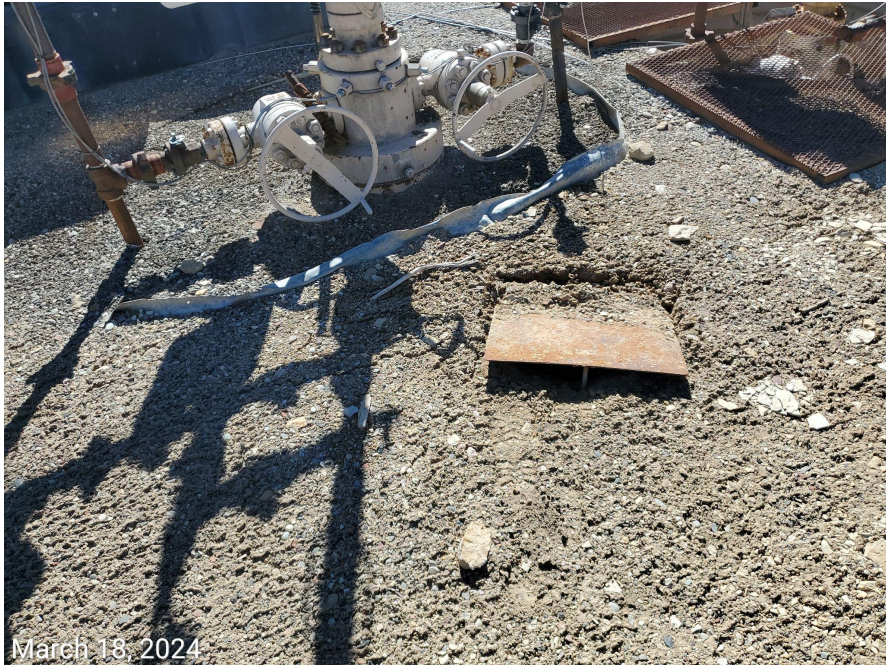
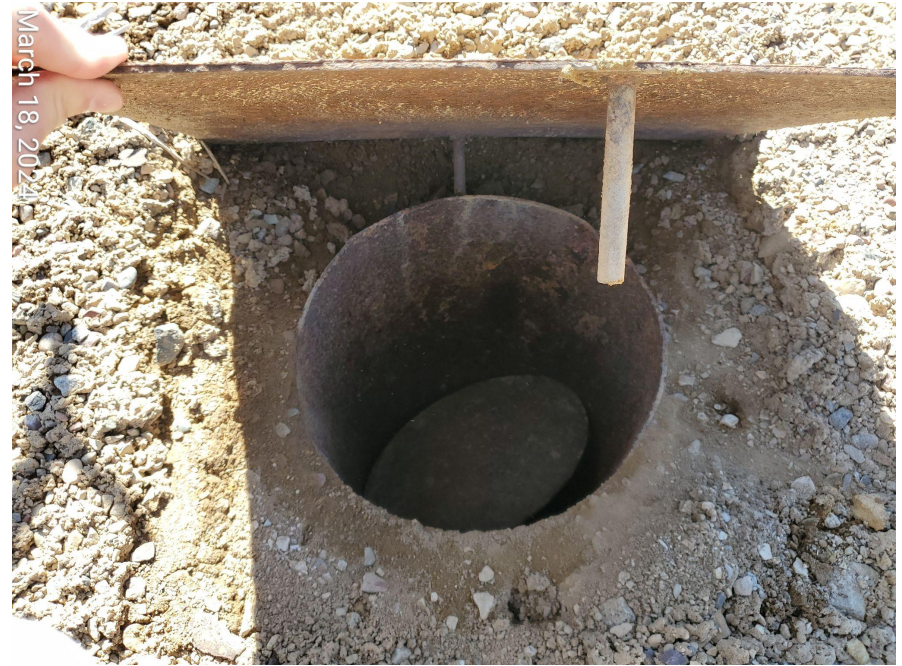
Photo 13: Photos taken from the wells on Location. Photos 13-14 examples showing what appears to be open mouseholes remaining on the Location; Operator has placed unsecured metal plates over the pipes. Hole/Pipe has not been properly closed or backfilled in accordance with Rule 1003.a.

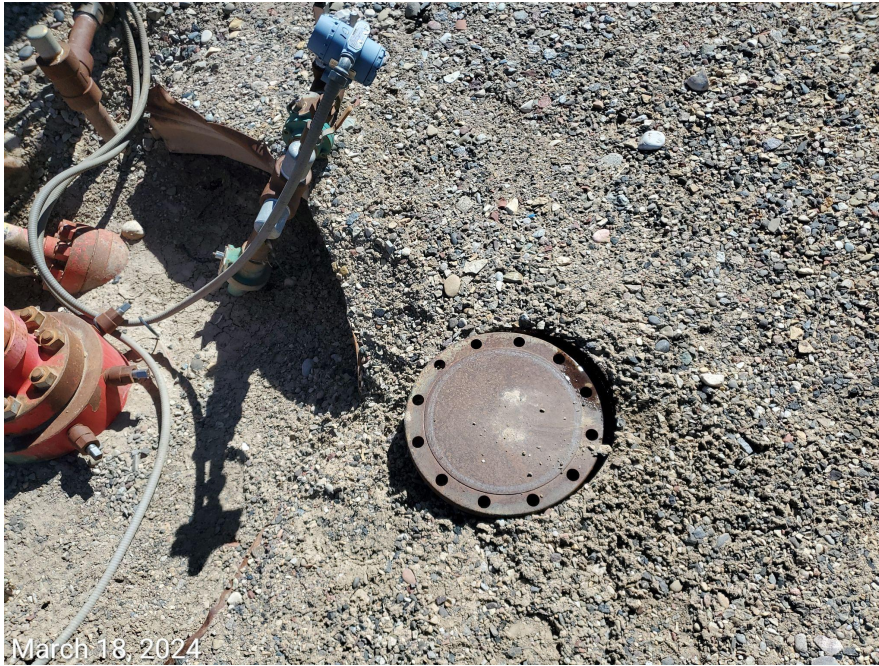
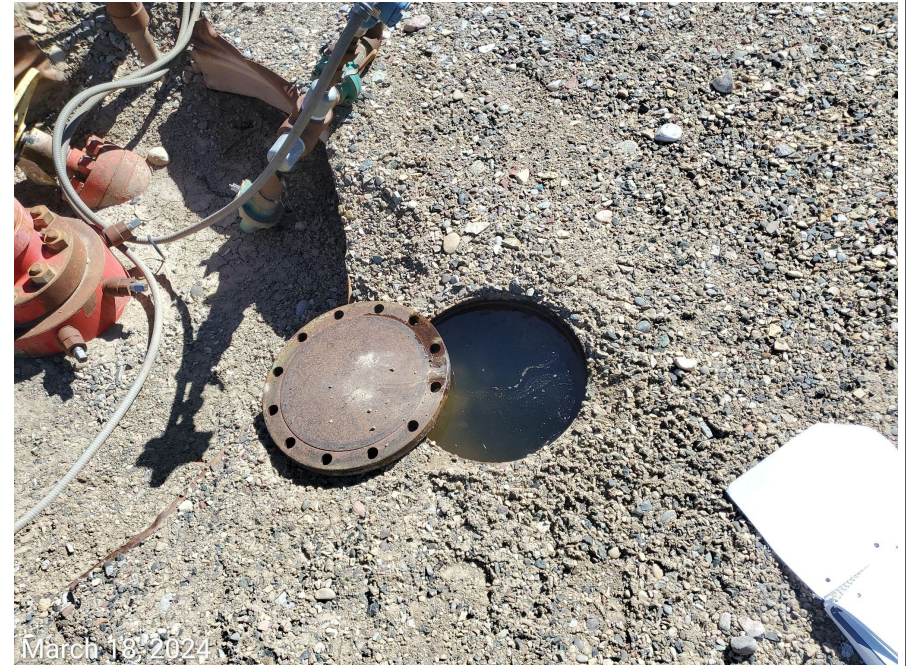
Photo 14: See comments under photo 13.

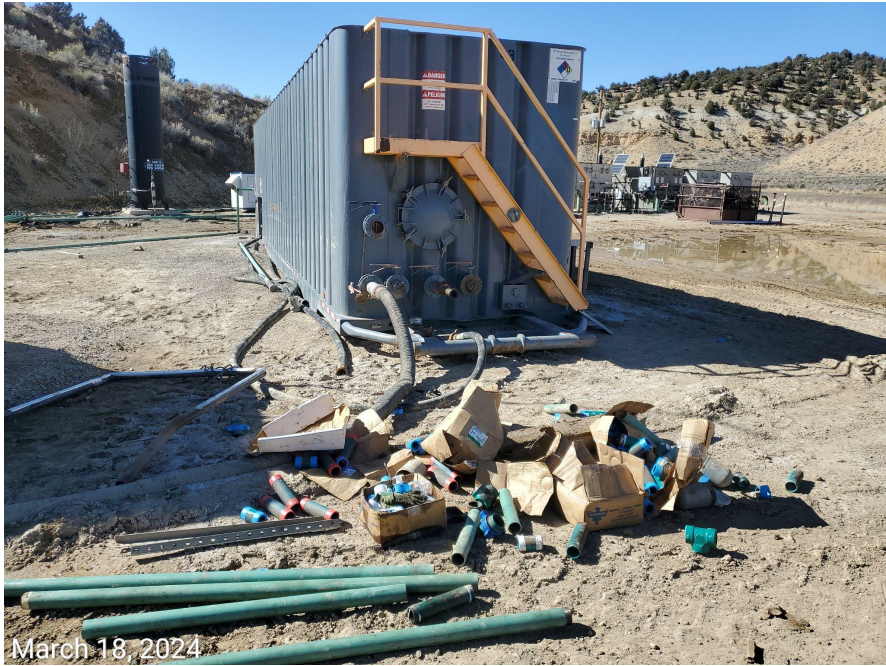
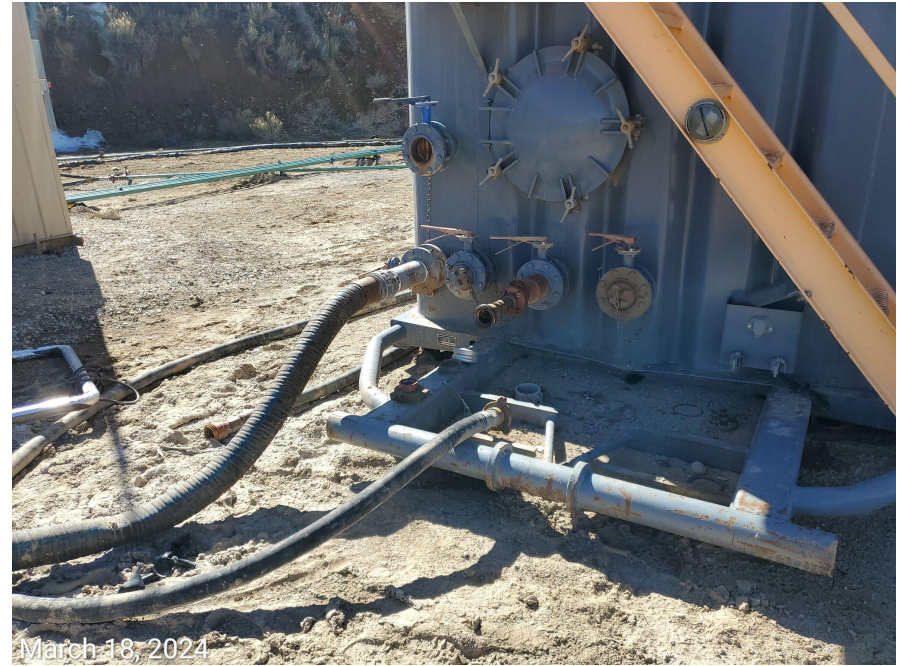
Photo 15: Photo shows produced water tank. Tank appears to be connected to the battery facility on the Location. Secondary containment measures to contain a spill or release from the tank has not been installed. Photo right also shows lines at the tank have not been capped/plugged.

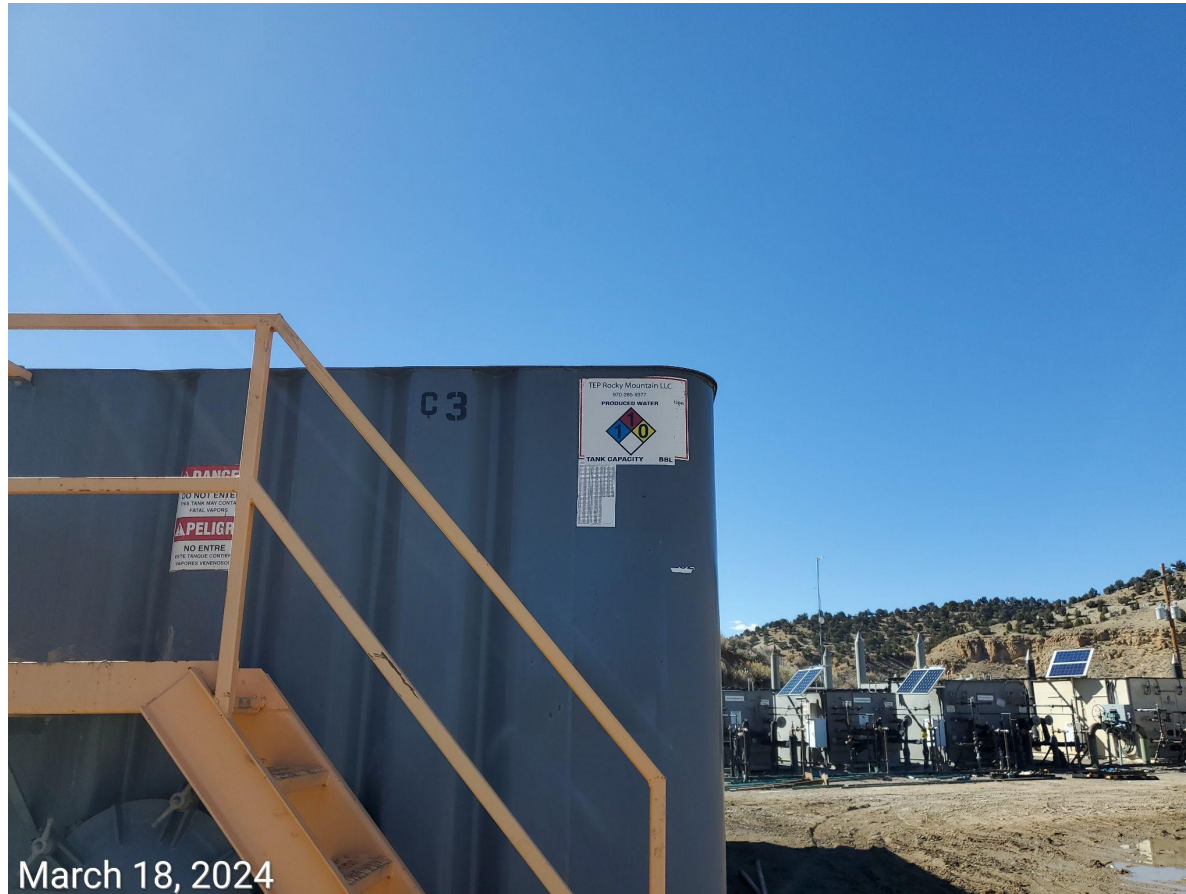
Photo 16: Continued from photo 15. Capacity information not observed on tank.

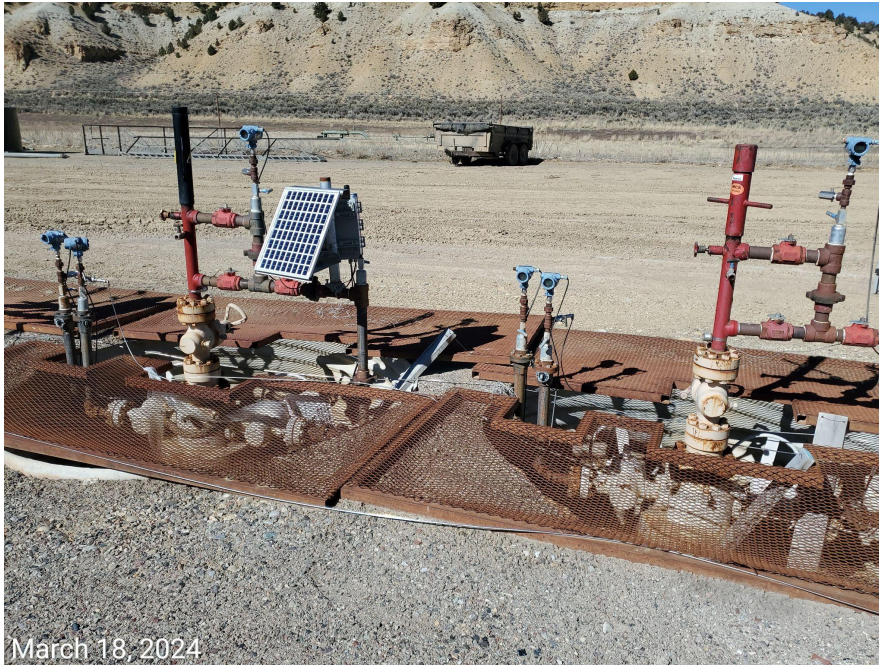
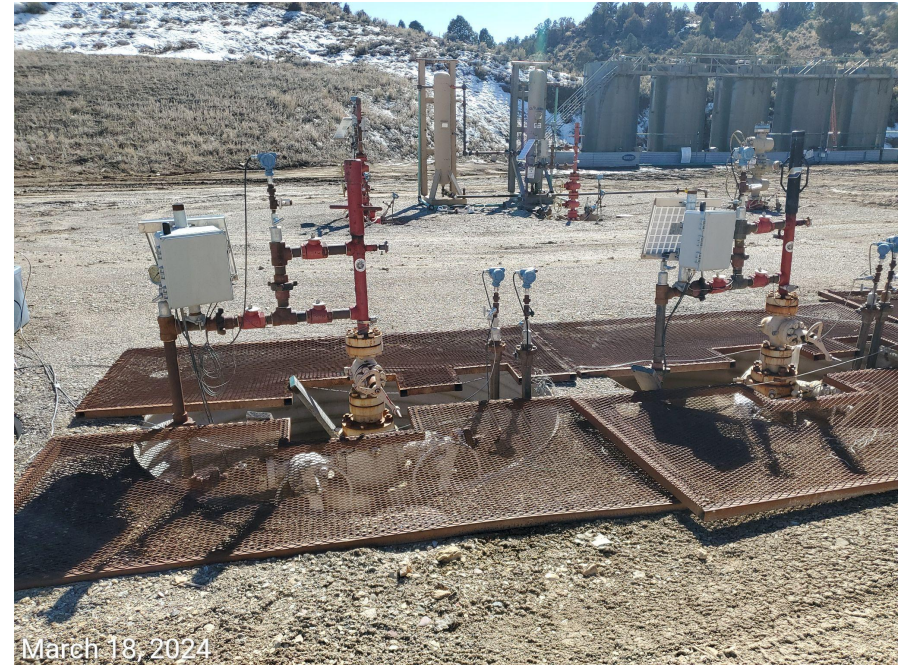
Photo 17: Signage missing from wells on Location.
